# OPERATION **PLUMB BOB**

NEVADA TEST SITE  
MAY-OCTOBER 1957

Project 30.2

RESPONSE OF DUAL-PURPOSE  
REINFORCED-CONCRETE MASS SHELTER

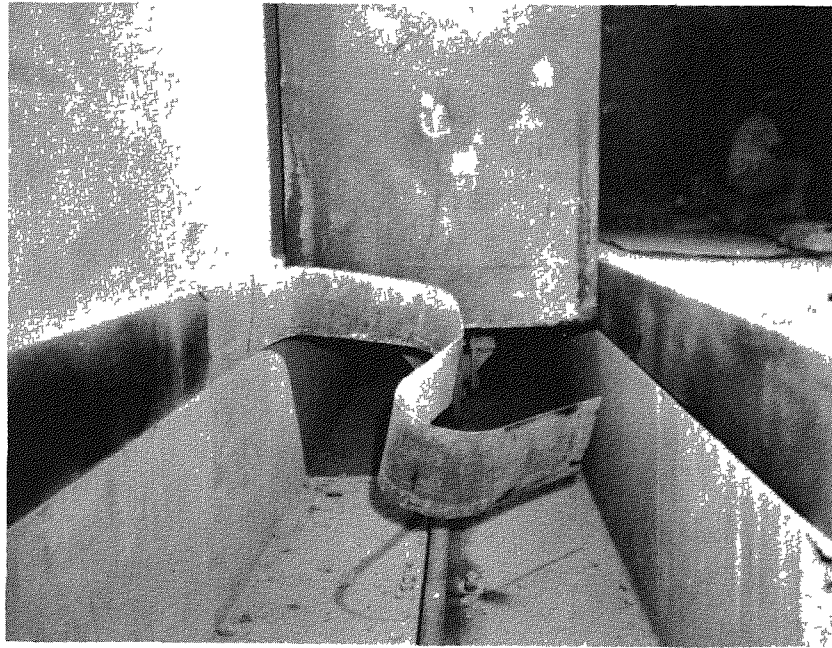
The door withstood the blast without any evidence of shifting or disalignment. Locking bolts in the door were intact and retracted freely (Fig. 3.8). The  $\frac{1}{4}$ -in. cover-plate angle at the exposed top edge of the door frame was separated from the concrete at several locations. The 12-in. steel guide plate on the 4.5-ft wall was not made continuous as intended and was torn back by the door during the postshot opening (Fig. 3.9). The door wheels were not damaged, and the track was not displaced (Fig. 3.10). The door and end pilaster were partially blackened by thermal radiation.

Fig. 3.9—Torn guide plate before removal to allow opening of door (postshot).

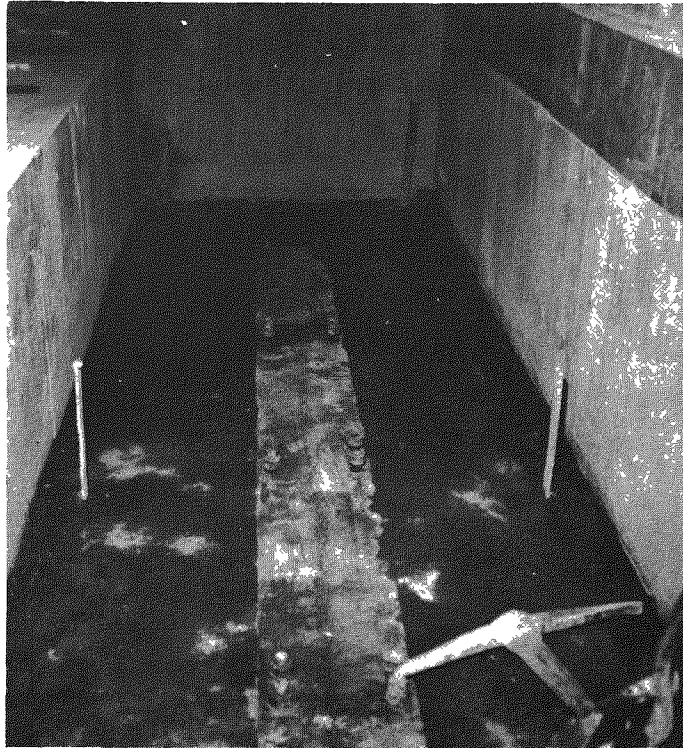
The face plates for the rolling door and all corner protection angles were poured integral with the various concrete members they framed into. The face plates were not made continuous the entire length of the door pit. This deviation from the design drawings caused some postshot door-operating difficulty.

Fig. B.31—Rolling-door pit before installation of rail.

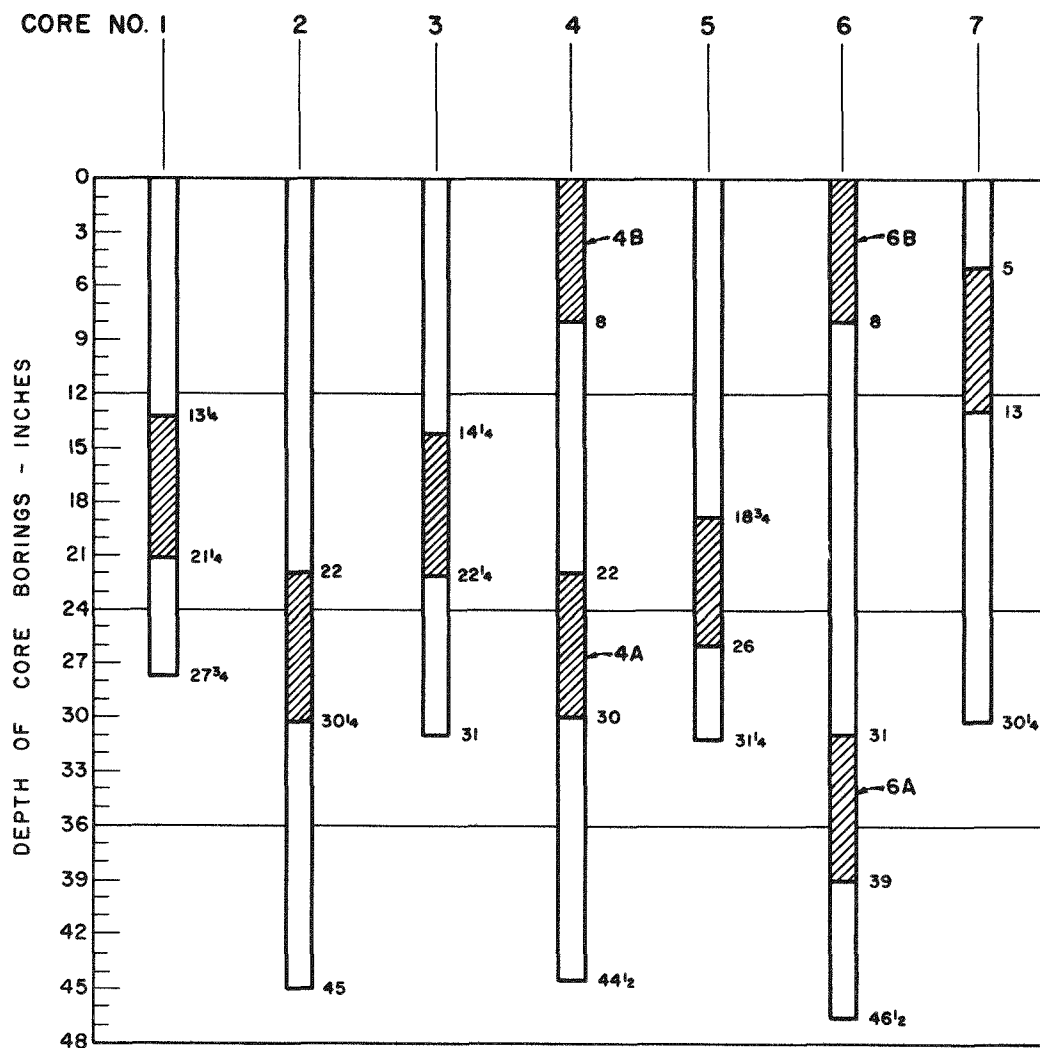
Fig. B.33—Location of postshot core holes in roof slab.

**NOTE :**

Crosshatched area indicates section of core tested.

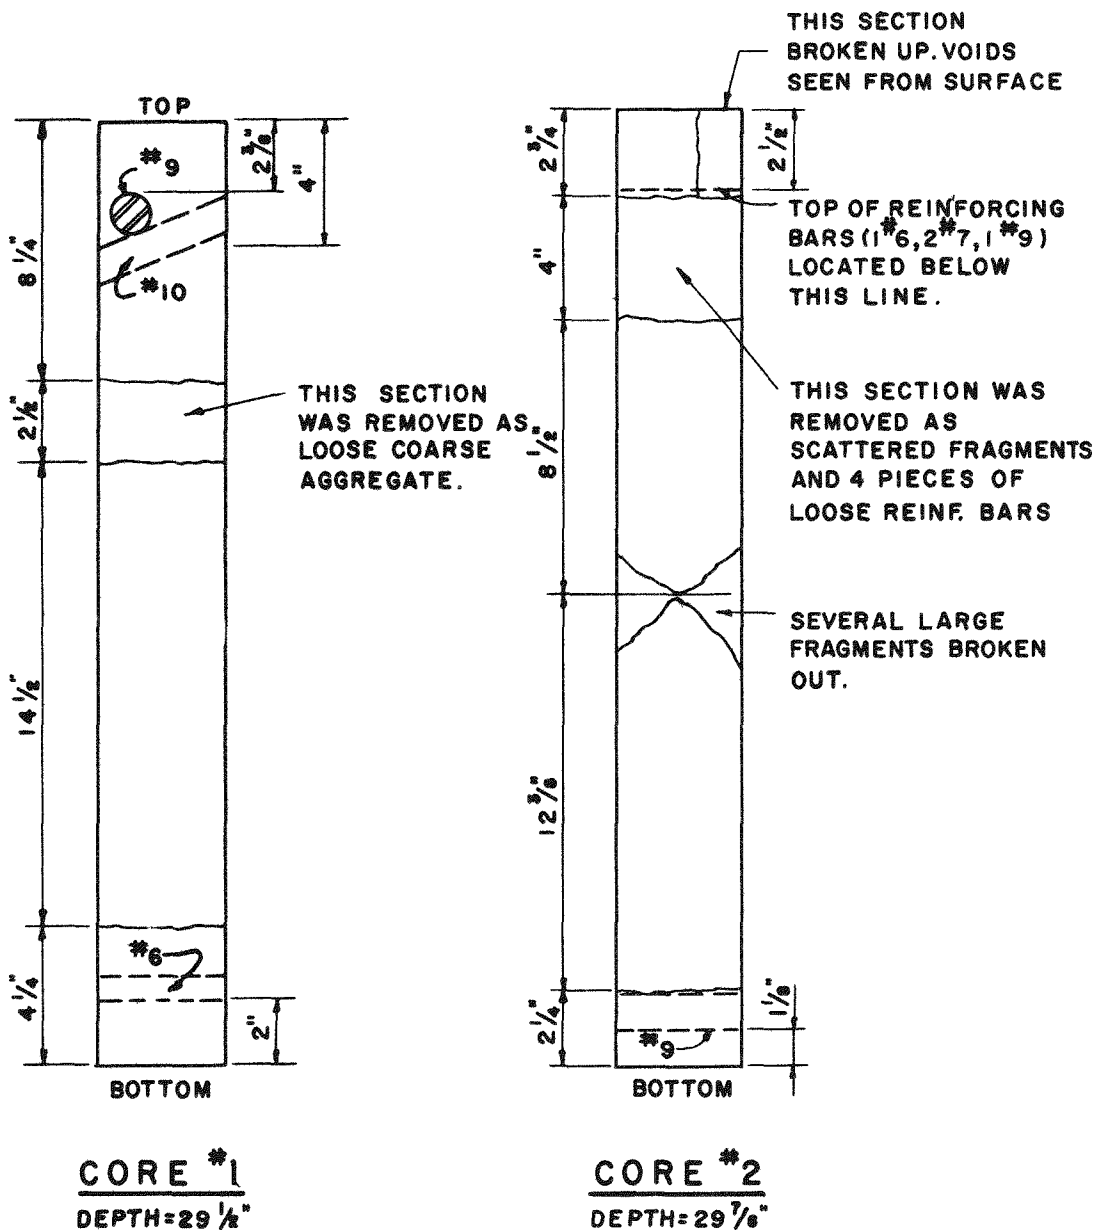
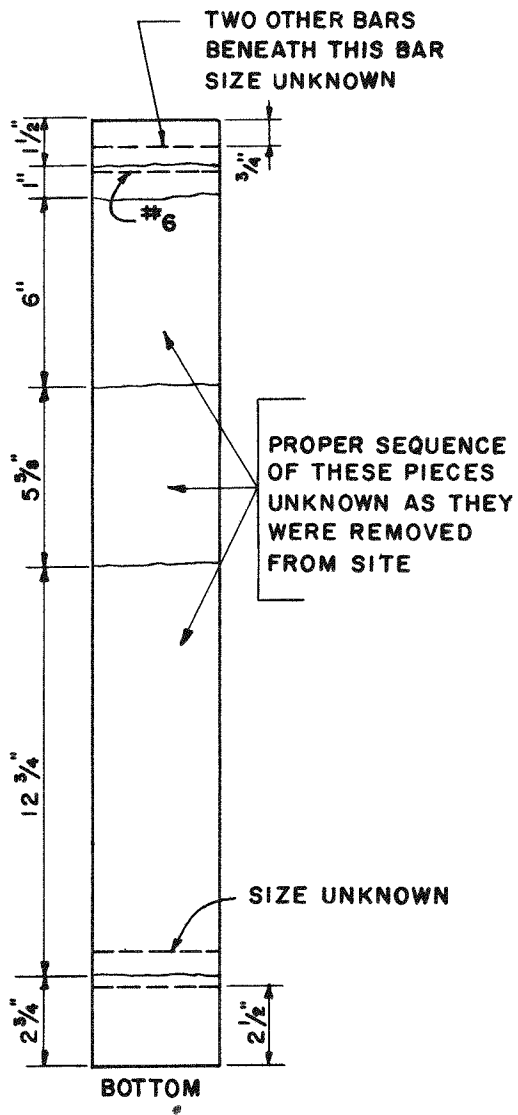
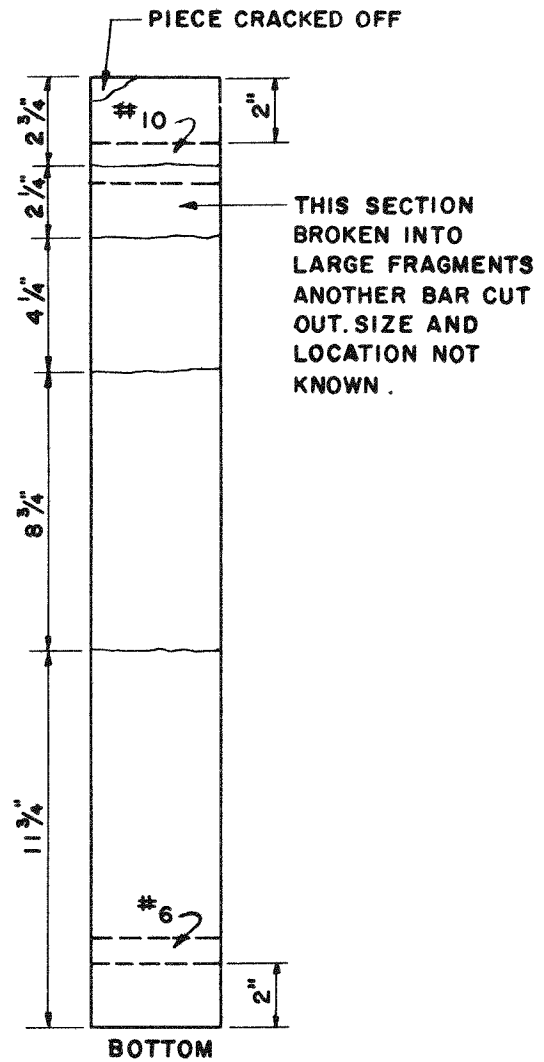
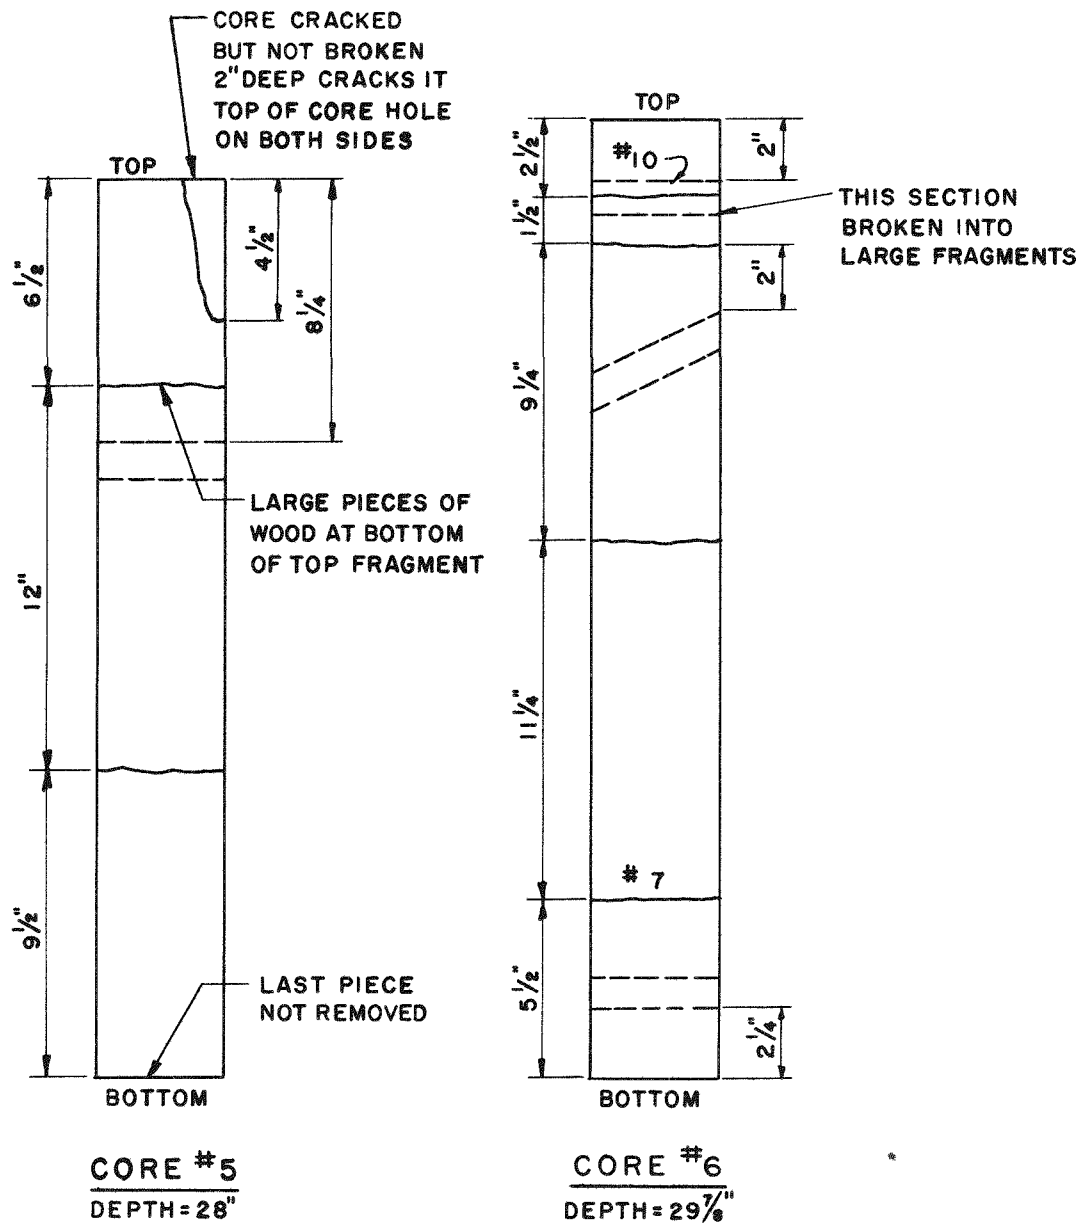
Fig. B.34 — Postshot core compression-test specimens.

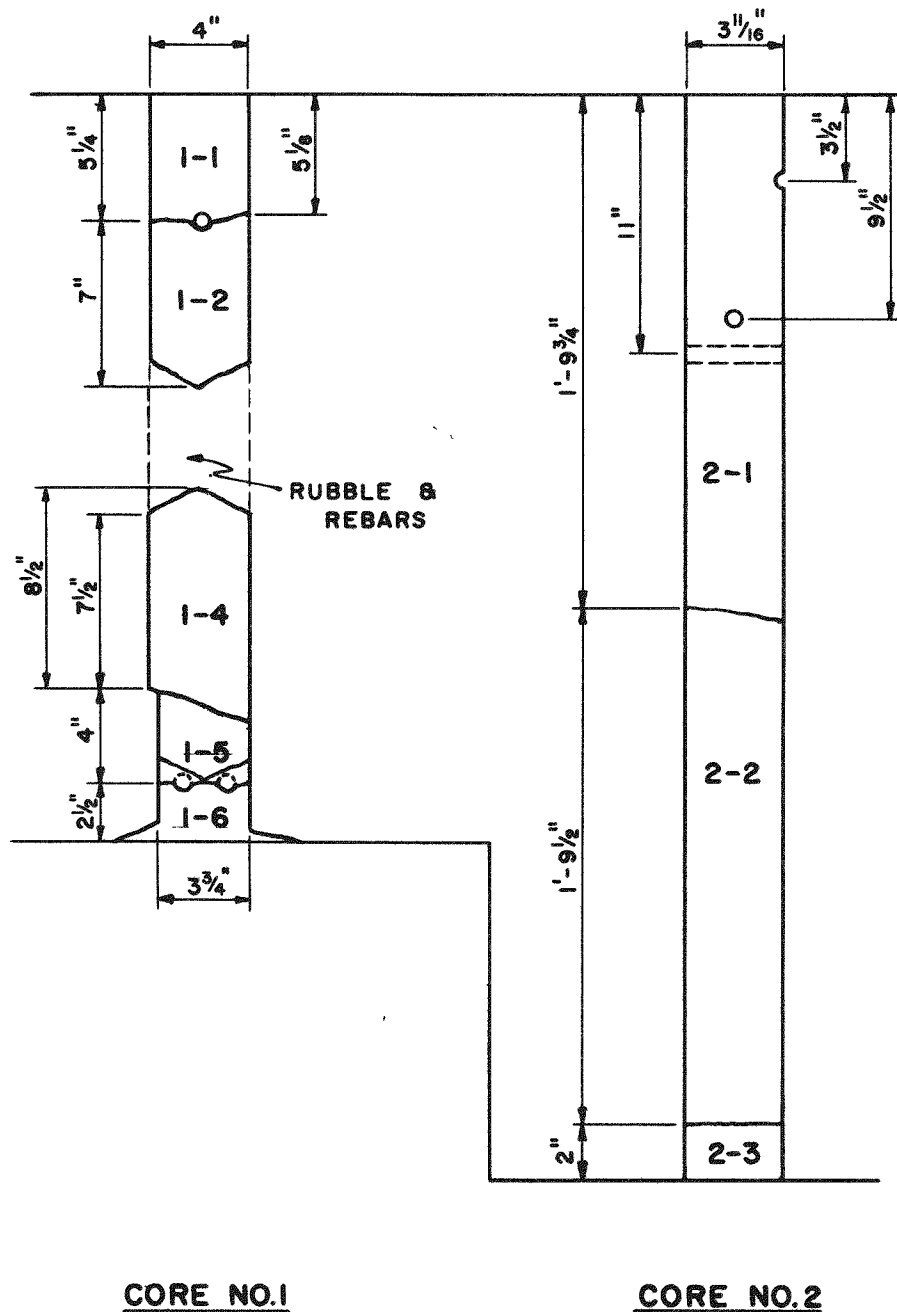
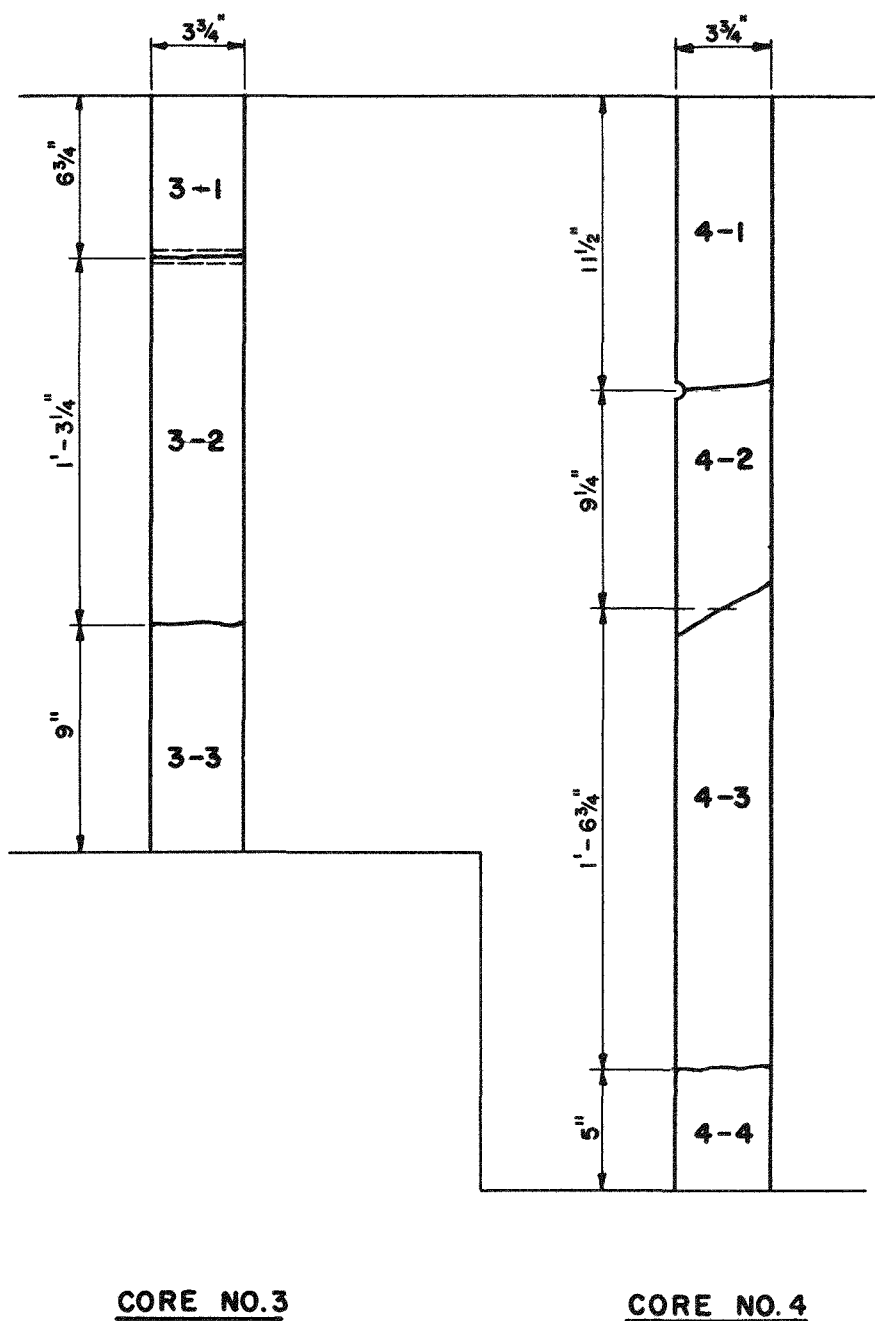
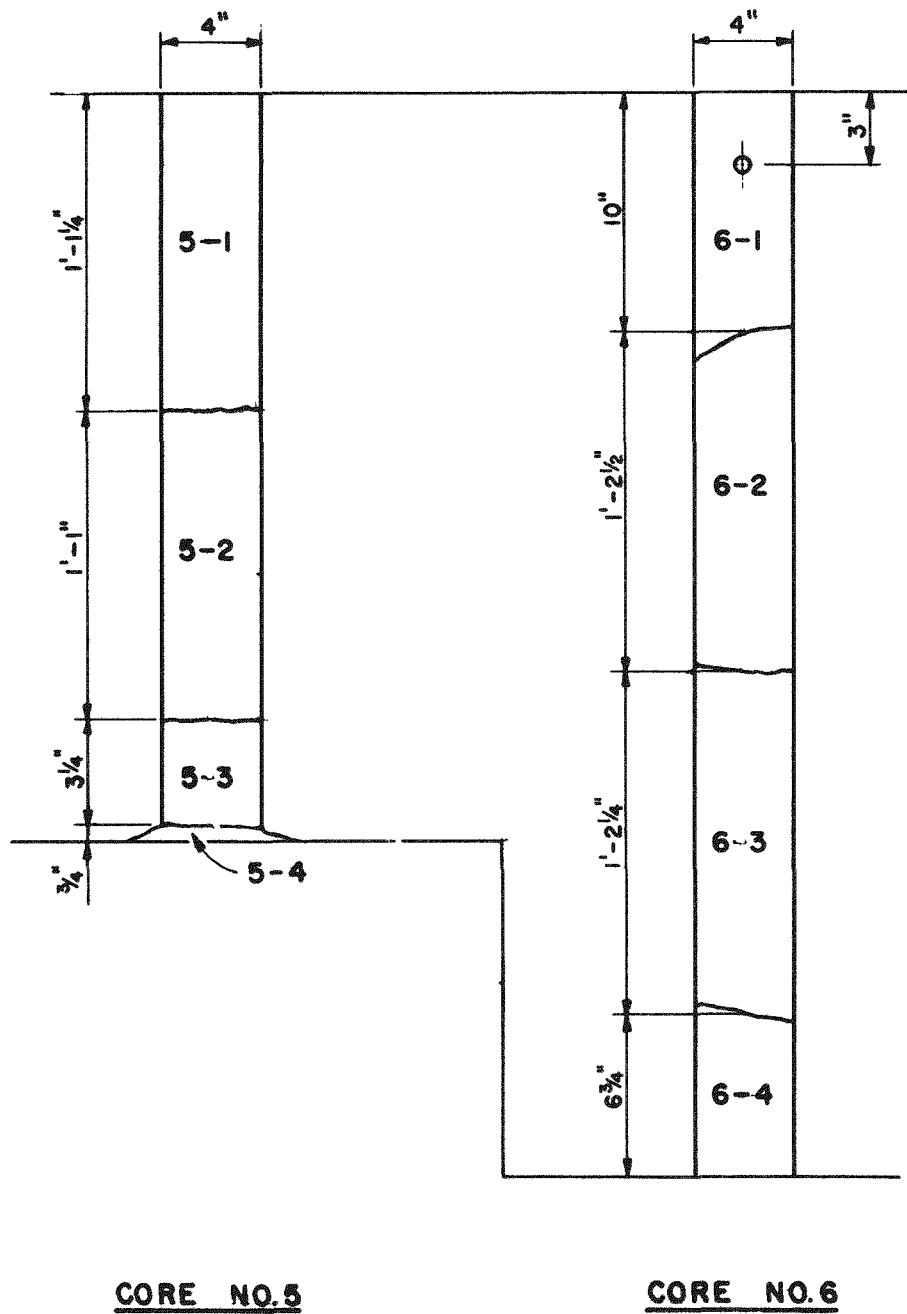
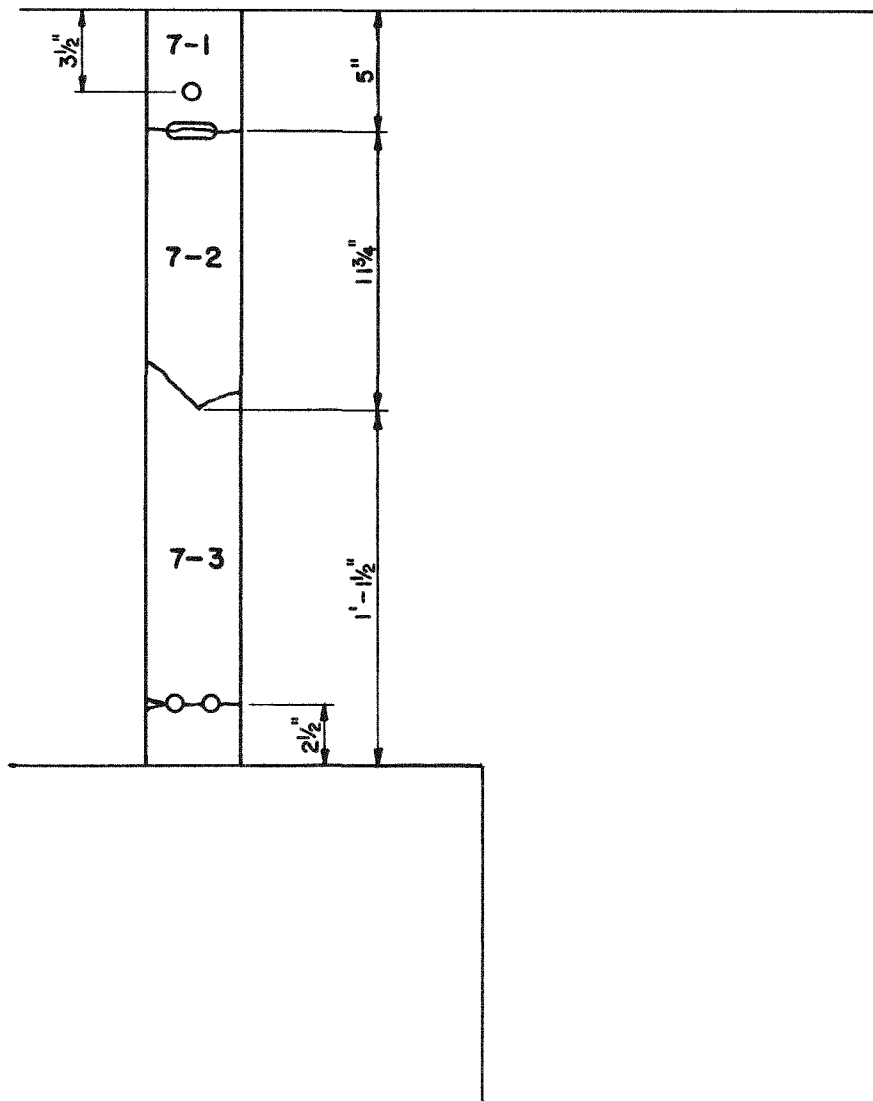
Fig. B.35—(Continued)

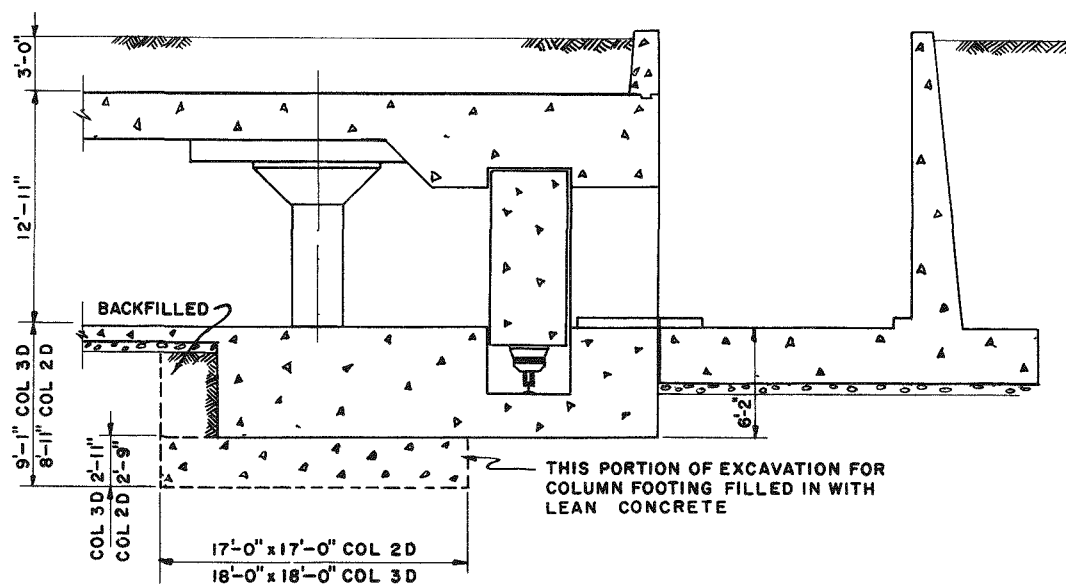
Fig. B.37 — Backfilled area under combined footing

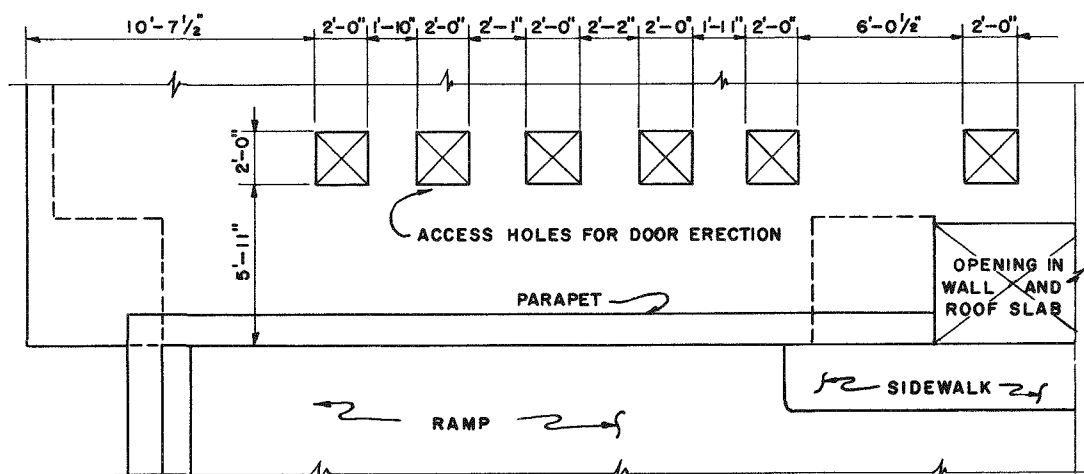
NOTE REINFORCEMENT THROUGH HOLES WAS CUT OUT, AND THEN WELDED BACK INTO PLACE UPON COMPLETION OF DOOR ERECTION

Fig B 38 — Access holes for door erection.

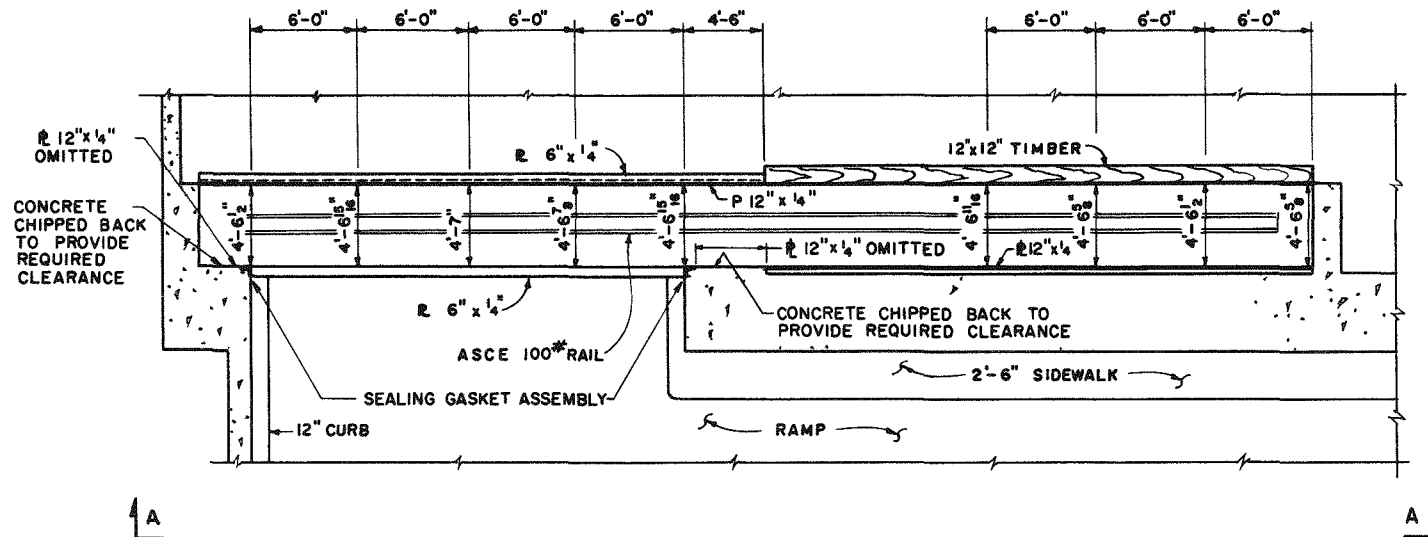
Fig. B.39 — Plan of garage rolling-door pit

1. HORIZONTAL PIT DIMENSION SHOULD BE 4'-6 1/4"
2. DOOR NOT SHOWN
3. MEASUREMENTS TAKEN AT FLOOR LEVEL

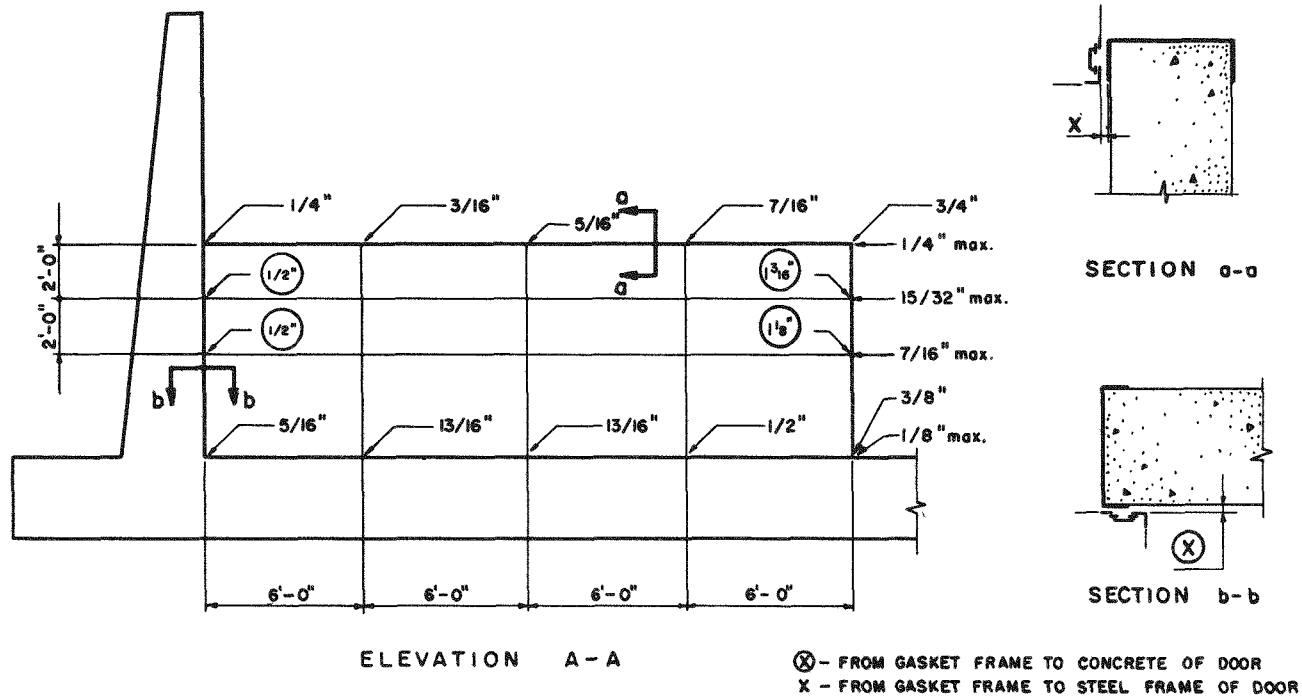
Fig. B.40 —Door clearances, door closed.

1. DIMENSIONS AT T&B OF DOOR ARE HORIZONTAL DIMENSIONS MEASURED FROM FACE OF DOOR R. TO FACE OF 3"x3"x1/4" GASKET ANGLE. ALLOWABLE MAXIMUMS ARE INDICATED. OTHER DIMENSIONS ARE MEASURED FROM CONCRETE FACE OF DOOR TO FACE OF 3"x3"x1/4" GASKET ANGLE. THE CLEARANCES ARE NOT TRUE MINIMUM OR MAXIMUM OPENINGS AS THE GASKET ASSEMBLY WAS NOT TRULY VERTICAL & THERE WAS A VARIATION IN CLEARANCE BETWEEN THE INDICATED POINTS & THE INSIDE EDGE OF DOOR.

2. DIMENSIONS WITH DOOR IN CLOSED POSITION.
