Report IDO-19308

INTERNATIONAL ATOMIC ENERGY
AGENCY SYMPOSIUM ON REACTOR
SAFETY

**SOME
ASPECTS
OF THE
WTR & SL - I
ACCIDENTS**

SOME ASPECTS OF THE WTR AND SL-1 ACCIDENTS

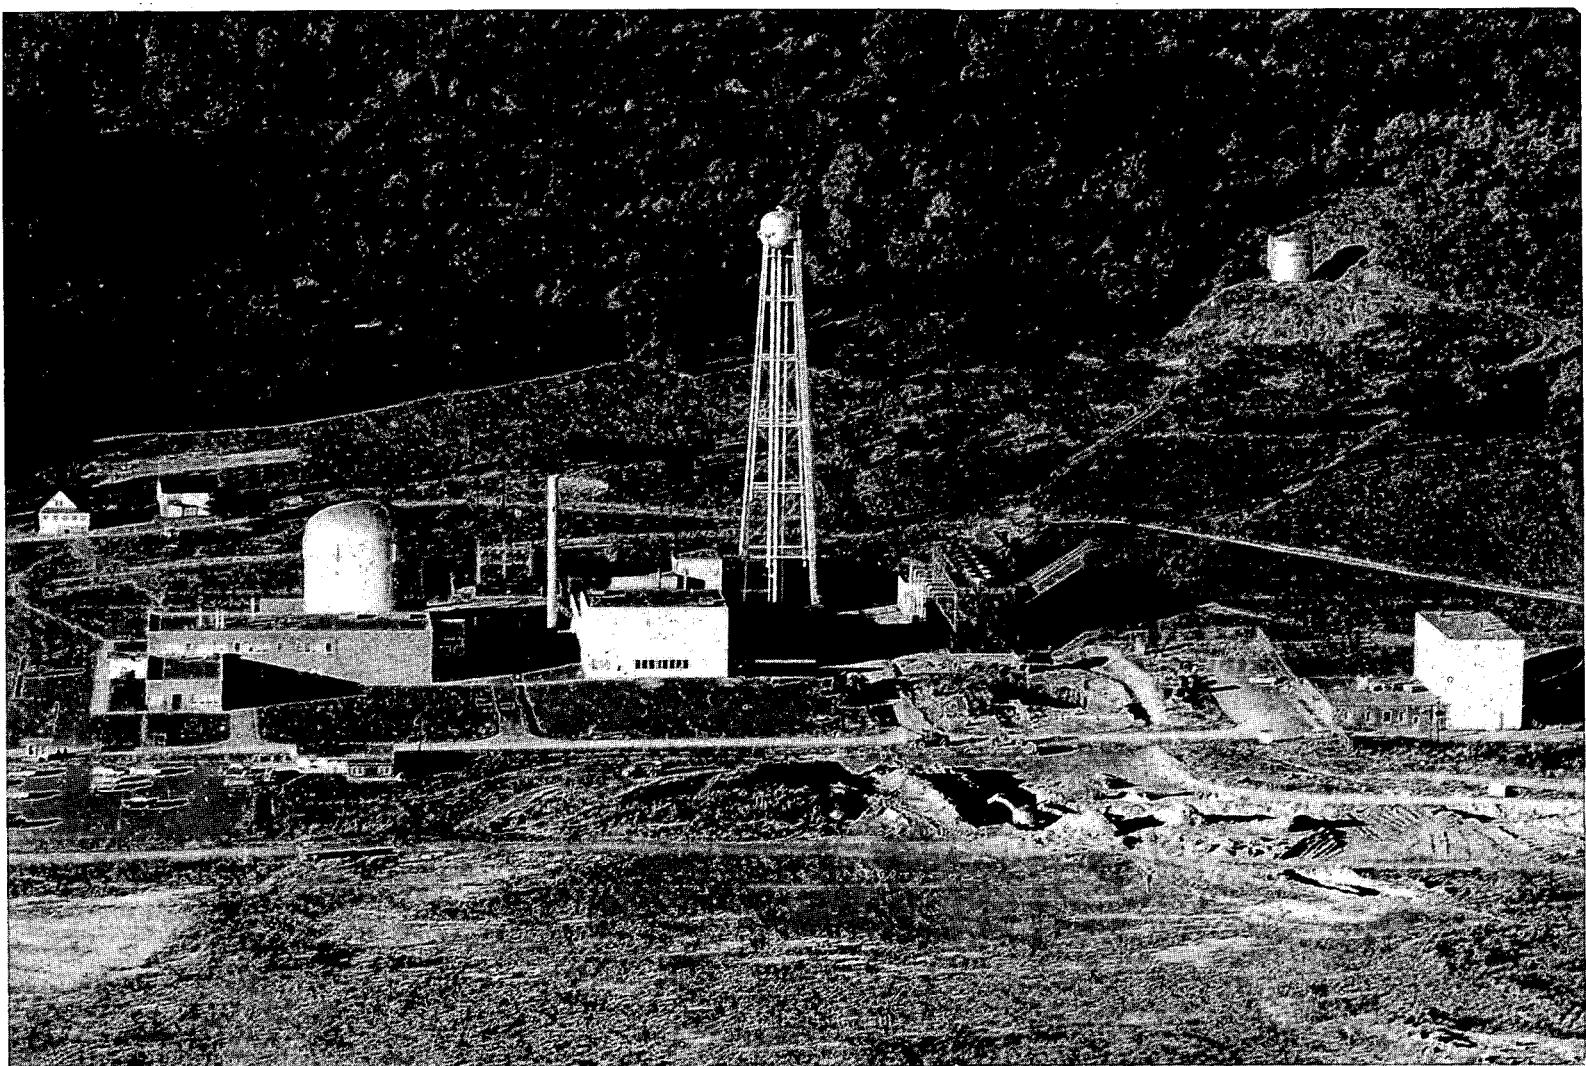
**Figure 1 Westinghouse Testing Reactor Located 20 Miles
Southeast of Greater Pittsburgh**

The Westinghouse Testing Reactor (WTR) is located on an 830 acre tract, approximately 20 miles southeast of Greater Pittsburgh. The surrounding land area usage is predominantly farming (Figure 1).

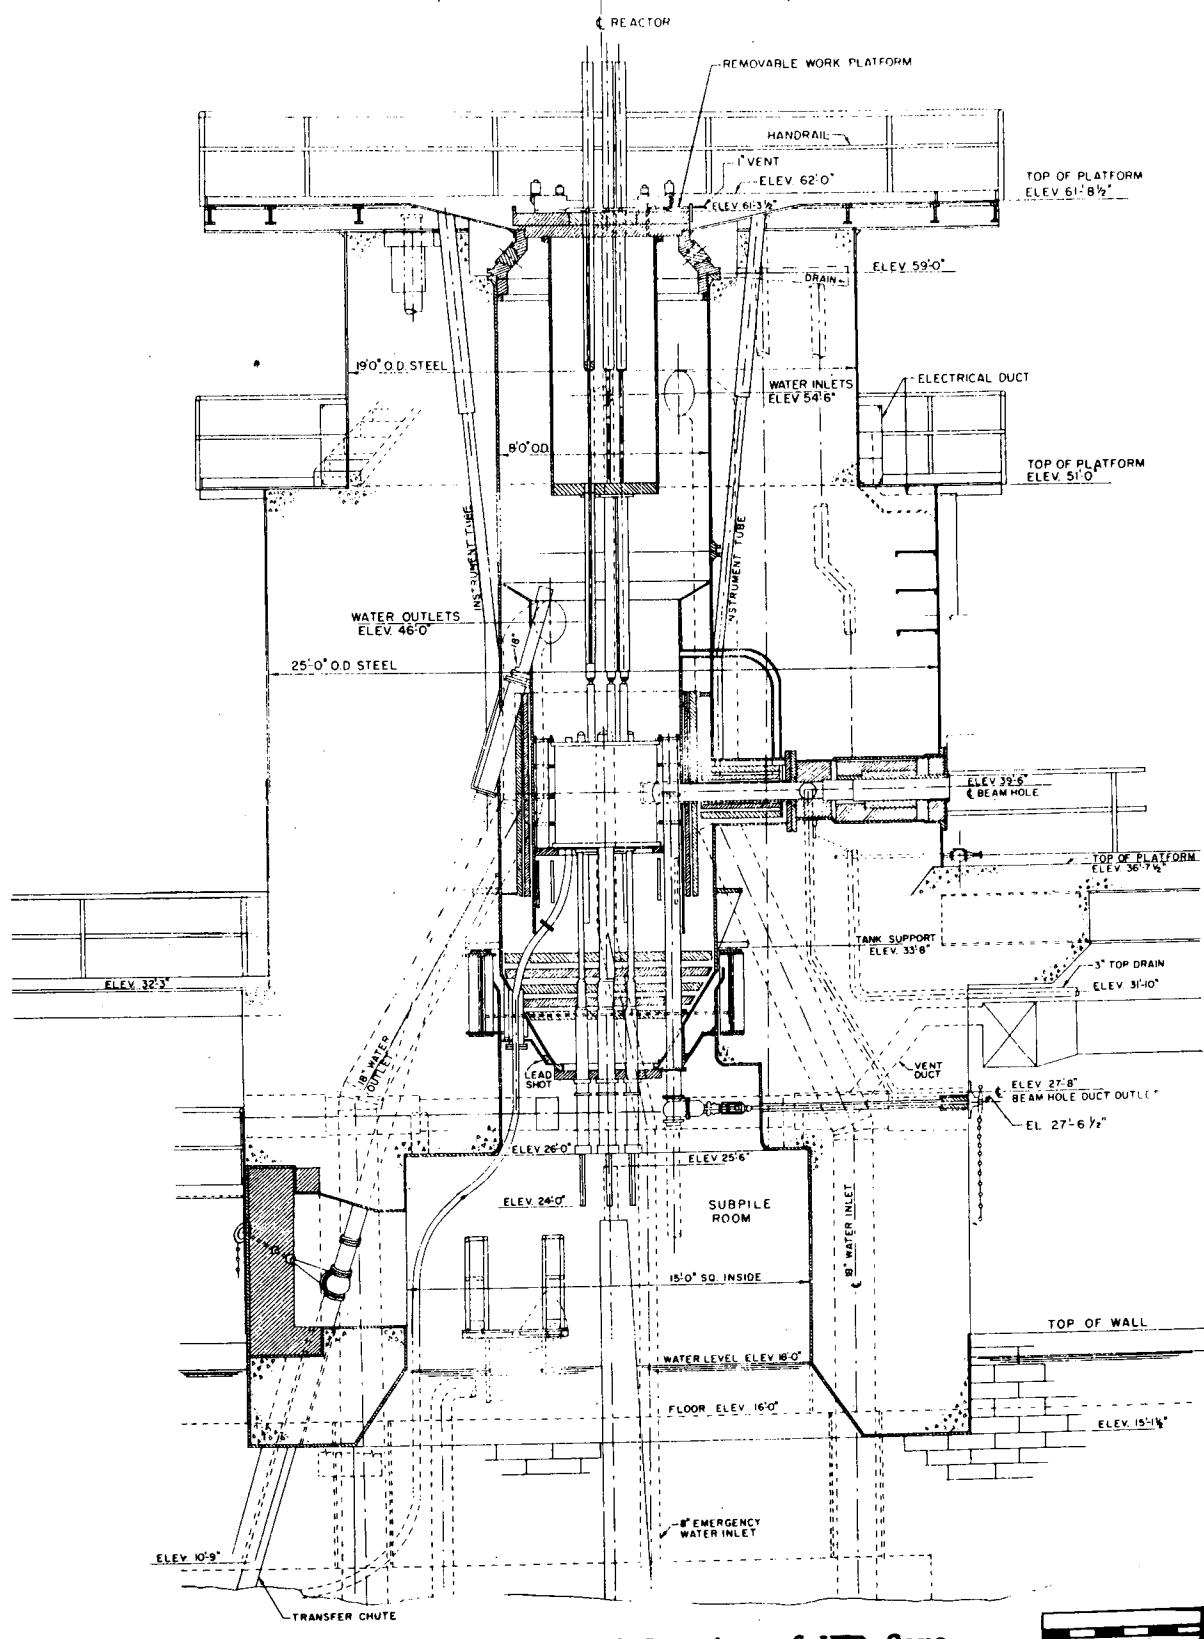
Figure 2 Vertical Drawing of WTR Core

Figure 2 shows the relationship of the reactor core to the reactor vessel. A plan view of the core barrel is shown in Figure 3. The inner hexagon contains fuel elements, test loops, and control rods, while the outer segments are used for experimental purposes.

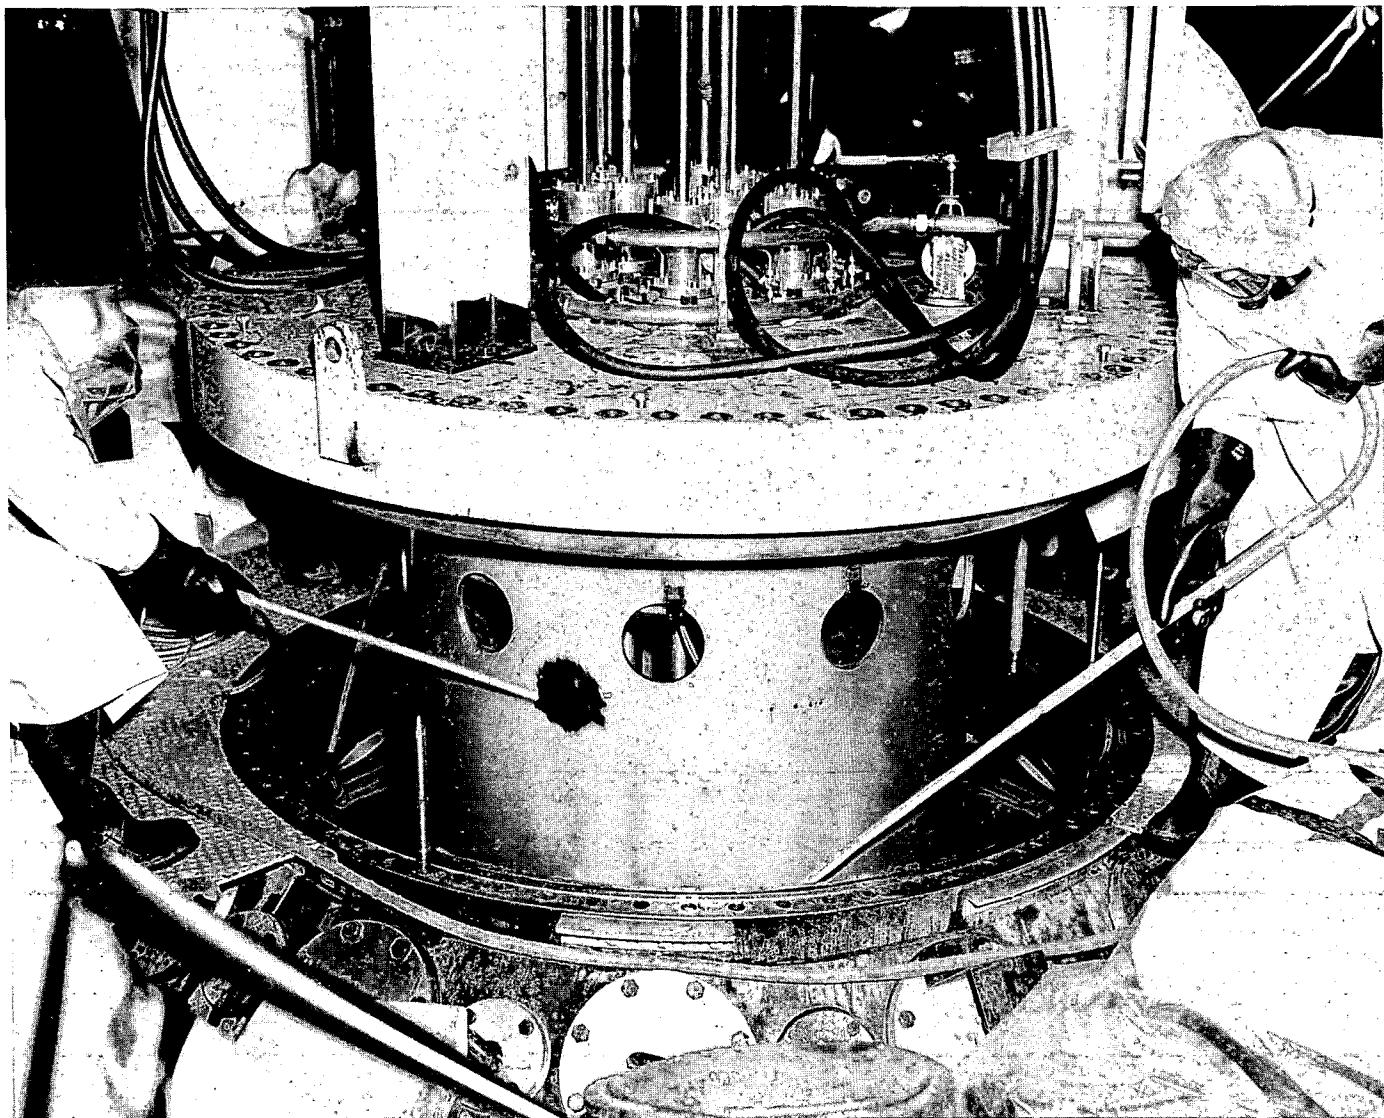
Figure 5 WTR Reactor Vessel Head Removal and Decontamination

By April 9, decontamination efforts had proceeded sufficiently so that the reactor head was raised one foot for examination and radiation survey. Since the radiation levels close to the head were approximately one roentgen/hr, the head was replaced pending construction of shields and to prepare washing and decontamination equipment. A system of car-wash brushes was hooked up for continuous scrubbing during the raising of the head (Figure 5). A three-inch thick iron shielding platform was constructed to permit visual observation of

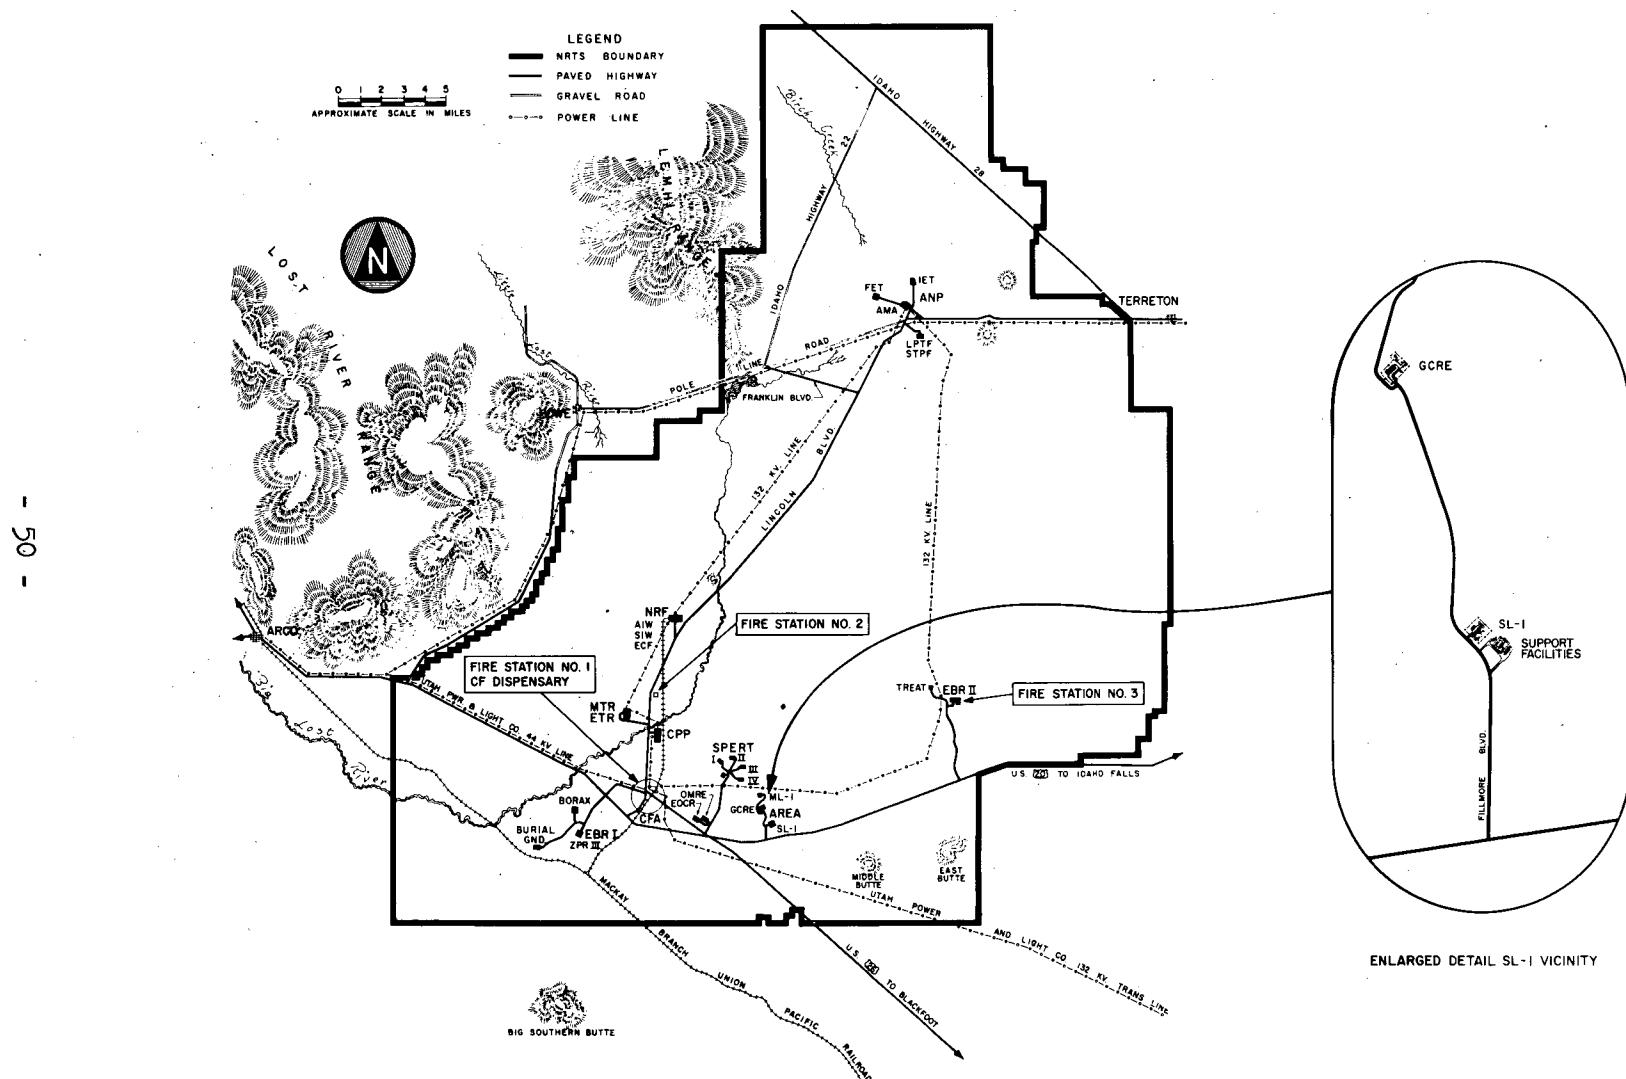
Figure 9 National Reactor Testing Station

The SL-1 site is located at the National Reactor Testing Station about 3/4 mile north of Route 20 (Figure 9). Site facilities consisted of the reactor building, an adjoining support building which contained the control room, and miscellaneous service buildings (Figure 10).

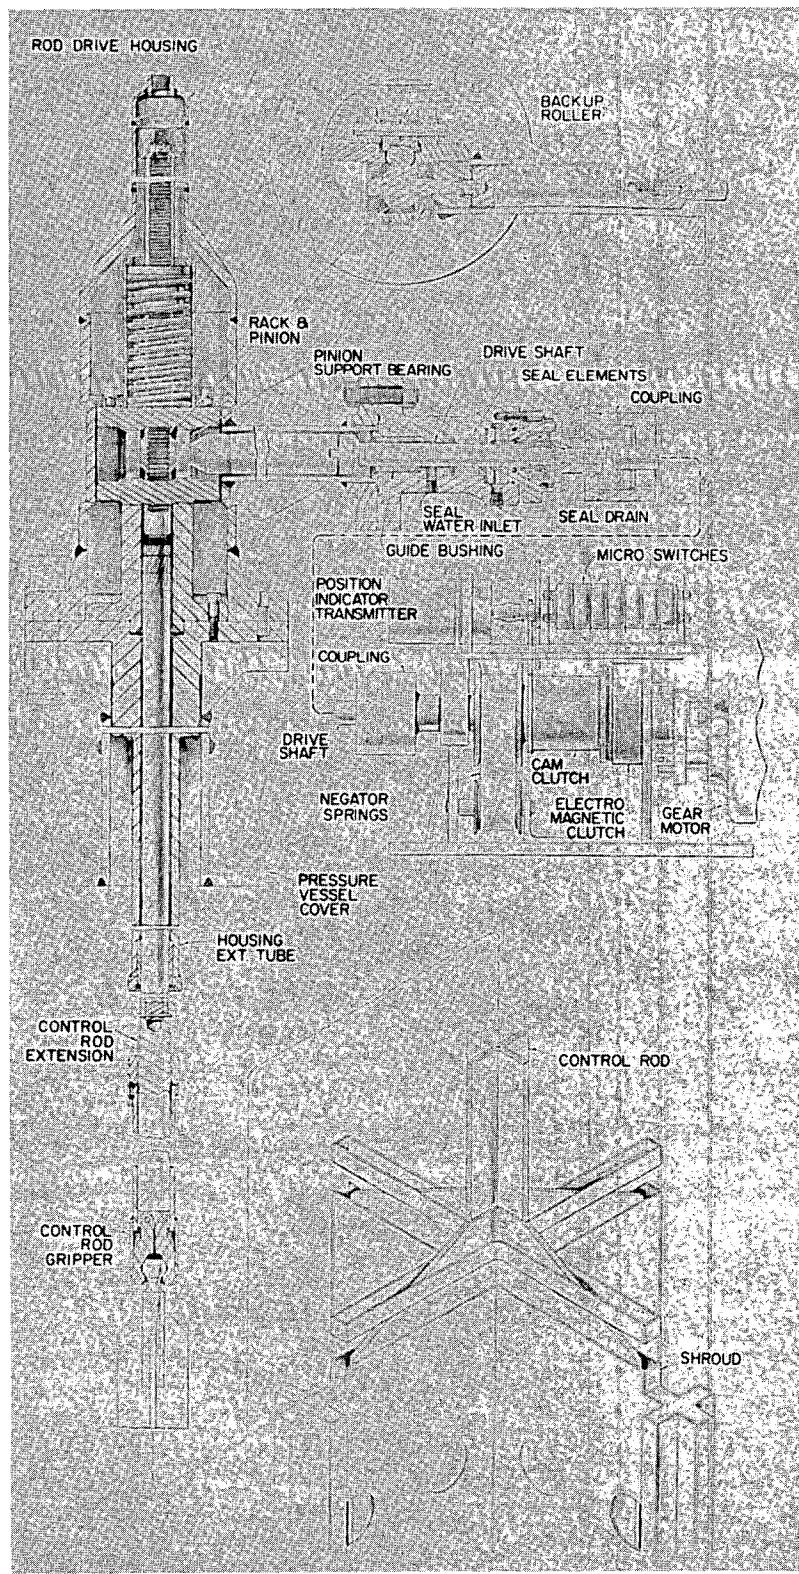
Figure 39 SL-1 Control Rod Drive Mechanism

located in a pressure housing (also called a "bell housing") on the head of the reactor vessel as shown in Figure 39. The control rod blades were guided by shrouds within the core. At a ball joint, the blades were connected to vertical control rod extensions and racks. The racks meshed with a pinion gear. The horizontal pinion shaft penetrated the wall of the thimble through a rotating seal and was driven by a motor through a gearbox and magnetic clutch. By de-energizing the clutch coil, the pinion was released from the motor, and the rod could then fall by gravity, with the rack and pinion gear "free-wheeling." Any friction in the seal on the horizontal pinion shaft would tend to impede the fall of the rod. An auxiliary clutch permitted the motor to drive the released rod downward and, if necessary, prevented upward rod motion after release.

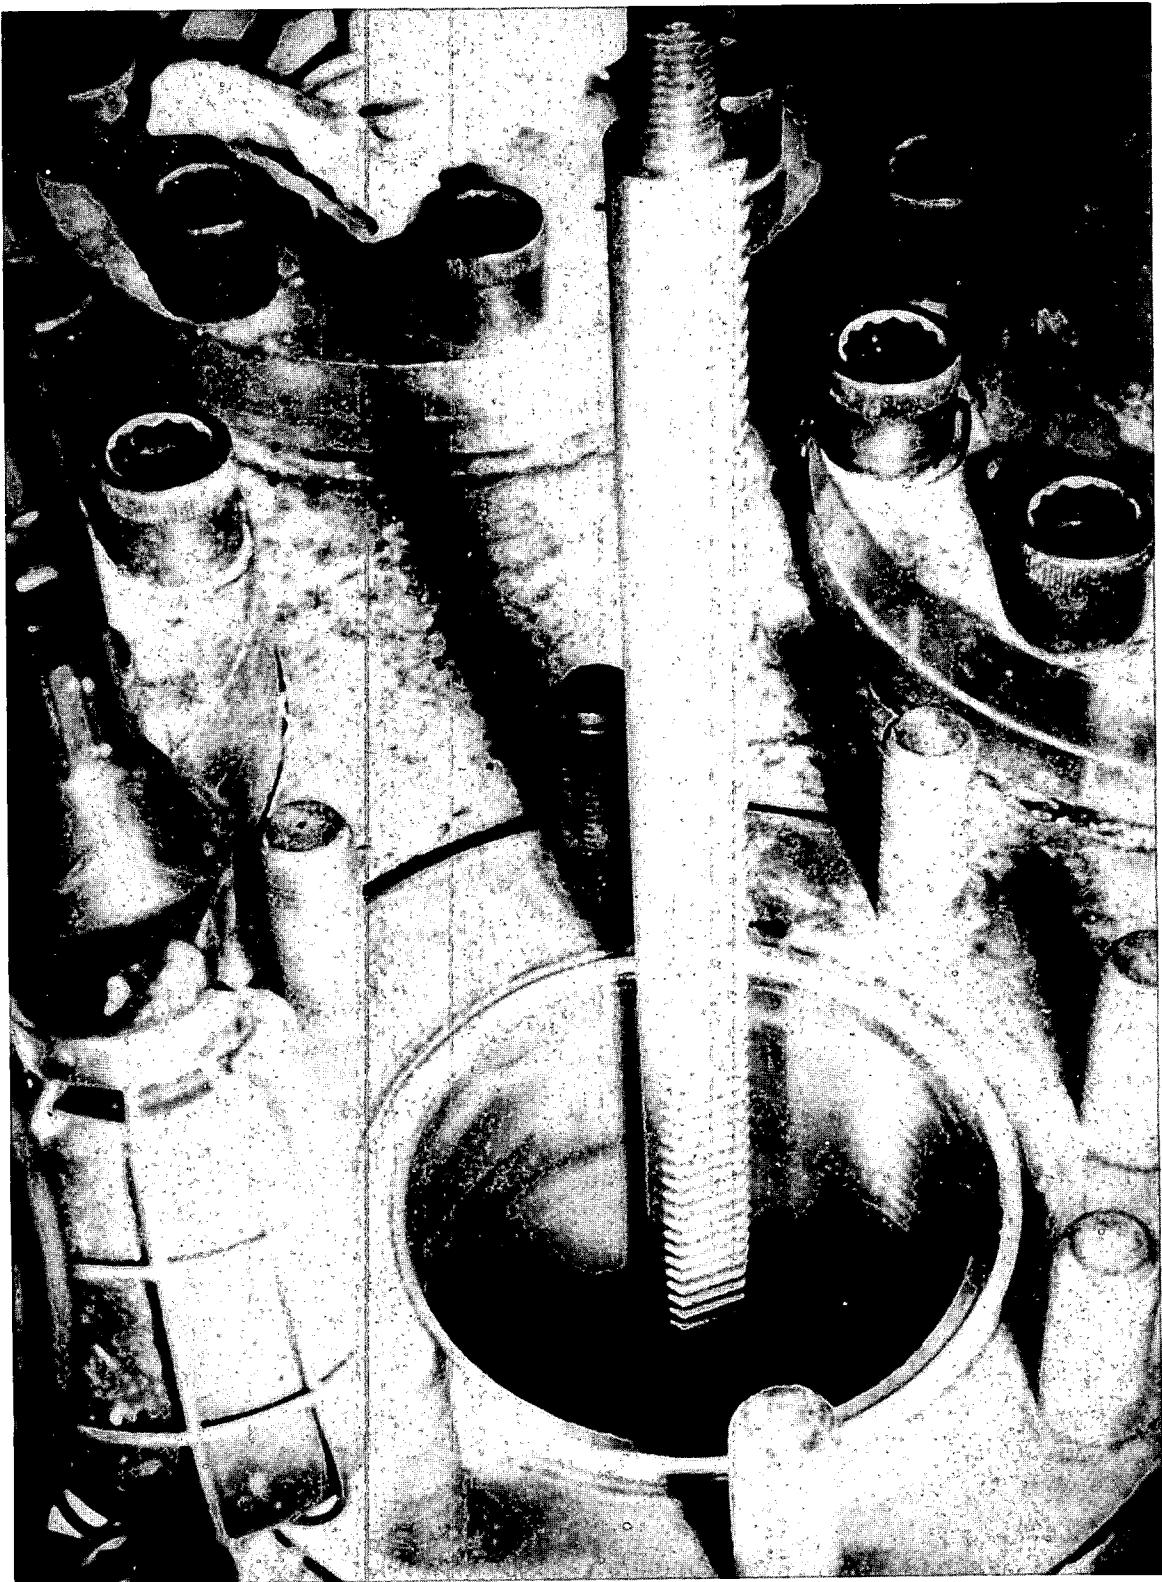
Figure 42 SL-1 Control Rod Drive Rack (Pre-accident photo)

When an SL-1 drive mechanism was disassembled, all the drive components were removed from the reactor head and, hence, access to the core was possible. This situation is shown in a pre-accident photograph, Figure 42, with only the control rod rack protruding through the reactor nozzle.

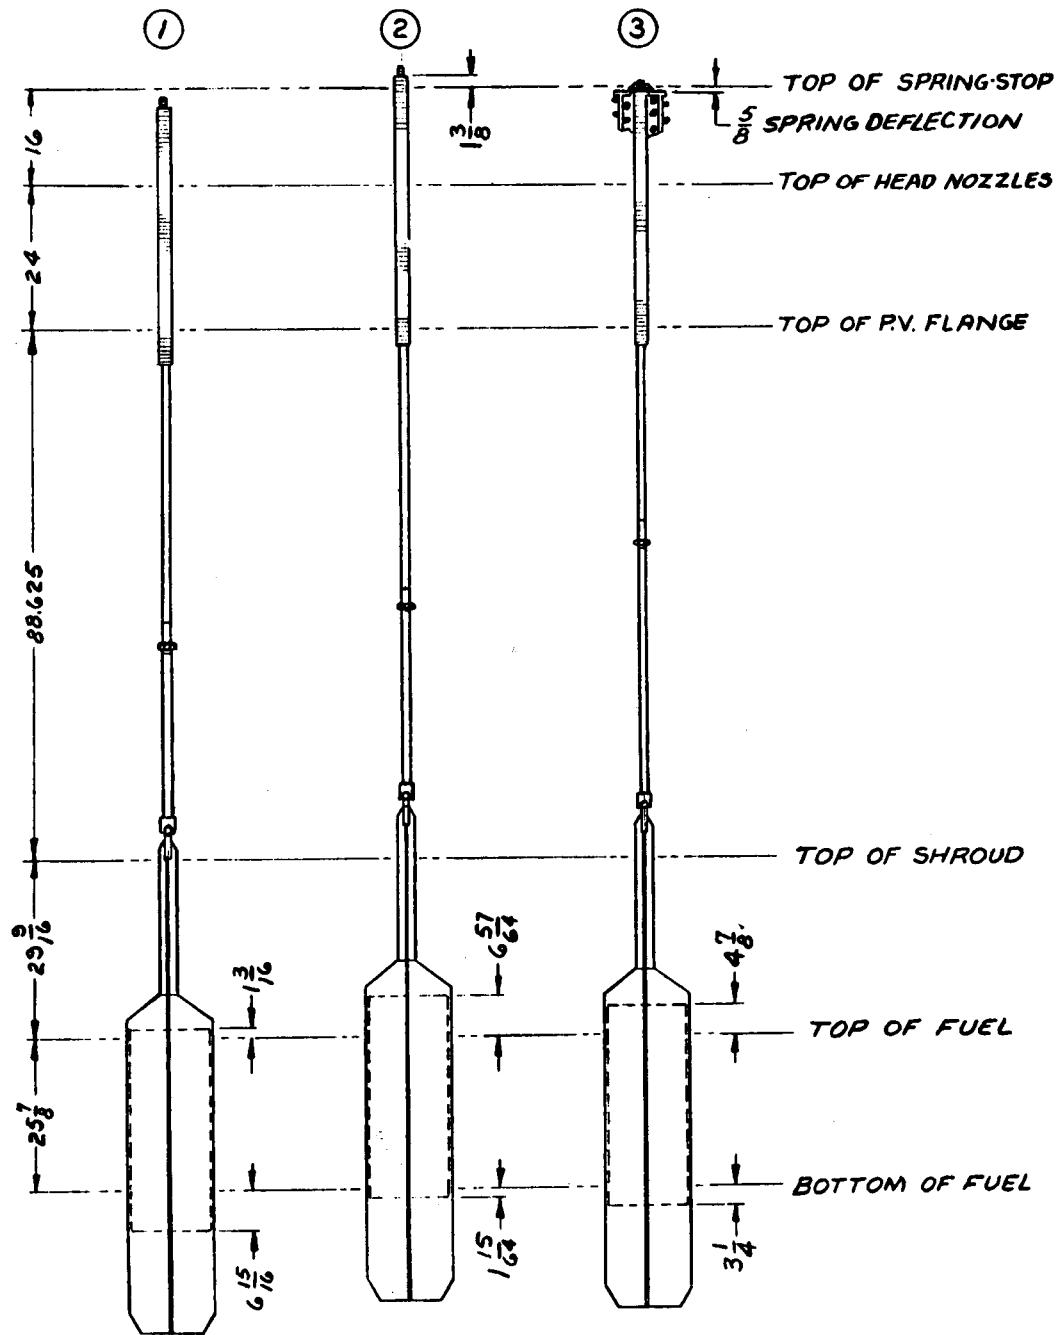
SL-1 CONTROL ROD CADMIUM OVERLAP OF ACTIVE CORE FOR VARIOUS CONDITIONS

With the "C" clamp on the rack, the lifting tool was removed and a washer and nut were placed on the rack. This nut and washer acted against the spring to hold the rod in the zero operating position and to absorb the force of scrams. The lifting tool was again attached and the rod lifted to free the "C" clamp. The rod was then lowered to the spring. This point in the reassembly is shown in Figure 43. Figure 44 shows the cadmium overlap in the active core at various positions during this reassembly procedure.

- ① CONTROL ROD POSITION WITH SCRAM STOP WASHER AND NUT REMOVED.
- ② CONTROL ROD POSITION FOR INSTALLATION OF SCRAM STOP WASHER AND NUT.
- ③ CONTROL ROD ZERO POSITION
