Common Causes of Material Degradation in Buried Piping (U)

C. F. Jenkins

Westinghouse Savannah River Company

A document prepared for ASME PRESSURE VESTER & PIPING CONFERENCE at Orlando, FL, USA from 7/27/97 - 7/31/97.

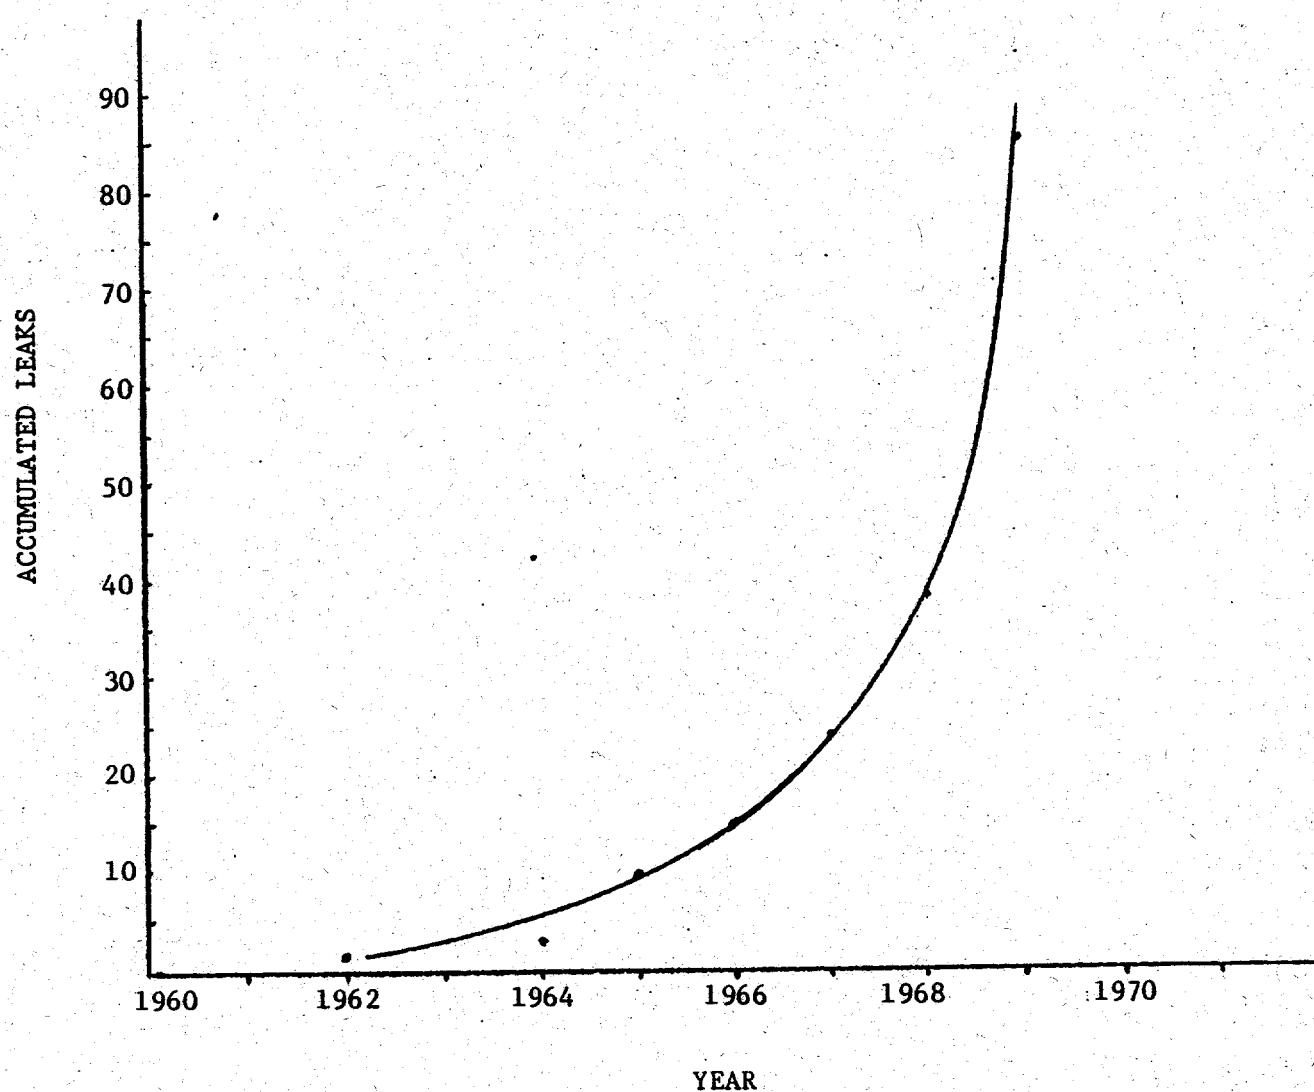
General experience with underground corrosion indicates that once leaks start to occur, an increase in the rate of development of leaks can be anticipated. The accumulated number of leaks typically follows an exponential curve with time (Fig. 1, after Ref. 1). As suggested in the graph in Fig. 1, a normal leak-free infancy can be expected. However, the natural tendency to corrode or oxidize eventually leads to some leaks.

Figure 1. Leak history of an underground pipeline. The curve is prototypical and exponential. Reference 1.
