CORROSION PROBLEMS IN Ti/KClO<sub>4</sub> LOADED DEVICES WHEN SUBJECTED TO HUMID ENVIRONMENTS\*

T.M. MASSIS, J.T. HEALEY, D.H. HUSKISSON and W.G. PERKINS  
Sandia National Laboratories, Albuquerque, NM 87185\*\*

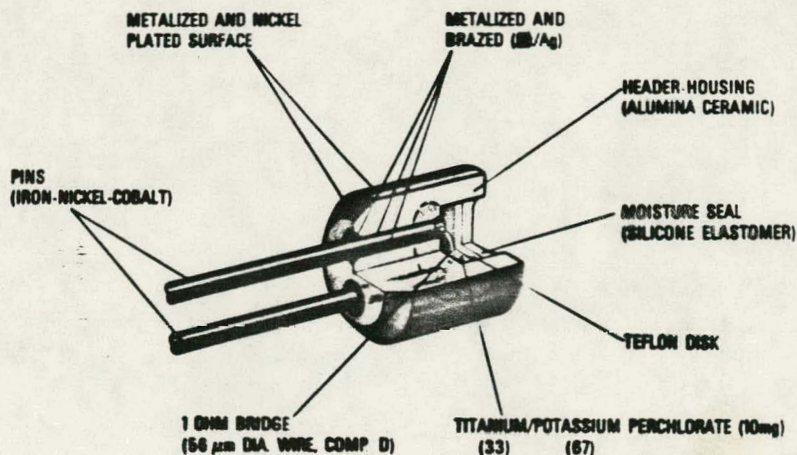
Fig. 1. Cutaway view showing design of igniter

Figure 1 shows the configuration of the igniter. Its primary function is as an ignition source in thermal battery applications. Table 1 lists the materials used in the igniter design.

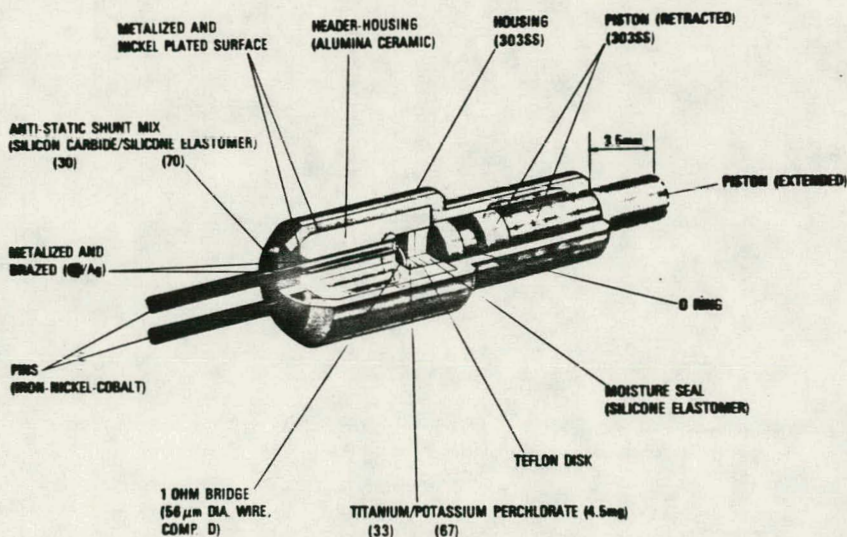
Fig. 7. Cutaway view showing design of piston motor.

The piston motor is in many respects similar to the thermal battery igniter. The header design, materials, manufacturer, processing, and pyrotechnic are similar. The piston motor, shown in Figure 7, is a smaller version of the igniter. The design is considered to have a nonhermetic seal.

Previous evaluations of this device from early lots (nearly eight years old) revealed the presence of minor corrosion. Such corrosion was best described as small isolated areas of corrosion most often associated with contamination on the electrode pin surface. Such contaminants included  $S^{-2}$ ,  $Cl^{-}$ , and  $Si^{+4}$  containing materials. The observed corrosion was similar in extent to that found on unloaded header assemblies. No potential corrosion or failure of the weld was observed. Likewise no corrosion of the bridgewire was observed.

It was concluded that the corrosion and cracking could be solved by eliminating the source of moisture by hermetically sealing the devices. Tests of hermetically sealed units have confirmed this conclusion.

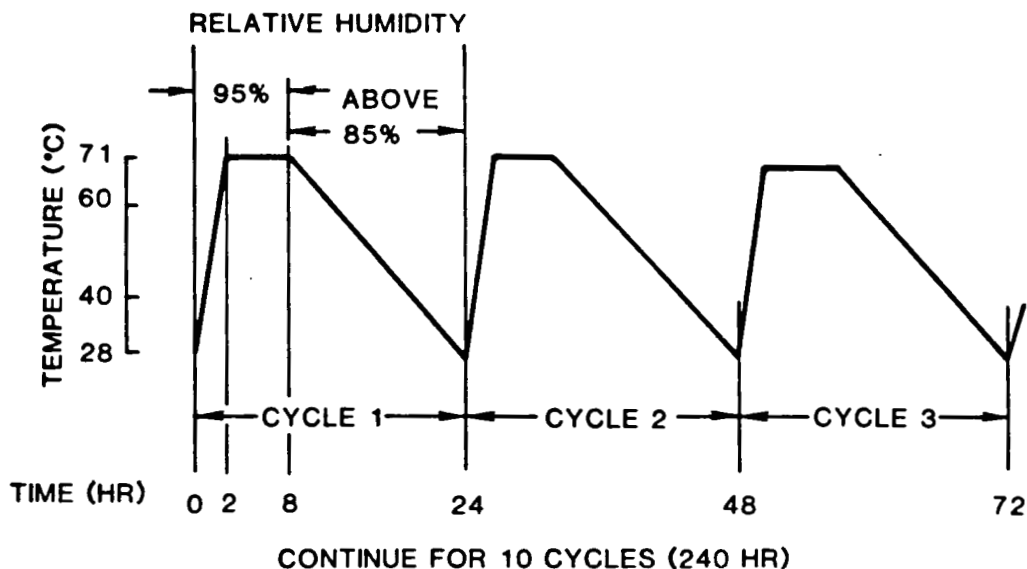
Fig. 8. The humidity cycle used for the piston motor

The original design applications of the piston motor, including the ones examined for corrosion, did not require the use of the component in a high humidity environment. However, a recent application of this device required a severe humidity test cycle as shown in Figure 8. Measurement of the bridgewire resistance after humidity testing revealed values significantly above the  $1.0 \pm 0.1$  ohm specification for the circuit. In many cases, an open circuit was indicated.

Disassembly and evaluation of the header revealed massive corrosion of the electrode pins (Figure 9). Nearly all of the surface was corroded. Either one or both of the bridgewire/pin welds were detached at the weld interface in one-half of the units evaluated. Optical and SEM examinations revealed similar corrosion of the electrode pins and weld areas as previously found for the thermal battery igniter. No bridgewire corrosion was observed. Similar units subjected to the same thermal cycle but without the humidity environment were found not to be corroded.
