Defect Characterization by Acoustic Holography  
Volume 1: Imaging in Field Environments

NP-1534, Volume 1  
Research Project 605-1

Final Report, September 1980

COE ASSOCIATES  
2672 Bayshore/Frontage Road, Suite 1000  
Mountain View, California 94043

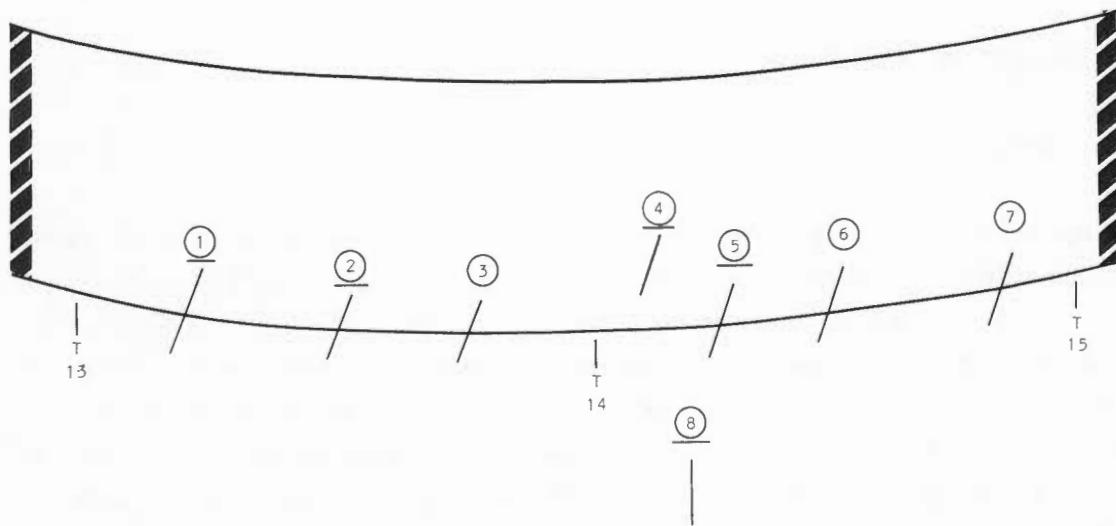
Figure 3-1 Sketch Showing the Location of Indications as Detected by Radiography

Radiographic inspection of a large, curved, thick, carbon structural steel plate indicated discontinuities (shrinkage voids) near and possibly in the weld zone of the seam being inspected. The location of these discontinuities is shown in Figure 3-1. Radiographic images indicated that there were a number of stringer -type discontinuities, some of which appeared to extend from the base metal to the weld zone. Five of these defects were selected for AH imaging based on the severity and/or location of the defects. The selected defects were Nos. 1, 2, 4, 5 and 8 (4 and 5 were treated as one area).

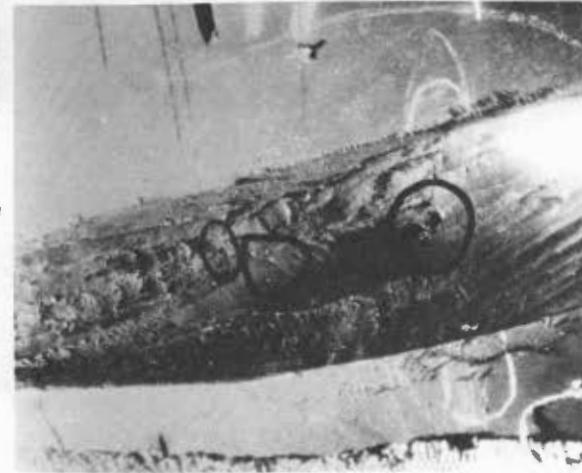
Figure 3-4 Base Metal DT Test Photos - Depth 4 to  $4 \frac{1}{2}"$

Photographs of the results obtained during the destructive tests are presented in Figures 3-4 and 3-5. These photos provide cross sections of the flawed volume, located between 3 inches and 5 inches beneath the vessel surface.

(d) Cavity Depth  $4 \frac{1}{2}"$   
New Area Detected

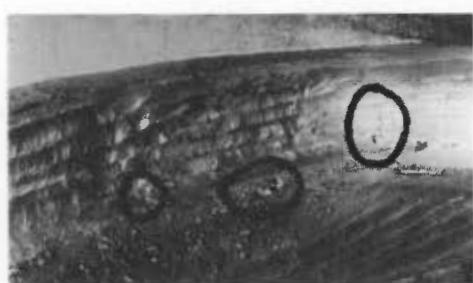
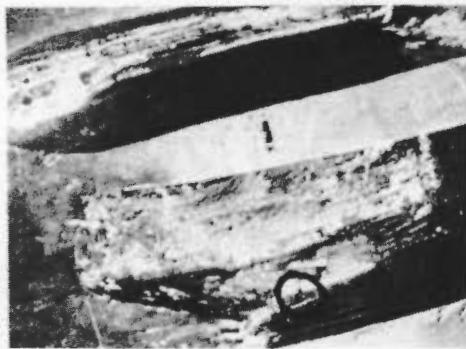
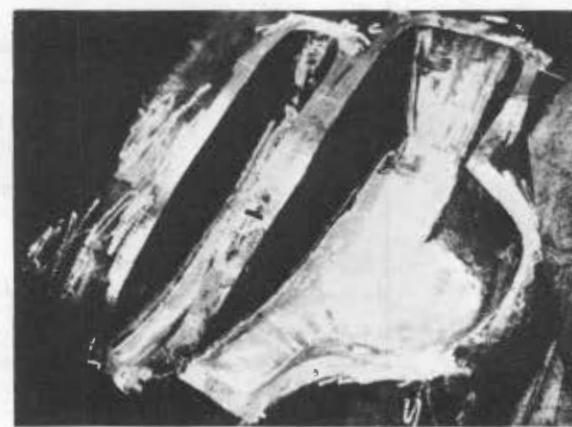
Figure 3-5 Base Metal DT Tests Photos - Depth 5" to 5 5/8"

(a) Cavity Depth 5"  
New Area Detected

(b) Cavity in (a) Widened

(d) Another Void Revealed by Arc-Air

(f)  
Appearance of Cavity  
After Last Visible  
Defect Removed.

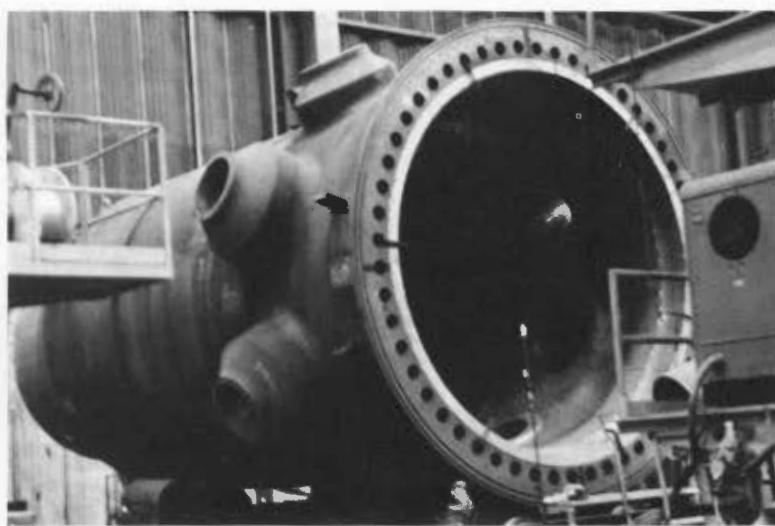
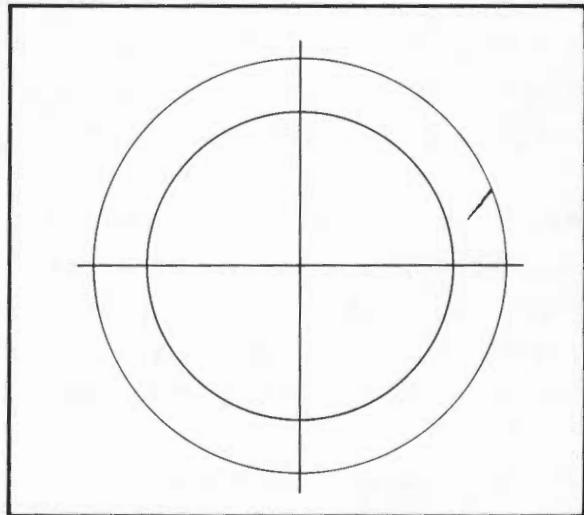
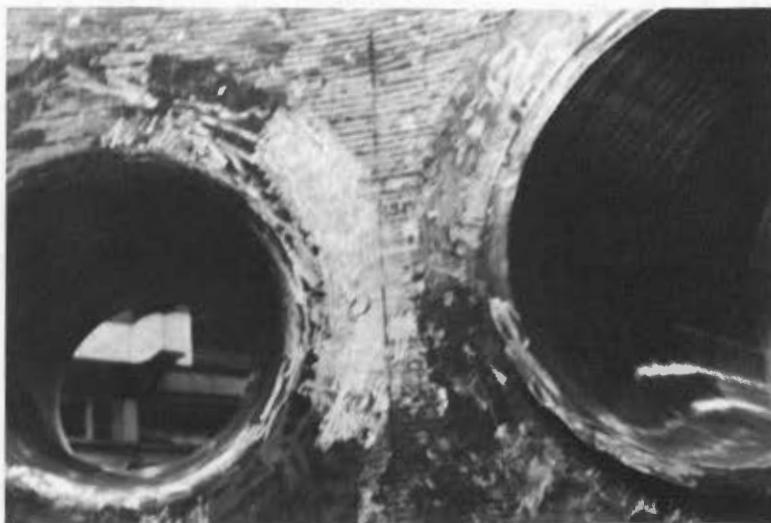
Figure 3-6 Approximate Location of Defects

Radiographic inspection of the welds of the nozzles of a pressure vessel indicated defects in two different nozzles. The defects appeared to be transverse to the welds. Pulse-echo ultrasonic examinations were used (2.25 MHz 45° and 60° incident angle) to verify the initial radiographic results. The approximate locations of the defects are shown in Figure 3-6.

(b) Approximate Location and Orientation of Defect in Nozzle

(c) Location of Defects and Area Where Cladding Had Been Ground

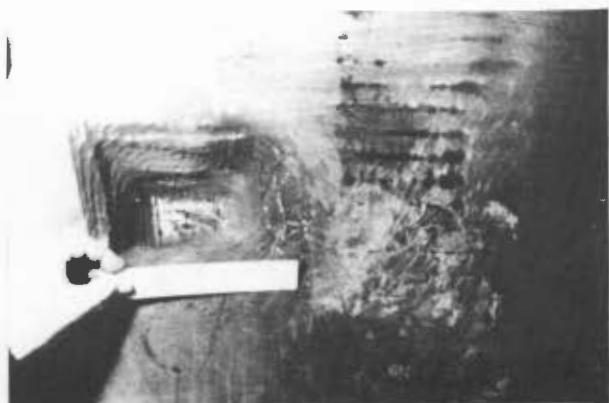
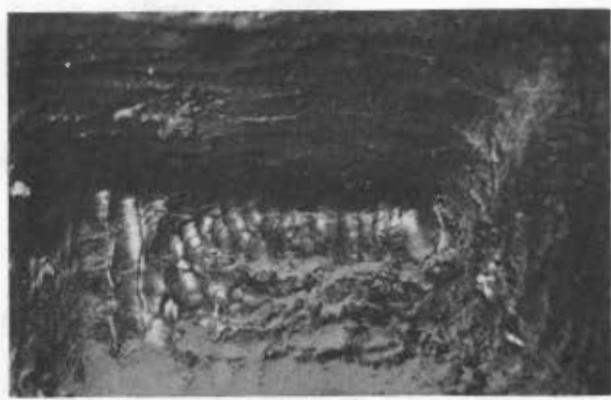
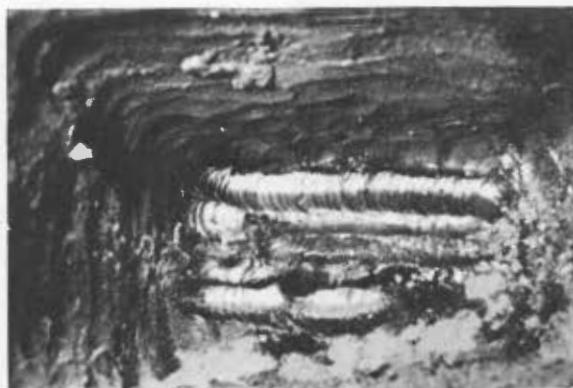
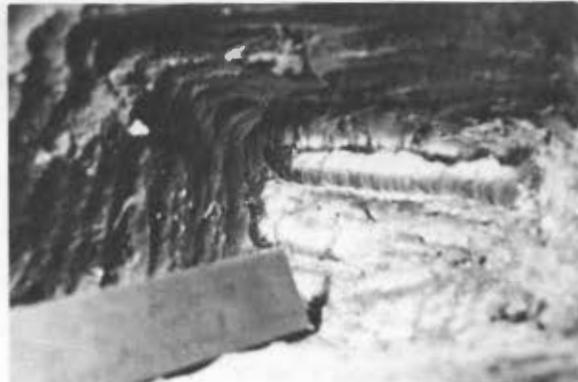
Figure 3-8 Destructive Test Results

Photographs of the AH images are presented in Figure 3-7. The images disclosed by the destructive tests are shown in Figure 3-8. Arc-air techniques were used for the destructive tests. The AH results were verified by the destructive tests.

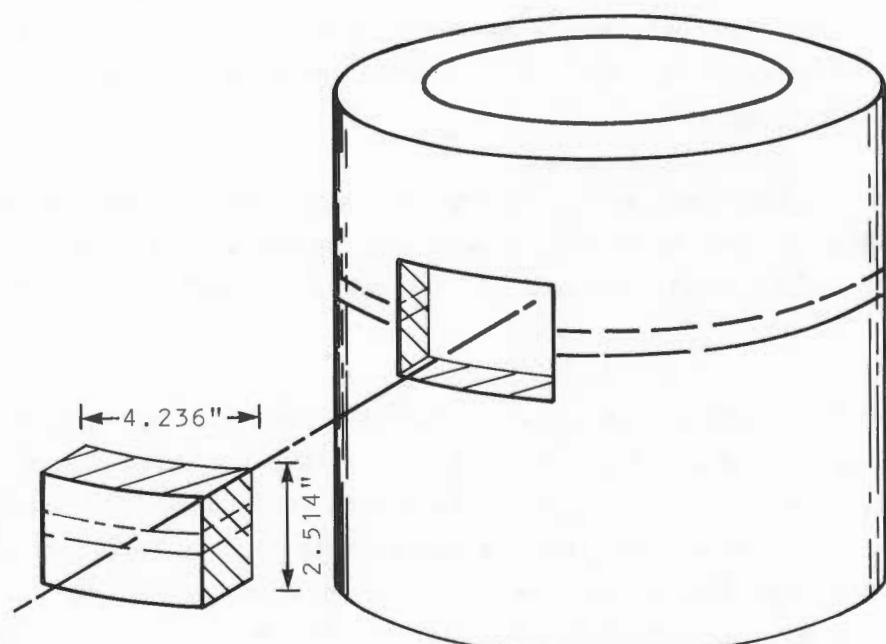
Figure 3-9 Circle Seam Test Sample Location

Ultrasonic examinations of a reactor vessel circle seam indicated the presence of flaws. The results obtained with standard UT shop practices were ambiguous with respect to acceptability of the flaws. Significantly different results were obtained at different ultrasonic frequencies using conventional UT. The location of the defects that were examined is shown in Figure 3-9A.

The section of the component that was of interest was removed after the initial AH images were obtained (Figure 3-9B). Radiographic images were made of the removed section. Additional tests using conventional UT equipment were made for both contact and immersion type examinations. The additional UT tests were still ambiguous although the immersion procedure did provide higher sensitivity than the contact procedure.

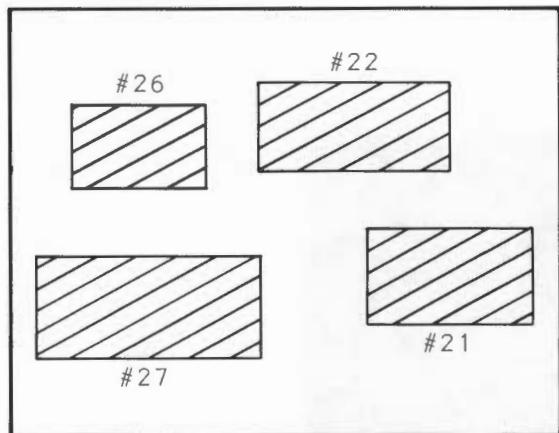
Conventional UT indications of potential defects in a section of a long seam weldment were observed during a routine examination. The ultrasonic inspection data indicated that the discontinuities were oriented in the weld such that the normal to the major reflecting surfaces was parallel to the weld axis. It appeared that the plane containing these cracks was parallel to the longitudinal cross section of the weld (normal to the surface).

Sketch of AH Images Obtained with 0°  
Longitudinal 3MHz Beam.

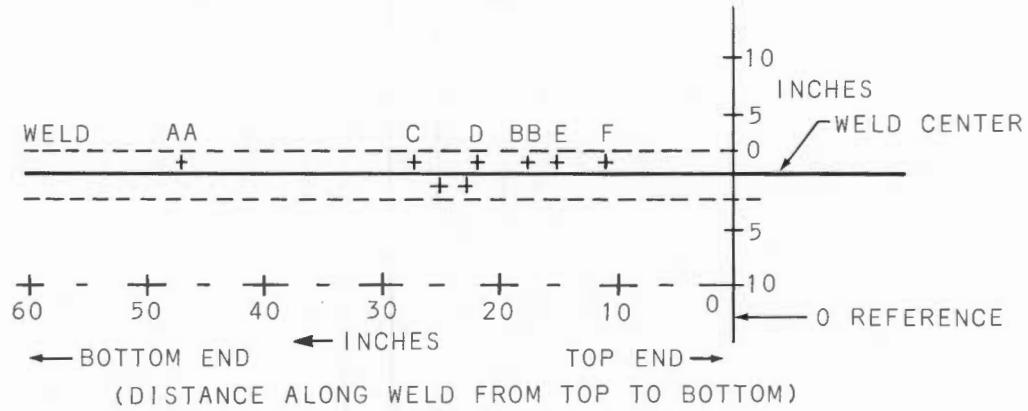
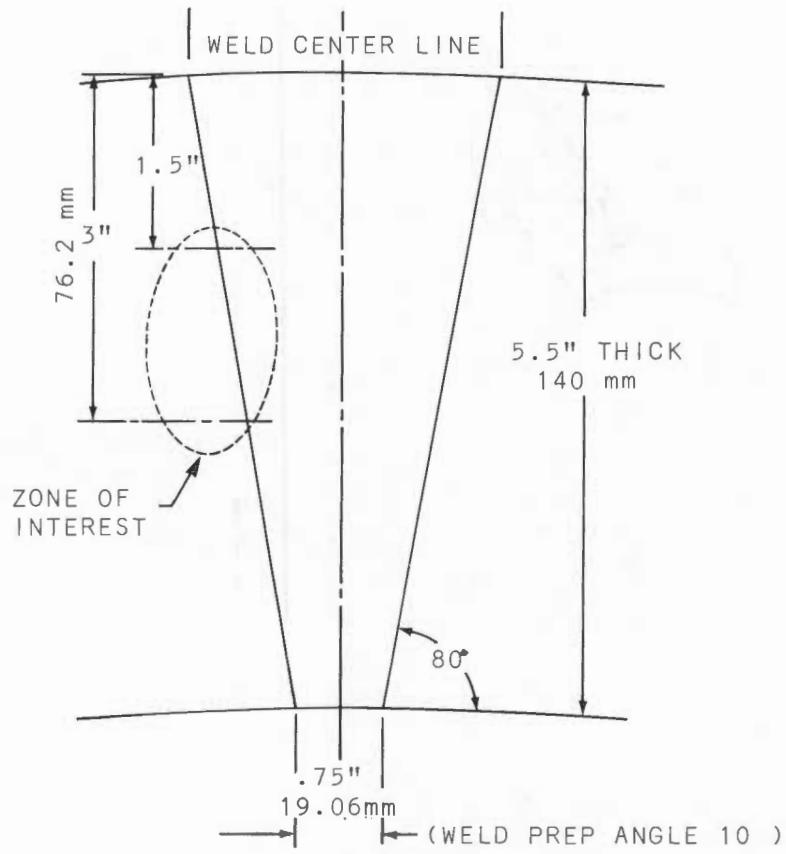
Figure 3-12 Location of Defects

Areas designated C, D, E, and F on Figure 3-12A contained clusters of discontinuities of the type of interest. Indications in areas AA and BB appeared to be isolated discontinuities of the same type as in areas C through F. Conventional UT indicated that the defects in areas XX and YY were of a different type and of different orientation.

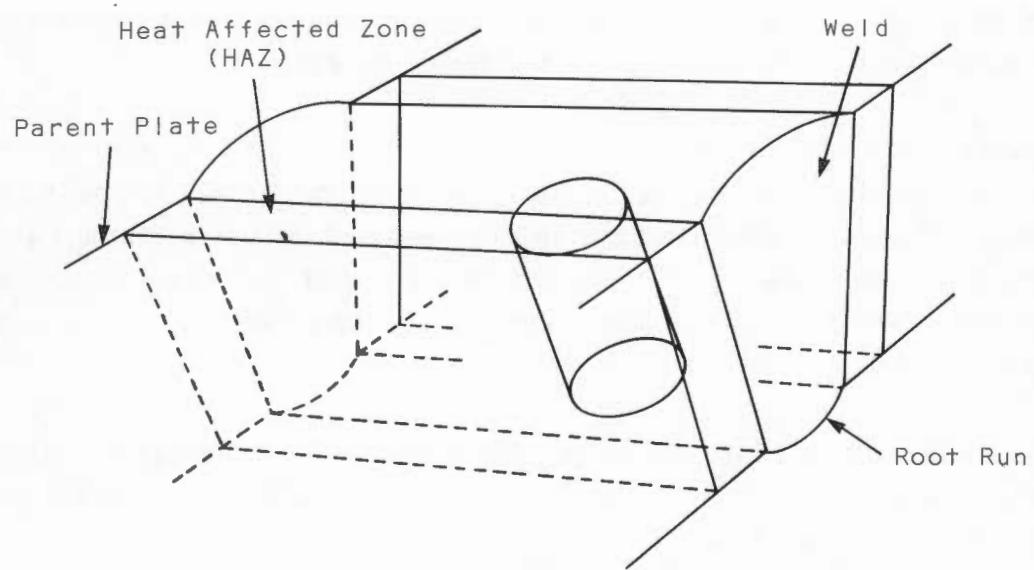
Figure 3-15 Position and Orientation of Core Plug Sample

Destructive tests (DT) of core plugs from areas D, E, and F were conducted that did not quantify the transverse dimension of the defect (see Figure 3-15). Additional DT results are incorporated in Appendix B. DT was performed at a site and by personnel that were not under the control of the RP-605 team. The transverse orientation of the defect was verified and the thru-wall extent measured.

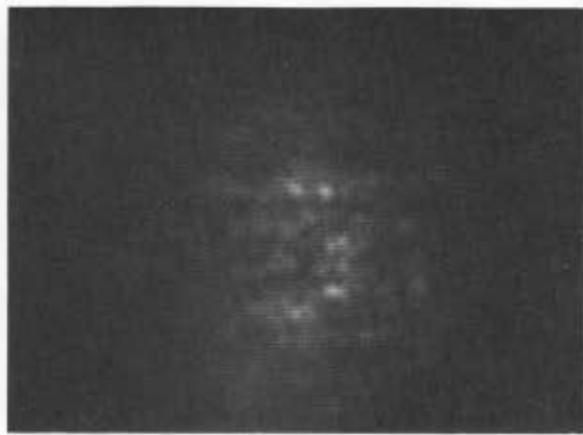
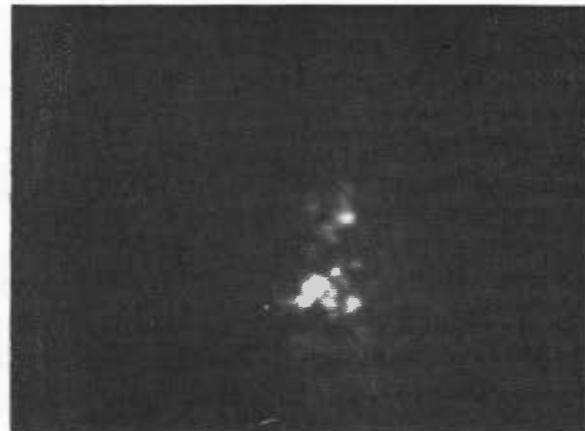
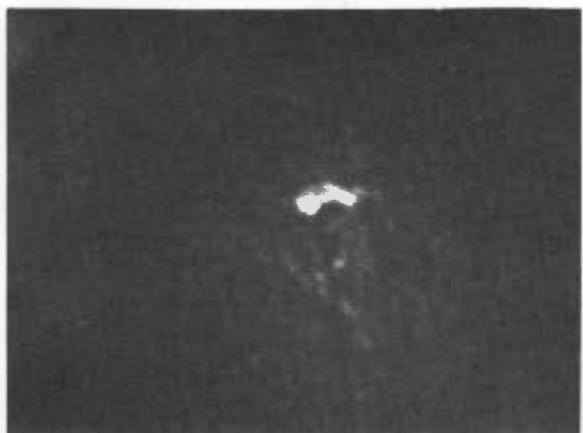
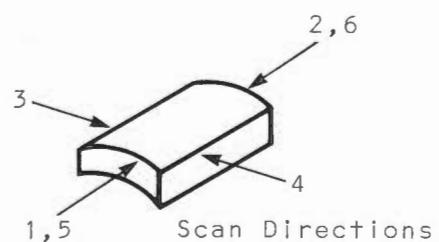
Figure 3-16 AH Images of Defect "D"

- a. In area D a crack was found to be present in the plate material immediately adjacent to the heat affected zone (HAZ), at a depth of 1.89" (48 mm) below the weld surface (see Appendix B, Figures B-1 and B-2). Closer examination of the crack showed it to be intergranular and further grinding showed the defect to be 0.07" (1.8 mm) in the thru-wall dimension parallel to the weld. The transverse nature of the crack was verified, but the dimension was not recorded.

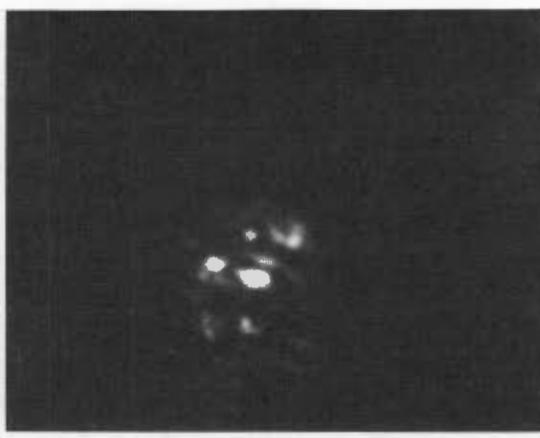
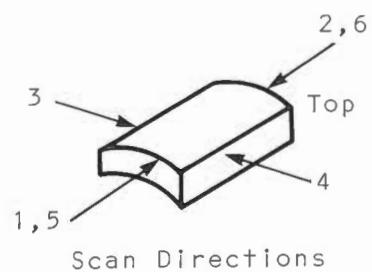
Figure 3-17 AH Images of Defect E

- b. In area E, a macro-section (see Appendix B, Figure B-3) showed two cracks to be present. The larger crack was at a depth of 1.96" (50 mm), with a thru-wall dimension of 0.43" (11 mm). The other crack, which had a thru-wall of 0.08" (2 mm), was near the bottom of the plug at a depth of 2.4" (61 mm). In both of these cases, the cracks were oriented transverse to the weld, similar to the crack in area D. Appendix B, Figures B-4 and B-5, shows that these cracks were also intergranular in nature.

- c. An additional crack was found in area E at a depth of 1.77" (45 mm). This crack was oriented in a horizontal plane, i.e., in a plane at right angles to the other cracks in this area. The dimensions of this crack were 0.04" X 0.004" (1 mm X 0.1 mm) (see Appendix B, Figures B-6 and B-7).

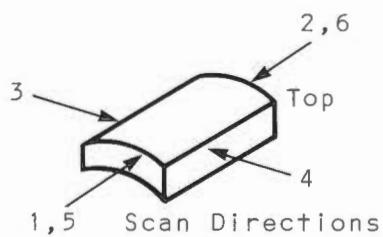
Figure 3-18 AH Images of Defect "F"

- d. In area F the crack found was also transversely oriented relative to the weld axis. The defect was at a depth of 1.81" (46 mm) (see Appendix B, Figure B-8). It was not possible to accurately measure the thru-wall extent of this crack since it had been partly removed by machining. Appendix B, Figure B-9 also showed this crack to be intergranular in nature.

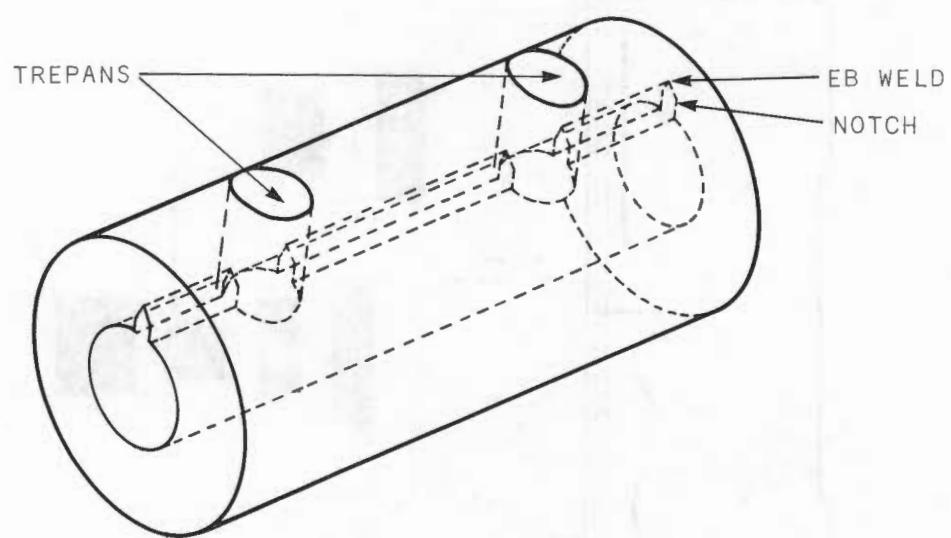
Figure 4-5 Location of HSST#1 Trepans

HSST No. 1 had two trepans removed after the first thermal shock. The baseline AH images indicated that the size of the insert that was installed in the holes, created by the trepans, was within 5% of the actual size. The relationship of the trepans to the test specimen is shown in Figure 4-5. The baseline and post test AH images are shown in relationship to the test specimen and the scan segments in Figure 4-6 (HSST No. 1) and Figure 4-7 (HSST No. 2). The HSST No. 1 AH images showed that the thermal shock did create a crack and that the extent of the crack increased in the area of the trepan replacements. The trepan replacements consisted of inserts that were welded in place at the outer surface of the pressure vessel. Post-shock destructive tests indicated that the AH results were accurate and valid (see Table 4-1). The AH derived measurement of the thru-wall extent of the crack was within 10% of the actual value. The HSST No. 2 AH images also agreed with the destructive test results.

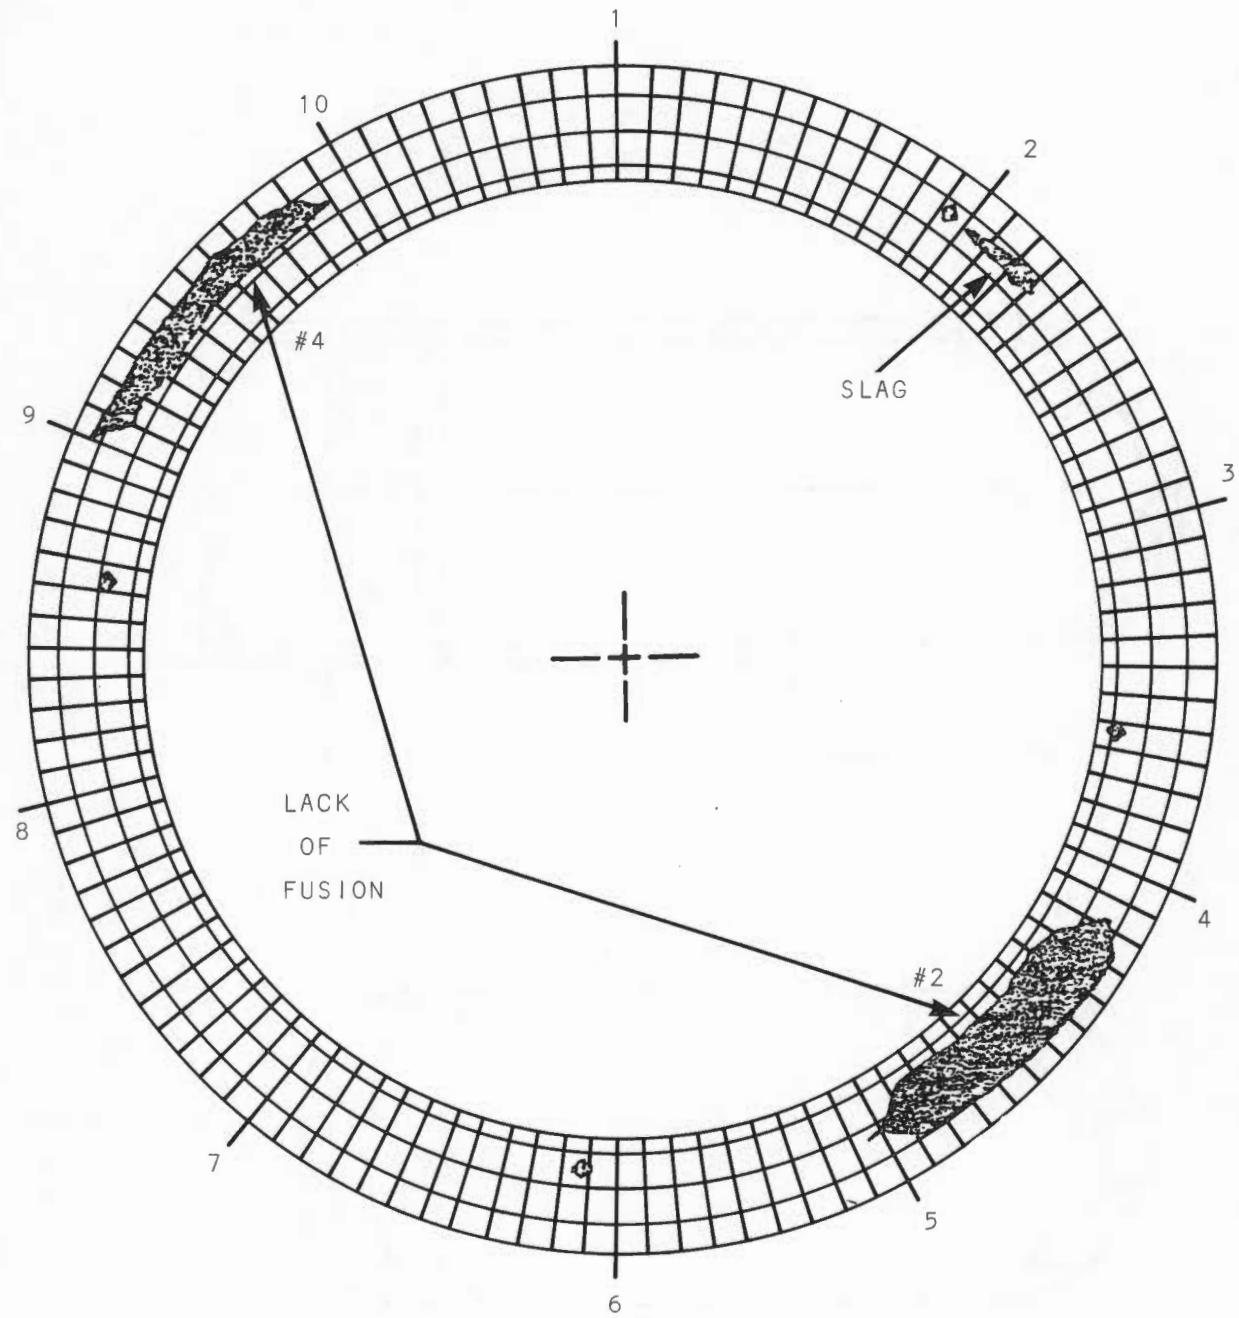
Figure 4-11 Cross-sectional View of Head Weld Defects and Radiographic Test Stations

degree beams. RT was performed in accordance with ASME Section III code. Two defects (No. 2 and No. 4) were selected for AH imaging. The characteristics of these two defects are given in Table 4-2 as determined from the UT and RT inspections.

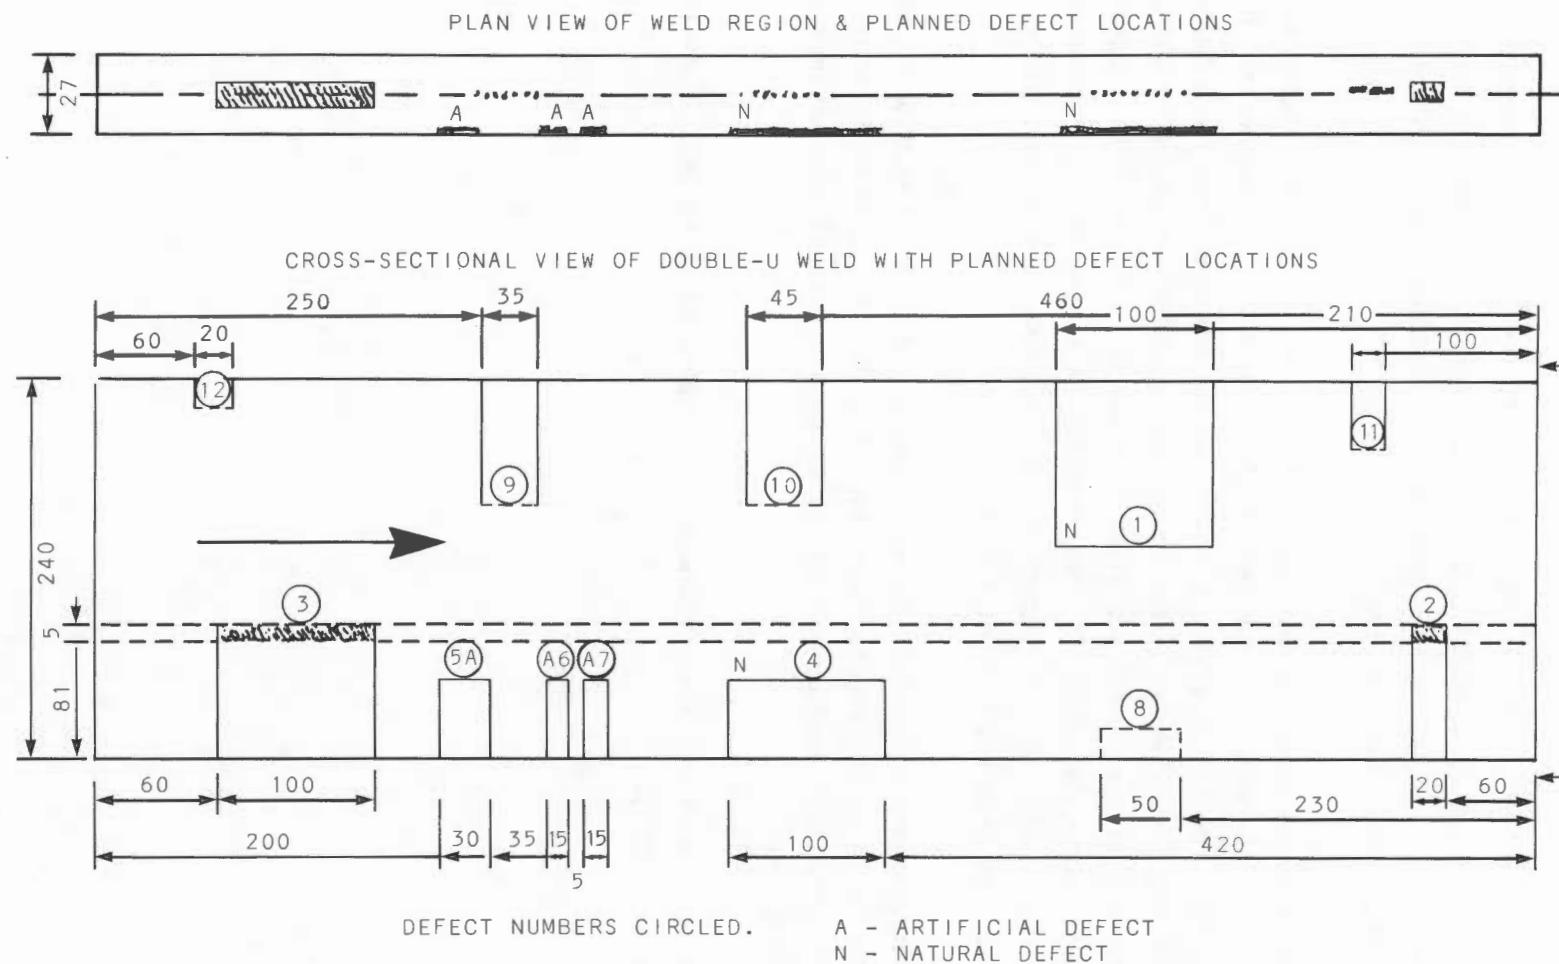
Figure 4-20 Reduced Sketch of the French Fabrication Drawing Used to Weld the Test Block

All the discontinuities identified in Figure 4-20 were imaged except for defects Nos. 2, 11 and 12. Defects 2, 11 and 12 were located near the ends of the block and the rough ends of the test block introduced signals that masked the returns from these three defects.
