PERFORMANCE EVALUATION OF AUTOMATIC EXTRACTION SYSTEM

VOLUME II - PERFORMANCE EVALUATION OF THE AES

FINAL TECHNICAL REPORT

CONTRACTOR - THE DEPARTMENT OF MINERAL ENGINEERING
THE PENNSYLVANIA STATE UNIVERSITY

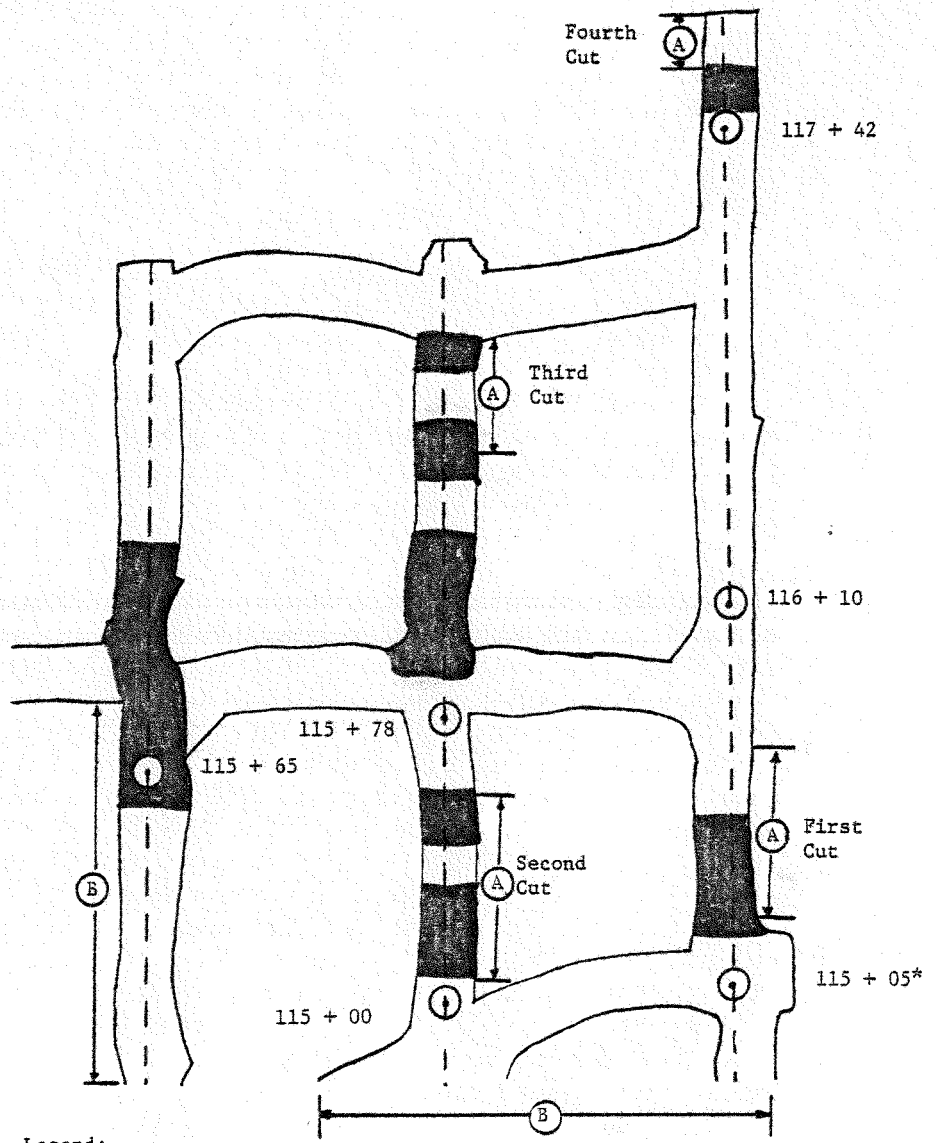
2.6.22 Section Plan Map: Figure 25 shows a plan map of the section showing roof falls. A detailed roof-condition report is being prepared at the time of this writing under a contract extension. That report will be submitted separately, and will show other pertinent geological data.

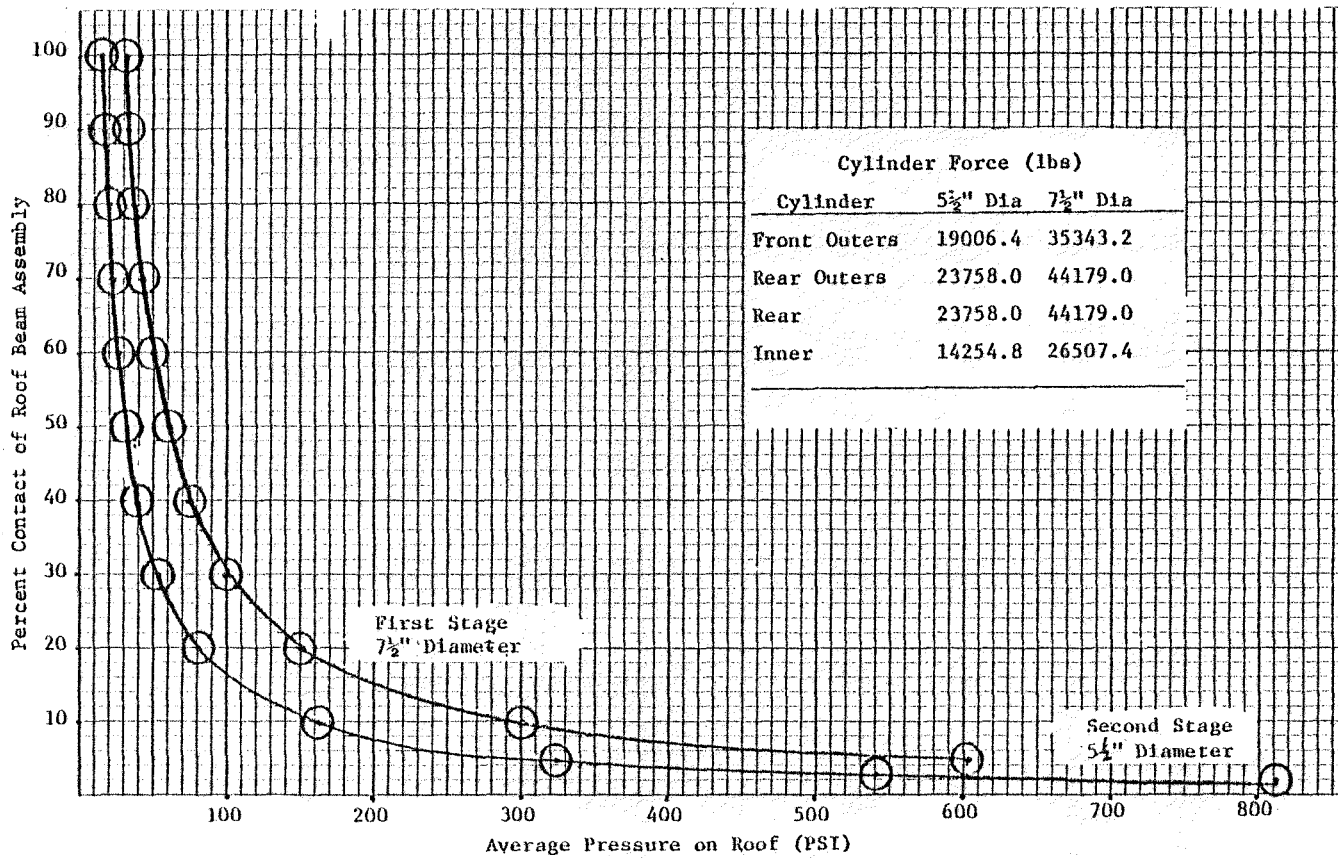
Percent Contact of Roof Beams vs. Roof Pressure at Cylinder Operating Pressure

delays during bolting are believed to have been partially responsible for this fall. 3) When the roof beams were used, they caused the roof to deteriorate. Point loading situations appeared to have increased the pressure applied to the roof. Figure 26 shows the relationship between roof pressure and the amount of contact area achieved by the roof-beam assembly. At 100 percent effective contact, the roof pressure ranges from about 15 psi to about 32 psi. However, at ten percent contact, the range is from about 163 psi to about 302 psi.

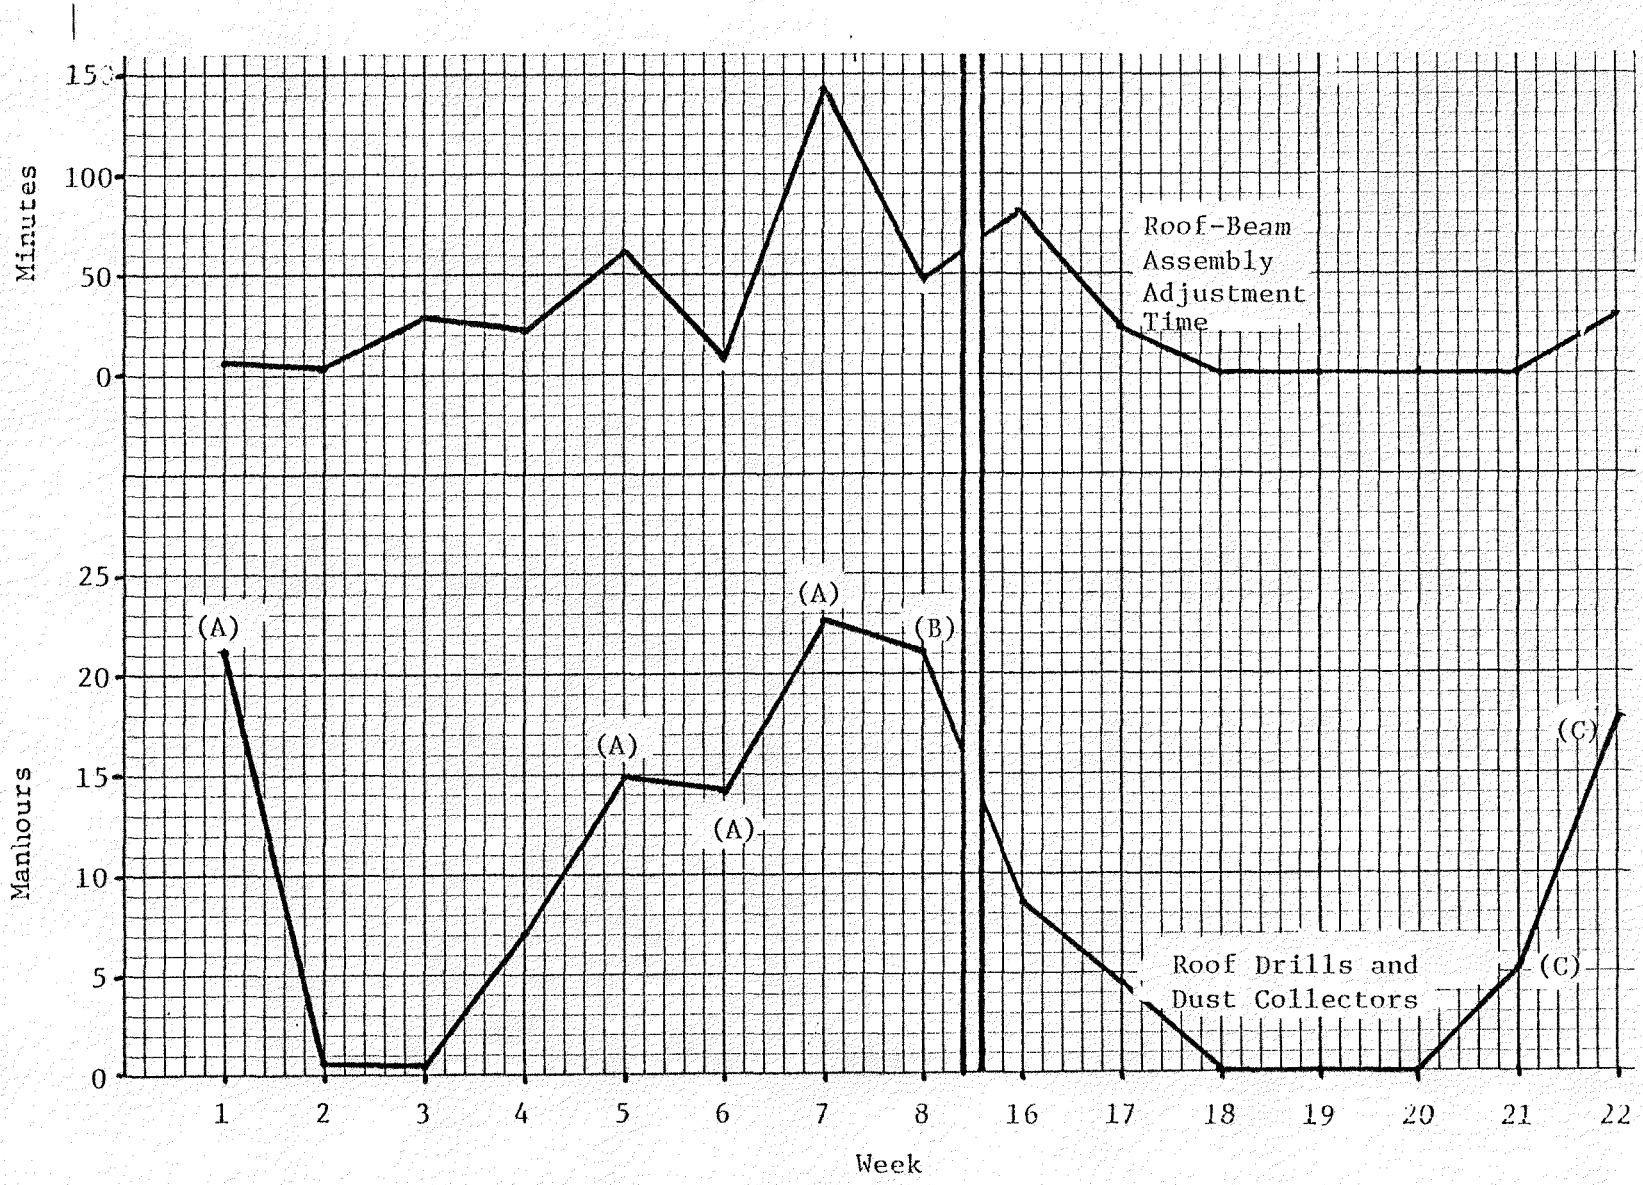
Figure 35
 Roof Drills and Dust Collector Maintenance Manhours vs. Time
 Roof-Beam Assembly Adjustment Time vs. Time

The lower portion of Figure 35 shows the maintenance manhours on a week-by-week basis, and the upper graph shows an operating parameter. In this case, the maintenance parameter is the manhours required to maintain the AES' roof drills and dust collectors. The upper graph portrays the number of roof bolts inserted during each week. Reference A shows maintenance on broken dust-collector couplers, motors, or blowers. Reference B shows the maintenance in broken piping or hoses that were replaced, a damaged dust collector motor that was replaced, and oil leaks that were repaired. Reference C shows when maintenance was performed on the right-inner drill-rotation potentiometer.

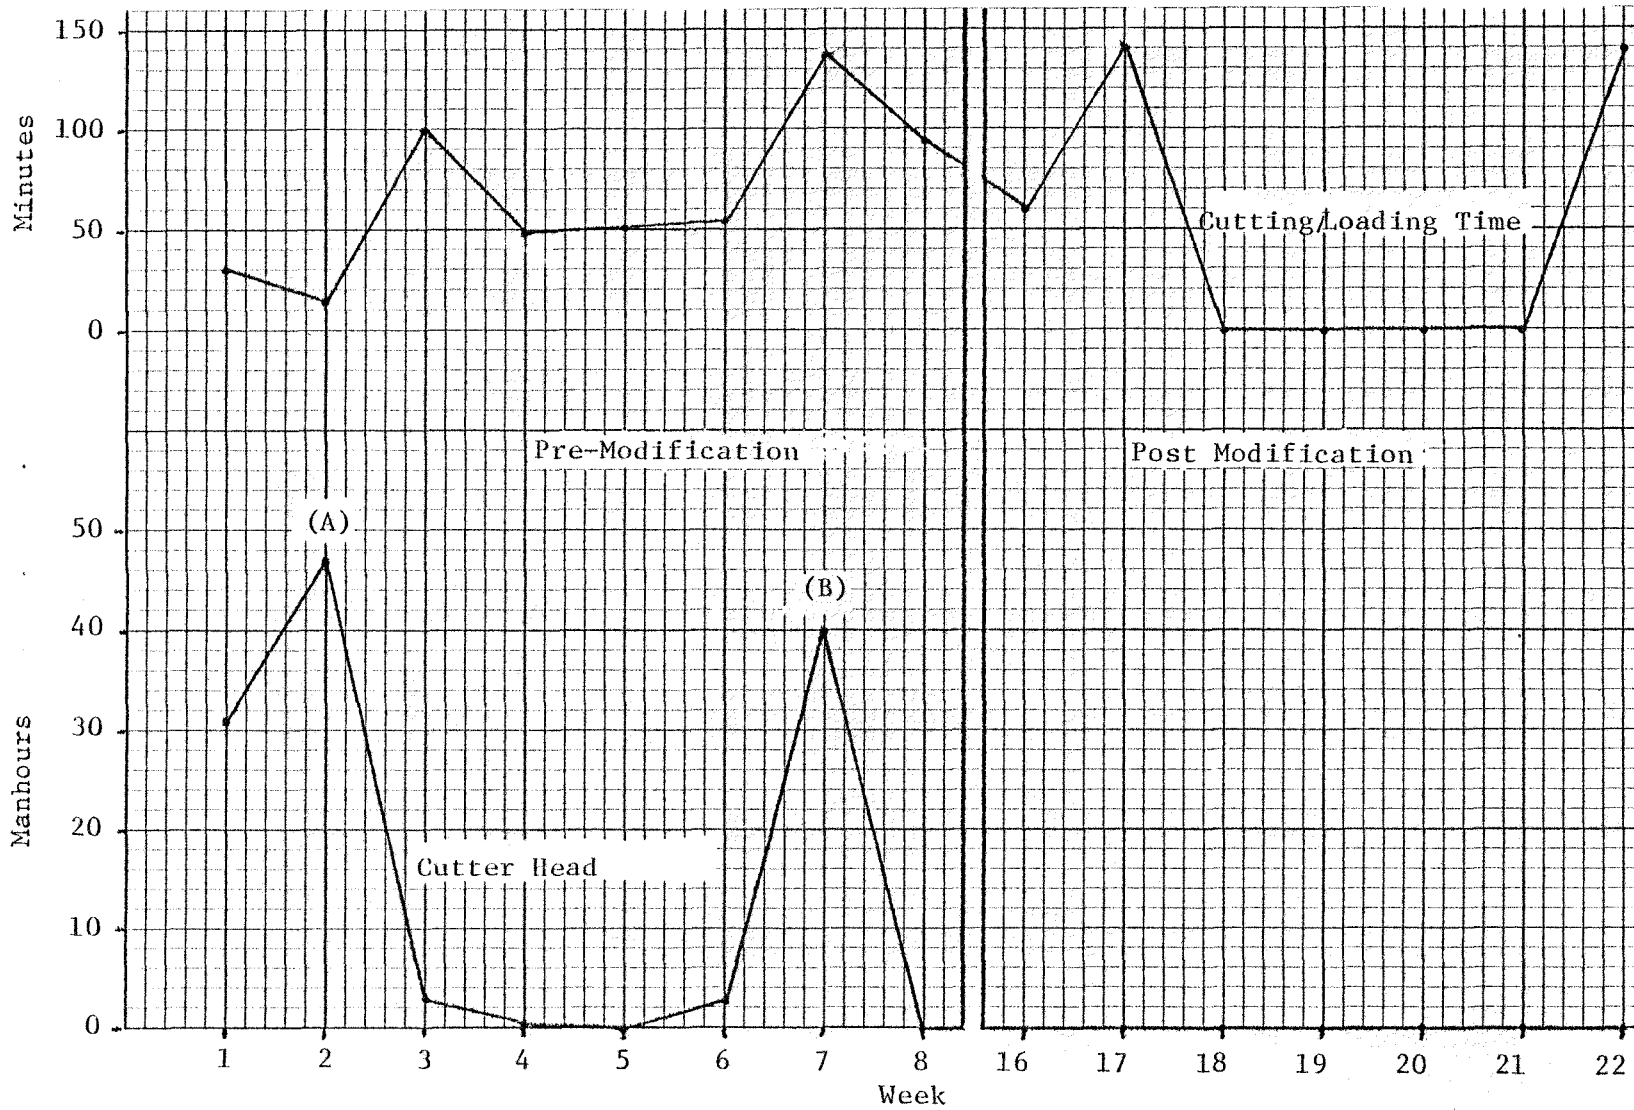
Figure 36
 Cutter Head Maintenance Manhours vs. Time
 Cutting/Loading Time vs. Time

In Figure 36 (Cutter Head vs. Cutting and Loading Time), reference A shows maintenance on the damaged cutter-head tie-shaft. Reference B shows work performed on the damaged motion-control valve. The DSC was determined to be 55.9 percent for an r of 0.04.

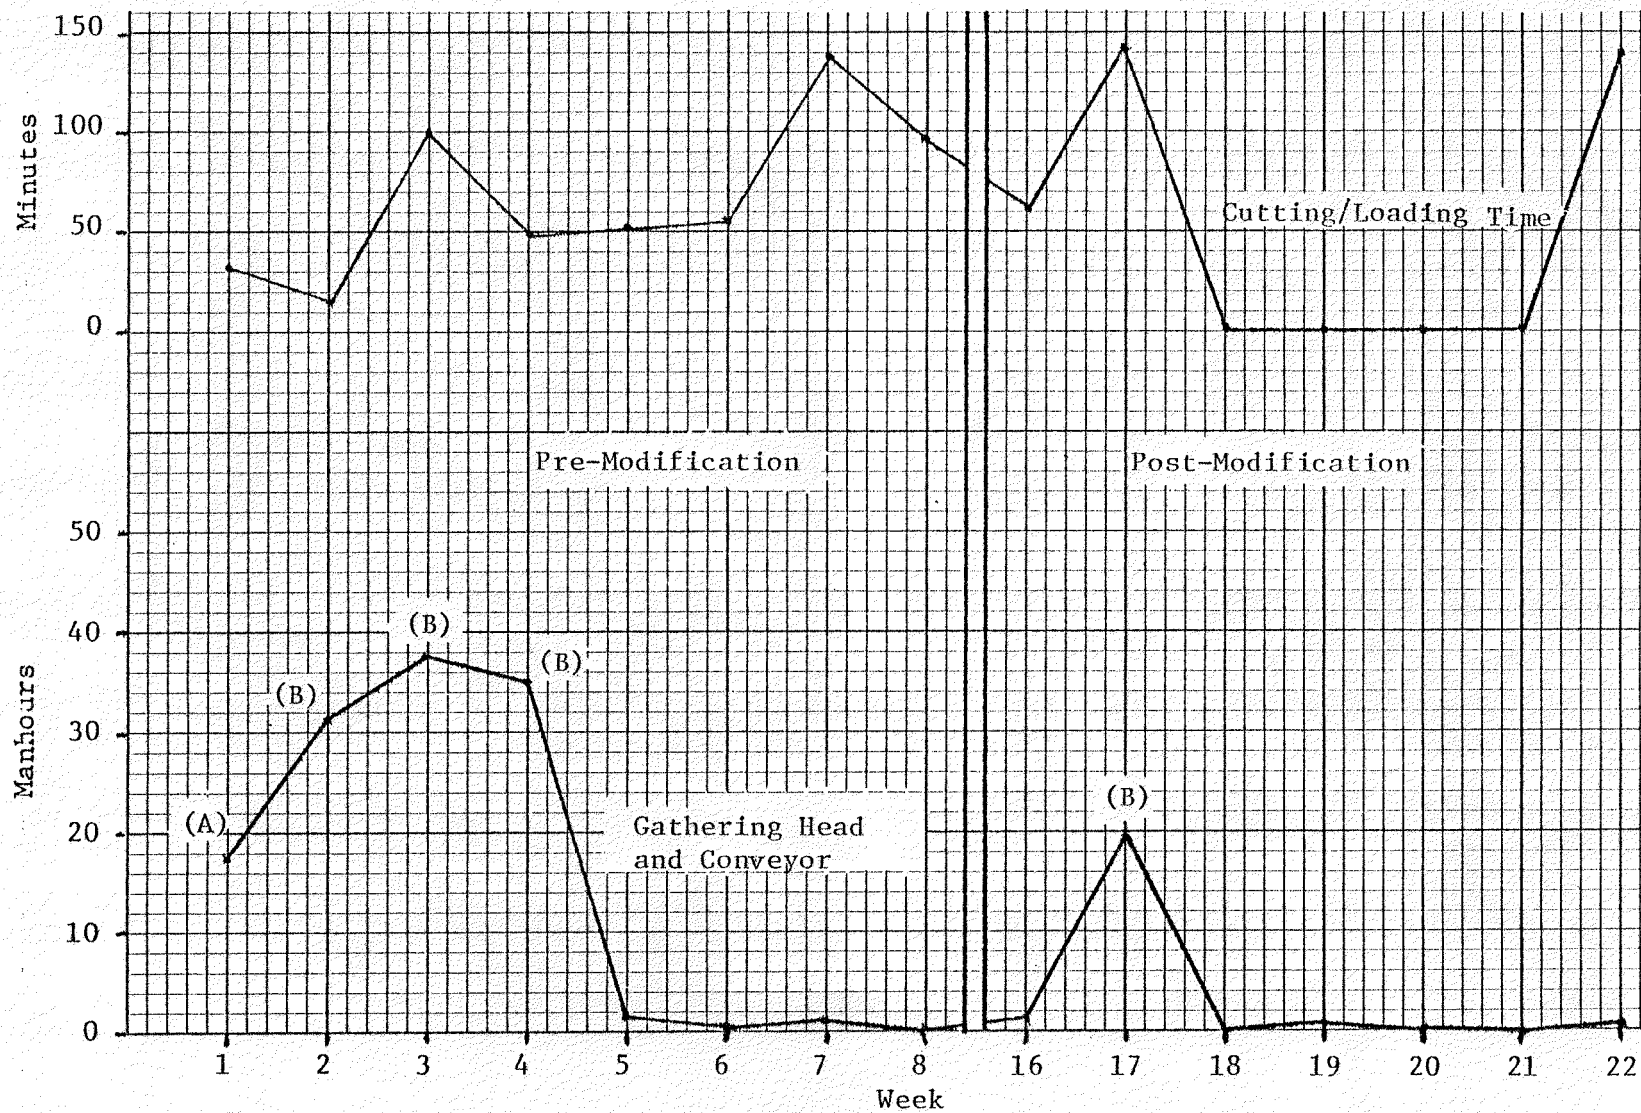
Figure 37
 Gathering Head and Conveyor Maintenance Manhours vs. Time
 Cutting/Loading Time vs. Time

In Figure 37 (Gathering Head and Conveyor vs. Cutting and Loading Time), reference A shows work performed on the repacking of the conveyor take-up cylinder. Reference B shows gathering-head motor-failures. The DSC was determined to be 63.9 percent for an r of 0.10.

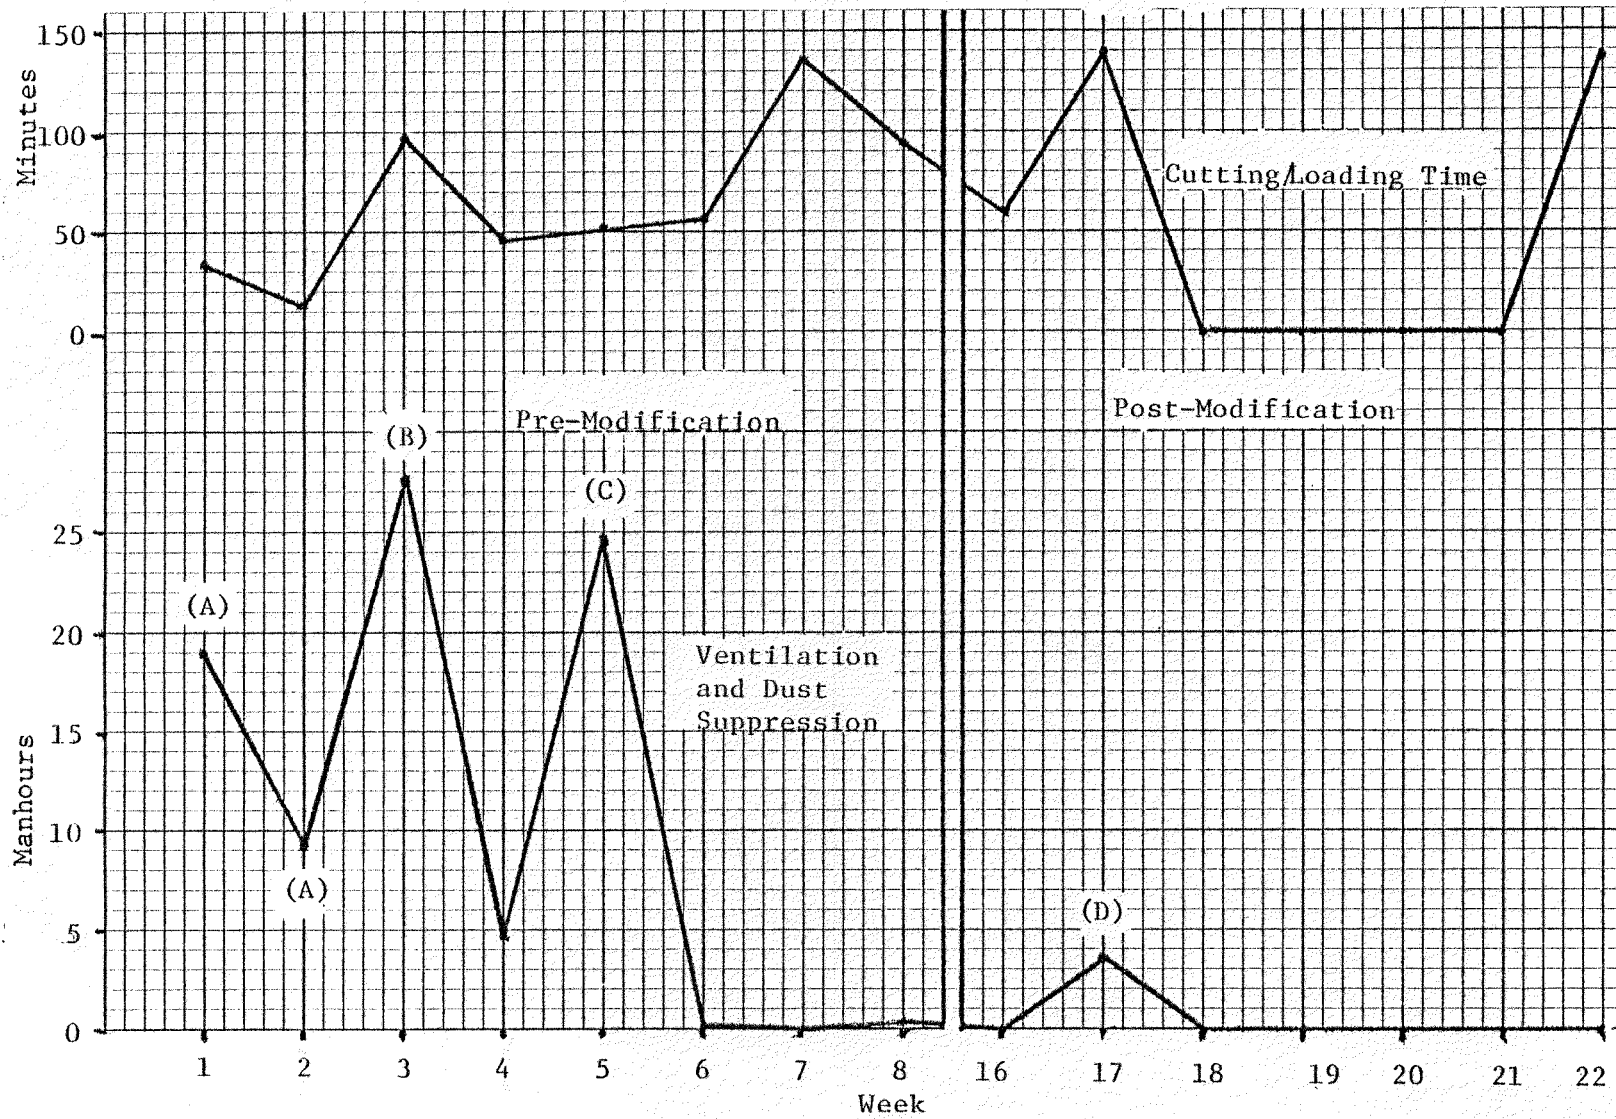
Figure 38
 Ventilation and Dust Suppression Maintenance Manhours vs. Time
 Cutting/Loading Time vs. Time

In Figure 38 (Ventilation and Dust Suppression vs. Cutting and Loading Time), reference A shows manhours used to plug water sprays in order to reduce the amount of water introduced into the face. Reference B shows repair time on a loose ventilation-fan wire in a junction box. Reference C represents a replacement of two ventilation-fan motors due to an undersized spring in a relief valve. Reference D represents welding on a crack in the extensible ventilation duct. The DSC was determined to be 56.3 percent for an r of 0.04.
