POSTIRRADIATION EXAMINATION RESULTS FOR THE IRRADIATION EFFECTS TEST SERIES IE-ST-2 ROD IE-002

TREE-NUREG-177

POSTIRRADIATION EXAMINATION RESULTS FOR THE IRRADIATION
EFFECTS TEST IE-ST-2 ROD IE-002

December 1977

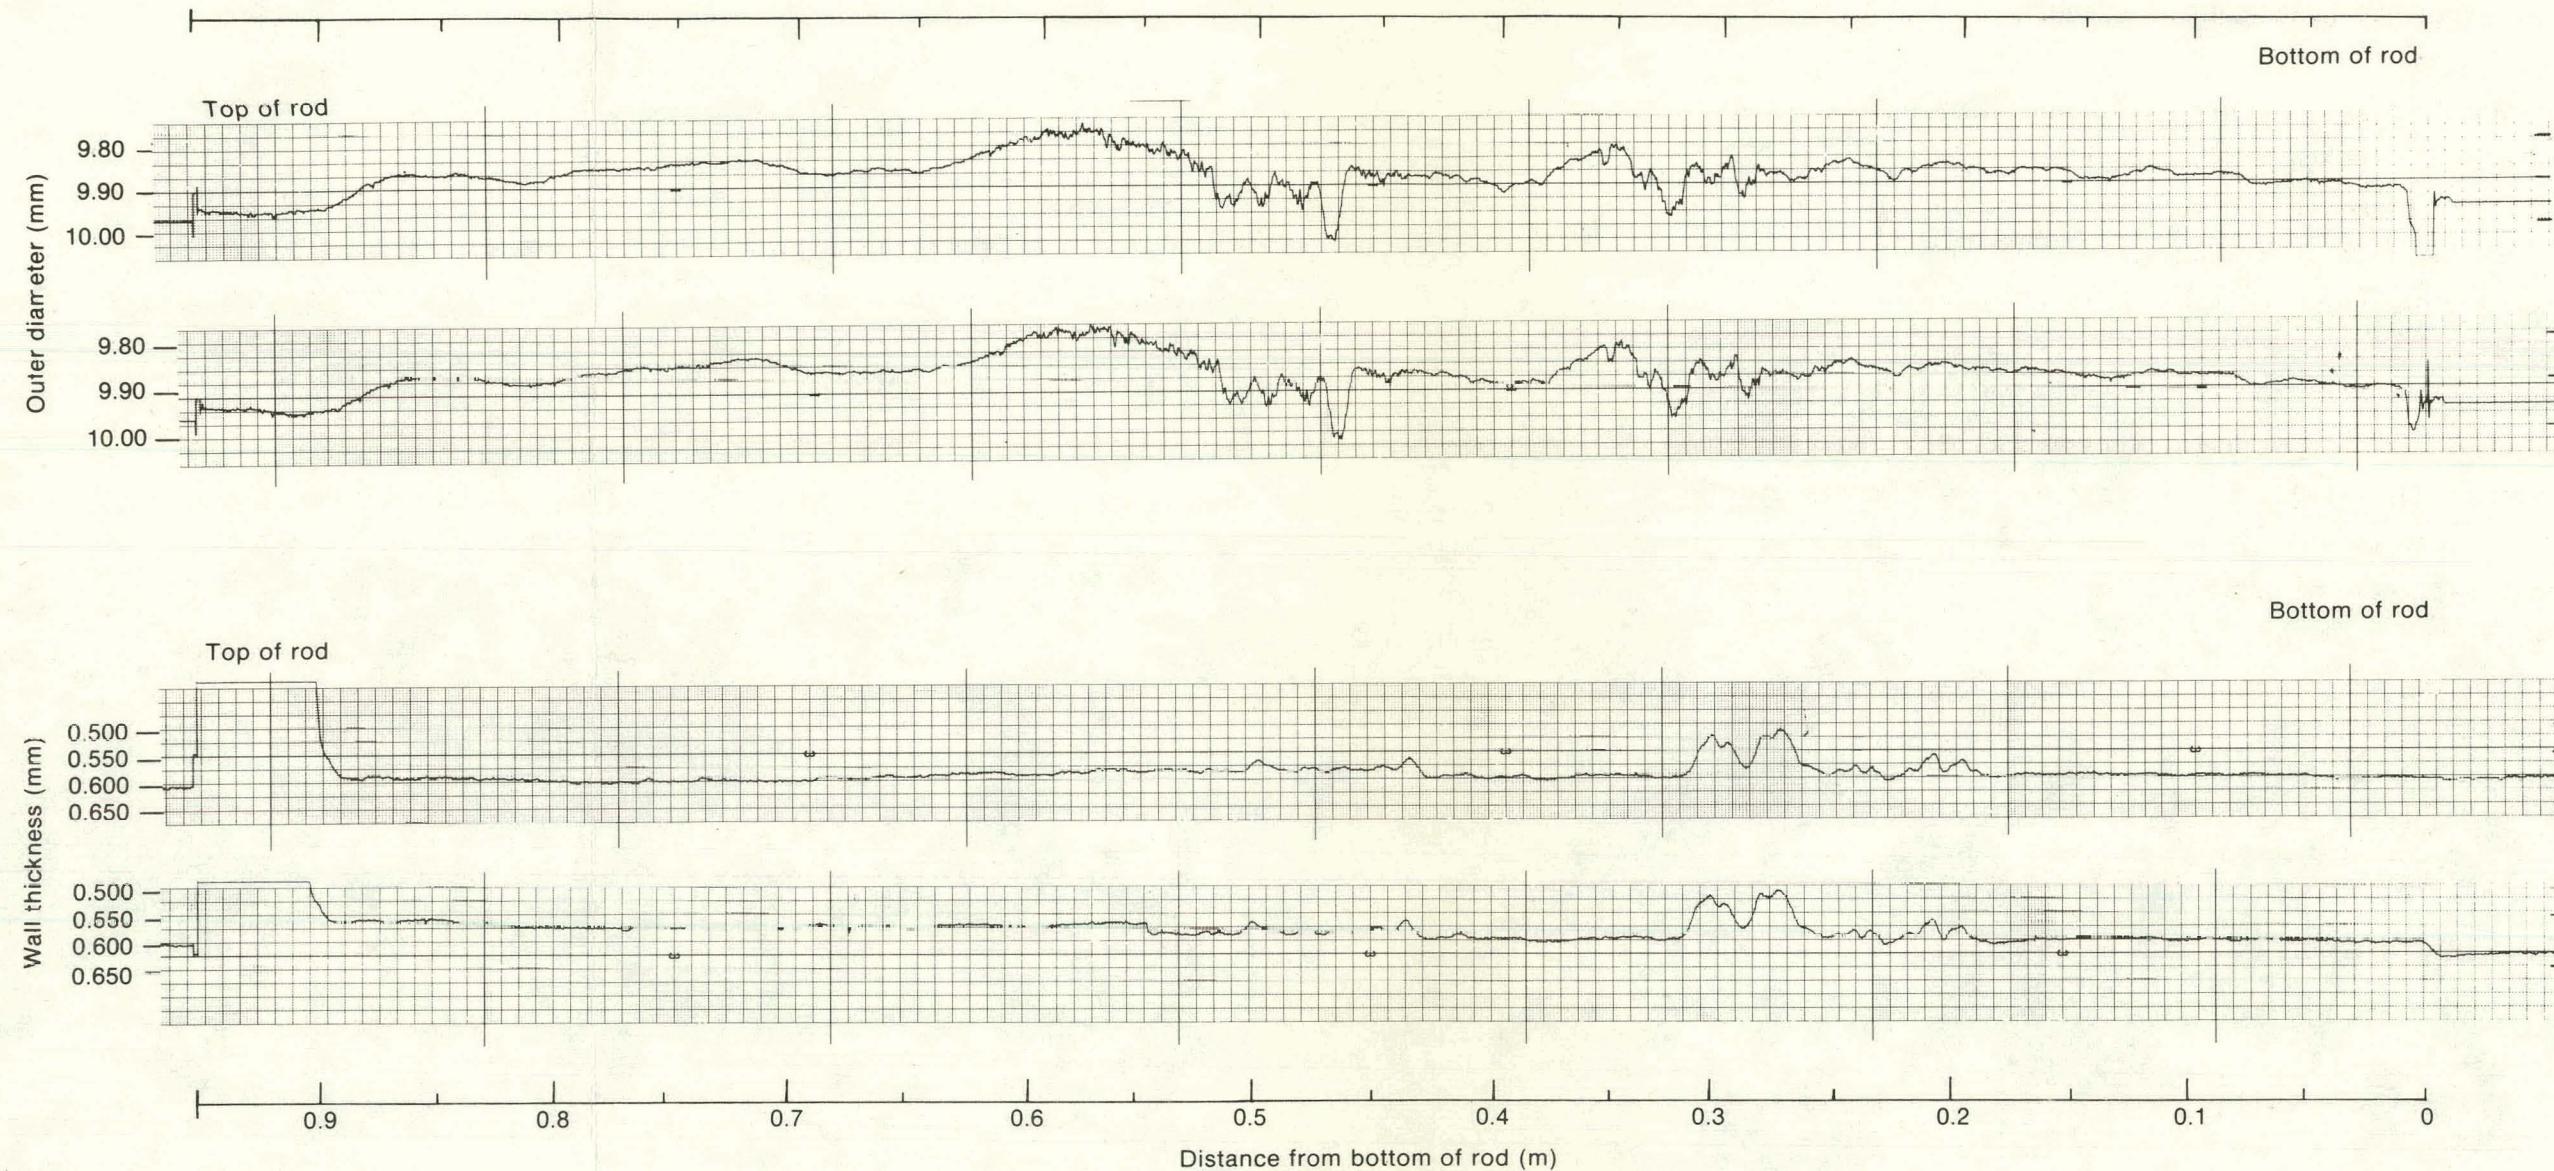
Fig. A-1 Pulsed eddy current scans of Rod IE-002.

Many of the orientations on fuel Rod IE-002 were scanned twice. Figure A-1 shows an example of two scans at one orientation for both the outer diameter channel and the wall thickness channel. The repeatability of these measurements was excellent. The accuracy of the diameter and wall thickness measurements was estimated to be within ± 0.008 mm. The precision of these measurements was 0.003 mm.
