FAILURE ANALYSIS OF GLASS-CERAMIC INSULATORS OF SHOCK TESTED VACUUM (NEUTRON) TUBES

R. K. Spears
Metallurgy and Ceramics Laboratory

August 25, 1980

General Electric Company
Neutron Devices Department
P. O. Box 11508
St. Petersburg, Florida 33733

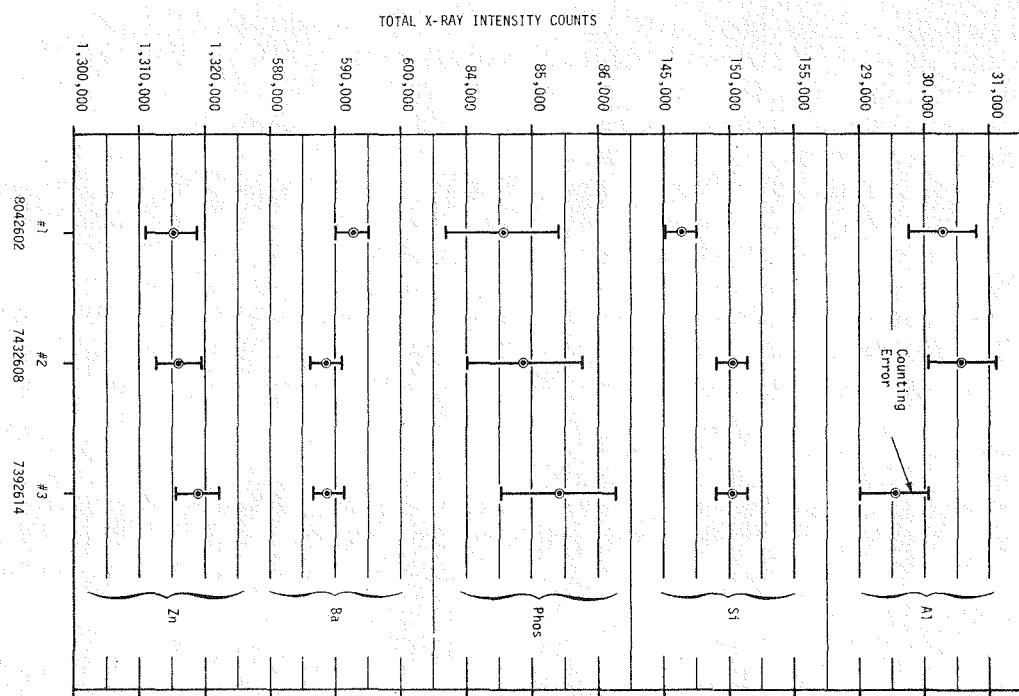
Gross differences in chemical elements having an atomic number of 13 (aluminum) or above can be determined using X-ray emission spectroscopy. Due to the fact that standards were never developed for this inspection technique, the analysis is not quantitative. However, by comparing the relative count it is possible to determine major differences. For this study, a 1/4-in. square area was polished to 16 microinches and examined for Si, Al, Zn, Ba and P by comparing the X-ray counts for a 100-s exposure in each sample. The results (shown in Figure 20) show no substantial differences in chemical content of the three samples submitted.

Figure 20. Graphical Comparison of Chemical Differences Detected in Insulators Using X-ray Emission

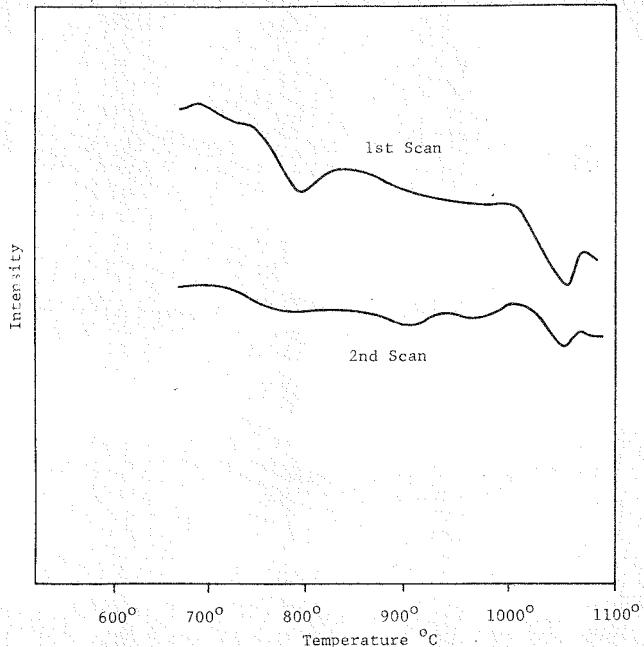
A differential thermal analysis thermogram was made on cubes (0.125 in. edge) from each of the three insulators. This analysis, using the second highest sensitive scale, showed a minor amount of activity in the crystal growth region. With the high sensitivity scale, there was considerable noise that may have been interpreted as annealing or ceraming activity. The rerun thermogram of the three samples showed a definite decrease in activity at 750 to 850°C . Figure 21 is a copy of the thermogram for Insulator A and is typical of all three units. The precise cause of this additional thermal activity or effect on the insulator is not known. The activity may be associated with coarsening of the crystalline phase of the glass-ceramic which has been evident in the past.

Figure 21. Comparison of Differential Thermal Analysis Thermograms. Insulator A. (The second scan is a repeat of the sample scanned initially. These are typical of the results on all three insulators. The decrease in activity at 800°C during the second scan is of interest.)
