Asphalt Emulsion Sealing of Uranium Mill Tailings 1979 Annual Report

June 1980

1979 ANNUAL REPORT

Pacific Northwest Laboratory
Richland, Washington 99352

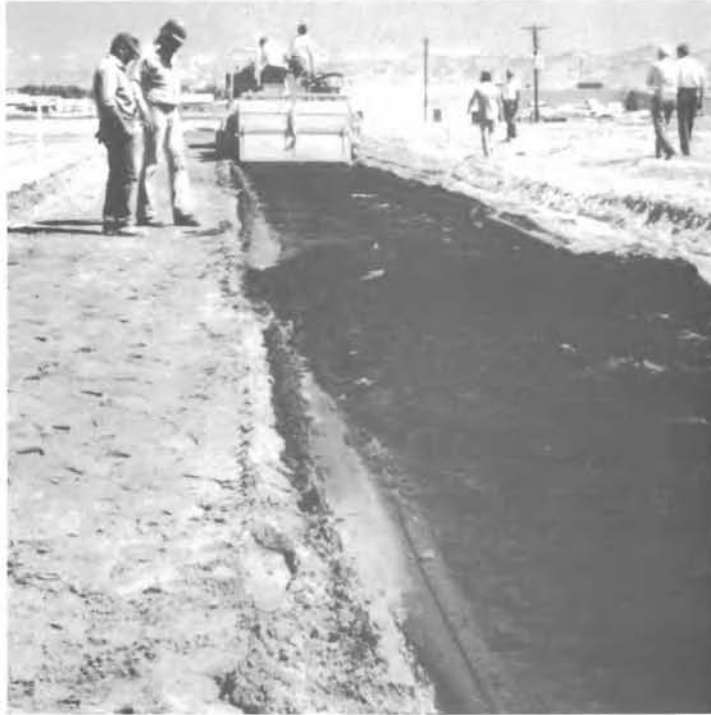
FIGURE 18. Preliminary Test of BOMAG MPH 100 Applying Asphalt Emulsion

For the first application of asphalt emulsion, an 18 wt% residual asphalt, one-pass, admix seal was attempted. The BOMAG MPH 100 connected to the distributor truck was operated at 6.1 m/min (20 ft/min). Poor traction caused the rear wheels to dig into the tailings, resulting in much deeper penetration of the blades into the tailings than planned. After approximately 15.2 m (50 ft), this pass was stopped and then continued at a rate of 12.2 m/min (40 ft/min) (see Figure 18). The MPH 100 continued to bog down somewhat due to the fact that the MPH 100 was pushing the distributor truck, which did not have good traction in the fluffed tailings. The admix was compacted with a BOMAG vibrator compactor (see Figure 19) about 4 h after the admix was applied.

Examination of the seal the next day showed that the admix seal had set up very hard. However, due to the problems with putting down the admix seal at slow rates and with pushing the distributor truck, this method was determined to be unsuitable for use on the main test plot.

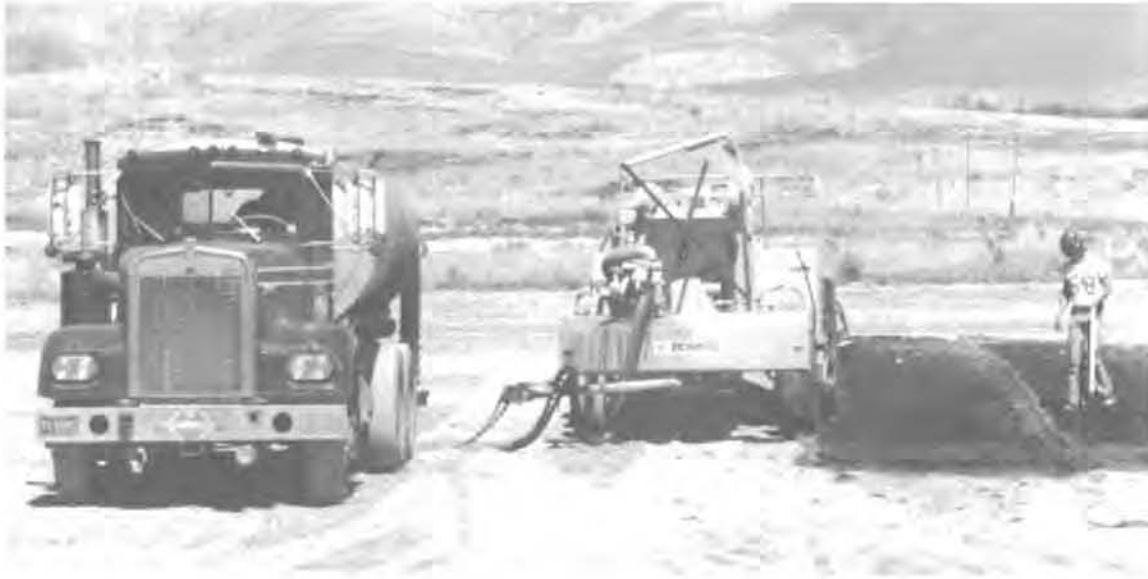
FIGURE 20. BOMAG MPH 100 and Distributor Truck Operating in Tandem

For the second preliminary test the distributor truck was hooked in tandem with the MPH 100, offset to the side, and traveled under its own power (see Figure 20).

Also, instead of applying 16 to 18 wt% residual asphalt in one pass, a series of passes was made to achieve the 16 to 18 wt% residual. The first pass, ~9 wt%, was made and allowed to set. Close inspection indicated inadequate mixing of the tailings and emulsion; the MPH 100 went back over it without applying any more emulsion and remixed it. A second application of ~9 wt% residual asphalt was then applied, and subsequently remixed as before. After a several-hour wait to allow the water to separate, the strip was compacted with the vibrating compactor and allowed to set. A suitable admix seal was obtained with this procedure, so it was chosen as the one to use for the main test plot.

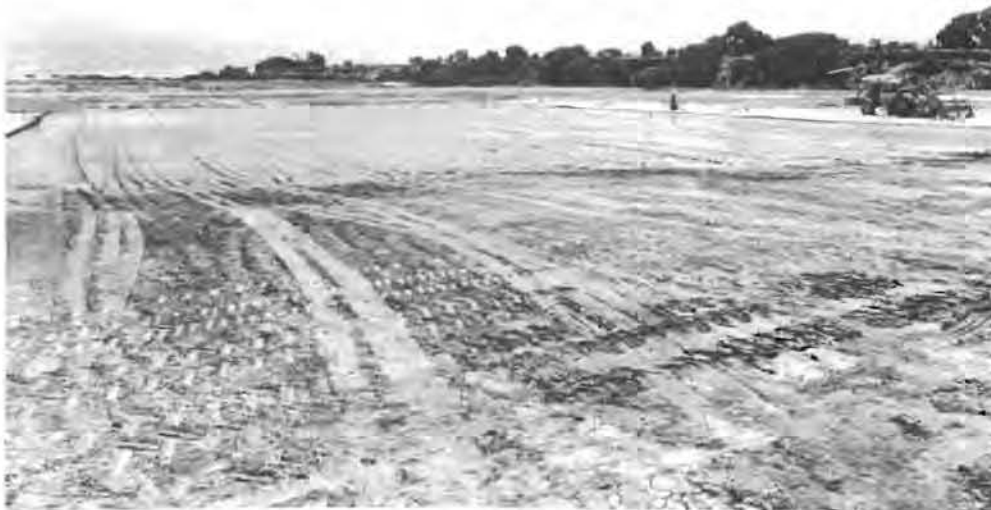
FIGURE 25. Spray-Coat-Sealed Major Test Plot

The next step in the tailings sealing procedure was the application of the spray-coat asphalt emulsion seal (see Figure 23). For the emulsion to penetrate the admix and bond well, the admix must be watered beforehand. However, when we were ready to apply the spray-coat seal, the water truck pump failed and we were not able to obtain a suitable substitute since it was on a weekend. The spray-coat seal was applied anyway, and a poor bond to the admix resulted. We could not wait until Monday because the admix seal would have been too cured for the spray-coat seal to bond. The sprayed-on asphalt emulsion was mechanically bonded to the compacted admix rather than electrostatically bonded. Therefore, the mechanical strength of the spray-coat seal was quite poor.

The spray-coat-sealed major test plot is shown in Figure 25.

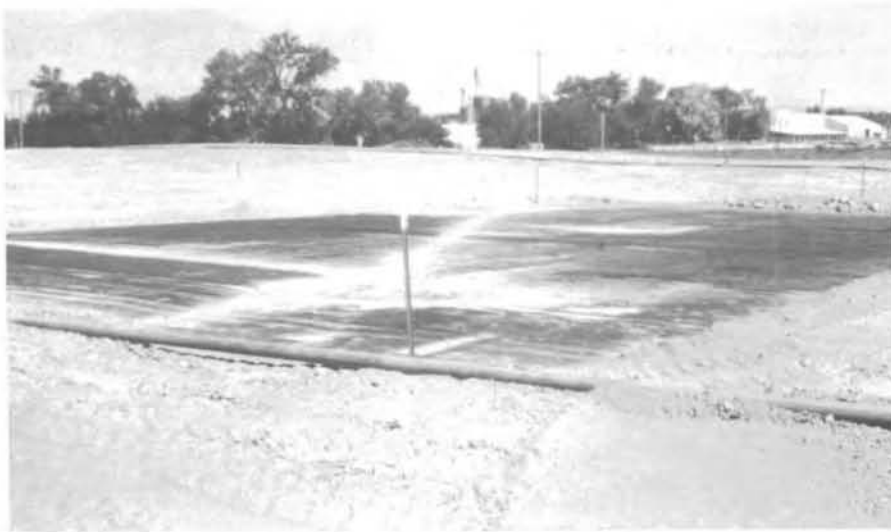
FIGURE 26. Overburden on Seal

The objective of the overburden application was to provide a protective cover over the asphalt emulsion seal. The cover/overburden depth must be deep enough to protect the seal from mechanical abuse as well as weathering. For this initial field test about two-thirds of the exposed seal was covered with 20 to 30 cm (8 to 12 in.) of soil overburden as shown in Figure 26.

Also included in part of the test plot was the addition of a herbicide, Treflan[®], to prevent root penetration. Treflan[®] was selected because of its ability to inhibit root growth rather than destroy the plant as most herbicides do. It was applied (Figure 27) after about 7.6 to 15.2 cm (3 to 6 in.) overburden was applied to the test area. Care was taken to prevent the overburden spreading equipment from breaching the admix spray-coat seal. Even with this care some breaching of the spray-coat seal occurred.

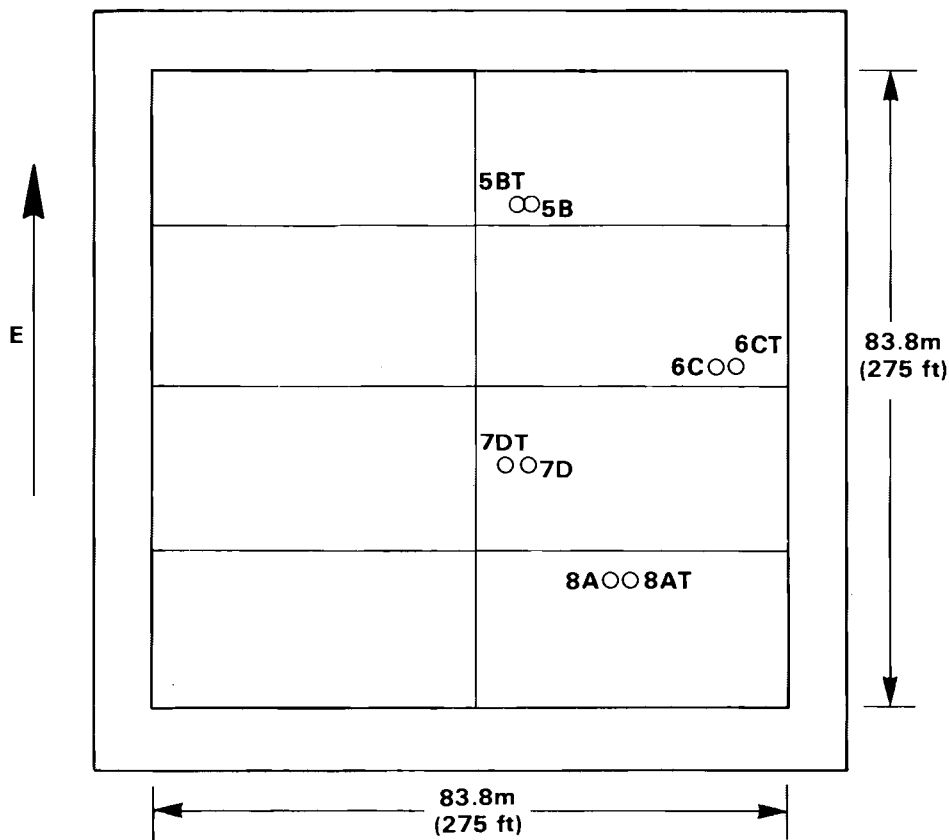
FIGURE 28. Approximate Locations where Seal Core Samples were Taken on the Grand Junction Tailings Site

In order to determine if the admix seal applied in the field was of the composition expected, core samples of the admix seal were taken and analyzed by an independent testing laboratory in Grand Junction. See Figure 28 for sampling locations. The laboratory encountered considerable problems in obtaining the core samples using standard paving industry testing procedures. The reasons for this difficulty is threefold. First of all, the asphalt seal had not completely cured at the time of sampling. Therefore, the cores were not very strong and could not withstand the shearing action of the coring device. Secondly, the seal contained a much higher asphalt content than is encountered in the paving industry, which further added to the weakness of the seal cores. Lastly, the seal was poorly mixed and compacted, which even

further reduced the mechanical strength of the seal. However, the laboratory was able to obtain nine core samples that were suitable for analysis.
