SAND81-7028/1  
Unlimited Release  
UC-62

# Final Report Solar-Collector-Materials Exposure to the IPH Site Environment

## Volume 1

V. L. Morris  
Huntington Beach, CA 92647

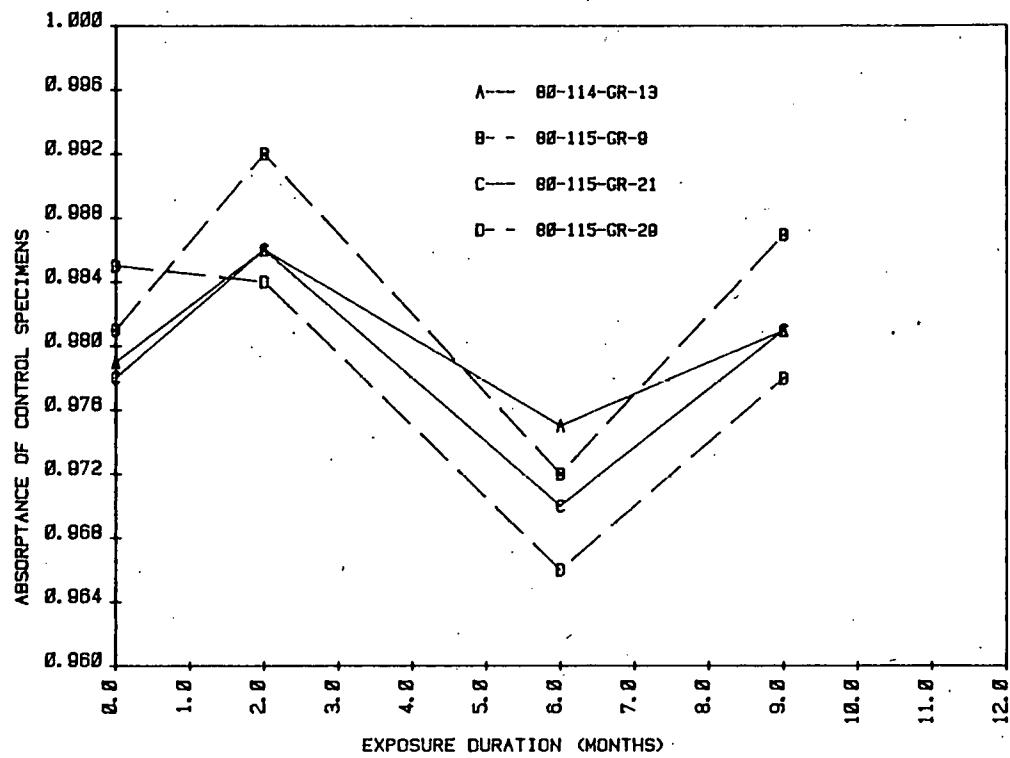
FIGURE 15. PLOT OF ABSORPTANCE VS EXPOSURE DURATION FOR BLACK CHROME CONTROL

Figure 15 shows the plot of  $\alpha_s$  versus exposure duration for the four specimens from the control experiment. The range of  $\alpha_s$  for the specimens before thermal cycling was 0.978 to 0.985. Following 2 months of thermal exposure,  $\alpha_s$  for three specimens increased by 0.011 absorptance units. After 6 months of exposure, all specimens showed a decrease from the initial measurement of  $\alpha_s$  by an average 0.010 absorptance units. The average  $\alpha_s$  of the four specimens following 9 months of thermal cycling was 0.982, as compared to the average of the original  $\alpha_s$  values of 0.982.

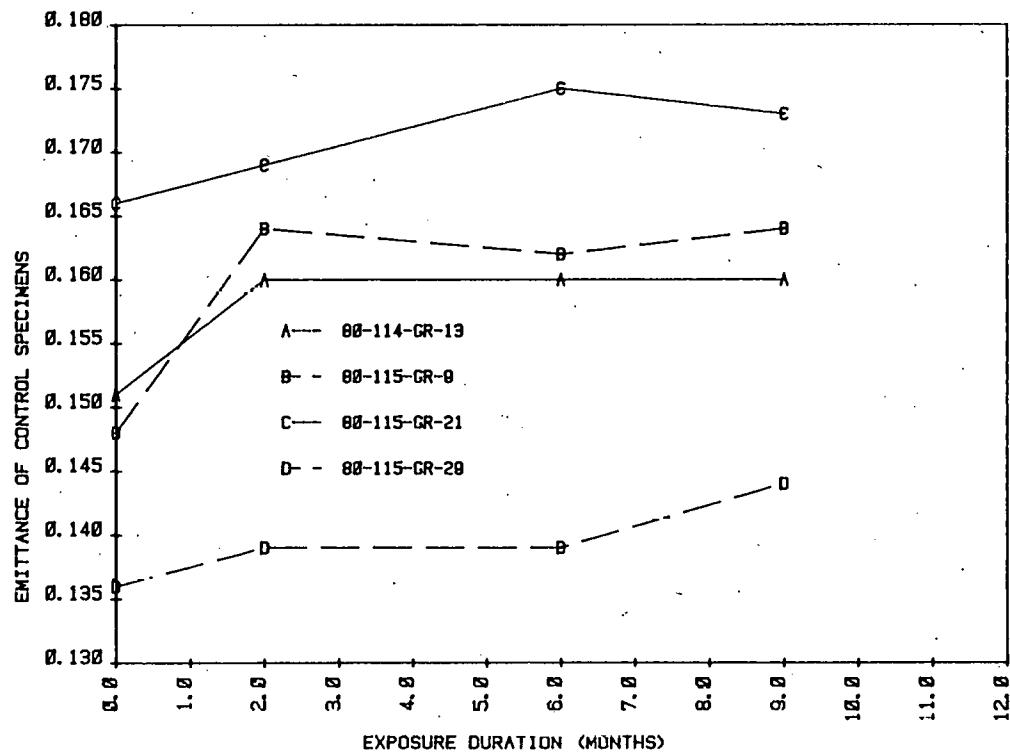
FIGURE 16. PLOT OF EMISSANCE VS EXPOSURE DURATION FOR BLACK CHROME CONTROL

Figure 16 shows a similar plot of emittance versus exposure duration for the same four control specimens. Original emittance measurements ranged from 0.136 to 0.166 ( $\bar{\epsilon}_0 = 0.151 \pm 0.009$ , where  $\bar{\epsilon}_0$  is the average initial emittance measurement). All four specimens showed average increases in  $\epsilon$ , following cycling, as follows:

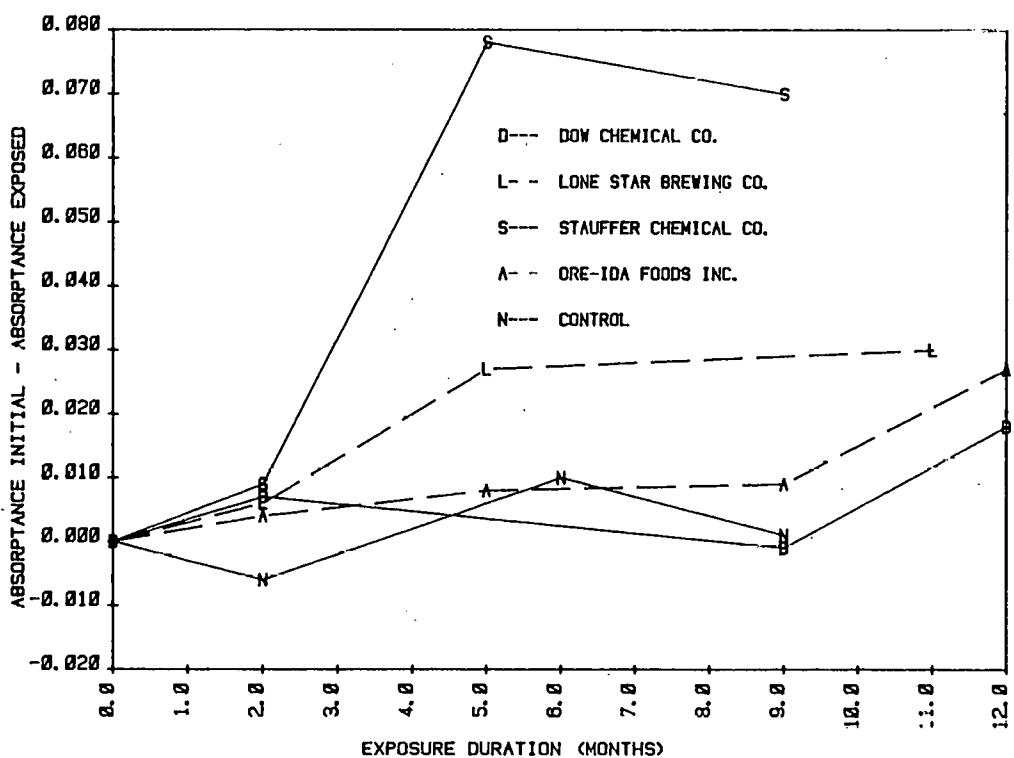
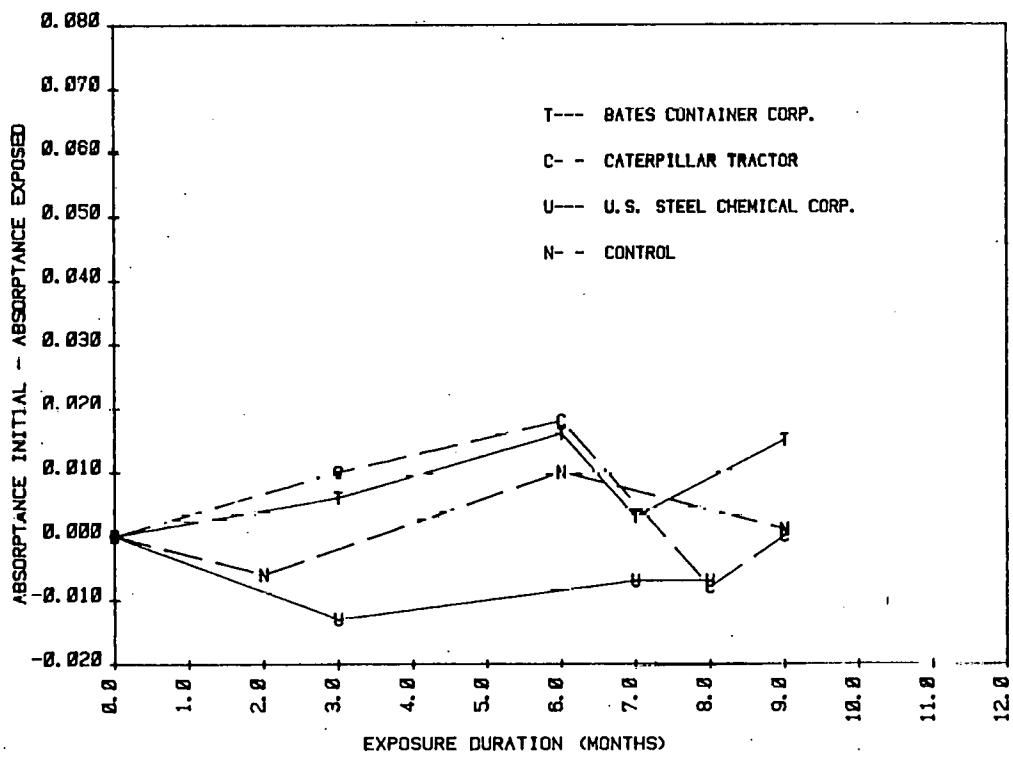
Figures 17 and 18 show the plots of  $\Delta\alpha_s$  versus exposure duration for specimens exposed at the IPH sites.  $\Delta\alpha_s$  is calculated as the  $\alpha_s$  of the exposed sample minus  $\alpha_s$  of the same specimen before deployment.  $+\Delta\alpha_s$  represents a decrease in the solar absorptance of the specimens. The lines N--- are the  $\Delta\alpha_s$  values of the control specimens, as previously described.

At three sites (Stauffer Chemical Co., Lone Star Brewing Co., Ore-Ida Foods, Inc.) black chrome specimens had measurable decreases in  $\alpha_s$ , within the instrumental error of  $\pm 0.015$  absorptance units, after 9 months of exposure. Stauffer Chemical Co. had the worst-case specimens, with a  $\Delta\alpha_s$  of  $0.079 \pm 0.015$  absorptance units after 6 months and a  $\Delta\alpha_s$  of  $0.071 \pm 0.015$  absorptance units after 9 months of exposure. Specimens exposed at Lone Star Brewing Co., had an average  $\Delta\alpha_s$  of  $0.030 \pm 0.015$  absorptance units over 6 to 9 months. Specimens from Ore-Ida Foods, Inc., did not show a measurable decrease in  $\alpha_s$  until the ninth month of exposure, with a  $\Delta\alpha_s$  of  $0.029 \pm 0.015$  absorptance units.

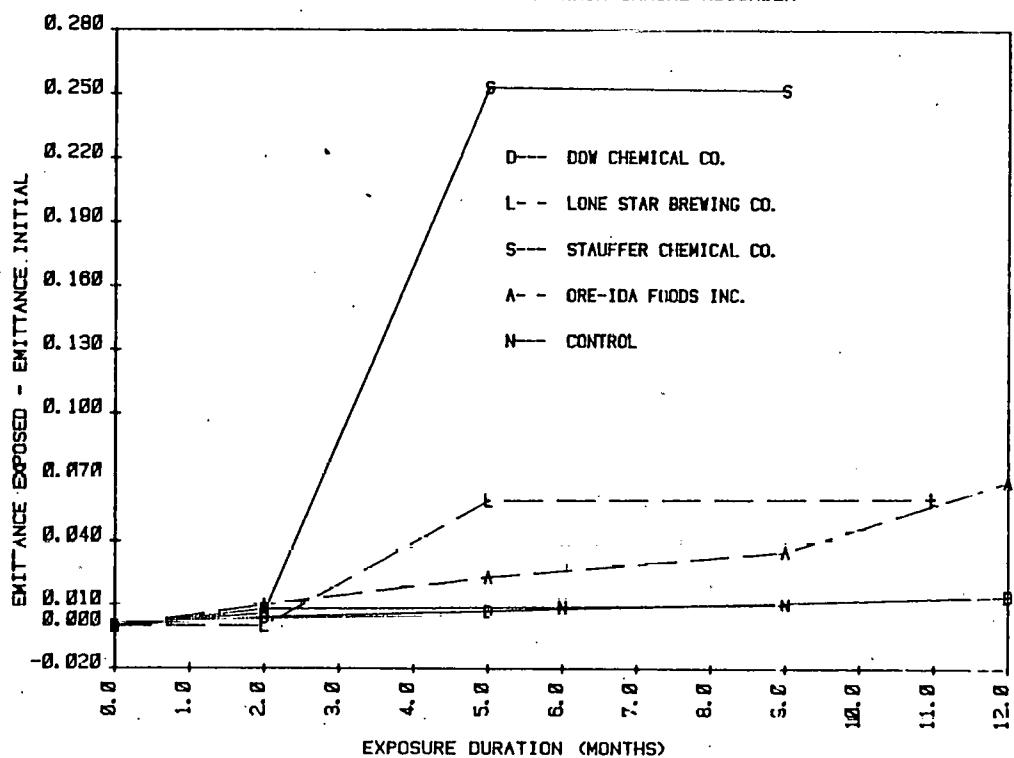
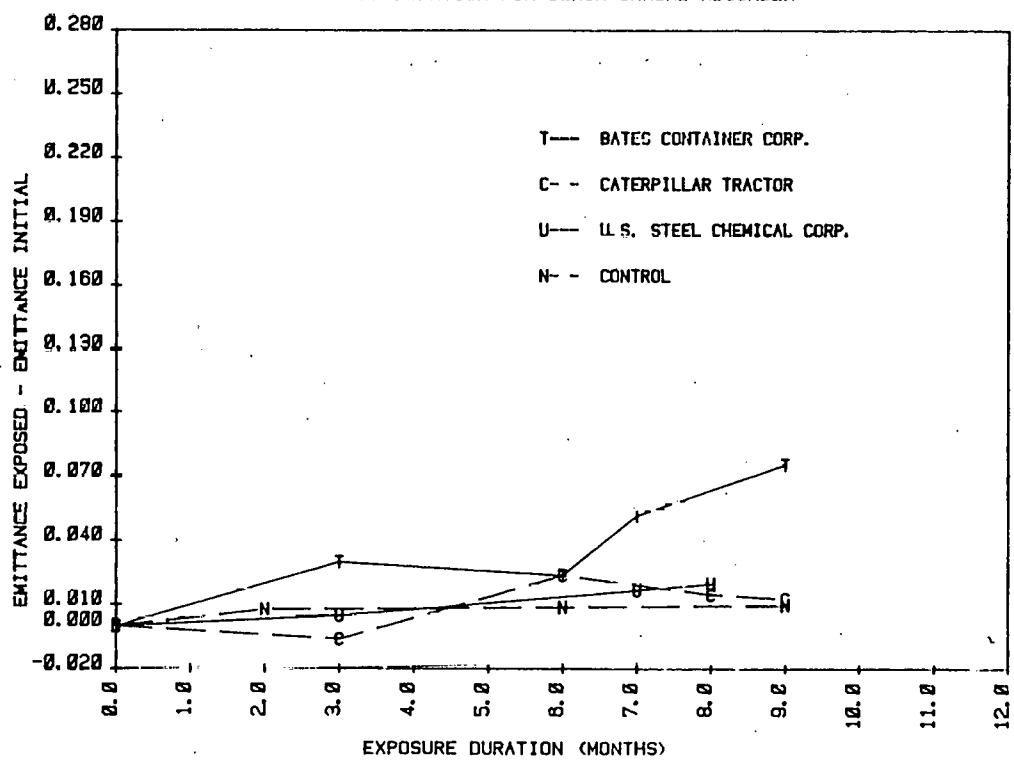
Figures 19 and 20 show the plots of  $\Delta\epsilon$  versus exposure duration for the exposed specimens.  $\Delta\epsilon$  is calculated as the emittance of the exposed specimen minus the emittance of the same specimen before exposure.  $+\Delta\epsilon$  represents an increase in the emissivity of the specimen. The lines designated N--- are the  $\Delta\epsilon$  values of the control specimens, as previously described.

Many black chrome specimens received from the test sites had a number of visual defects, in addition to changes in the emittance and solar absorptance. The specimens were soiled where dust had accumulated on the surfaces and, at some sites, foreign matter (e.g., white crystalline deposits) was observed on

the samples. At most sites, cracking of the black chrome plating was observed, and at some sites the rusting nickel support could be seen through holes which had developed in the plating. However, unless these localized defects were in one of three measurement locations on the specimens, they were not reflected in the  $\alpha_s$  and  $\epsilon$  measurements.

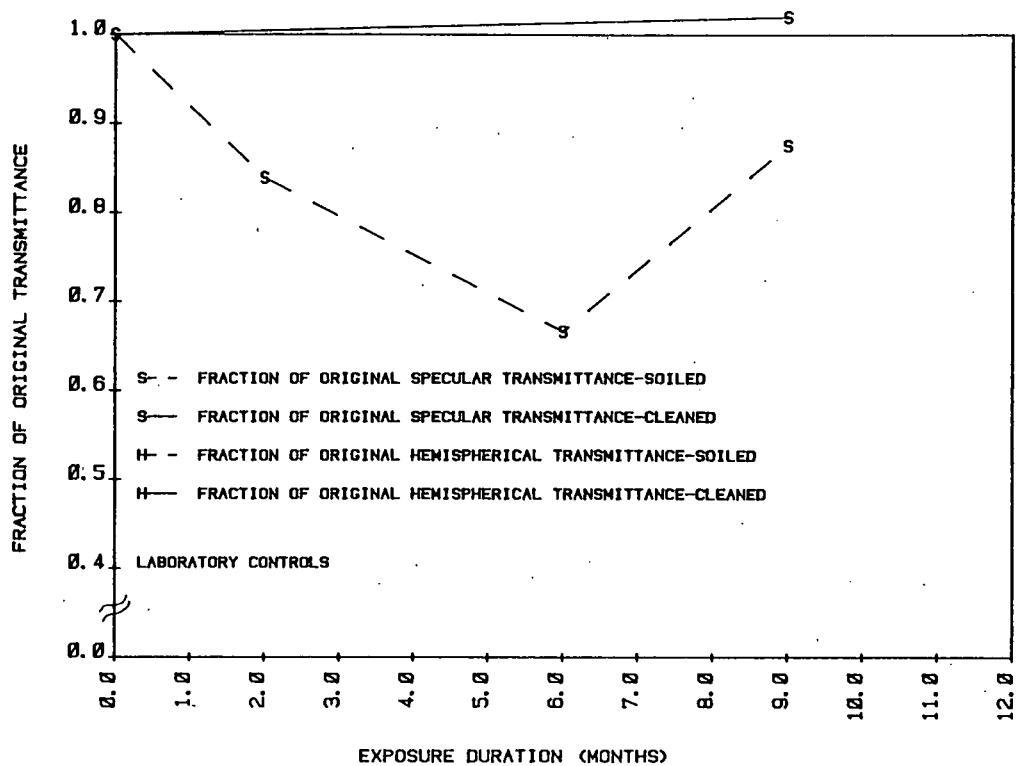
FIGURE 21. PLOT OF TRANSMITTANCE VS EXPOSURE DURATION FOR GLASS COVER PLATES

Figure 21 shows the results obtained for  $T_s$  measurements on the control specimens. The  $T_s$  measurements were made (1) before inception of the test, (2) following the prescribed exposure duration for the uncleaned specimen, and (3) following cleaning of the specimen. The Lime-Brite cleaning procedure was used. The test was conducted in the absence of light and in a laboratory environment; consequently, the only soiling which occurred was from normal laboratory dust. The  $T_s$  results for the control specimens were the arithmetic mean of four controls.

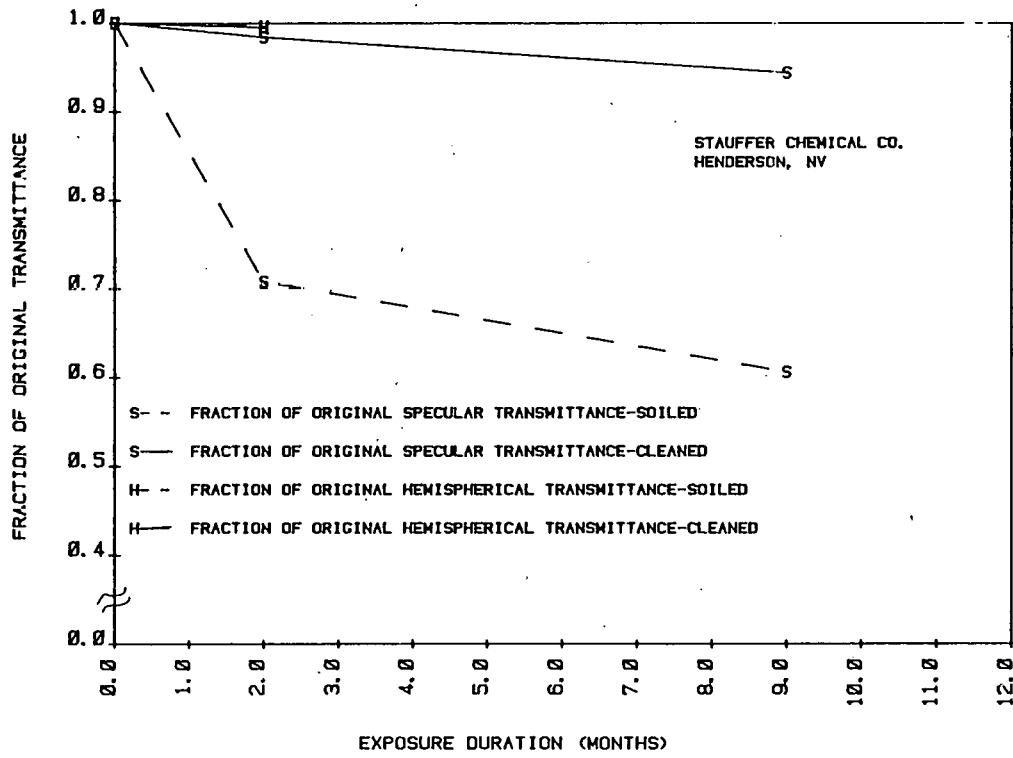
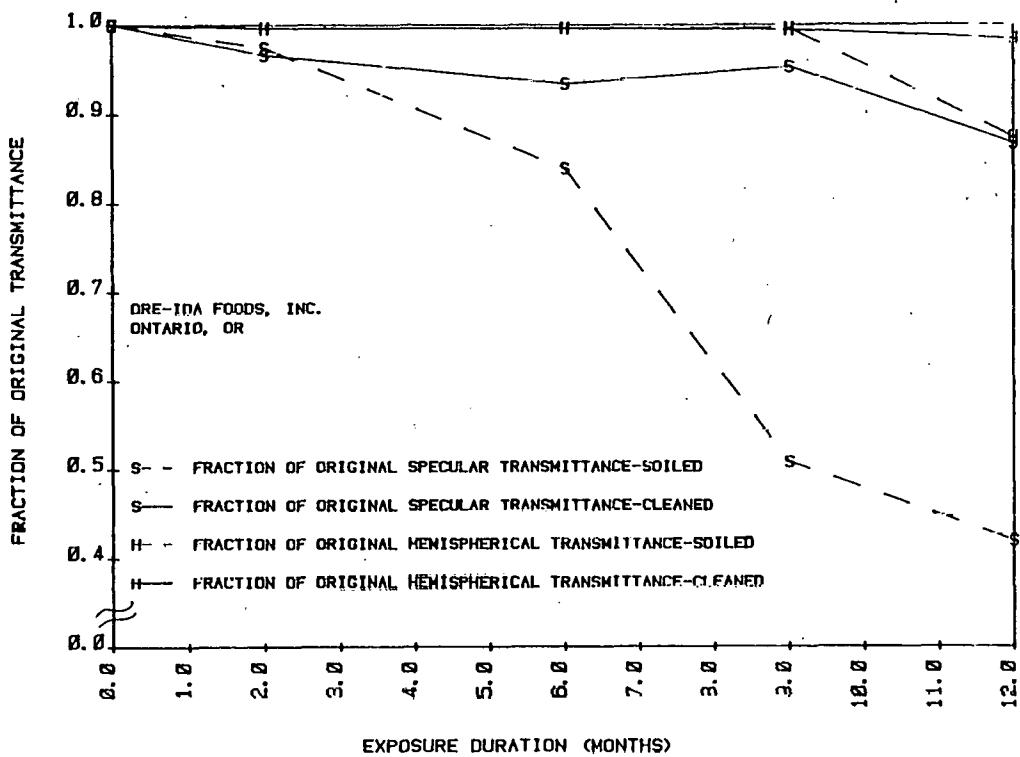
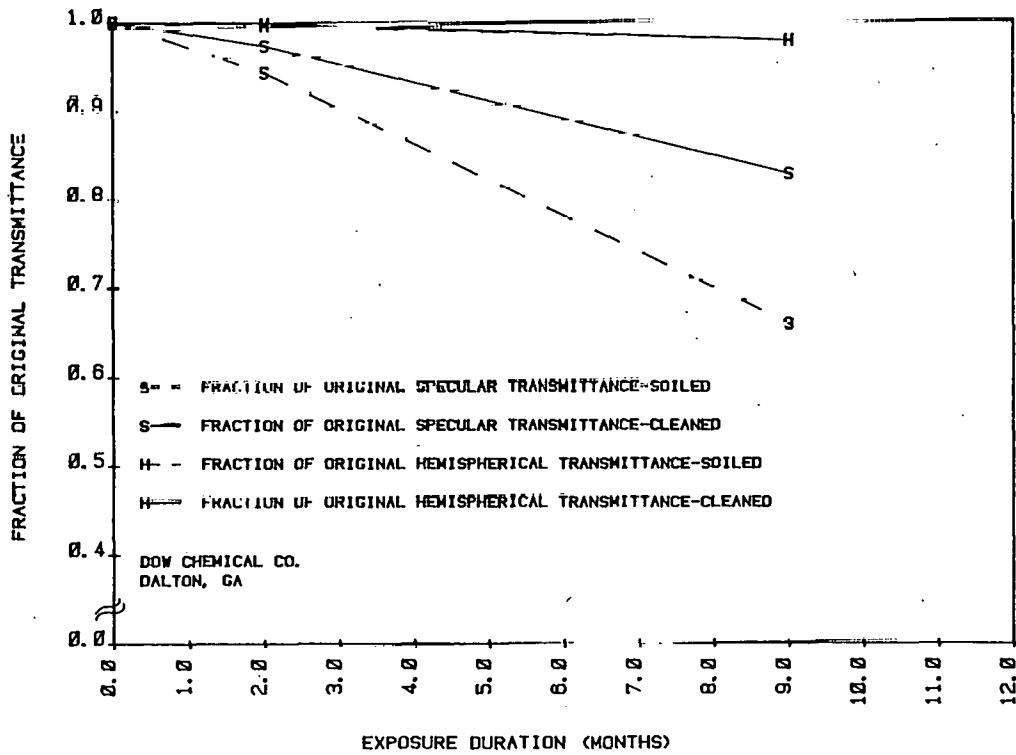
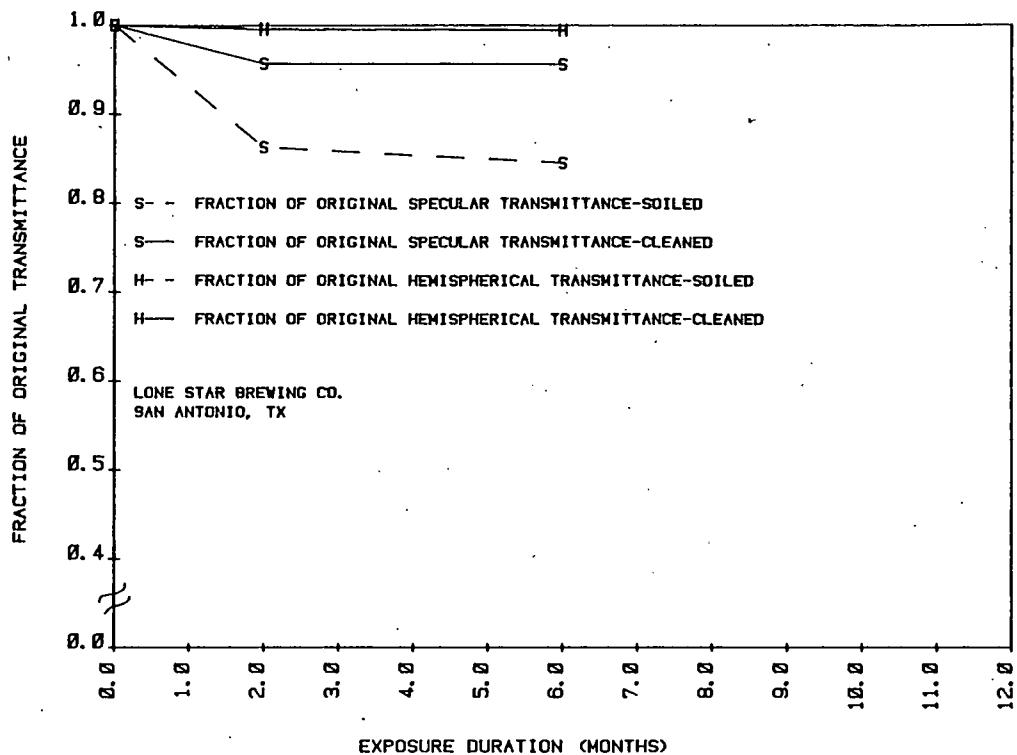
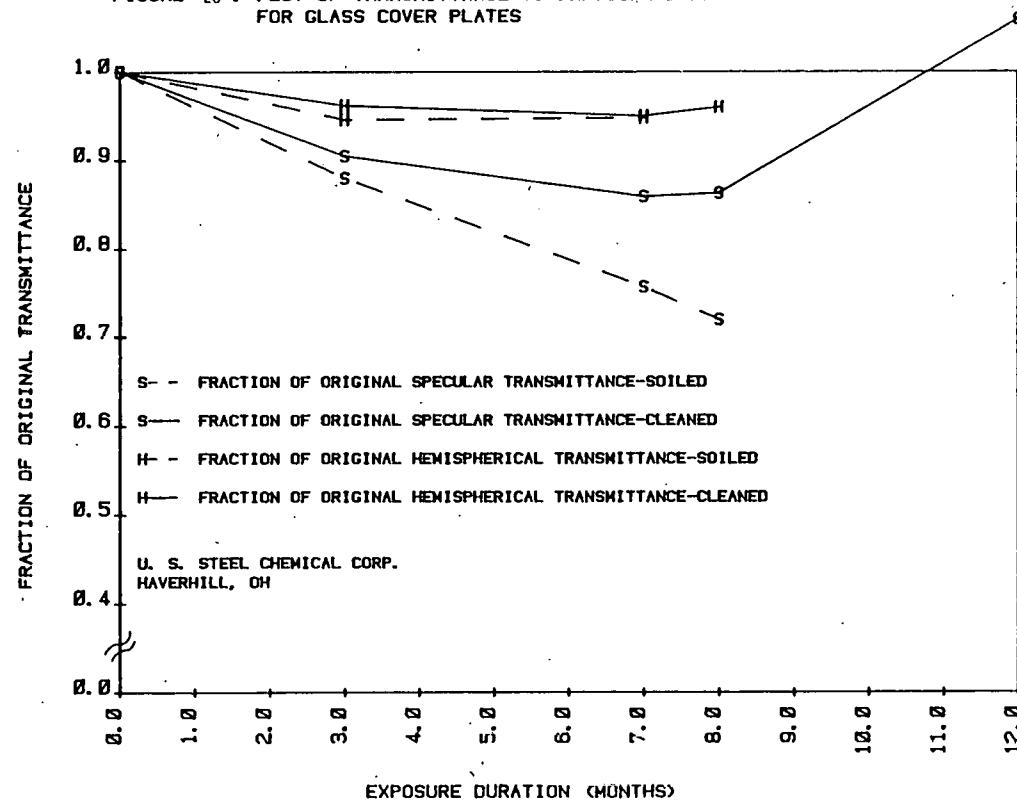
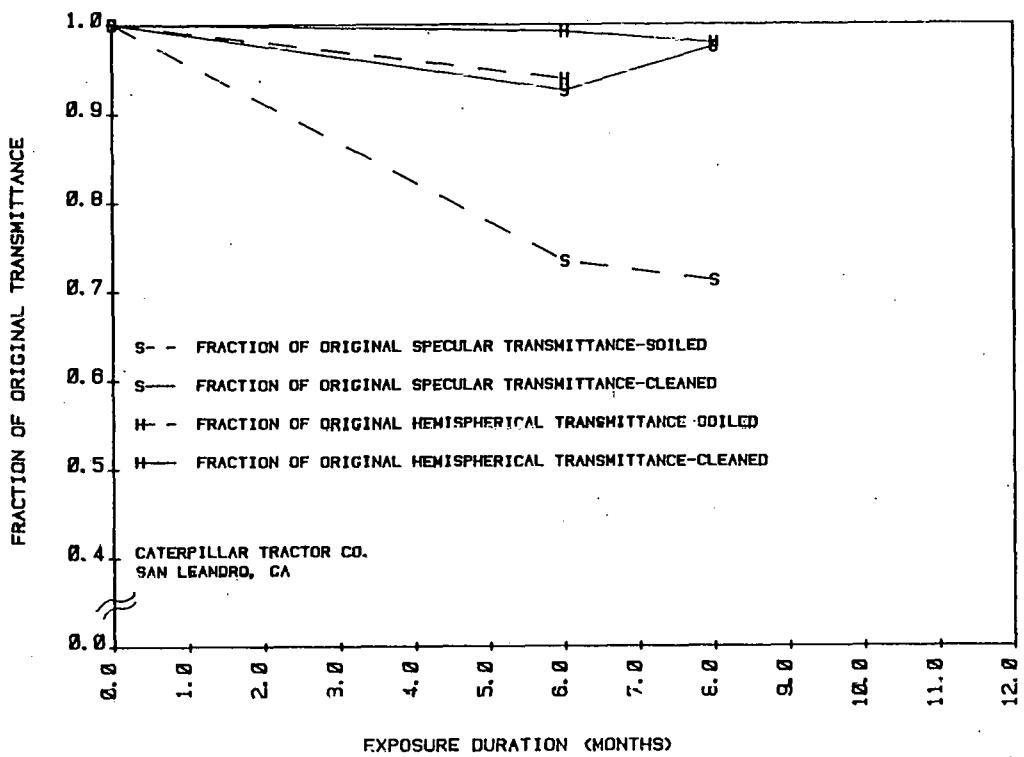
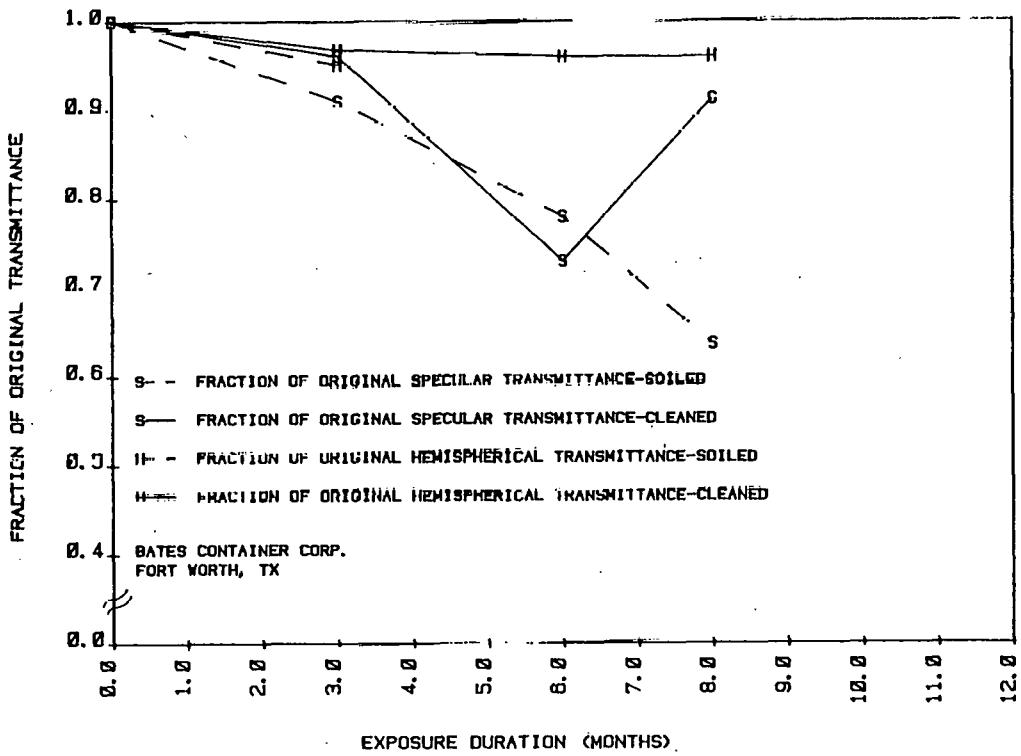
Figures 22 through 28 show the plots of the fraction of the original transmittance (specular and hemispherical) versus exposure duration for the glass cover plate specimens at the IPH sites. Four sites (Dow Chemical Co., Lone Star Brewing, U.S. Steel Chemical Co., Bates Container Corp.) showed virtually identical  $T_H$  measurements for both the soiled and cleaned specimens for the exposure duration and showed total losses in  $T_H \leq 5\%$  of the original transmittance. These four sites had  $T_s$  values for the soiled samples that were 65 to 85% of the original measurements. Upon cleaning, the  $T_s$  was restored to 75 to 95% of the original  $T_s$ .

Glass cover plates at Caterpillar Tractor Co. and Stauffer Chemical Co. behaved similarly to the Ore-Ida specimens, with losses in transmittance, both  $T_H$  and  $T_s$ , reported for the soiled specimens. Cleaning restored  $T_s$  to within 10% and  $T_H$  to within 1% of the original values.  $T_H$  values for exposed specimens at Stauffer Chemical Co. at 9 months are not available because the specimen was broken after the  $T_s$  measurement.

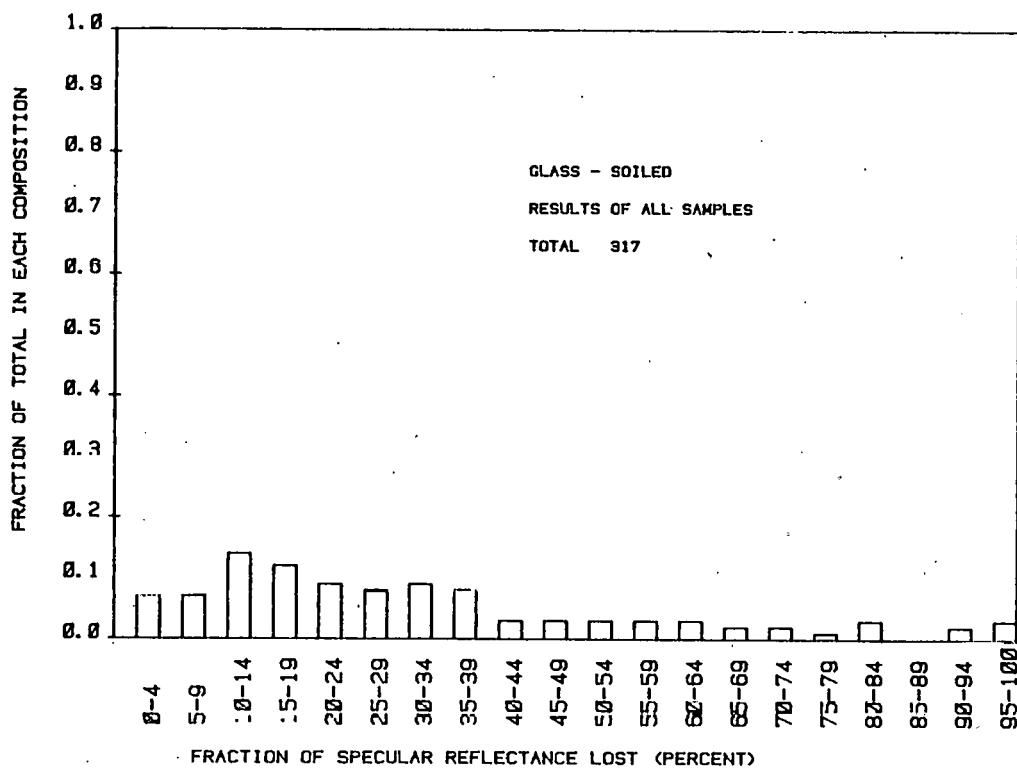
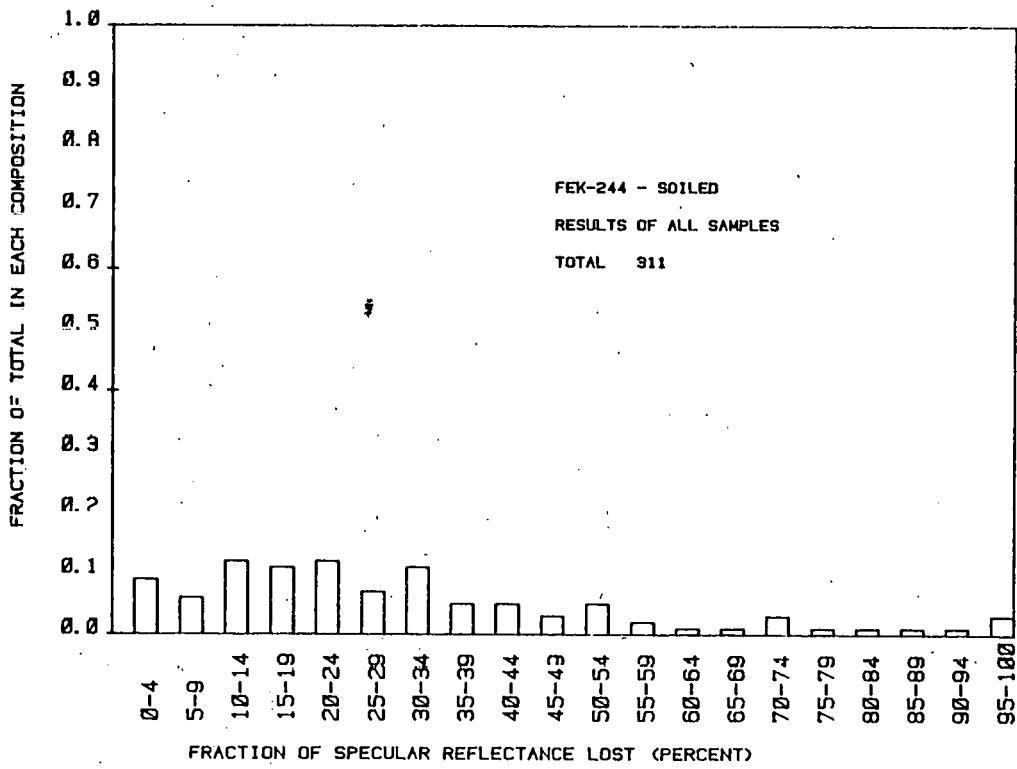
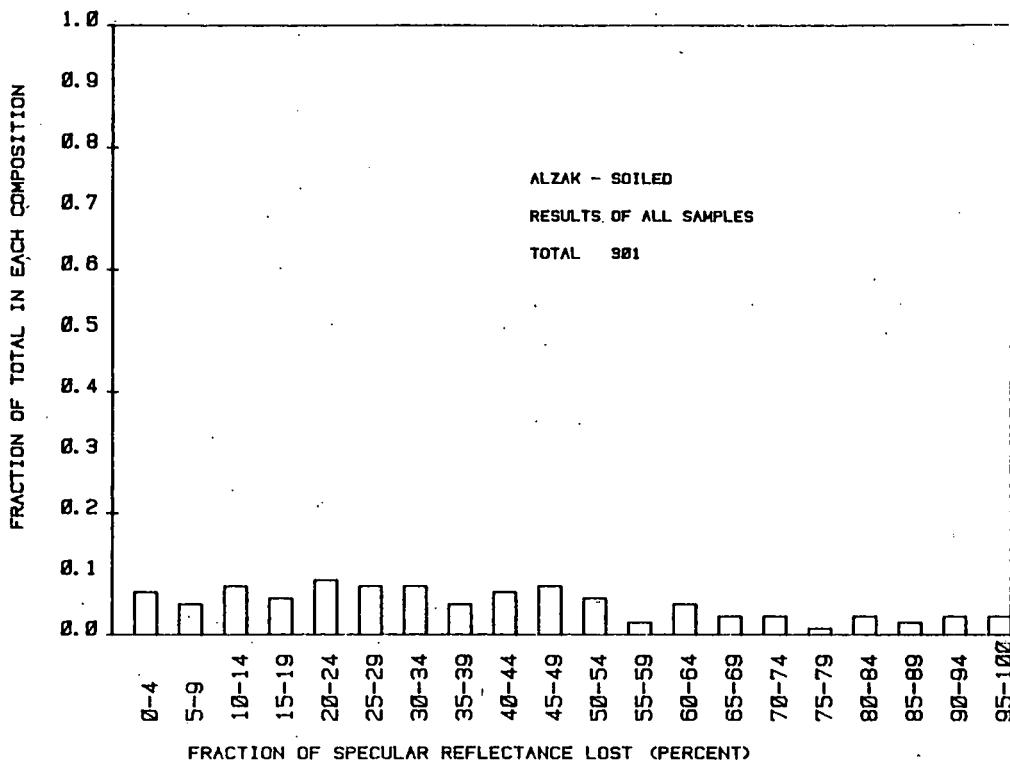
Figures 29 through 31 show the bar plots of the specular reflectance values for the soiled samples. The plots for the glass (Figure 29) and the FEK-244 (Figure 30) specimens show that the two materials have very similar susceptibilities for surface soil accumulation, with 70% of the sample population density losing 40% or less specular reflectance after 1 to 12 months of exposure.

The remaining 30% of the samples were fairly uniformly distributed from reflectance losses of 41 to 100%. The Alzak specimens had a different profile (Figure 31), with approximately 70% of the specimens losing between 0 to 54% specular reflectance. Thus, the Alzak material appears to be slightly more susceptible to soiling.

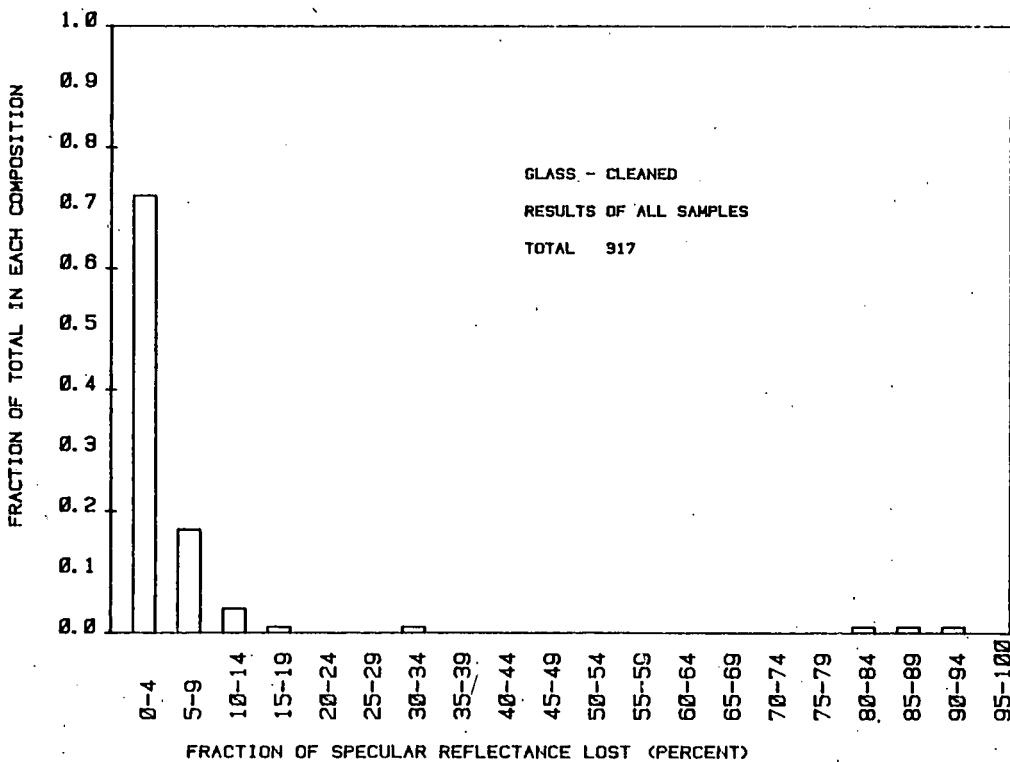
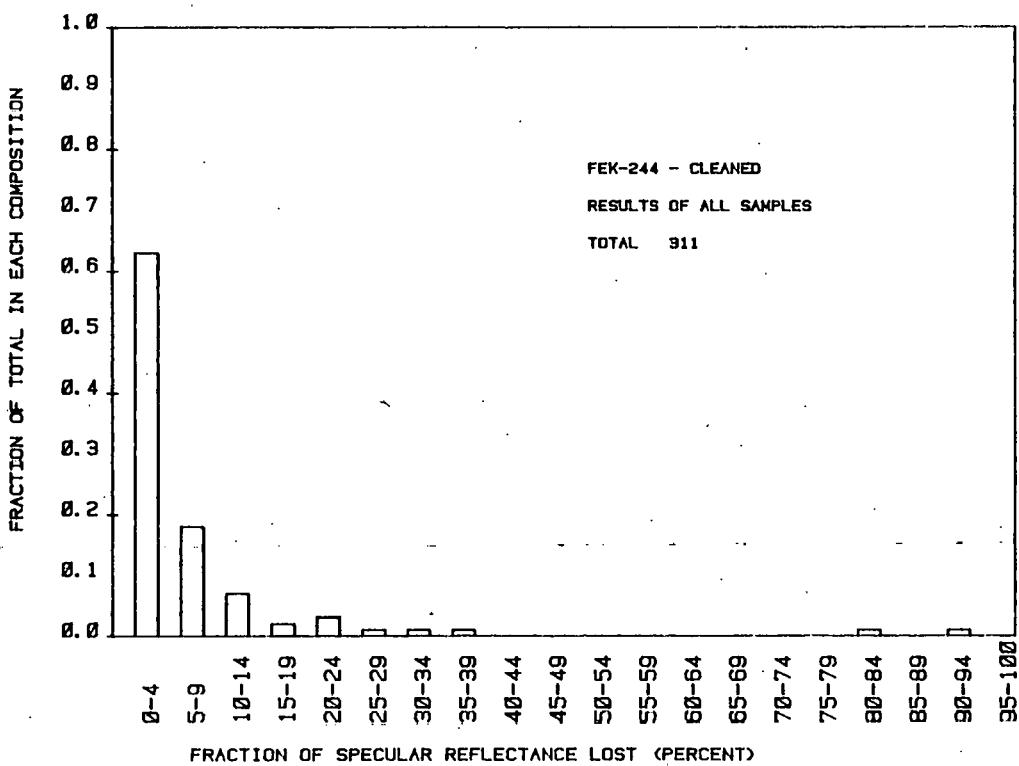
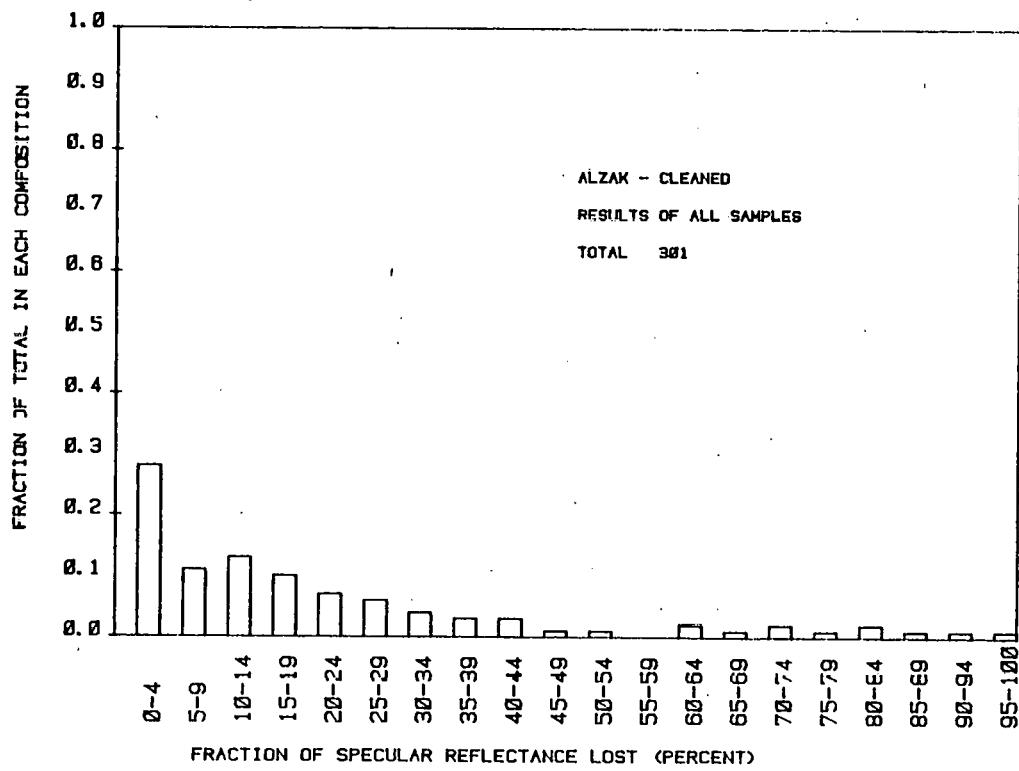
However, the real differences in the reflector materials become apparent in the specular reflectance measurements for the cleaned specimens (Figures 32 through 34). Approximately 8% more of the silvered-glass specimens could be restored to 96% of the original specular reflectance values than could the FEK-244 specimens. As these reflectance measurements for the cleaned speci-

mens represent reflectance losses caused both by corrosion and soiling, it is believed that the 8% figure should be higher since the FEK-244 specimens did not corrode as significantly as did the silvered-glass specimens. The most significant losses in specular reflectance were for the Alzak specimens. These measurements, again, reflect both corrosion and residual soil retention. A large contributor to the low specular reflectance values for Alzak was its low resistance to corrosion. However, the optical microscopic evaluation of the reflector specimens revealed that the Alzak specimens also had higher levels of residual soil retention than did the other two materials.
