SAND81-7028/1  
Unlimited Release  
UC-62

# Final Report Solar-Collector-Materials Exposure to the IPH Site Environment

## Volume 1

V. L. Morris  
Huntington Beach, CA 92647

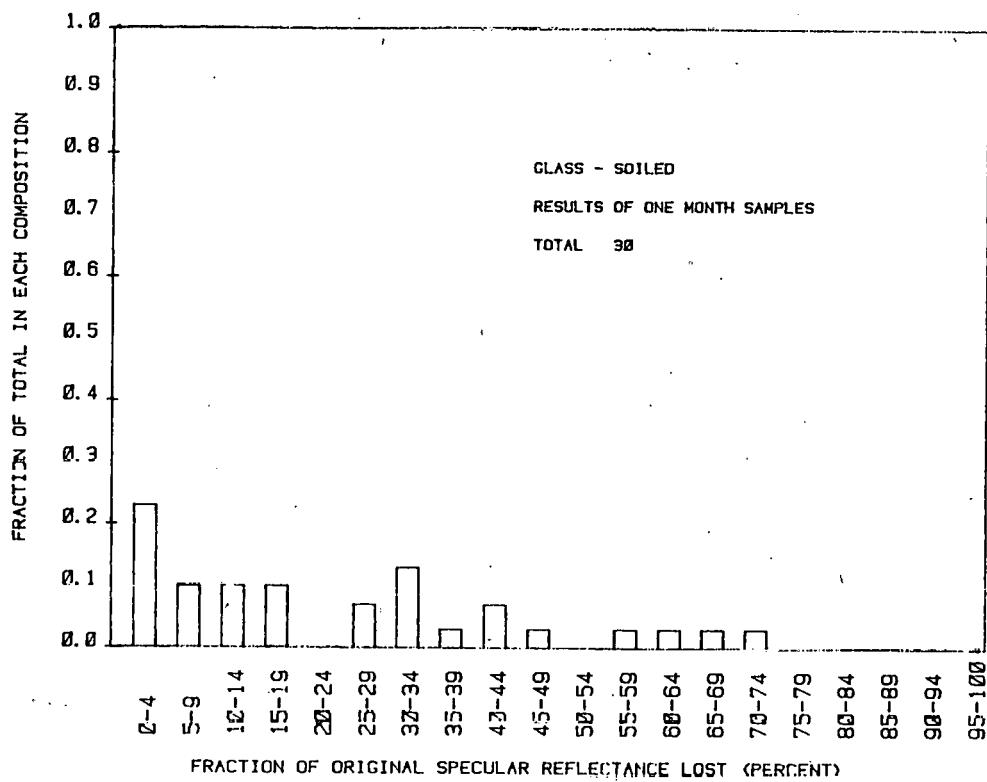
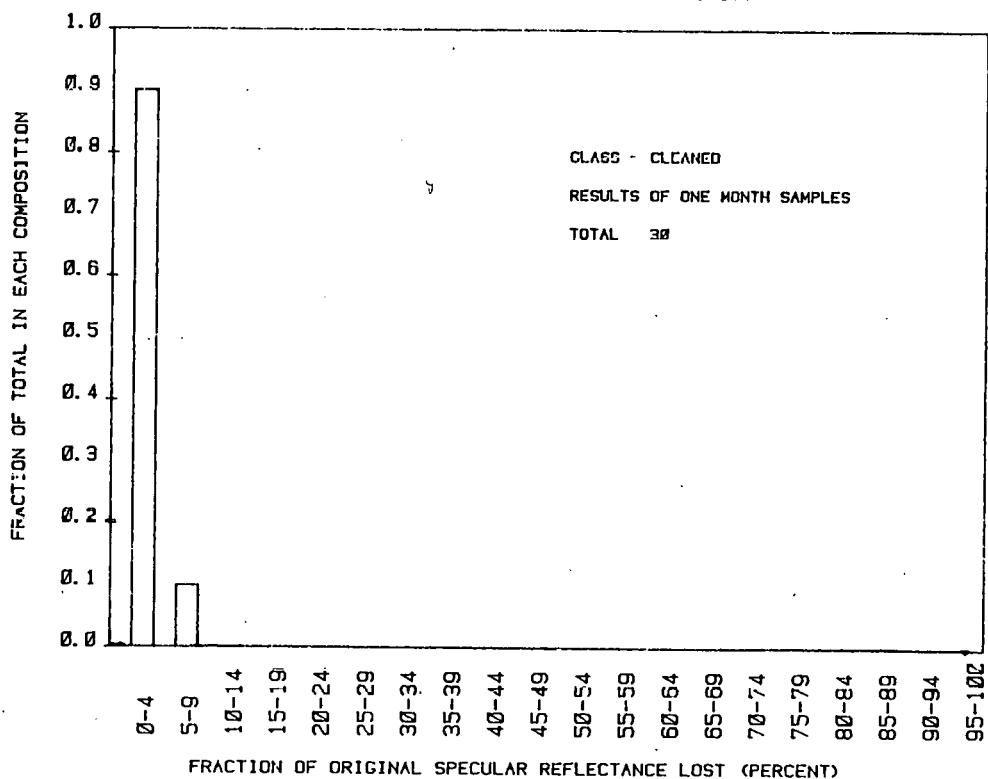
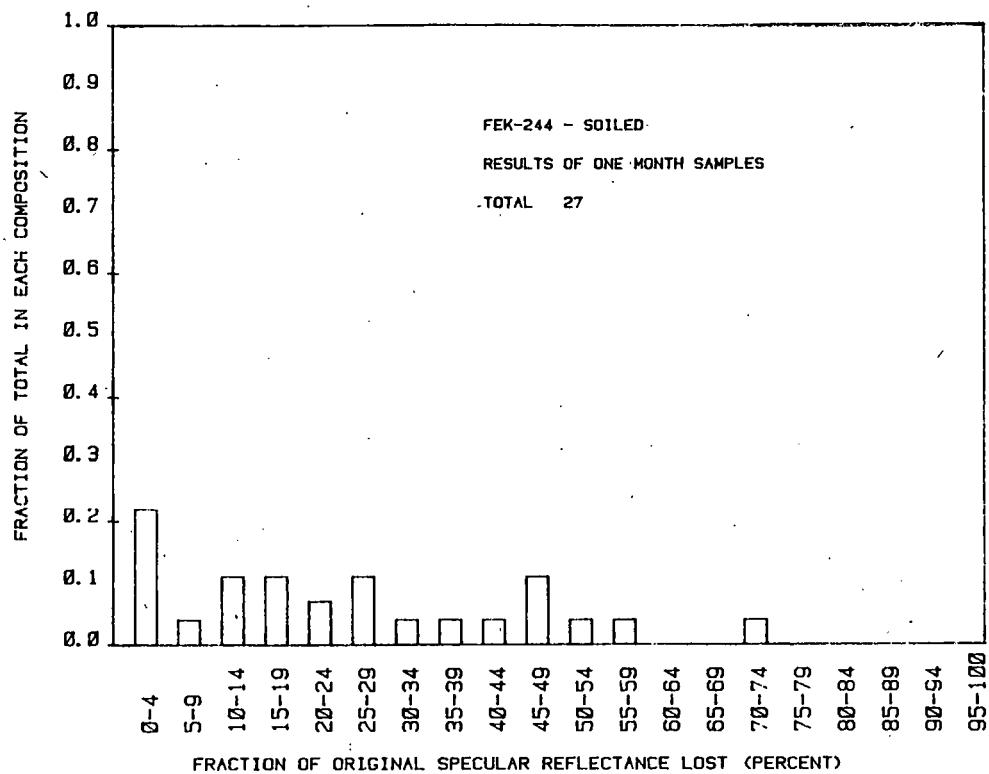
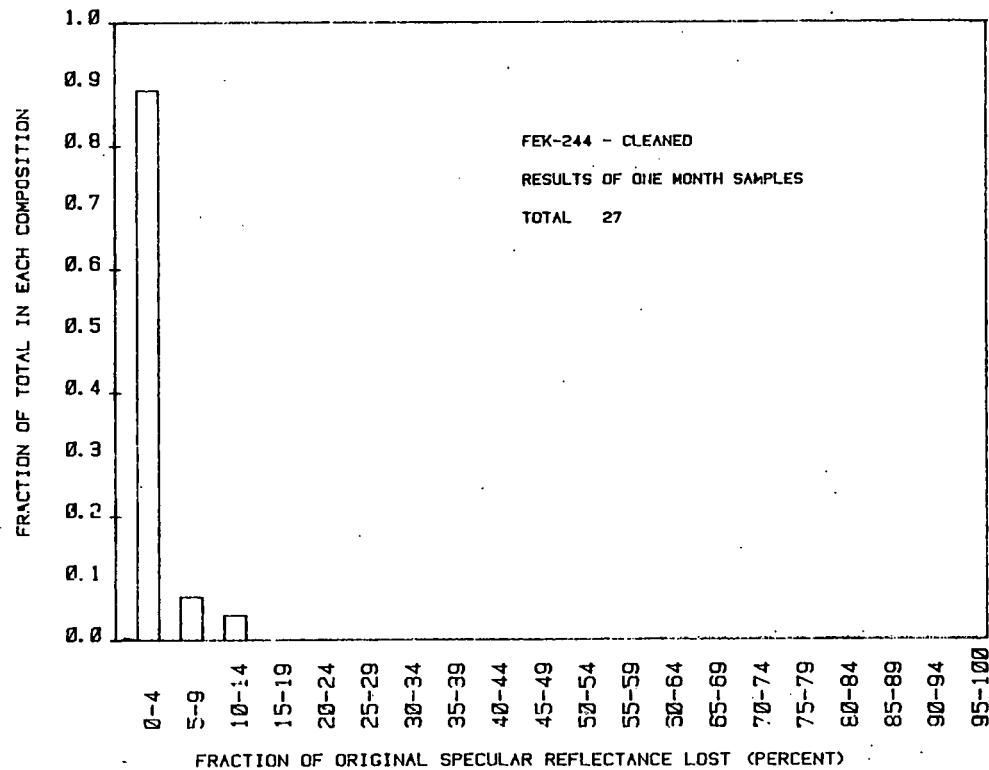
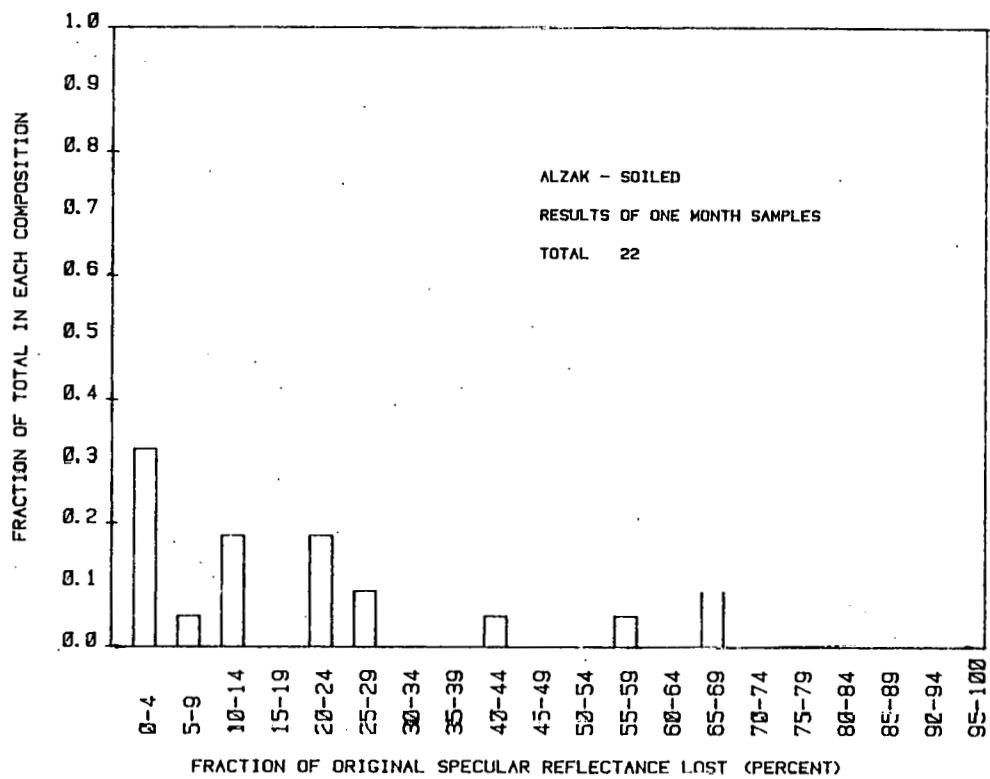
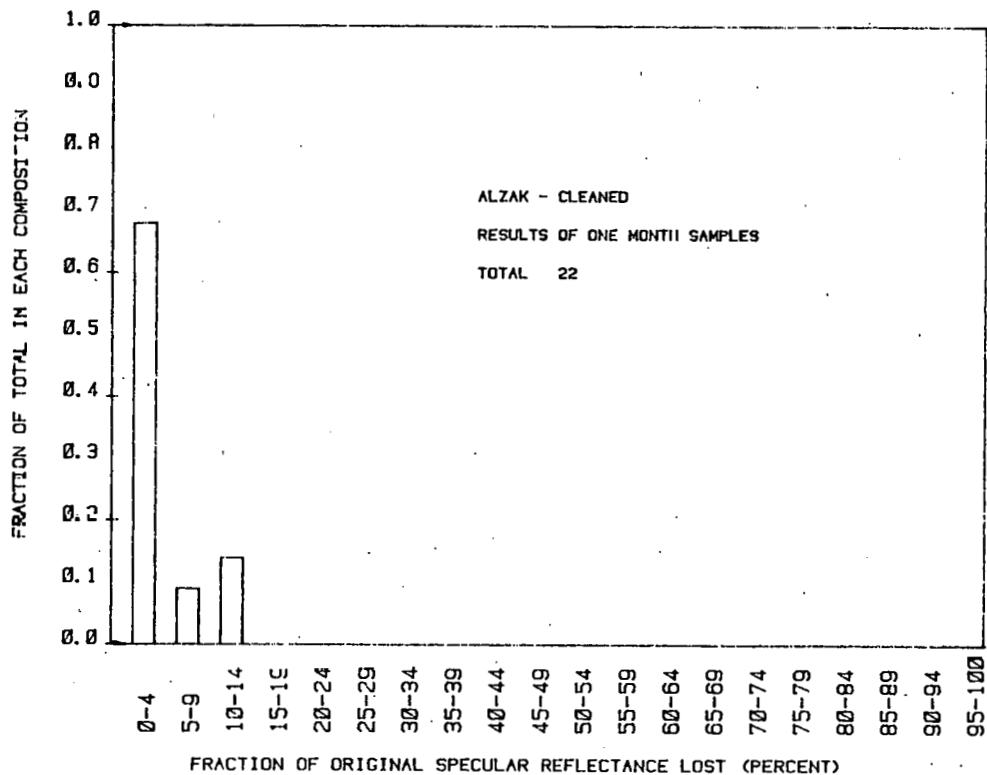
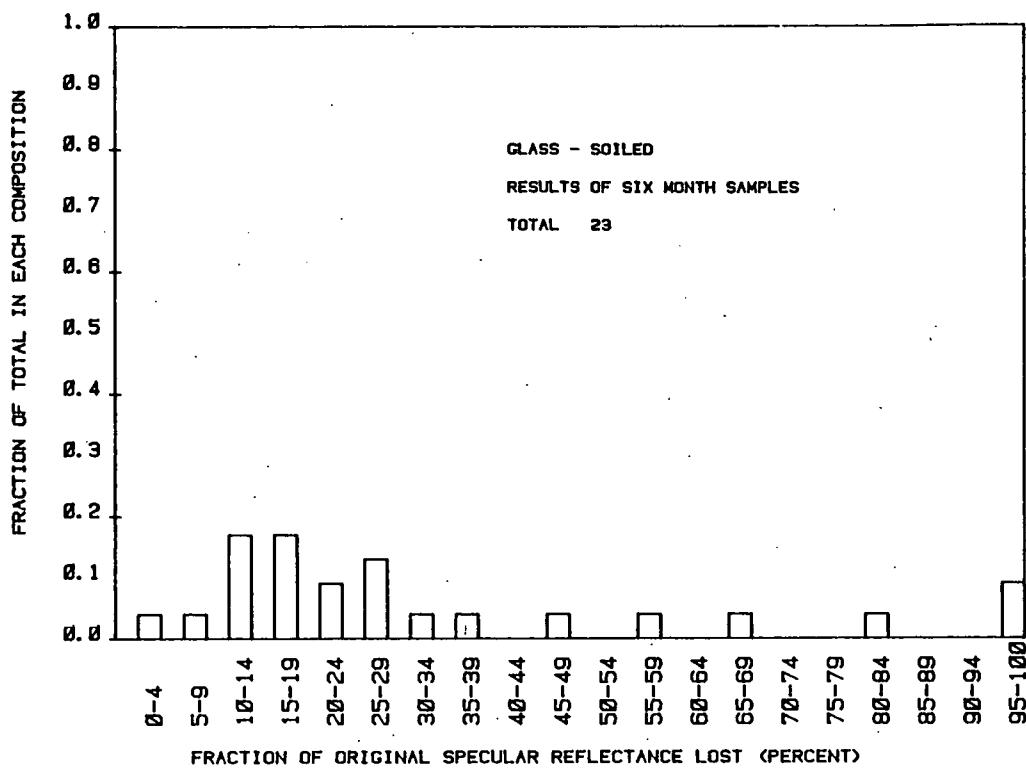
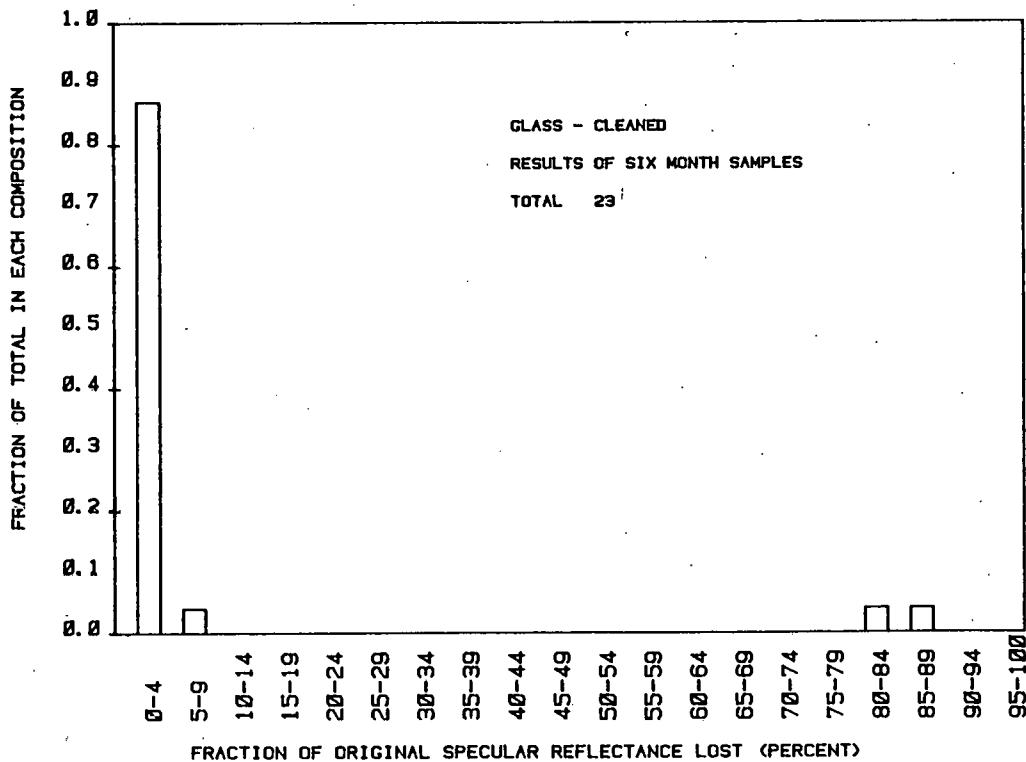
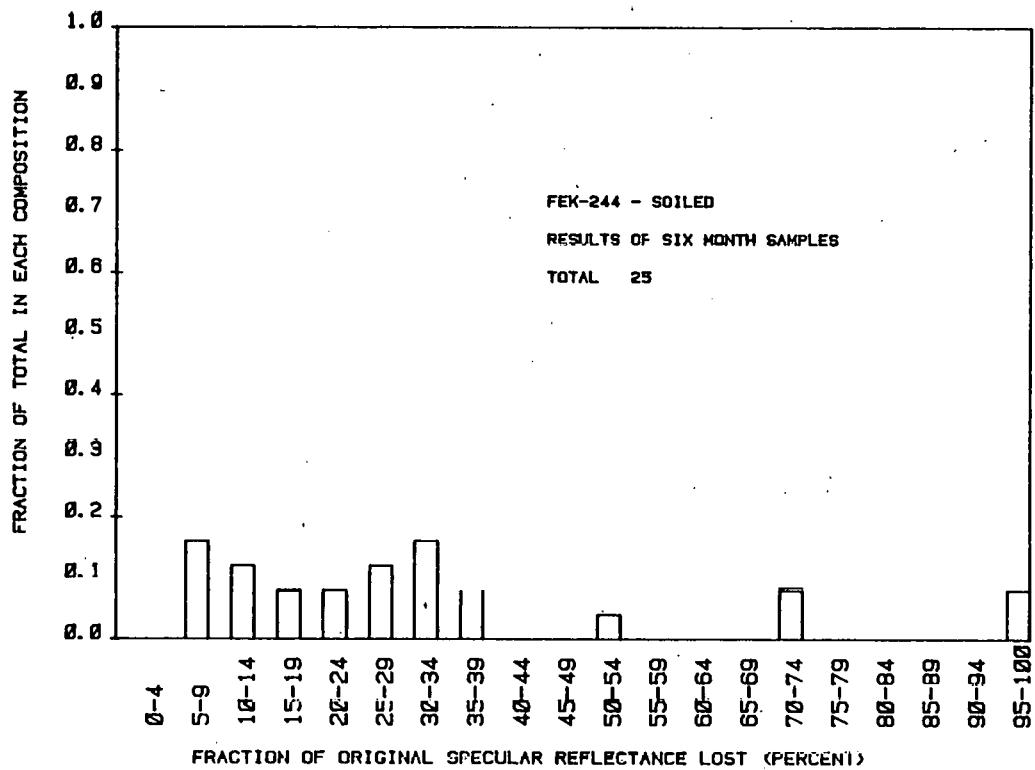
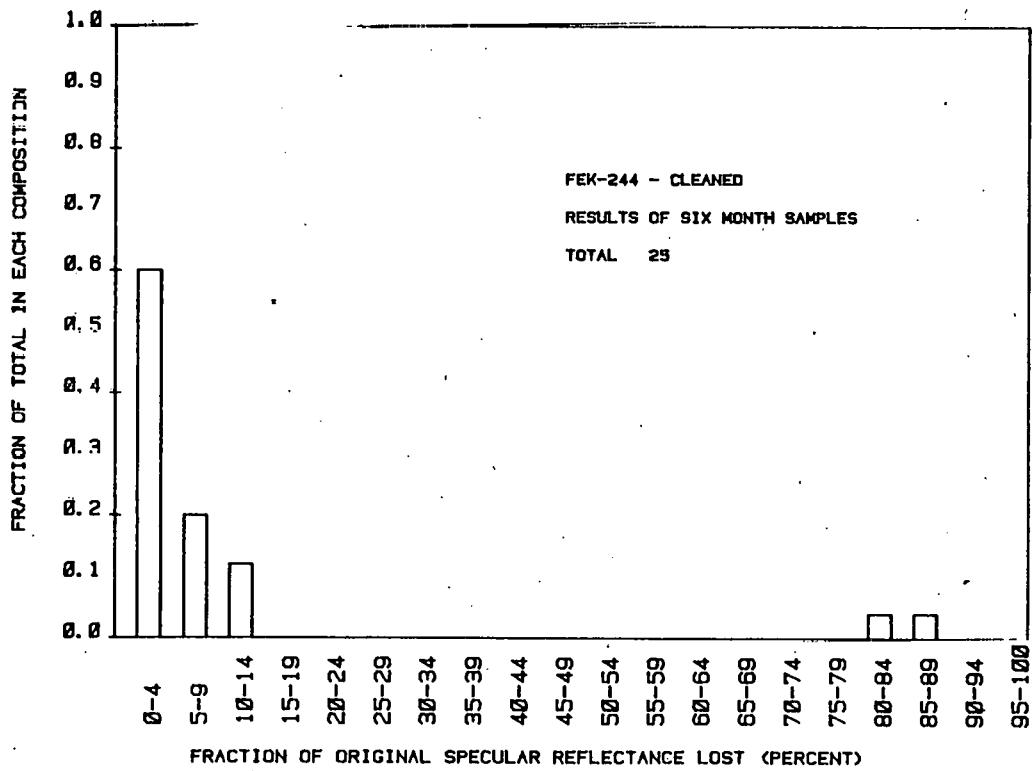
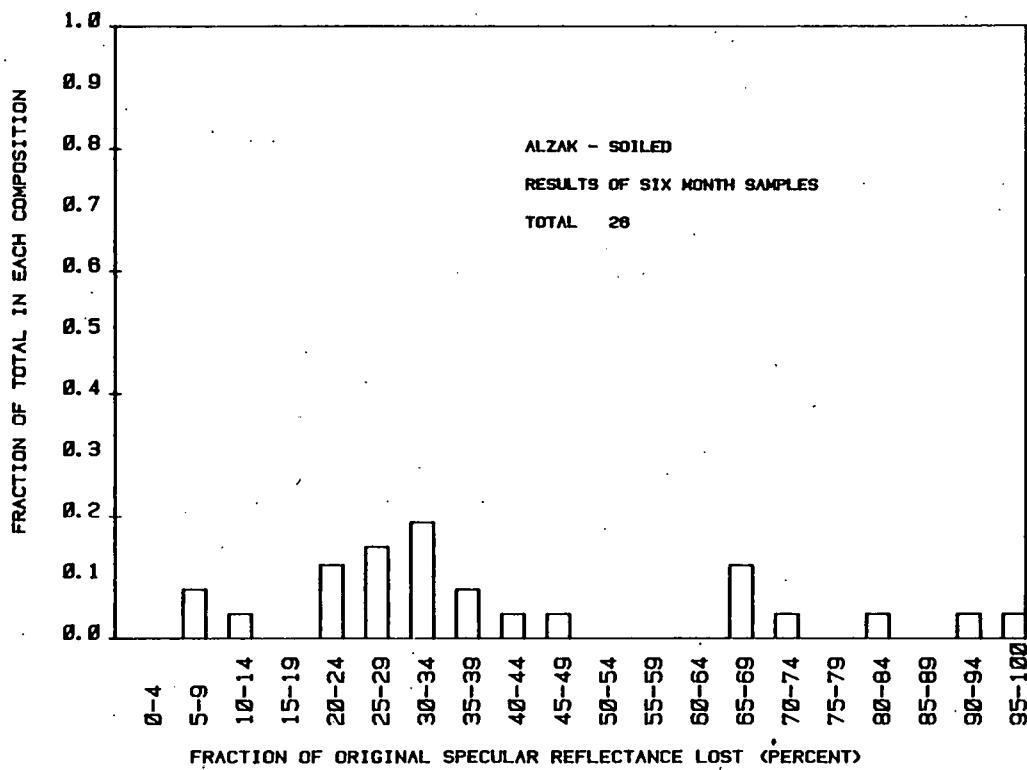
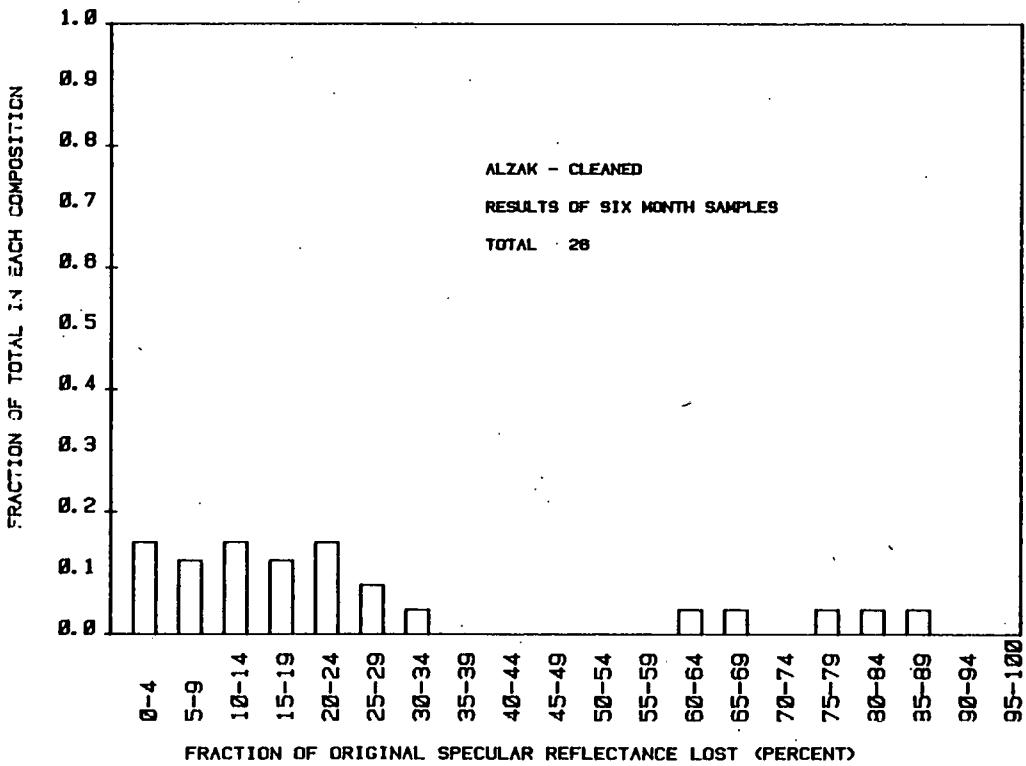
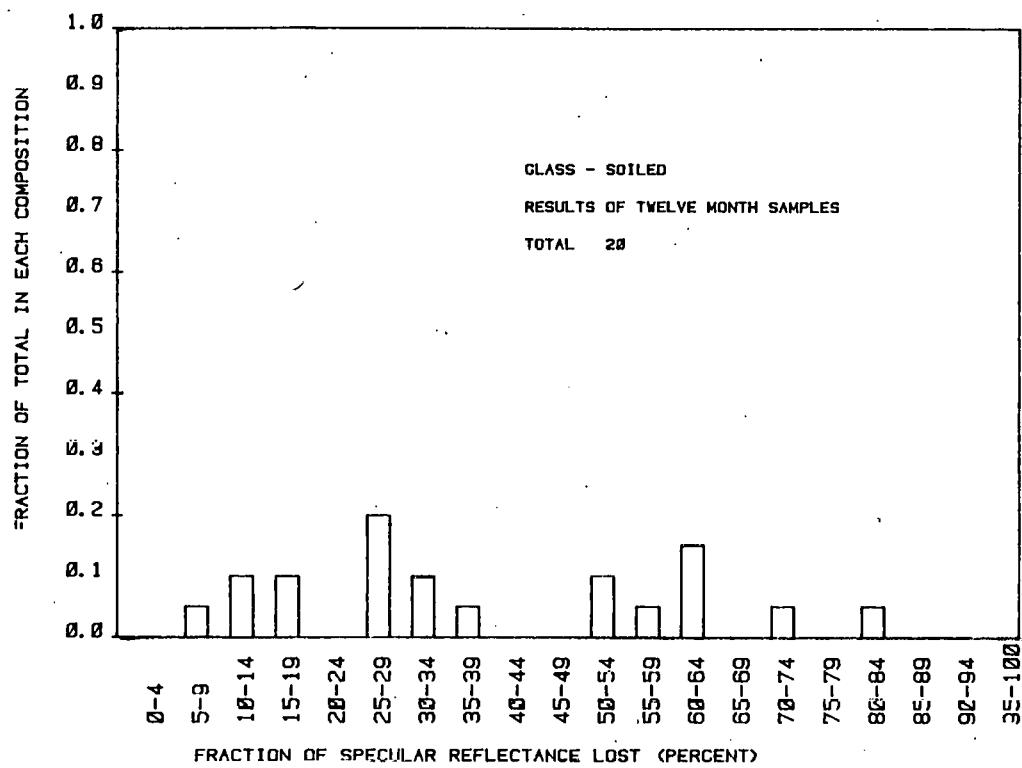
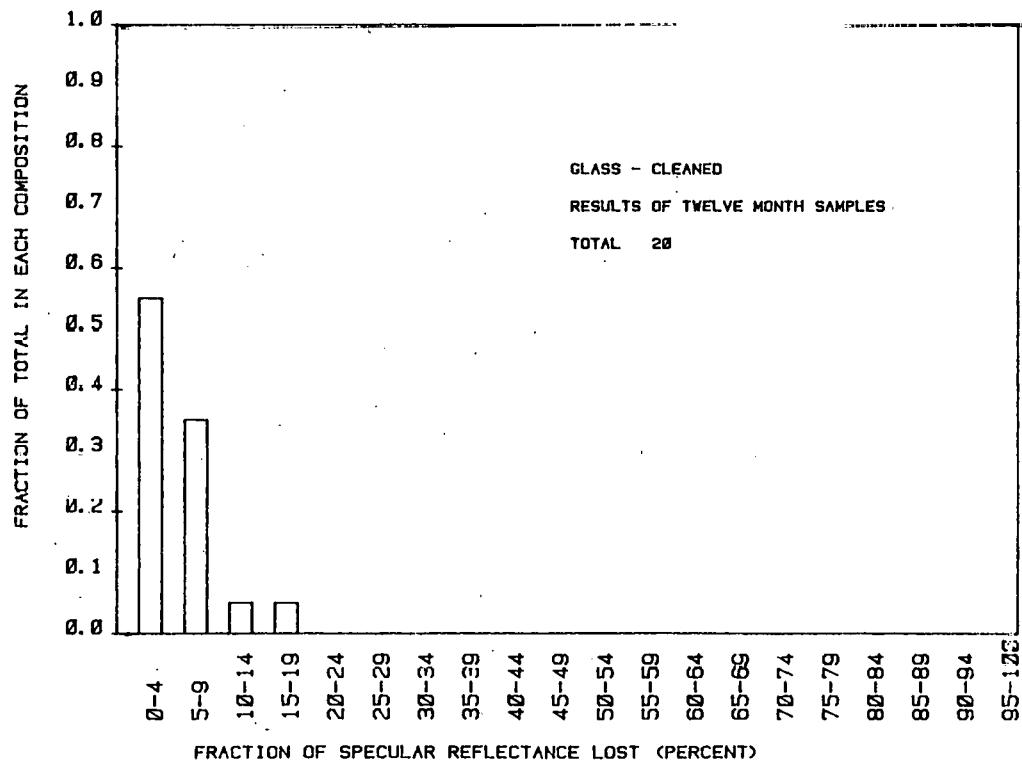
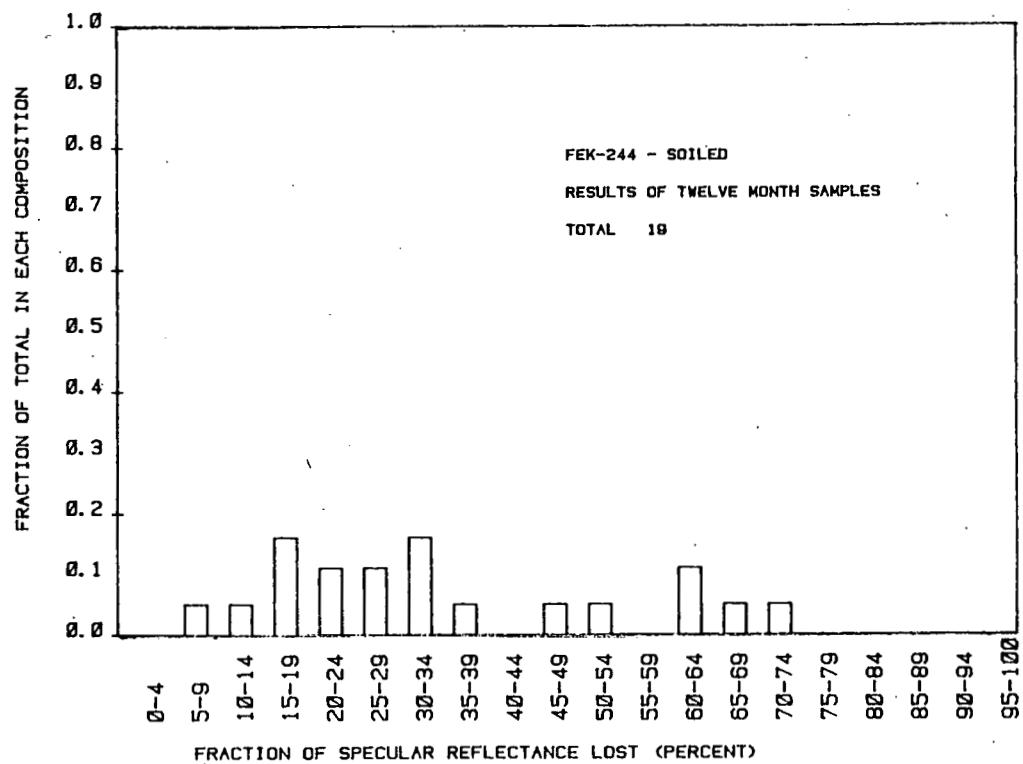
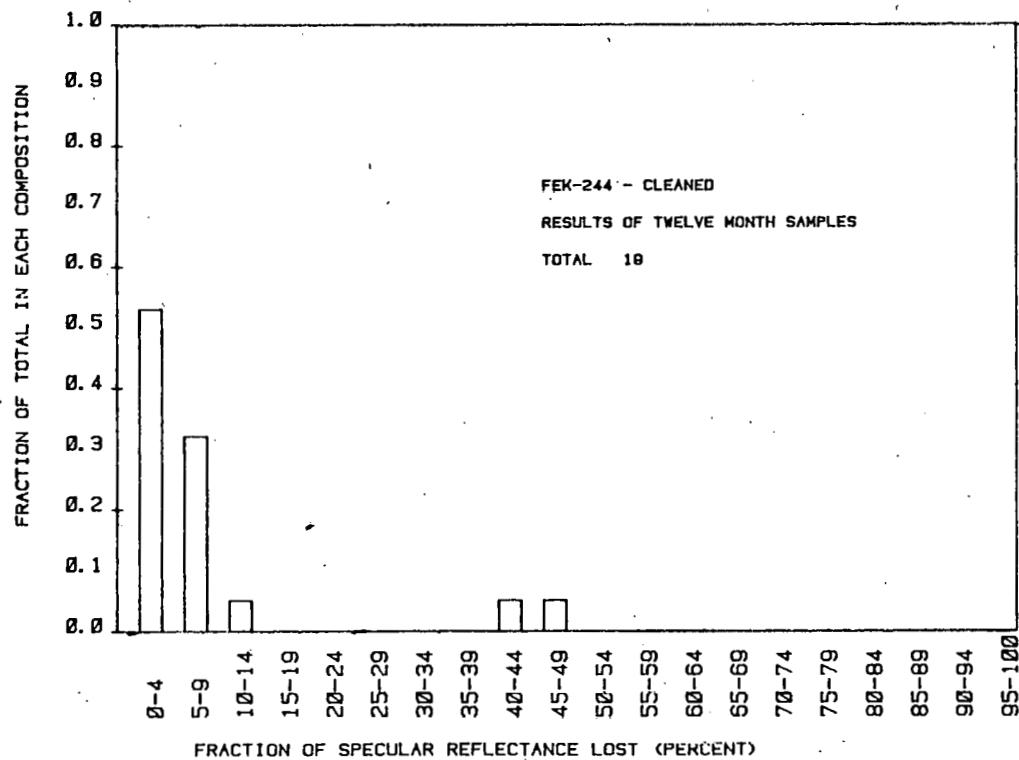
Figures 35 through 52 show the reflector material population that was exposed 1, 6, and 12 months as a function of percent specular reflectance loss for both the soiled and cleaned specimens. These plots show that increased duration of exposure shifts the population of the reflector specimens to the larger percentage of specular reflectance loss. The ability of the specimens to be cleaned also decreases with exposure duration, with glass reflectors having the greater ability to be cleaned over FEK-244, followed then by Alzak.

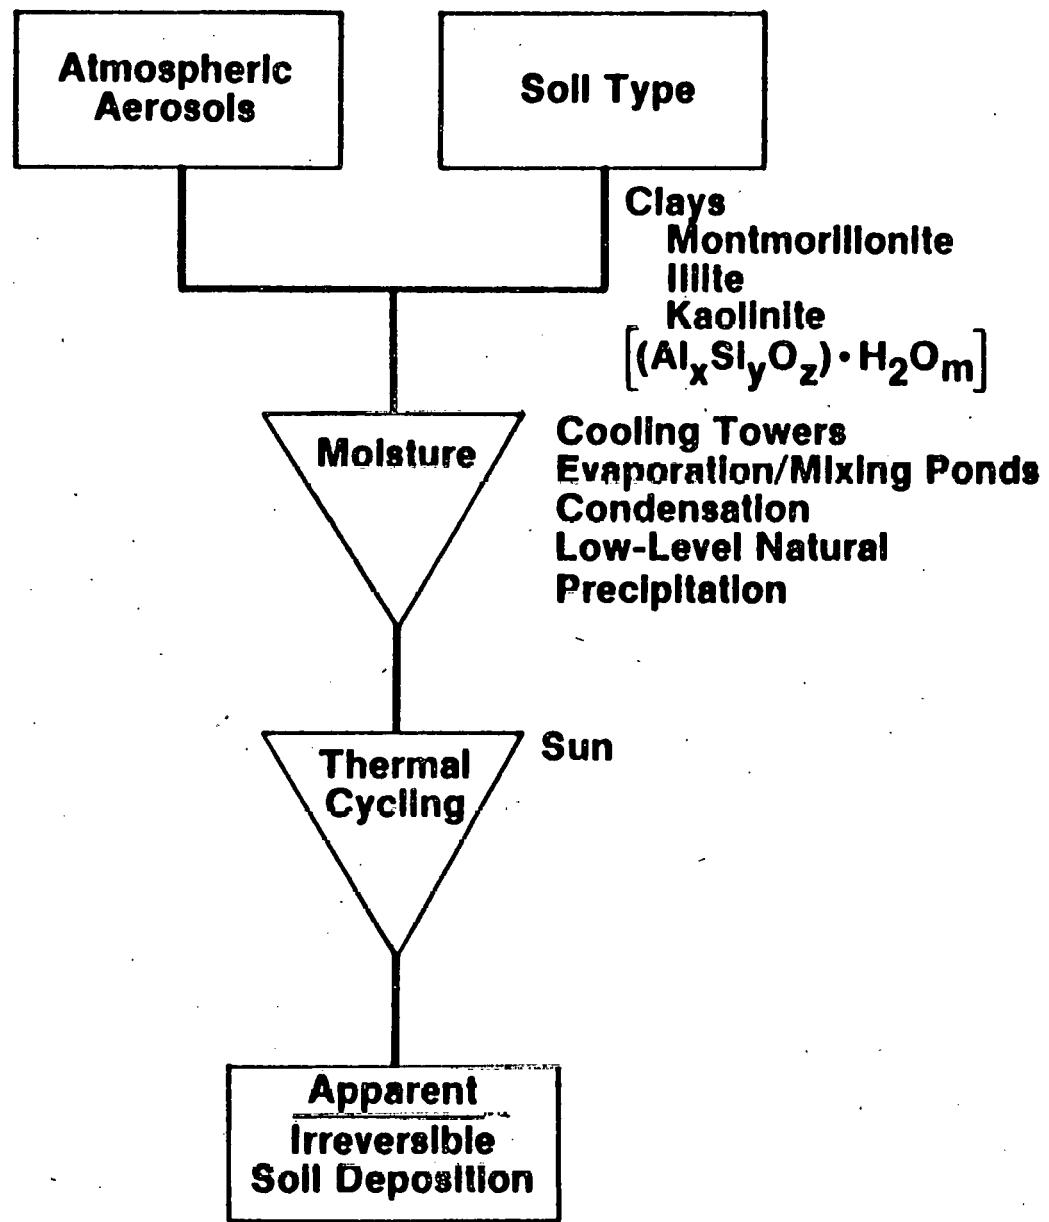
Figure 59. Soiling Mechanism

Two primary degradation mechanisms for solar collector materials were observed: (1) a residual layer of soil adhering to the cleaned mirror surfaces, which accounted for 5 to 15% loss in specular reflectance at all sites, and a 90% loss at one site, after 12 months of exposure; and (2) corrosion of metallic components of the reflector specimen at four of the nine industrial sites. A less serious degradation mechanism, abrasion of Alzak and FEK-244 specimen surfaces, did not appear to cause as large a loss in specular reflectance.

The impact of the soil retention problem on existing and proposed full-scale solar structures could be considerable. All test sites have shown evidence, in varying degrees of severity, that this problem could shorten the useful life of the reflector in field use unless appropriate corrective actions are taken. It is theorized that a combination of low levels of moisture and particular soil types, (specific types of clay), when subjected to thermal cycling (Figure 59) will create ideal conditions for the formation of the tenacious layer of soil that is not removable by non-contact cleaning methods. Although an extensive systematic evaluation of cleaning methods was beyond the scope of this effort, a variety of solvents and cleaning agents were tried (chelating agents, acidic and basic cleaning agents, organic solvents), using both contact and non-contact cleaning methods, on glass mirror surfaces. There was no significant improvement in the specular reflectance measurements using these cleaning methods. The two methods that did finally remove the soil layer, an acid wash (36.5% by volume HCl, which consumed all but the glass portion of the mirror, and the use of a surgical knife to scrape the soil off), showed

there was no apparent chemical attack by the soil layer on the glass. These methods could not be used with the FEK-244 and Alzak specimens because of their soft surfaces and the reaction of the reflector material with an acidic medium. Neither of these methods is feasible for field cleaning procedures.
