NUREG/CR-5334
SAND89-0327

Severe Accident Testing of Electrical Penetration Assemblies

Prepared by D. B. Claus

Sandia National Laboratories

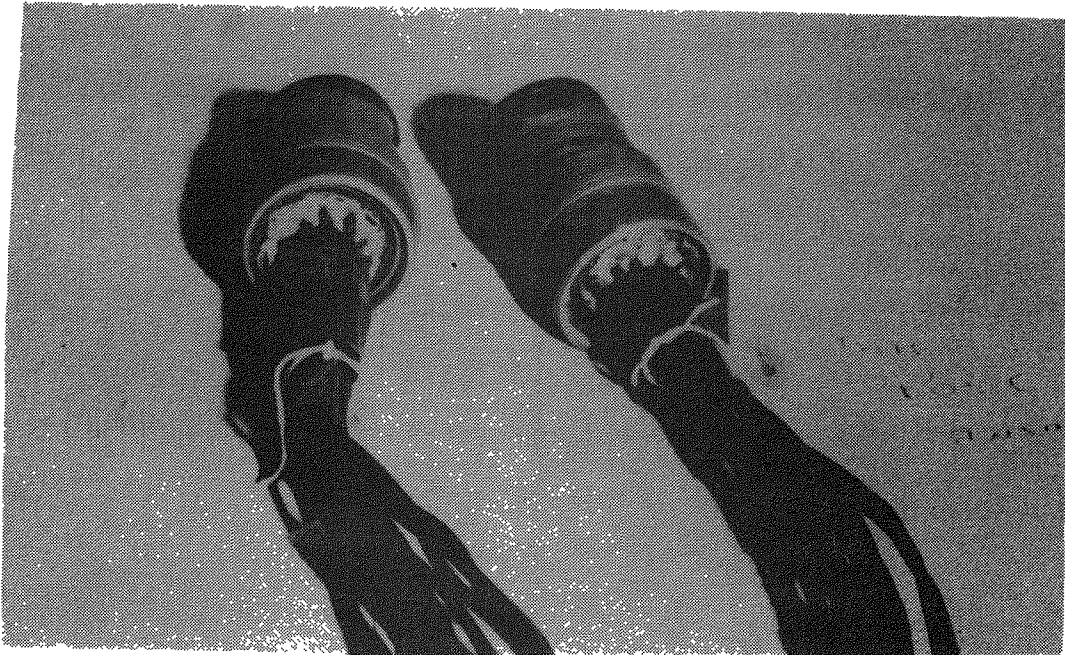
As indicated in Figures 4-63 and 4-64, a white material, similar to an epoxy, had extruded out the back of the coupling ring and from between the module and the plug skirt on the C42 series connectors, which were used "inside containment". This material may be a decomposition of the polysulfone used as a sealing material in the connectors; other products of such a decomposition could be responsible for the damage to the thermocouples. Speculation aside, the white material seized up the coupling rings and prevented removal of the inside connectors on both of the M02 and M13 modules.

Figure 4-63 Post-SAC Test : Material Extruding from M02 Connector

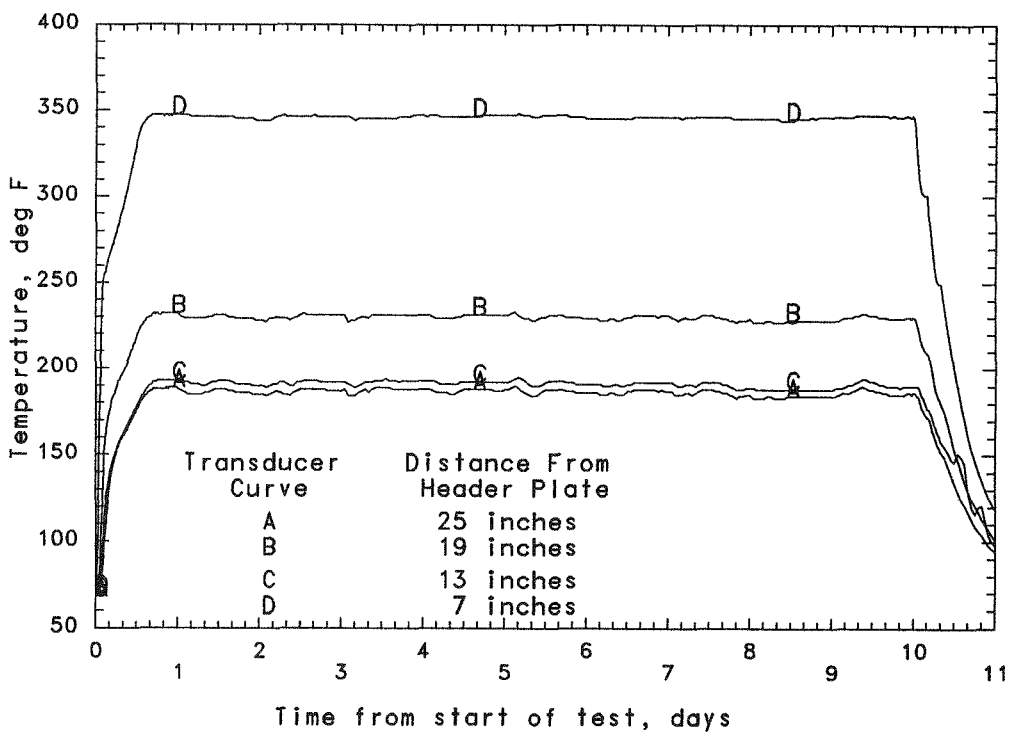
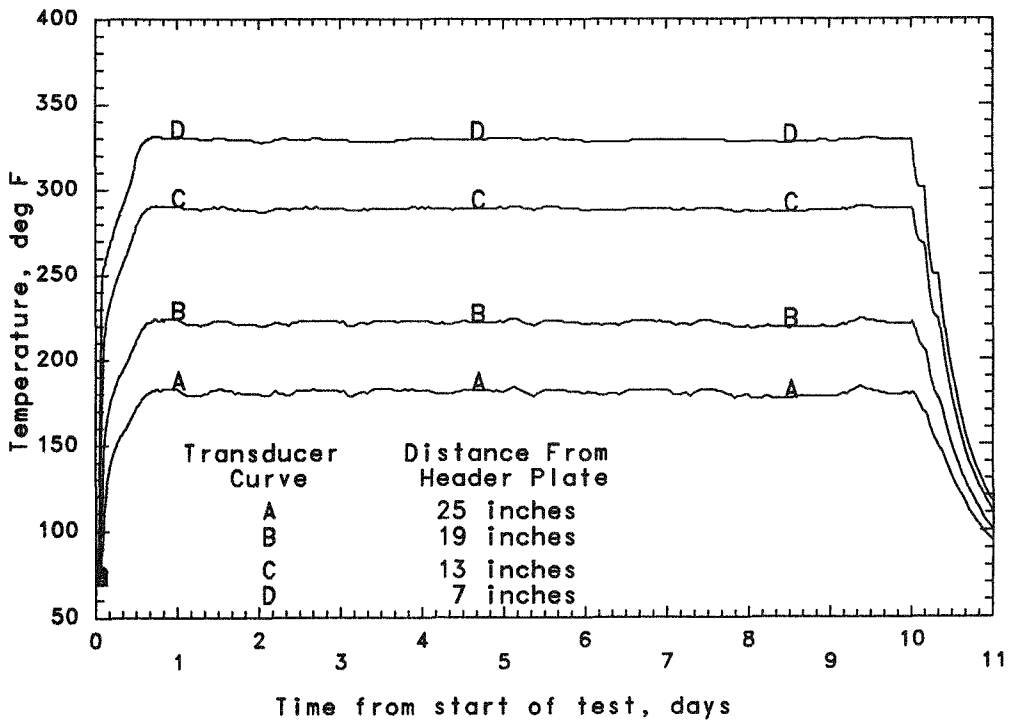
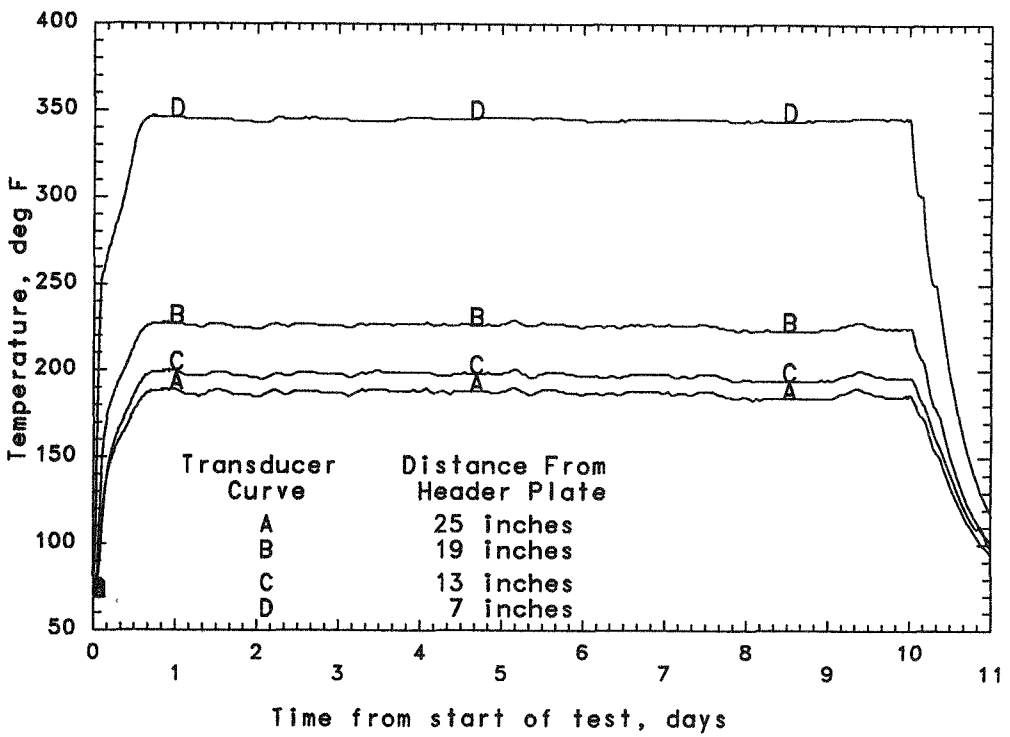
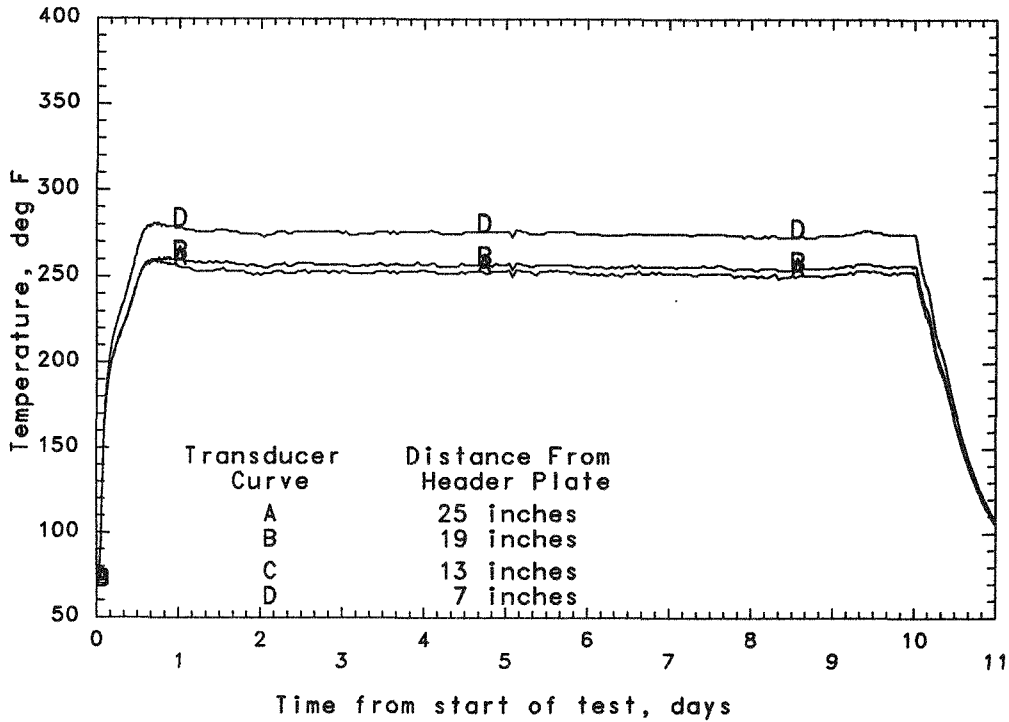
- Outside of the test chamber, there was a significant axial temperature gradient in the EPA nozzle (Figures 5-36 through 5-39). However, the air temperature inside the nozzle was much more uniform (Figure 5-40). Also, the following anomaly was observed during the SAC test (and not during thermal aging): at both 3 o'clock and 9 o'clock, the temperature of the nozzle 13 in. from the header plate was actually less than that 19 in. from the header plate.

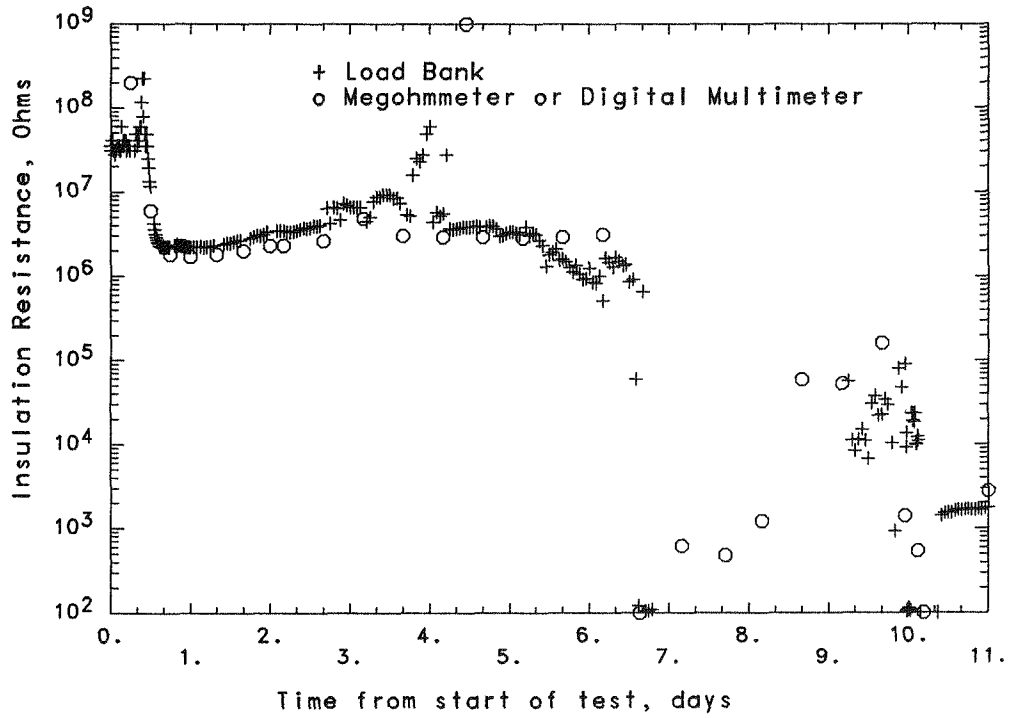
Figure 5-41 Insulation Resistance--ITT Suprenant Type KX, Red Conductor

The degradation in insulation resistance depended on the cable type and not on the EPA module. The first low resistance was in the ITT Suprenant Type KX cable. The insulation resistance to ground of the red cable, Figure 5-41, fell below 1 k Ω at about 4 days into the SAC test. However, the insulation resistance to ground of the yellow cable (Figure 5-42) remained above 0.1 M Ω for about 6 days, and the insulation resistance between the red and yellow cable was greater than 0.2 M Ω for just over 4 days.

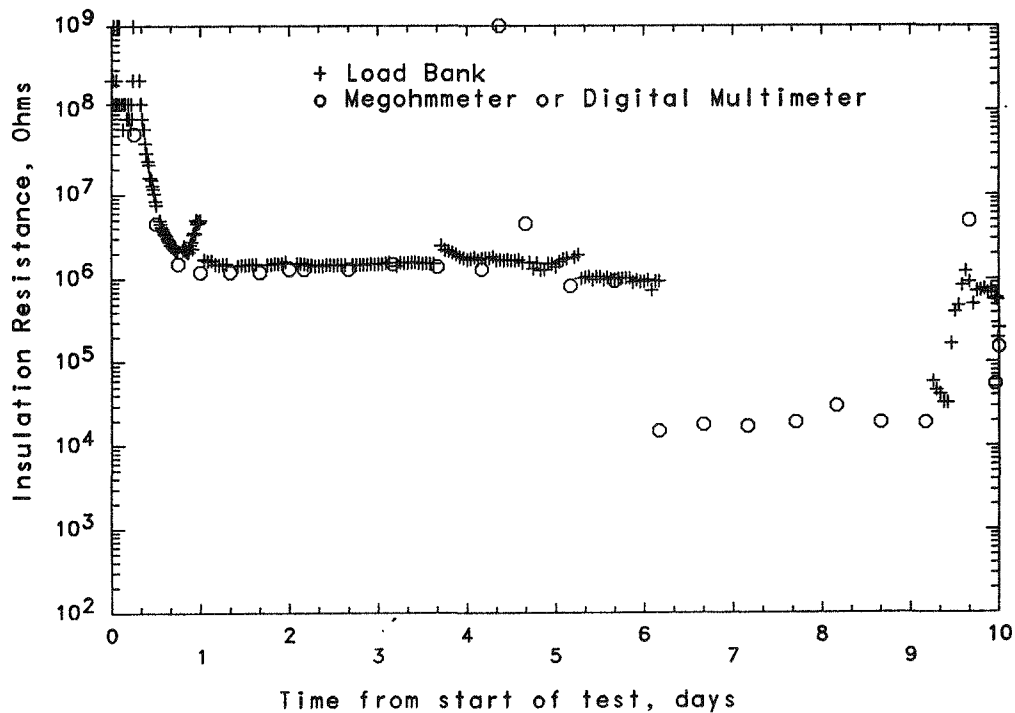
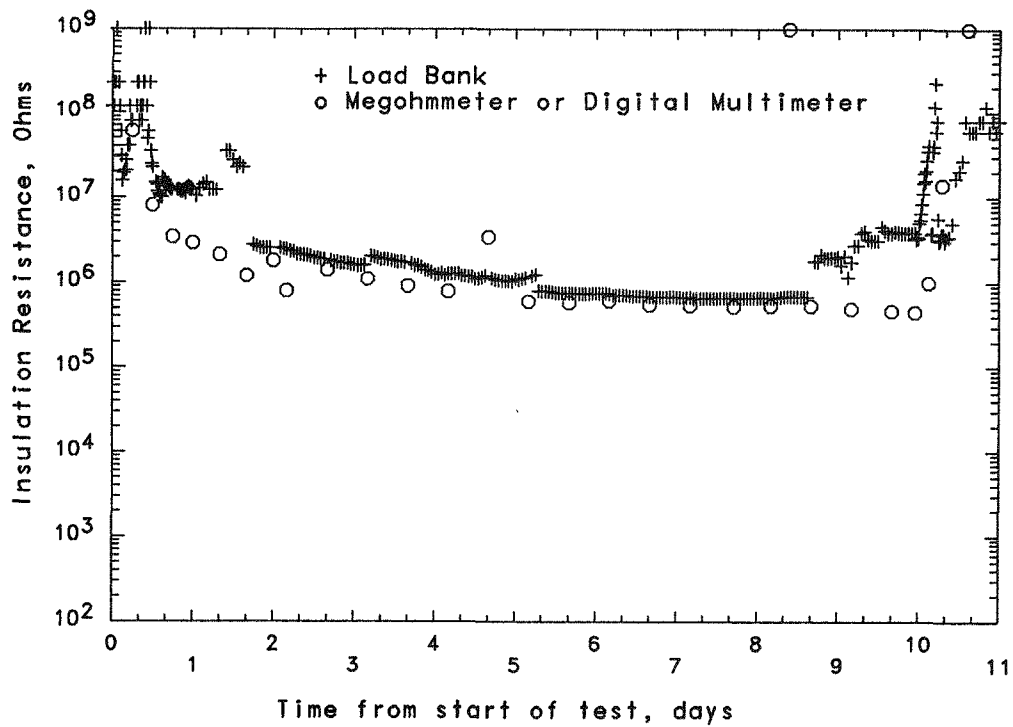
The load bank data for the ITT Suprenant Type EX cable show that the insulation resistance to ground for both conductors (Figures 5-43 and 5-44) was greater than 10 k Ω for the first 5 days of the test. Measurements taken with the Megohmmeter and the Digital Multimeter show a sharp drop in the insulation resistance of the red conductor from 3 M Ω to 1.5 k Ω between 12 and 18 hours into the SAC test. Although the insulation resistance of this cable subsequently recovered, it is believed that the insulator may have been damaged by the 500 V potential applied during the Megohmmeter measurement.

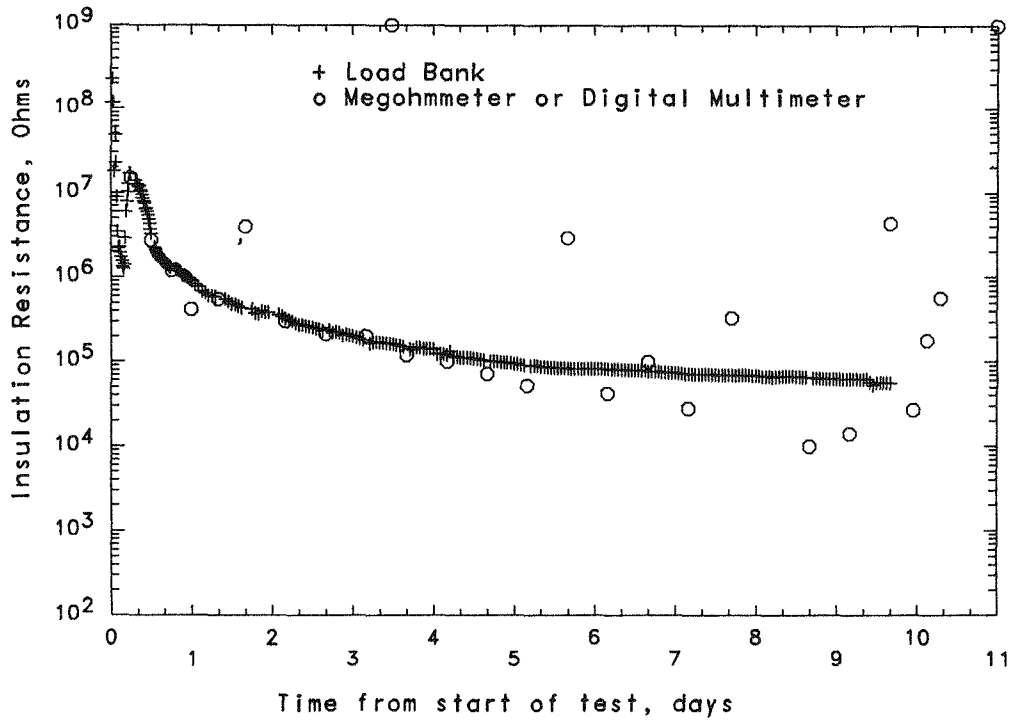
Figure 5-47 Insulation Resistance--Raychem Conductor

The insulation resistance of the Raychem #14 AWG cable, Figure 5-47, gradually degraded throughout the SAC test but remained quite high even at the end of the test. Although the rate of degradation was somewhat higher, similar behavior was recorded for the Okonite #2 AWG cable.

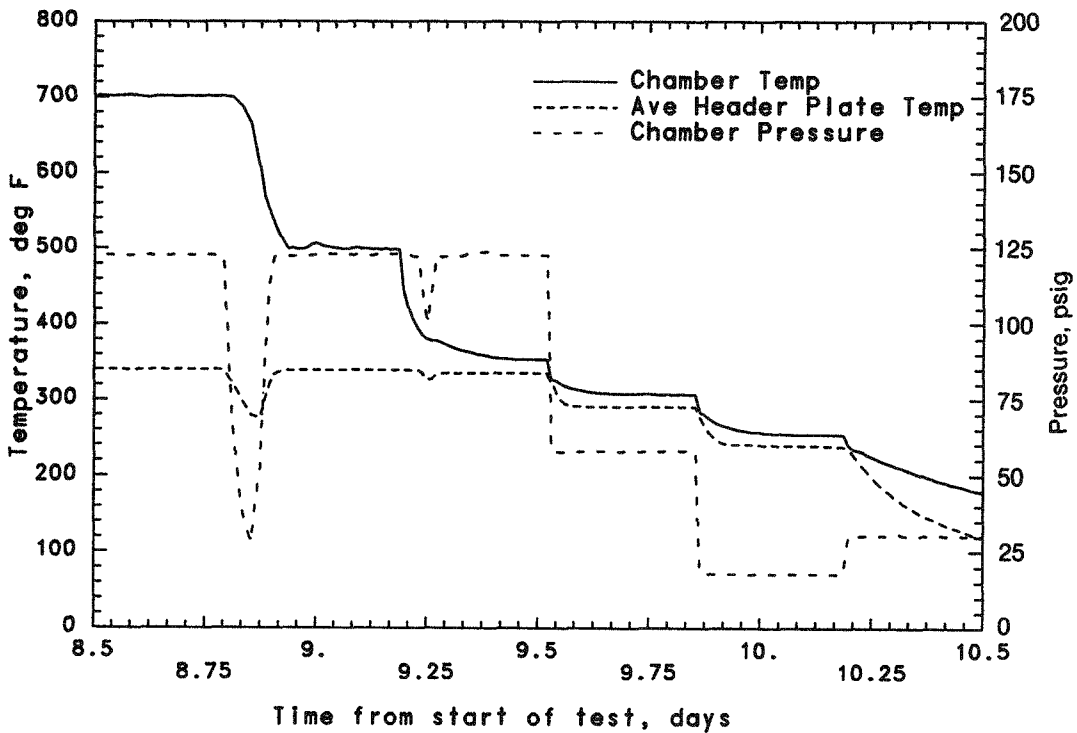
The temperatures on the EPA sleeve and header plate are plotted in Figure 6-27 and 6-28, respectively. Curiously, the temperature of the header plate was roughly equal to the saturation temperature corresponding to the test chamber pressure. At the four times when the steam system malfunctioned and test pressure dropped, the temperature of the header plate also fell such that it was always approximately equal to the saturation temperature at the current test pressure even though the chamber temperature did not change significantly during these events. The most graphic examples of this occurred during cool-down. Figure 6-29 shows the average temperature of the header plate as well as the chamber temperature and pressure as a function of time. This seems to suggest that the header plate temperature depended more strongly on pressure than on temperature; superheat in the chamber only affected the temperature gradient along the nozzle. Figure 6-30 supports this idea; the steady-state temperature is plotted as a function of position for several points during cooldown that include both superheat and saturated steam conditions in the test chamber. Clearly, the addition of superheat affected the gradient, but it did not have a significant effect on the average temperature of the header plate. Since the performance of seal materials is very sensitive to temperature, this observation has important ramifications: it suggests that the temperatures of seals in or near header plates located outside containment may be restricted to levels not significantly higher than the steam saturation temperature at a given pressure.

Figure 6-29 Dependence of Header Plate Temperature on Chamber Pressure

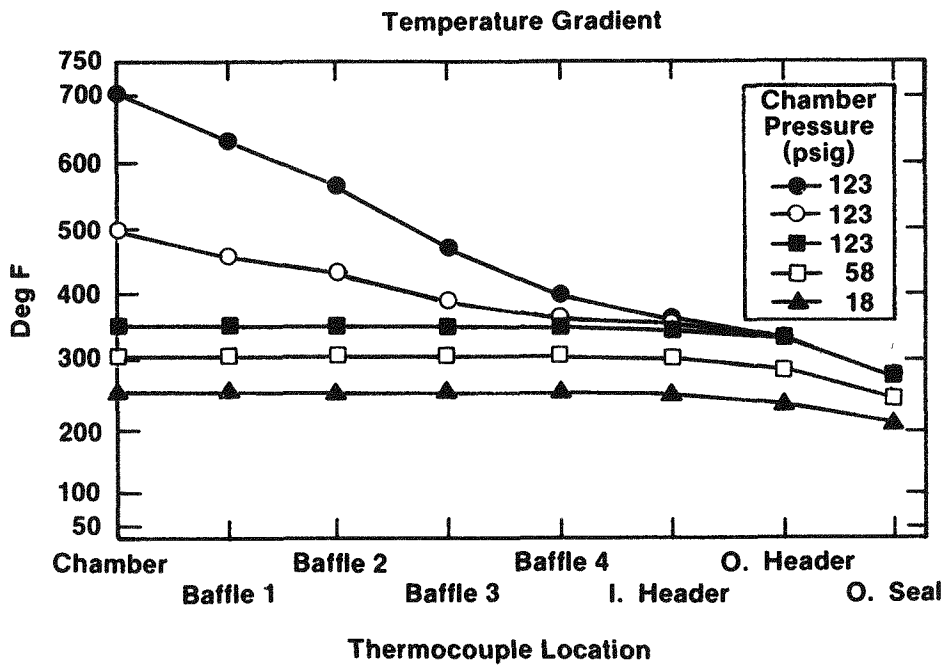
Figure 6-30 Temperature Gradient Along EPA Sleeve

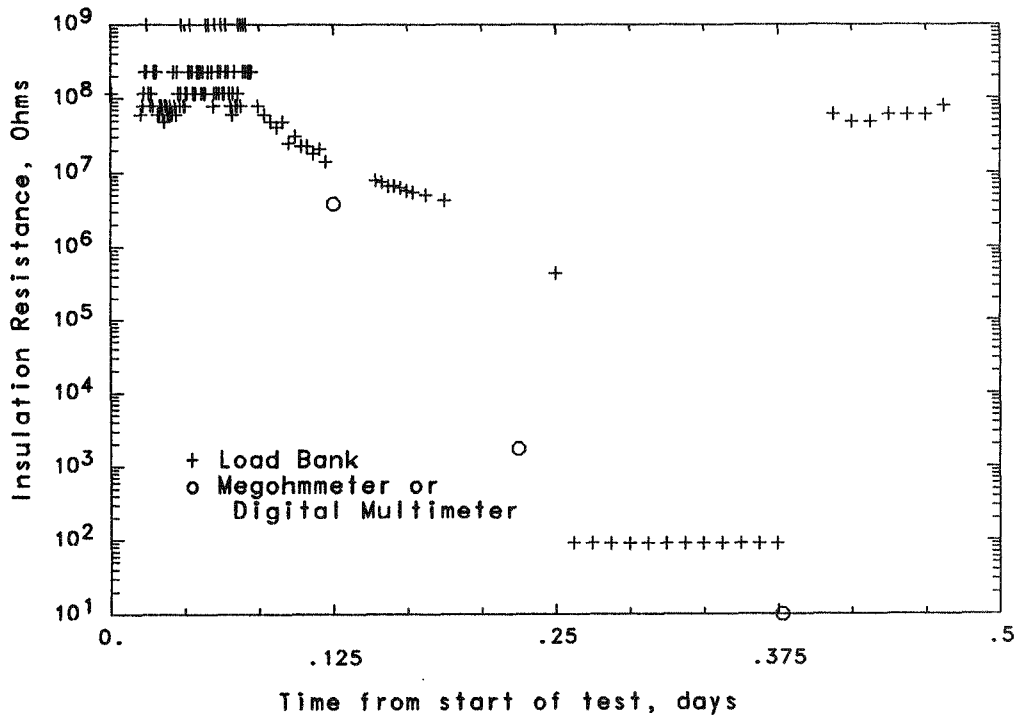
The insulation resistance of the copper cables degraded rapidly during the SAC test, as can be seen from Table 6-4. Figures 6-31 through 6-38 show the insulation resistance calculated from the load bank data using Equation 4-1 together with the data obtained from the Hippotronics Megohm meter and the Digital Multimeter. About five hours into the test, the insulation resistance of the cables in modules 3 (#12 AWG), 12 (#14 AWG), and 14 (#8 AWG) had dropped below 1 k Ω . The load bank data for Modules 12 and 14 (Figures 6-35 and 6-37, respectively) show that the insulation resistance of these cables tended to recover after a measurement with the Hippotronics Megohmmeter or the Digital multimeter. The insulation resistance of

Figure 6-31 Insulation Resistance for #12 AWG Cable, Module #3

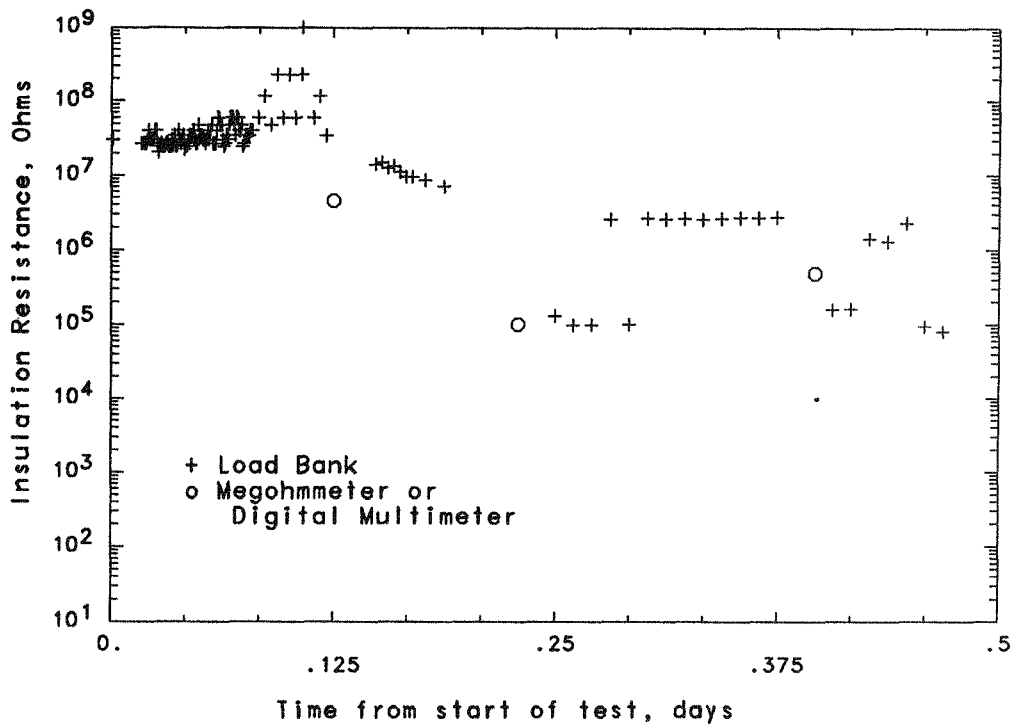
Figure 6-32 Insulation Resistance for #12 AWG Cable, Module #4

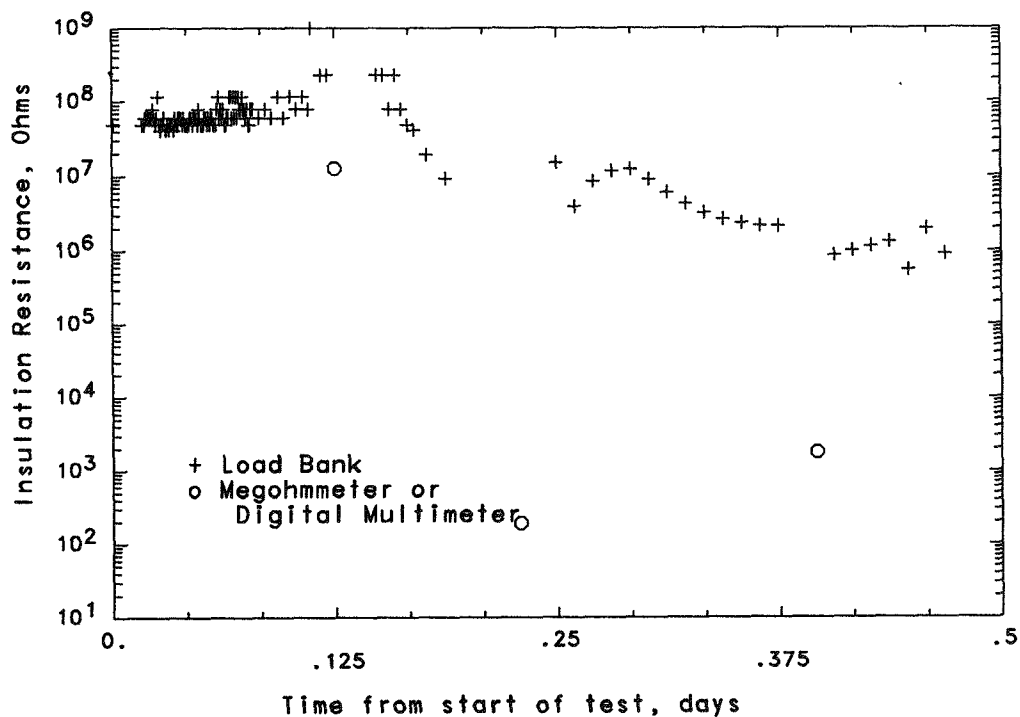
Figure 6-35 Insulation Resistance for #14 AWG Cable, Module #12

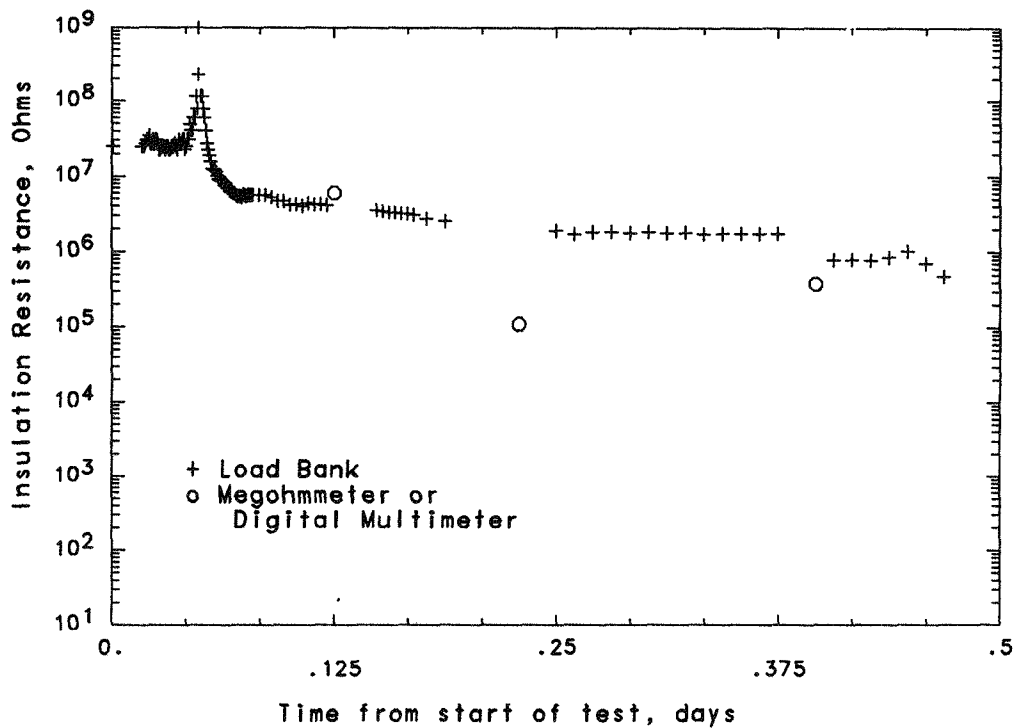
Figure 6-36 Insulation Resistance for #14 AWG Cable, Module #13

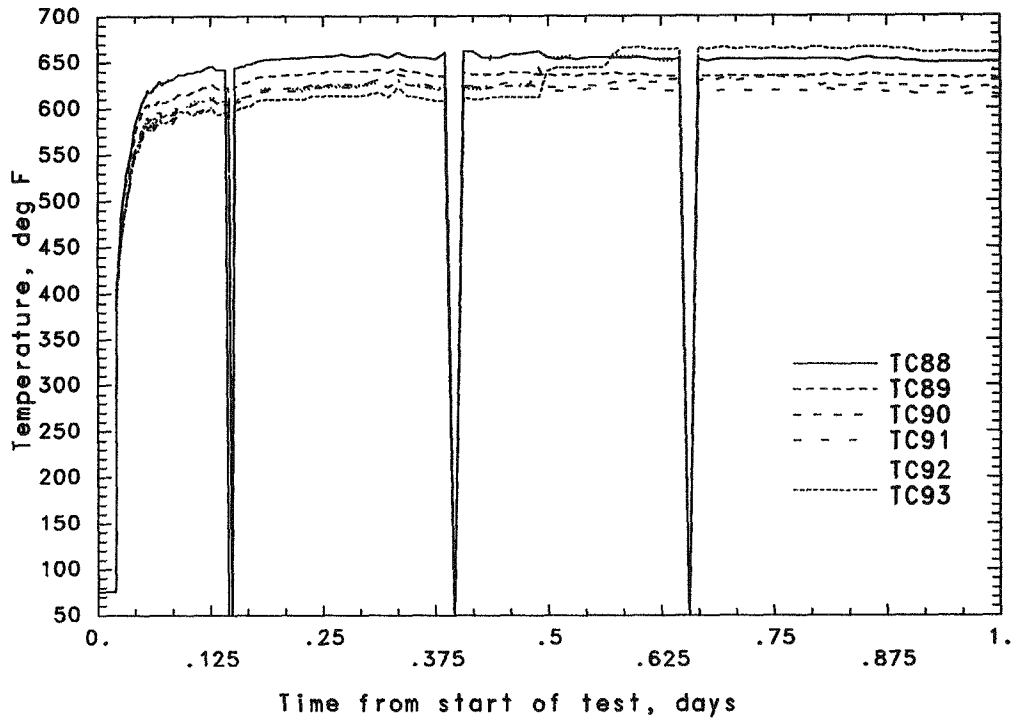
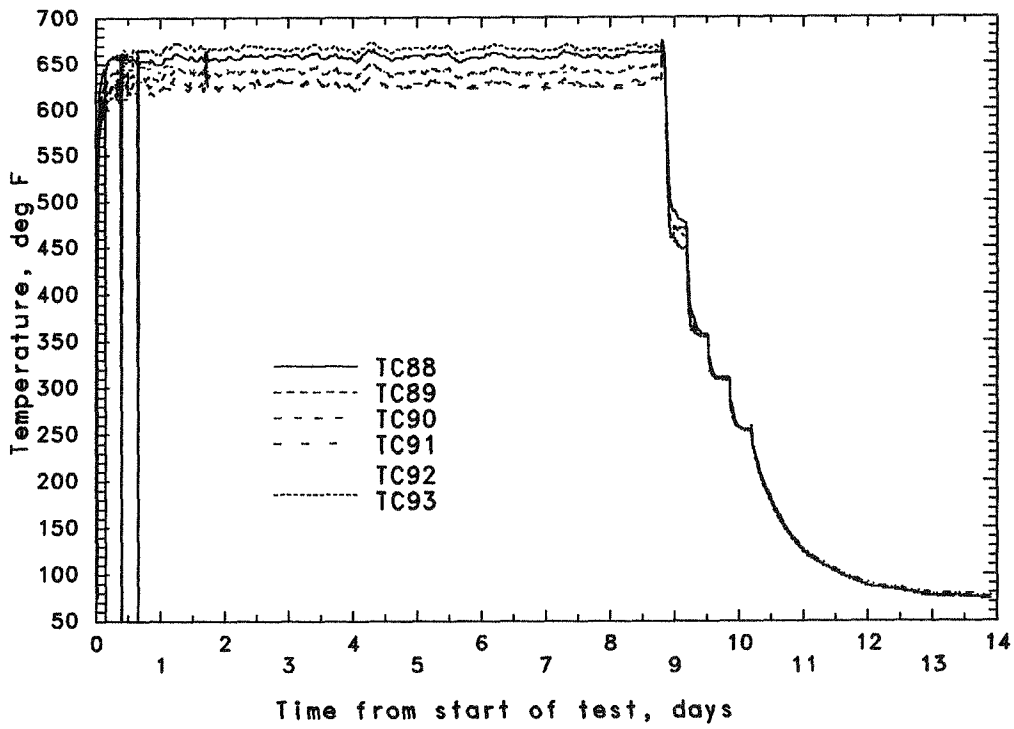
The insulation resistance to ground of the EPA thermocouple cables measured with the digital multimeter is recorded in Table 6-5. The insulation resistance of the cables just prior to the SAC test exceeded the range of the digital multimeter and are therefore not included in the table. As in the copper cables, there was significant degradation in the insulation resistance of the thermocouple cables very early in the SAC test. However, insulation resistance is only an indirect measure of electrical performance. In this test, the Type K cables in the EPA (modules 2, 9, and 10) were wired to simulate the output from thermocouples inside the junction box. This was intended to give additional insight into the electrical performance of the cables and the reliability of electrical signals during a severe accident. The output from the EPA thermocouple cables is shown in Figure 6-39. This figure shows that, despite the significant degradation in the insulation resistance of the cables, the signal still

Figure 6-39 Output from Conax EPA Thermocouples

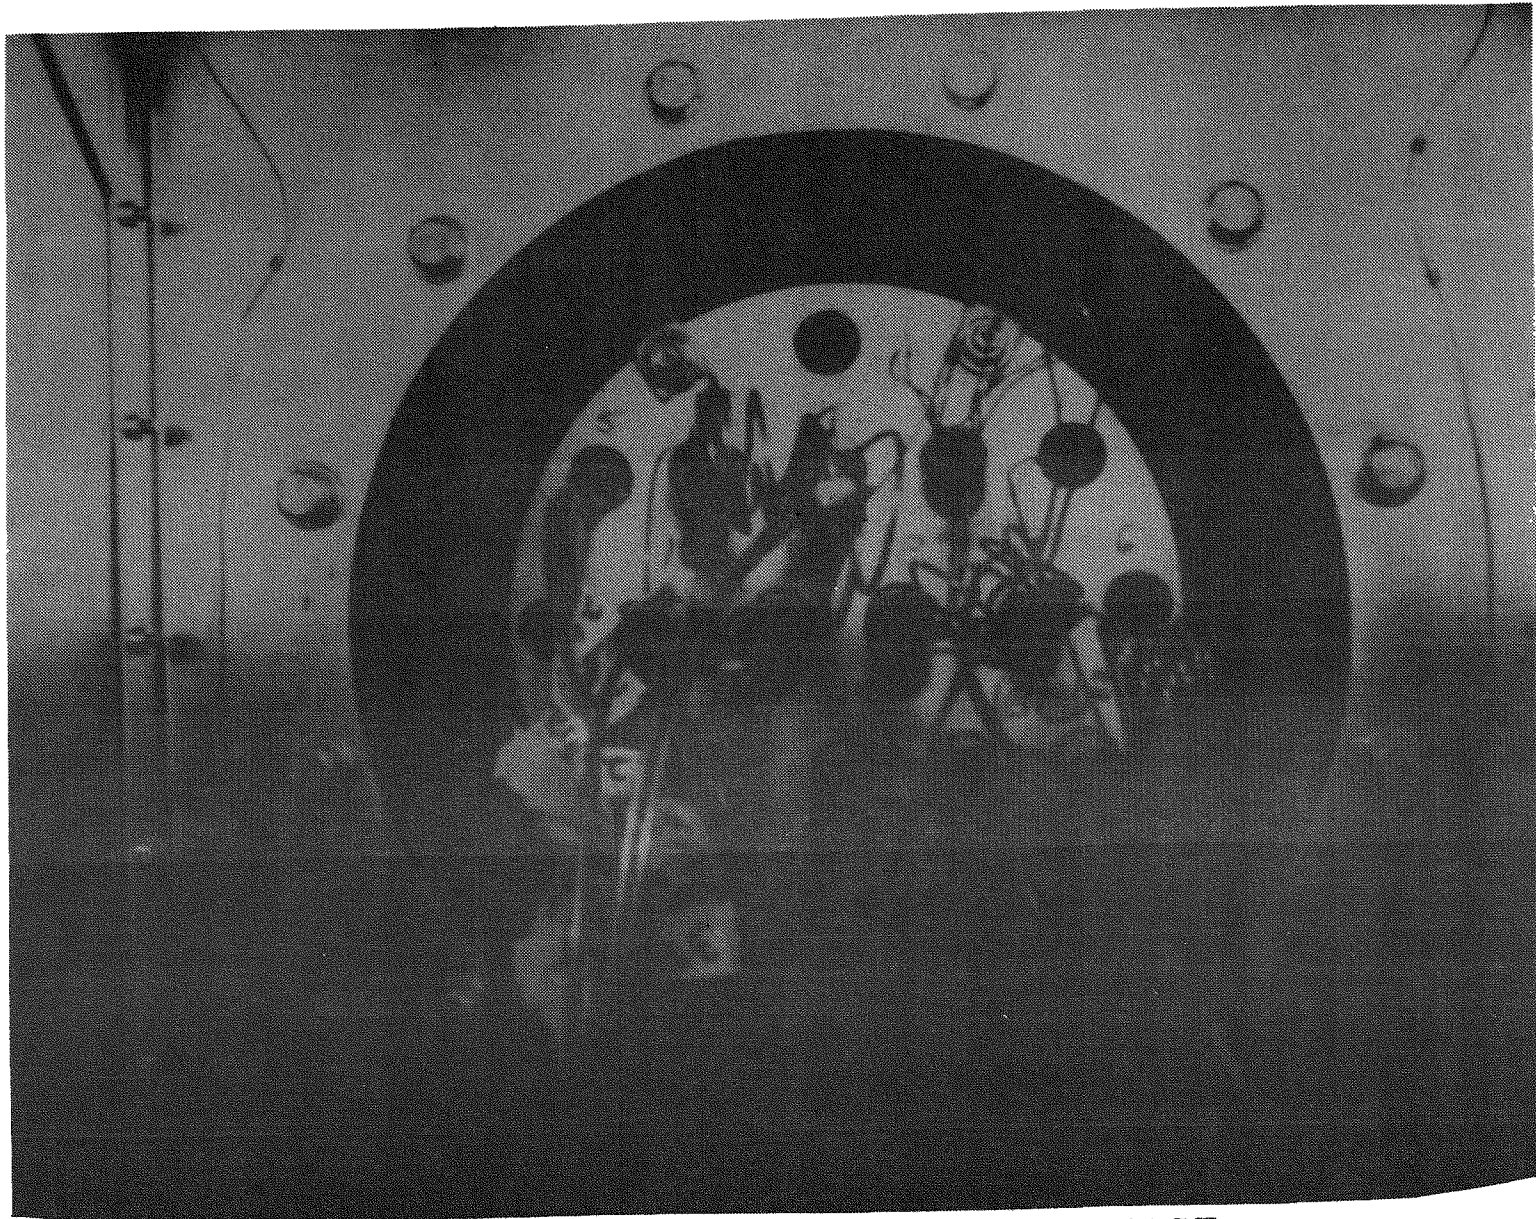
Figures 6-40 and 6-41 show the condition of the modules and the cables at the junction box (inside containment end) before and after the SAC test. The insulation on the cables inside containment had degraded to a black varnish-like coating that had high electrical resistance if the coating was not mechanically disturbed or measured with a potential greater than a few volts. If a measuring potential greater than two to three volts was applied for several minutes, the resistance would decrease.

Figure 6-40a Photograph of Inside Junction Box, Before SAC Test

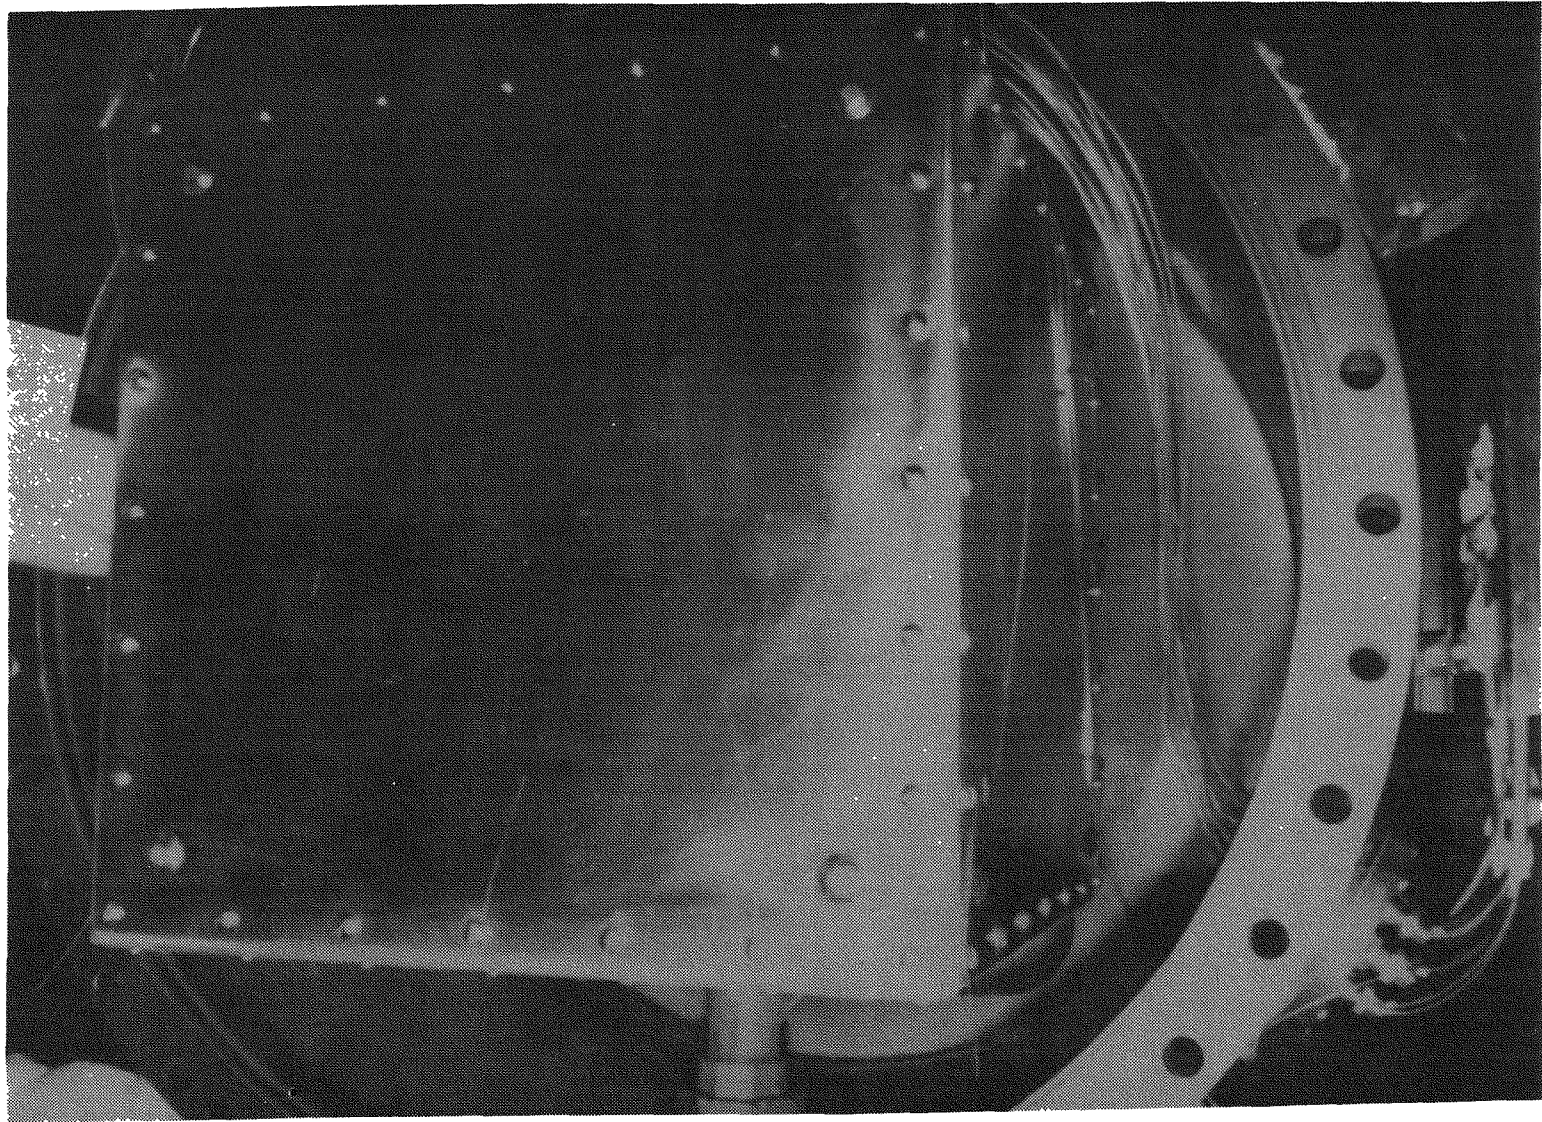
Figure 6-41a Photograph of Outside Junction Box, Before SAC Test
