**FLUIDIZED BED COMBUSTION 1000 HOUR TEST PROGRAM**

**Volume IV—Engineering Details and Post Test Inspections**

September 1981

NCB/Coal Utilization Research Laboratory  
Leatherhead, England

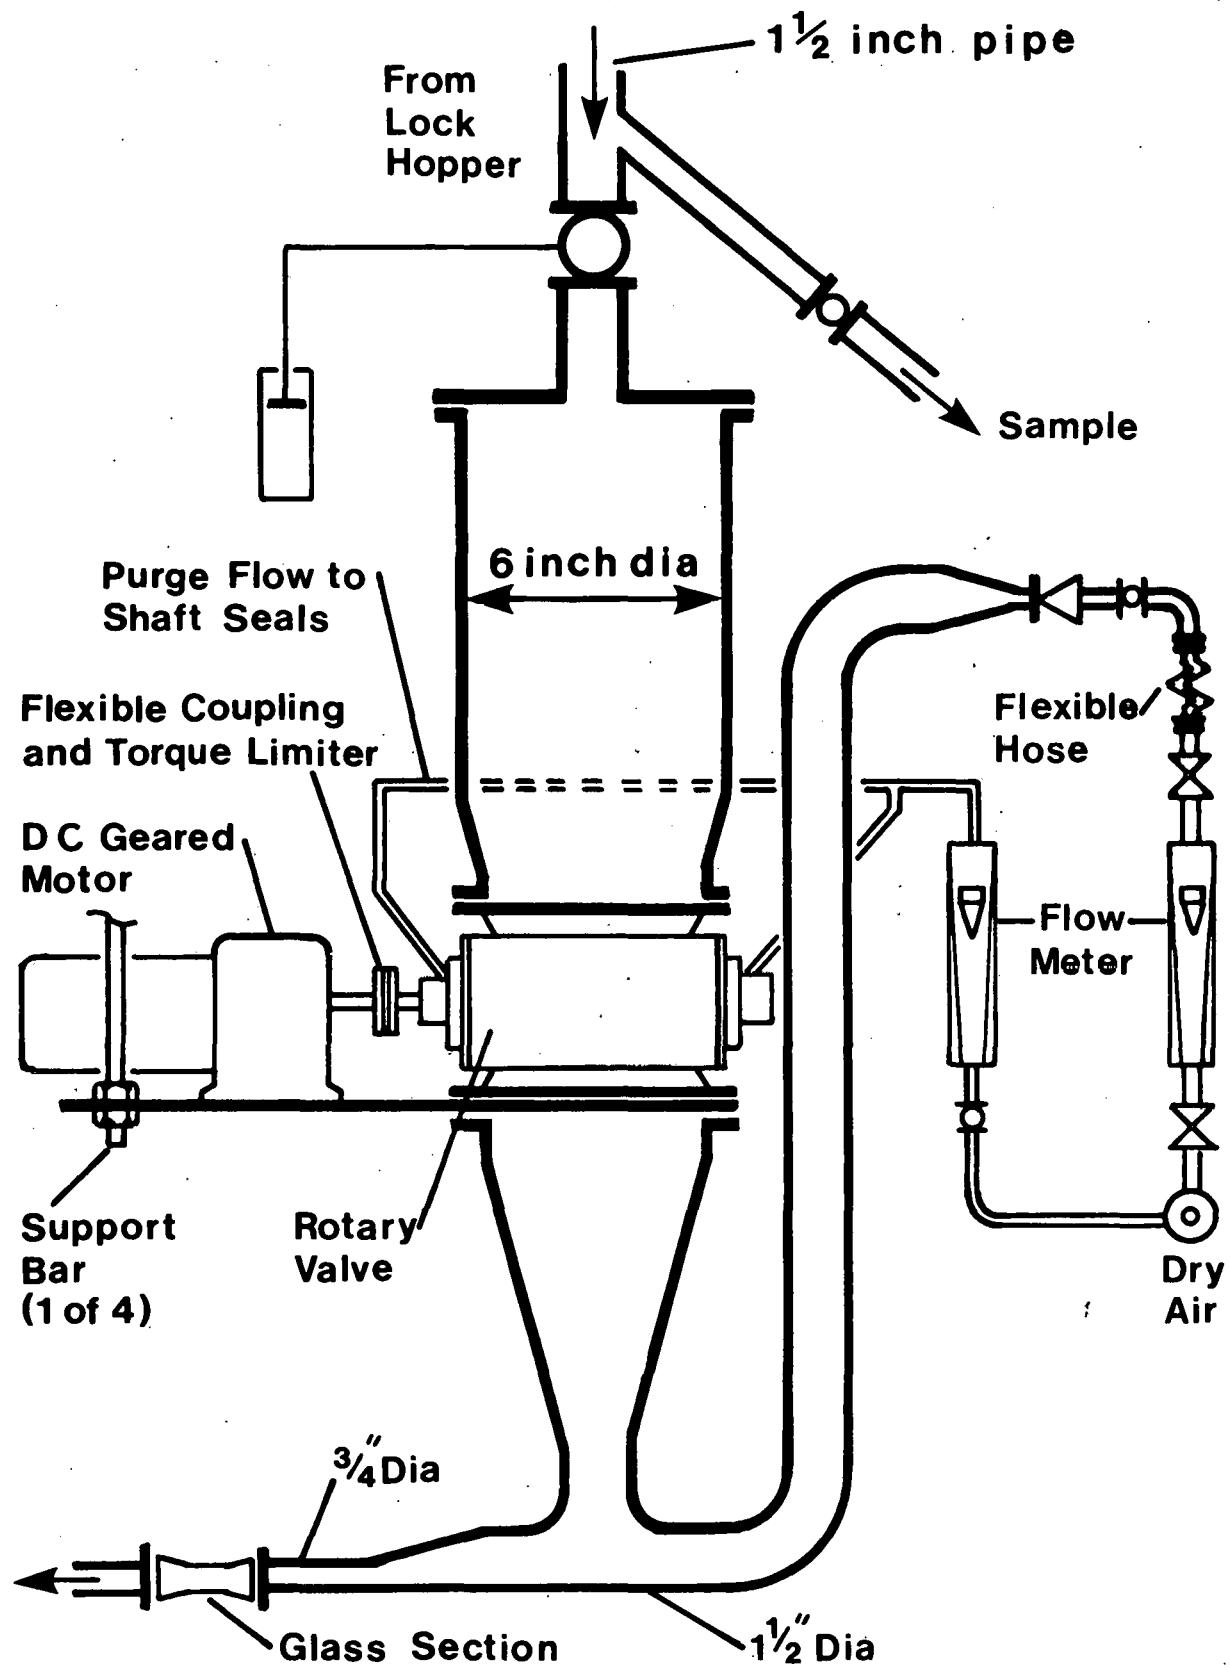
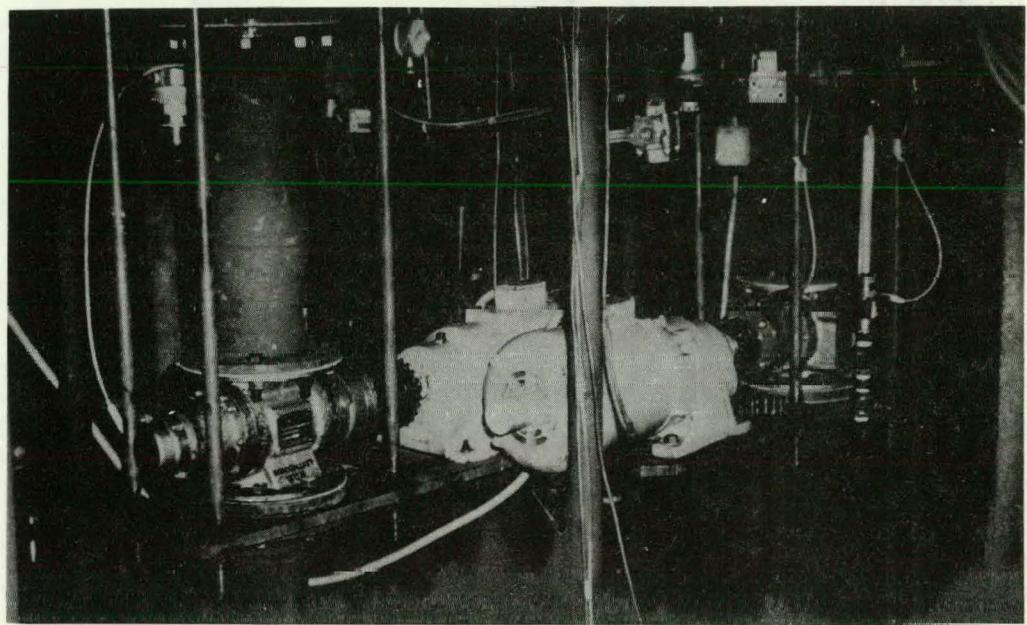
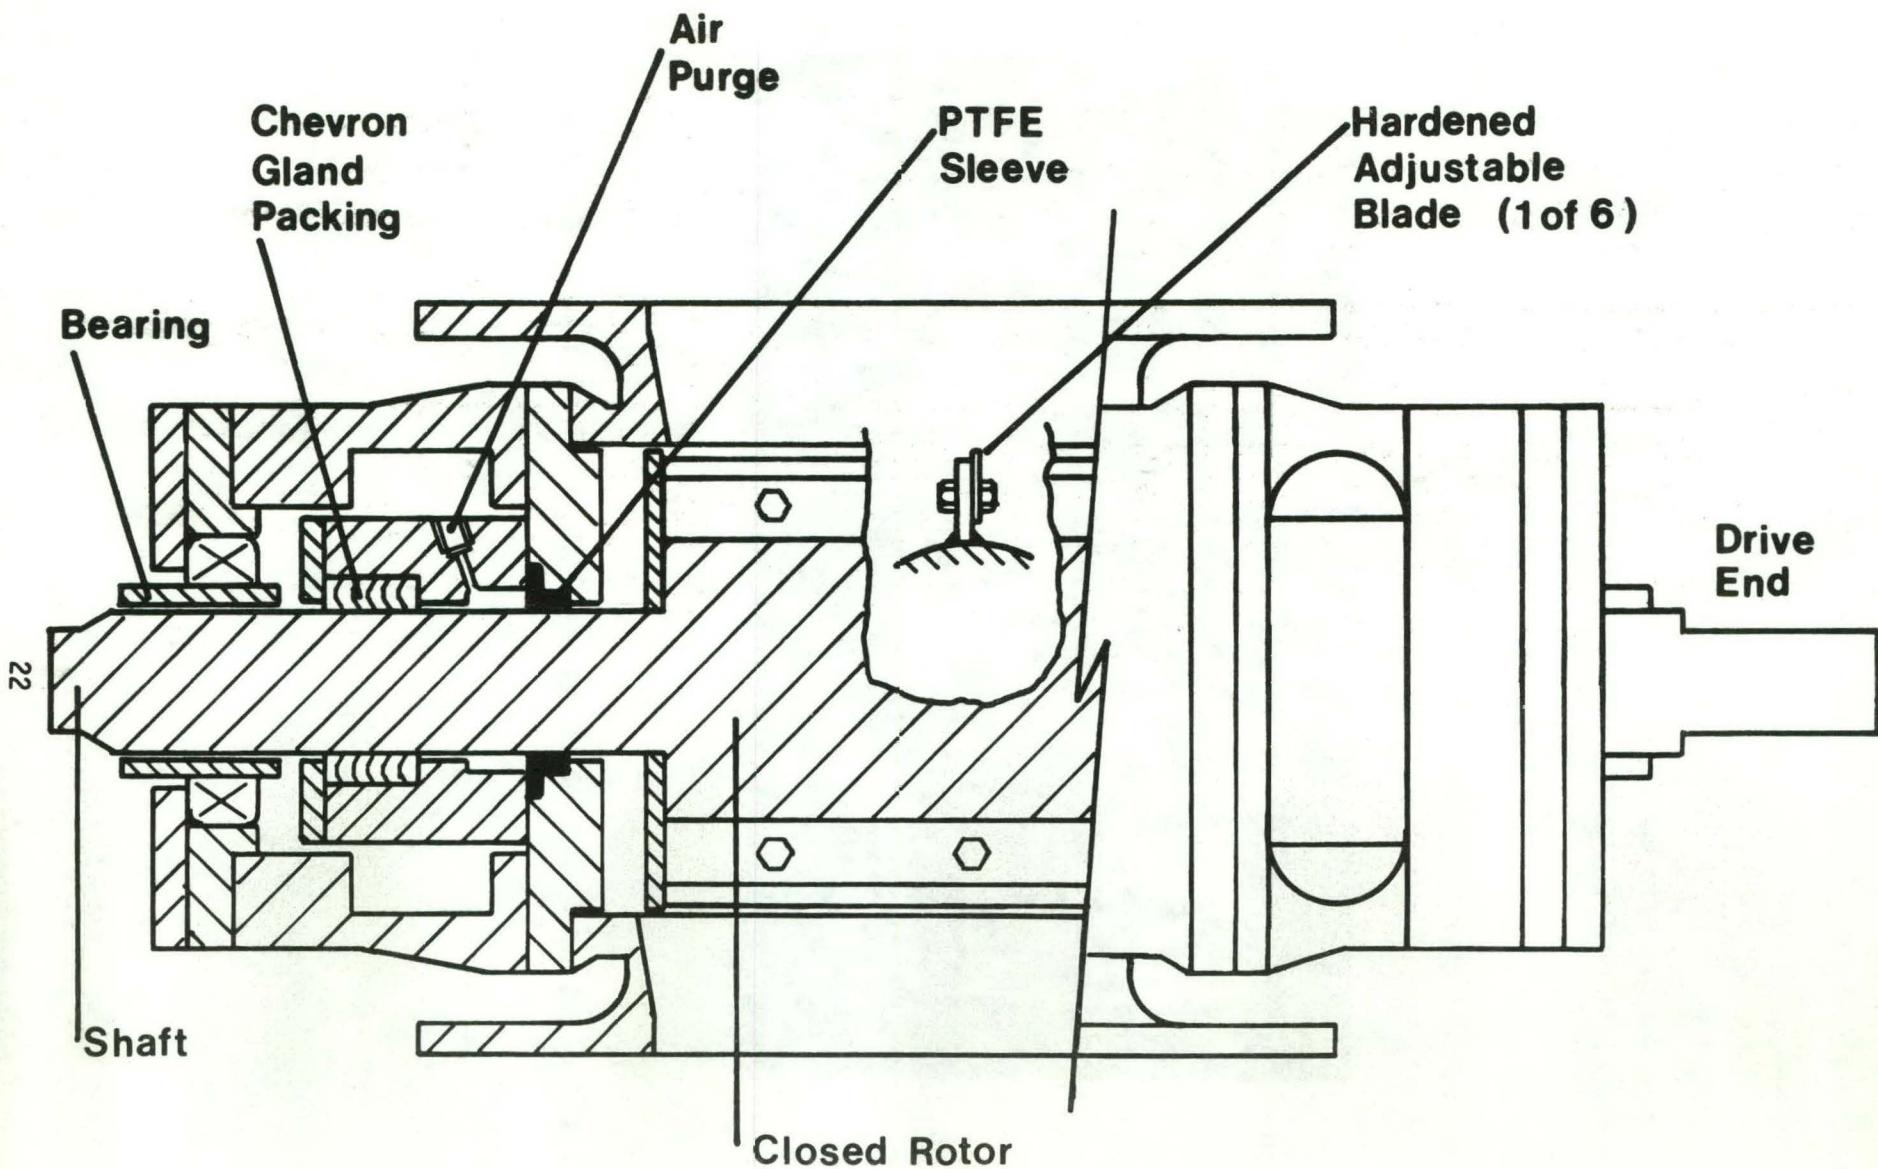
There was no leakage from the glands of the valves. However, on inspection after the first 250 hours operation the shafts were found to be grooved in the seal areas. These areas were hardened and reground after which the problem did not reappear. Failure to harden the shafts initially was an error on the part of the manufacturers. Blade wear was minimal (Figs. L.15 and L.16) and no wear of the body could be detected.

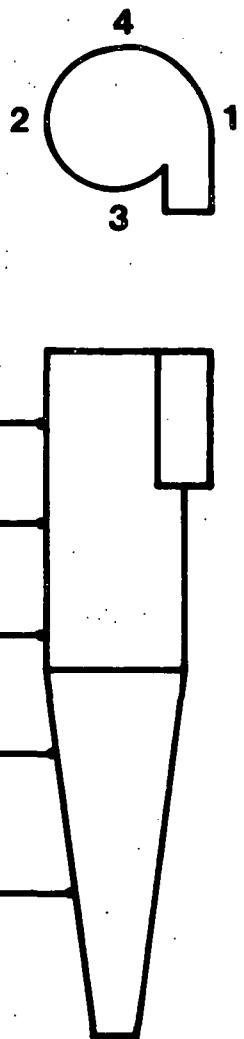
**Fig. L37 Wall thickness measurements on Stream 1 Van Tongeren cyclones.**

Position	1	2	3	4	1	2	3	4
	<b>Primary cyclone</b>				<b>Secondary cyclone</b>			
	1.9	1.1	1.5	0.9	—	2.8	3.3	1.6
Material loss	1.6	—	0.7	1.3	1.4	1.3	2.2	1.7
<u>1</u> (1000th.inch)	0.2	1.0	1.1	1.3	1.0	2.0	1.9	2.5
	1.3	0.9	0.9	1.9	1.4	2.5	3.0	—
	1.3	1.1	0.6	0.9	0.8	2.8	3.9	1.5

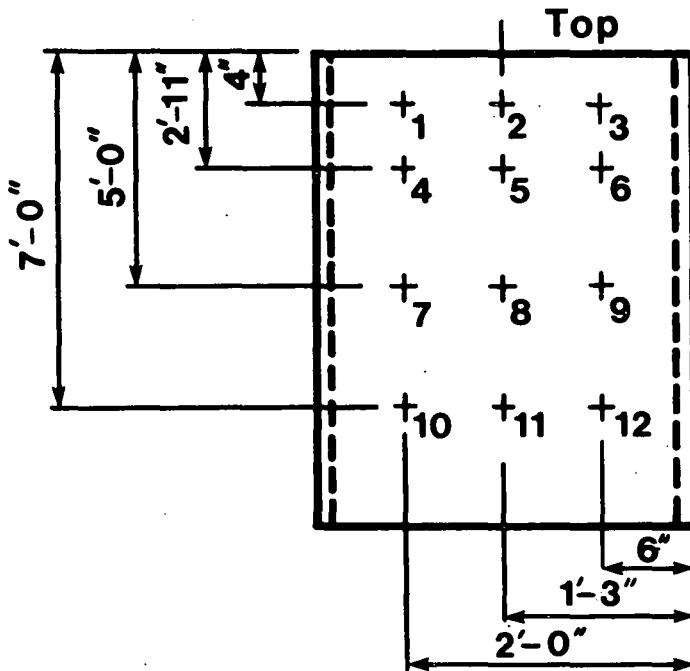
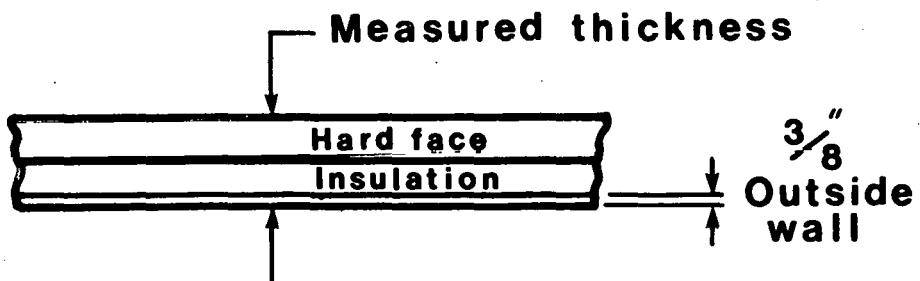
**Fig. L43(d) Combustor refractory thickness measurements**

**View on outside face 4  
(North end)  
Hard face material "Mizzou"**

Point No	1	2	3	4	5	6	7	8	9	10	11	12
Measured thickness loss ( $\frac{1}{1000}$ inch)	29	Gain	50	Gain	64

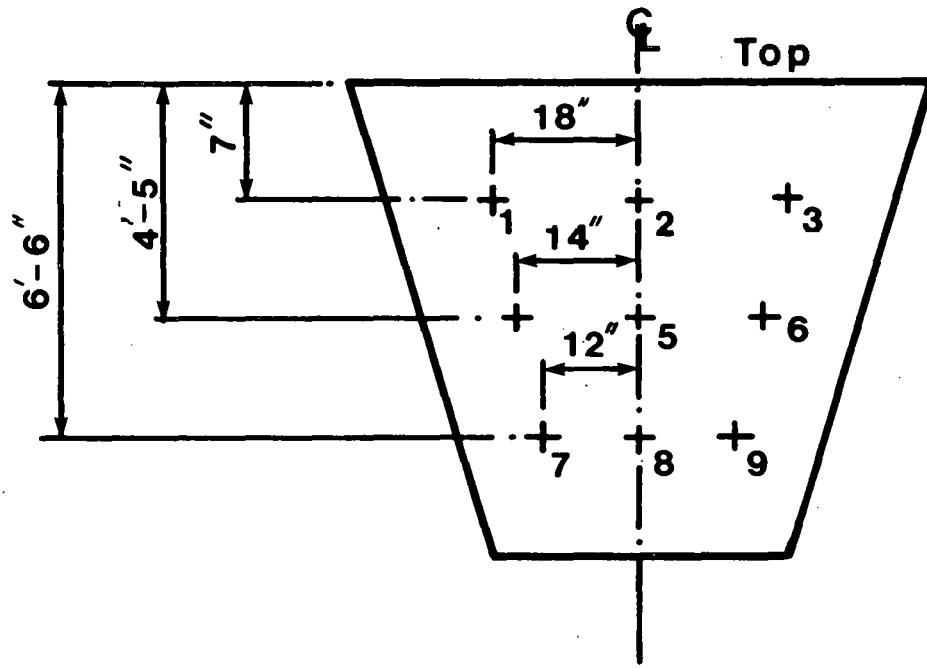
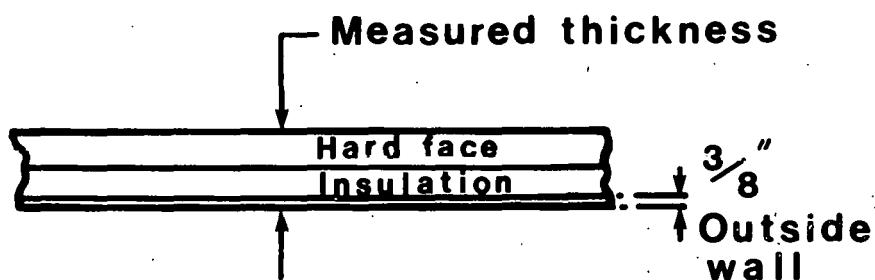
Fig.L43(a) Combustor refractory thickness measurements

View on outside face 1  
(East end)  
Hard face material "Mizzou"

Point No.	1	2	3	4	5	6	7	8	9
Measured thickness loss <u>1</u> (1000 inch)	50	50	87	54	34	61	Gain	103	177

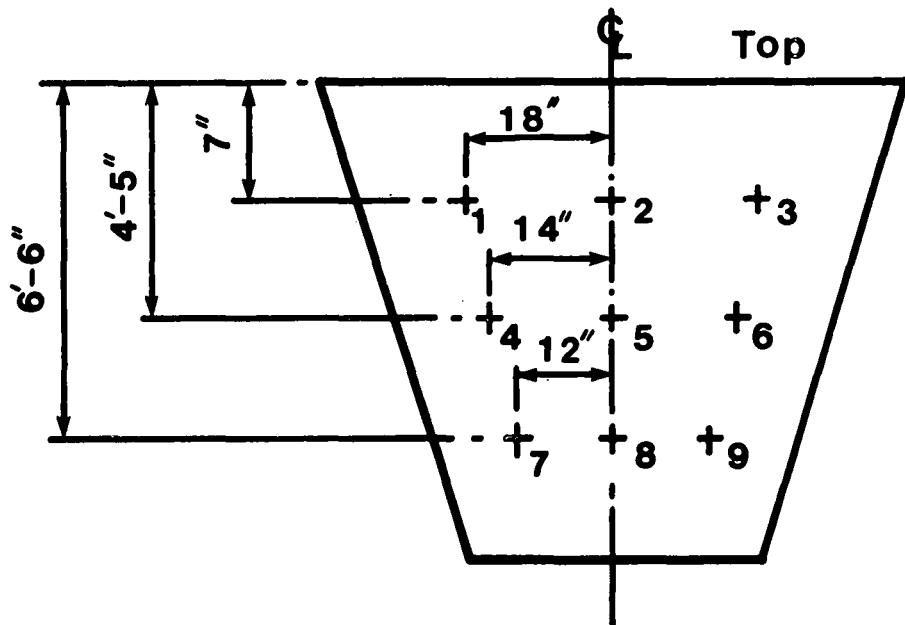
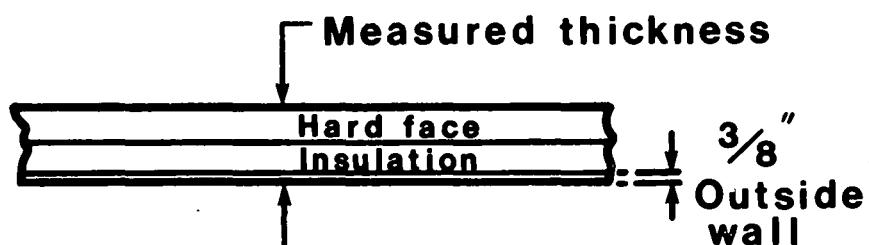
**Fig. L43(b) Combustor refractory thickness measurements.**

**View on outside face 2**

**( West end )**

**Hard face material "KS4"**

Point No.	1	2	3	4	5	6	7	8	9
Measured thickness loss 1 (1000 inch)	105	250	Gain	Gain	Gain	Gain	30	27	98

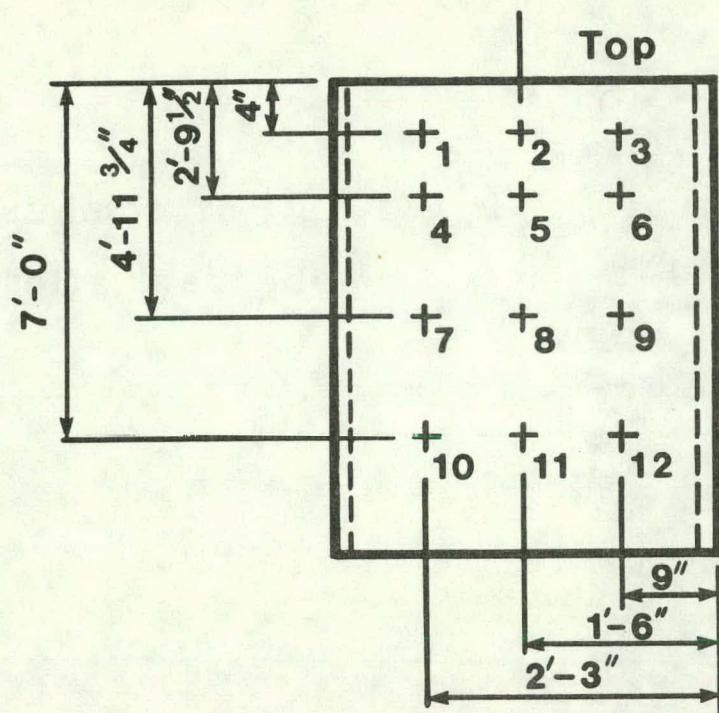
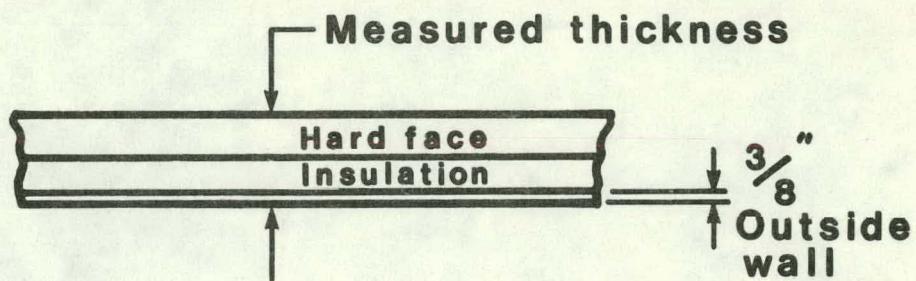
**Fig. L43(c) Combustor refractory thickness measurement**

**View on outside face 3**

**(South end)**

**Hard face material "Mid cast"**

Point No.	1	2	3	4	5	6	7	8	9	10	11	12
Measured thickness loss $\frac{1}{1000}$ inch	Gain 98	78	280	496	307	159	217	312	57	Gain	61

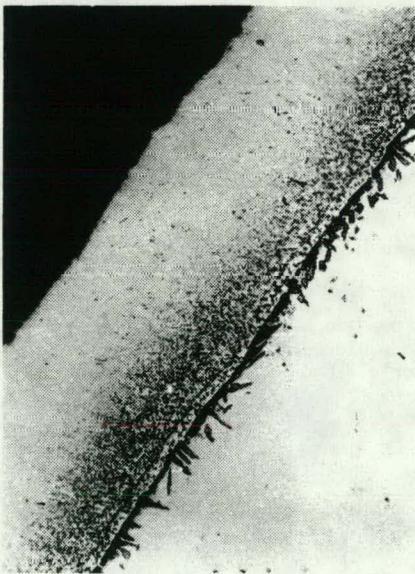
Figure 6. SEM-image of surface region (in cross section) of FeCrAlY-coated Udimet 500 blade. Coating thickness is approx. 100  $\mu\text{m}$ .

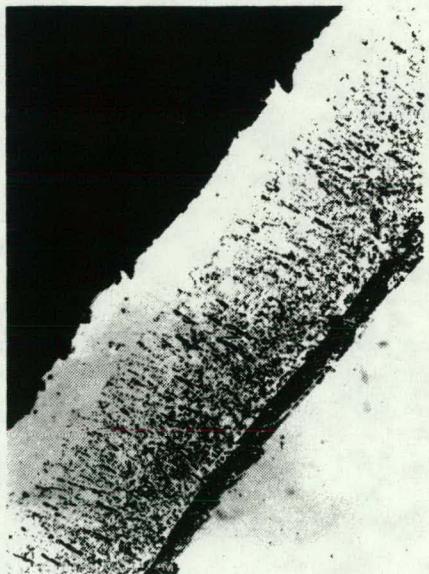
Figures 6 and 7 show scanning electron microscopy (SEM) photos of the surface region of the FeCrAlY-coated blade before and after 950 hours exposure to the combustion gases. The areas of the blade where these photos were taken from are on the pressure side near the leading edge. The photos show two changes to have occurred during the test. First, the microstructure of the coating, and especially at the blade material/coating interface, had changed. Second, the outer surface of the coating had become slightly roughened, suggesting deformation due to particle impact or else loss of local portions of the surface. Special notice should be paid to the two deeper indentations, at top and center of Figure 7, which have a common "angle of impact" and which, as judged from the contrast in the SEM image, are partly filled with some non-metallic material. This direction corresponds to the path rather large particles would take through the blade assembly. This is further illustrated in Figure 8 where the locations and directions of such "impact craters" are summarized schematically. As shown in Figure 8, similar craters were also found on the CoCrAlY-coated blade.

Figure 7. SEM-image of corresponding region after 950 hours exposure to PFBC combustion gases.
