September 1985

# **TMI-2 REACTOR VESSEL HEAD REMOVAL**

This report describes the safe removal and storage of the Three Mile Island Unit 2 (TMI-2) reactor vessel head. The head was removed in July 1984 to permit the removal of the plenum and the reactor core, which were damaged during the 1979 accident. From July 1982, plans and preparations were made using a standard head removal procedure modified by the necessary precautions and changes to account for conditions caused by the accident. After data acquisition, equipment and structure modifications, and training, the head was safely removed and stored; and the internals indexing fixture and a work platform were installed on top of the vessel. Dose rates during and after the operation were lower than expected; lessons were learned from the operation which will be applied to the continuing fuel removal operations activities.

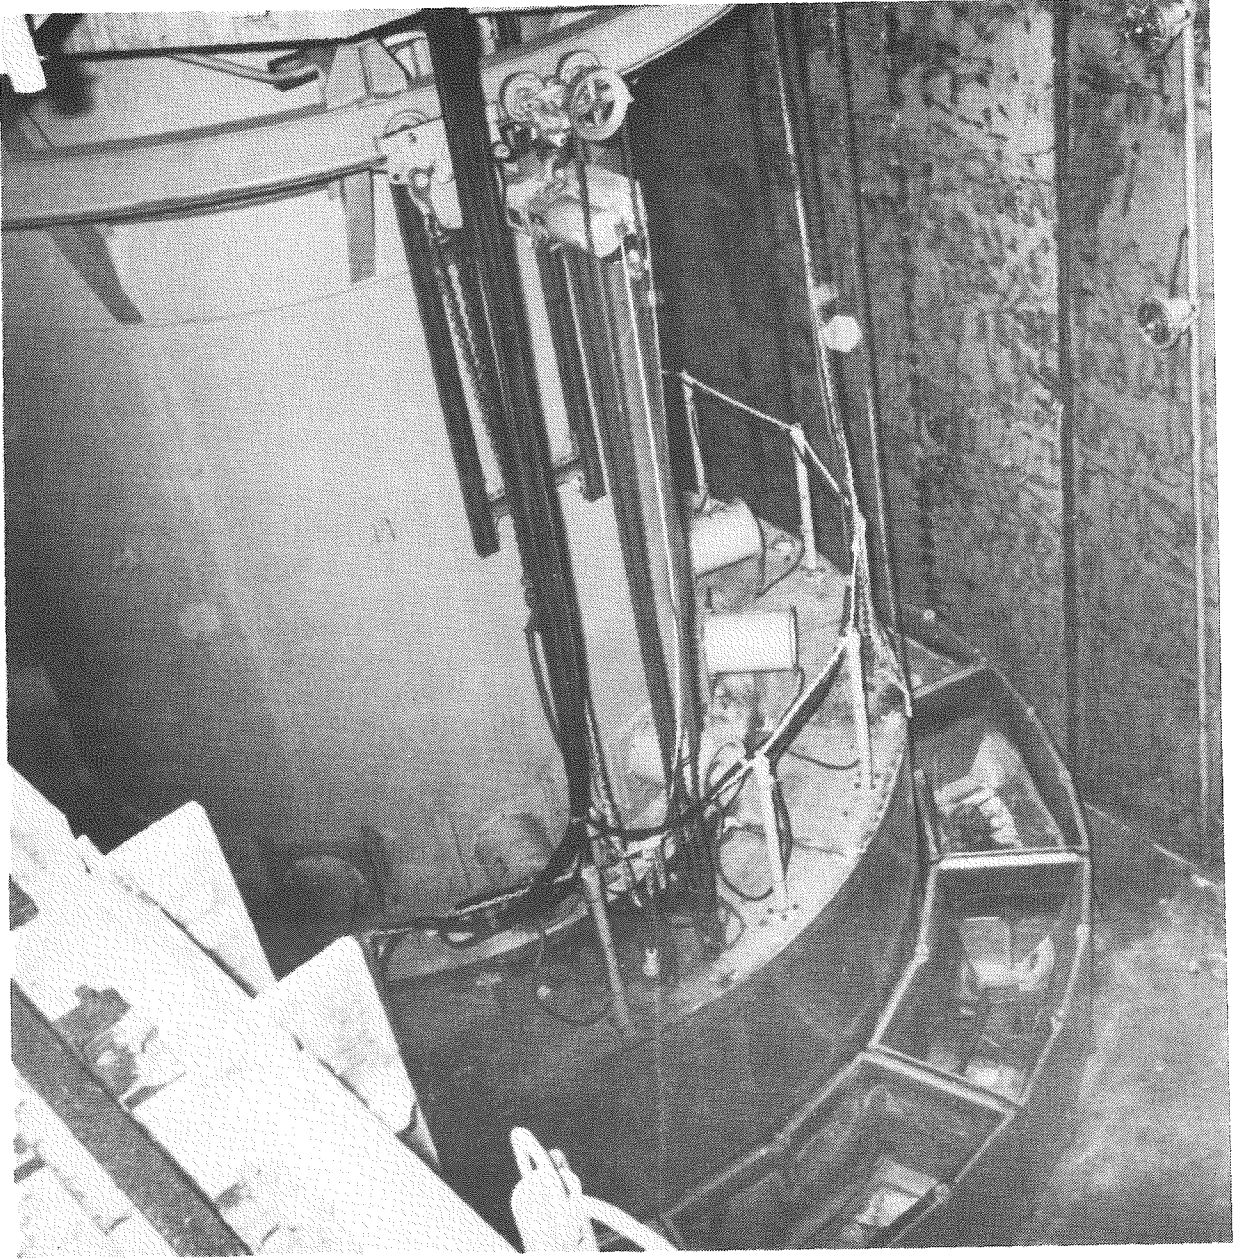
Figure 7. Service structure showing fans and exhaust ports, neutron shield tanks, walkway over reflective insulation, and hoist.

**3.2.2 Service Structure Fans.** During the accident, the service structure fans became highly contaminated because they were circulating contaminated reactor building air (Figure 7). The service structure was flushed to provide dose rate reduction in the area of the reactor vessel head flange. The flushing did reduce area dose rates but did not eliminate the dose rate contribution of the fans. After flushing, the 12 fans were removed from the service structure and disposed of as radioactive waste.

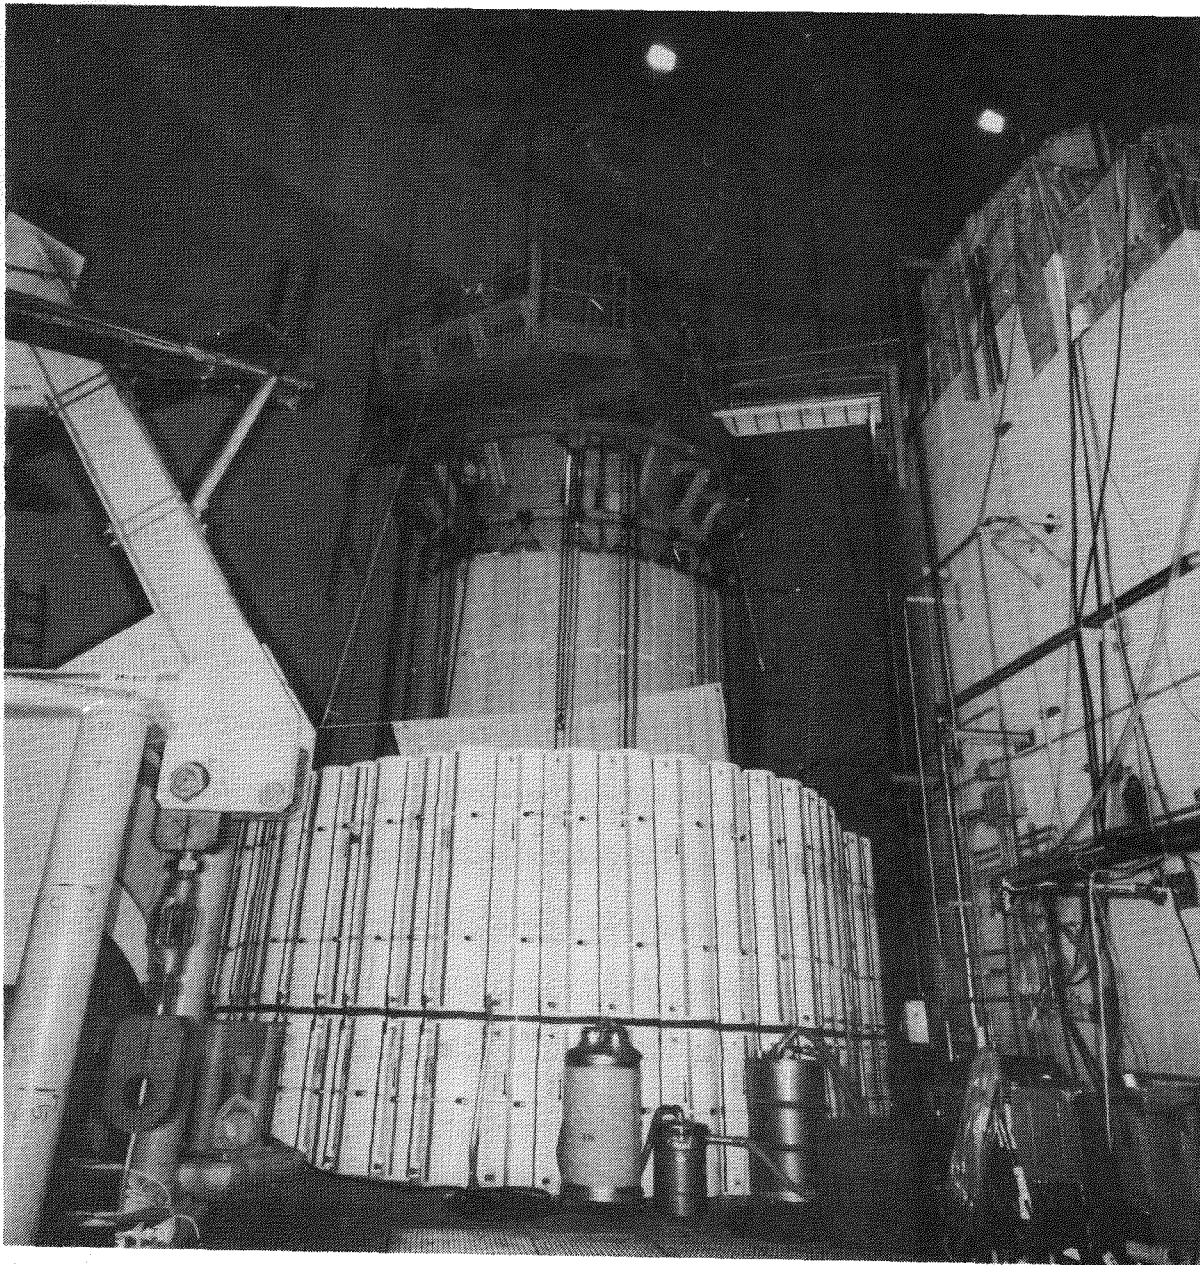
Figure 14. Shielded work station (upper right), walkway to service structure, tripod with turnbuckles (lower left), and 3.5 m sand column shielding.

**3.5.1 Head Lift Tripod and Turnbuckles Inspections.** As part of the lifting assembly inspection, the head lift tripod was cleaned and inspected (magnetic particle inspection) before and after the polar crane load test. Undersize weld lengths, discovered during the initial visual inspection, prompted a thorough re-evaluation of the tripod using sophisticated analytical techniques. Additionally, three of the more highly stressed welds were examined before and after the load test by magnetic particle testing and found to be acceptable. Both the analyses and the inspections verified that the tripod was qualified for lifting the head (Figure 14).

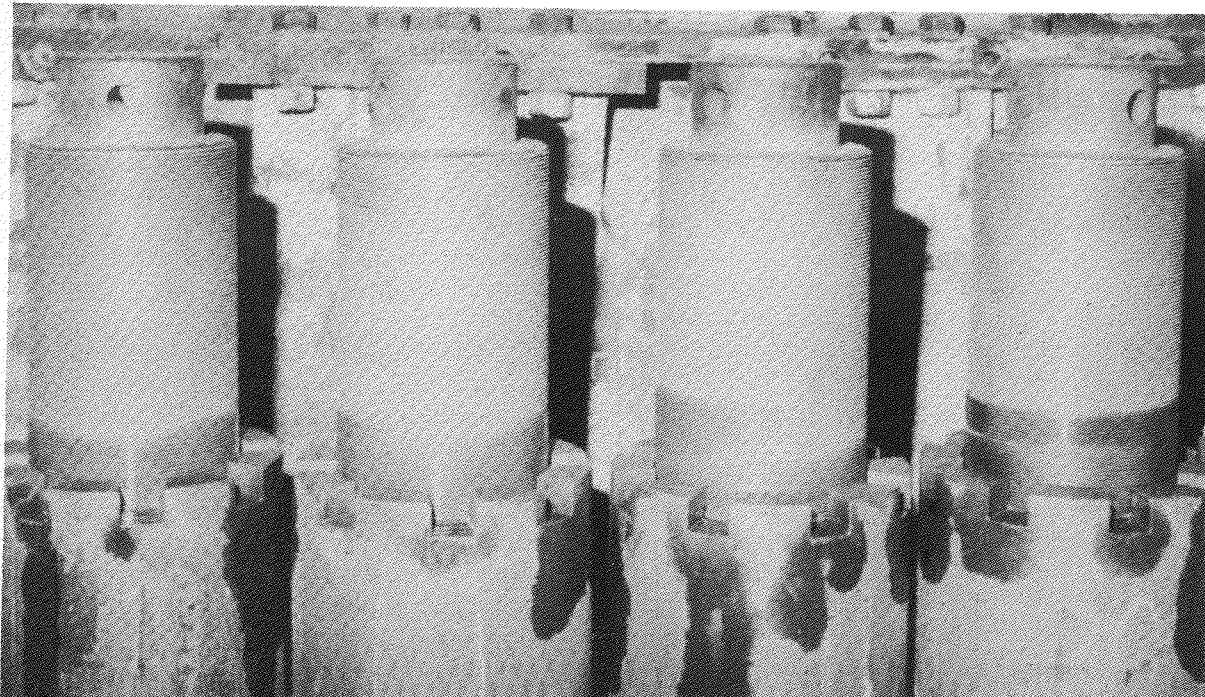
Figure 17. Cleaned and lubricated reactor vessel studs.

cles such as rust and boron crystals, and then the area was vacuumed to remove standing water. Oil of wintergreen was applied to preserve the threaded surface and to penetrate the nut/stud thread engagement. Prior to detensioning, the threads were cleaned with a wire brush and lubricated with Molycote (Figures 16 and 17).

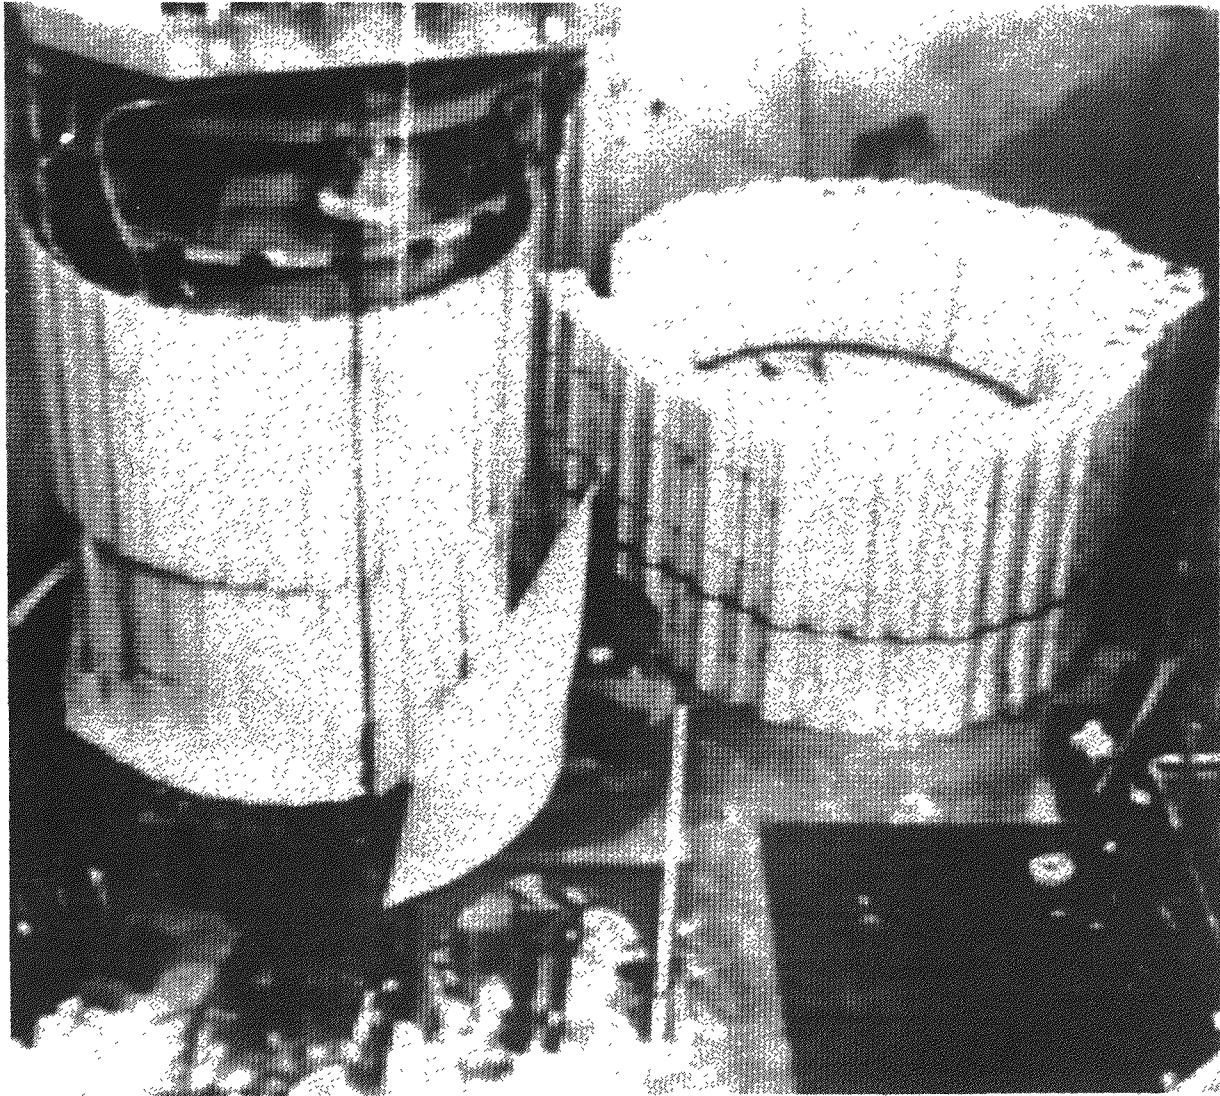
Figure 29. Head approaching its storage stand.

During the transfer of the head to the south end of the refueling canal, the CCTV cables to the two cameras on the head flange were severed. This loss complicated the positioning of the head on the storage stand because the guide pins could not be observed from the head flange vantage point.

Instead, the two backup cameras mounted on the head storage stand were used to monitor the landing of the head on the storage stand.

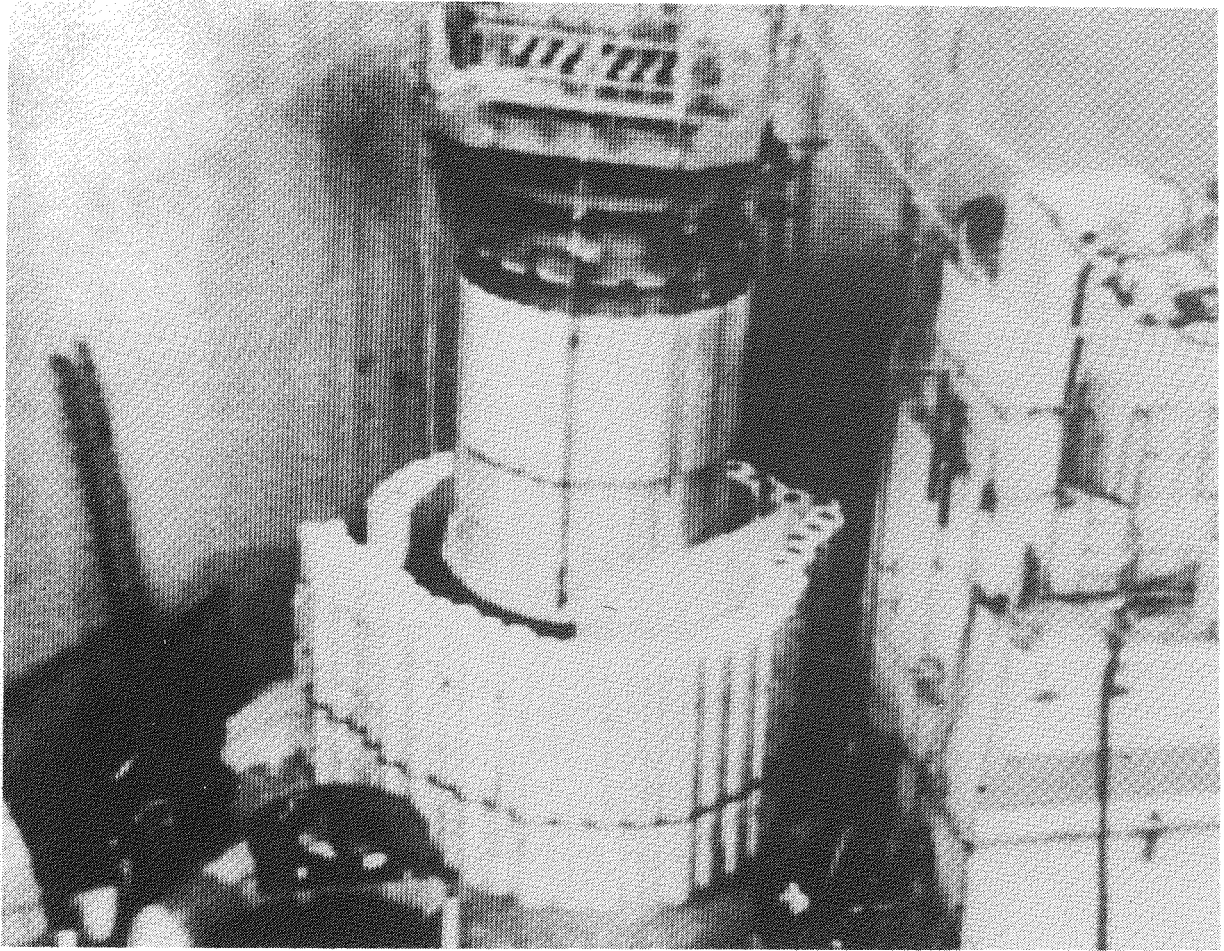
Figure 30. Head lowered onto storage stand.

While lowering the head onto the storage stand, the video cameras showed that stud hole 15 was aligned with the storage stand guide stud, but stud 45 was one hole short of proper alignment (a problem with alignment of the head storage stand had been reported during head lift operations prior to the 1979 accident). Preparations to correct alignment of the head with the storage stand included installing new bumper stops for the polar crane trolley to allow its centerline to travel to the centerline of the storage stand, and

pre-setting the two centerlines using a plumb bob to set the alignment targets from the main hook. When the head could not be positioned, a scaffold was erected alongside the storage stand shield wall to enable workers to gain access to the head flange. A combination of pry bars and a come-along rotated the head into position. A sleeve was lowered through stud hole 15 to capture a guide stud and provide a pivot point. The nature of the misalignment problem suggests that the center of gravity of the load shifted away from the centerline of the lift. To provide personnel access, a catwalk was installed from the A D-ring near the control station to the service structure. The head was set on the storage stand at noon on July 25 (Figure 30).

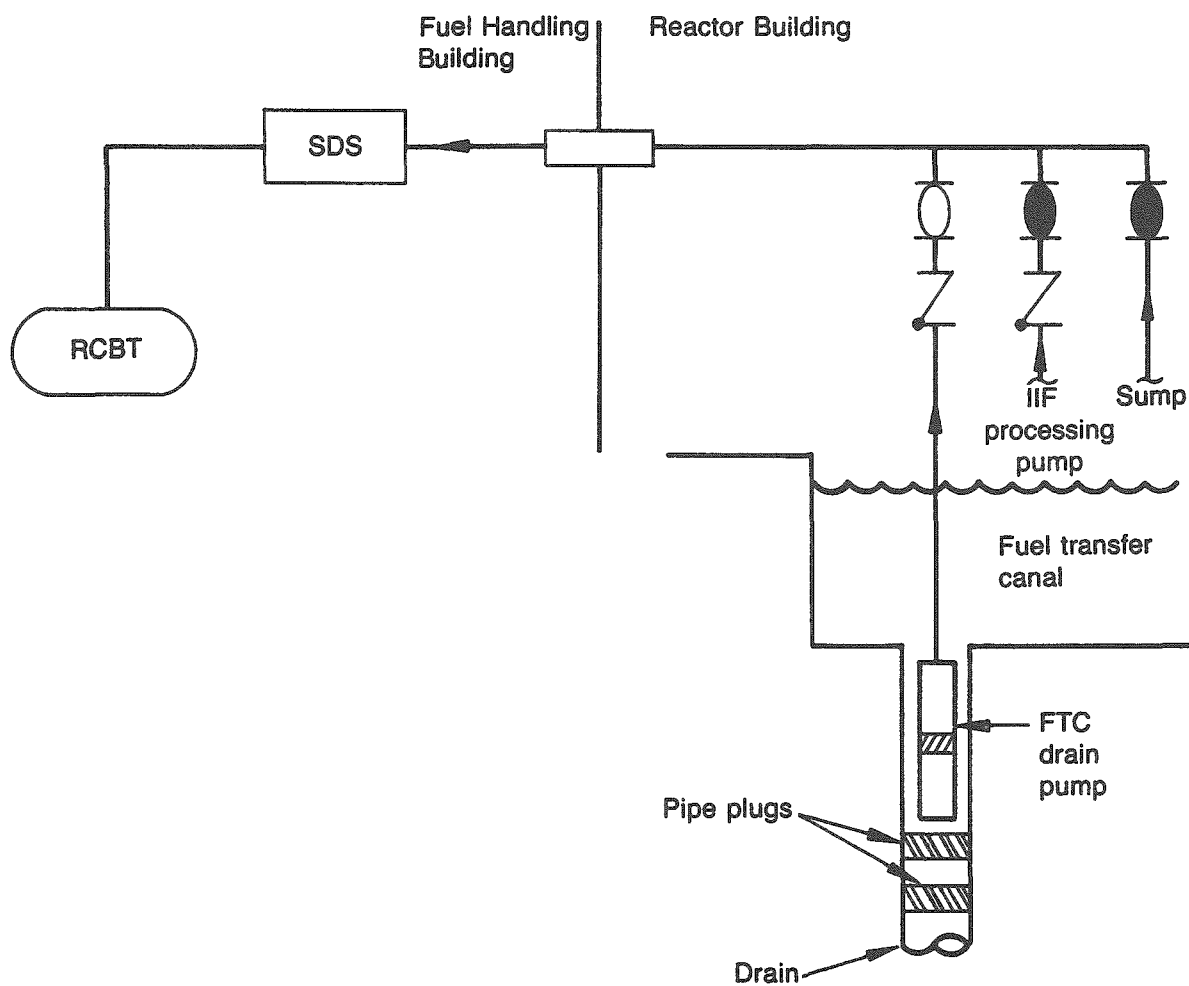
Figure A-5. Fuel transfer canal draining system.

To drain the fuel transfer canal, if flooded, a submersible well pump was to be installed in the existing FTC drain line. The drain line was isolated below the pump using two stainless steel pipe plugs (see Figure A-5). Due to inability to seat the plugs because of tolerance incompatibilities, it was necessary to blank off the drain line at the floor level; therefore, the FTC drain pump was positioned horizontally on the FTC floor in the deep end of the canal (308 ft elevation). The pump could then be operated via a control switch located on submerged demineralizer system (SDS) control panel CN-PNL-1 at the 347 ft-6 in. elevation of the fuel handling building.
