NUREG-1154

Loss of Main and Auxiliary Feedwater Event at the Davis-Besse Plant on June 9, 1985

U.S. Nuclear Regulatory Commission

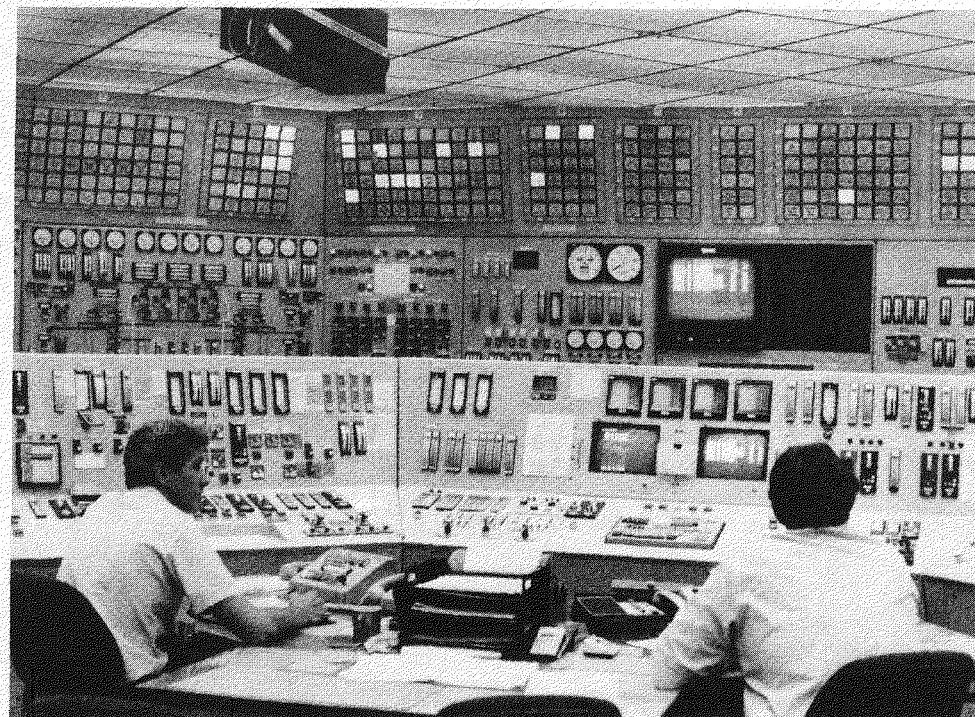
Figure 3.4 Davis-Besse Control Room

The assistant shift supervisor entered the control room (shown in Figure 3.4) and was examining one of the consoles when he noticed that main feedwater flow was decreasing and that the No. 1 main feedwater pump had tripped. Since the No. 2 feedwater pump was in manual control, it could not respond to the integrated control system demand automatically to increase feedwater flow.

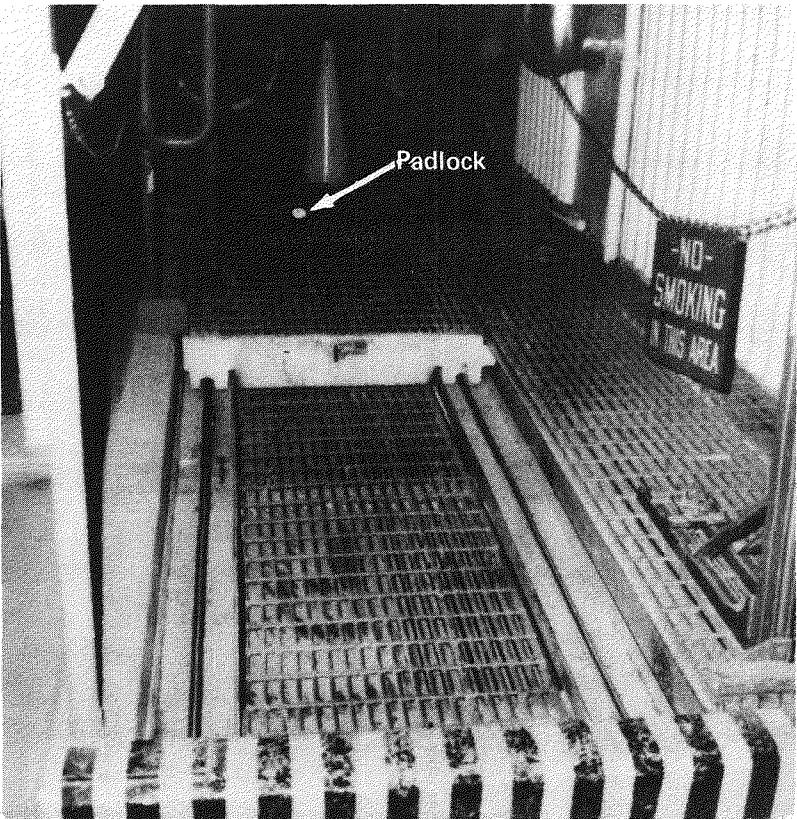
Figure 3.7 Grate Leading to Auxiliary Feedwater Pump Room

The pump room, located three levels below the control room, has only one entrance: a sliding grate hatch that is locked with a safety padlock (Figure 3.7). One of the operators carried the key ring with the padlock key in his hand as they left the control room. They violated the company's "no running" policy as they raced down the stairs. The first operator was about 10 feet ahead of the other operator who tossed him the keys so as not to delay unlocking the auxiliary feedwater pump room. The operator ran as fast as he could and had unlocked the padlock by the time the other operator arrived to help slide the hatch open.

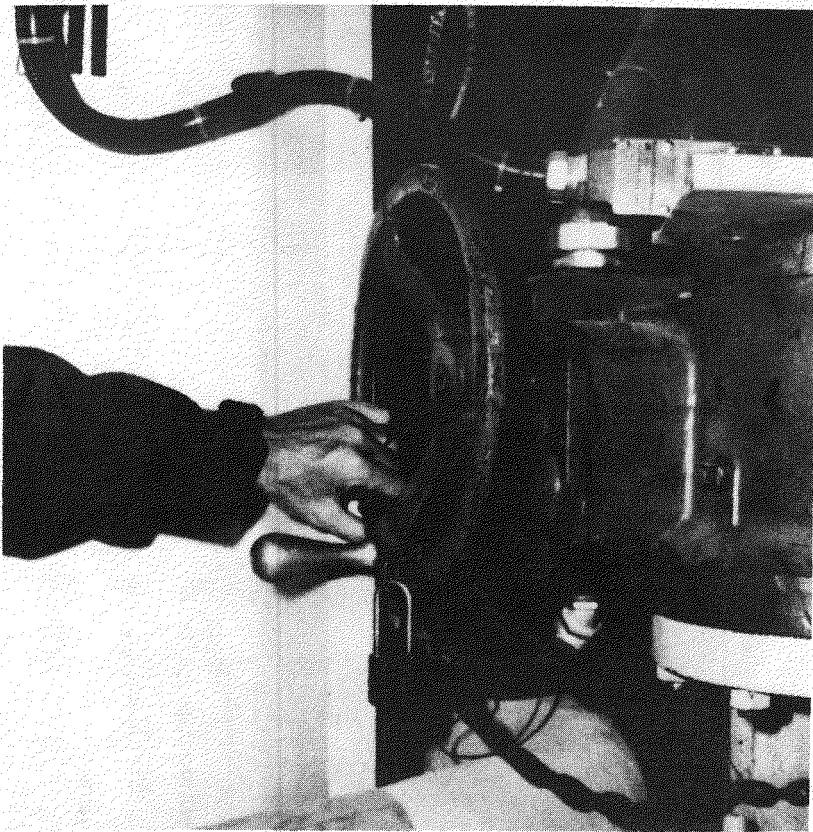
Figure 3.9 Chained and Locked AF-608 Valve

The shift supervisor had just dispatched a third equipment operator to open AFW isolation valves AF-599 and AF-608. These are chained and locked valves, as shown in Figure 3.9, and the shift supervisor gave the lock-valve key to the operator before he left the control room. He paged a fourth equipment operator over the plant communications systems and directed him also to open valves AF-599 and AF-608. Although the operators had to go to different rooms for each valve, they opened both valves in about 3½ minutes. They were then directed to the AFW pump room.
