PNL-SA-7529

X-RAY MONITORING OF 230-KV CABLE
POTHEADS FOR MAINTENANCE INSPECTIONS

Robert C. Lawrence
Pacific Northwest Laboratory
Richland, Washington

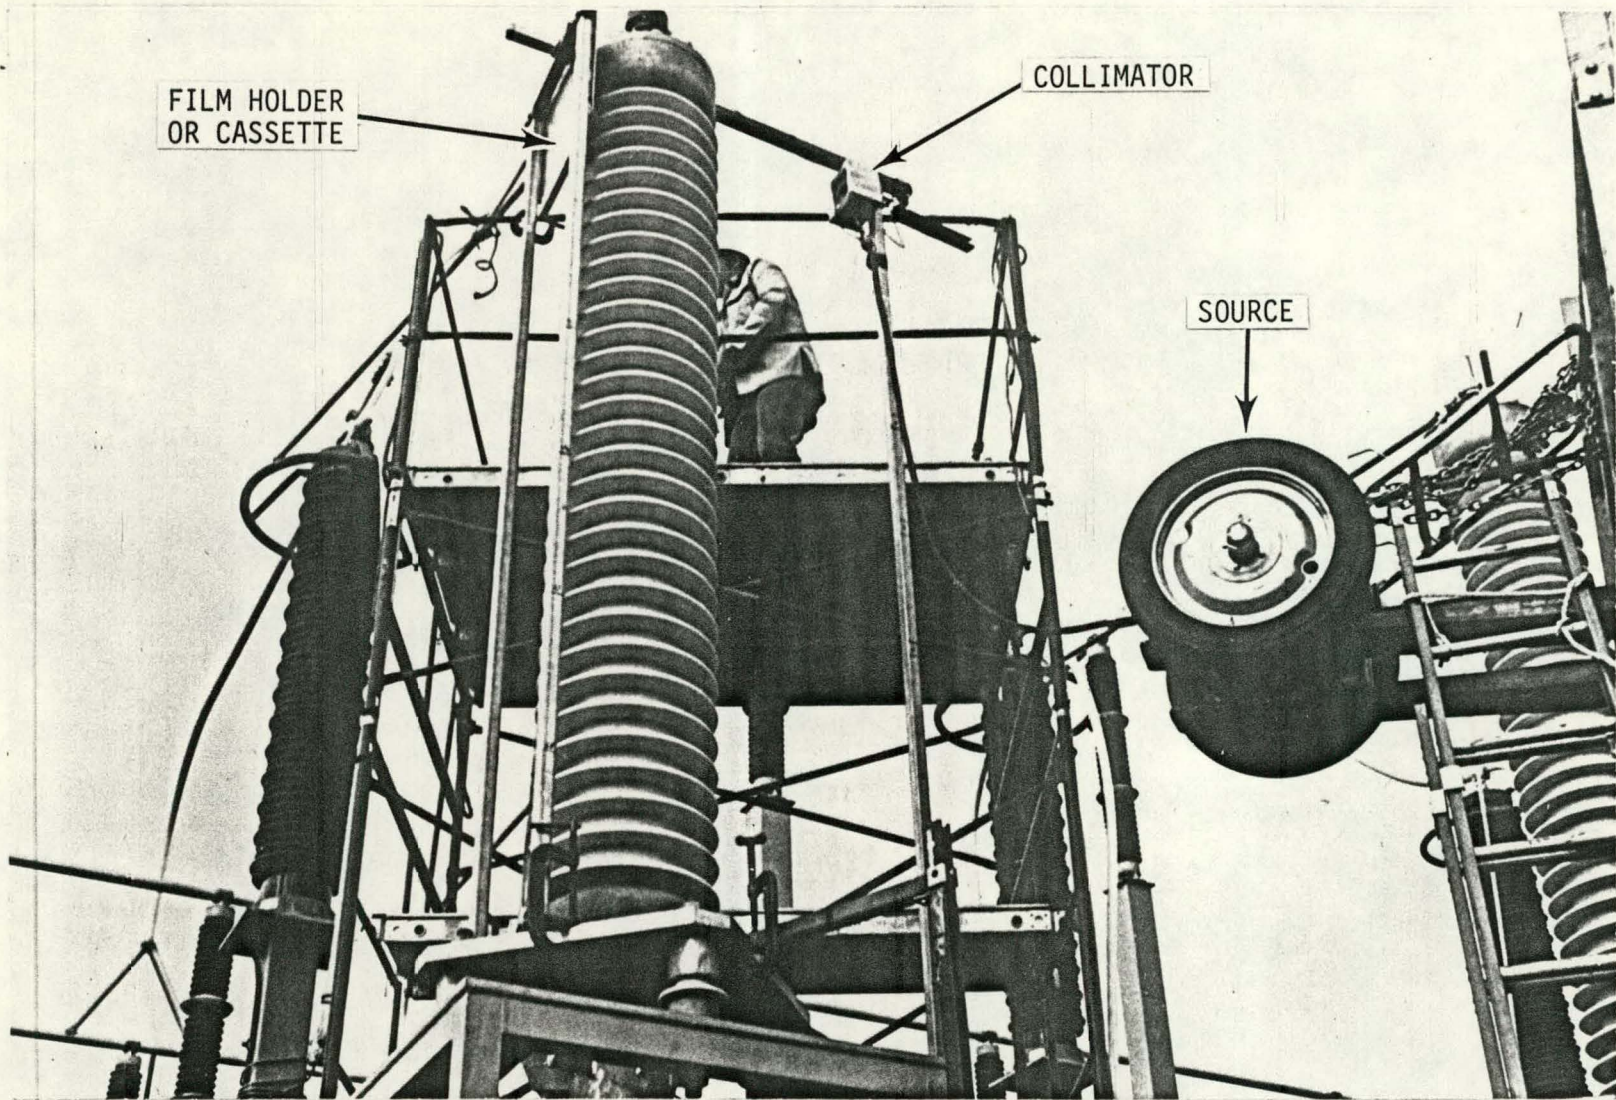
FIGURE 1. Equipment Setup around 230 kV Pothead

were mounted on a special steel framework, which was attached to the top of the potheads. Vertical guide rails on the framework allowed precise positioning of the film cassette and the source collimator. Figures 1 and 2 show the equipment setup around a 230 kV pothead.
