Final Battery Evaluation Report
Energy Research Corporation
Zinc/Bromine Battery

P. C. Butler, D. W. Miller, C. E. Robinson,
Anthony Leo

Prepared by
Sandia National Laboratories
Albuquerque, New Mexico 87185 and Livermore, California 94550
for the United States Department of Energy
under Contract DE-AC04-76DP00789

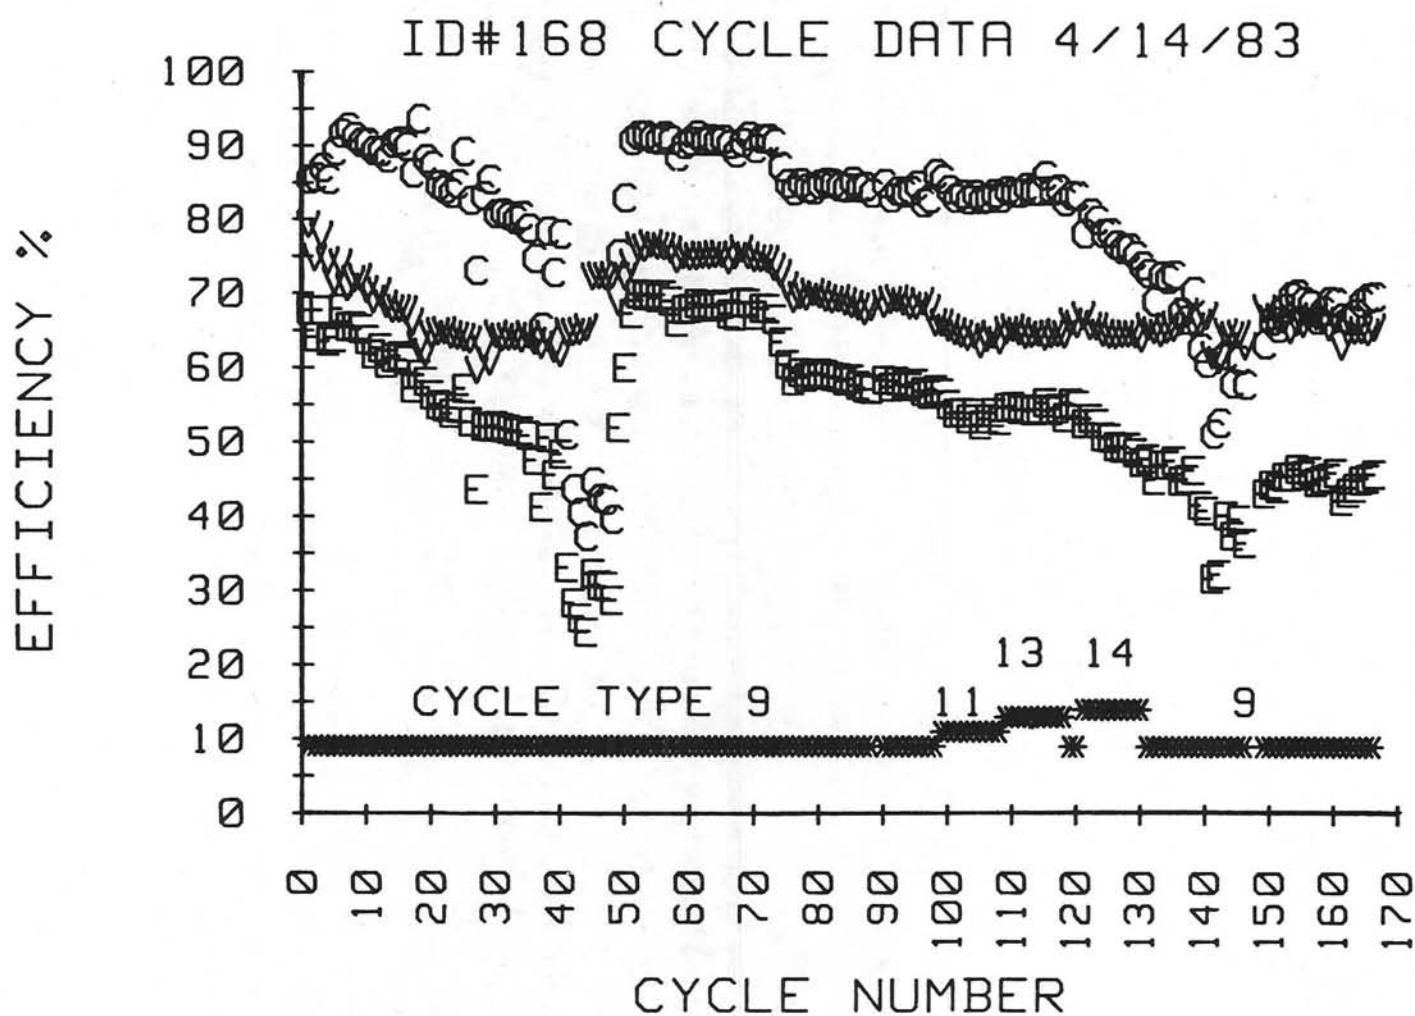
Figure 3. Efficiency and Cycle Type Versus Cycle Number for Battery 168
C = coulombic; V = voltaic; E = energy; X = cycle type identification number

During the first 48 cycles, efficiencies generally declined. This trend was reversed at cycle 48. Two major changes were made in the system at this point. Flow filters in both the catholyte and anolyte pipes had become blocked

Performance improved drastically following these two changes. No other major revisions were made to the battery during cycle life testing. While the efficiencies fluctuated somewhat after cycle 48, no clear-cut cause and effect relationships have been established.

Electrolyte flow management difficulties and generally low efficiencies after cycle 150 resulted in a decision by Sandia, EPRI, and ERC to terminate cycle testing and begin failure analysis.

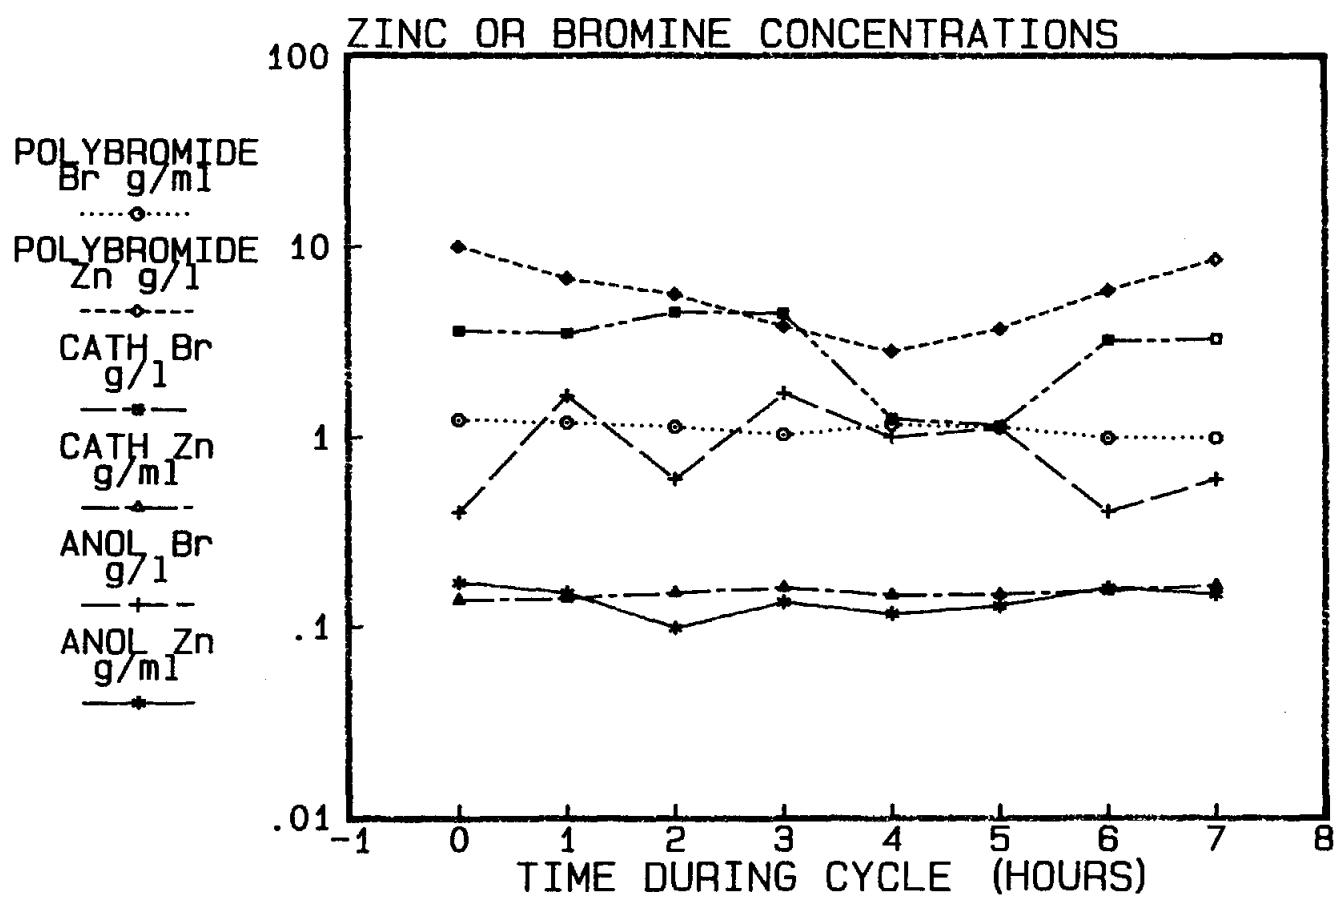
Figure 10. Zinc and Free-Bromine Concentrations During Cycle 163

this poor performance, discussed in the failure analysis section, very likely influenced the results in Figure 10. Random fluctuations occurred in the zinc concentration in the anolyte and catholyte, while a pattern indicated in the polybromide solution. Bromine levels changed in an expected pattern in the anolyte, but randomly varied in the catholyte and were relatively constant in the polybromide. Precision of these results is estimated at +5%.

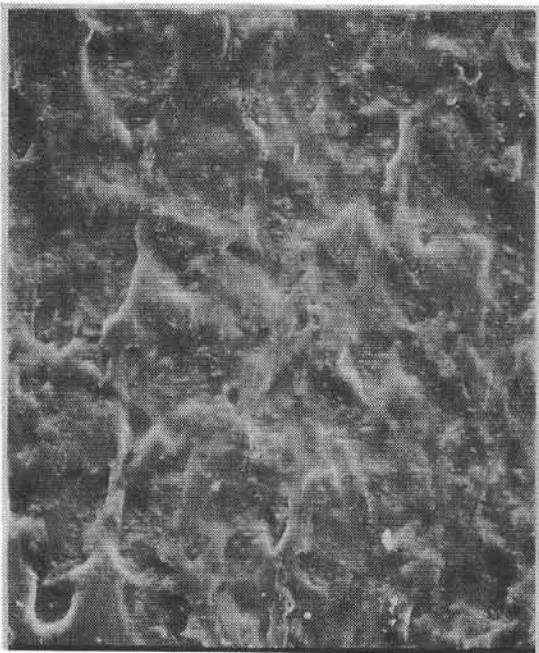
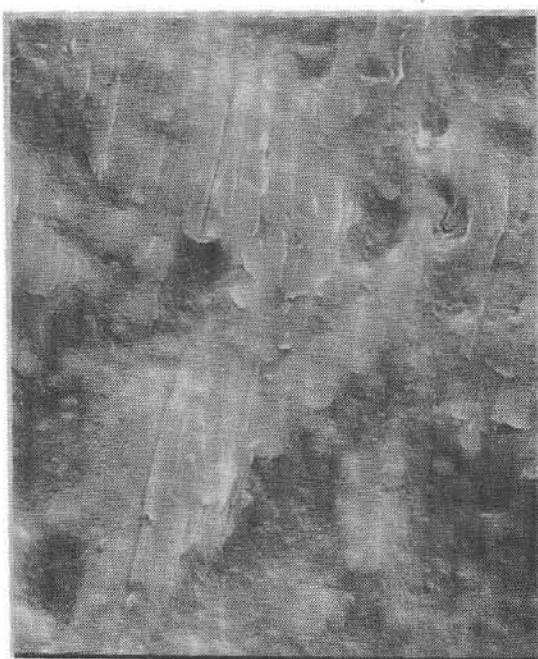
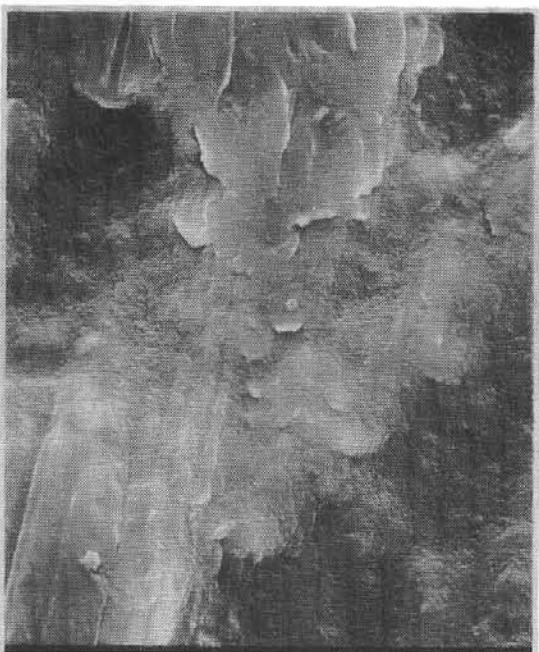
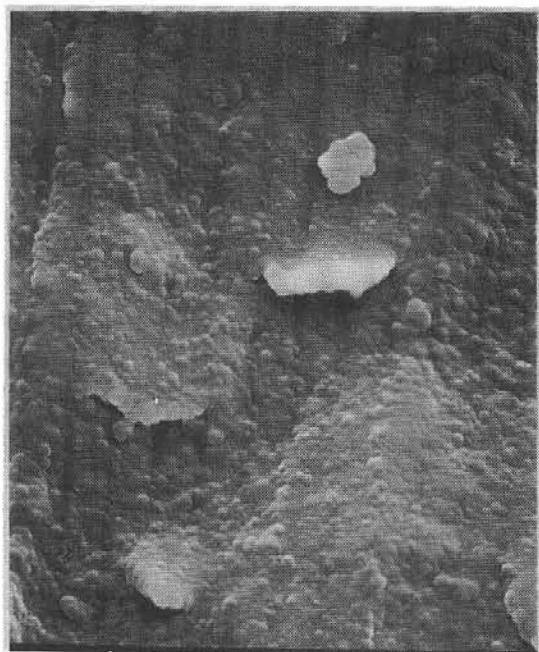
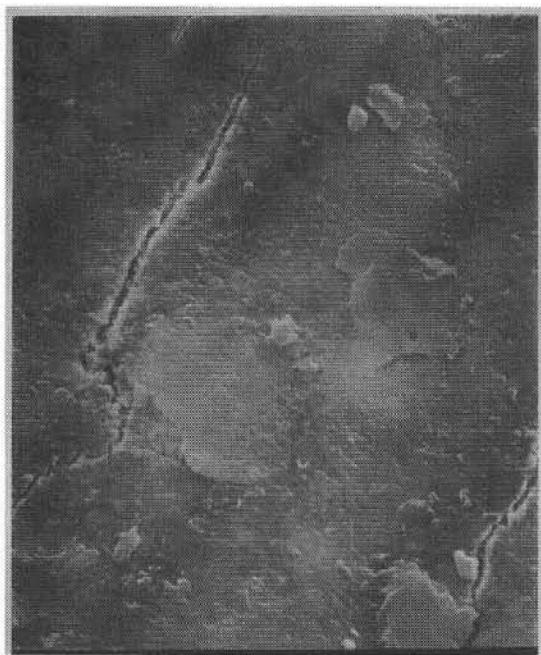
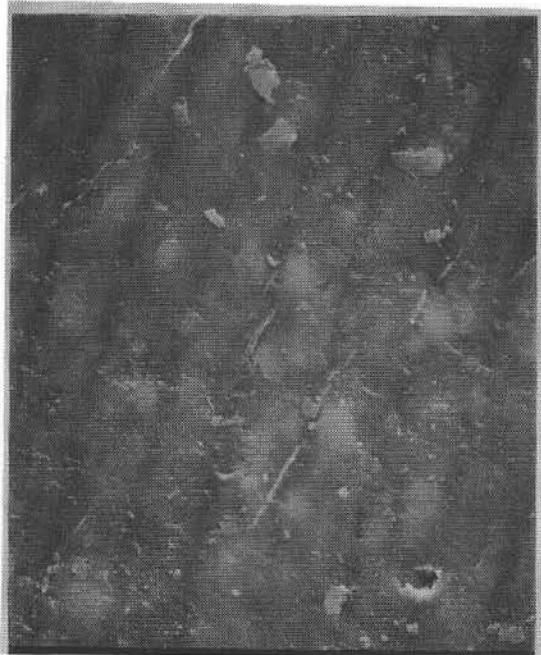
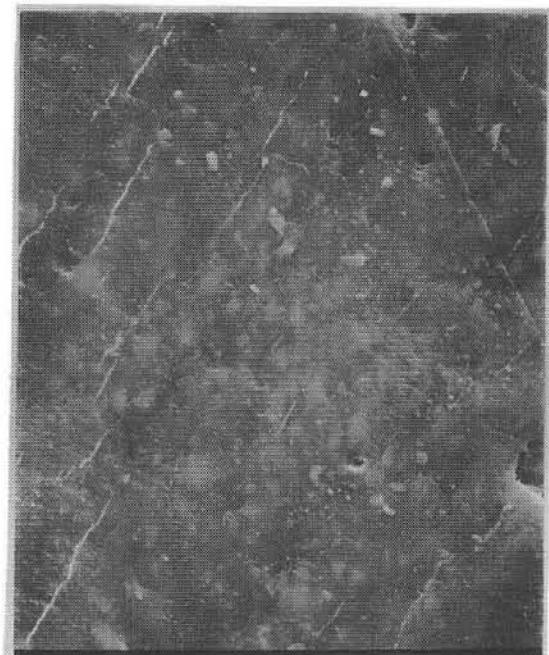
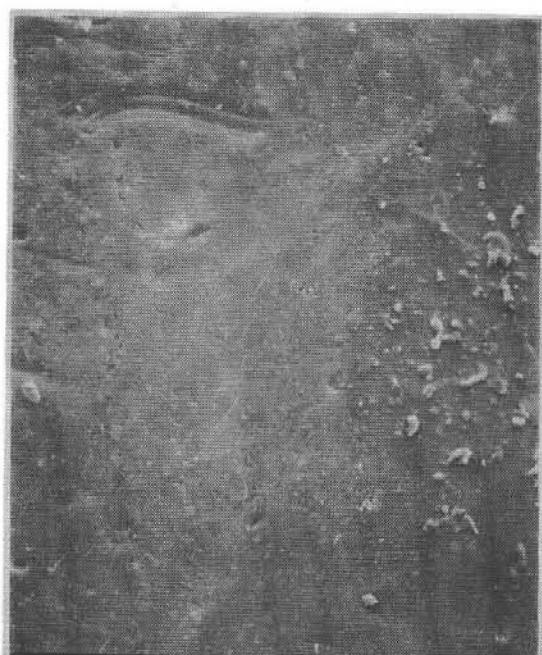
Scanning electron microscope (SEM) photographs were made of each major battery component. New materials directly comparable to the parts removed from the cell stack were obtained from ERC. Figure 11 is a series of SEM photographs of new and cycled separators at several magnifications. Note the surface cracks evident on the used material. Figure 12 is a series of SEM photographs of a new electrode and used anode surfaces. Areas labeled "dark" were locations where zinc was deposited on the electrode while "light" areas were covered by the plastic grid spacer. The used electrodes had been washed and rinsed with deionized water twice before being photographed. Zinc crystals are visible in some photographs. Figure 13 is composed of SEMs of cathode felt material. The used felt shows signs of compression with several broken fibers. Figure 14 is a series of SEM photographs of a roughened area found on one bromine graphite electrode.

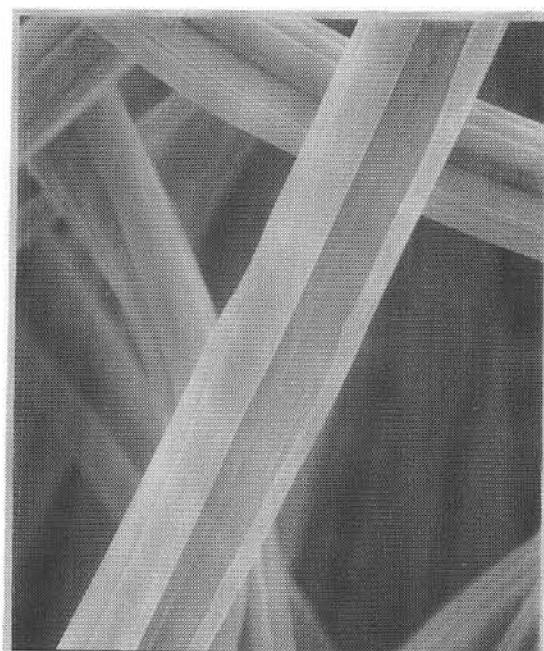
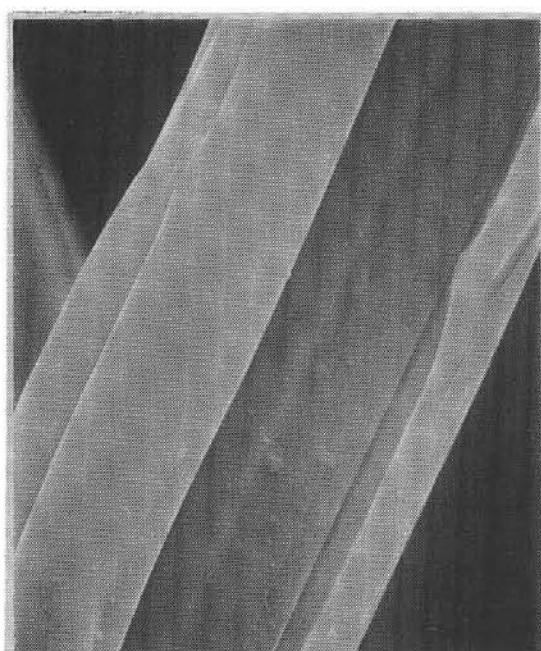
Figure 13a. SEM of New and Used Carbon Felt From Battery 168
at 100x, 500x, 1000x, and 3000x

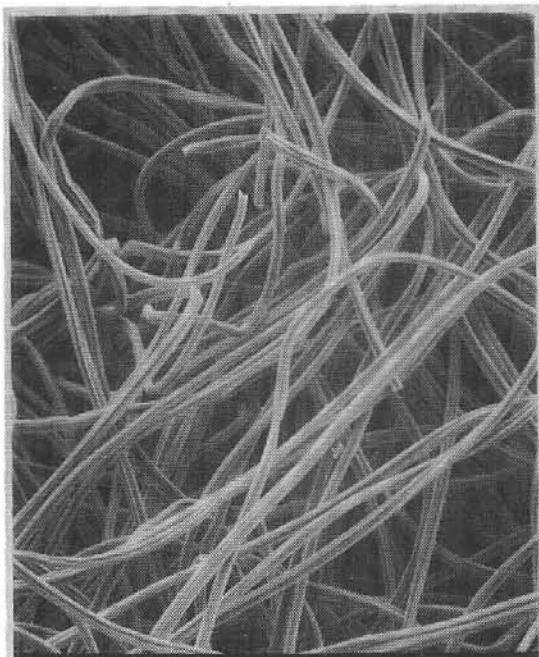
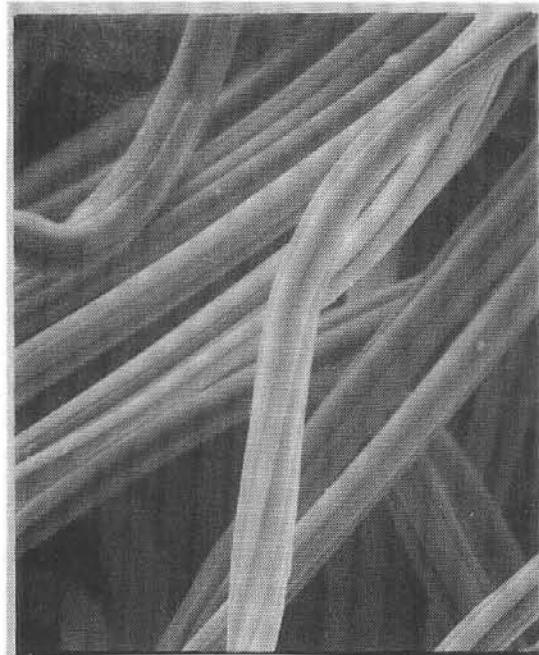
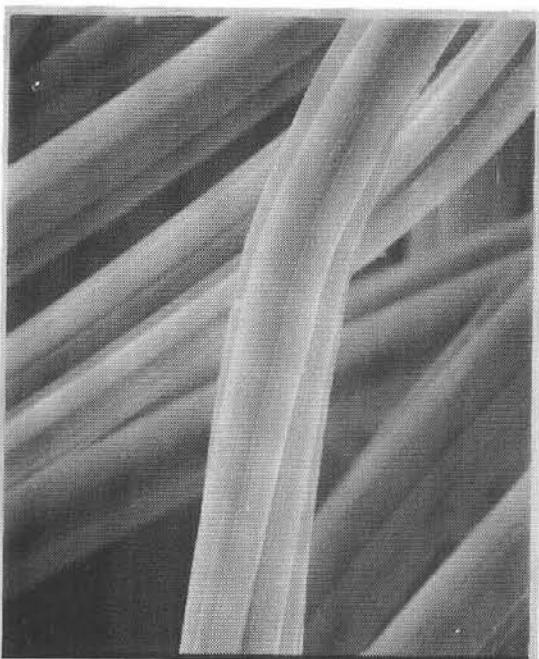
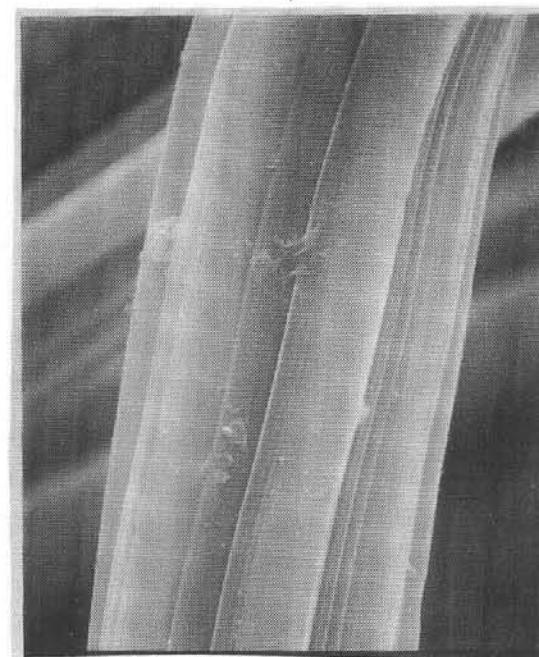
Used Felt

Figure 13b. SEM of New and Used Carbon Felt From Battery 168 at 100x, 500x, 1000x, and 3000x

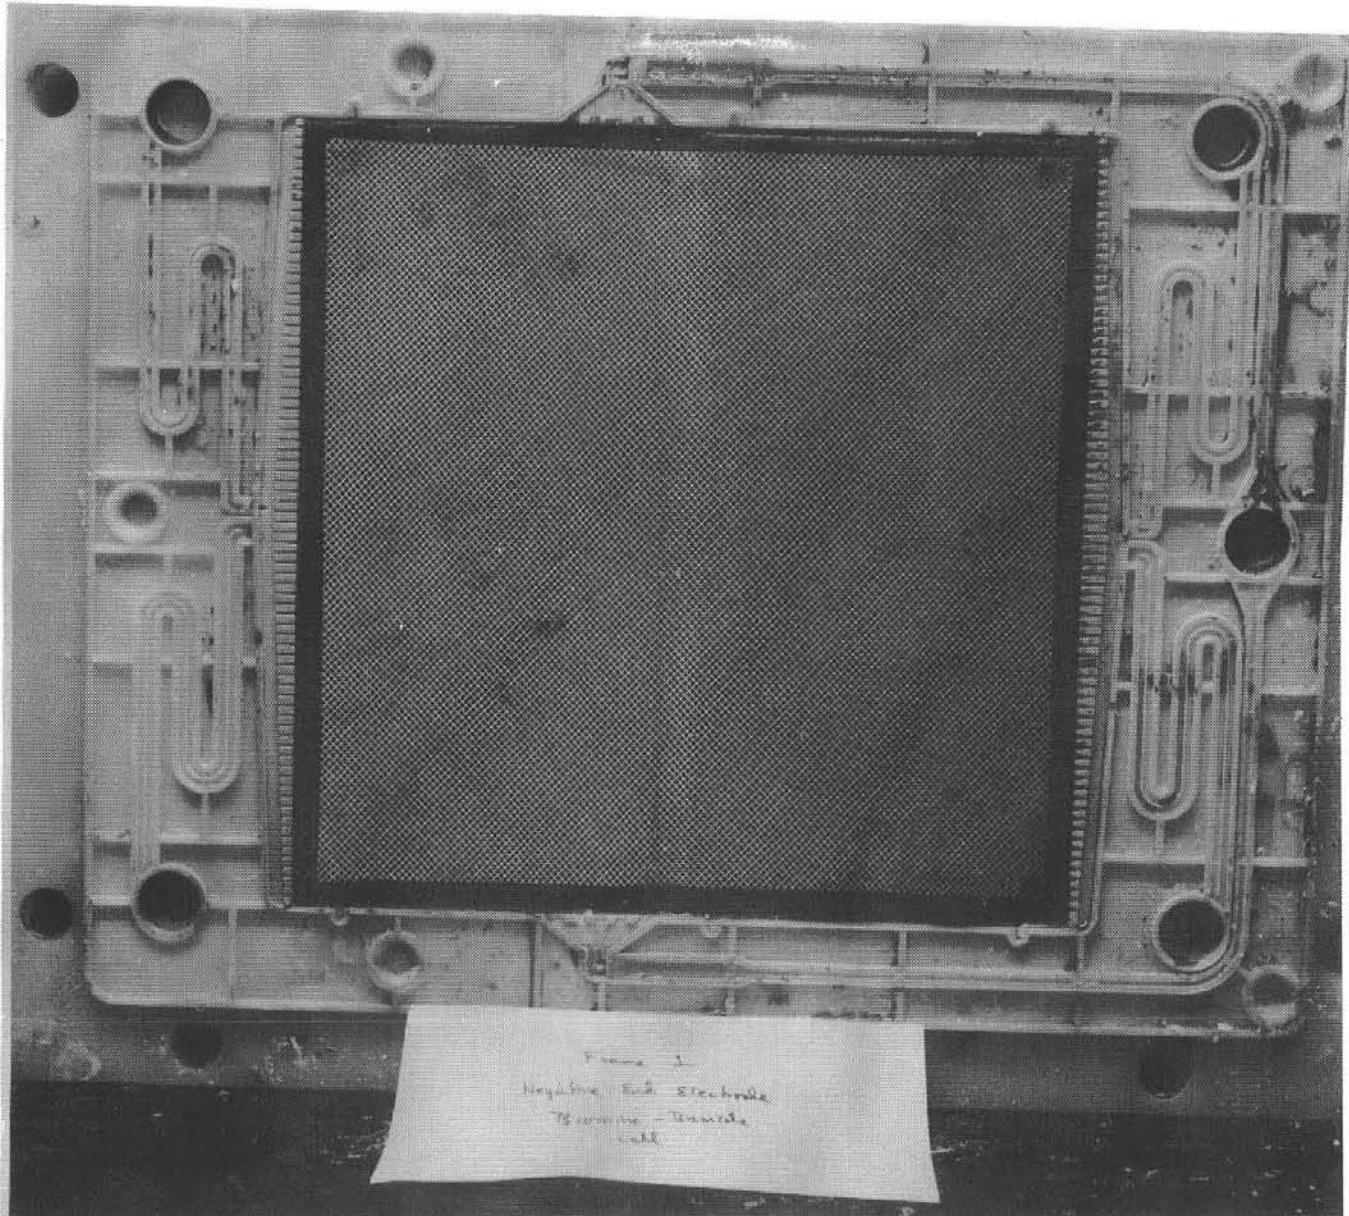
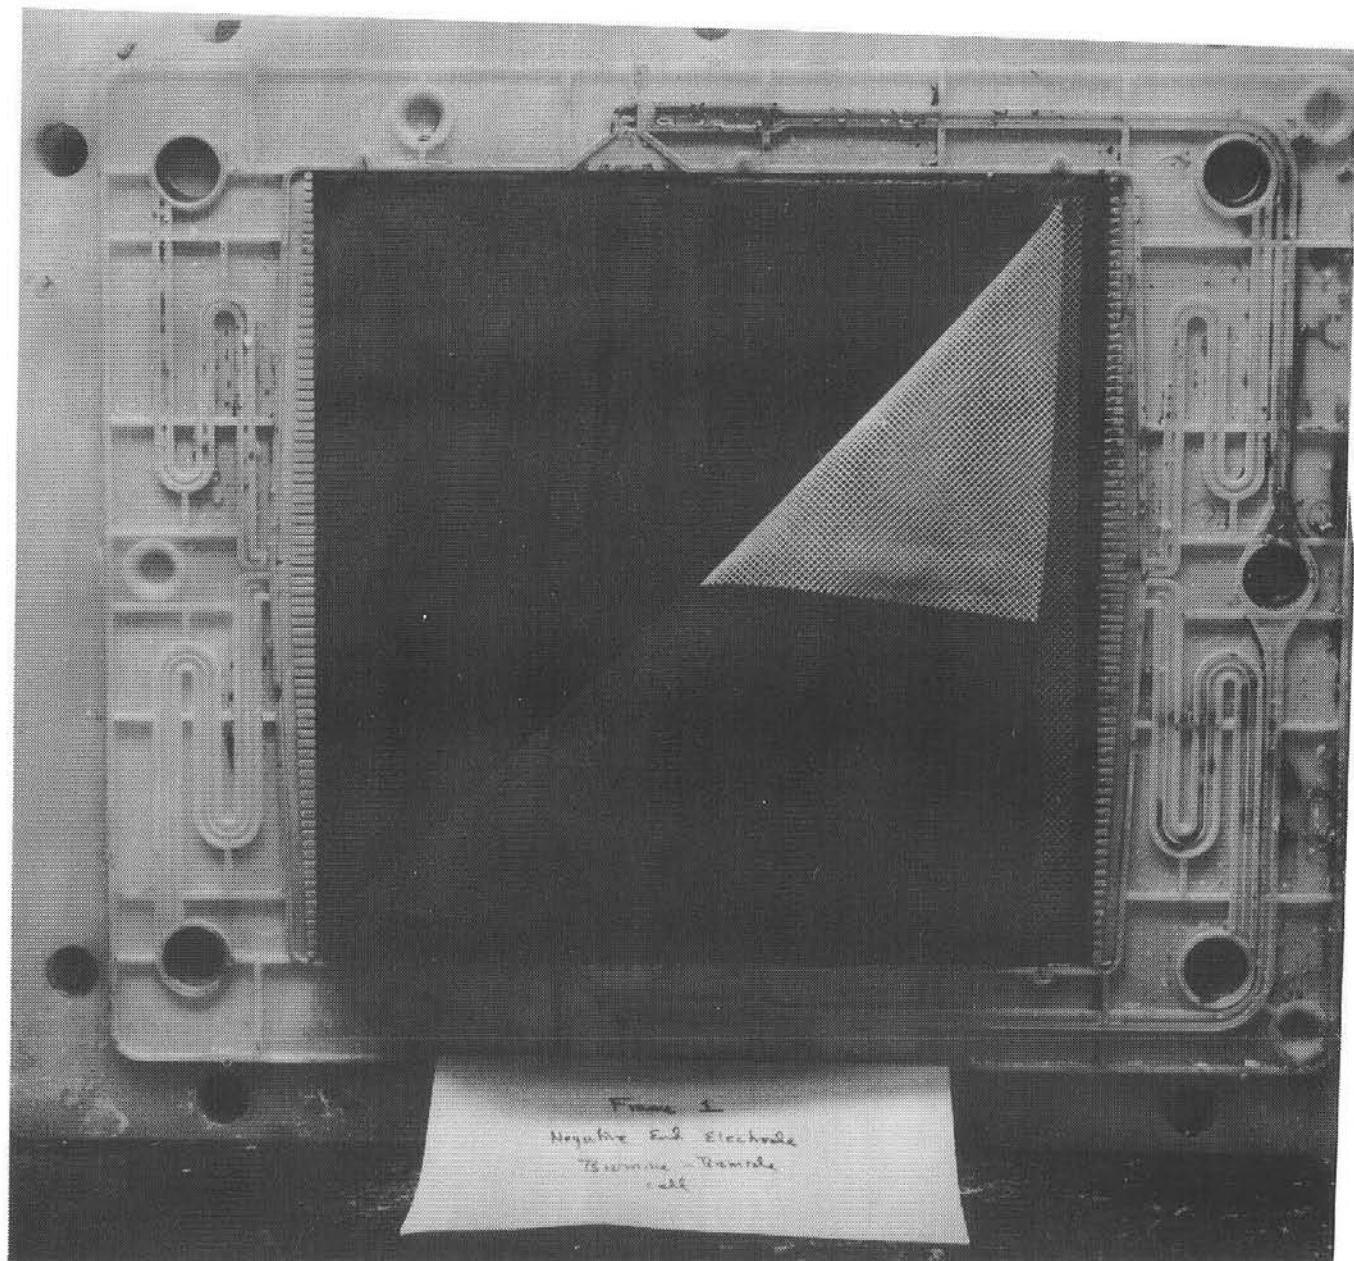
Frame 1

Negative End Electrode
Bromine-Bromide
Cell

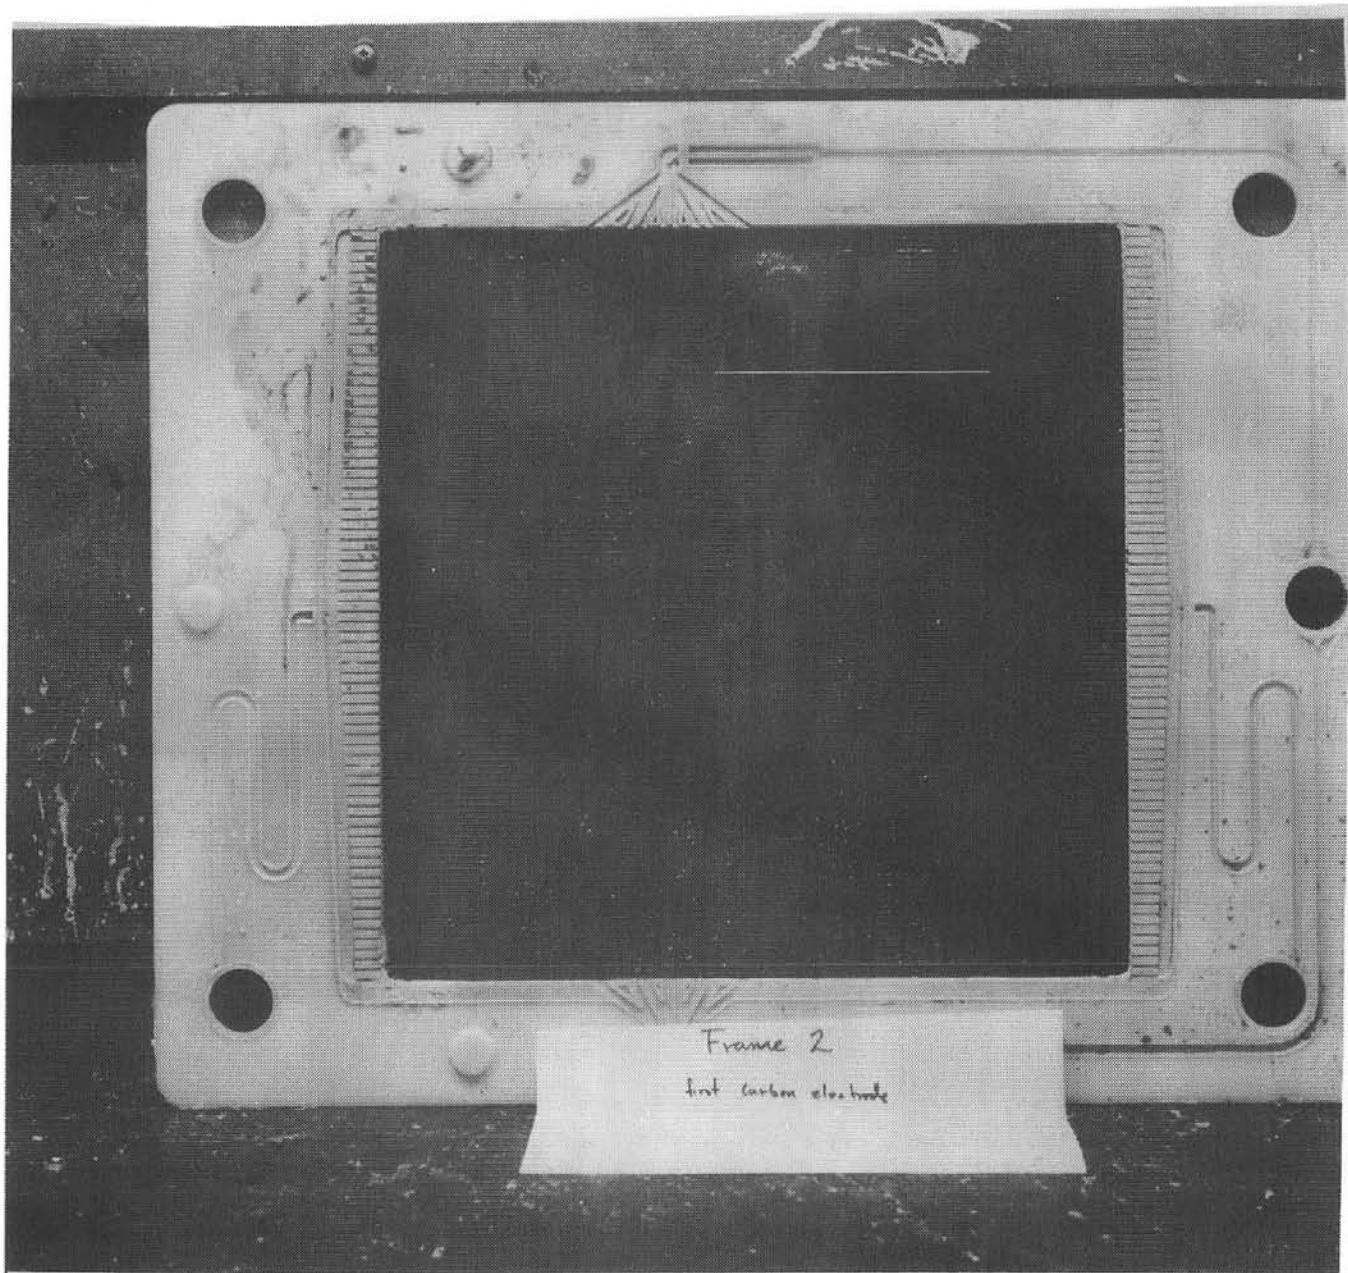
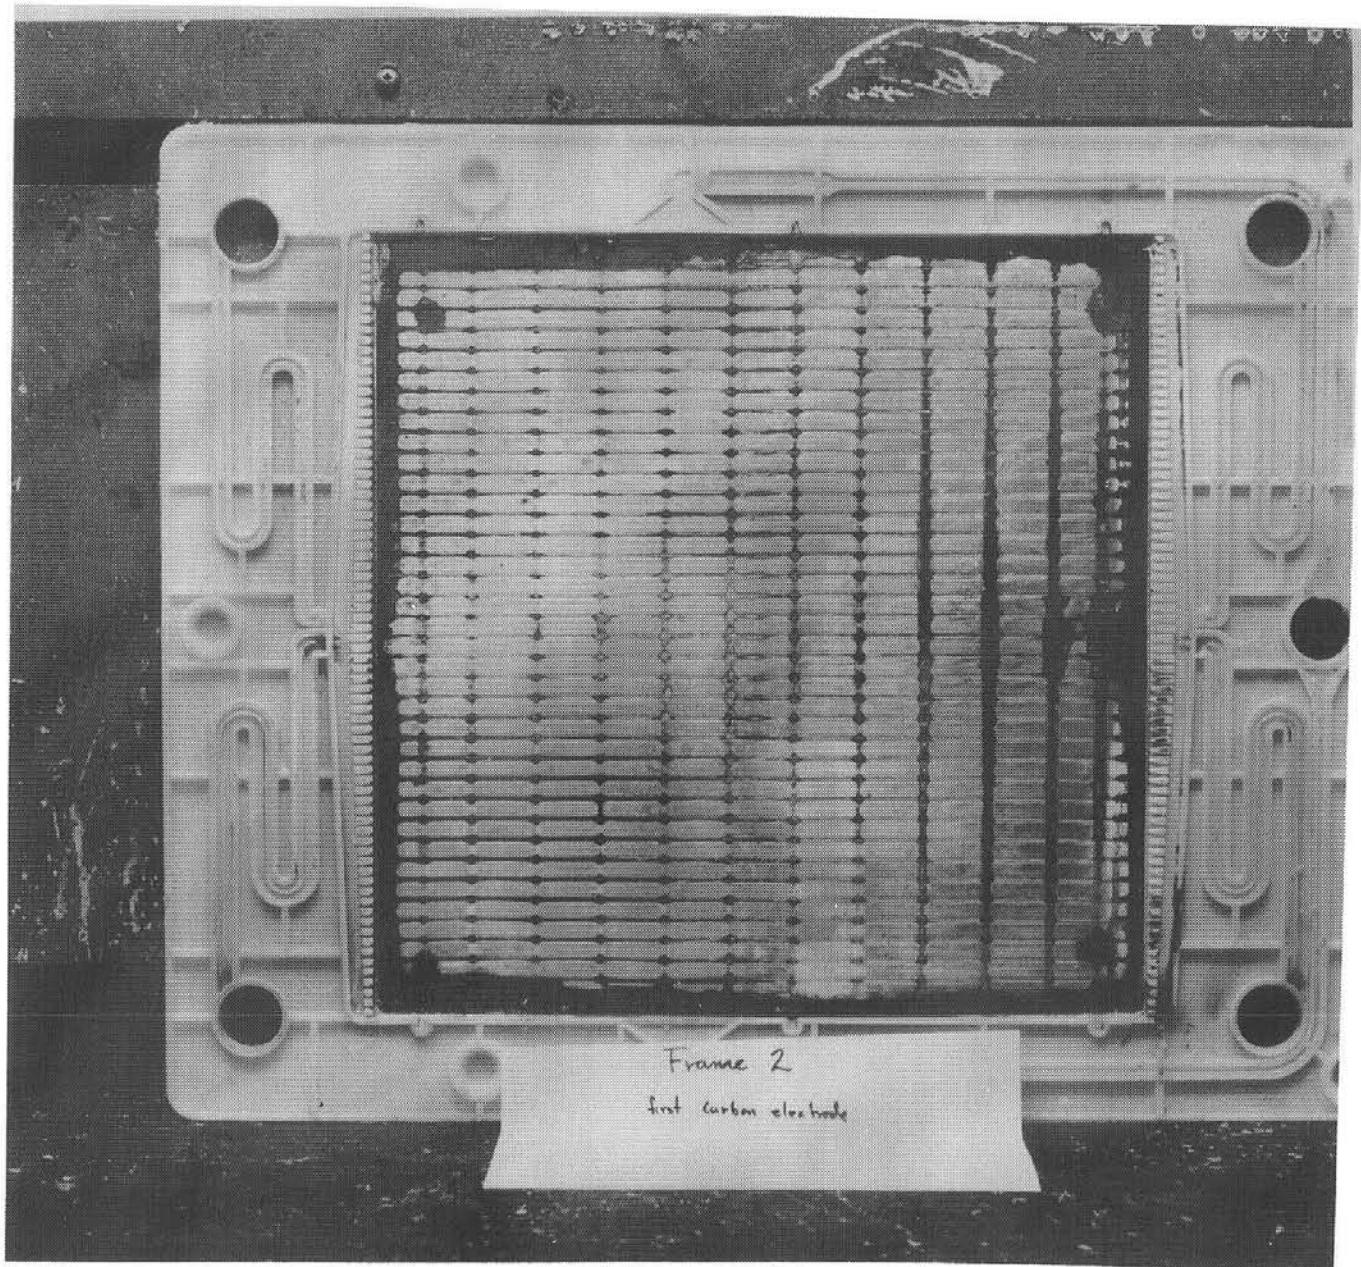
Frame 2
First Carbon Electrode

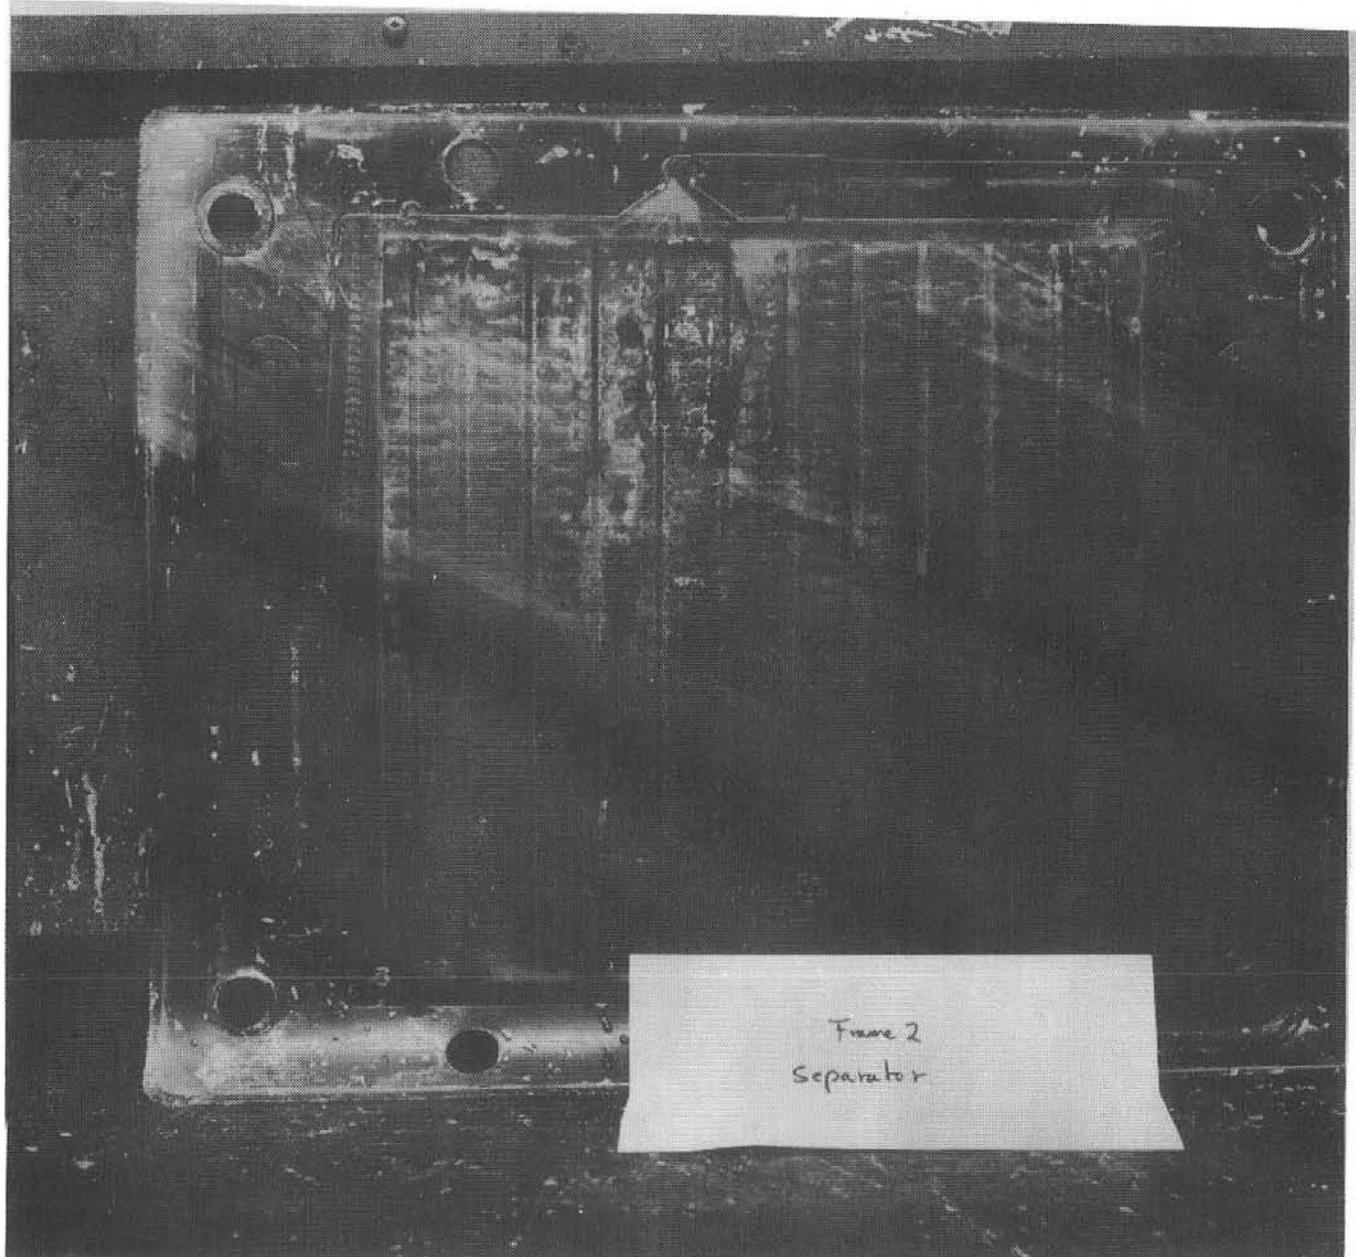
Frame 2
Separator

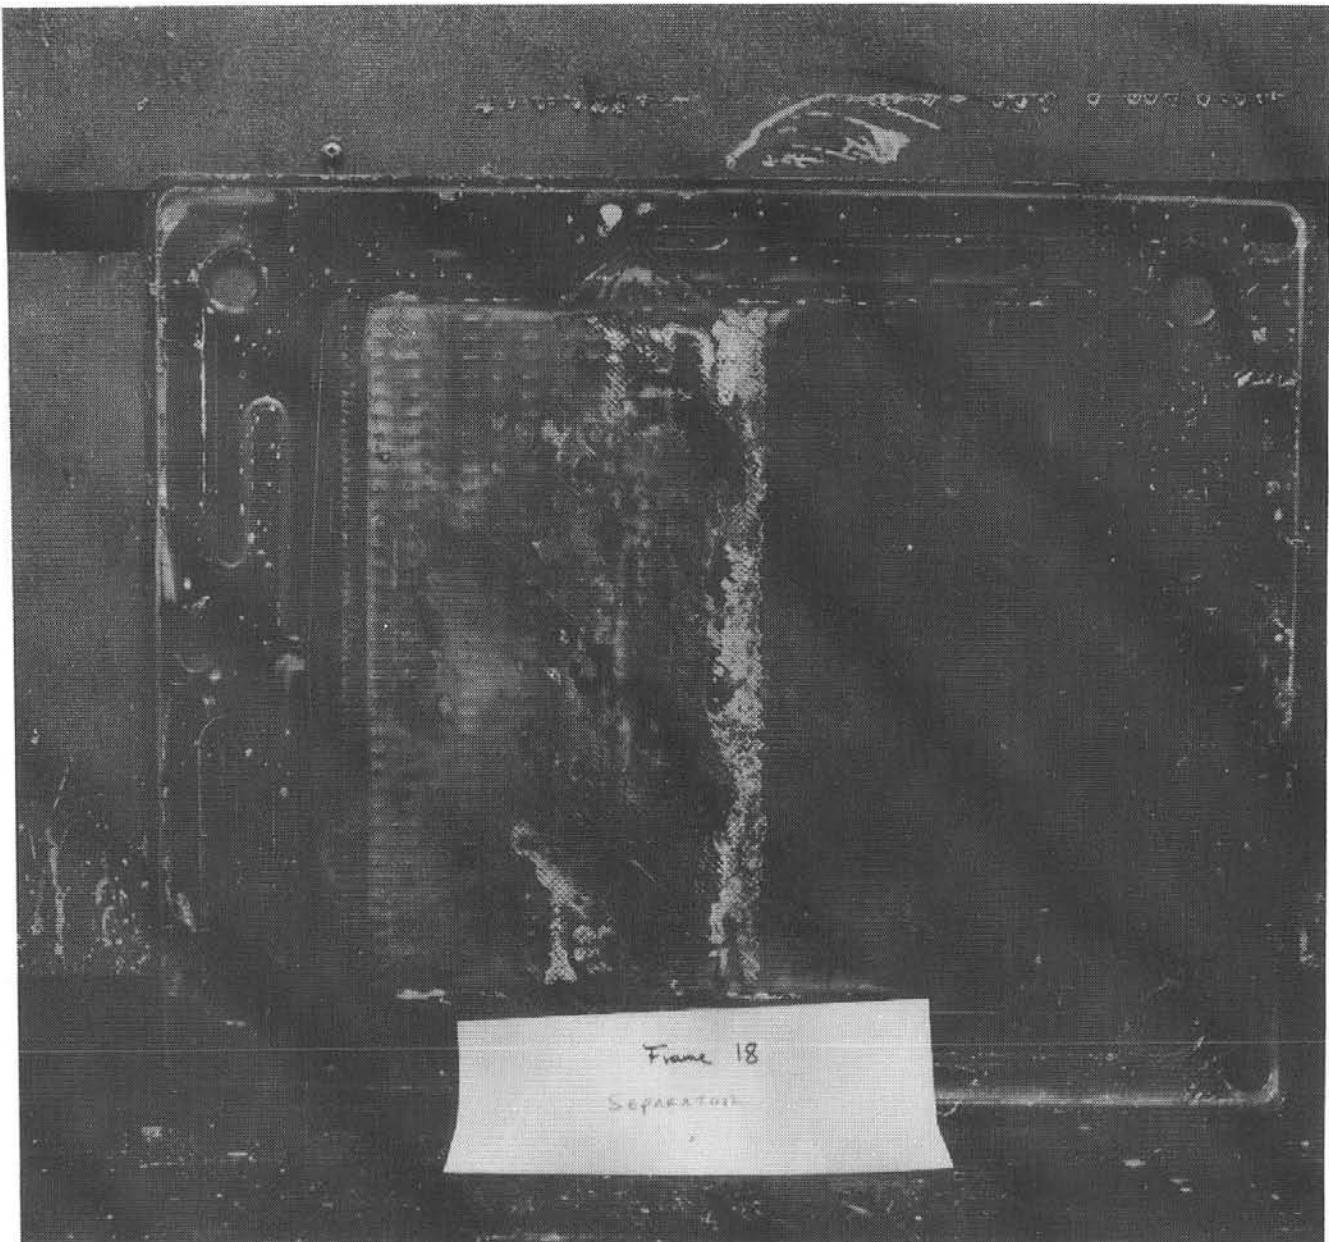
Frame 18
Separator - anode side

The separator material did not appear to swell, increase in linear dimension, or warp. The material had darkened with usage and had roughened in areas of zinc penetration. While the darkening is not necessarily an ongoing degradation process, the irreversible roughening due to zinc penetration is certainly a problem.
