MADISONVILLE AREA WIDE SUBSIDENCE INVESTIGATION (1986). 181 pp.
(USDOI-Office of Surface Mining and Enforcement, Pittsburgh PA)

MADISONVILLE AREA WIDE SUBSIDENCE INVESTIGATION

OFFICE OF SURFACE MINING RECLAMATION AND ENFORCEMENT
EASTERN TECHNICAL CENTER
TEN PARKWAY CENTER
PITTSBURGH, PA 15220

SEPTEMBER, 1986

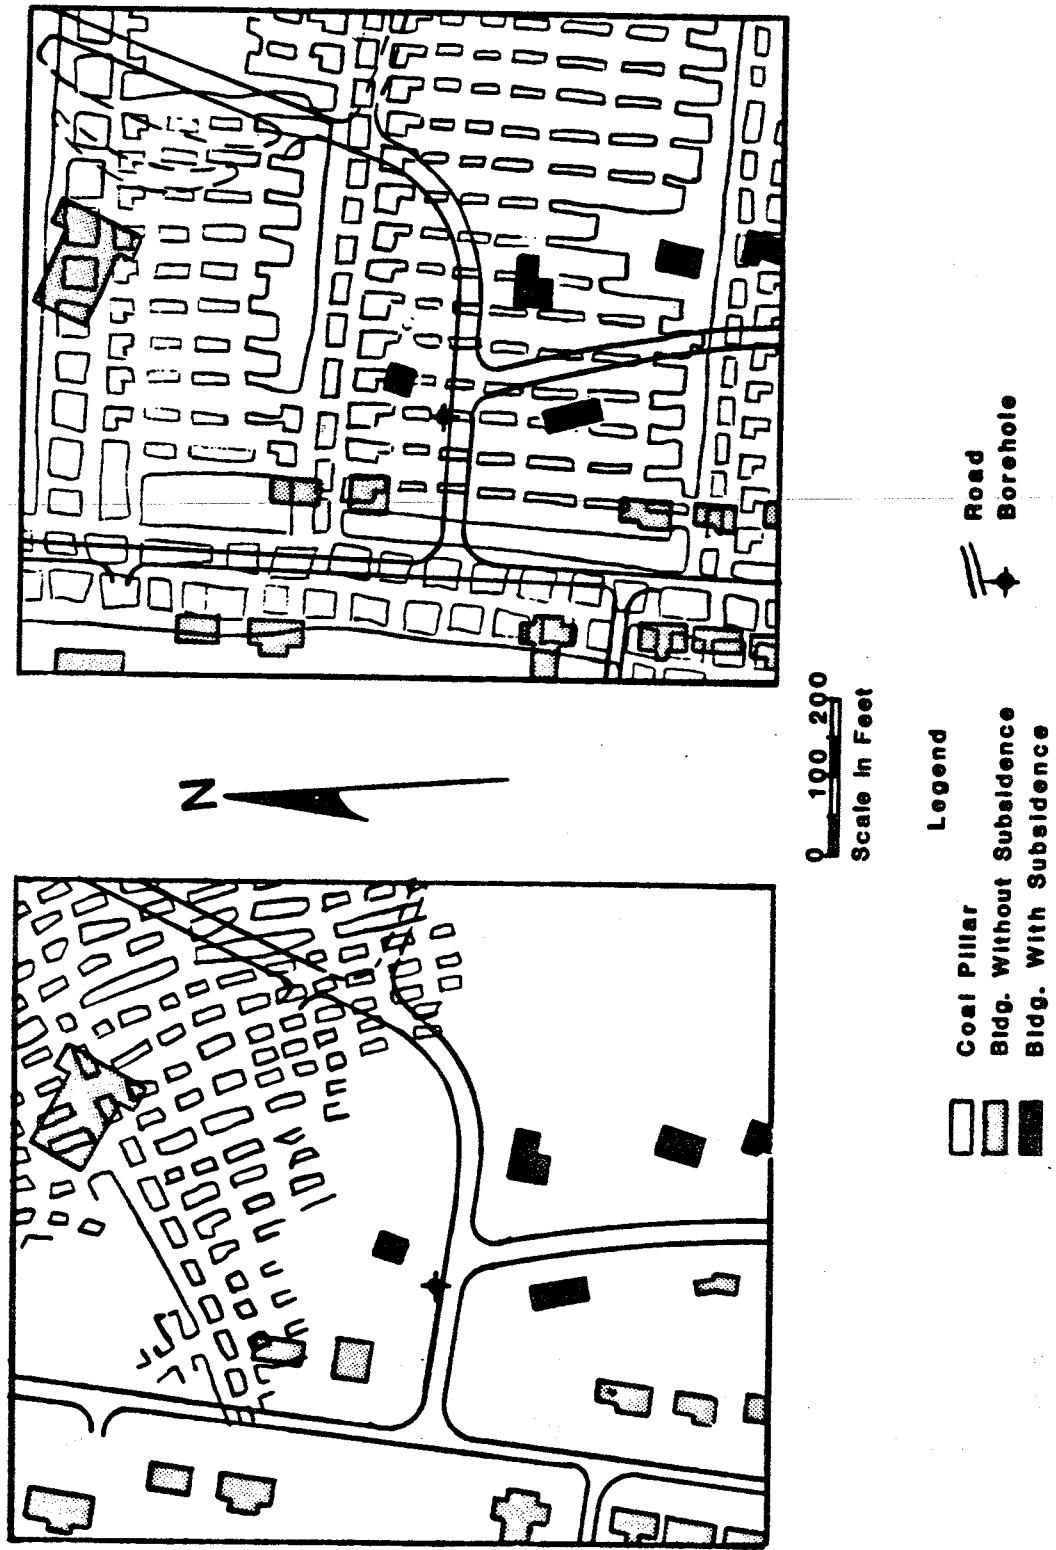
Drill hole 4 (DH-4) was positioned just south of 601 Montrose Drive (Figure 11) and penetrated a void in the Number 11 Coal (Table 2). The Number 9 Coal was in place. Horizontal fractures were found in the strata above the Number 11 Coal but no roof collapse appears to have occurred. Methane gas and sewage odors were noted. Water depth in the drill hole was 86 feet, indicating that the mines were flooded.

Superposition of the surface features over the Sunset Mine map (Figure 11) indicates DH-4 most likely penetrated either a cross entry or a room just south of the cross entry. Therefore the residence at 601 Montrose Drive is probably positioned at least partly above the cross entry pillars. Pillar crush analysis for these cross entry pillars (Table 4) indicates that they should not crush. The smaller pillars in nearby panels, however, probably would crush (Table 4). An additional hole drilled into a panel north of DH-4 (Etue and others, 1985) found crushed pillars and collapsed overburden in the Number 11 Coal. Large volumes of gas (69.5 percent methane, 3.8 percent oxygen) flowed from this drill hole when drill rods were removed. This is consistent with the release of gases from the coal in zones of pillar crushing (Appendix D).

Figure 11. Mine map of Number 11 Coal (right) and Number 9 Coal (left) with cultural features and location of drill hole (DH-4). For more detailed information see Number 9 Coal Map 2C, Number 11 Coal Map 2B and Topographic Map 2A.

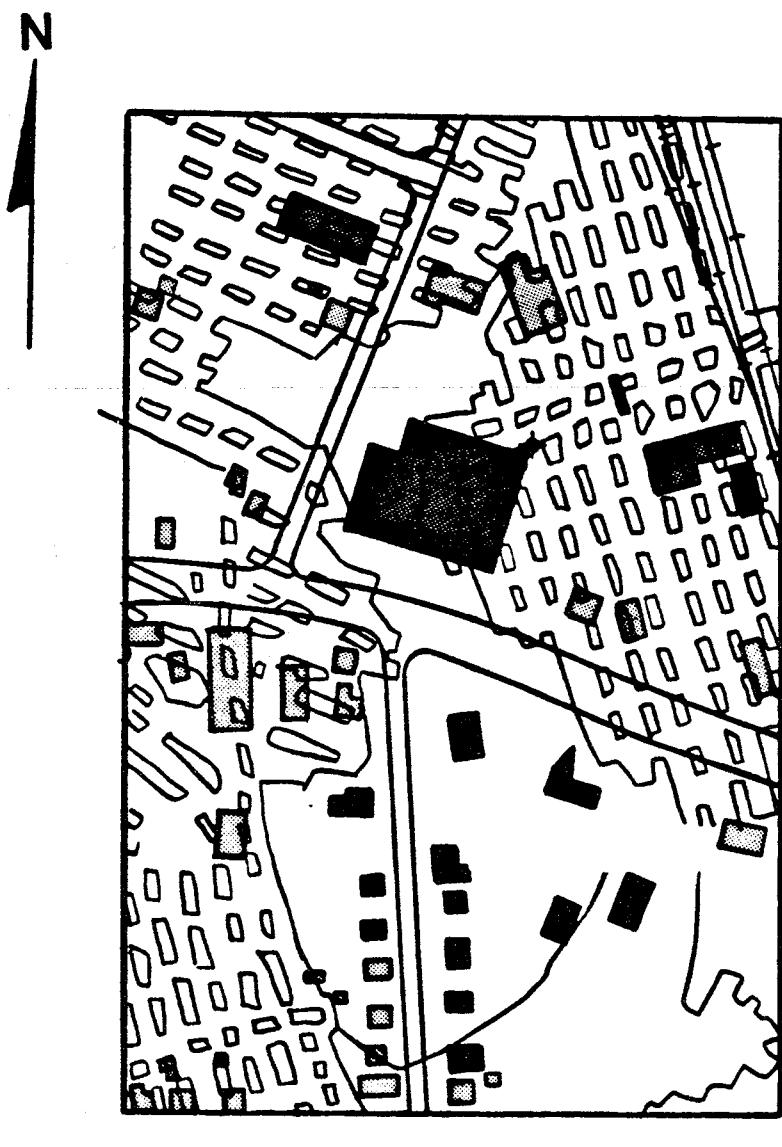
Drill hole 7 (DH-7) was sited in a central location relative to a number of damaged buildings (Figure 14). The Number 11 Coal was encountered at a depth of 226.5 feet (Table 2). Horizontal and angle fractures were observed in rock strata above the Number 9 Coal but these fractures did not extend up to the Number 11 Coal. The roof at the Number 9 level had collapsed and the 4.5 foot void was filled.

Map 4B shows the proximity of the damaged buildings to barrier pillars in the Coil Mine which were left under the railroad at the east side of the subarea and to the irregular block of coal left between panels to the west. Based on the pattern of the nearby mining as shown on the mine map (Figure 14) and an extraction ratio of 85 percent, the panel pillars should crush. Some panel pillars have probably failed and others may fail in the future. Pillar strength analysis for the cross entry pillars at 80 percent extraction (Table 6), indicates they are barely adequate to support the weight of the overburden load and may also be failing.

Figure 14. Mine map of Number 11 Coal with cultural features and location of drill hole (DH-7). For more detailed information see Number 11 Coal Maps 2B and 4B and Topographic Maps 2A and 4A. There are no Number 9 Coal mine maps for this site (Maps 2C and 4C).

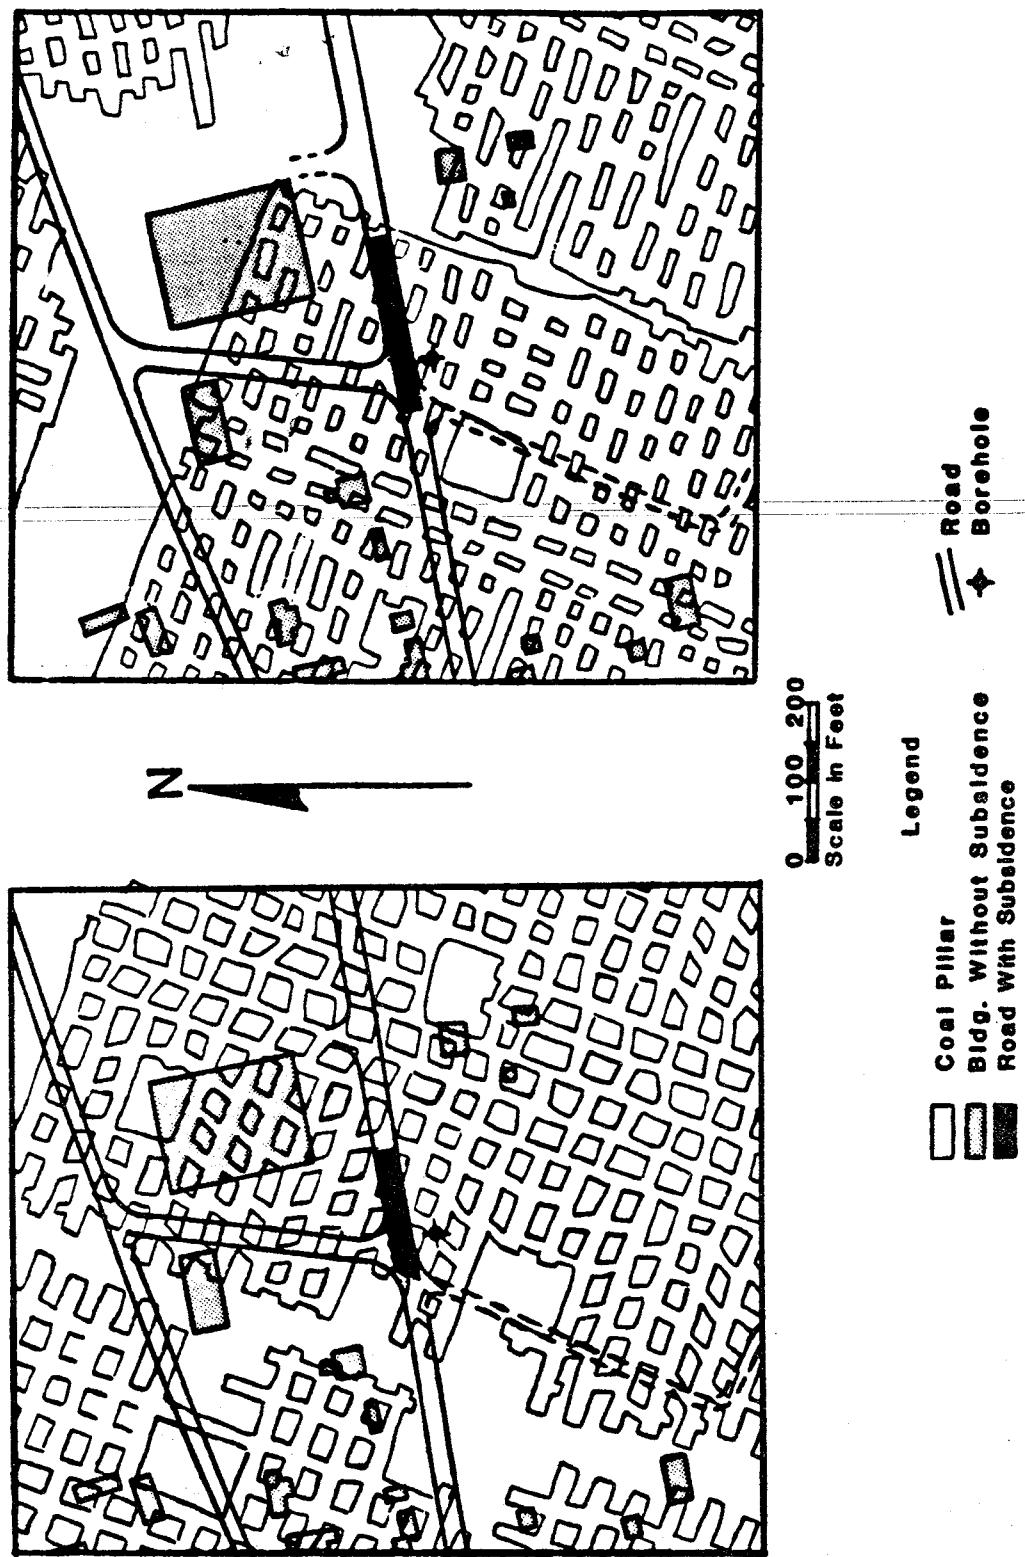
Figure 19. Mine map of Number 11 Coal (left) and Number 9 Coal (right) with cultural features and location of drill hole (DH-13). For more detailed information see Number 11 Coal Map 5B and 6B, Number 9 Coal Map 5C and 6C, and Topographic Map 5A and 6A.
