**SUMMARY REPORT
FOR
1990 INSERVICE INSPECTION (ISI)
OF
SRS 100-K REACTOR TANK (U)**

Savannah River Laboratory
Equipment Engineering Section
Reactor Tank Inspection Program

Issued: May 15, 1990

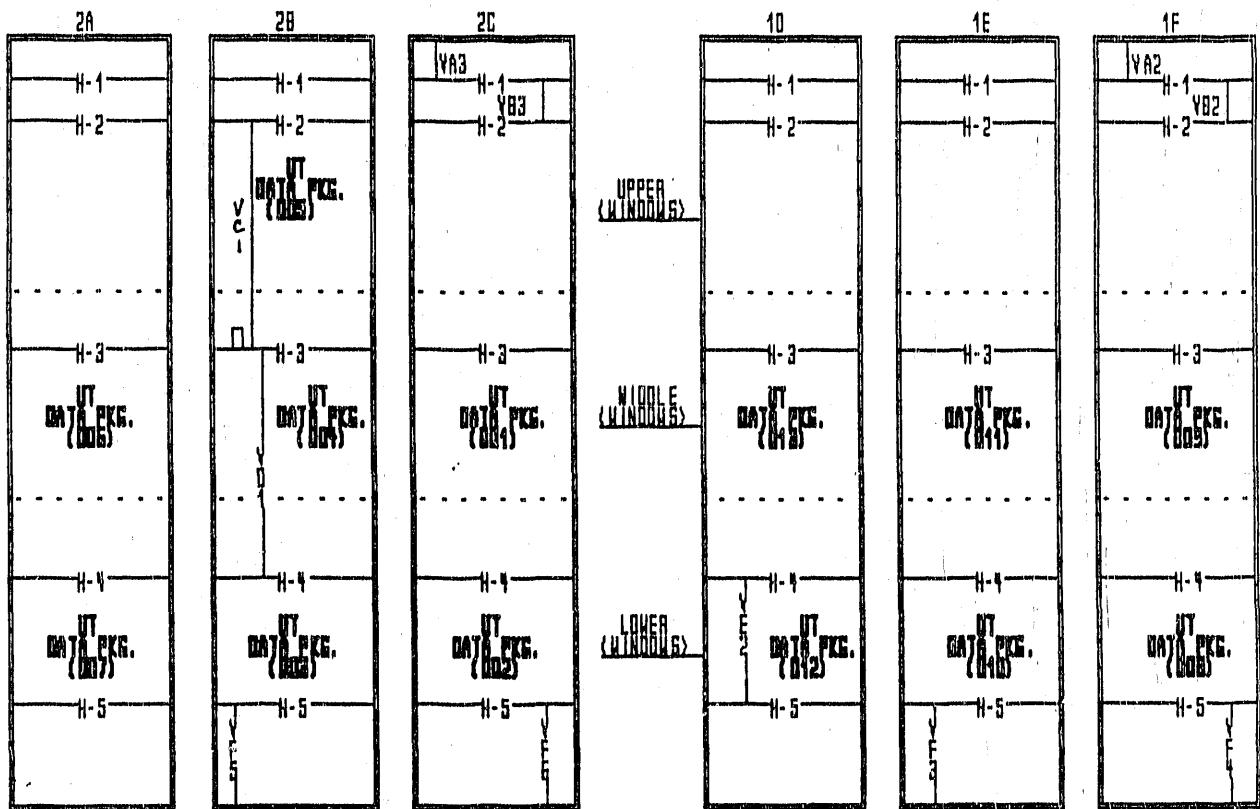
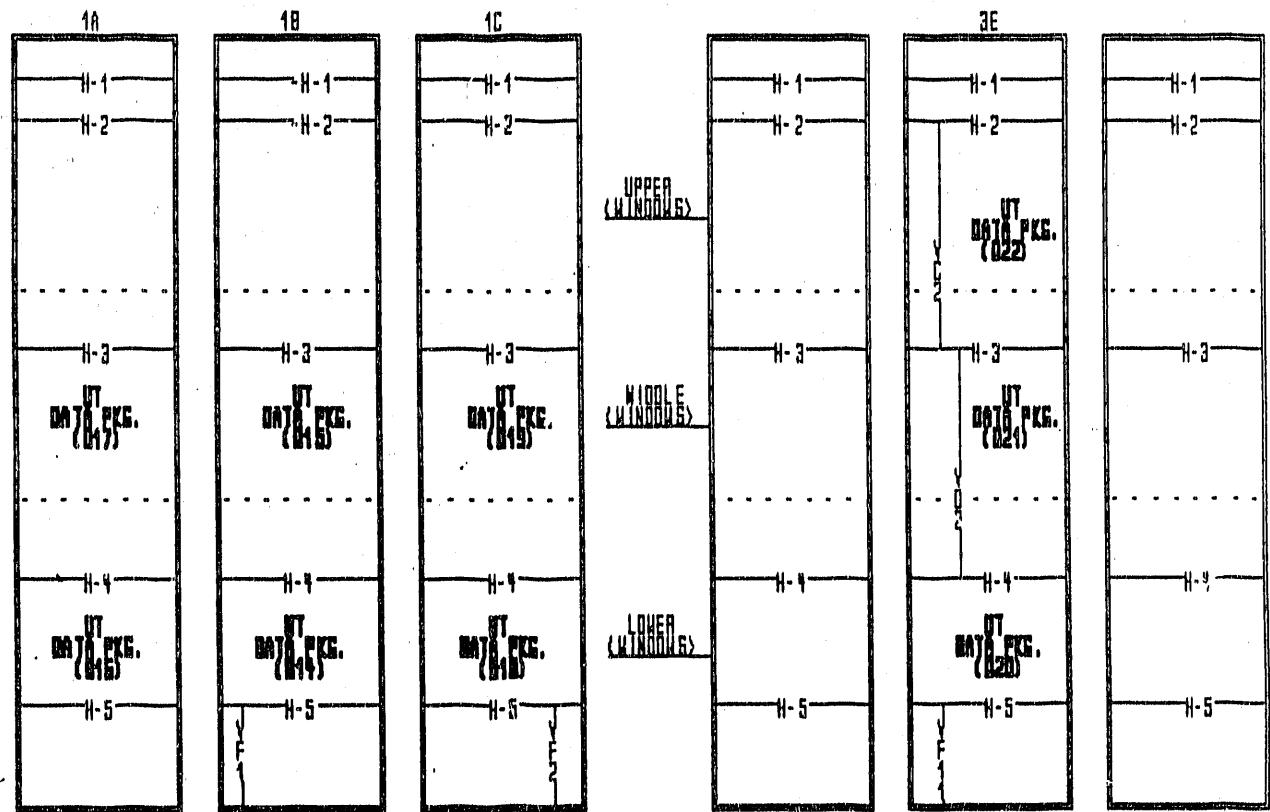
Figure 1-A. "K" Reactor Ultrasonic Scan Envelopes

Figure 1-A. "K" Reactor Ultrasonic Scan Envelopes (Continued)

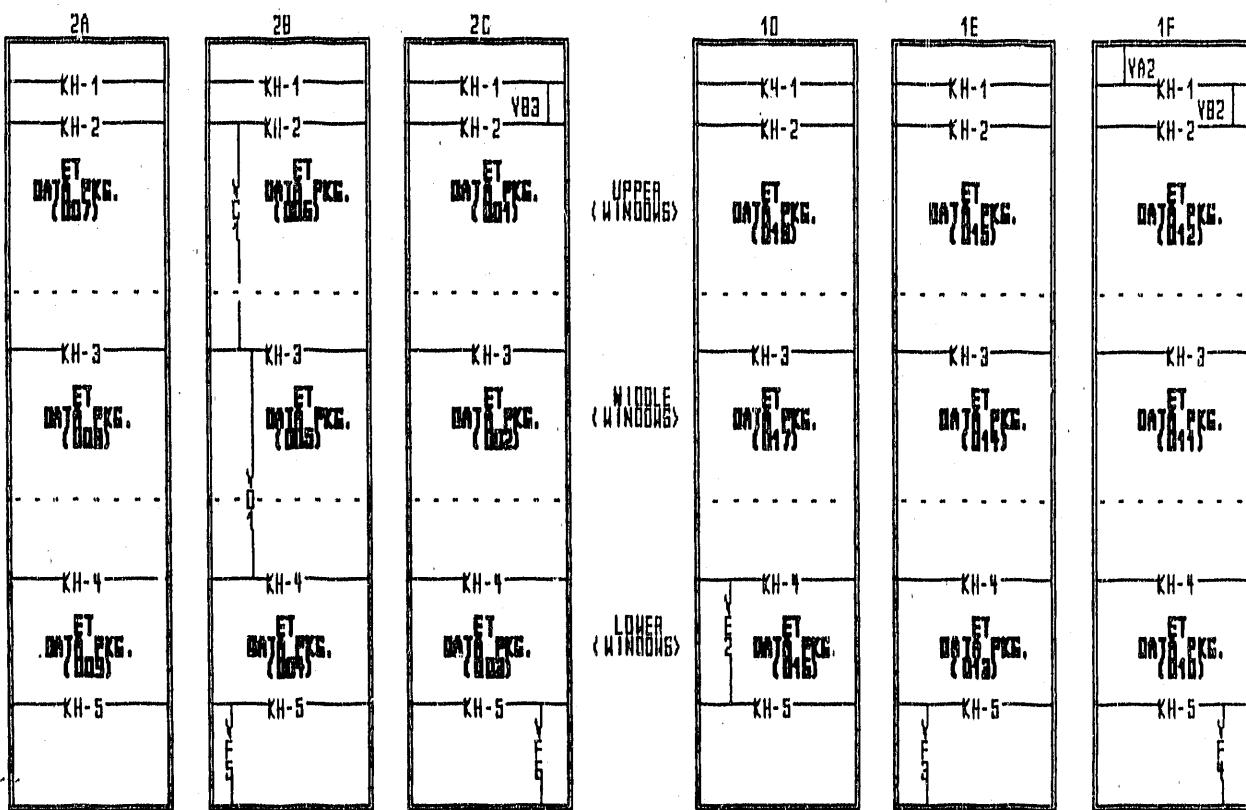
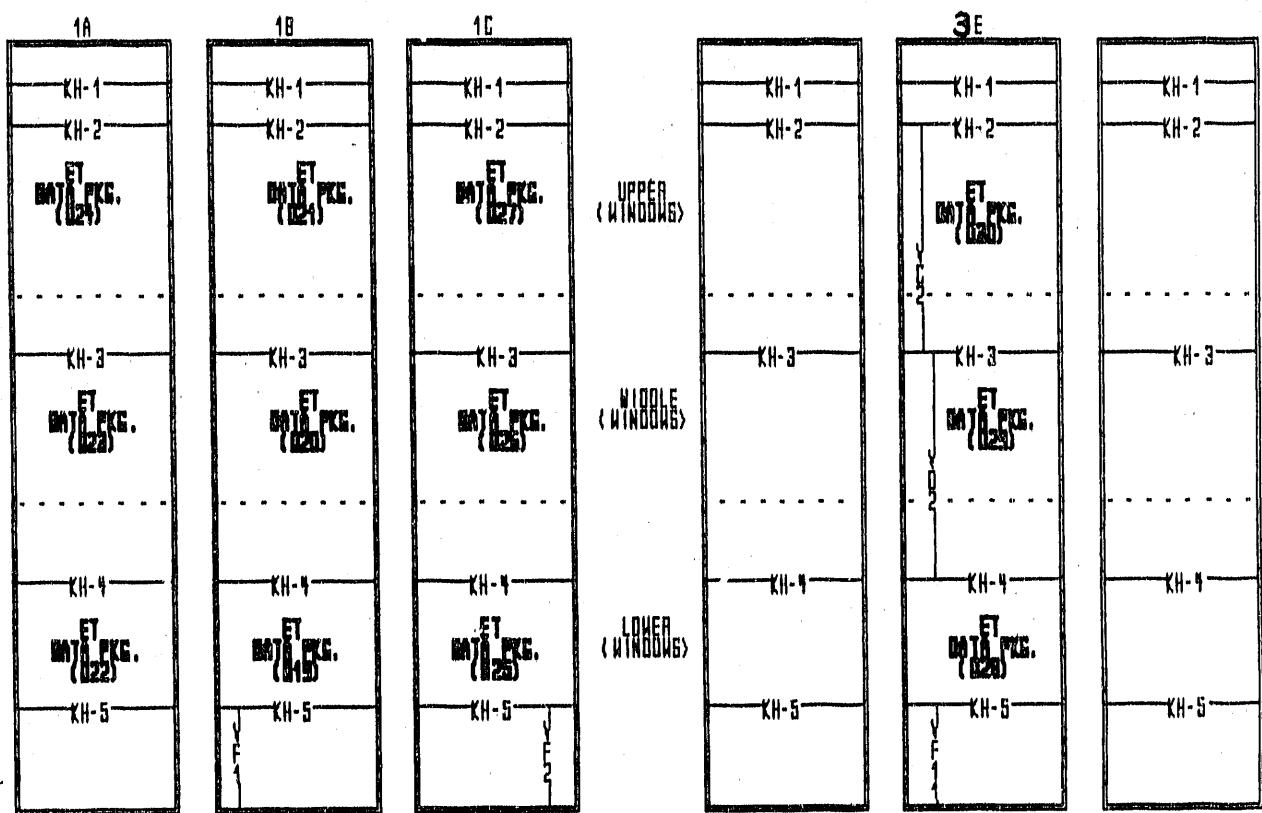
Figure 1-B. "K" Reactor Eddy Current Scan Envelopes

Figure 1-B. "K" Reactor Eddy Current Scan Envelopes (Continued)

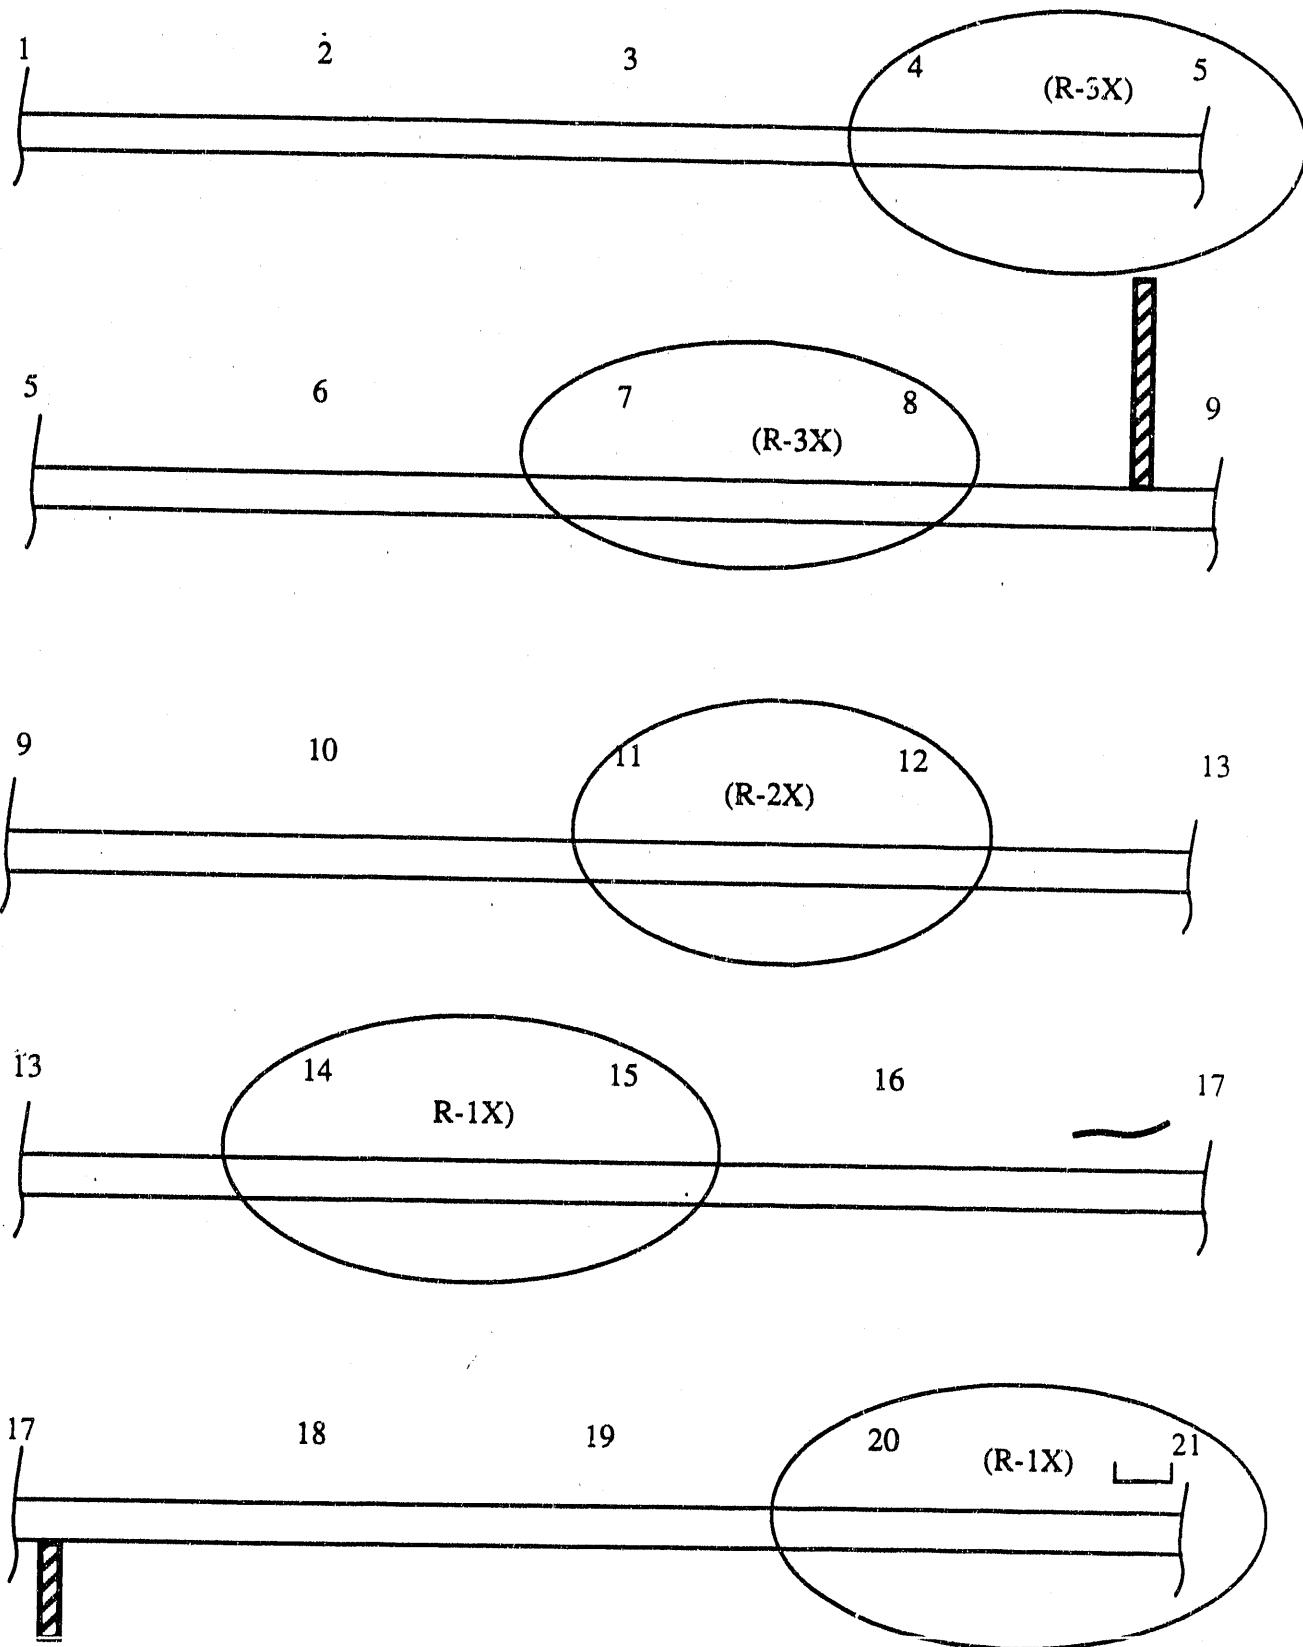
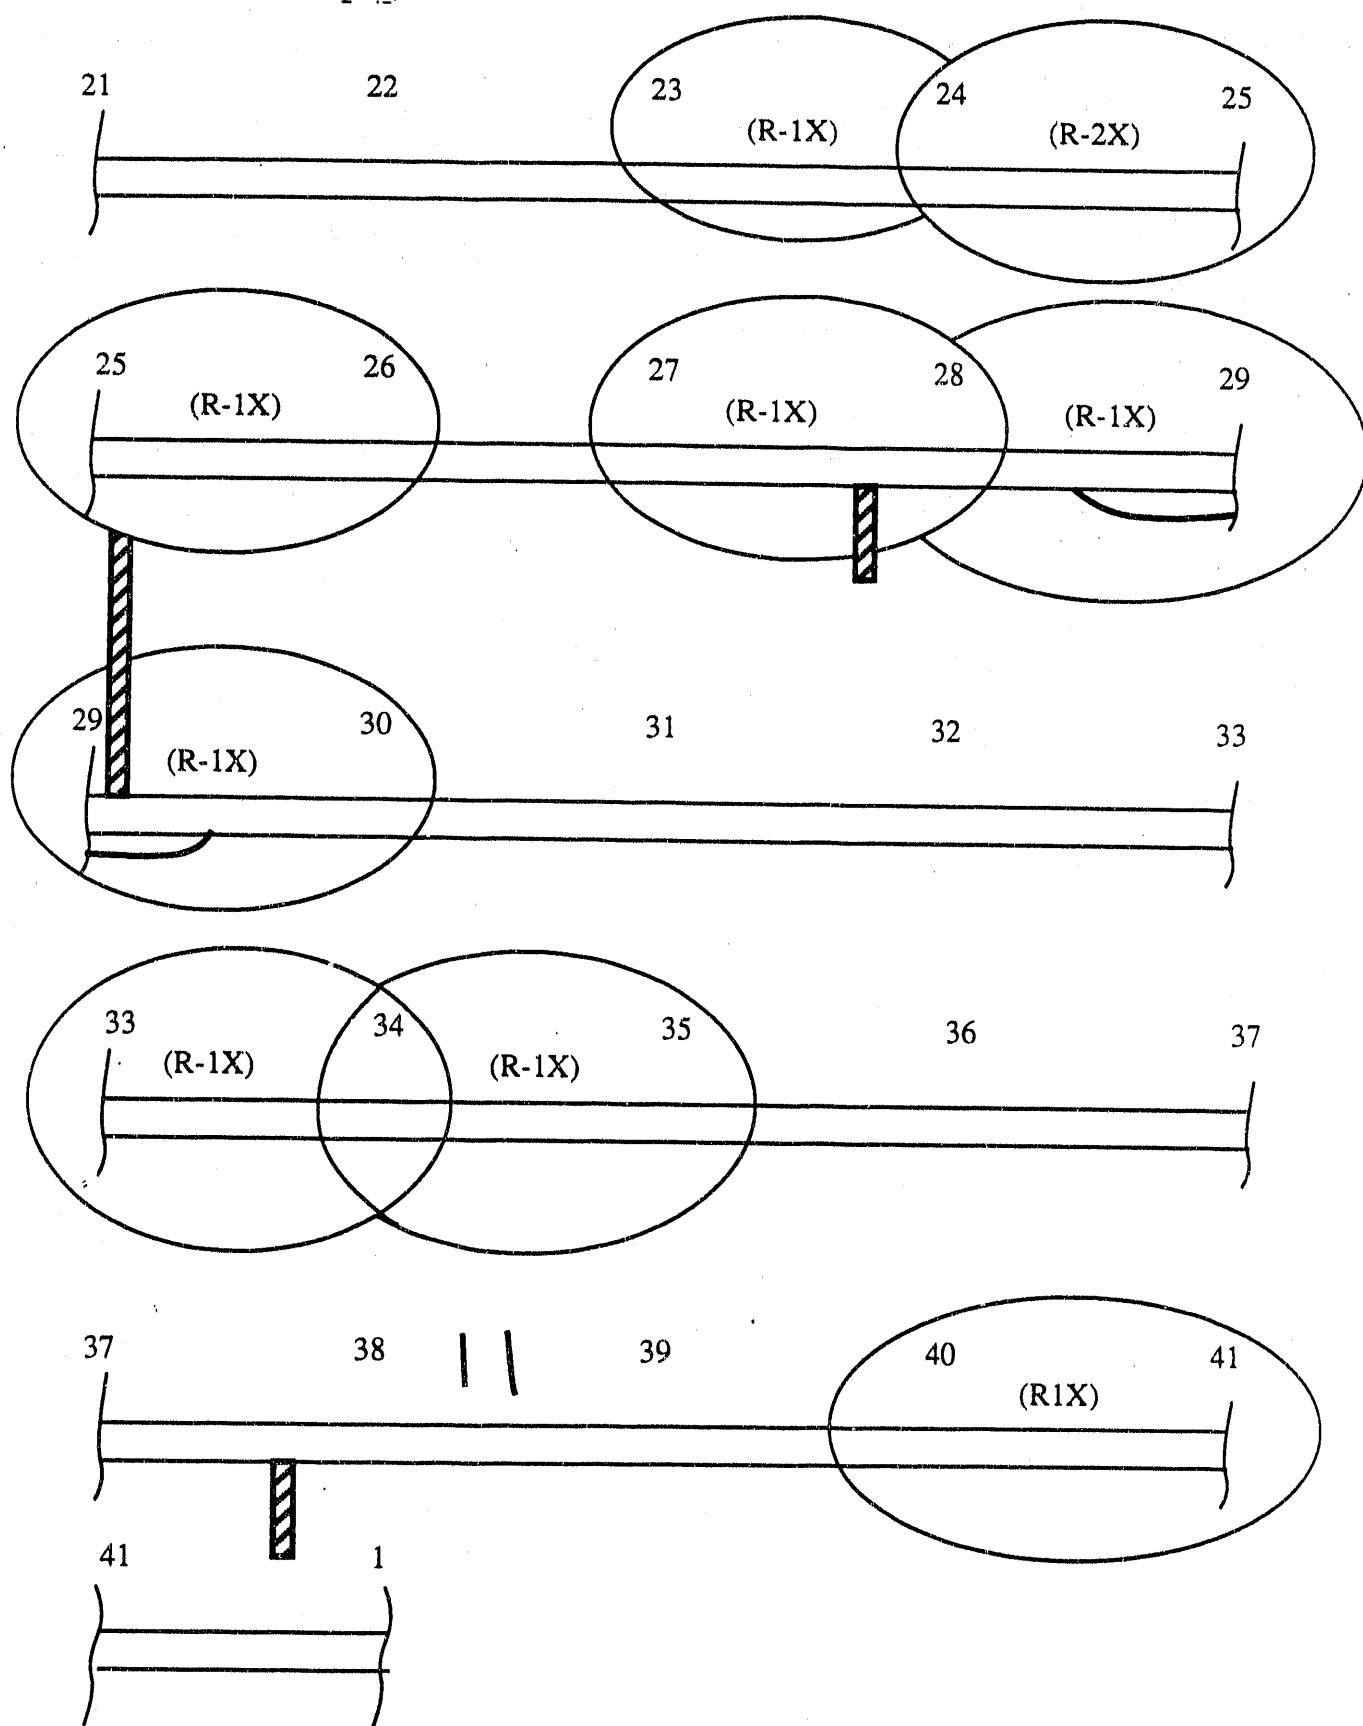
ATTACHMENT 1

A graphic presentation of this review is included as Attachment 1. The specific review results are included as Attachment 2. Figure 1 is a simulated tracing of the original final radiograph of exposure 4-5 of weld K-H4 showing the extra weld crown width and its presence above the original weld edge.

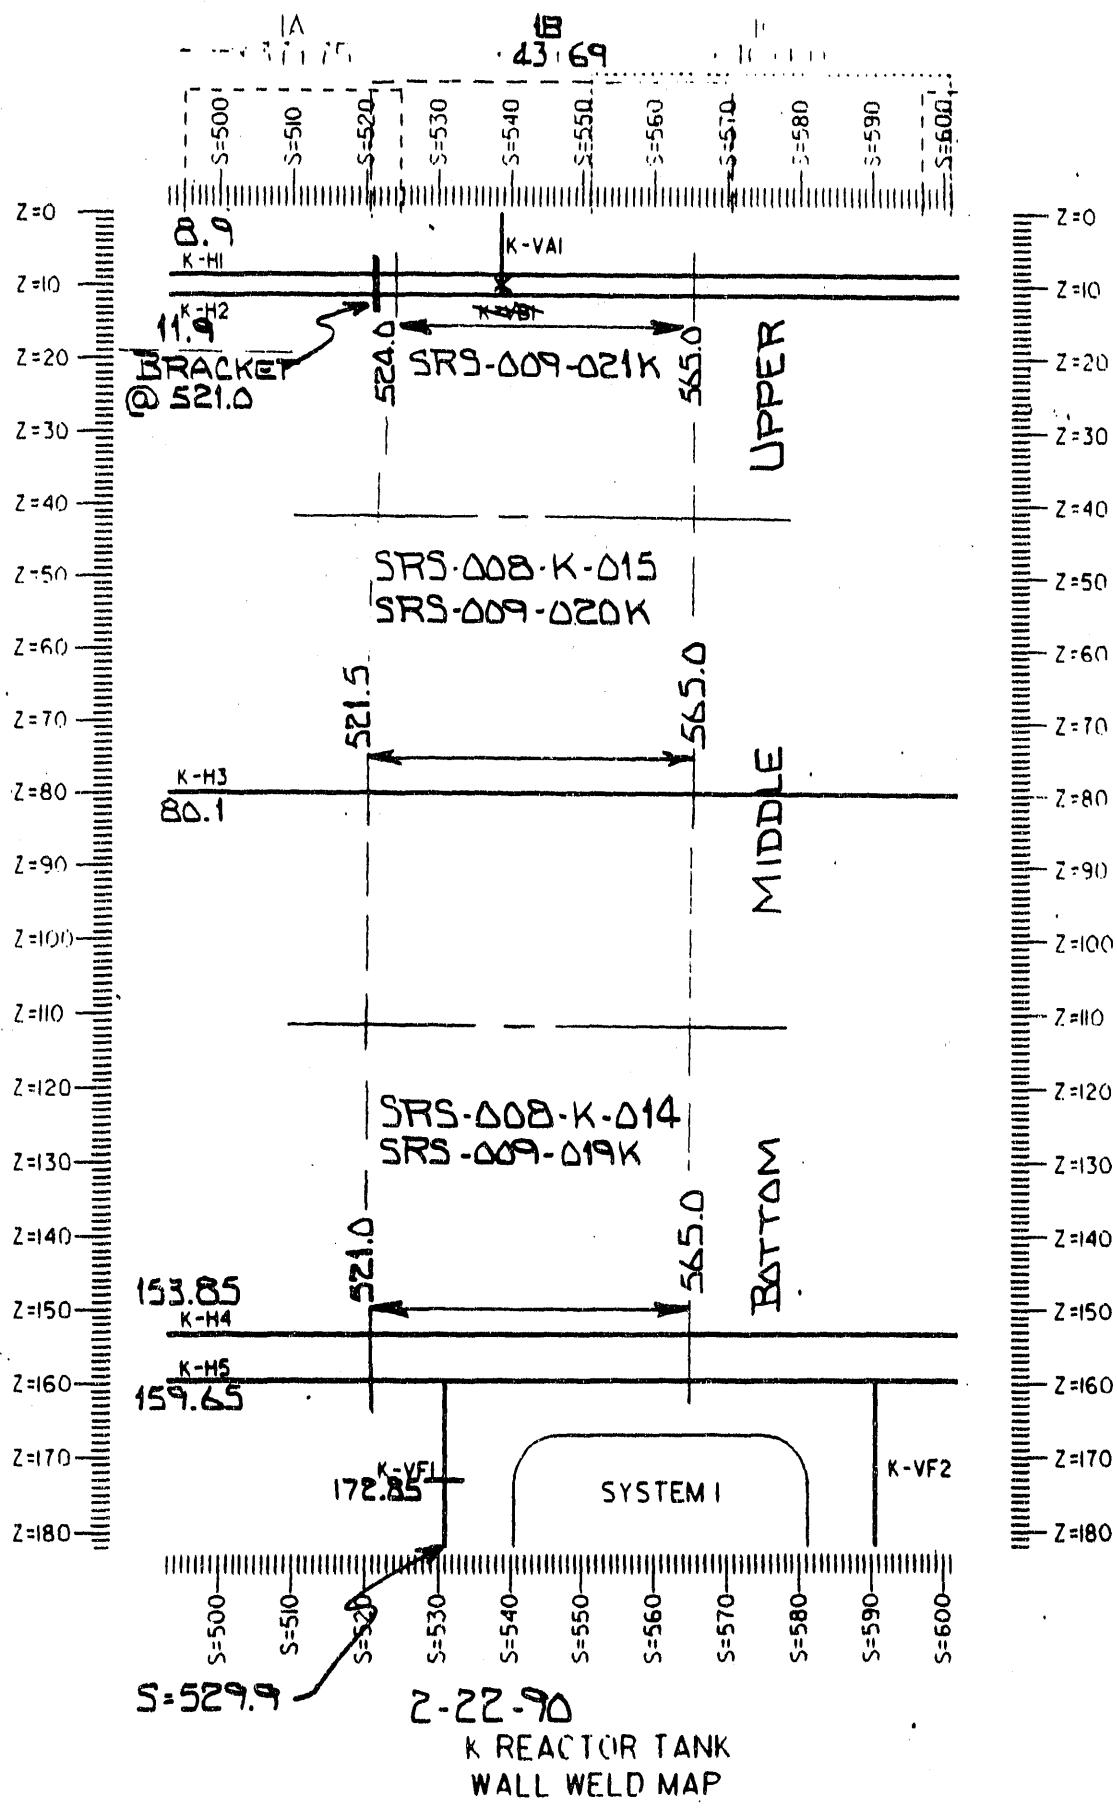
K REACTOR TANK
WALL WELD MAP

RTIP IRC Daily Report		Report No.: <u>10</u>
RTIP - 002 [Exhibit 1]		Date: <u>2/22/90</u>
Members In Attendance:		
Chairman:	<u>E.G. CAVUNESS</u> Name	Signature
EES/RTIP:	<u>E.G. CAVUNESS</u> Name	<u>E.G. CAVUNESS</u> Signature
Rx. Eng.:	<u>DR Ketcham / C.D. Castle</u> Name	<u>DR Ketcham / C. Castle</u> Signature
Rx. Ops.:	<u>K. W. ATKINSON</u> Name	<u>K. W. ATKINSON</u> 2-22-90 Signature
EES/MAT:	<u>E. J. Mazzlik</u> (Acting Chairman)	<u>E. J. Mazzlik</u> 2/22/90 Signature
QA:	<u>R.L. Malloy</u> Name	<u>R.L. Malloy</u> 2/22/90 Signature
Inspection Reports Reviewed: DATA PACKAGES SRS-009-021K, -020K, AND-019K (GT) AND SRS-008-K-015, -014, (GT), FOR ALL WINDOWS OF SECTOR 1B.		
Relevant Indication (Tank Location and Dimensions): <u>No Reportable indications.</u>		
Classification of Indication: <u>N/A</u>		
NCR's Generated: (Yes/No) <u>Yes</u>		
NCR Nos.:		
Comments: ONE EXTERNAL ATTACHMENT AREA FOUND ABOVE K-44 AND AN INDICATION of a short AREA of undercut. ONE INTERNAL ATTACHMENT AREA ON 1D Below K-45 AND ONE O.D. ATTACHMENT REMOVAL AREA. FOUR O.D. WOLD ATTACHMENT AREAS AND A WOLD ROPER AREA ASSOCIATED WITH K-44. ALL ACCEPTABLE WITHIN ACCEPTANCE CRITERIA

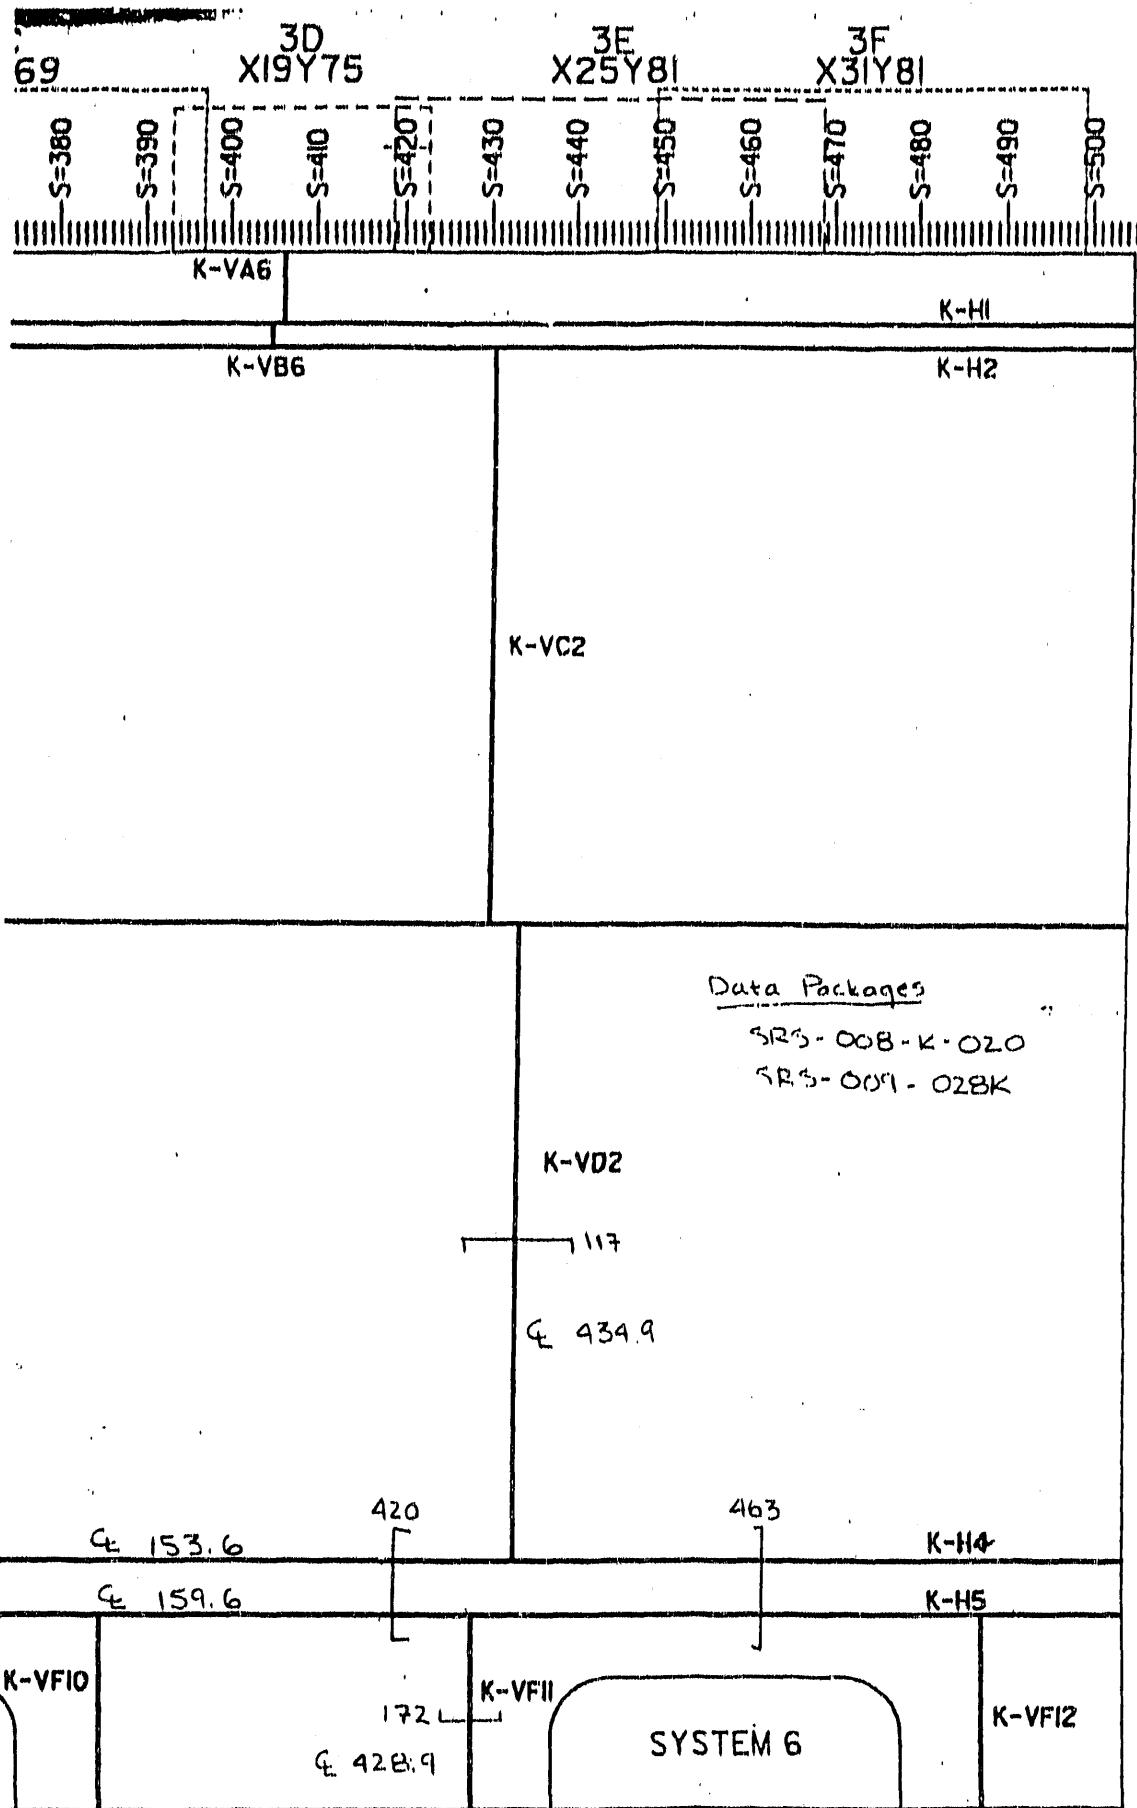
Comments: Noted 3 areas of weld repair on I.D. of Weld K-H4, and one very wide repair (up to 2 inches), about 10" long, on O.D. Two attachment removal areas on I.D. on K-H4, Weld K-VF11 was noted as being about 0.4 inches off vertical in the 12 inches Scanned, One attachment removal area on O.D. of K-H4, below weld, and one on O.D. area of weld K-VD2.
