TUBING WASTAGE IN FLUIDIZED-BED COAL COMBUSTORS  
(TVA, 20 megawatt AFBC Pilot Plant)

By  
Charles E. Witherell

Prepared by  
Lawrence Livermore National Laboratory  
Livermore, California 94550-0808

April 7, 1989

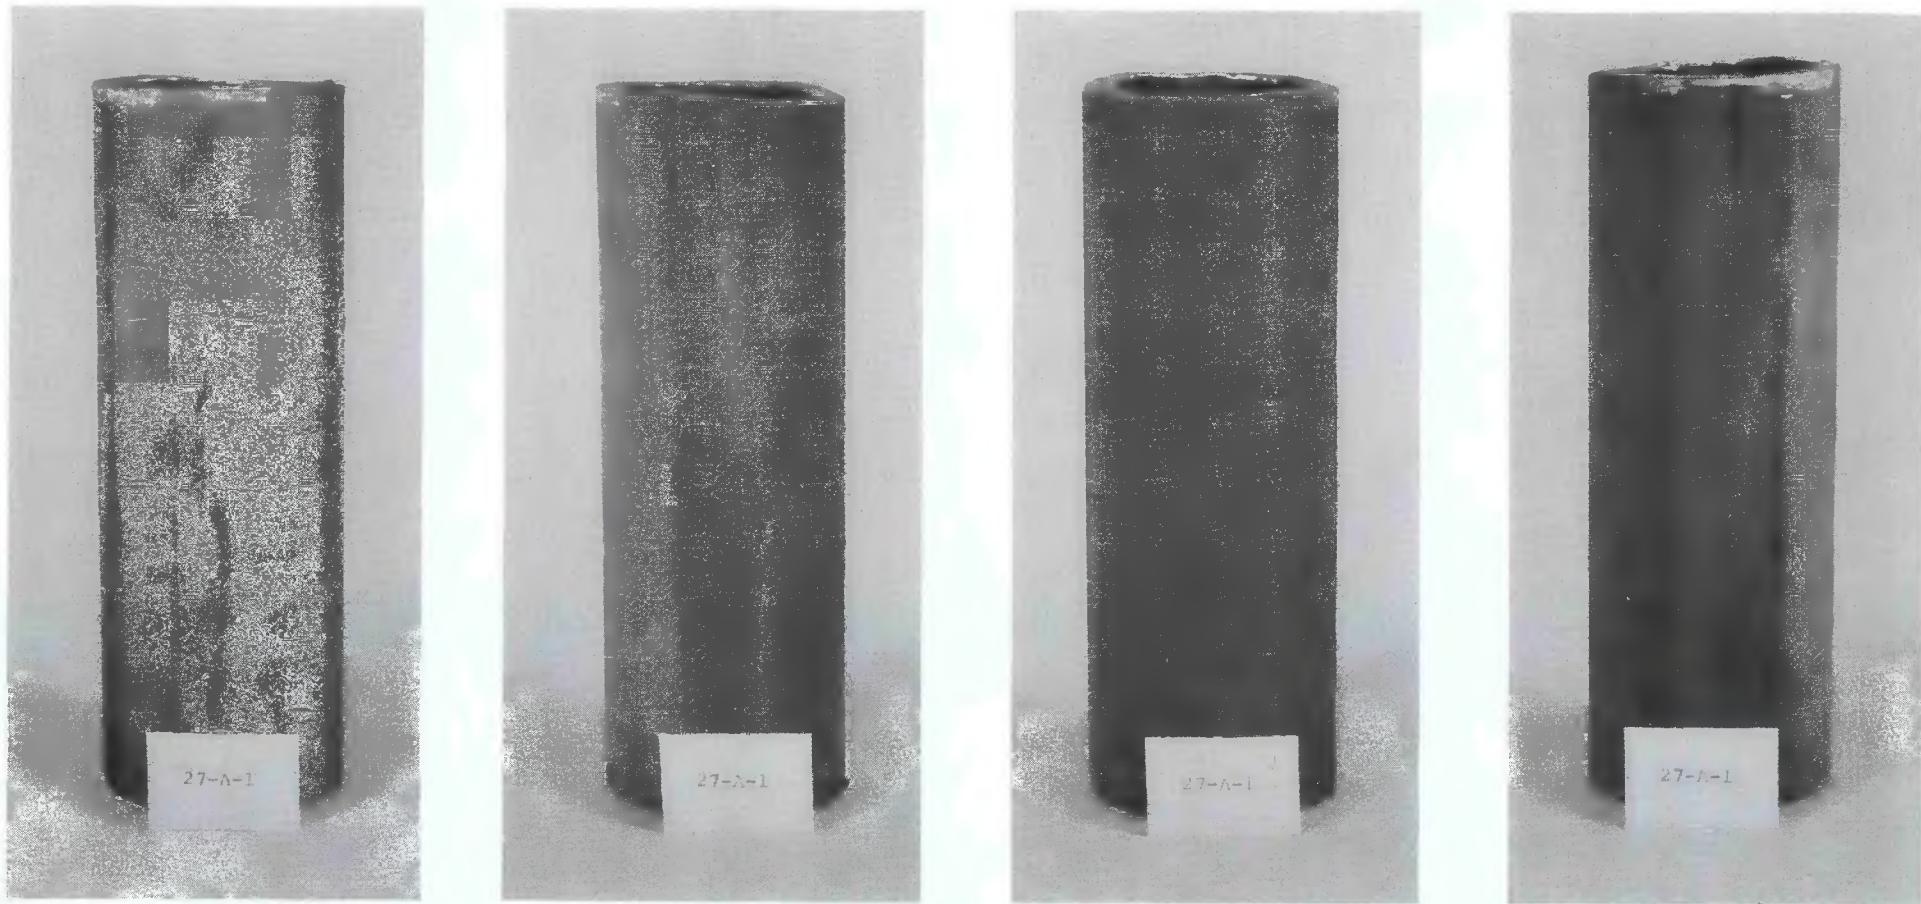
FIGURE 4-A

For example, non-wasted surfaces of tubes 27-A-1 and 27-A-4 (Figure 6 and 7, respectively) have similar appearance, with rough heavy-appearing scales, showing evidence of fractures and exfoliated layers. Wasted regions are quite different in appearance – both from each other and from non-wasted regions. The wasted region of 27-A-1 (Figure 6) has a fine granular texture that appears to be a coating of agglomerated particulates that are adhering to the tubing surface. This is more clearly evident in the higher magnifications of Figure 10. Wasted surfaces of tubing sample 27-A-4 do not have this appearance. Figure 11 shows the appearance of the wasted region at a higher magnification than Figure 7. While the scale appears more dense, there are some scattered particulates similar to those in Figure 10 on the surface. Also, cracks in the scale are present in these areas devoid of the coating of fine particles.

External Appearance of Tubing Sample 27-A-1

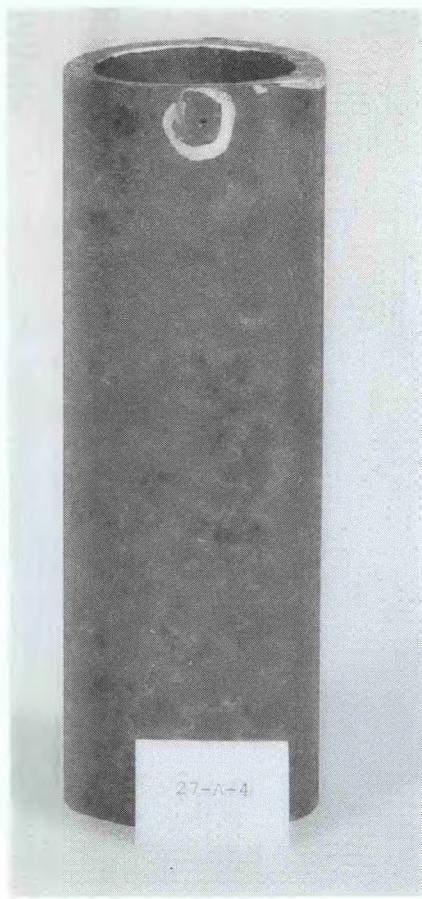
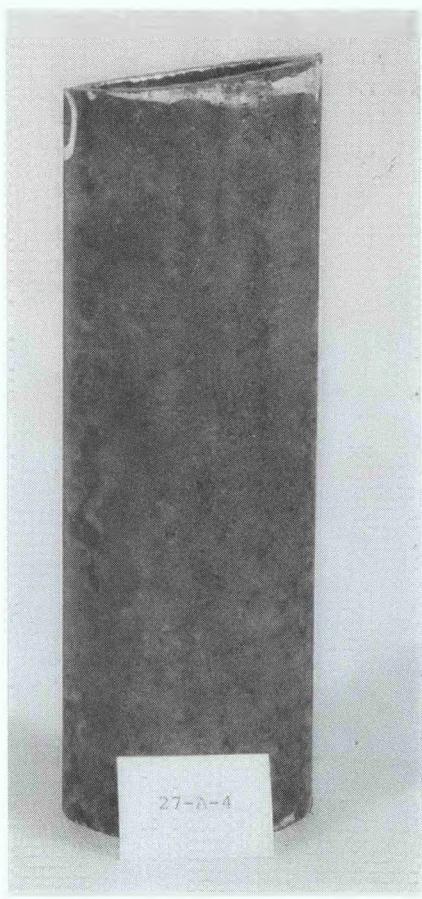
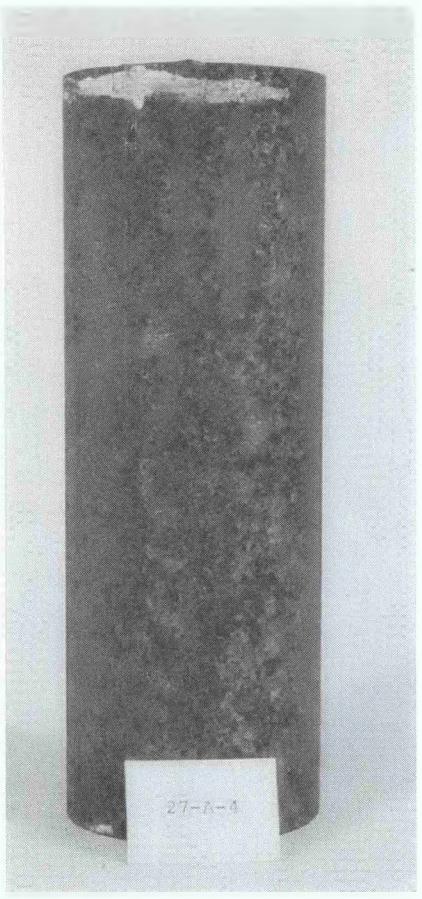
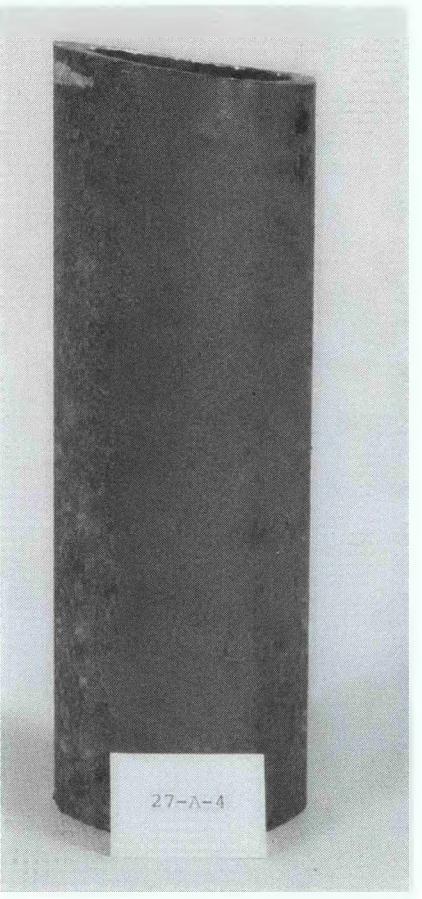
FIGURE 4-B

External Appearance of Tubing Sample 27-A-4

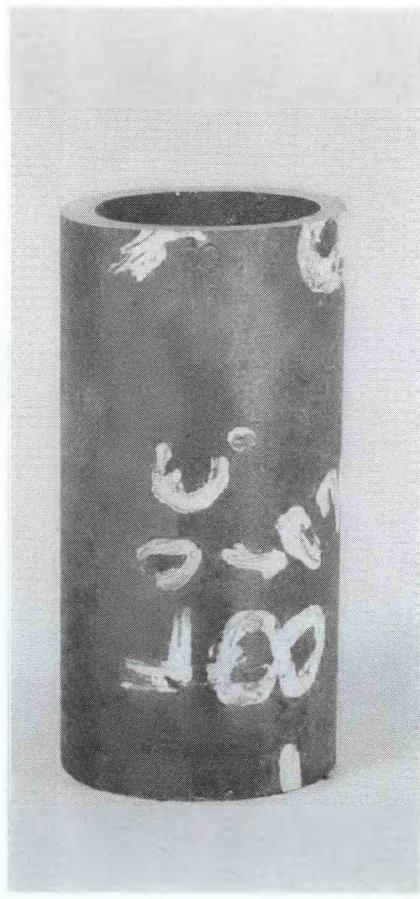
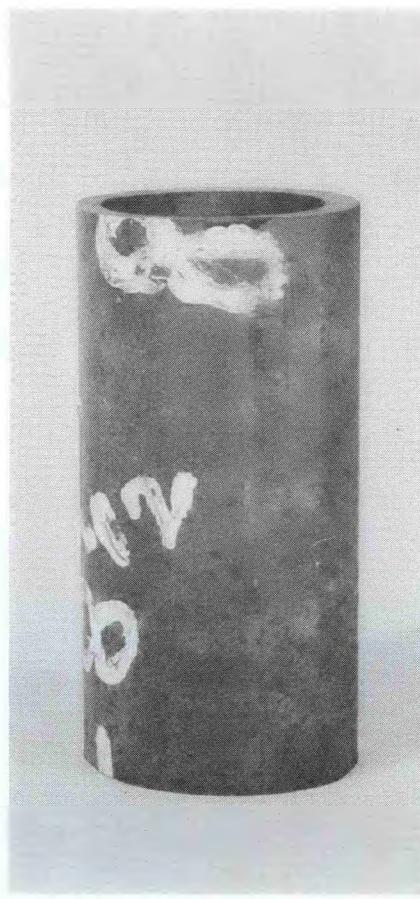
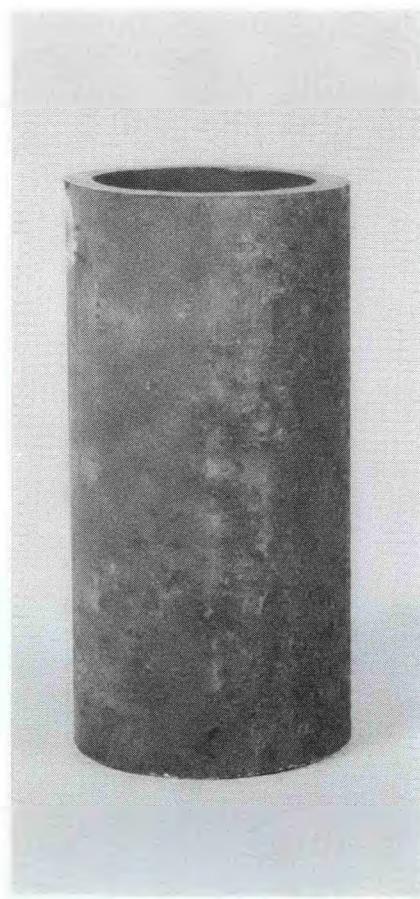
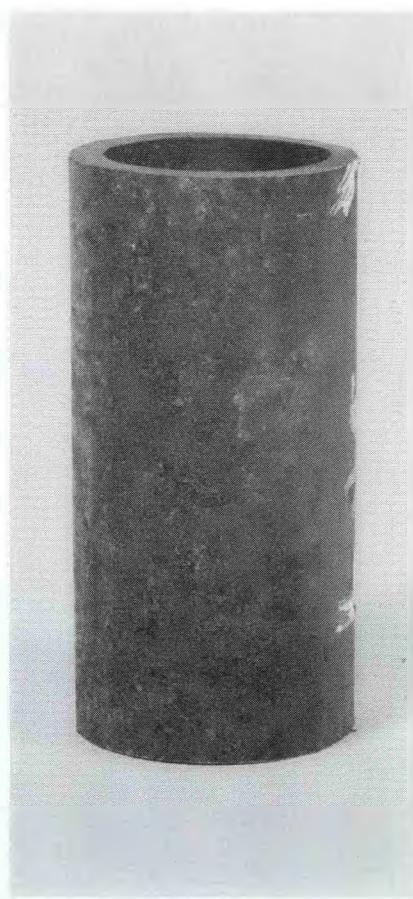
FIGURE 4-C

External Appearance of Tubing Sample 8-1

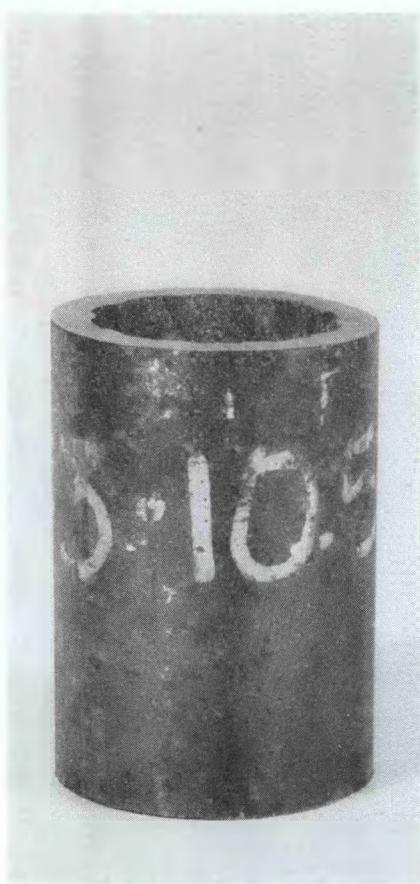
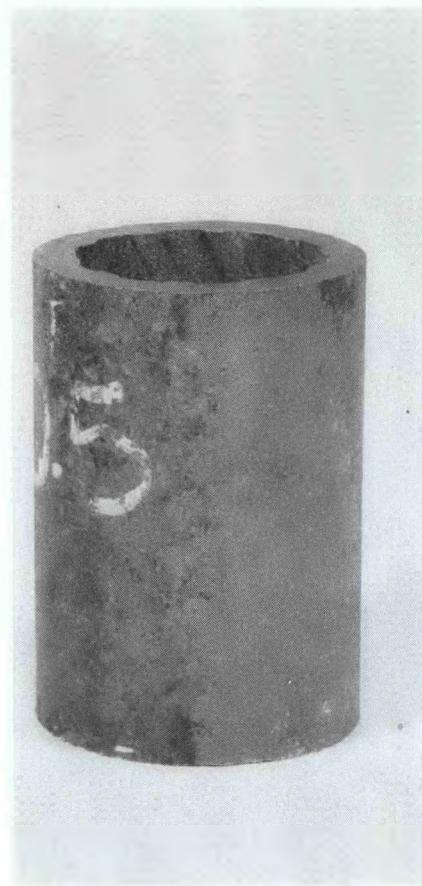
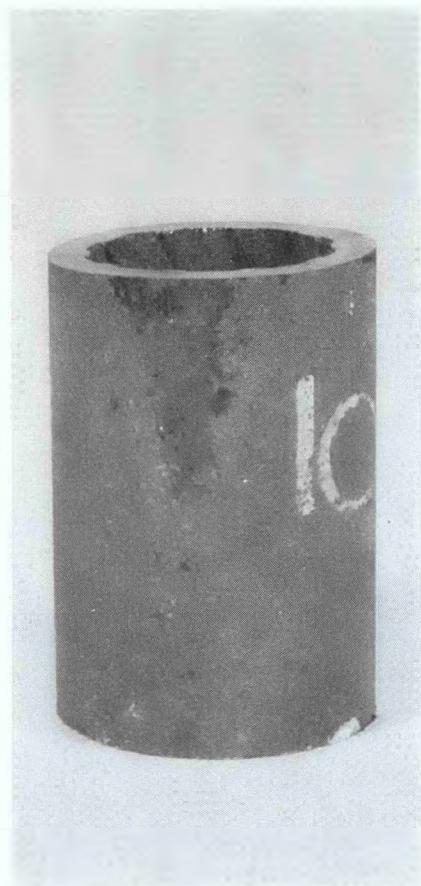
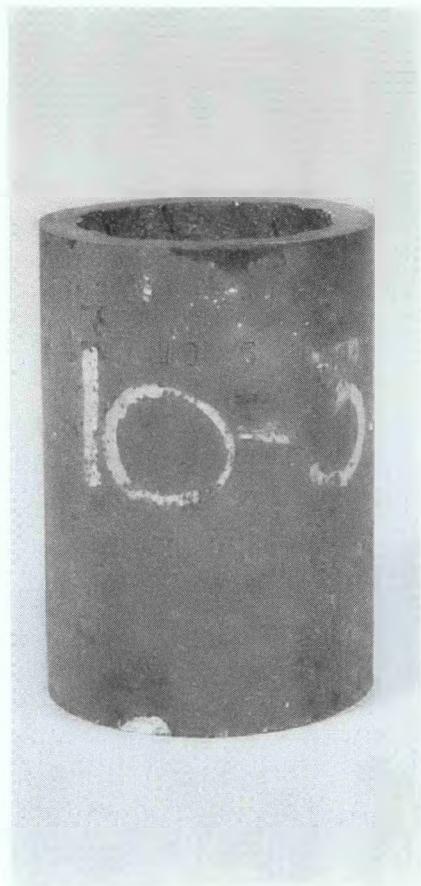
FIGURE 4-D

Tube 10-3-105, that had minimal wastage, had generally the same surface appearance around its periphery and typical appearance is shown in Figure 9. The surface is similar in appearance to other non-wasted regions in that it has a coarser texture with evidence of flaking or exfoliation in scattered regions. This tube bank had much longer combustor exposure than the other three tubes and this exposure involved the use of different coal than was used for the combustor runs involving the other three tubes.

External Appearance of Tubing Sample 10-3-105

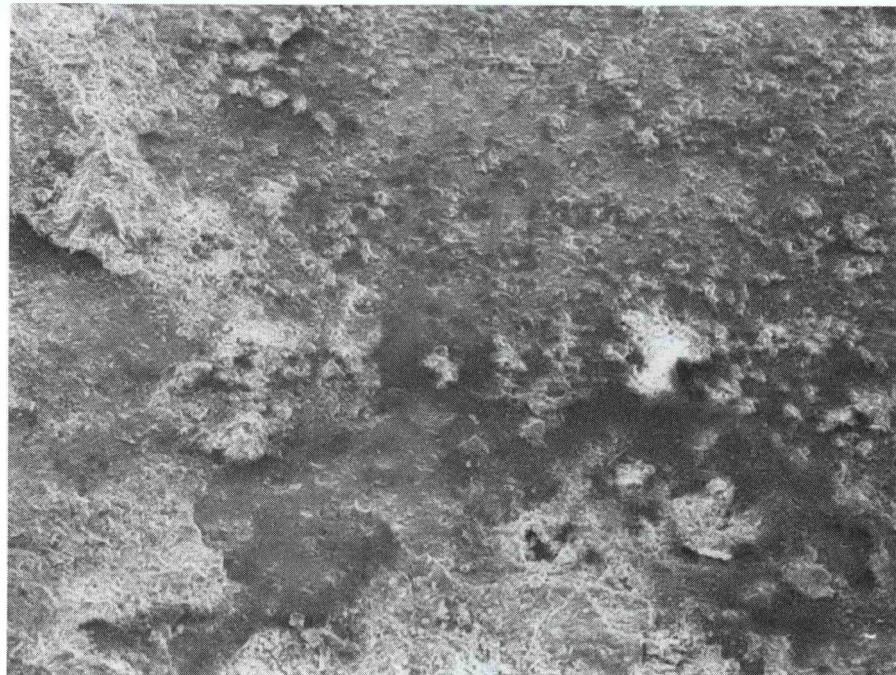
FIGURE 9

Typical Appearance of Fireside Surface of Tubing Sample 10-3-105  
(SEM Photomicrograph)

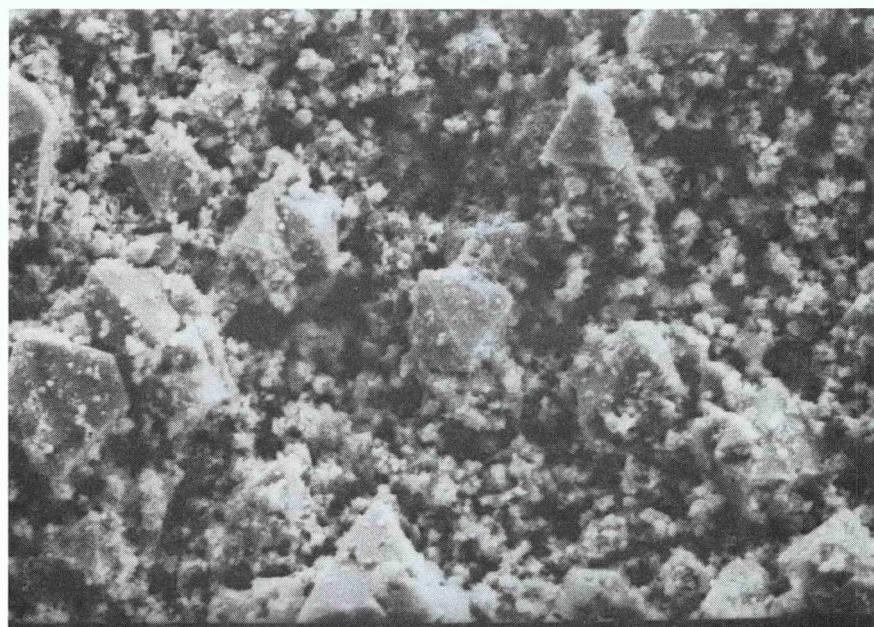
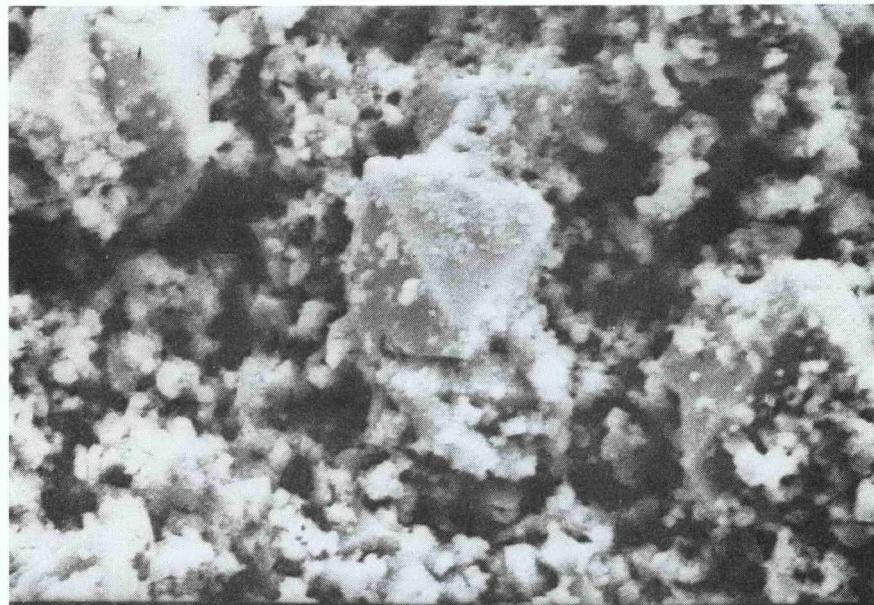
FIGURE 10

There was significantly higher calcium content in the scale of wasted surfaces of tubing 27-A-1 than on non-wasted surfaces of the same tube. This seems to be related to the heavy distribution of fine particulates on these surfaces, (per Figure 10 and lower photo of Figure 6), as these particles had high calcium content. Wasted surfaces of this tubing sample also had titanium present, although none was detected on non-wasted surfaces or on either region of any of the other samples. Small amounts of aluminum, silicon, sulfur, chlorine and manganese were present on both wasted and non-wasted surfaces. Chlorine and manganese levels were higher in non-wasted regions of this tube sample (27-A-1).

Wasted Surface of Tubing Sample 27-A-1  
(SEM Photomicrographs)

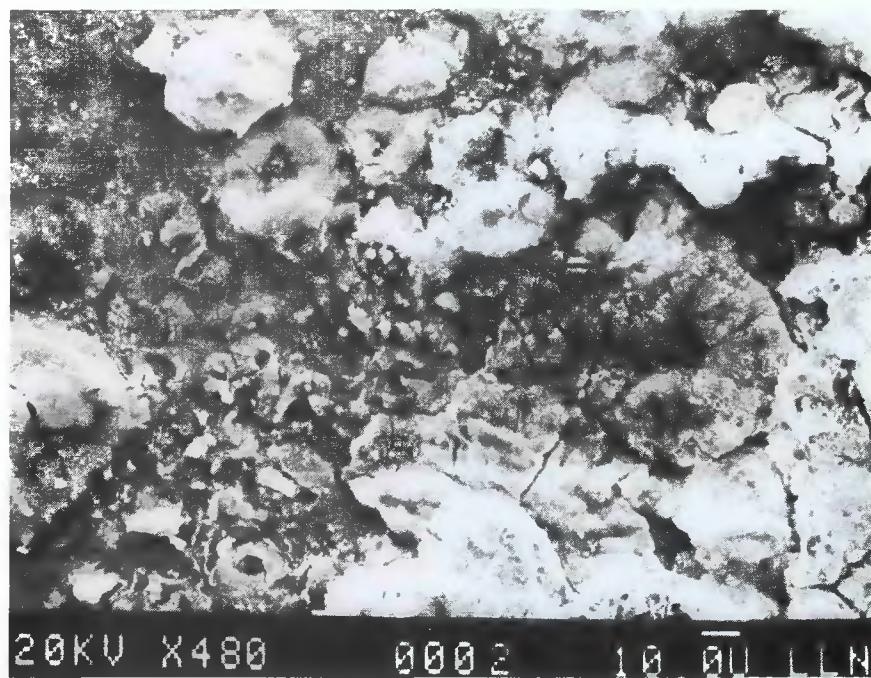
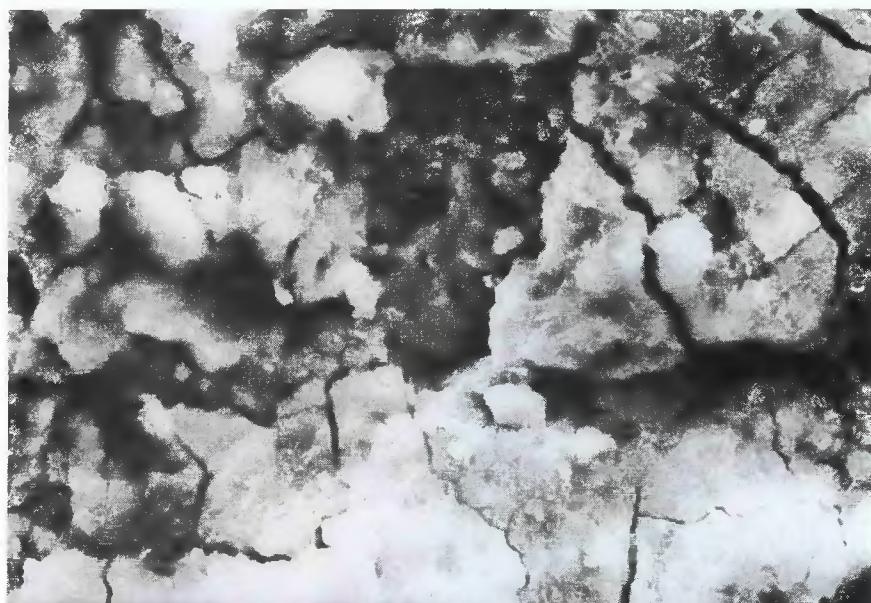
FIGURE 11

Wasted Surface of Tubing Sample 27-A-4  
(SEM Photomicrographs)

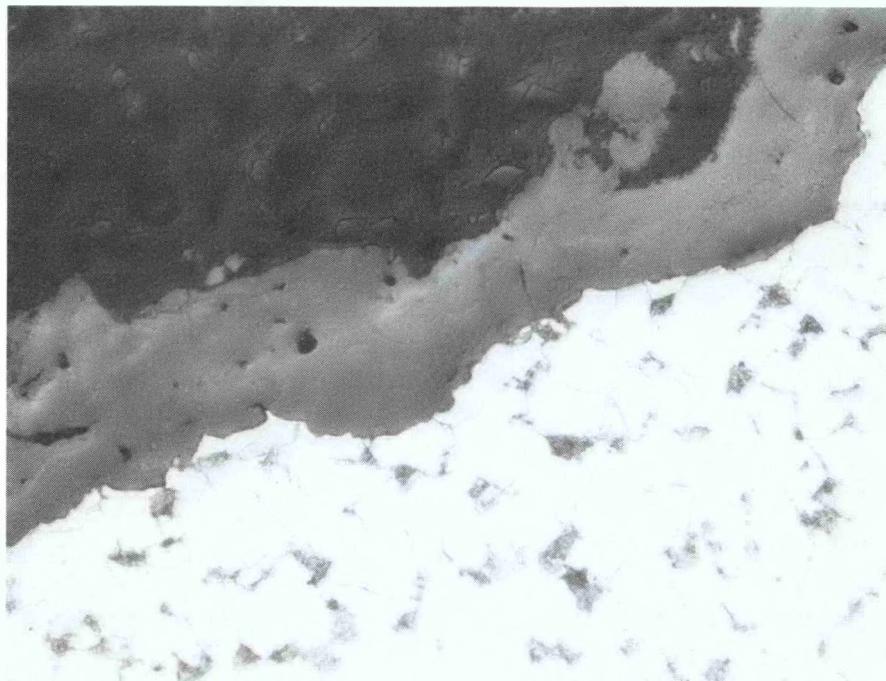
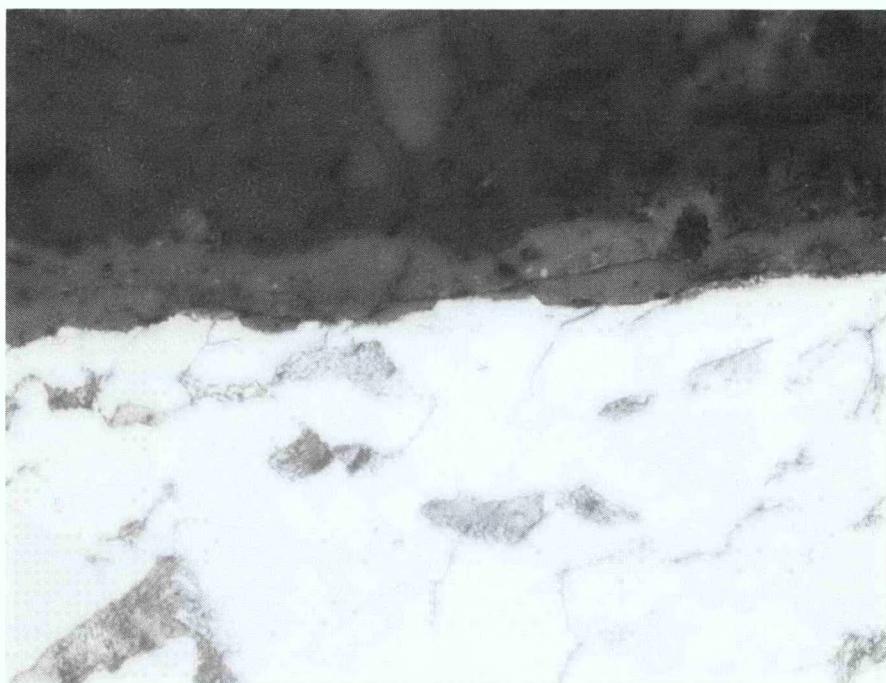
FIGURE 12

Figures 12 and 13 are optical photomicrographs that show typical appearance of surface scales on tubes that experienced different wastage response in the combustor. Figure 12 shows tubing sample 8-1 which experienced considerable wastage in just under 4,000 hours; whereas Figure 13 shows tubing sample 10-3-105 from another tube bank that had only minimal wastage after more than 13,000 hours. In Figure 12, different magnifications were used to preserve detail without excluding pertinent areas. The difference in scale thickness from one region to the other (thicker in non-wasted region) is apparent when magnification differences are taken into account. Also note that the oxide in either region has not preferentially attacked any particular microstructural region. Slight deformation is apparent in some locations (photo center) of the wasted region although it is difficult to discern in photographs.

It is of interest to note that the scale thickness of tube sample 10-3-105, shown in Figure 13, is thinner than that of the non-wasted region of Sample 8-1 (Figure 12) but heavier than that of the wasted region of the same sample. Also, despite the favorable combustor response of tube 10-3-105, there is evidence of deformation having occurred along the undersides. Deformation is evident in the upper photomicrograph of Figure 13 in the metal substrate just below the scale interface. The scale/substrate interface of this tube sample otherwise resembled that of non-wasted regions of the other three samples in that it was smoother and not as irregular and ragged as it was in wasted regions of those other samples that had been susceptible to wastage.

Cross Sections of Tubing Sample 8-1 Showing Appearance  
of Surface Scale in Wasted and Non-Wasted Regions  
(Optical Photomicrographs - Note different magnifications)

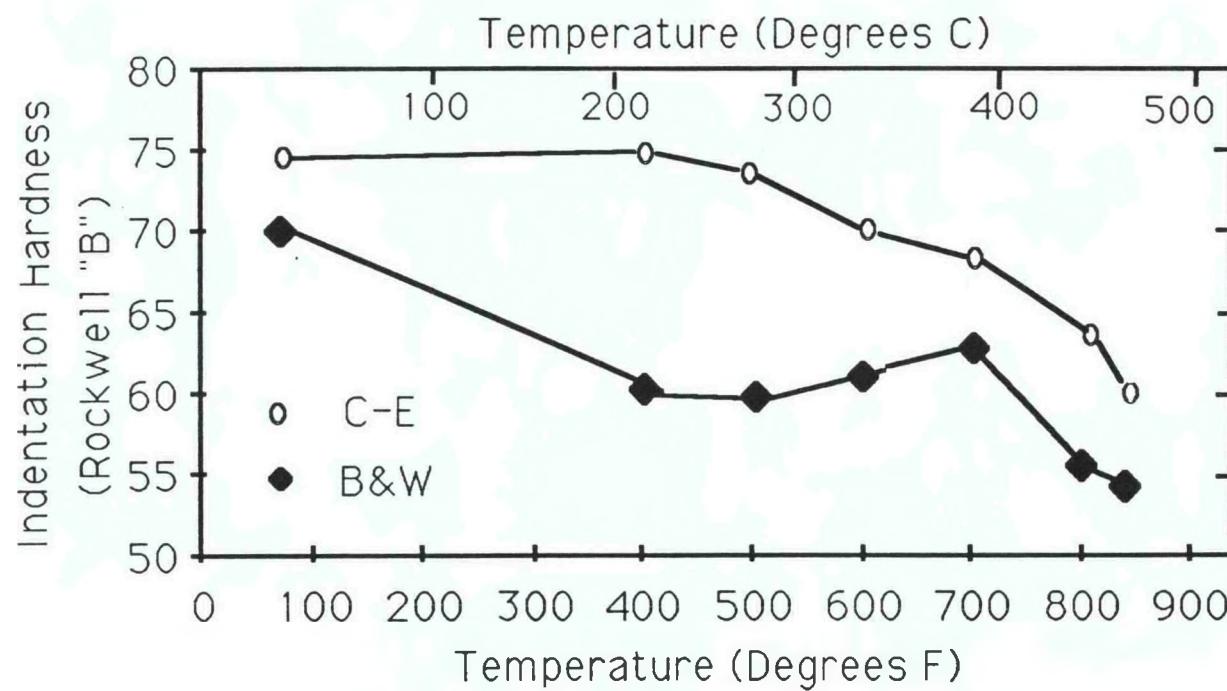
Figure 20  
INDENTATION HARDNESS OF  
EVAPORATOR TUBING STEELS

These tests also showed differences in the two steels. The average indentation hardness values obtained are plotted in Figure 20. As shown, the B&W tube steel is softer over the entire test range than the C-E steel. Although room temperature hardness of the two steels is similar, hardness of the B&W steel drops off with increasing temperature to 400-500 F while that of the C-E steel remains nearly constant over the same temperature range. Above about 400 F, hardness of the C-E steel drops gradually as that of the B&W steel remains unchanged (with a slight increase at 700 F, possibly due to strain-aging as a result of the higher levels of residual elements), but decreases thereafter. While the hardnesses of the two appear to converge at temperatures above about 900 F, and may do so, a difference between them persists throughout the entire range of tube operating temperature.
