Instrumentation Report No. 2: Identification, Evaluation, and Remedial Actions Related to Transducer Failures at the Spent-Fuel Test—Climax

Manuscript Date: November 30, 1981

LAWRENCE LIVERMORE LABORATORY

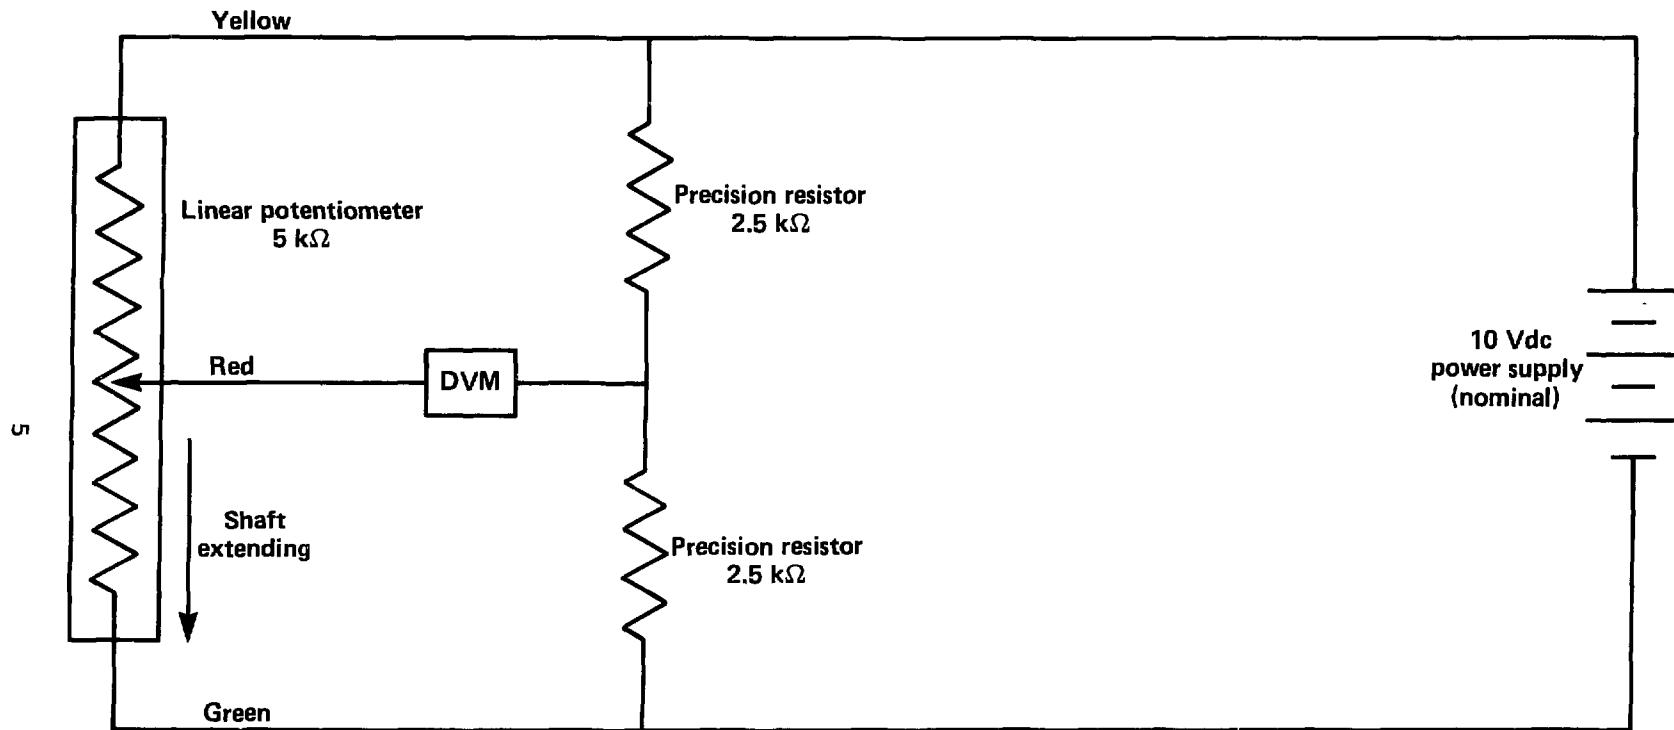
FIG. 2. Schematic of the transducer electrical circuit using linear potentiometer.

The rod extensometer transducer circuit is shown in Fig. 2. The potentiometers are Bourns Model 5184 (5 k Ω \pm 10%, 25-mm stroke units). These units feature infinite resolution by means of a resistive polymer element. In this configuration, the ratio of output voltage to excitation is linear with respect to the position of the potentiometer wiper. Output voltage is 0.0 at the wiper center position as a result of the precision Visnay 2.5 k Ω resistors in the circuit.

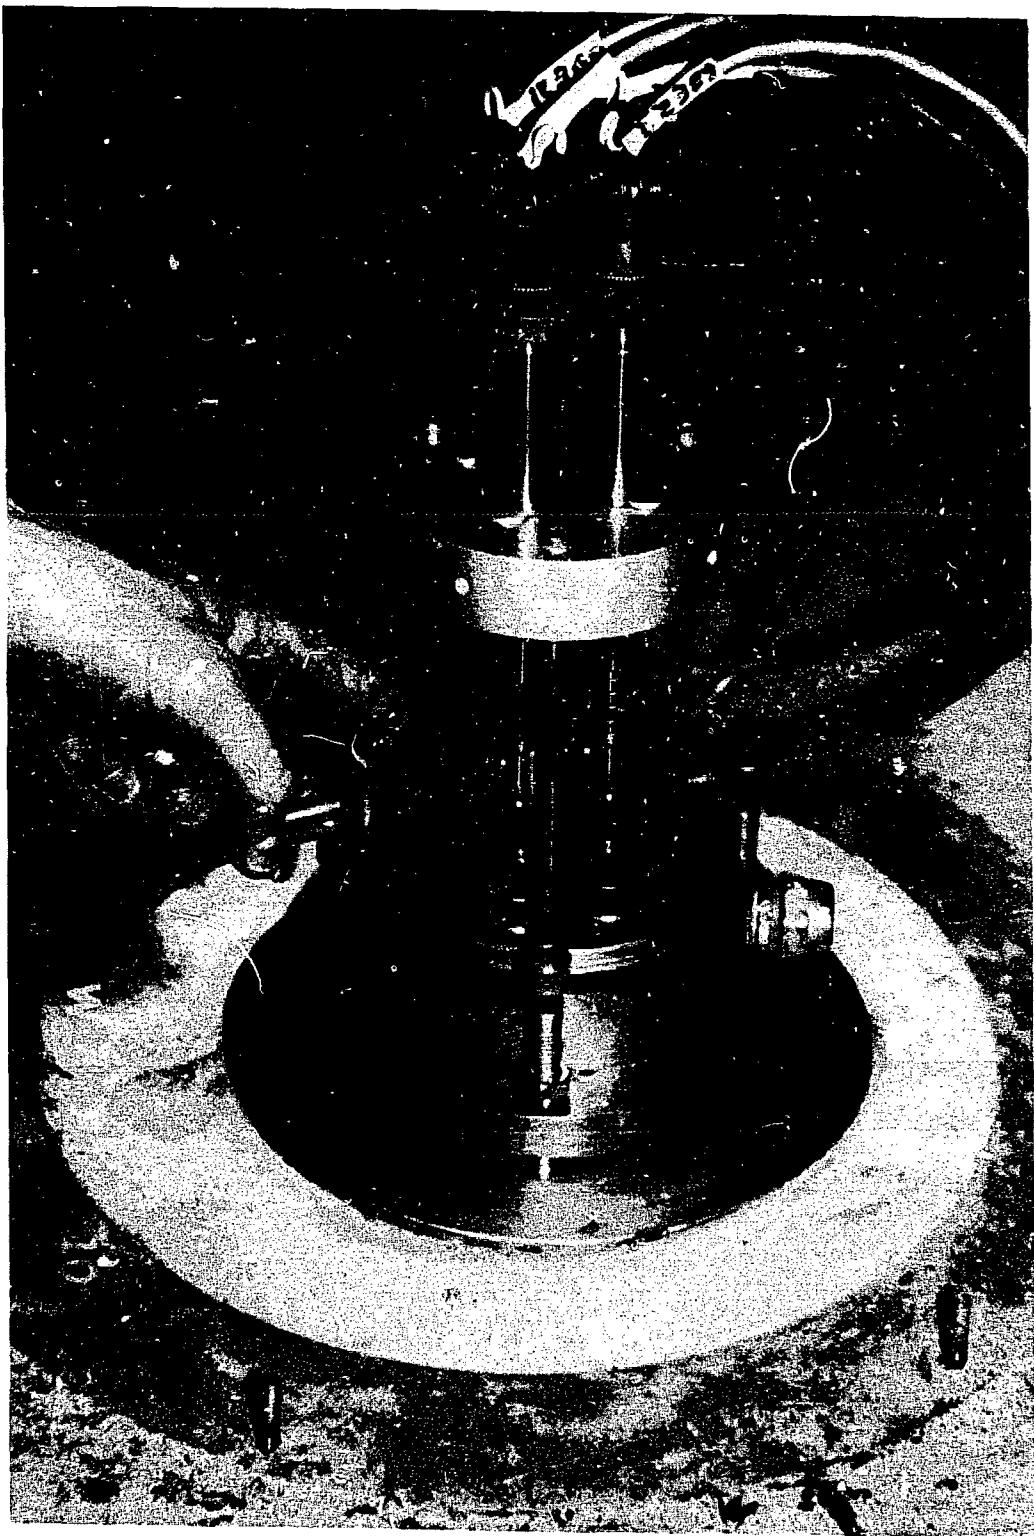
FIG. 7. GBE extensometer with Schaevitz LVDT's.

The Schaevitz DCDT possesses more favorable resolution, hysteresis, and linearity characteristics, has a broader operating temperature range, and requires no force to actuate the core (see Fig. 7). These advantages are achieved at the cost of range. Prior to actual field experience, we would

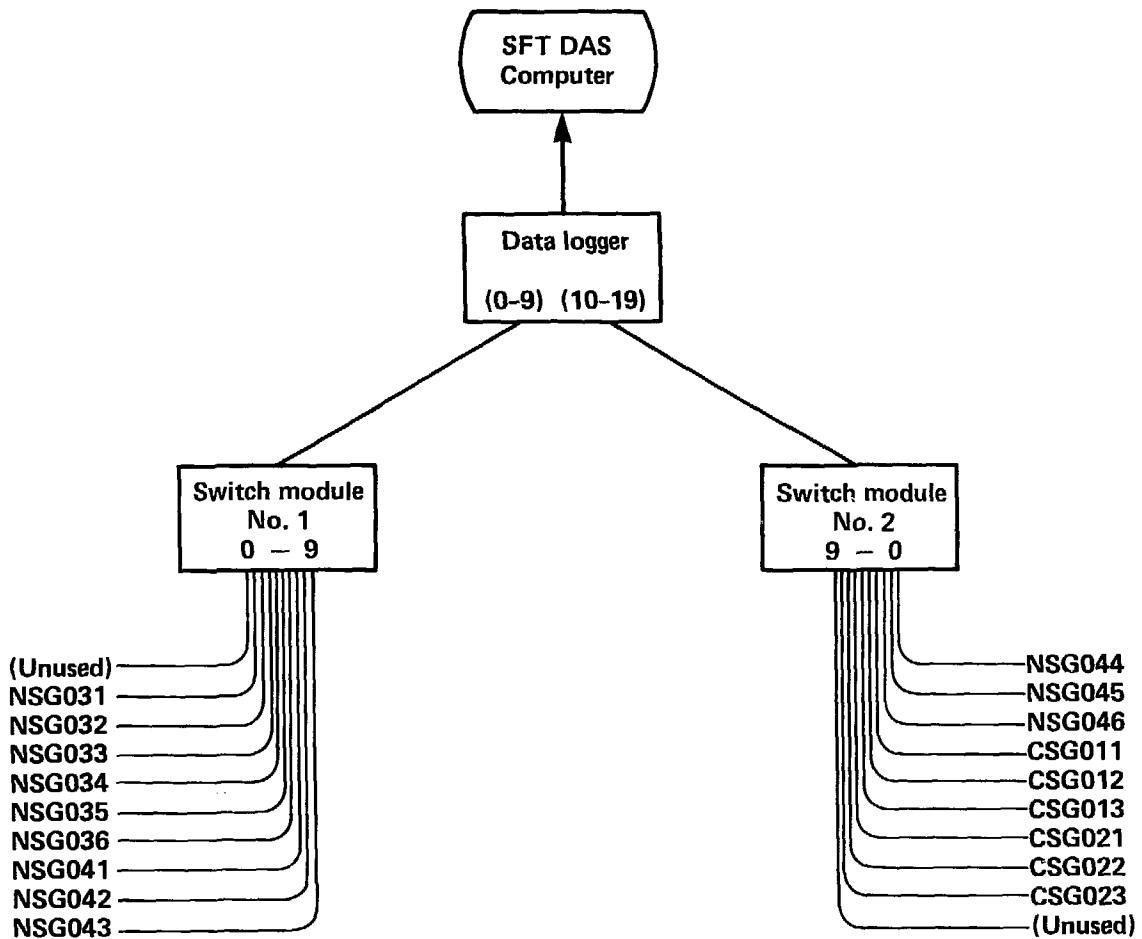
FIG. 9. SFT VWSM system as installed March 1980.

The complete system consists of the 18 gauges, 2 switch modules, and 1 data logging unit, connected as shown in Fig. 9. The gauge itself is quite simple and rugged as shown in exploded view in Fig. 10. This figure shows an early version of the gauge. More recent gauges have two epoxy plugs inserted from opposite ends of the gauge after the vibrating wire is in place. One plug contains the core magnet assembly and cable exit; the other plug is solid epoxy.

Once again, it is not completely clear when the stressmeters and data became unreliable. The stressmeters tend to exhibit very erratic behavior just before final failure. On the other hand, gauges which ultimately failed showed a period of increasingly high readings before erratic behavior began (see Fig. 9). This suggests that corrosion can cause sufficient mass loading or weakening of the wire to markedly change its frequency without making the gauge erratic or unreadable. Periodic reading of the Q of the wire, using the MB-6 readout unit and oscilloscope, should resolve whether or not either mass loading or weakening of the wire is occurring as a precursor to failure. Since this was not done on the original stressmeters, we must conclude that all data from failed stressmeters are erroneous.
