HEDL-TME 79-23  
UC 79, b, h

RESULTS FROM THE  
RUN-BEYOND-CLADDING-BREACH IRRADIATION  
OF A PREDEFECTED FUEL PIN (RBCB-6)

**D. C. Langstaff  
M. Y. Almassy  
D. F. Washburn**

**August 1979**

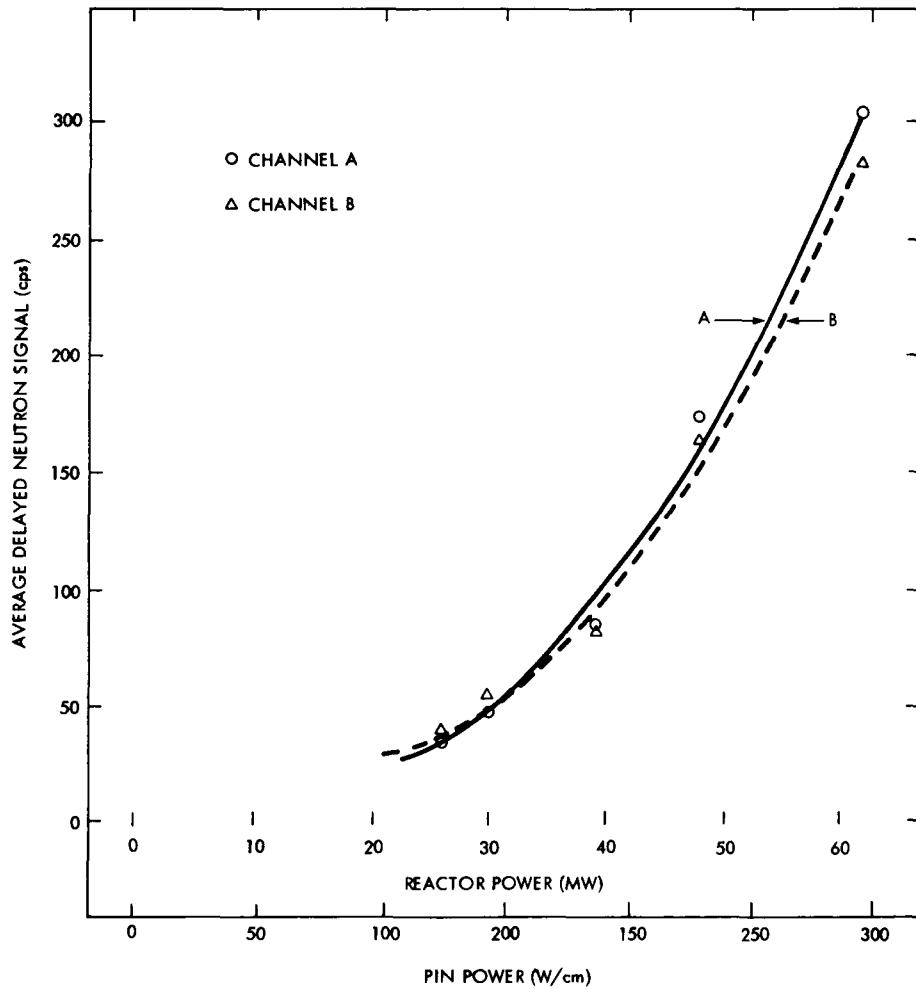
FIGURE 6. DN Signal from Test RBCB-6 (increased linearly with reactor or fuel pin power).

The change in the average DN signal during the rise to power is shown in Figure 6. The rapid increase in the DN signal beyond 30 MW power was not expected, and as a result there were several "holds" at intermediate power levels to insure that the DN signal increase was due to power increase rather than to increased exposed fuel area. Each of these holds was several minutes long; therefore, the results shown in Figure 6 were obtained by averaging the signal over a 12-minute period. (DN signal data were recorded at the rate of 2 points per second.)

During the holds at constant power the DN signal remained fairly constant suggesting that the rapid increase in DN signal was related to the power change and a nonrecoil source rather than to a rapidly increasing defect area. After reaching full power (62.5 MW), the alarm settings of the FERD system were set at  $\sim$ 120 cps above the peak DN signal. Alarm settings on the three FERD channels were: Channel A - 550 cps; Channel B - 530 cps; and Channel C - 520 cps. Normal background for these channels was about 50 cps. These alarm settings were all based on peak values.

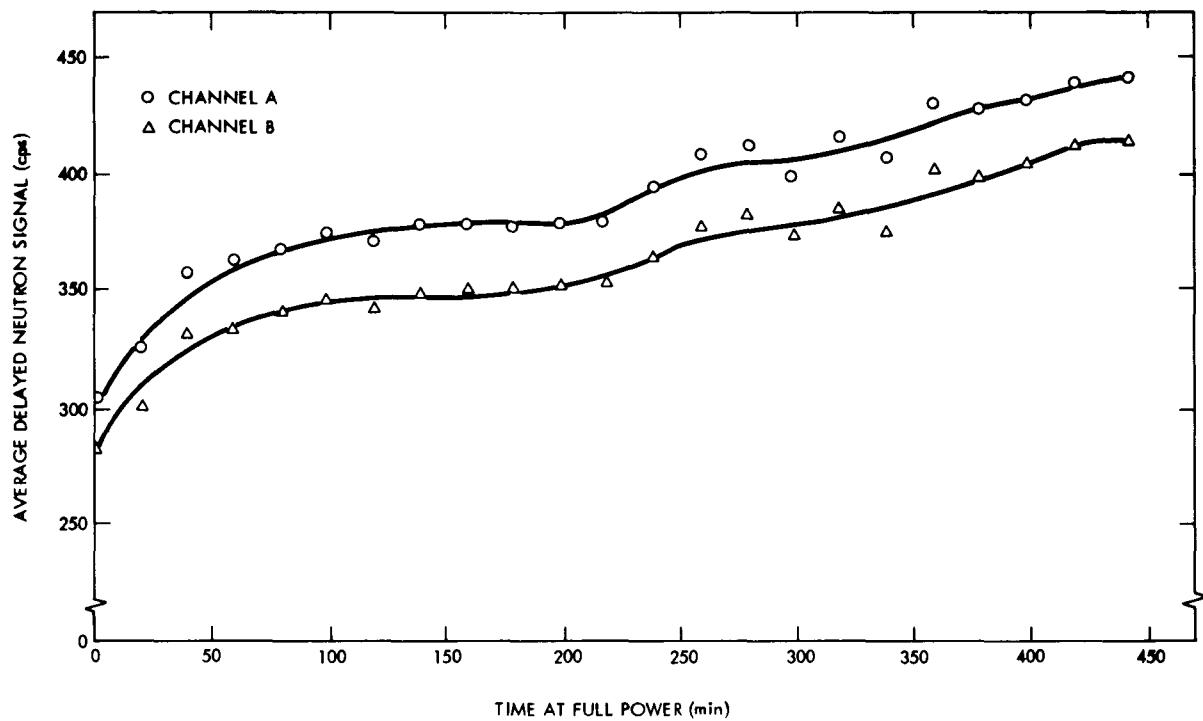
FIGURE 7. Average DN Signal (increased continuously until administrative shutdown limit was reached).

During operation at full power (62.5 MW) the DN signal continued to increase gradually as shown in Figure 7. The curves in Figure 7 were obtained by averaging DN data, recorded at a rate of 2 points per second, over 5-minute intervals. (Only Channels A and B are shown since Channel C closely followed Channel B.) The alarm settings on FERD were reached on Channels B and C 7.5 hours after reaching full power and a manual scram was initiated.

The gradual increase in DN signal at full power is attributed to the growth of cladding cracks at both ends of the slit. The driving force of these slit extensions is the sodium-fuel reaction. With longer irradiation time, the slit would continue to extend in the downward direction. The extension in the upward direction would stop at the top of the fuel column since the upper UO<sub>2</sub> insulator did not react with sodium.

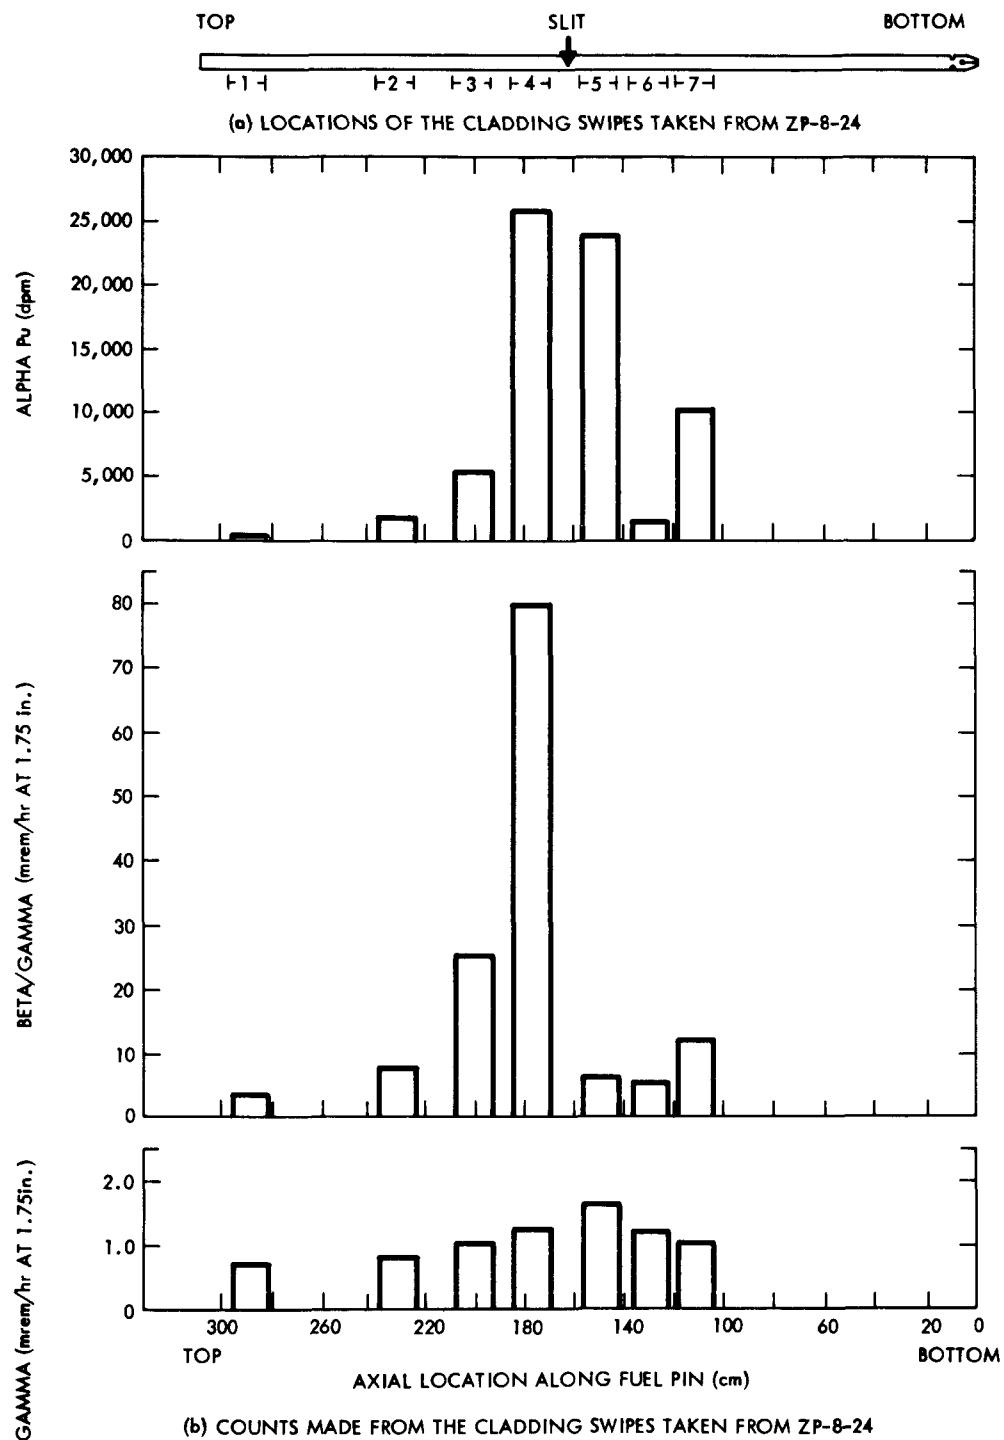
FIGURE 9. HFFE In-Cell Smear Survey Data Taken from ZP-8-24 After RBCB Irradiation.

After pin ZP-8-24 was removed from the subassembly, smears were taken from about 3-in. lengths of the cladding at seven axial locations. The locations and results from these smears are shown in Figure 9. Absolute levels for alpha (fuel), beta-gamma, and gamma (fission product) contamination have little significance in themselves since the areas of the smears were not closely controlled.

Fuel and fission product contamination levels were highest adjacent to the breach and decreased rapidly with distance from the breach. The exceptions to this behavior were the two higher readings from the seventh smear for alpha and beta-gamma contamination. Conceivably this could be due to transport of fuel and/or fission products down the pin in a sodium droplet after the pin was removed from the reactor.

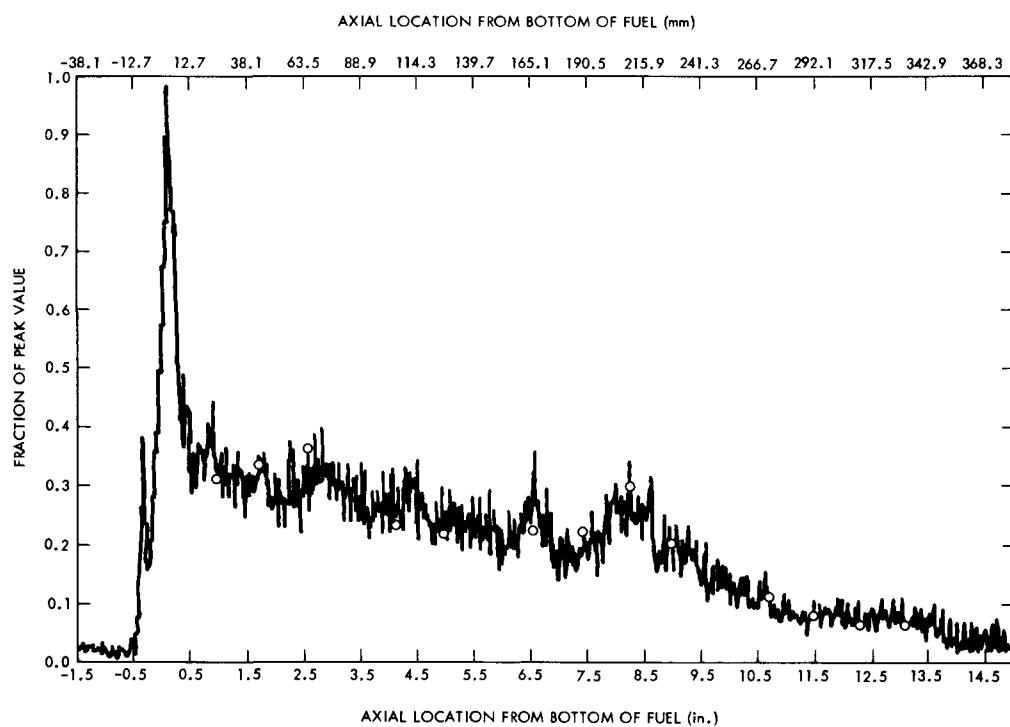
FIGURE 11. Cesium Gamma Scan for Pin ZP-8-24 After RBCB Irradiation (HEDL data).

Enlarged plots of HFEF data from fuel pin gross gamma activity showed little or no difference between pre- and post-RBCB irradiation. Two post-RBCB gross gamma scans, which were taken at HFEF, showed no decrease in gamma activity near the top of the fuel column, indicating that there was no significant loss of fuel during RBCB irradiation. However, isotopic gamma scan data showed that a gradual depletion of  $^{137}\text{Cs}$  over the top two-thirds of the fuel column took place during RBCB irradiation (see Figure 11).

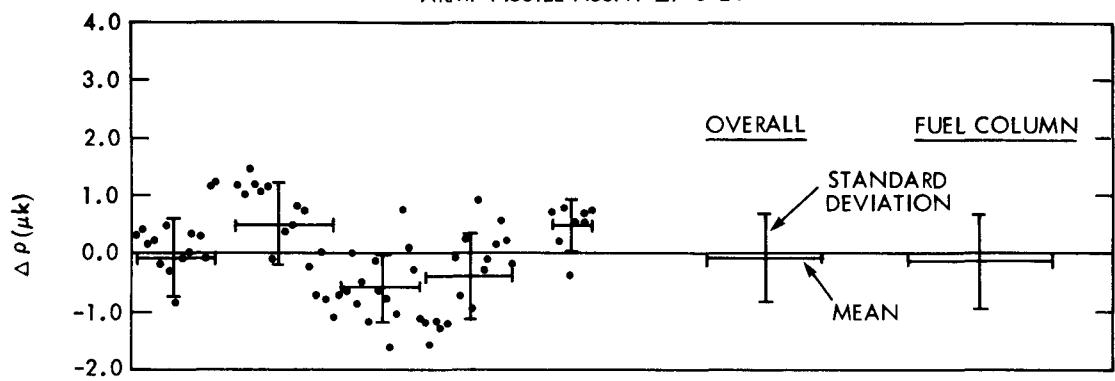
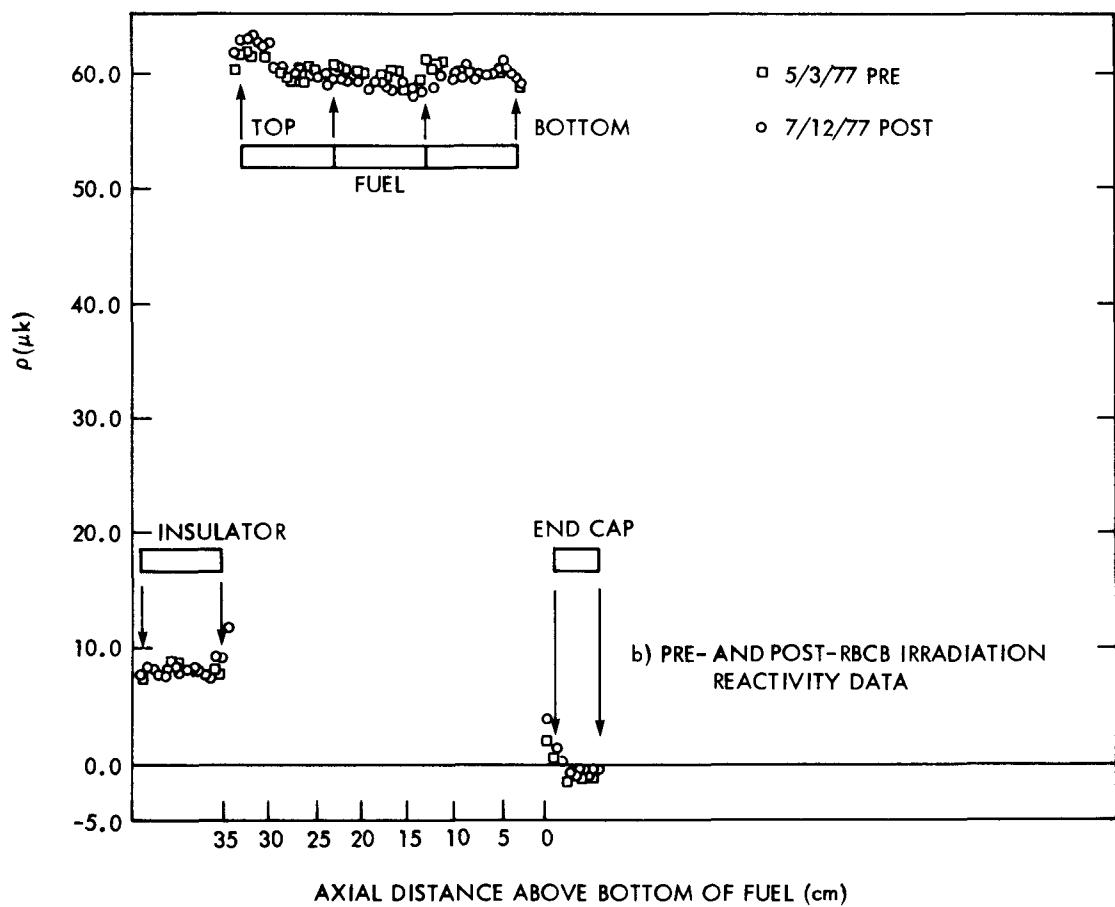
FIGURE 12. Fissile Assay Reactivity Data for Test RBCB-6 (ZP-8-24).

Reactivity profiles determined for the predefected irradiated fuel pin (ZP-8-24) after defecting and again after subsequent irradiation are shown in Figure 12. The scatter in the data made it difficult to discern the effect of RBCB irradiation; therefore, a statistical analysis was performed to determine whether the pre- and postirradiation profiles were statistically the same. Using the student's "t" test, the hypothesis that the pre- and postirradiation means were the same could not be rejected. This implied that there was no net change in fuel content over the length of the fuel column during RBCB irradiation.

Evaluation of these and other data from irradiated fuel pins suggests that fuel column end effects, fuel composition, burnup, and presence of fission products may affect reactivity measurements. If so, these factors may limit the sensitivity of the technique. Analysis of reactivity data from several fuel pins is being conducted by EG&G Idaho, Inc., to resolve the effect of other variables on the measured reactivity.

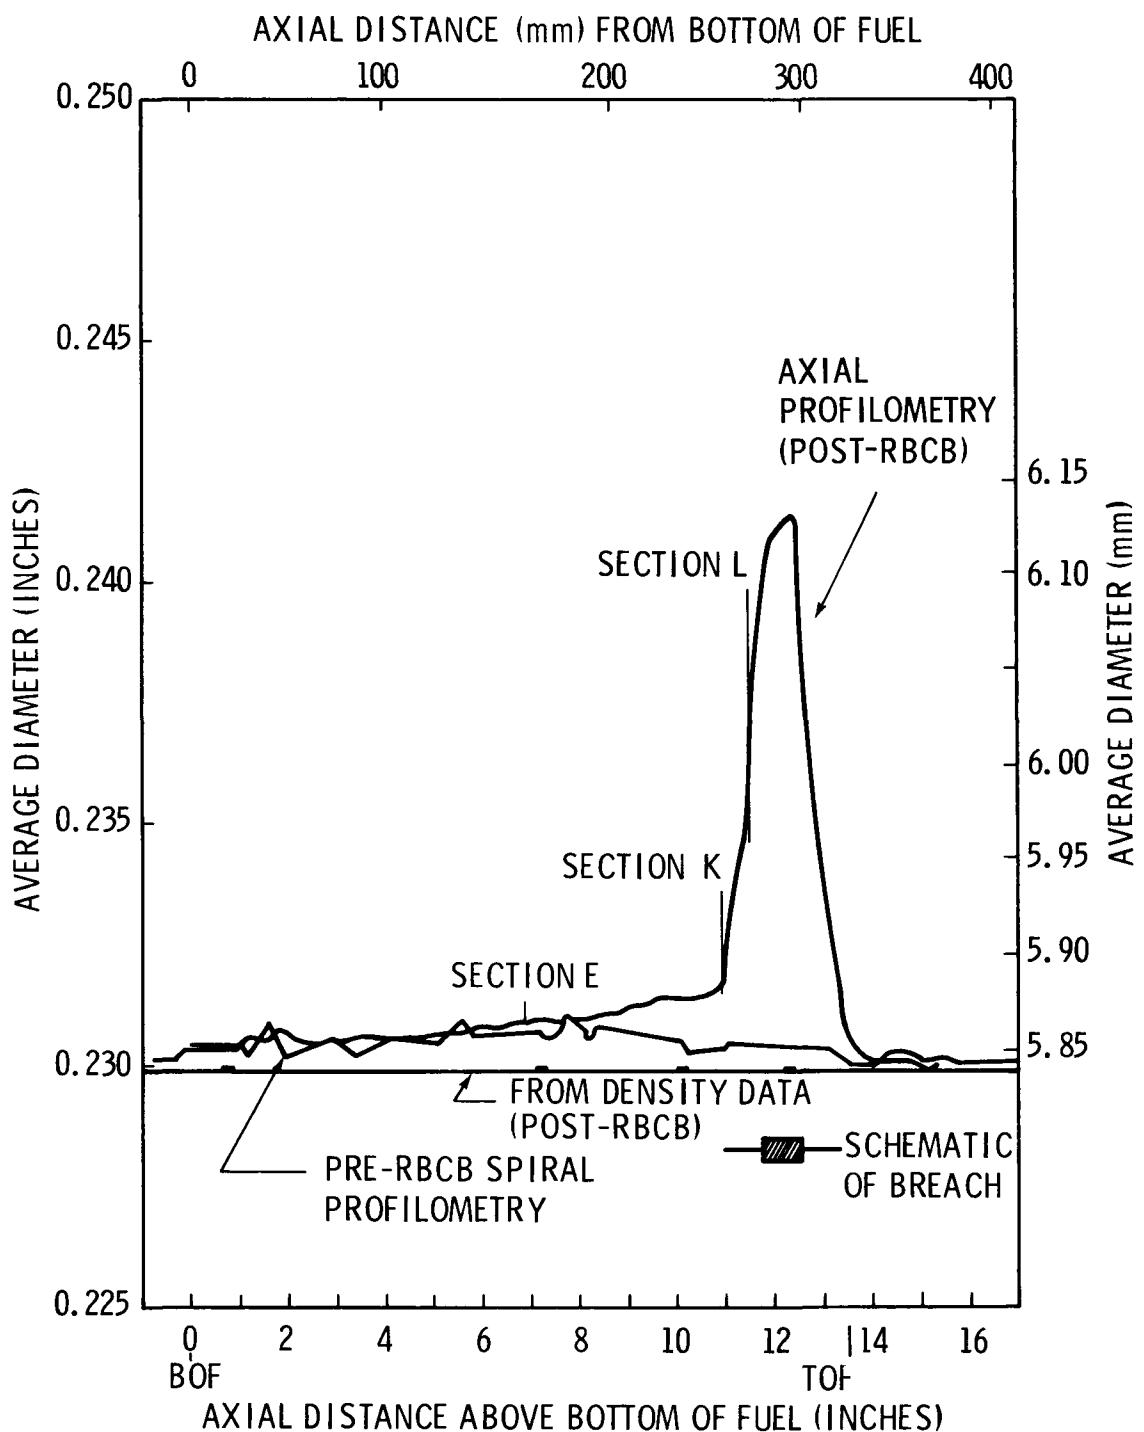
FIGURE 13. Diameter of RBCB-6 Fuel Pin Before and After RBCB Irradiation.  
Neg 7908107-1

Pre- and post-RBCB irradiation diameters for pin ZP-8-24 are shown in Figure 13. The localized diameter increase of 4.9% was near the center of the as-machined slit and was due to RBCB irradiation. The pre-RBCB diameter prior to machining the slit was about 5.85 mm or 0.2% greater than the as-fabricated diameter, and the neutron-induced cladding swelling (as determined from density measurements) was less than 0.01% ( $\Delta V/3V \times 100$ ). Machining the slit in the cladding may have allowed relaxation to occur, which would affect the final pin diameter. No attempt was made to measure the pin diameter after the slit was machined, but the effects of relaxation on pin diameter are expected to be negligible. The net increase in pin diameter during RBCB irradiation was attributed to the effects of the sodium-fuel reaction.

The diameter change at the ends of the slit extension provided an indication of the strain required to cause crack extension. An estimate of the cladding strain for crack extension from this fuel pin is 0.7%.

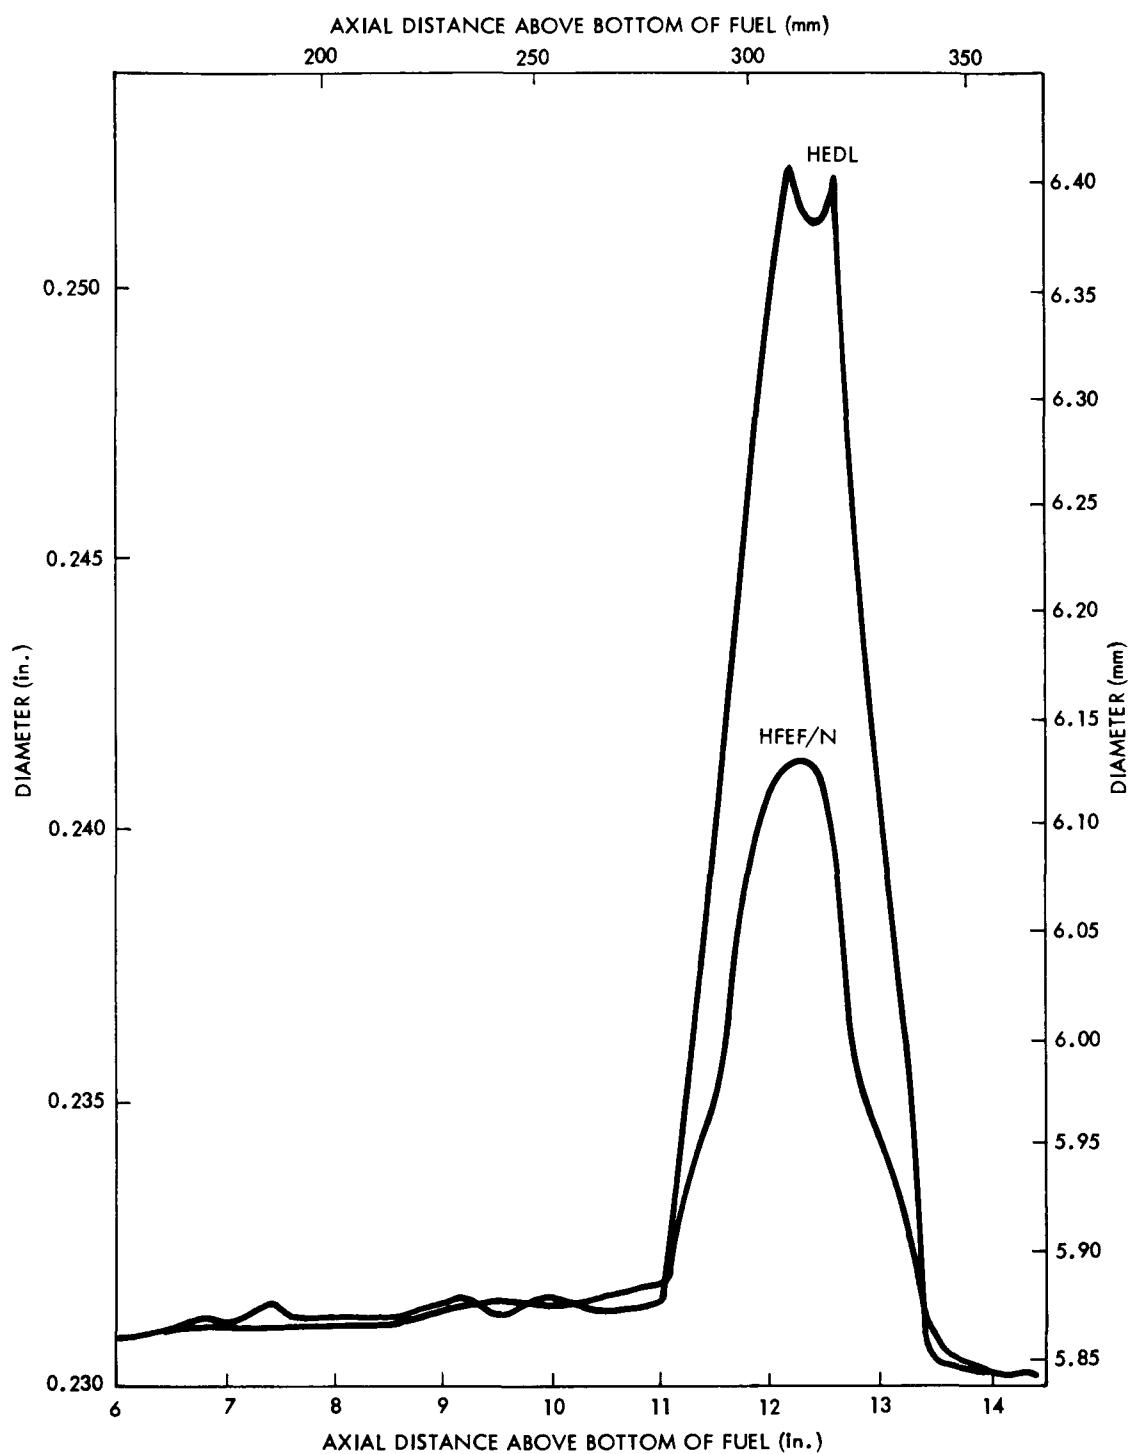
FIGURE 17. Profilometry of RBCB-6 Fuel Pin Showing the Diameter Changes That Occurred During Shipment from HFFEF to HEDL.

Prior to sectioning the pin for destructive examination, diameter measurements were made at selected axial heights in the vicinity of the cladding defect. The results of these measurements are shown in Figure 17. Agreement between axial profilometry measurements (HFEF) and diameter measurements (HEDL) away from the defect is excellent and serves to confirm that the large diameter change in the slit region occurred during shipment. This diameter change was attributed to reaction between the environment and sodium-fuel reaction product or residual, unreacted sodium.

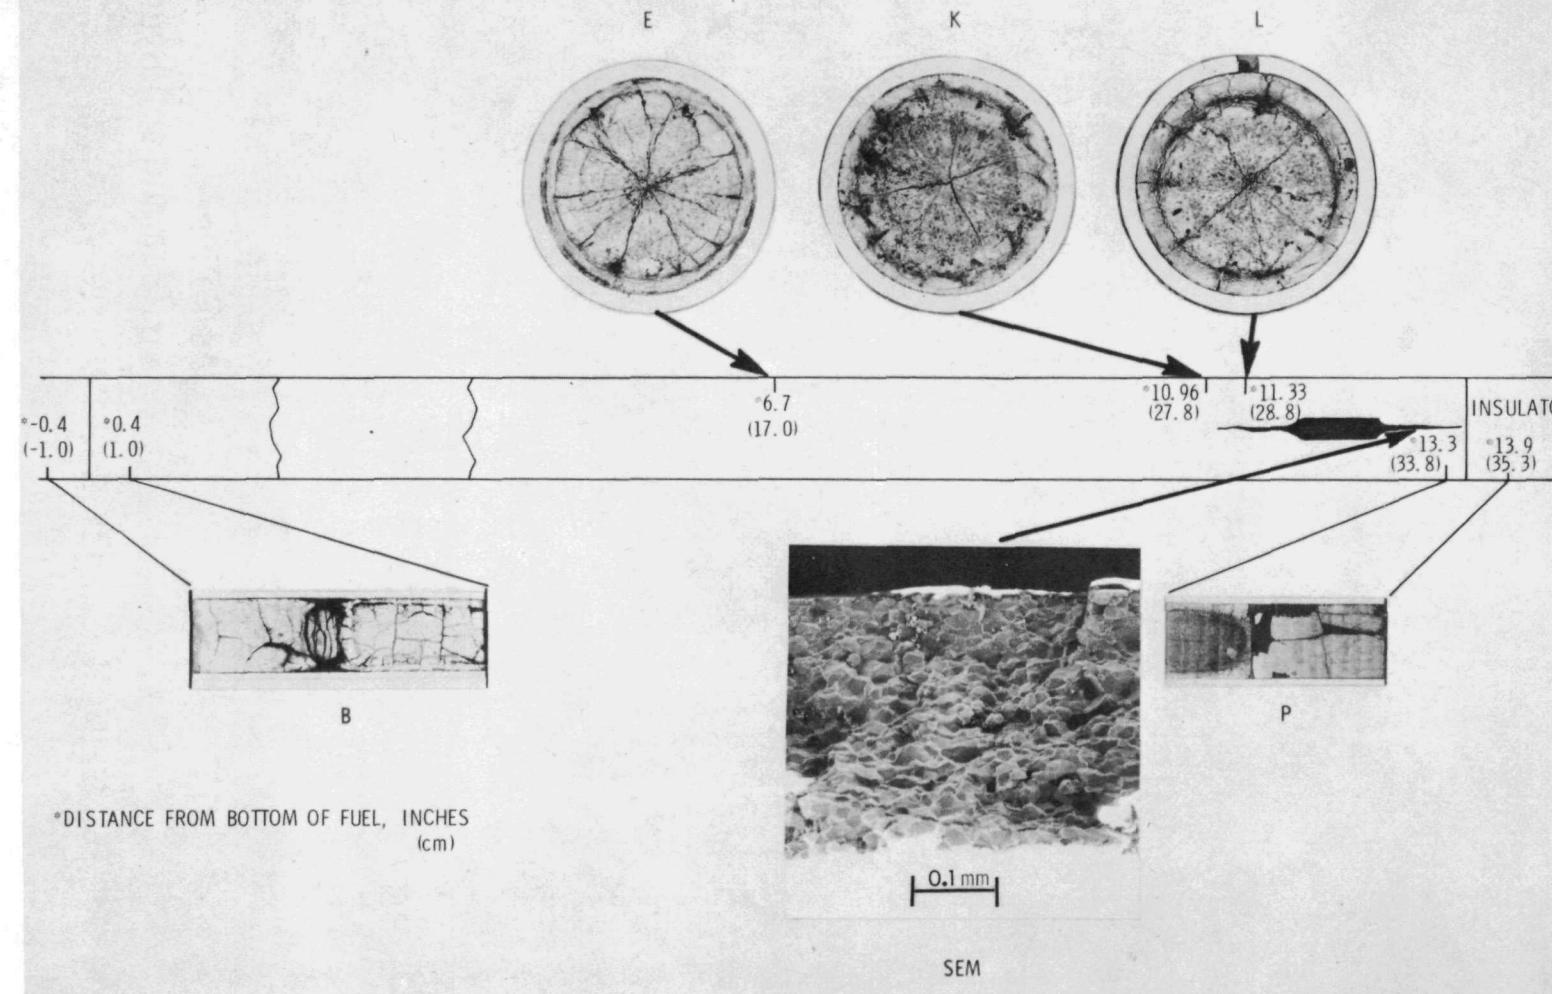
FIGURE 18. Summary of the Photomicrography from Pin ZP-8-24.

Pin ZP-8-24 was sectioned to provide five ceramography samples, five cladding density samples, and the fracture surface of the upper slit extension. The five cermographic sections were obtained from positions along the entire fuel column, including the top and bottom  $UO_2$  insulators as shown in Figure 18. Because of the reaction that occurred during pin shipment, fuel microstructure in the middle of the machined slit no longer represented the in-reactor pin condition; therefore, this region was not examined in detail.

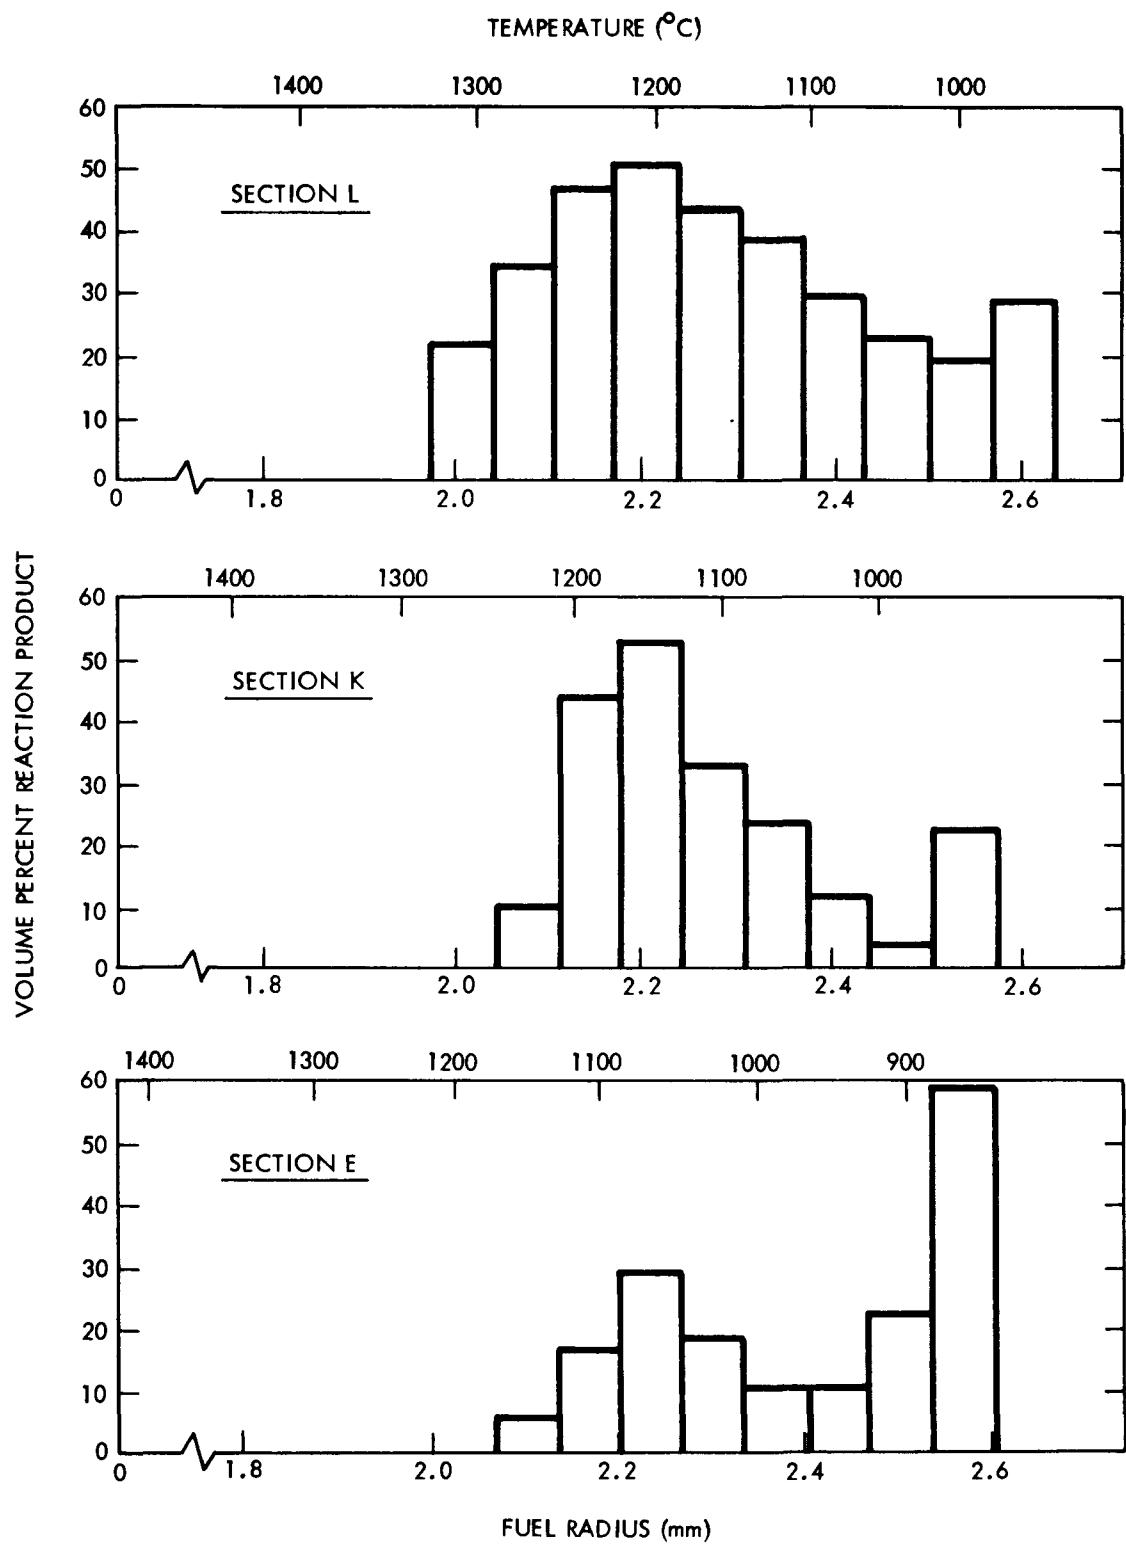
FIGURE 26. Radial Profile of Sodium-Fuel Reaction Product in RBCB-6 Fuel Pin ZP-8-24.

Radial distributions of reaction product for the three transverse sections are shown in Figure 26. These distributions were obtained by averaging the sector values for each of the 0.2-in. wide annuluses. Figure 26 also shows the calculated fuel temperatures for each of the sections. These temperatures were calculated without adjusting the fuel or gap thermal conductivity for the presence of sodium-fuel reaction product.

The results shown in Figure 26 indicate a decrease in reaction product volume as the distance from the slit increases. Presumably this reflects the decreasing availability of sodium to continue the reaction. In each of the cross sections there is a well-defined boundary separating the region with sodium-fuel reaction from the region without reaction. In Section L (the section through the slit extension) the calculated temperature at the boundary is about 1325°C. In Section K the temperature at the boundary is about 1225°C, and in Section E it is about 1150°C. The different temperatures associated with reaction termination may result from not accounting for sodium-fuel reaction product in the temperature calculations or from the accessibility of sodium. Hopefully, additional RBCB tests will aid in defining temperature limits for the sodium-fuel reaction.
