QUARTERLY REPORT
SOLAR PHOTOVOLTAIC PROJECT,
MATERIALS, PROCESSES, AND TESTING ACTIVITIES,
FOR THE PERIOD
1 JANUARY TO 31 MARCH 1979

S.E. Forman
M.P. Themelis

COO-4094-55
30 June 1979

Massachusetts Institute of Technology
Lincoln Laboratory
Lexington, Massachusetts 02173

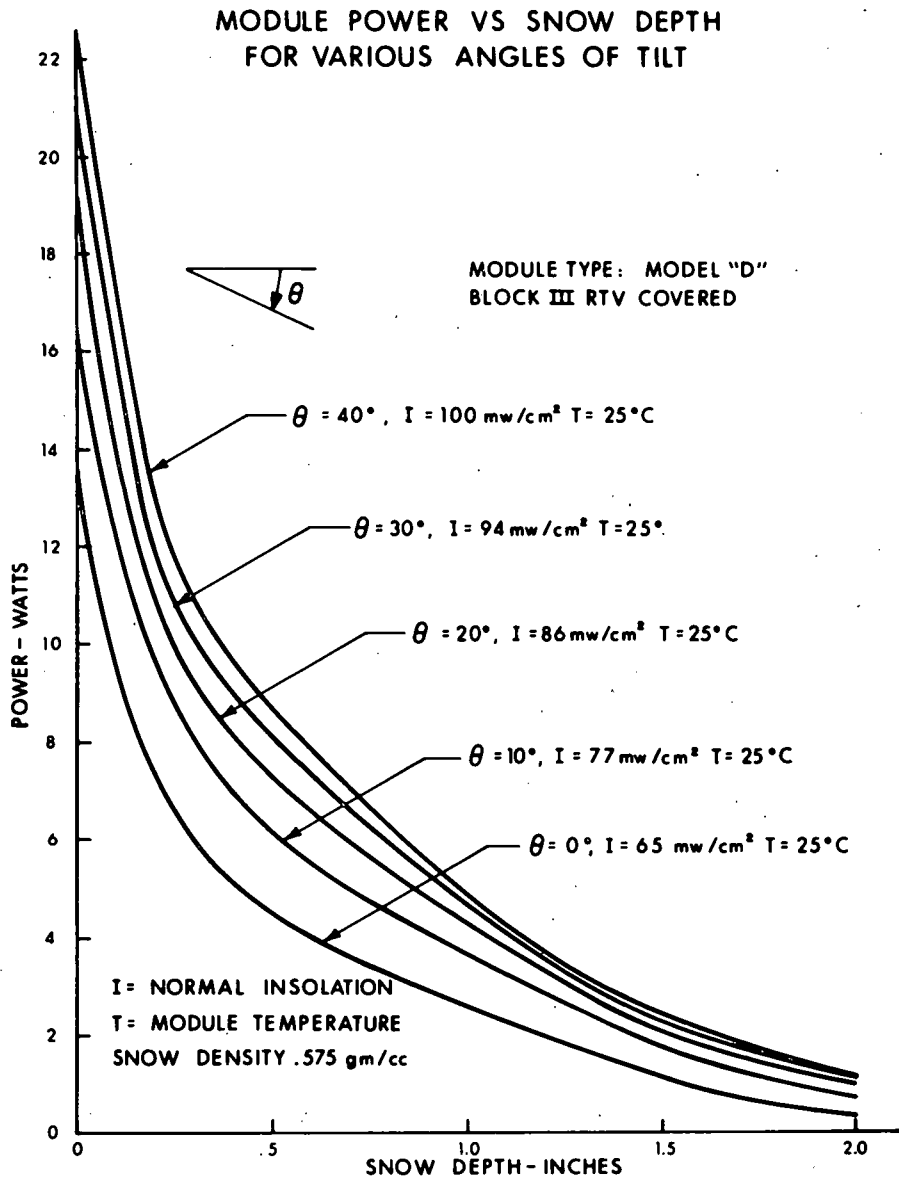
From outward appearances, the glass cover of the Model E module appears to provide better optical coupling for the snow than RTV and, as a result, less power is lost. It may be, however, that the Model E cells are more responsive to the wavelengths which penetrate the snow than are Model D cells. For Model D, the percentage of power lost due to tilt varied very little; for Model E there seemed to be wider variations.

Fig. 2. Module power vs. snow depth - Model D.

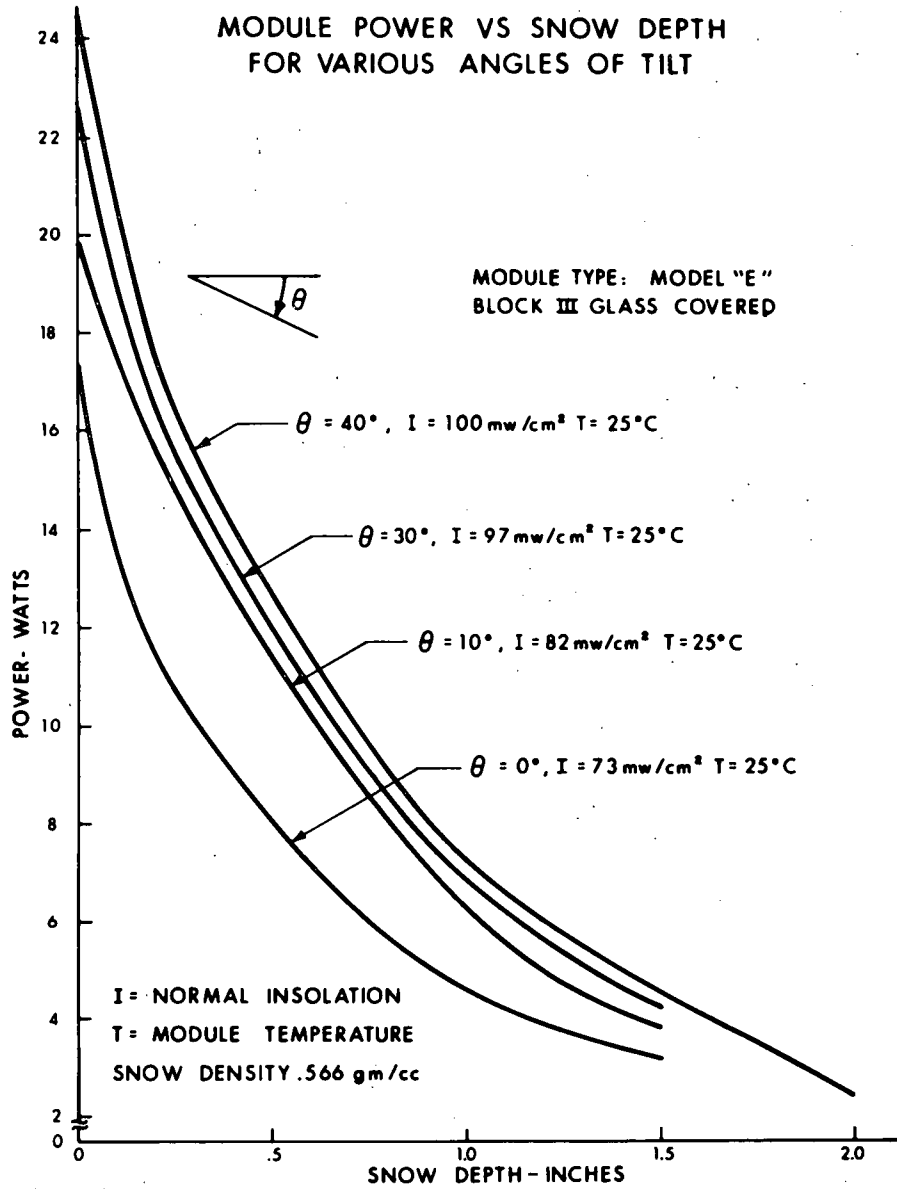
Fig. 3. Module power vs. snow depth — Model E.

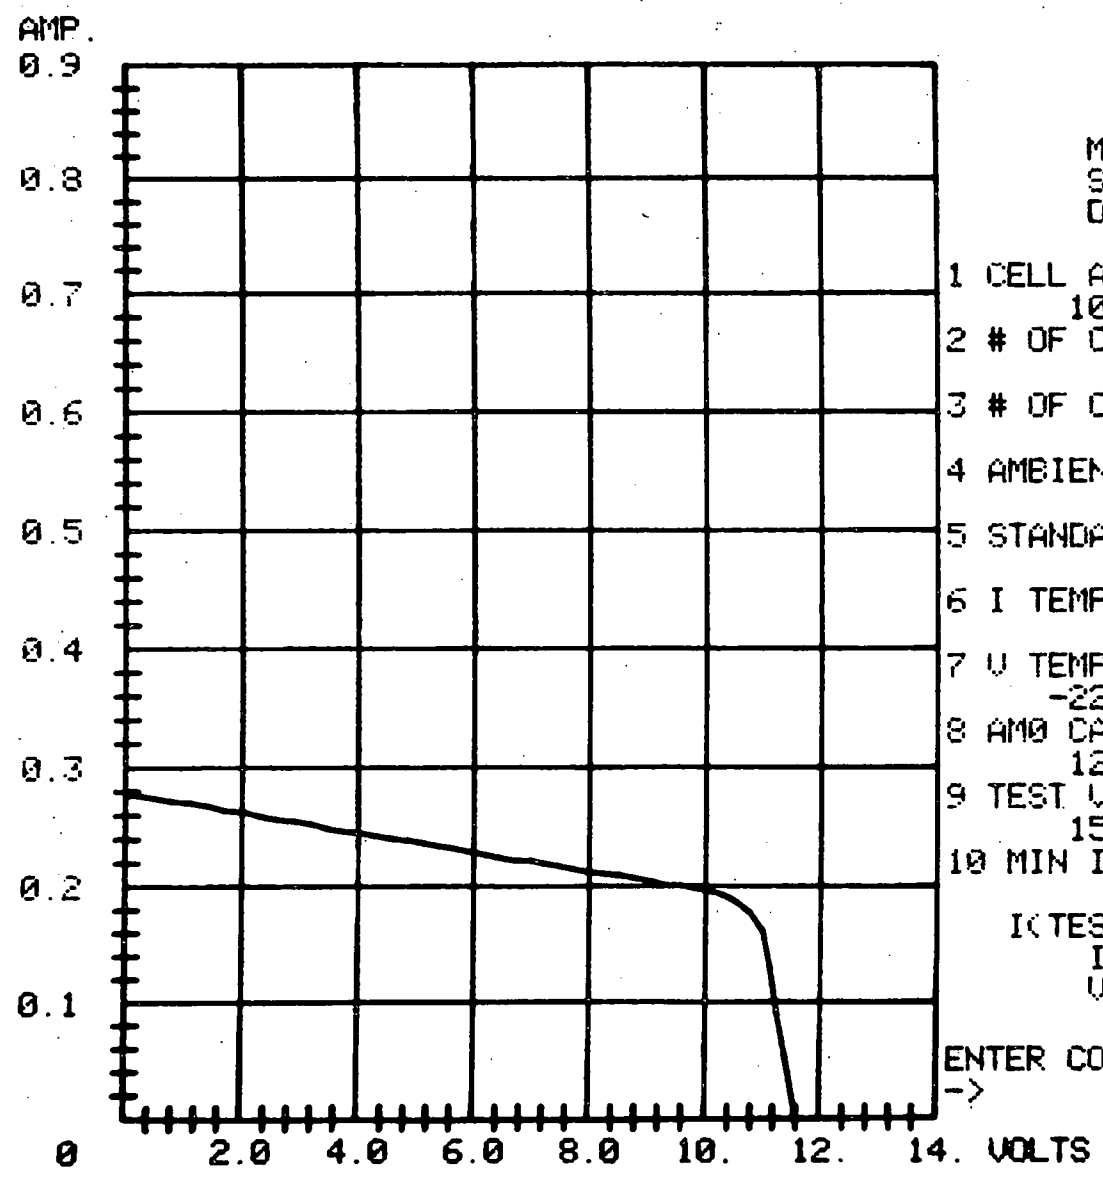
Two of the Model B modules were found to be operating at reduced short-circuit current. When flashed in the Lincoln Laboratory Large Area Pulsed Solar Simulator (LAPSS), the short-circuit current was reduced by 52% and 46%, respectively, of the normal values, as shown in Figures 6 and 7.

Figure 6. Model B - 52% reduction of ISC.

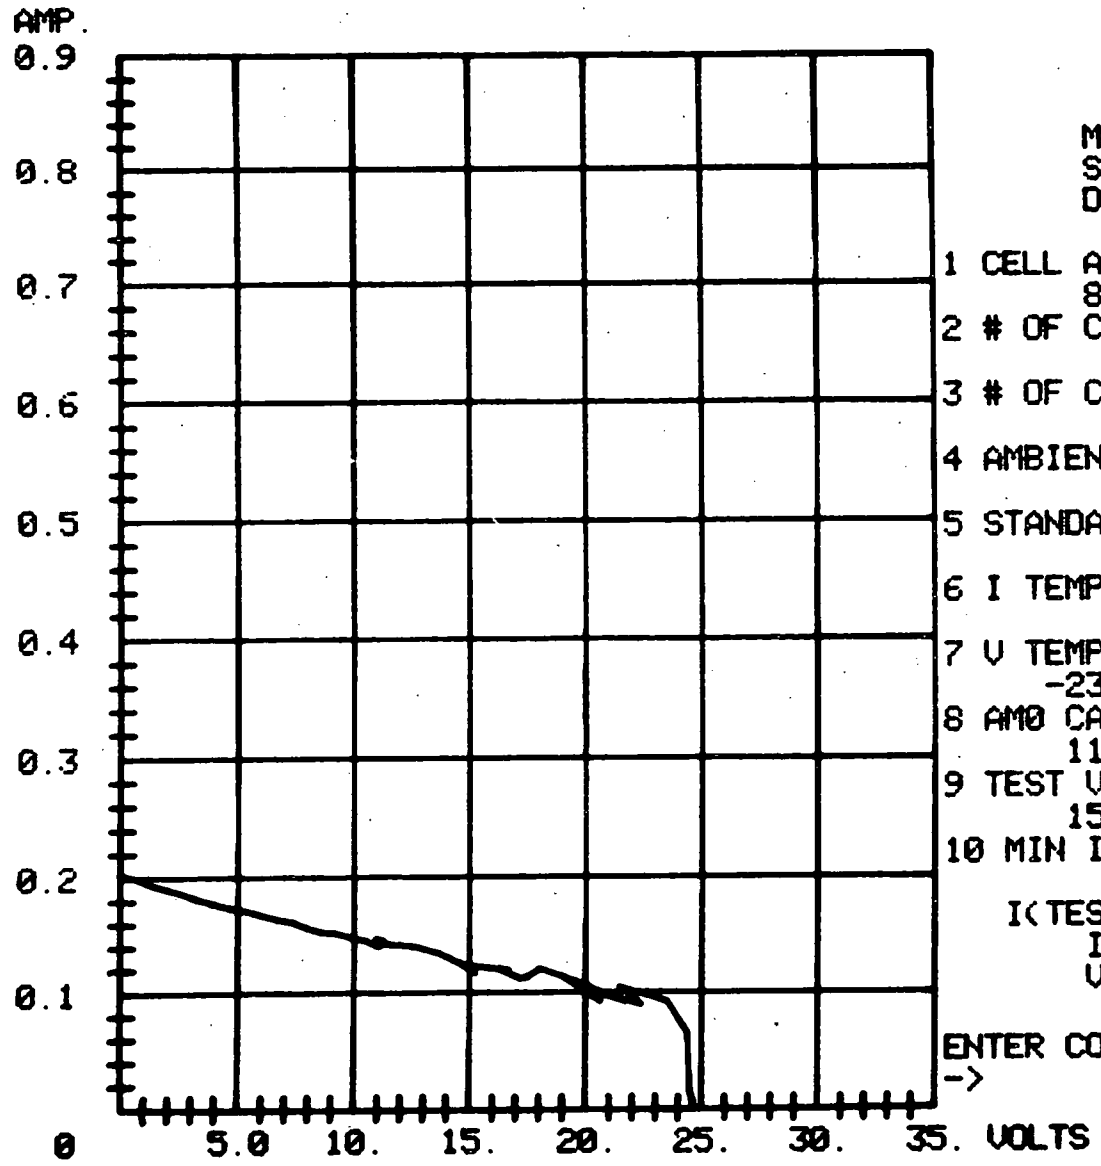
Both modules were found to have reduced short-circuit current at the Mead test site on 28 March 1979. Flashing in the LAPSS showed both modules to have dropped to 1/3 of their normal values, as shown in Figures 8 and 9.

Figure 8. Model A - ISC reduced to 1/3 the normal value (1).
