**Effects of Alternate Fuels Report No. 7:
Analysis of Failure of a Mullite-Based
Refractory Brick in an Industrial
Oil-Fired Burner**

EFFECTS OF ALTERNATE FUELS REPORT NO. 7: ANALYSIS OF FAILURE OF A
MULLITE-BASED REFRACTORY BRICK IN AN INDUSTRIAL OIL-FIRED BURNER

Date Published: July 1979

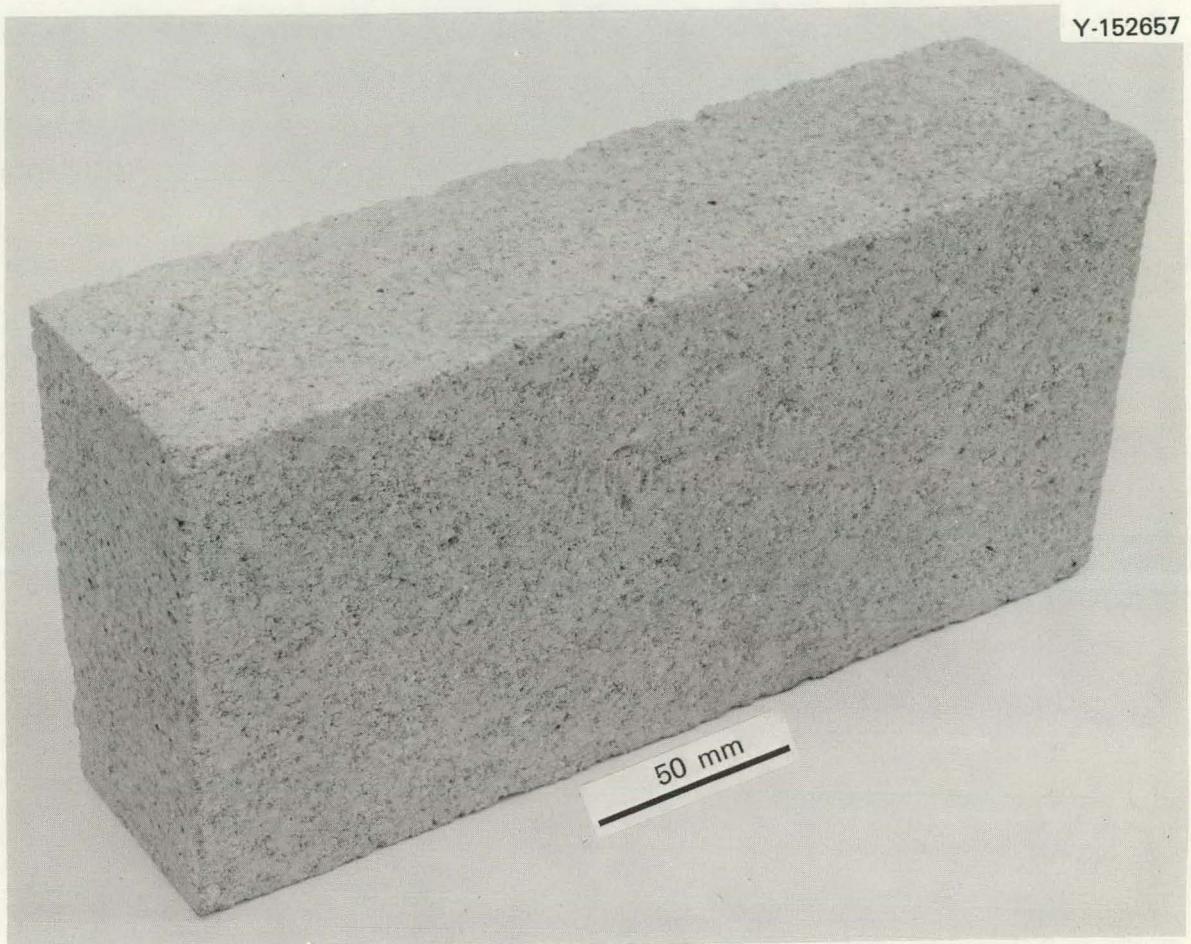
Fig. 2. Original Brick Used in Construction of the Oil Burner.

An example of the original brick is shown in Fig. 2, and pieces of the degraded brick are shown in Fig. 3. Specimens were cut or broken from pieces shown in Fig. 3 to provide samples for chemical analysis, ceramography, scanning electron microscopy, electron microprobe, and x-ray diffraction.
