## A Fractographic Study Of A Thick Wall Pressure Vessel Failure

D. A. Canonico, R. S. Crouse and T. J. Henson

The vessel described in this paper is identified as Intermediate Test Vessel 1 (ITV-1) and was fabricated of SA508, Class 2 Steel. It was tested to failure at 54°C (130°F). The gross failure appeared to be a brittle fracture although accompanied by a measured strain of 0.9%. Seven regions of the fracture were examined in detail and the observed surfaces were compared to Charpy V-notch ( $C_V$ ) specimens of SA508, Class 2 steel broken at temperatures above and below the ductile to brittle transition temperature. Three samples from the vessel were taken in the region around the fatigue notch and four from areas well removed from the notch. All these were carefully examined both optically and by scanning electron microscopy (SEM).

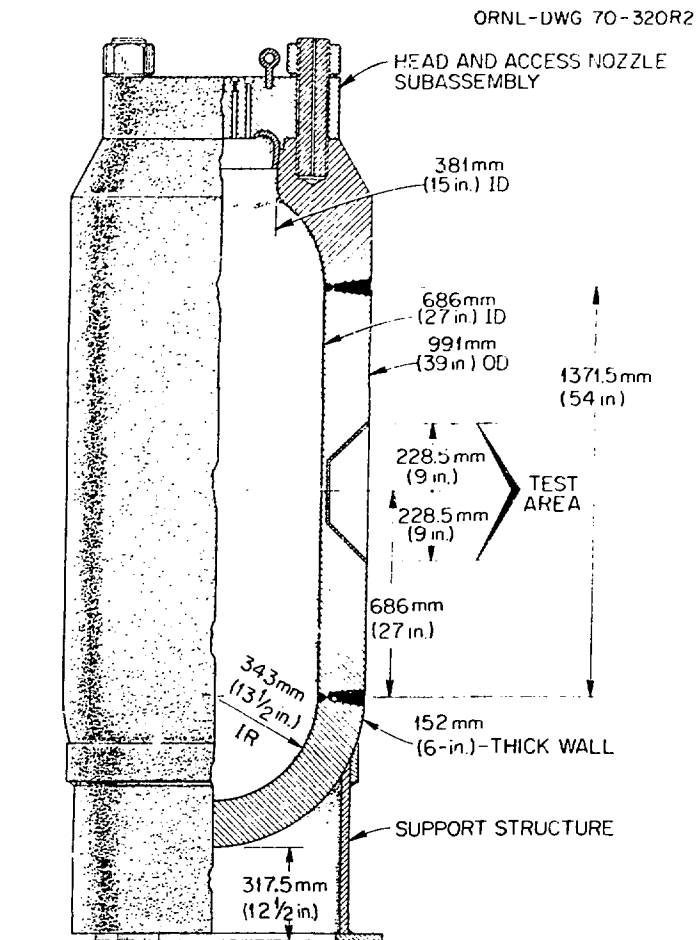
FIG. 1. A TYPICAL INTERMEDIATE TEST VESSEL (ITV). FROM TEST TO TEST THE FLAW LOCATION AND CONFIGURATION VARIED.  
(1 INCH = 0.0254 m)

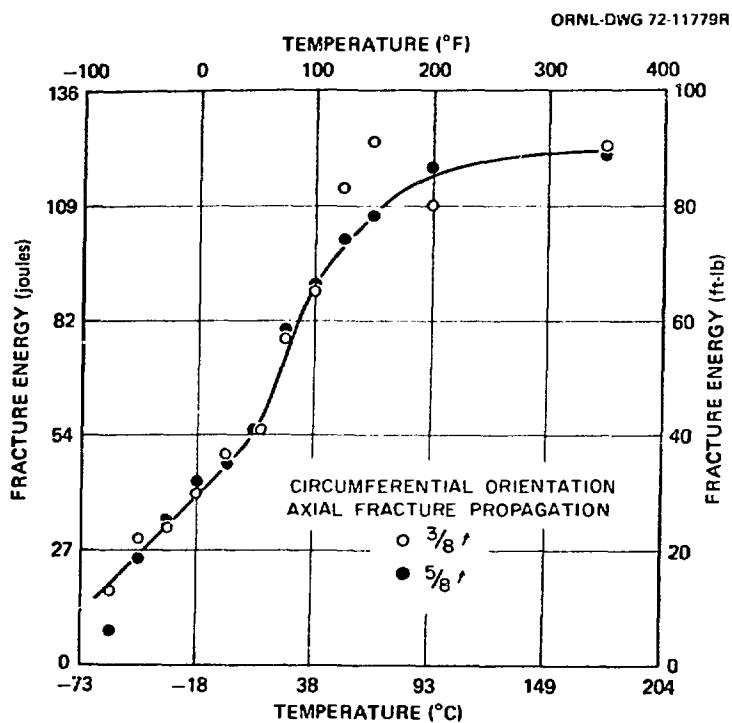
This well-documented test allowed the complete evaluation of the vessel failure. The test temperature,  $54^\circ\text{C}$ , is  $56^\circ\text{C}$  above the drop weight nil ductility temperature (NDT) for the SA 508 Class 2 heat of steel from which ITV-1 was fabricated. Moreover,  $54^\circ\text{C}$  is approximately the temperature of the onset of upper shelf for this heat of steel. Figure 4 contains the Charpy V-notch ( $C_v$ ) curve for the 3/8 T and 5/8 T location for the ITV-1 steel.<sup>3</sup>

FIGURE 4. CHARPY V-NOTCH IMPACT TEST RESULTS OBTAINED FROM INTERMEDIATE VESSEL V-1, 152 mm THICK, ASTM A508, CLASS 2 FORGING.

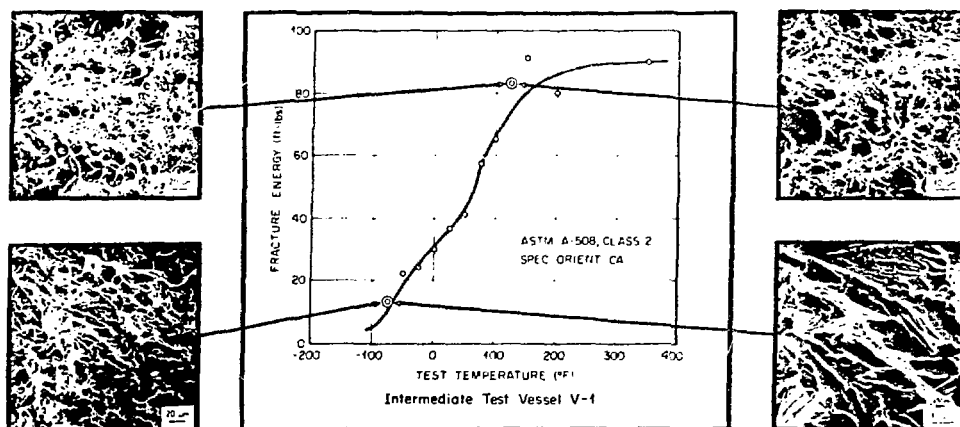
cylindrical test section. Specimens from the  $C_V$  curve shown in Figure 4 were used. A specimen tested at  $59^{\circ}\text{C}$  which absorbed 18 J of energy was used to illustrate brittle fracture appearance. A specimen tested at  $50^{\circ}\text{C}$  ( $4^{\circ}\text{C}$  below the ITV-1 test temperature) which absorbed 112 J of energy was used to depict ductile behavior. Figure 6 shows the difference in appearance of a brittle and ductile fracture surface. Note the ribbon-like pocked appearance of the ductile failure. It is characterized by a dull appearance with surface contour somewhat akin to a classical cup-cone fracture of a ductile tensile failure. In contrast, the brittle fracture surface is faceted and both possess distinct characteristics that make each easily discernible.

FIG. 6. CHARPY V-NOTCH TEST RESULTS. CAREFULLY CONTROLLED TOUGHNESS TESTS OF ITV-1 STEEL PROVIDED BASE LINE DATA FOR EVALUATION OF THE VESSEL TEST. (1 FOOT POUND = 1.36 JOULES;  $t_c = (t_F - 32) / 1.8$ )
