BUILDING 11-14A INCIDENT INVESTIGATION

Mason & Hanger-Silas Mason Co., Inc.
Partex Plant

On March 30, 1977, an explosion occurred in Building 11-14A, Bay 8, during a contact machining operation. An immediate investigation, under the direction of an Energy Research and Development Administration (ERDA) investigating board, was conducted. The board concluded the accident resulted from one or a combination of four probable causes.

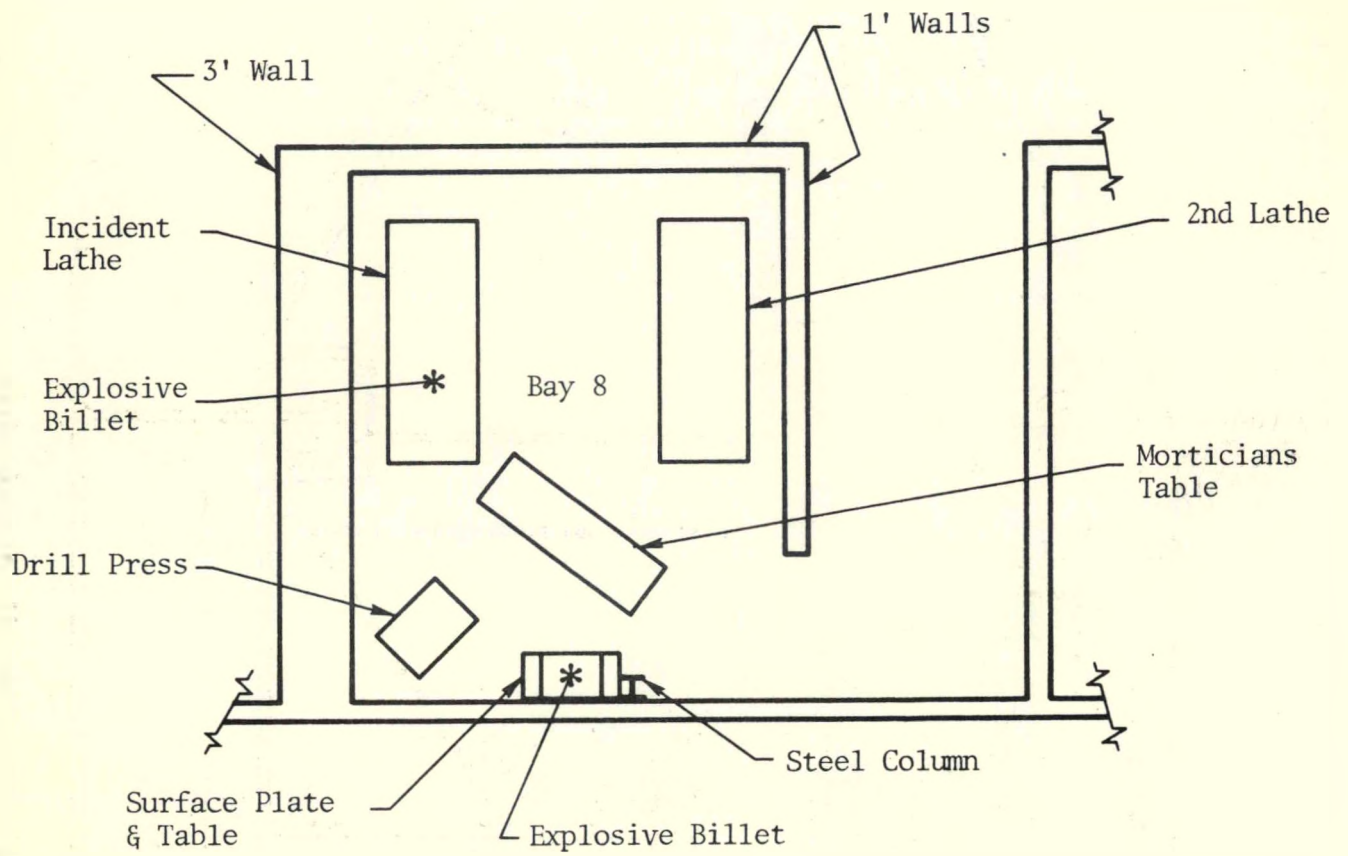
Fig. 2. Bay 8 Layout

From the damage pattern produced in the structure and machines in the bay, it was evident that one billet was on a Series 60 Monarch Lathe and the other on or in the immediate vicinity of the surface plate approximately 3.5 meters from the lathe near the south wall as shown in Fig. 2. It was concluded that the initial explosion occurred on the lathe rather than the surface plate since the lathe represented the greater potential energy source required for initiation, short of dropping the second piece at the surface plate. But the area of maximum damage to a steel column adjacent to the surface plate table corresponded to a height comparable to the table height, indicating that the billet initiated on the surface plate, not on the floor as one would expect if the billet had been dropped sufficiently far to cause initiation. Additionally the missile pattern and missile generating potential of the lathe constituted more evidence for initial detonation on the lathe rather than the surface plate.

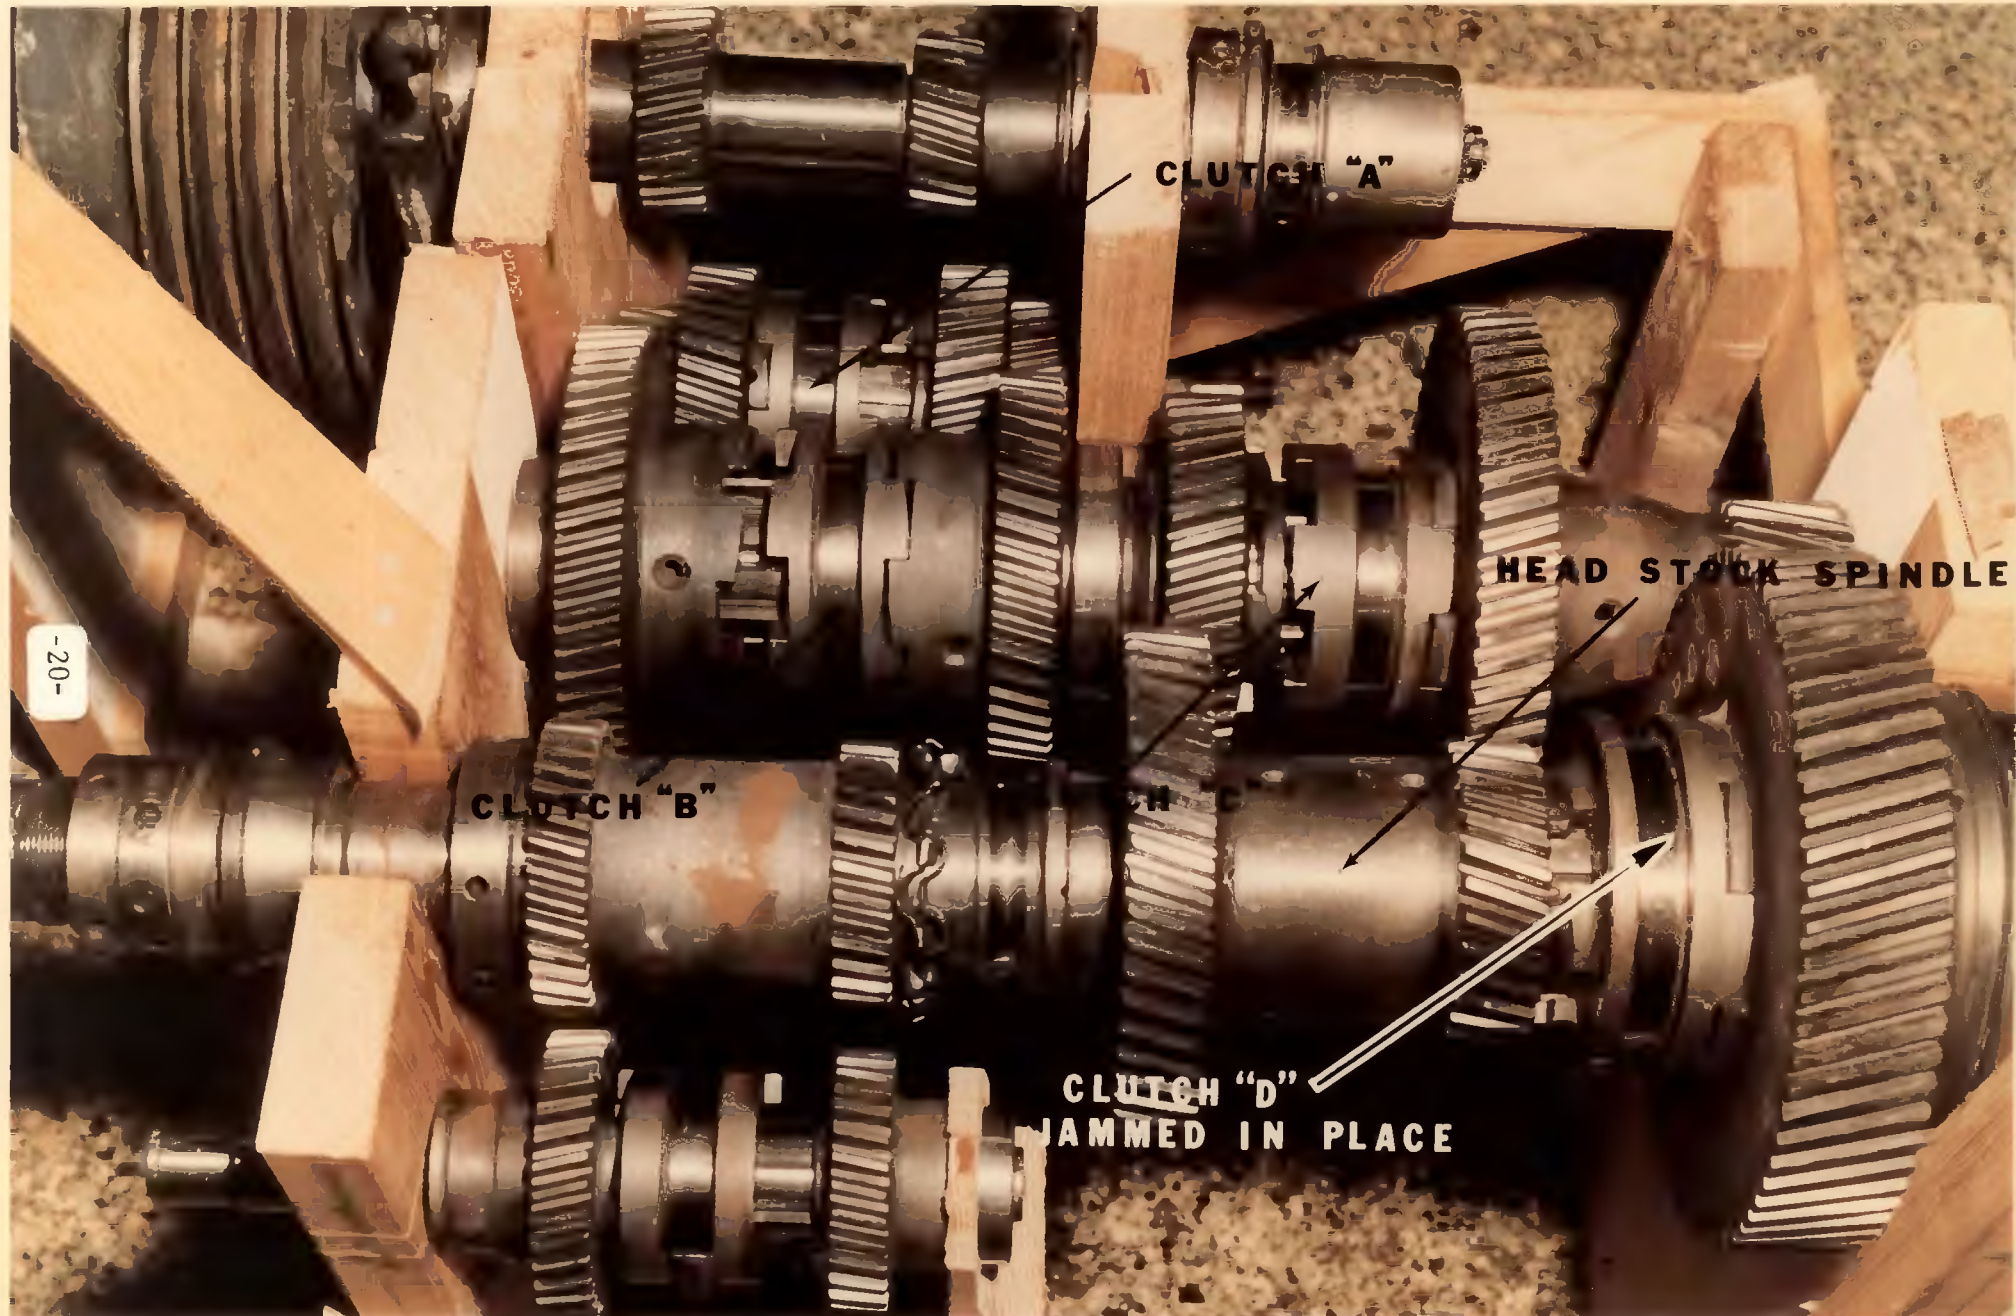
Fig. 14. Reconstructed Drive Train

The other lathe control setting of concern was the spindle speed which is determined by the combination of four clutches in the drive train controlled by levers on the headstock. Each clutch has three possible positions: (a) fast speed, (b) slow speed, or (c) disengaged. If any of these or the main power clutch were disengaged the spindle would not be turning. Inspection of the external levers revealed no information but reconstruction of the lathe drive train gears, Fig. 14, in the headstock did provide information on possible settings. Clutch "D" shown in closeup in Fig. 15, was found to be jammed permanently in the slow or down position. The gear train housing shown in Fig. 16 was reconstructed to determine the relative positions of the drive train shafts and allow matching of impact marks. By matching gear-to-gear and gear-to-housing impact marks Clutch "C" was determined to be in its fast or up position. However, positions of Clutches "A" and "B" were not so well defined with contradictory, poorly defined marks being found. The clutch arrangement is such that the extent of influence on final spindle speed increases from "A" through "D". Therefore, not knowing "A" and "B" had little effect on spindle speed determination. From Table III one can see that with "D" down, "C" up and "B" and "A" unknown the speed range, if the spindle were rotating, would have been from 64 to 140 rpm. For the particular piece size involved, the maximum allowable speed by operating standards would have been 56 - 57 rpm.

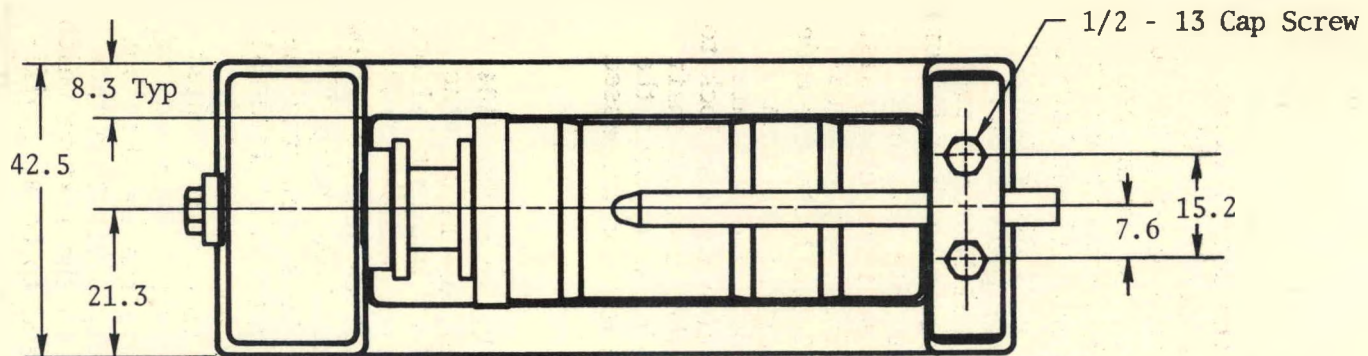
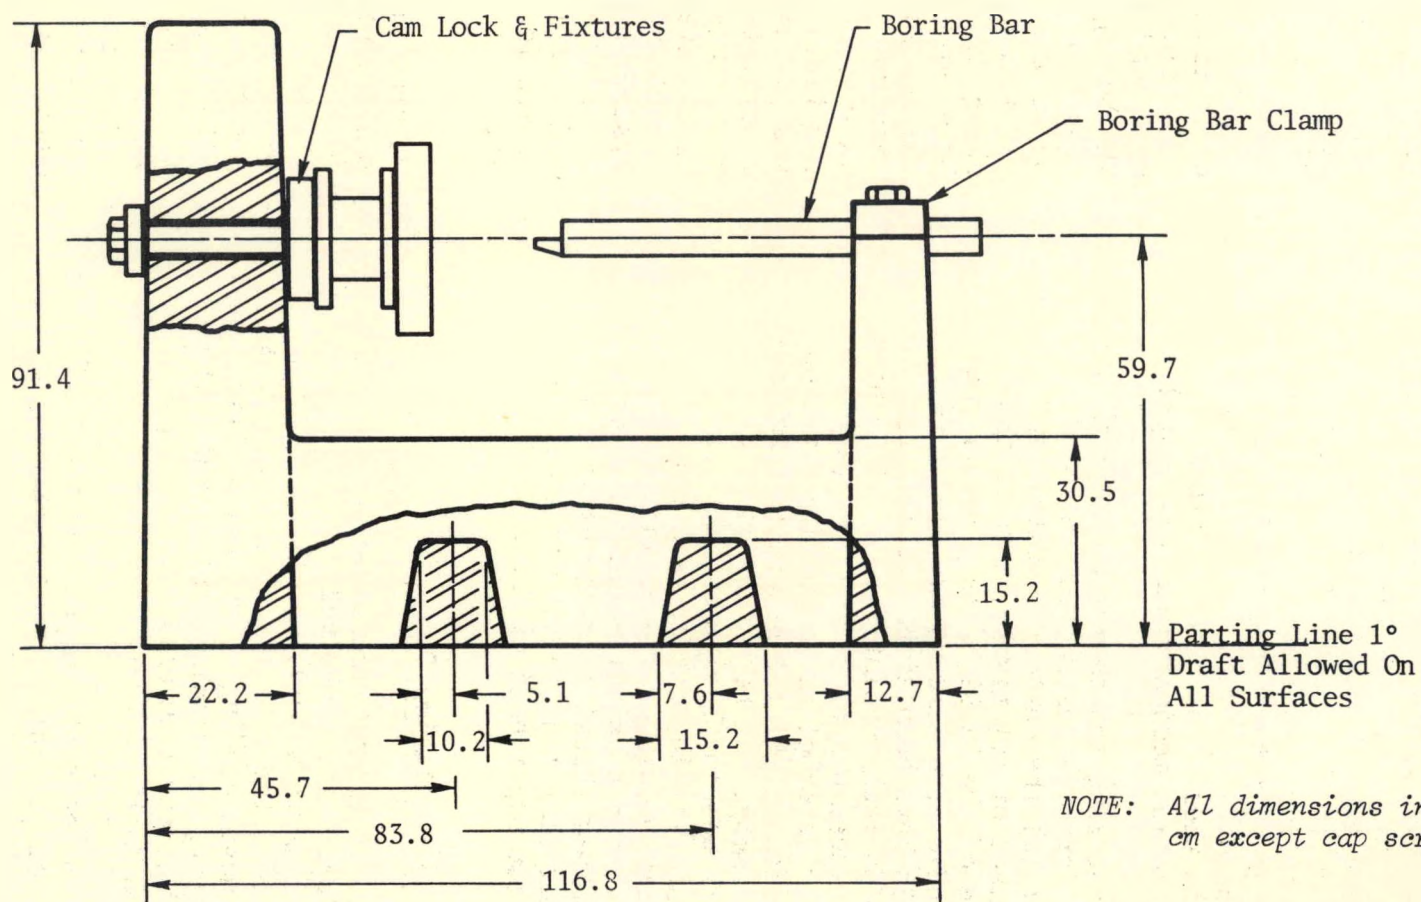
Fig. 19. Lathe Simulator (Grey Cast Iron)

Rather than use actual lathes, 1100 kilogram castings simulating the area of interest from headstock to carriage were made as shown in Fig. 19. For the headstock area a solid approximately 20 cm thick casting to simulate the mass of the housing and drive train was used. Reinforcement ribs between the lathe bed runners were used as in the actual lathe. The boring bar holder (Fig. 20) though not identical was similar to an actual holder. The boring bar was similar to the incident bar as shown in Fig. 21 but did not have a hole through the bar, nor a flat on the top and was one piece rather than two. An actual button cutter was used. The vacuum holding fixture and lathe adaptor, Fig. 22, were made as duplicates of the originals. A simulated cam lock, Fig. 23, was made since actual cam locks are made as an integral part of the main spindle of a lathe. Two separate systems for mounting the cam lock to the simulated lathe, a solid shaft and a hollow shaft, were used; the reason for which will be discussed later.

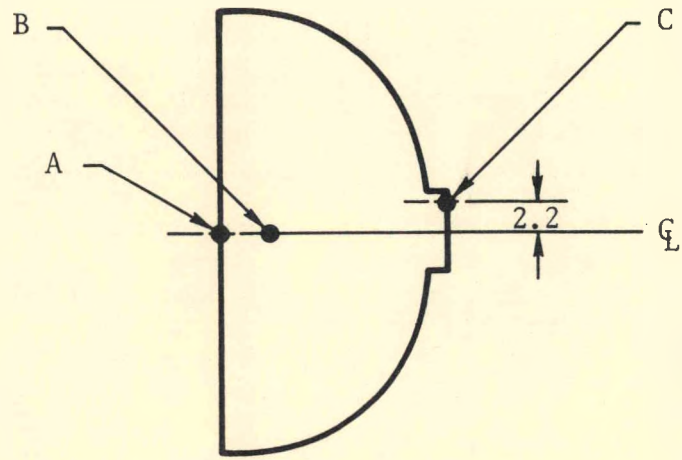
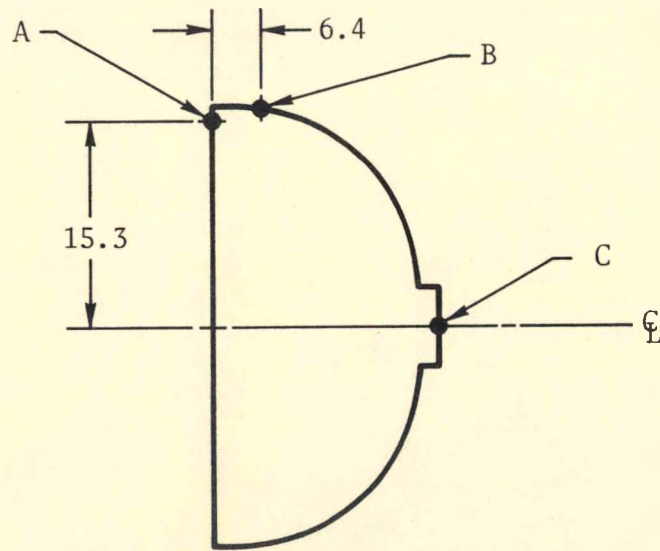
Fig. 24. Points of Initiation

A series of tests was planned using three different points of initiation shown in Fig. 24 for comparison of the resulting damage pattern to the incident pattern. Point A was on the top side of the equatorial surface attached to the vacuum holding fixture. Point B was on the top side of the circumferential surface approximately 6.4 cm from the vacuum holding fixture surface. The last point, C, representing the location of the cutter, was on the horizontal center line of the billet in the plane of the cutter and displaced to the rear of the billet (relative to a machinist position) approximately 2.2 cm from the center of the billet.

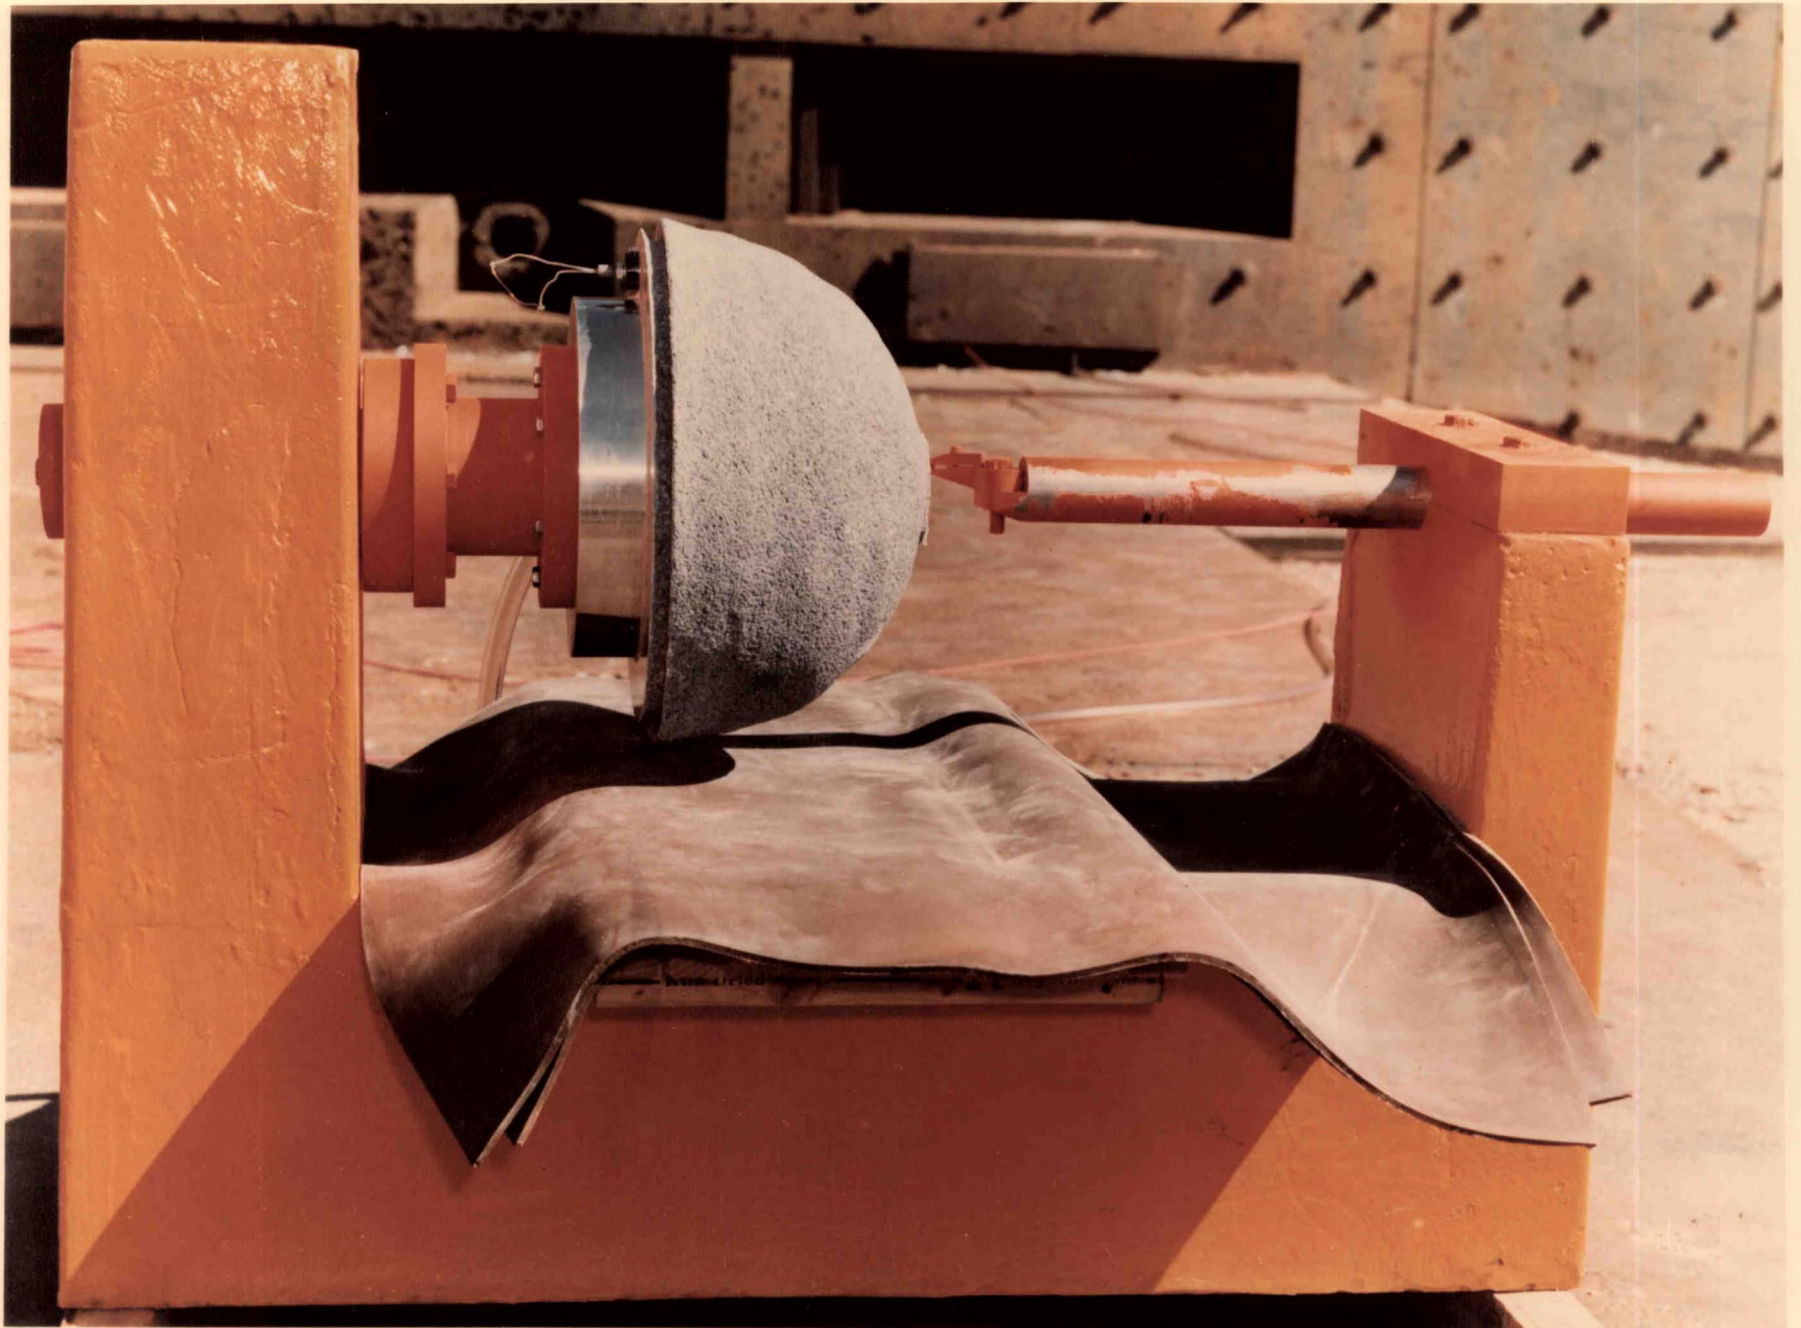
Fig. 25. Typical Test Fire Setup

The first shot in the series was set up as shown in Fig. 25 with the detonator assembly at position A. The rubber and table shown across the lathe bed were for safety purposes and were removed prior to the shot exposing the lathe bed. Actually Fig. 25 is typical of all five shots in this series with the only major difference being the point of initiation. Fig. 26 and Table IV summarize the design conditions for all five tests. In all cases the cutter was positioned in contact with the billet angled toward the
