K/GD-1631, Rev. 1

THE PATTERN OF EXPLOSIVE REACTION BETWEEN
URANIUM HEXAFLUORIDE AND HYDROCARBON OILS

Karl E. Rapp

Oak Ridge Gaseous Diffusion Plant

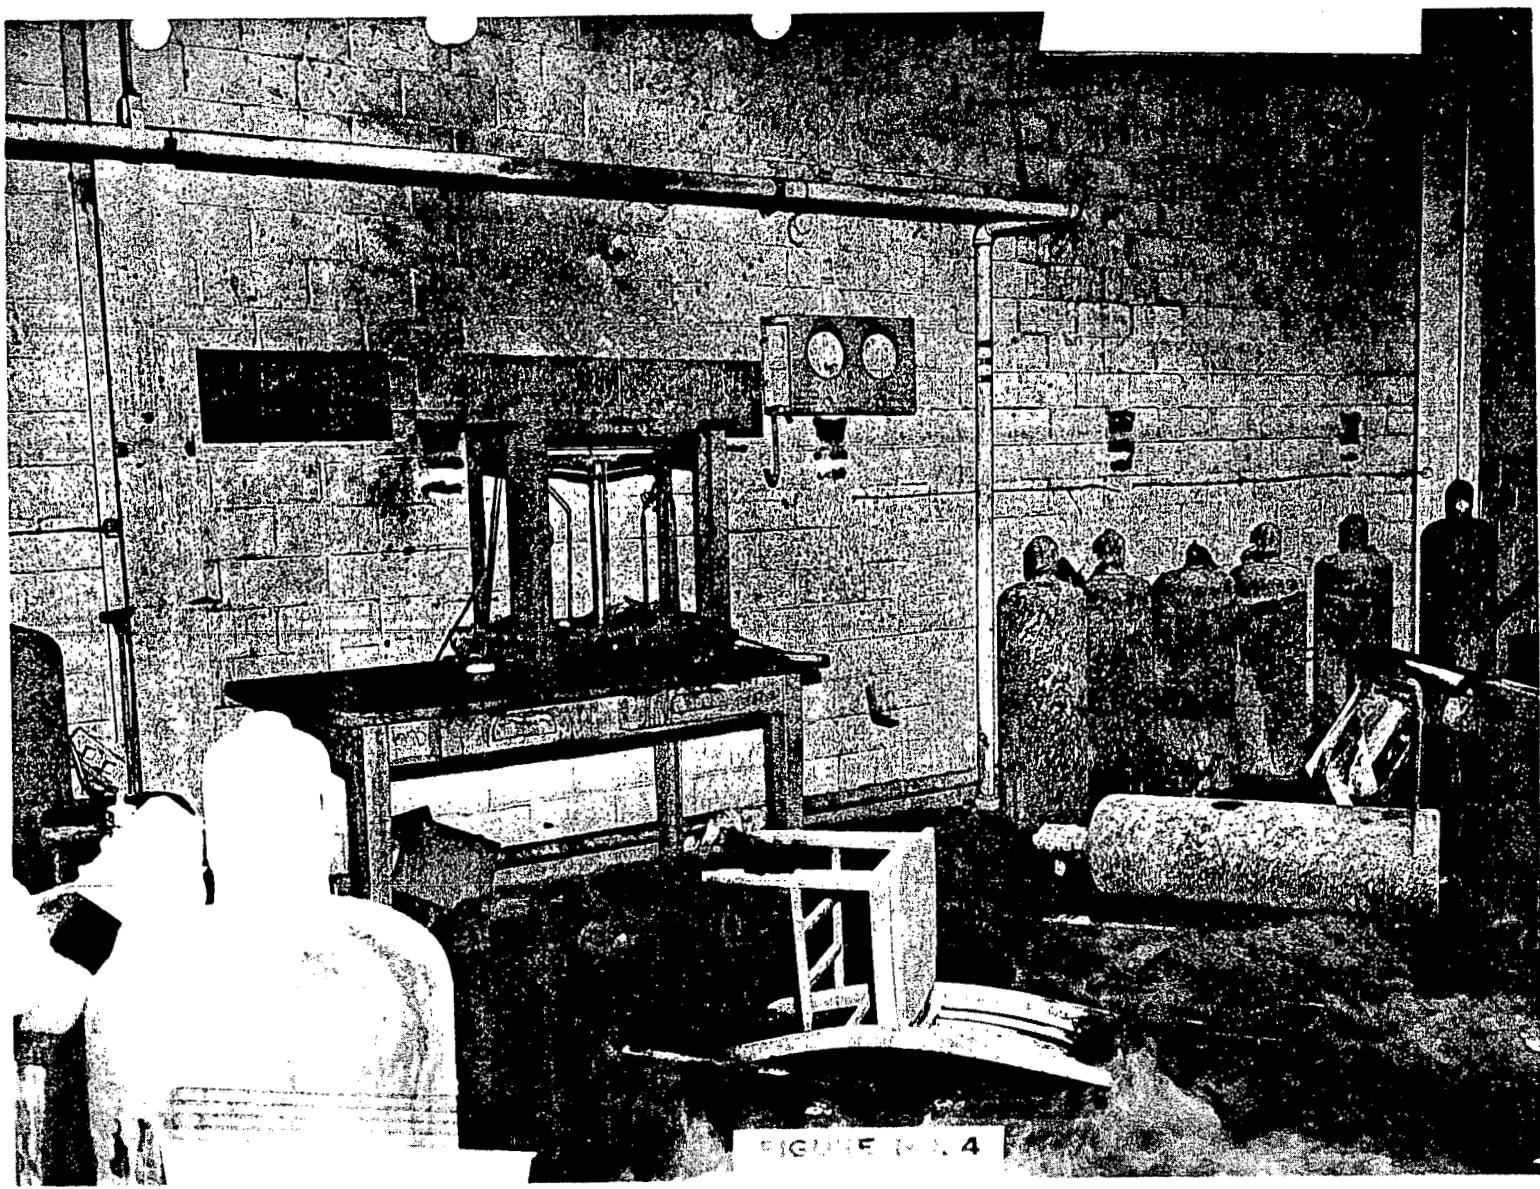
FIGURE NO. 3

- b. Photograph No. 2. Broken windows in the interior of the building, taken from the overhead pipe gallery.
 - c. Photographs Nos. 3 and 4. General views of room.

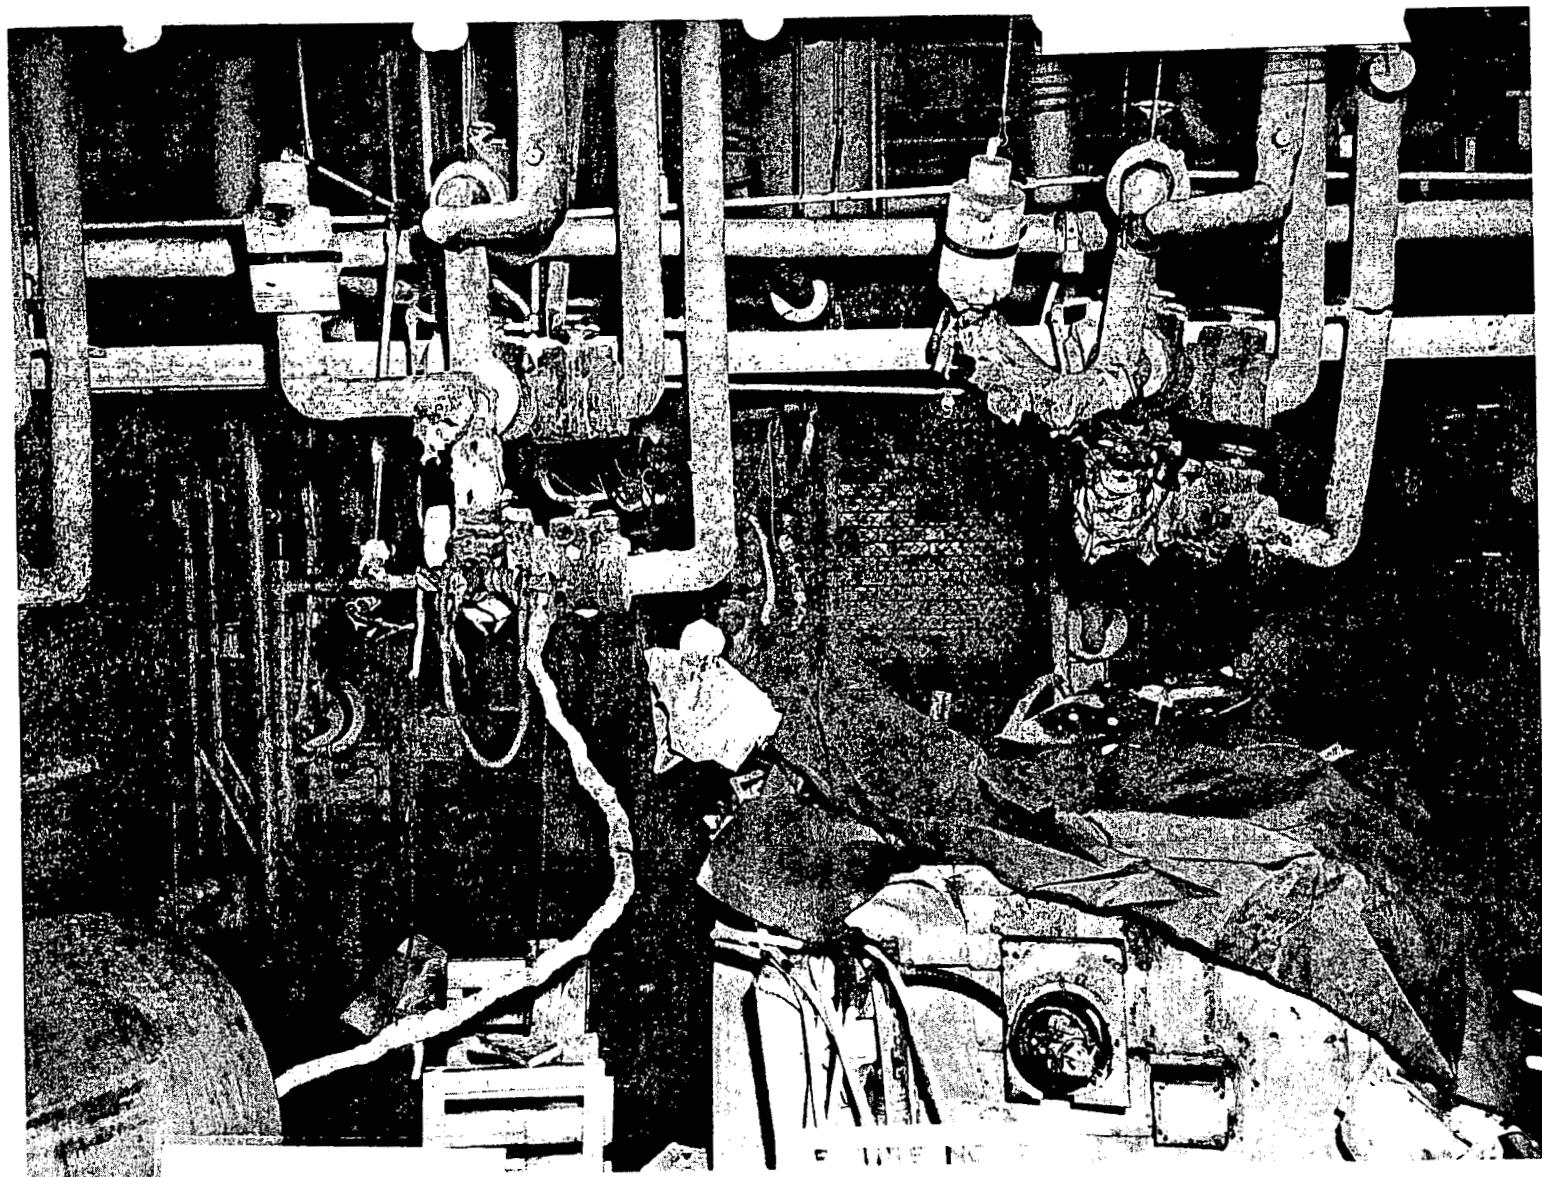
FIGURE NO. 6

- e. Photograph No. 6. Largest piece of cylinder found; it had looped itself in the insulated piping as shown.
 - f. Photograph No. 7. Damage done to transfer piping. The feed bath is also shown; the cylinder which did not explode was immediately frozen down with dry ice.
