**TS-1 AND TS-2 TRANSIENT**

**OVERPOWER TESTS ON FFTF FUEL**

A. L. Pitner, P. C. Ferrell, G. E. Culley, E. T. Weber

October 3, 1985

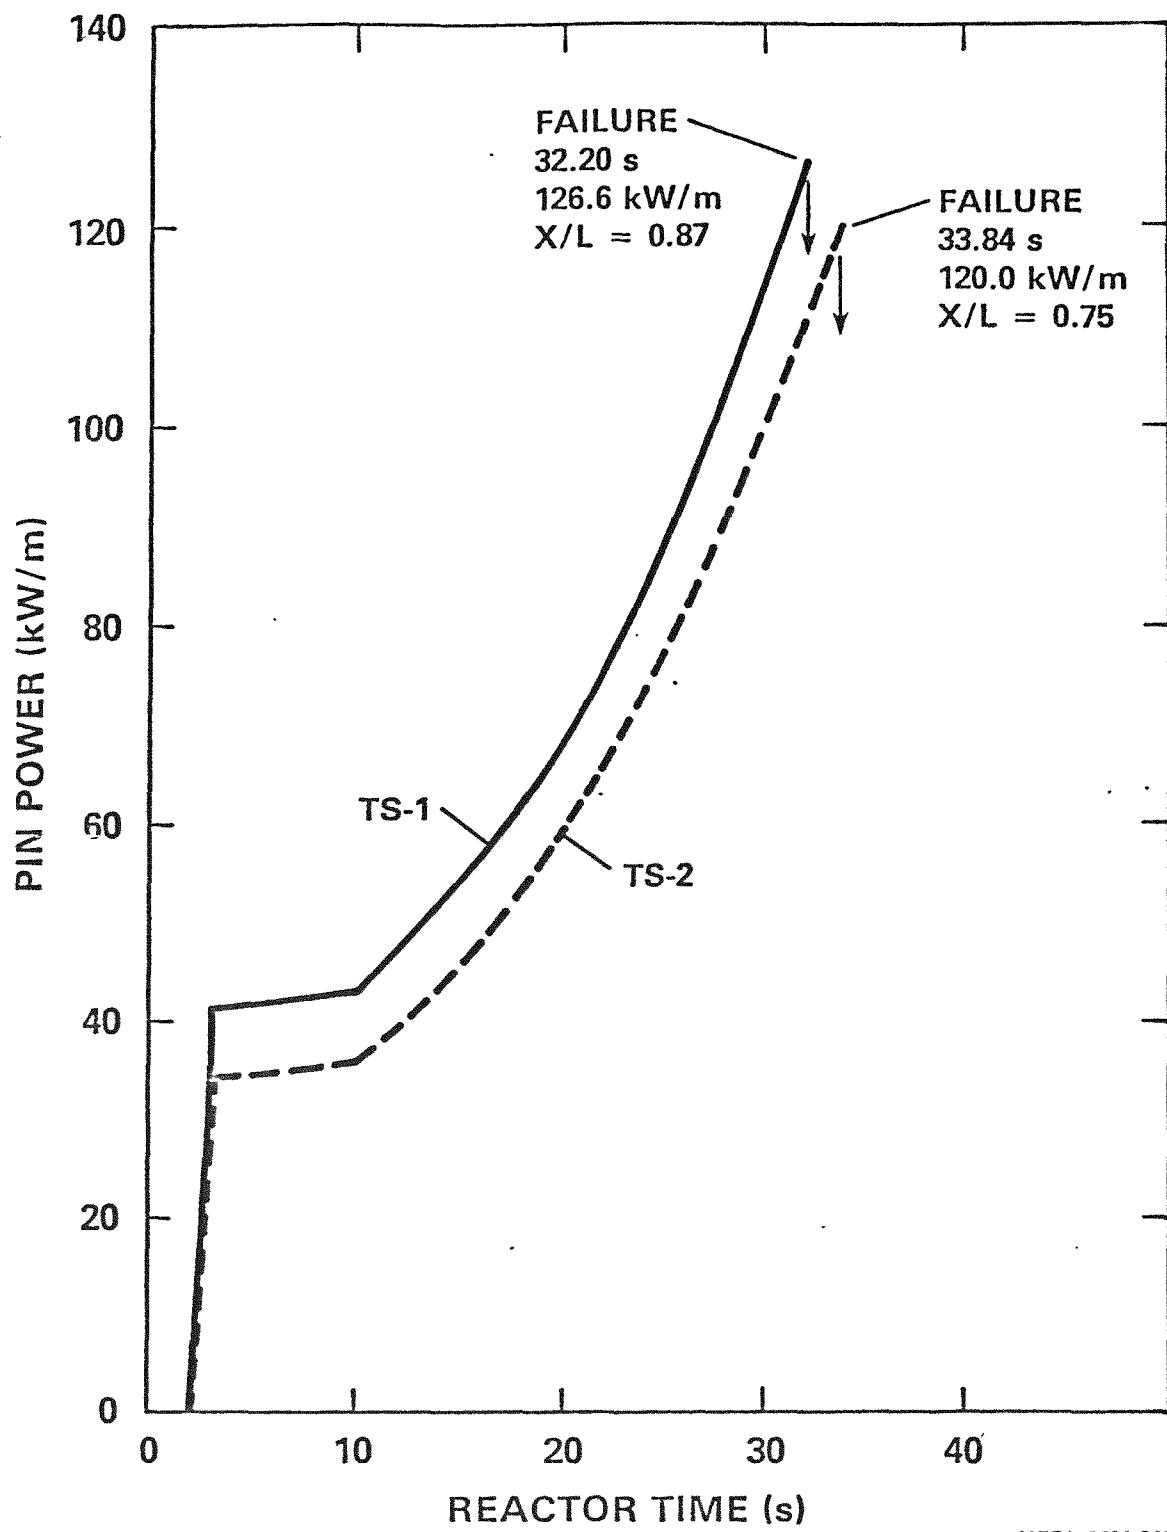
Applying the PCF's derived from the heat balance runs to the final transient runs gives the power histories presented in Figure 3. The overpower transient in each test was preceded by a 7 s flat-top period to simulate steady state thermal conditions in the fuel pin. At the 10 s mark, a power ramp simulating a 5 $\delta$ /s reactivity insertion was initiated, and continued until pin failure occurred. It is seen that failure occurred at about the same time in each test pin. The TS-1 pin failed at 22.21 s into the transient, while the TS-2 pin failed at 23.83 s into the transient. Because it started at a lower steady state power level, the TS-2 pin actually failed at a slightly lower power level than the TS-1 pin, even though at a later point in the transient. The ratio of the pin power at failure to the steady state power was 3.1 for TS-1, and 3.4 for TS-2.

In spite of the large difference in burnup, there was only a 5% difference in pin power at failure for TS-2 and TS-1 (120 kW/m vs. 127 kW/m). Thus it would appear that the failure threshold for these types of fuel pins and transients is relatively insensitive to burnup level, at least up to about 60 MWd/kg. As indicated in Figure 3, failure occurred at an upper level in each pin (87% of the fuel column height for TS-1, and 72% of the fuel column height for TS-2).

FIGURE 3. Final Transient Power Histories

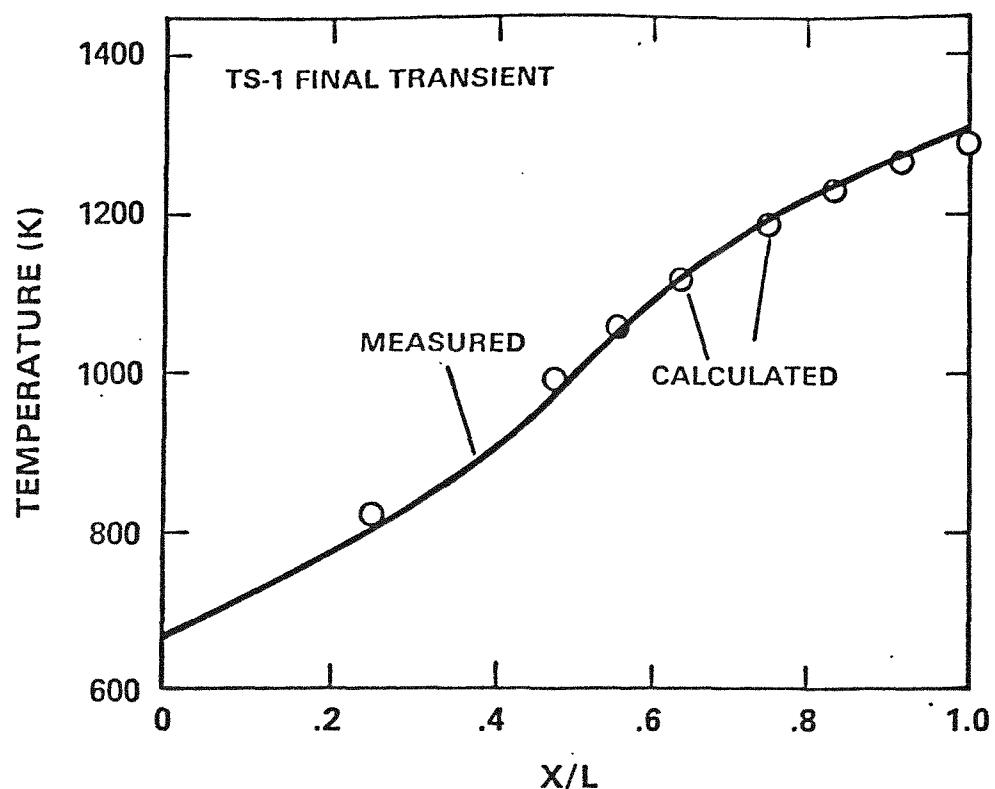
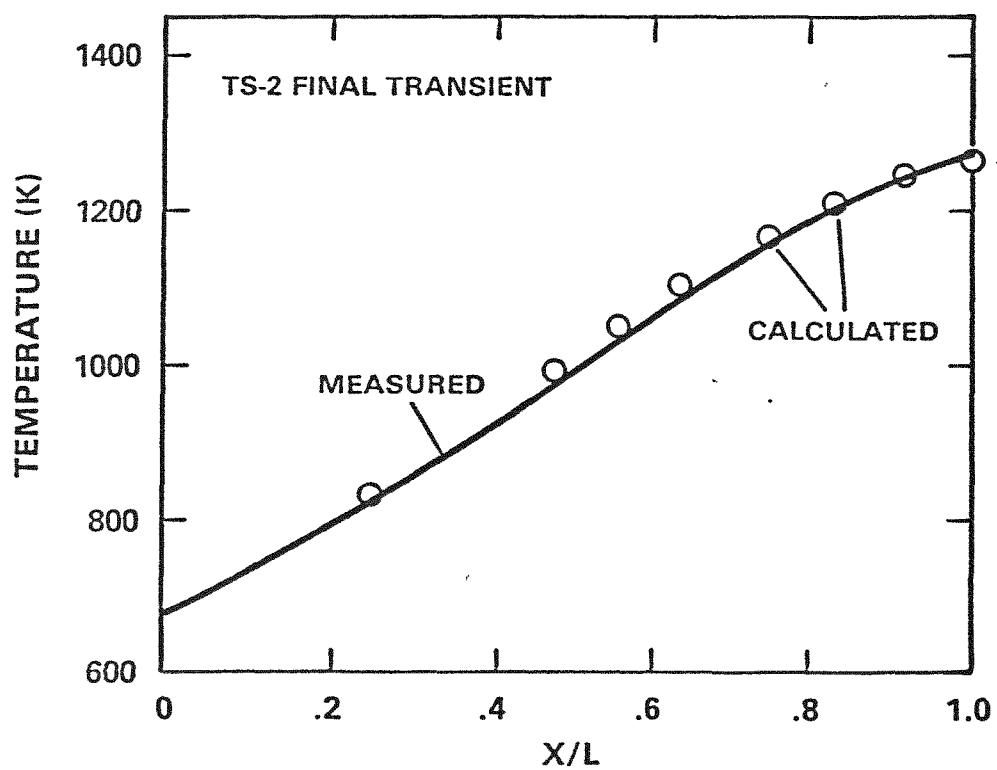
Calculated flow tube temperatures during the final transients agreed well with measured values, as depicted in Figure 4. The indicated temperatures in the figure correspond to those at the end of each

FIGURE 4. Measured and Calculated Flow Tube Temperature Profiles at Pin Failure Time
