**^{238}Pu FUEL FORM PROCESSES
QUARTERLY REPORT**

OCTOBER - DECEMBER 1980

**E. I. du Pont de Nemours & Co.
Savannah River Laboratory
Aiken, SC 29808**

Impact Response of SRP MHW $^{238}\text{PuO}_2$ Fuel Spheres 7

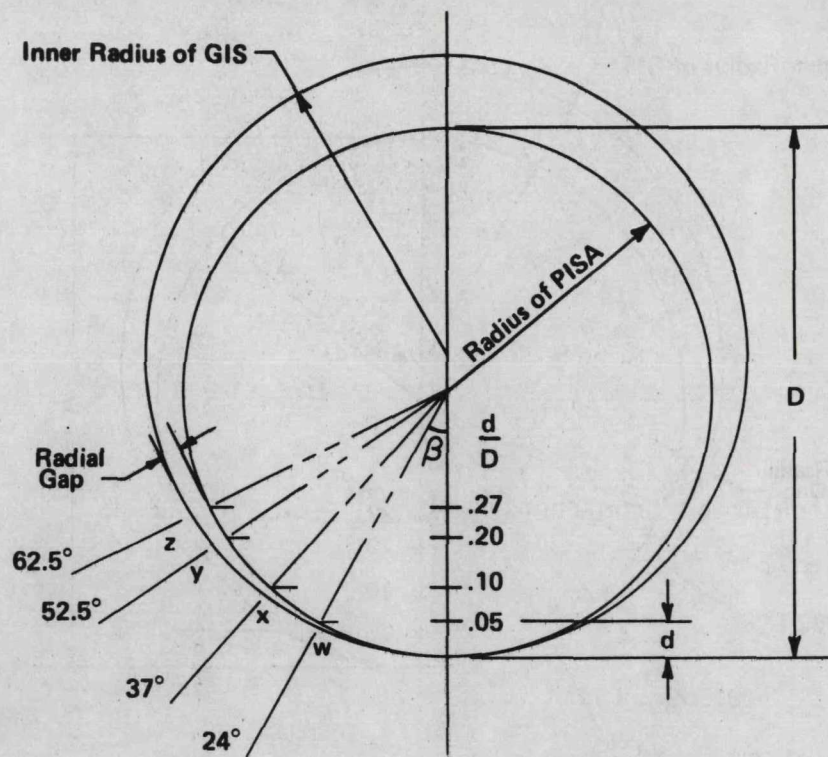
FIGURE 6. Impact Geometry of FSA

Figure 6a shows the geometry of the FSA at the moment of contact of the PISA with the GIS. (Deformation of the inner radius of the GIS due to its own impact is considered negligible at this early time.) Points along the PISA circumference corresponding to different d/D (see Figure 6a) ratios used in the computer modeling are labeled w,x,y,z. These same relative points are shown for comparison on the cross section of impacted MHFT 61 (Figure 6b). Point x corresponds very closely with the point of contact of the hypothesized push-through or shear plane of the pieces of fuel. In Figure 7, the calculated radial gap for each point is compared with the maximum radial shear experienced by the push-through in MHFT 61 estimated as shown in Figure 8. Though the radial displacement of MHFT 61 push-through is difficult to determine accurately, it is clearly larger than the radial gap between the GIS and the PISA. Hence, to accommodate the observed displacement, the GIS had to give way.

b. Extrapolation of Points w,x,y,z to Impacted MHFT 61

$\frac{d}{D}$	Initial angle, β	Initial radial gap,* in.	Relative Impact Times**	
			Ir-GIS, μsec	Fuel-Ir, μsec
0.05	24	0.004	17	45
0.10	37	0.009	28	53
0.20	52.5	0.016	52	72
0.27	62.5	0.023	72	83

Maximum radial displacement of push-through for MHFT 61 is estimated from Fig. 11 to be ~ 0.090 in.

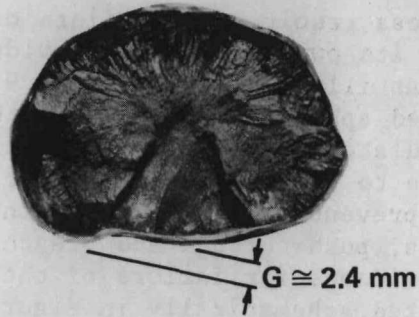
FIGURE 7. Initial Contact Geometry of FSA

According to results of computer simulations of impact, the GIS-iridium impact occurs before the fuel-iridium impact at points corresponding to the point of push-through seen in Sphere MHFT 61 and other spheres. Figure 7 shows the geometry of the FSA at the moment of impact and the times of contact for points w,x,y,z around the sphere. At all these points, the fuel does not contact the iridium before the iridium contacts the GIS. Once again, push-through would not be possible without failure of the GIS.

**Based on computer model "FSA 4": Strong GIS-Hard fuel-friction between GIS-Ir and Fuel-Ir. However, all other computer models (e.g. Strong GIS - Weak fuel - no friction) also showed the same relative impact sequence up to $d/D = 0.15$ (Ref. 3).

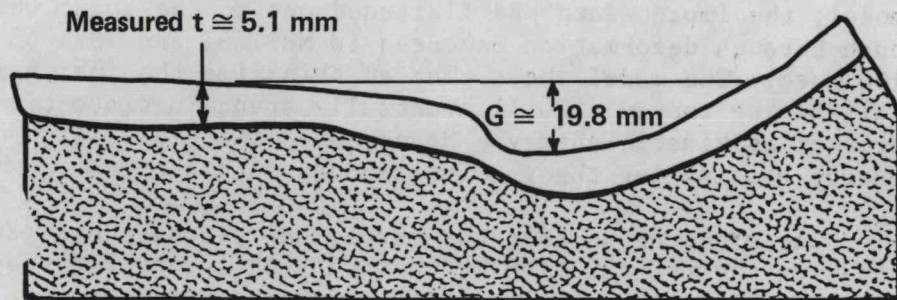
a. Calculation From Photograph

Scale Factor to Reduce G to Actual Size = 0.916

$$\therefore G_{\text{Actual}} \cong 2.2 \text{ mm} = 0.087 \text{ in}$$

Actual Thickness t of Iridium = 0.024 in

$$\therefore \text{Estimated Displacement, } G = \frac{19.8}{5.1} \times 0.024 = 0.093 \text{ in}$$

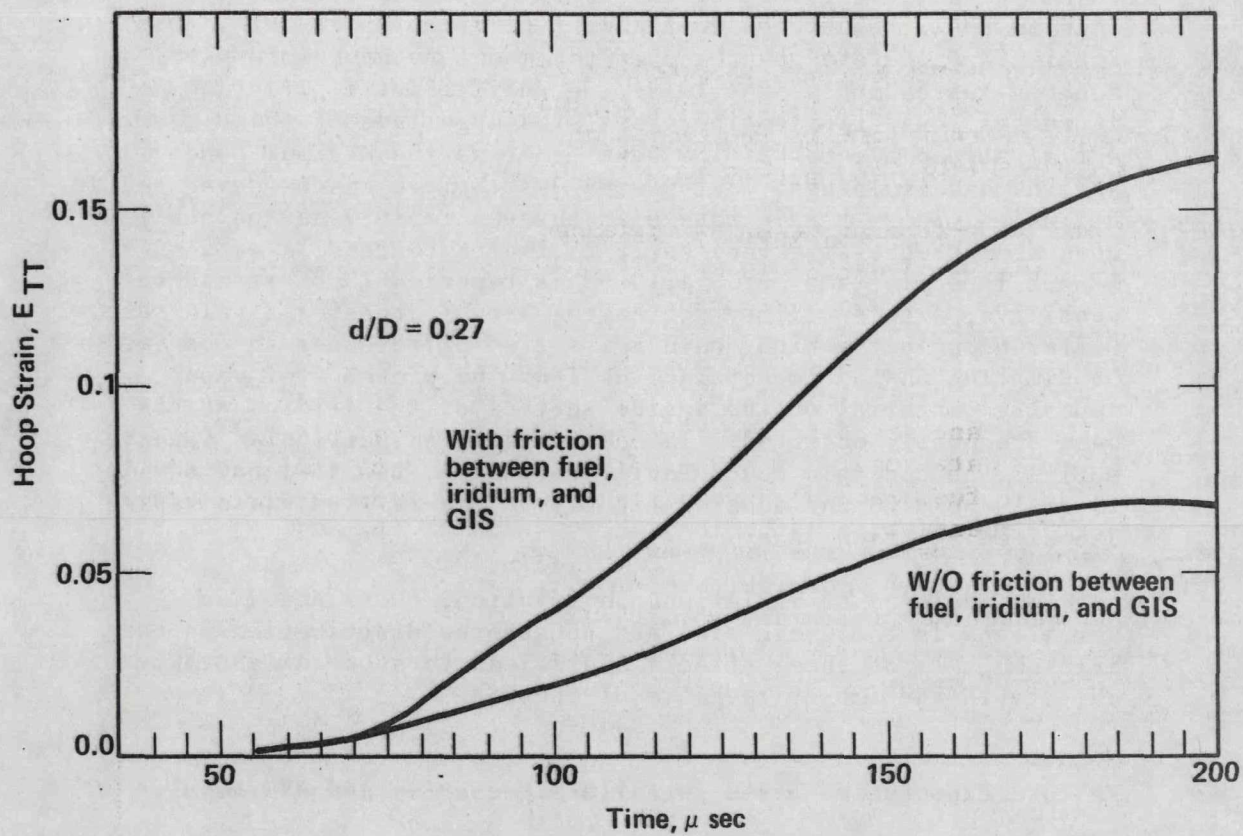
FIGURE 11. Comparison of Hoop Strain-Time Histories in the Iridium Zone⁵

Another factor affecting step two that has a large potential for variation is friction at the GIS-iridium and iridium-fuel interfaces. This friction was emphasized in the computer modeling study and may vary widely enough to cause failure or nonfailure at random among FSAs, especially those in which the iridium has a higher phosphorus content. For example, the difference in the calculated hoop strain with and without friction (Figure 11) is large enough to suspect possible effects to occur with variations in friction forces.

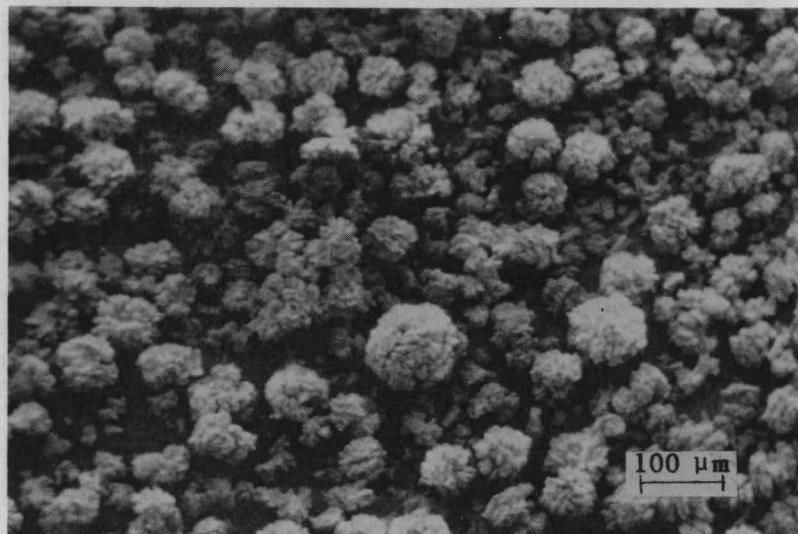
FIGURE 21. " $^{242}\text{PuO}_2$ " Rosettes, As Received

SEM Characterization of the $^{242}\text{PuO}_2$ rosettes indicated that this material was an adequate simulant for $^{238}\text{PuO}_2$ direct-strike rosettes. As shown in Figure 21, the $^{242}\text{PuO}_2$ consisted of spherical aggregates, up to 120 μm in diameter but with a large volume of fines. Metallographic characterization indicated that $^{242}\text{PuO}_2$ rosettes sintered in dry argon at 1600°C for 6 hr had a density of only about 85% TD (Figure 22a) while $^{242}\text{PuO}_2$ rosettes sintered 6 hr at 1600°C in He/4% H_2 had a density >95% TD (Figure 22b). (A further discussion of atmosphere effects on granule densification will be discussed in a later quarterly report.)

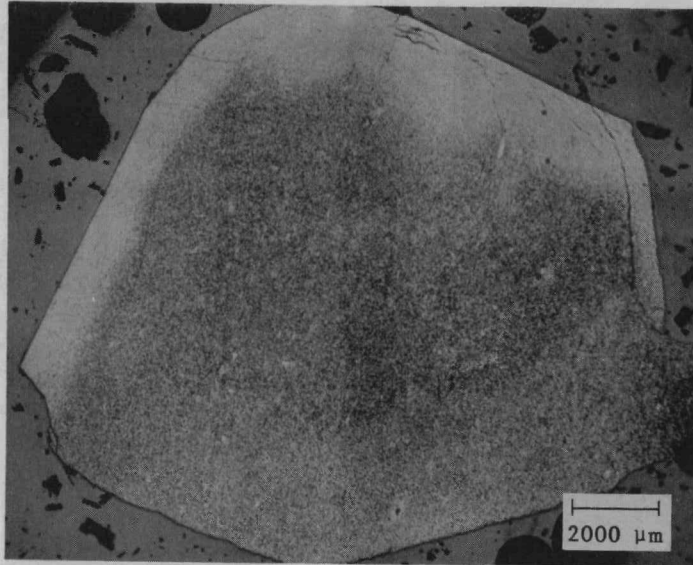
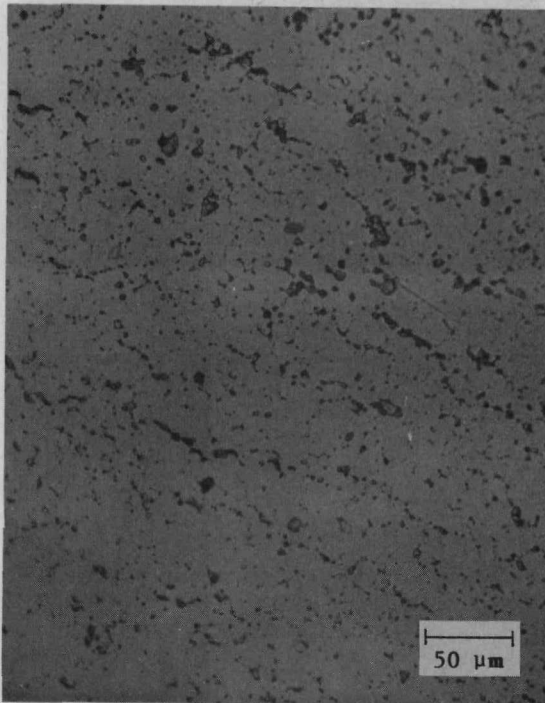
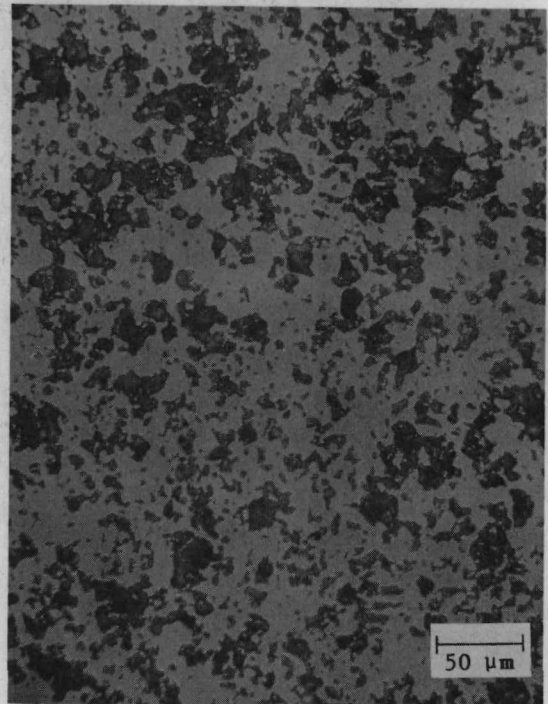
FIGURE 23. DF Pellet 1

These differences in the granule feed material were the likely causes for the relatively high temperature (1615°C versus a GPHS centerline temperature of 1525°C) and pressure (10,700 psi versus a GPHS centerline condition of about 2700 psi) required to hot press DF Pellet 1. It should also be noted that DF Pellet 1 was hot pressed in a W-2% ThO₂ die¹² and that this test apparently exceeded the physical limitations of the die. As discussed in a previous report, DF Pellet 1 had broken when the die liner fractured during pellet extraction. Additional surface cracks formed in the piece which was heat treated. As shown in Figure 23, the metallographic examination of a section from DF Pellet 1 revealed a clearly defined, high-density (~98% TD) outer shell which was ~2 mm wide. The density of the remainder of the pellet was ~83 to 85% TD and fairly uniform. The high-density shell may have been related to the characteristics of the granules and/or the hot pressing parameters.

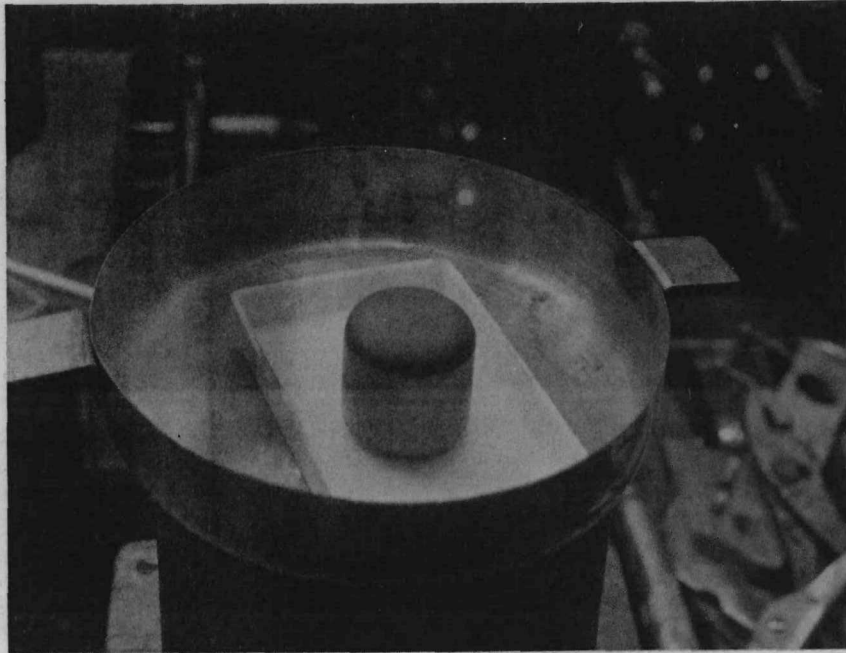
FIGURE 24. DF Pellet 2 After Final Heat Treatment

The conditions used to sinter the granules for DF Pellet 2 were adjusted (Table 4) to produce denser, high-fired granules and more-sinterable, low-fired granules. These changes in granule sintering conditions helped reduce the pressure and temperature required to hot press the pellet. The pellet had no visible surface cracks following heat treatment (Figure 24). On the basis of microstructural analysis (Figure 25), the change in process conditions apparently helped to alleviate density gradients. There was no evidence of a high-density shell in DF Pellet 2 although a slightly higher density was observed near the side of the pellet than at the ends or center of the pellet. Some cracking, probably from reoxidation stresses, was also observed in a section of the pellet cut from near the side of the pellet.
