## **MATERIALS TECHNOLOGY FOR COAL-CONVERSION PROCESSES**

**Fifteenth Quarterly Report,**

**July—September 1978**

**ARGONNE NATIONAL LABORATORY, ARGONNE, ILLINOIS**

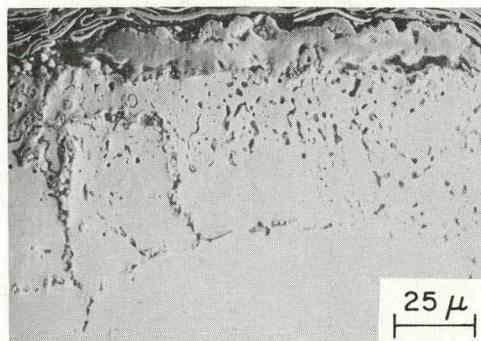
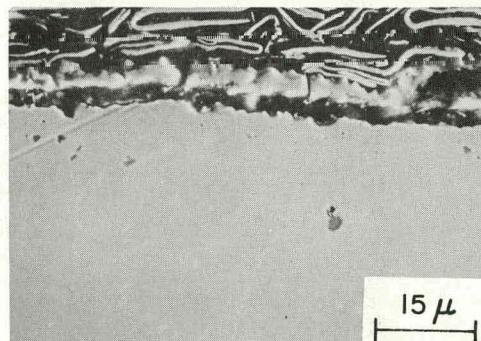
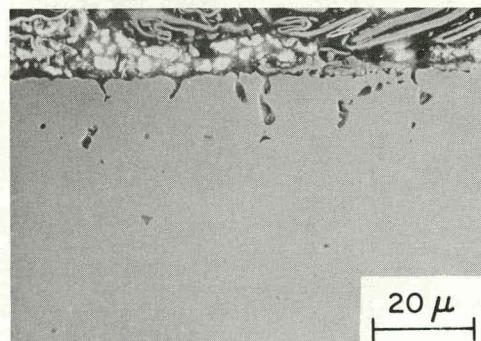
Detailed metallographic examination was made of all the specimens to determine the distribution of corrosion products. Figures 17 to 22 show scanning-electron micrographs of the cross sections of specimens of Types 304 and 310 stainless steel, Incoloy 800, Inconel 600, Inconel 601, and RA333 exposed under different test conditions. The specimens exposed to the environment with NaCl or CaCl<sub>2</sub> exhibited large cavities along the grain boundaries. Micrographs of the specimens indicate that in the presence of salt, the internal corrosive attack is primarily caused by the preferential oxidation of the carbide phases. Carbon from the carbides diffuses into the material and reprecipitates ahead of the oxidation front, as shown in Figs. 19 and 22b. These specimens showed a depletion of chromium in the surface region. The x-ray microprobe line analyses for nickel, iron, and chromium on Incoloy 800 specimens, which were exposed above the bed without and with NaCl, are shown in Figs. 23a and 23b, respectively. In the absence of NaCl, the distribution of nickel, iron, and chromium in the specimen is relatively uniform. However, in the presence of NaCl, the surface region is depleted in chromium and iron to a depth of ~60  $\mu\text{m}$ . The specimen matrix in this region consists primarily of nickel.

Fig. 22. SEM Micrographs of RA333 After a 100-h Exposure at 1123 K.  
(A) Exposed in bed, (B) exposed above bed, (a) without salt,  
(b) solid NaCl, (c) 1.0 mole % NaCl, and (d) 0.1 mole %  $\text{CaCl}_2$ .  
ANL Neg. No. 306-78-793.

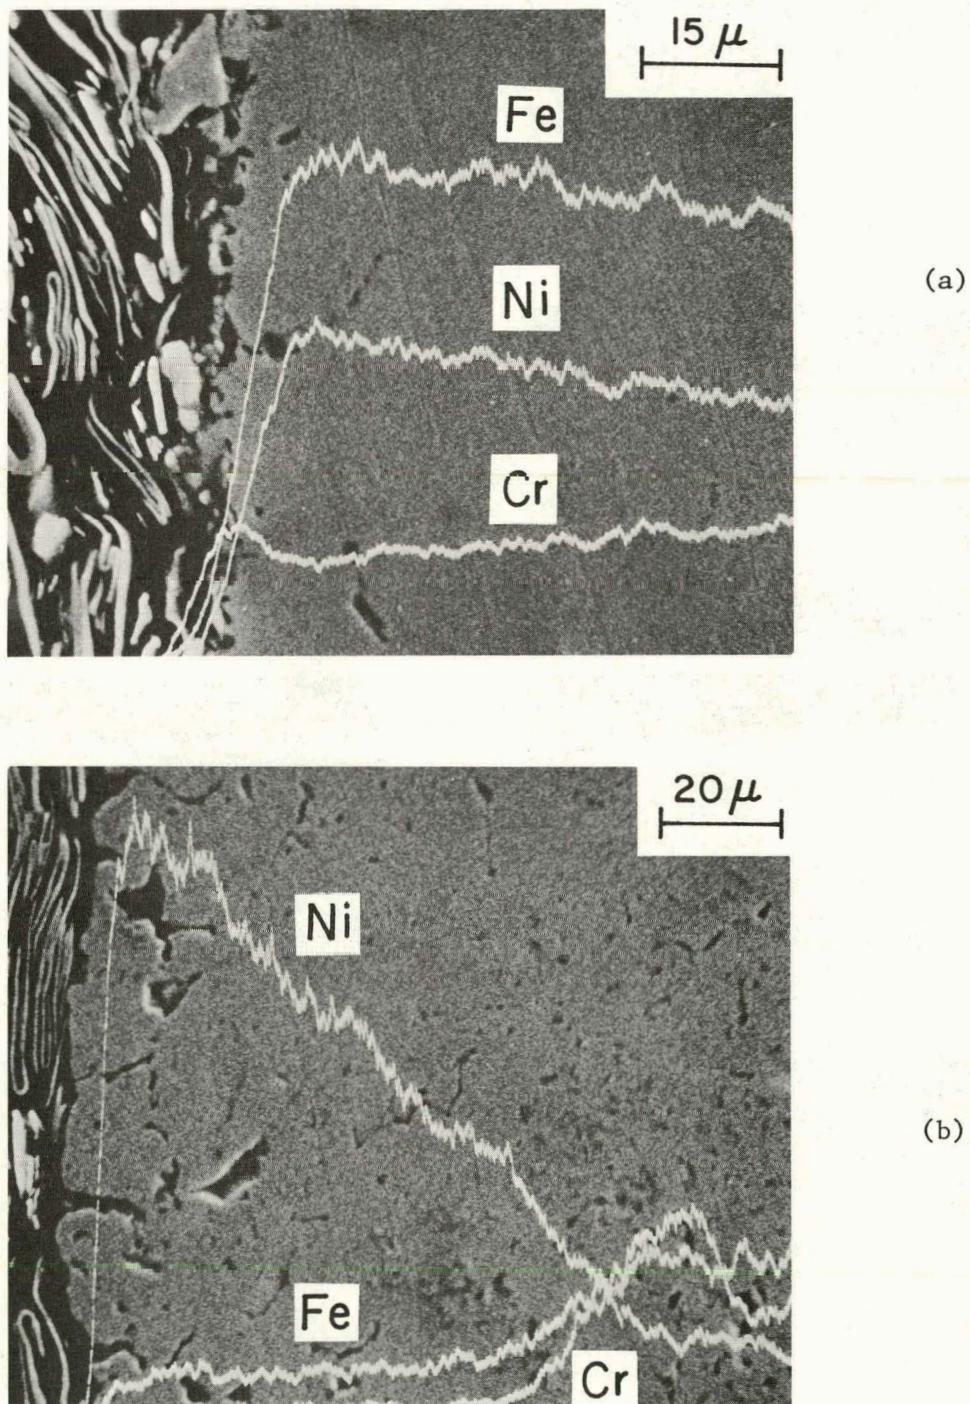
Fig. 23. X-ray Microprobe Line Analyses for Ni, Fe, and Cr on Incoloy 800 Specimens Exposed above the Bed for 100 h at 1123 K.  
 (a) Exposure without salt and (b) with solid NaCl.  
 ANL Neg. No. 306-78-787.

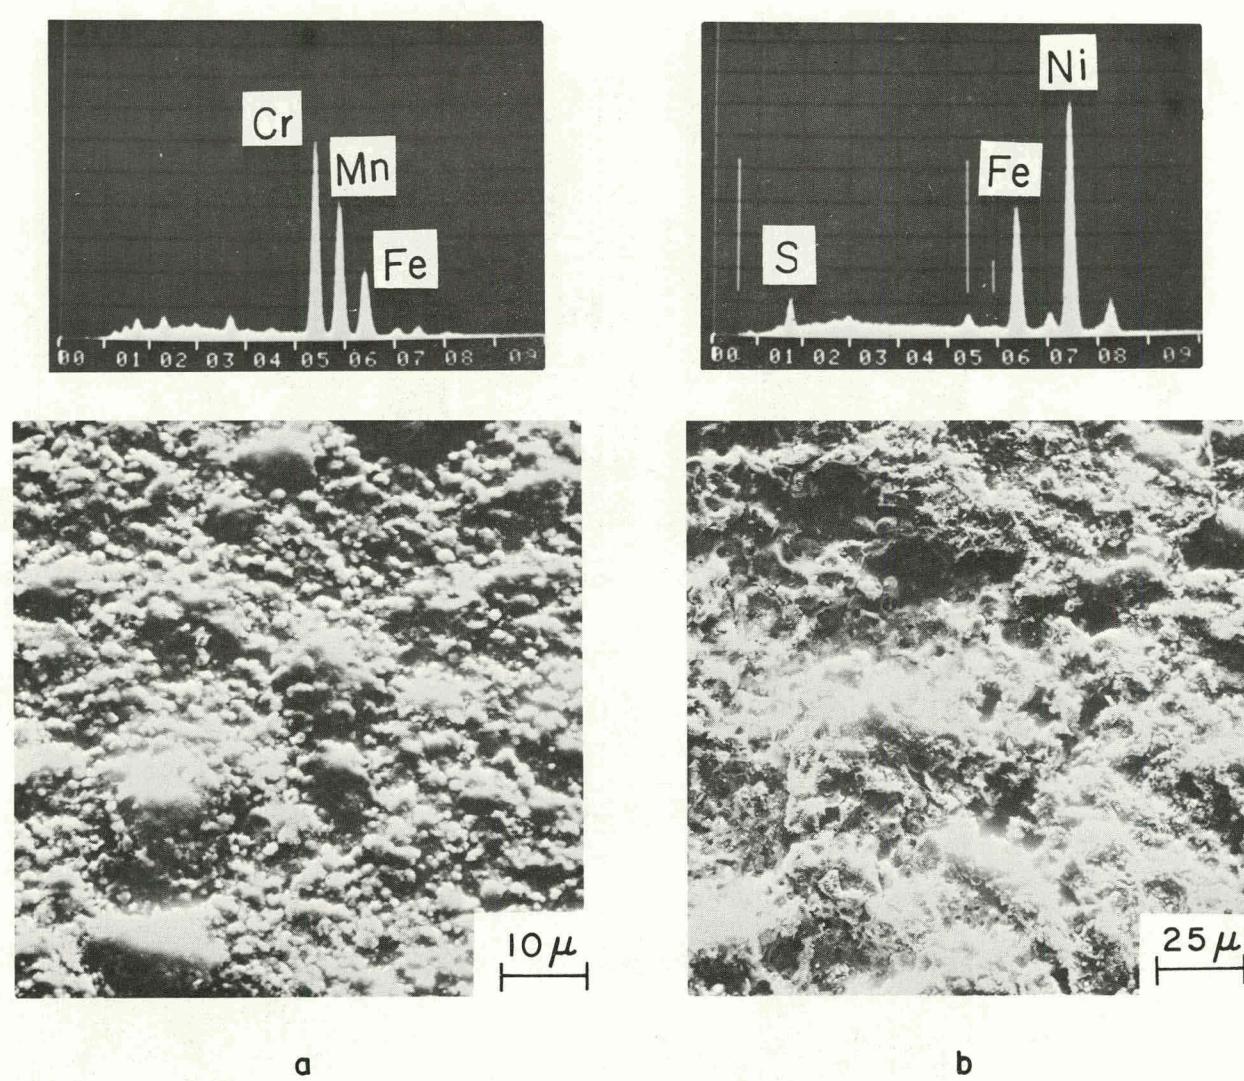
Scanning-electron micrographs and EDAX analyses of the surface of the scales formed on Incoloy 800 specimens that were exposed above the bed are shown in Fig. 24. In the absence of NaCl (Fig. 24a), a continuous oxide scale formed on the specimen surface. The major elements in the scale are chromium, manganese, and iron. Minor amounts of calcium, magnesium, silicon, sulfur, aluminum, and titanium are also observed. Sulfur is probably present in calcium sulfate particles that deposit on the scale. When NaCl is present in the bed (Fig. 24b), the specimen surface is quite corroded and the metal grains underneath the scale are exposed. The EDAX analysis of the surface shows the presence of nickel, iron, and silicon.

Fig. 24. SEM Micrographs and EDAX Analysis of the Surface Scales Developed on Incoloy 800 Exposed above the Bed for 100 h at 1123 K. (a) Exposure without salt and (b) with solid NaCl.  
ANL Neg. No. 306-78-458.

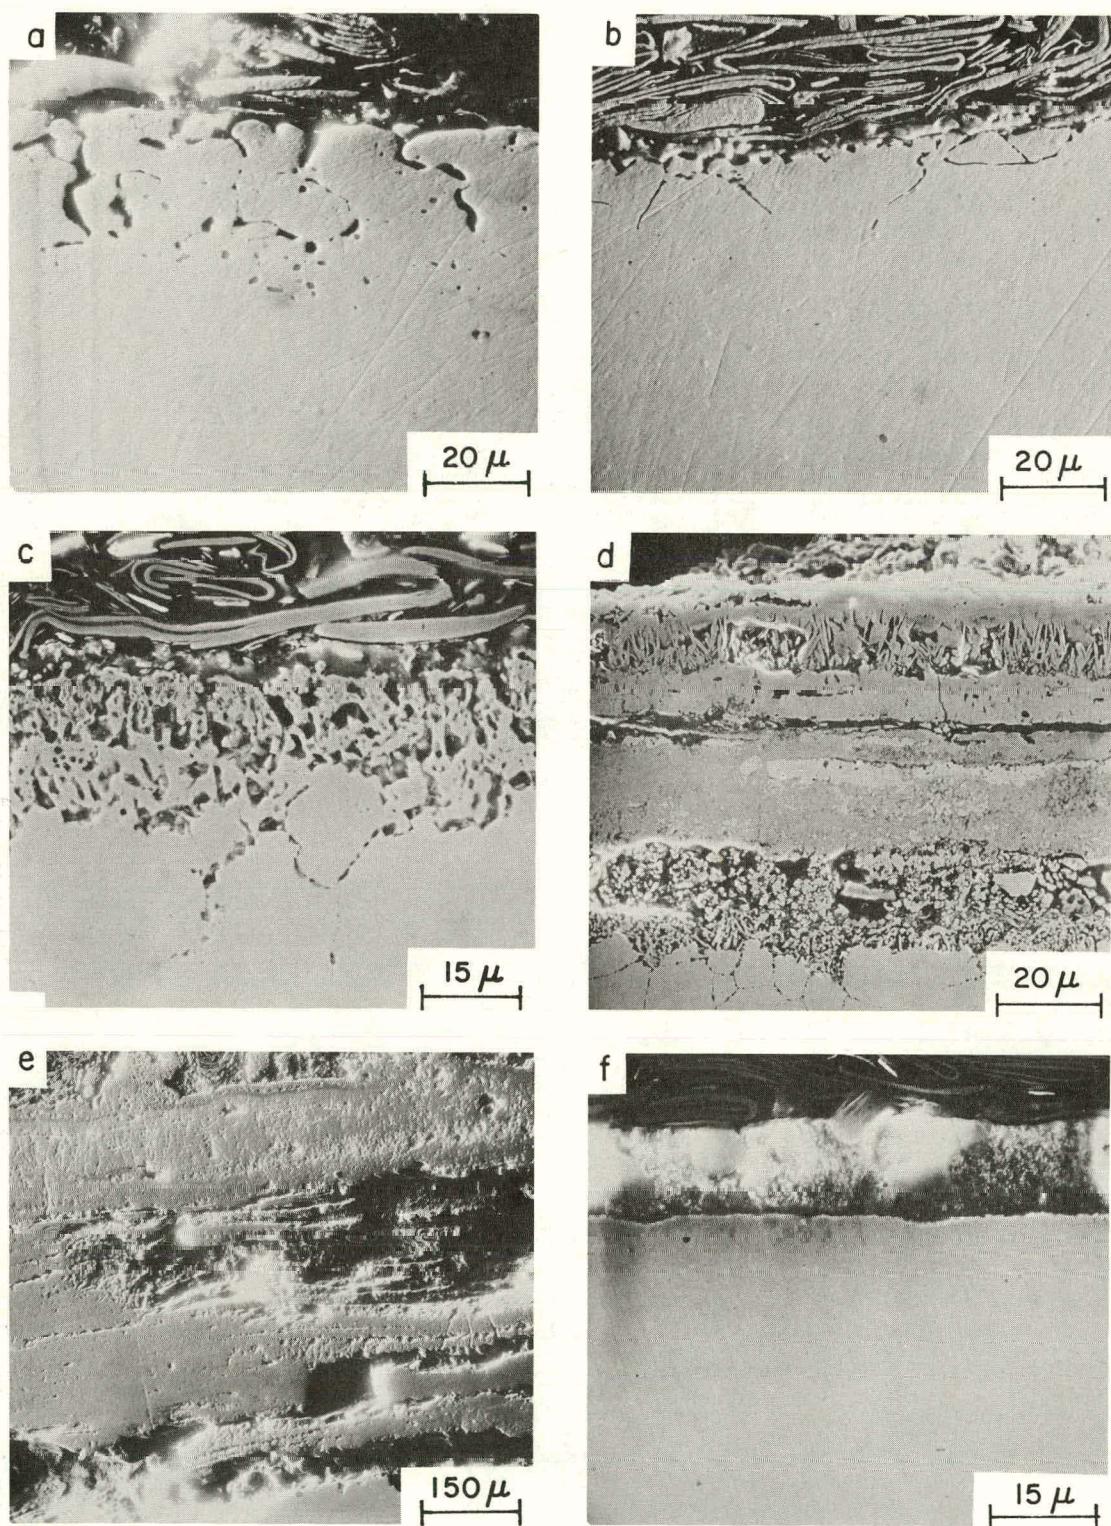
To evaluate the effect of temperature on the corrosion behavior of materials in the presence of salt, corrosion specimens were placed at different heights above the fluidized bed. The temperature of the specimens varied from 1123 to 723 K. For these tests, the fluidized bed contained 3.0 mole % NaCl. Micrographs of Types 304 and 310 stainless steel specimens exposed inside and above the bed at different temperatures are shown in Figs. 25 and 26, respectively.

Fig. 25. SEM Micrographs of Type 304 Stainless Steel after a 100-h Exposure.  
 (a) Exposed in bed at 1123 K, (b-f) exposed above bed at (b)  
 1123 K, (c) 1073 K, (d) 923 K, (e) 823 K, and (f) 723 K.  
 ANL Neg. No. 306-78-791.

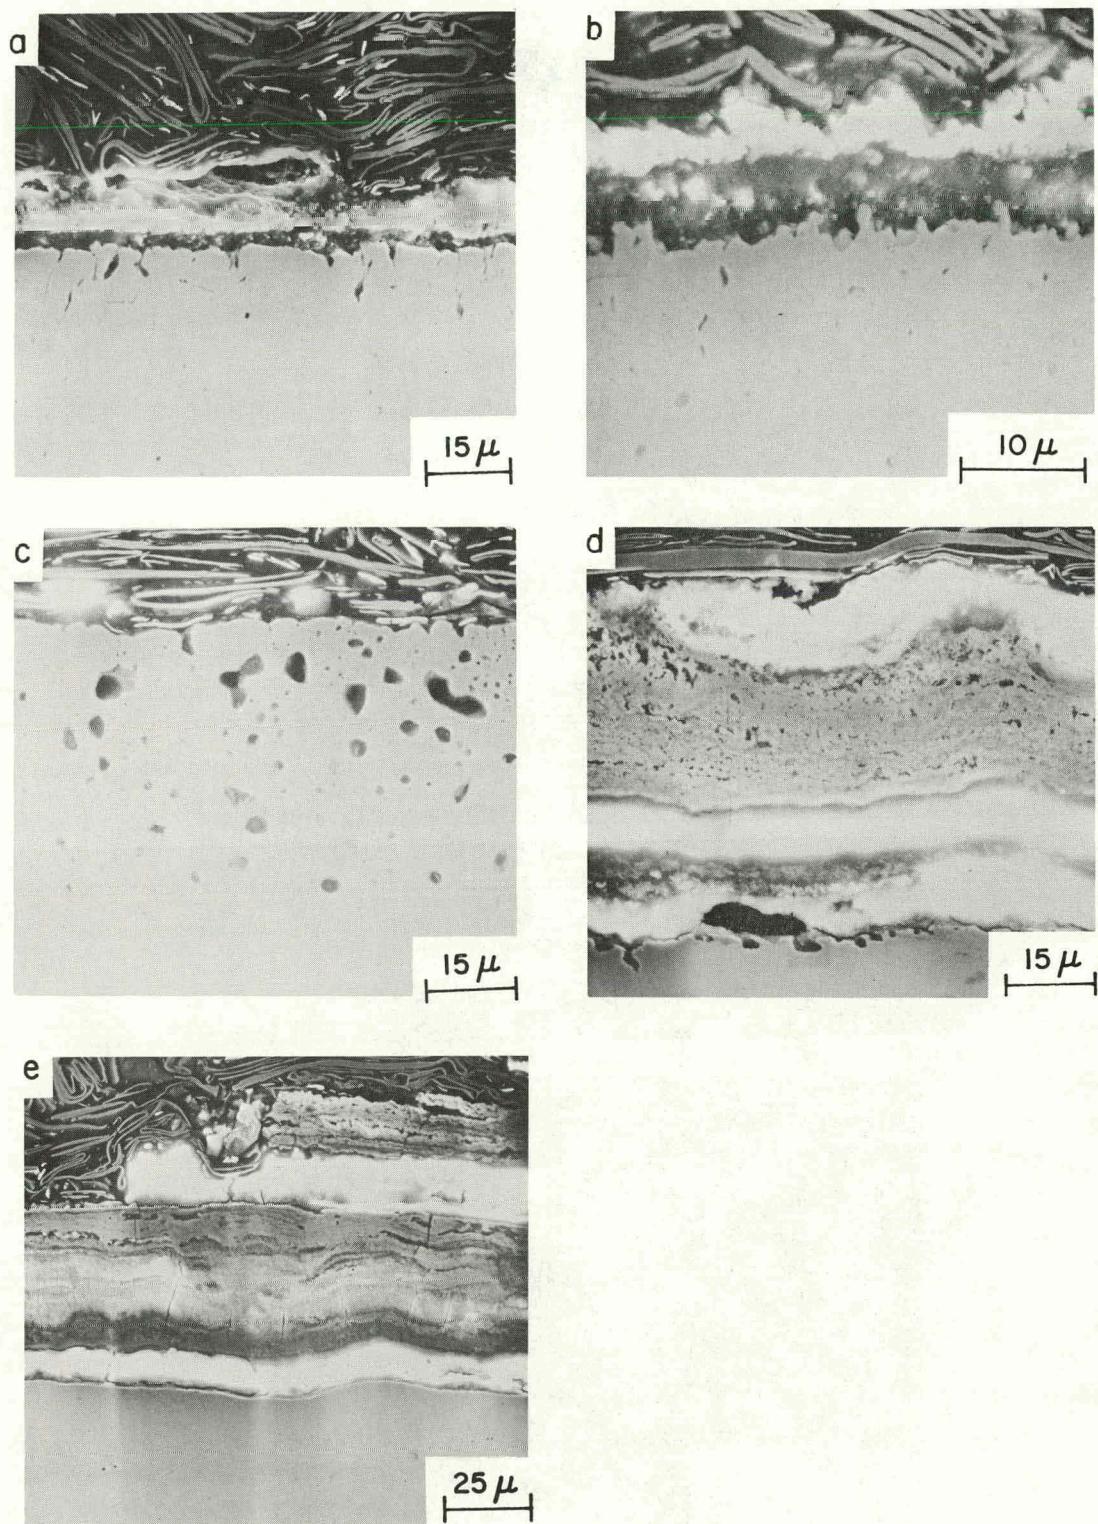
Fig. 26. SEM Micrographs of Type 310 Stainless Steel after a 100-h Exposure.  
 (a) Exposed in bed at 1123 K, (b-e) exposed above bed at (b)  
 1123 K, (c) 1073 K, (d) 923 K, and (e) 823 K.  
 ANL Neg. No. 306-78-792.

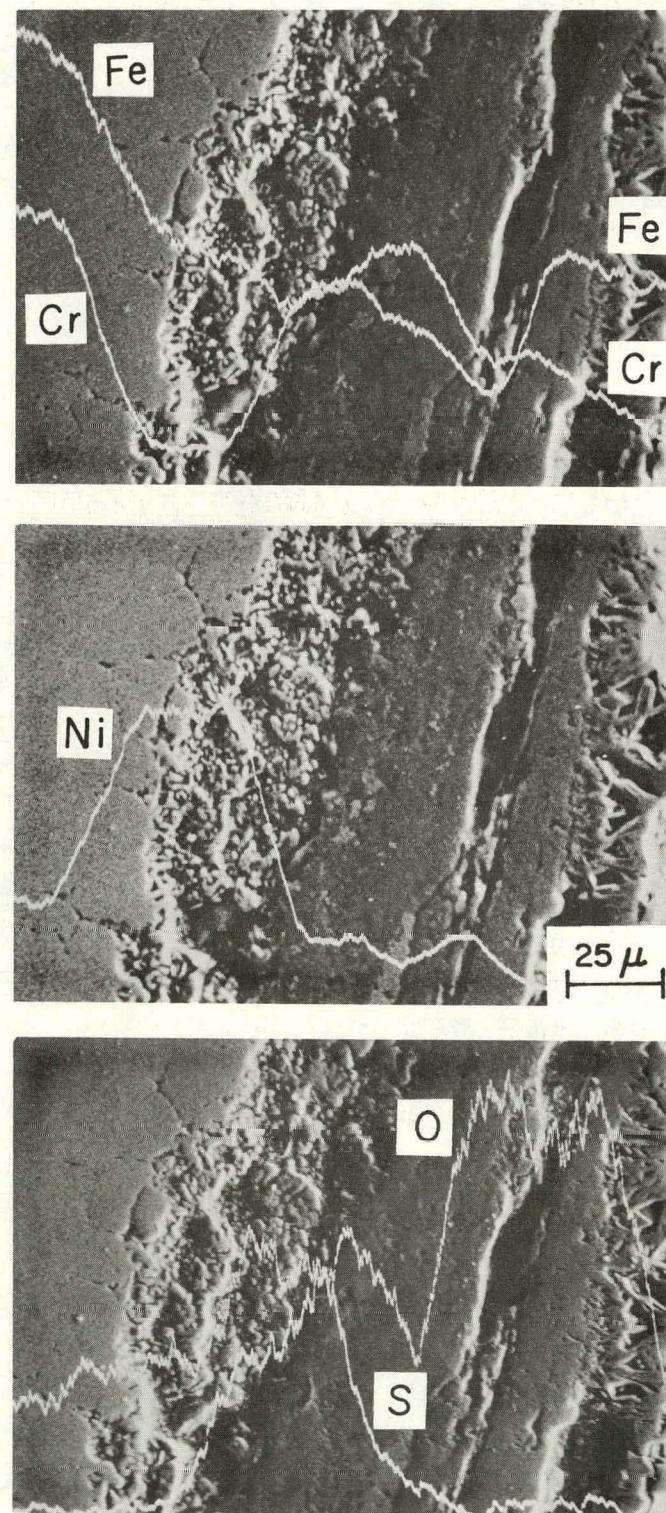
The x-ray microprobe line analyses for iron, chromium, nickel, oxygen, and sulfur on Types 304 stainless steel specimens exposed at 923 K above the bed containing NaCl are shown in Fig. 27. The relative concentration of these elements shows that the outer surface scale consists mainly of iron and oxygen. The inner scale contains iron, chromium, and oxygen. The region below the oxides consists of nickel, iron, and sulfur. The x-ray images for the above elements and chlorine are shown in Fig. 28 along with a micrograph of the surface scale on the same specimen. The distribution of the various elements shows the two oxide layers and the region of internal sulfidation and oxidation. The x-ray image for chlorine shows that this element is present in regions which show a higher concentration of sulfur. This behavior was observed in all the specimens exposed at 923 and 823 K. Chlorine was observed in the region between the oxide layer and the area of internal sulfidation. The sulfide/mixed-oxide and the mixed-oxide/iron-oxide interfaces observed in Type 304 stainless steel specimens exposed at 823 K are shown in Figs. 29a and 29b, respectively. Cubes of NaCl can be clearly seen in the sulfide region.

Fig. 27. X-ray Microprobe Line Analyses for Fe, Cr, Ni, O, and S on Type 304 Stainless Steel Specimen Exposed above the Bed for 100 h at 923 K. ANL Neg. No. 306-78-788.

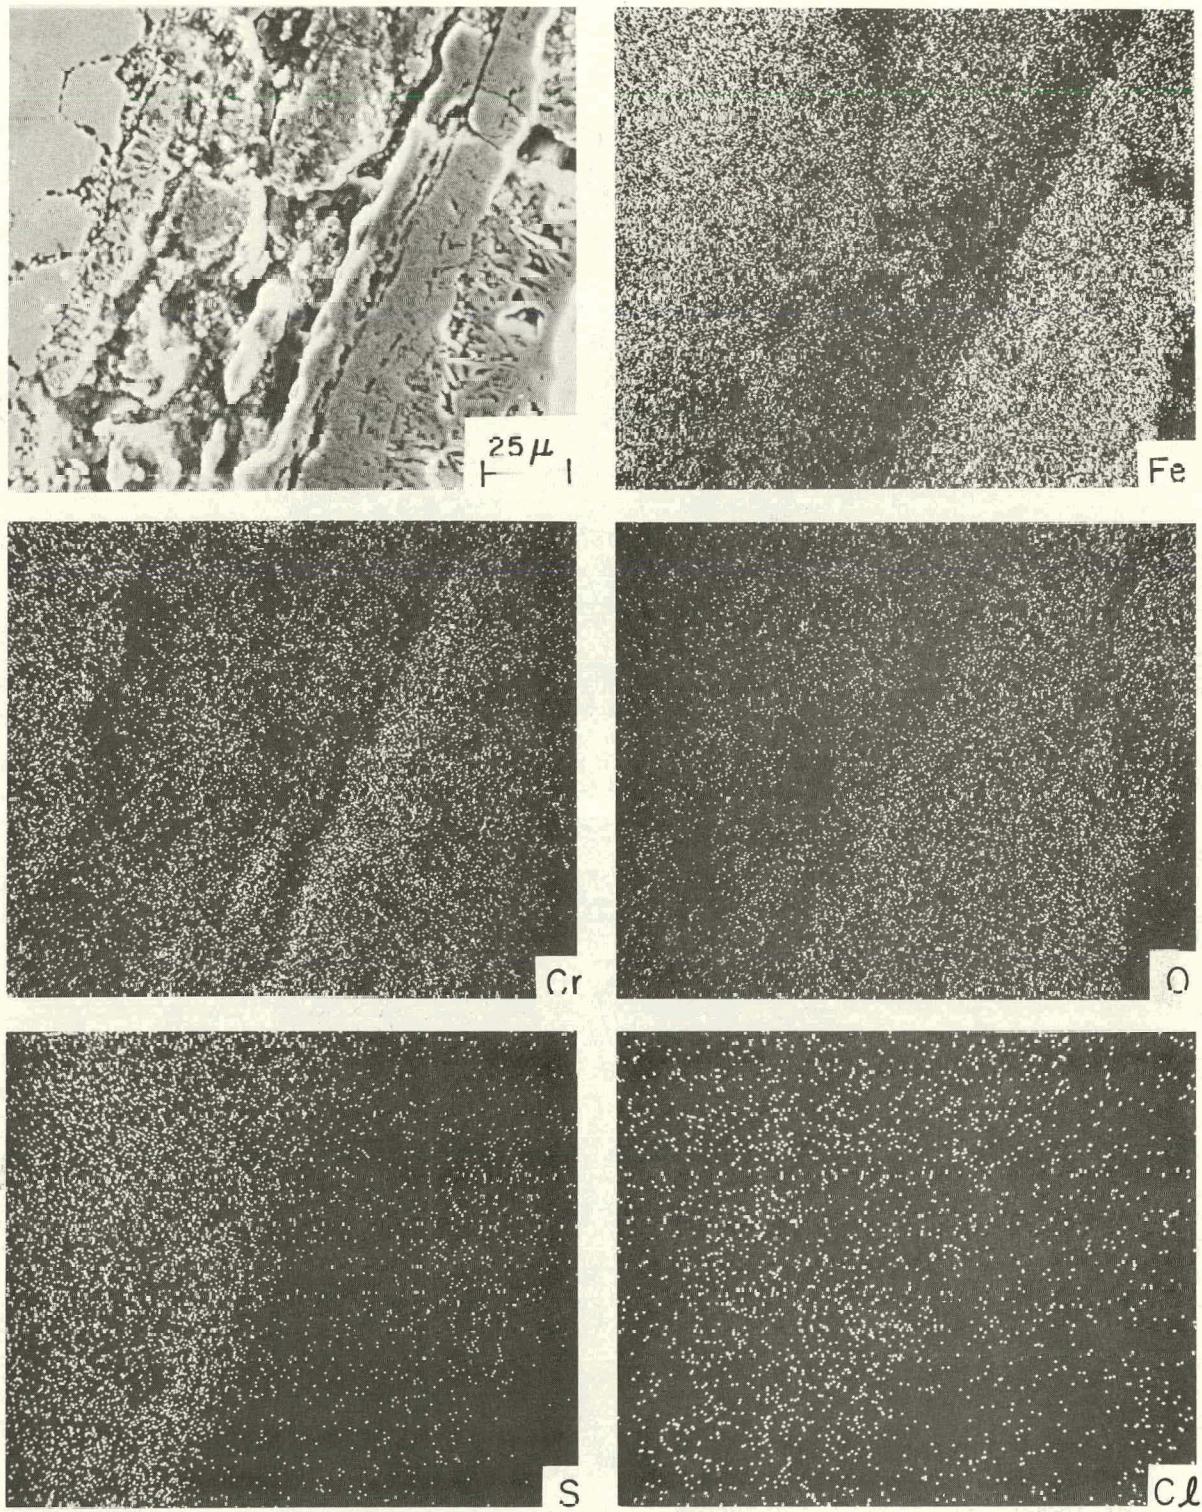
Fig. 28. SEM Micrograph and X-ray Images for Fe, Cr, O, S, and Cl of Type 304 Stainless Steel Specimen Exposed above the Bed for 100 h at 923 K. ANL Neg. No. 306-78-789.

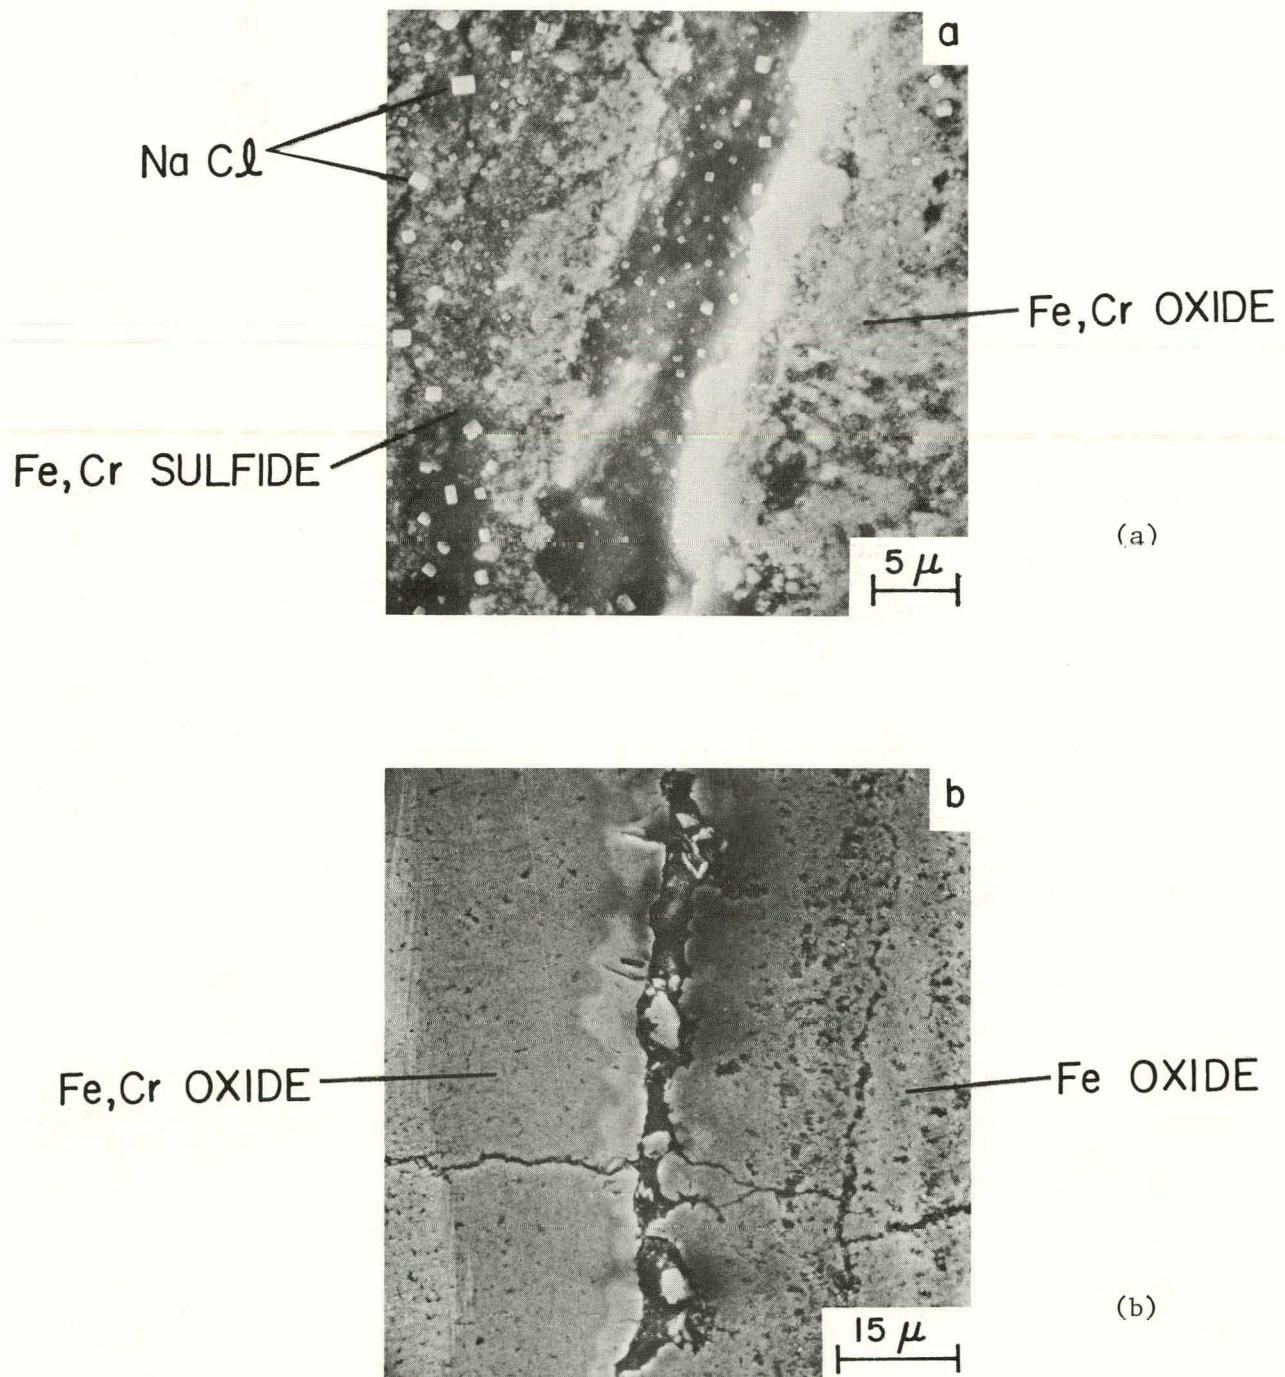
Fig. 29. SEM Micrograph of (a) Sulfide/Mixed-oxide Interface and (b) Mixed-oxide/Iron-oxide Interface Observed in Type 304 Stainless Steel Specimen Exposed above the Bed for 100 h at 823 K.  
ANL Neg. No. 306-78-790.
