Solar Thermal Power Systems Project
Parabolic Dish Systems Development

Bearing Development Program for a 25-kWe Solar-Powered Organic Rankine-Cycle Engine

JPL Publication 85-81

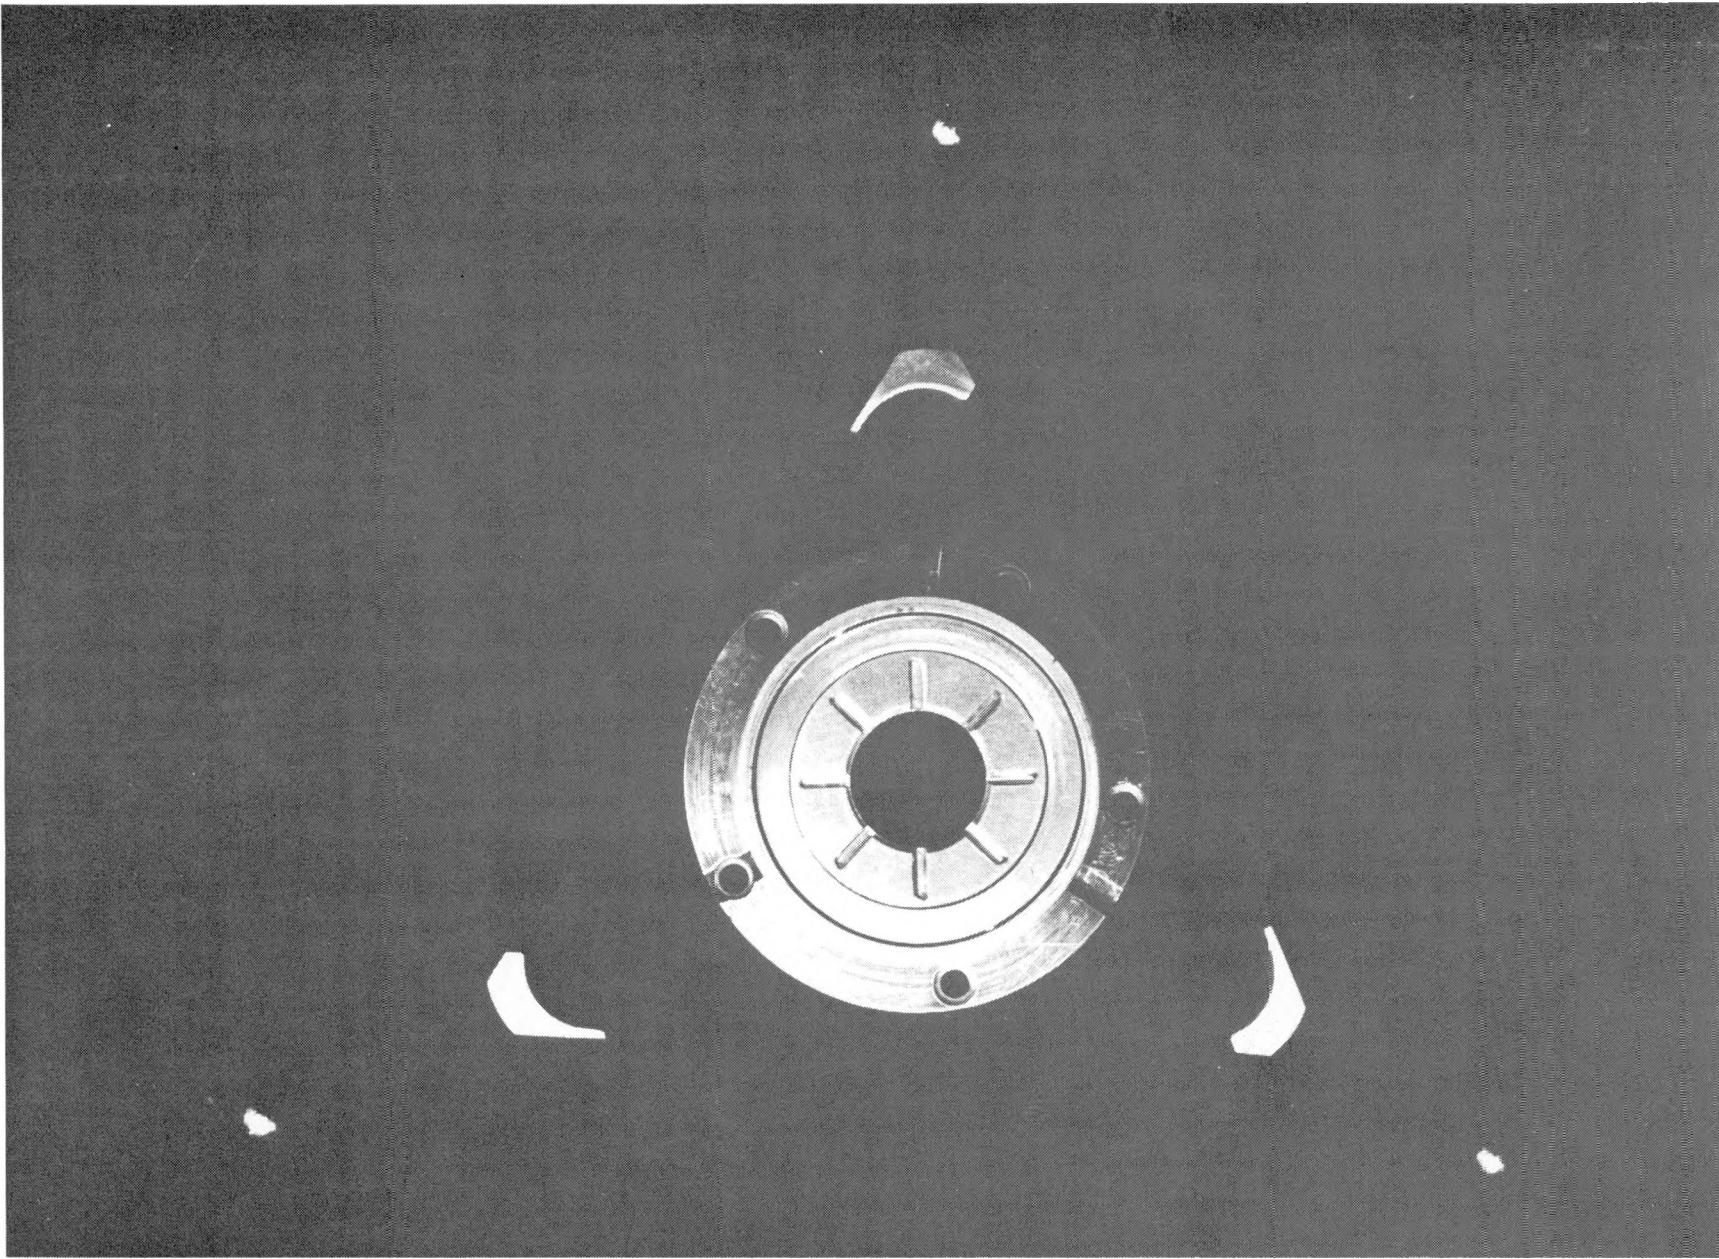
Figure 3-2. Reduced-Mass Tilting Pads with 10-deg Leading Edge Chamfer

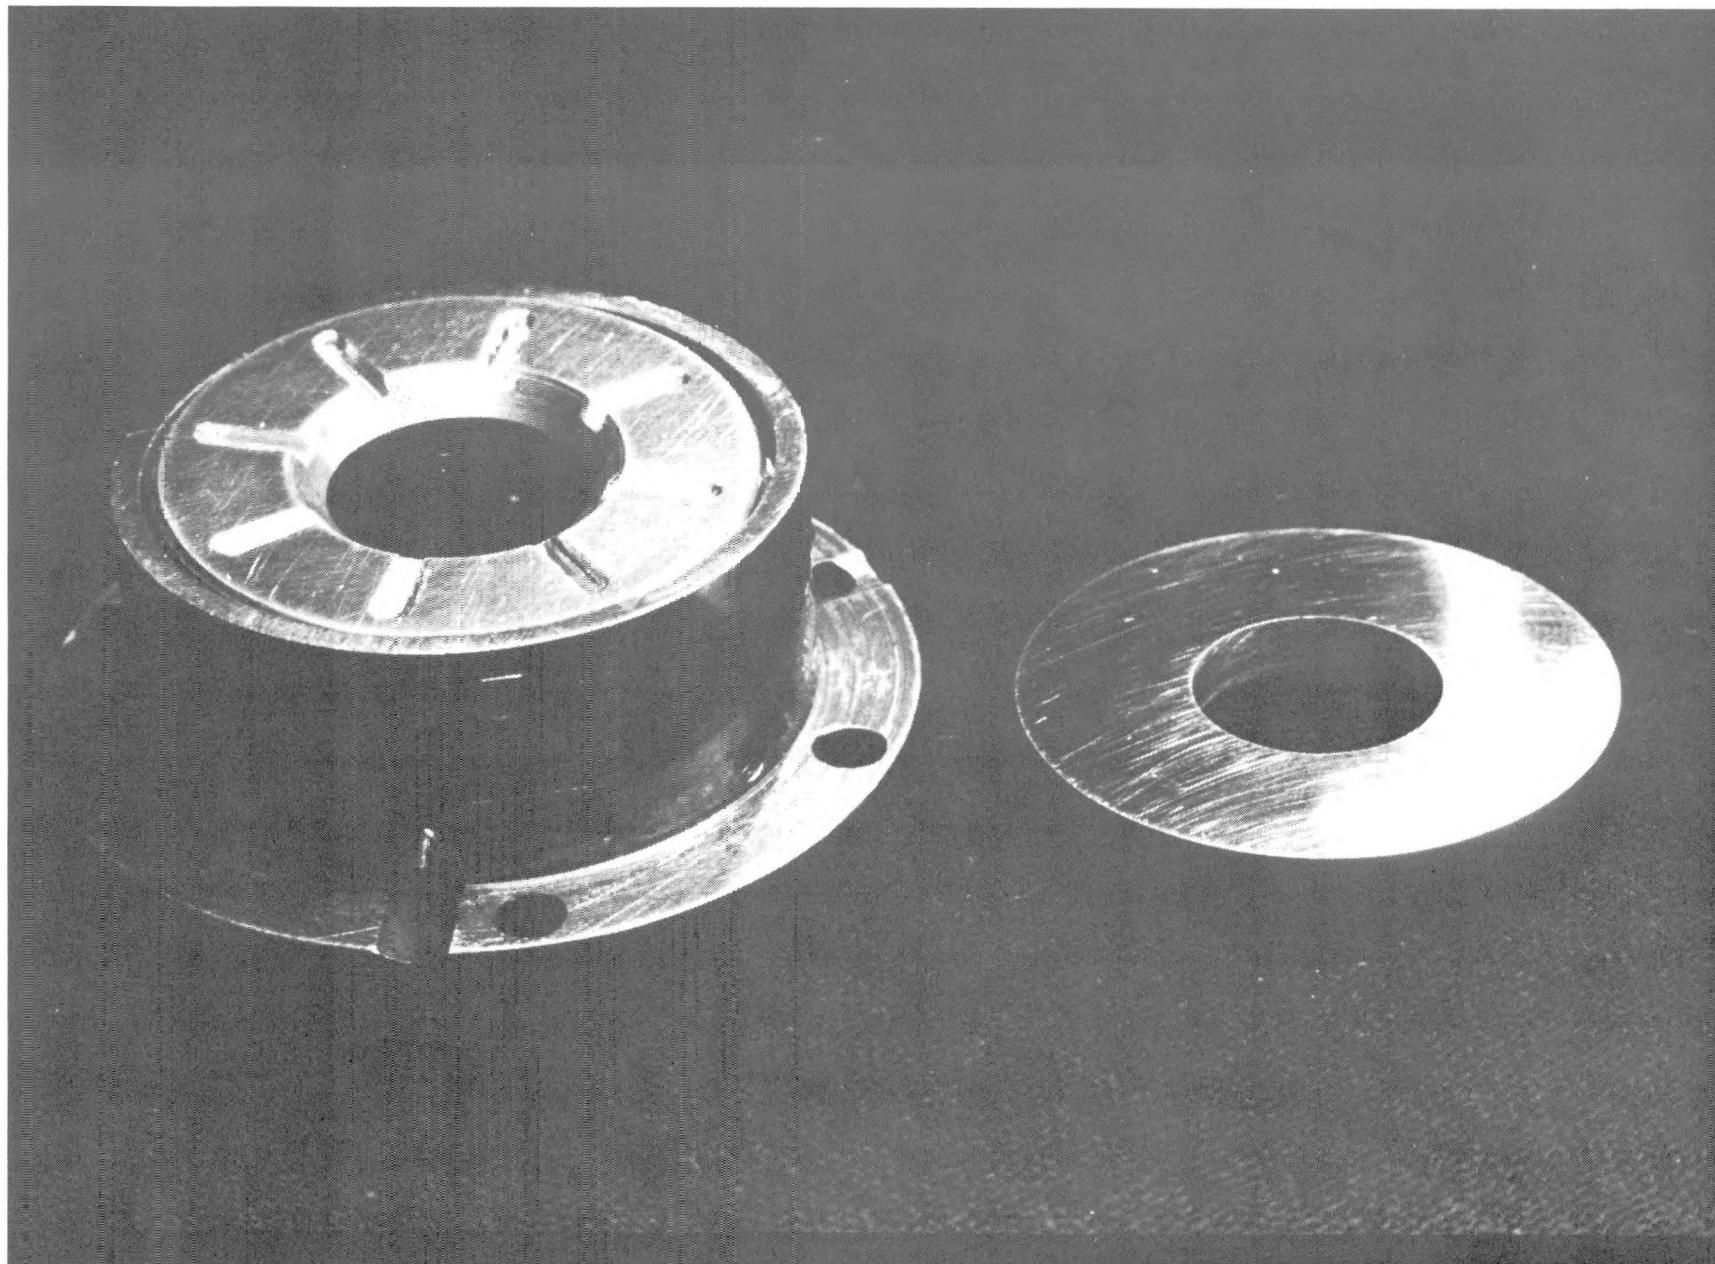
All accelerometer measurements were extremely high and fluctuating both in frequency and amplitude, making conclusive results impossible. In TAP build 8 the turbine end thrust bearing was redesigned to increase the diameter from 1.19 to 1.5 in., and the bearing material was changed from bronze to flame-sprayed babbitt on 52100 steel (Figure 3-4). The thrust runner diameter was also increased, and the material was changed from 304 stainless to 17-4 PH steel. A silver flash coating was applied over the babbitt on the journal bearing pads in an effort to further minimize start-up and shutdown contact wear.

Figure 3-4. Thermal Wedge (Fogg) Turbine End Thrust Bearing (left) made of 52100 Steel with Flame-Sprayed Babbitt Surface and Thrust Runner (1.5-in. diameter) made of 17-4 PH Steel

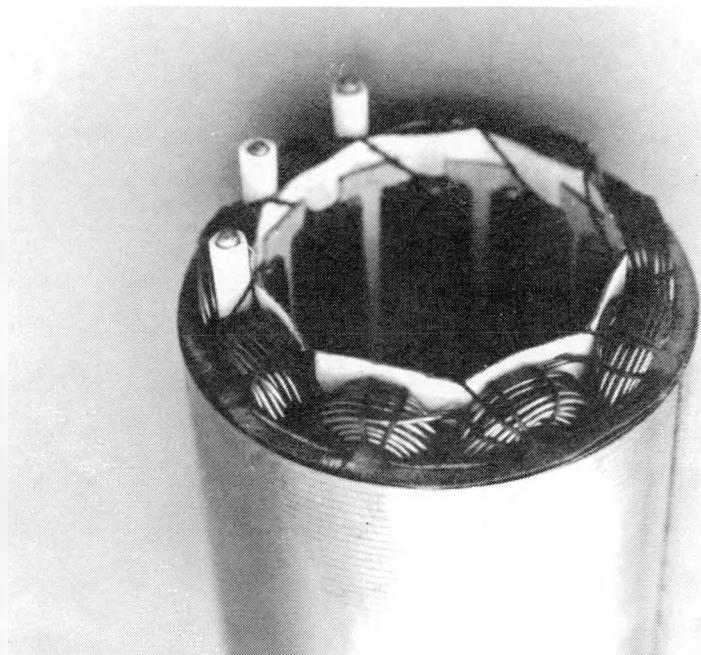
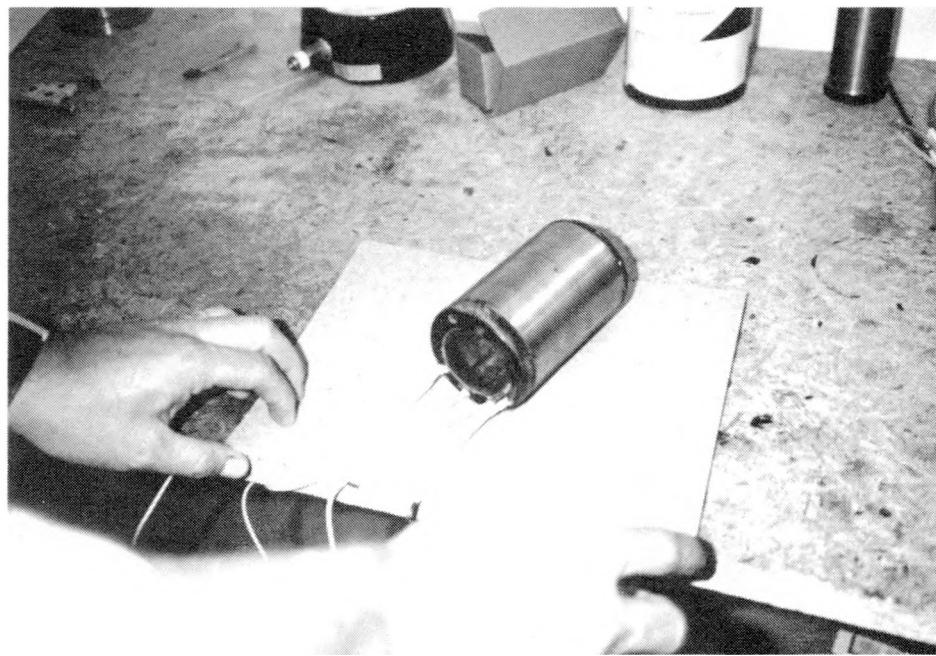
Figure 5-7. (a) Rewound Stator and (b) Rewound Stator after Potting and Encapsulation

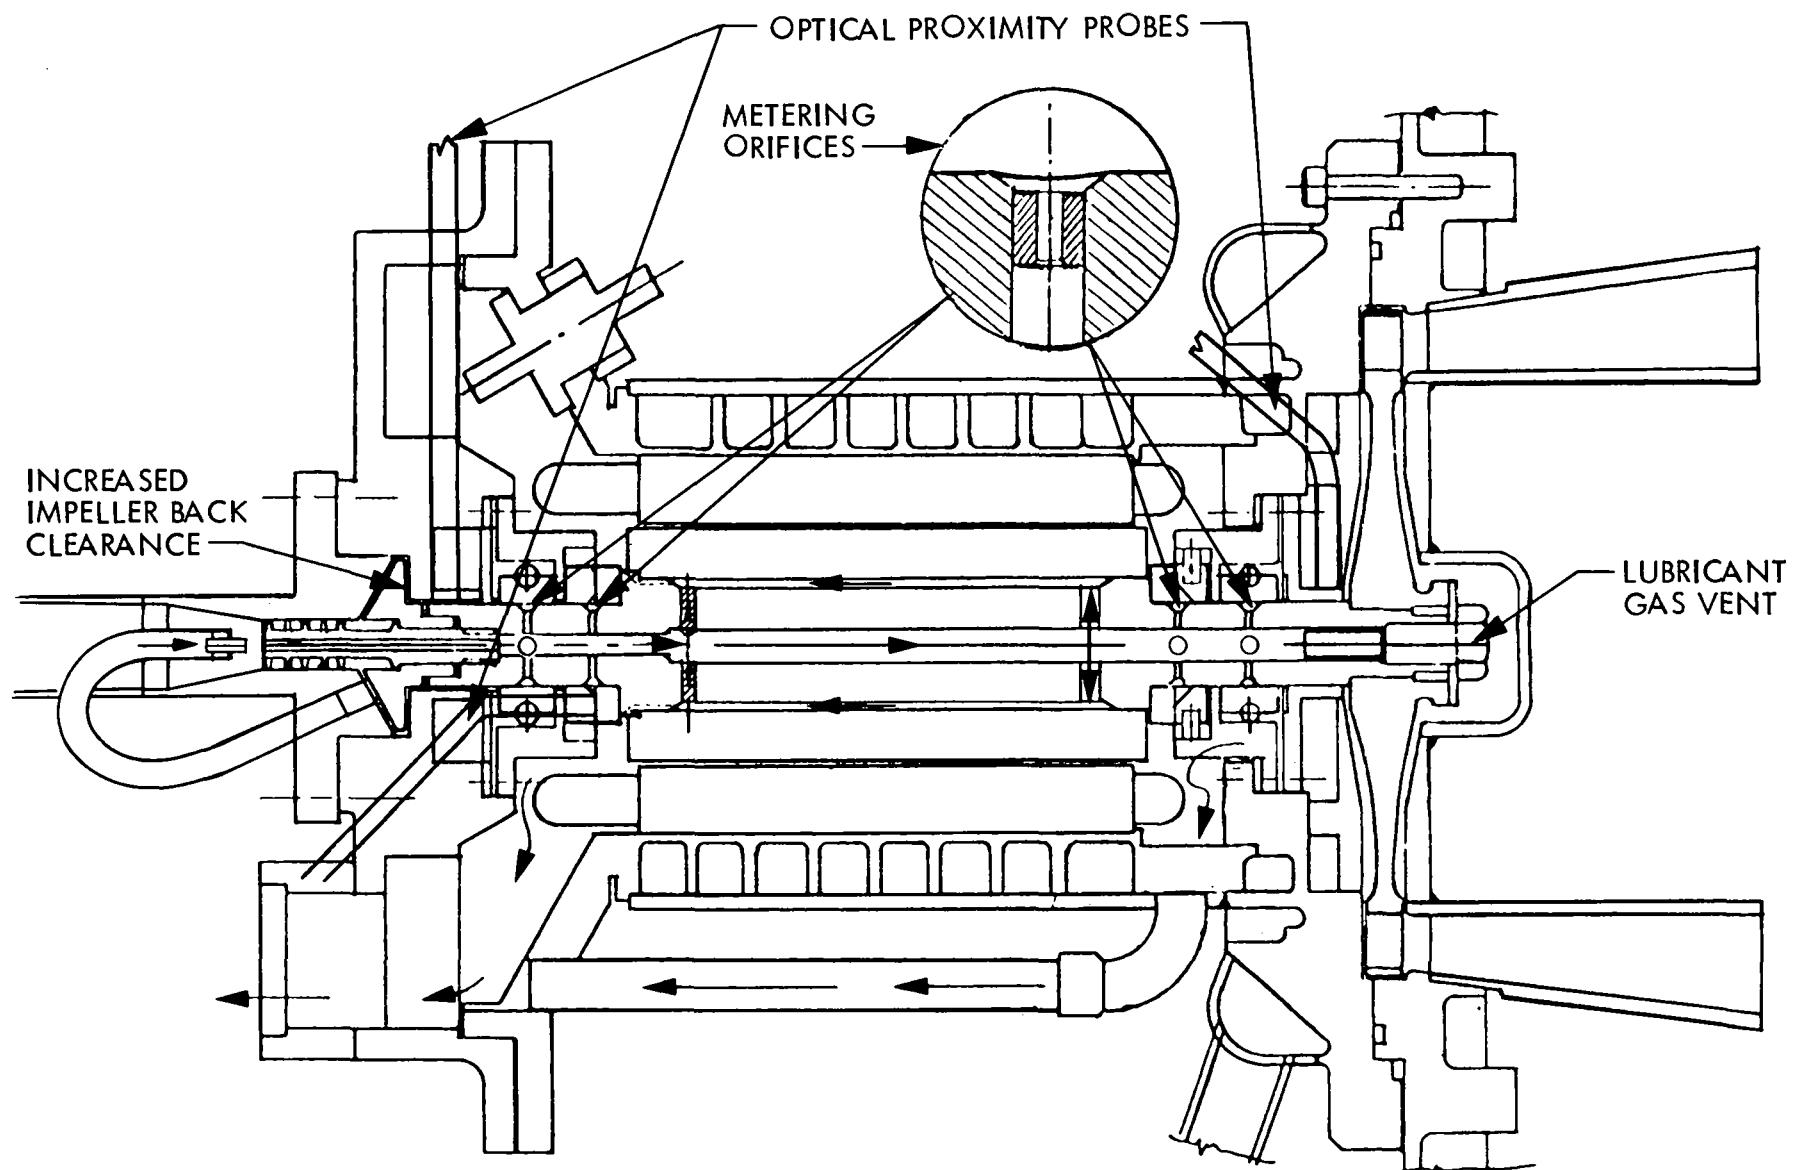
Figure 7-2. Metering Orifices Installed in each Radial Lubricant Hole (TAP Build 14)

The bearing lubrication and rotor coolant channels within the rotating shaft were the most obvious unconventional aspect of the TAP design and were extensively analyzed by B-N, FACC, and JPL personnel. Because of the extreme complexity of the fluid dynamics, only a few general conclusions were made. Cavitation was occurring at the entrance of each radial bearing lube hole and limiting the amount of fluid delivered to each bearing. The combination of cavitation and fluid momentum introducing vapor and dividing the hydrodynamic film under the pad may have significantly altered the stiffness and damping of the bearings and thus introduced rotordynamic instabilities. Modifications made to reduce this possibility were: (1) to install small orifices at the exit of each radial lube hole to minimize cavitation in the lube channels (Figure 7-2), (2) to enlarge the jet pump exit and shaft lubricant inlet to

increase total flow and pressure, and (3) to install a small vent on the shaft centerline at the turbine end to eliminate any possibility of trapped gases restricting flow to the bearings.

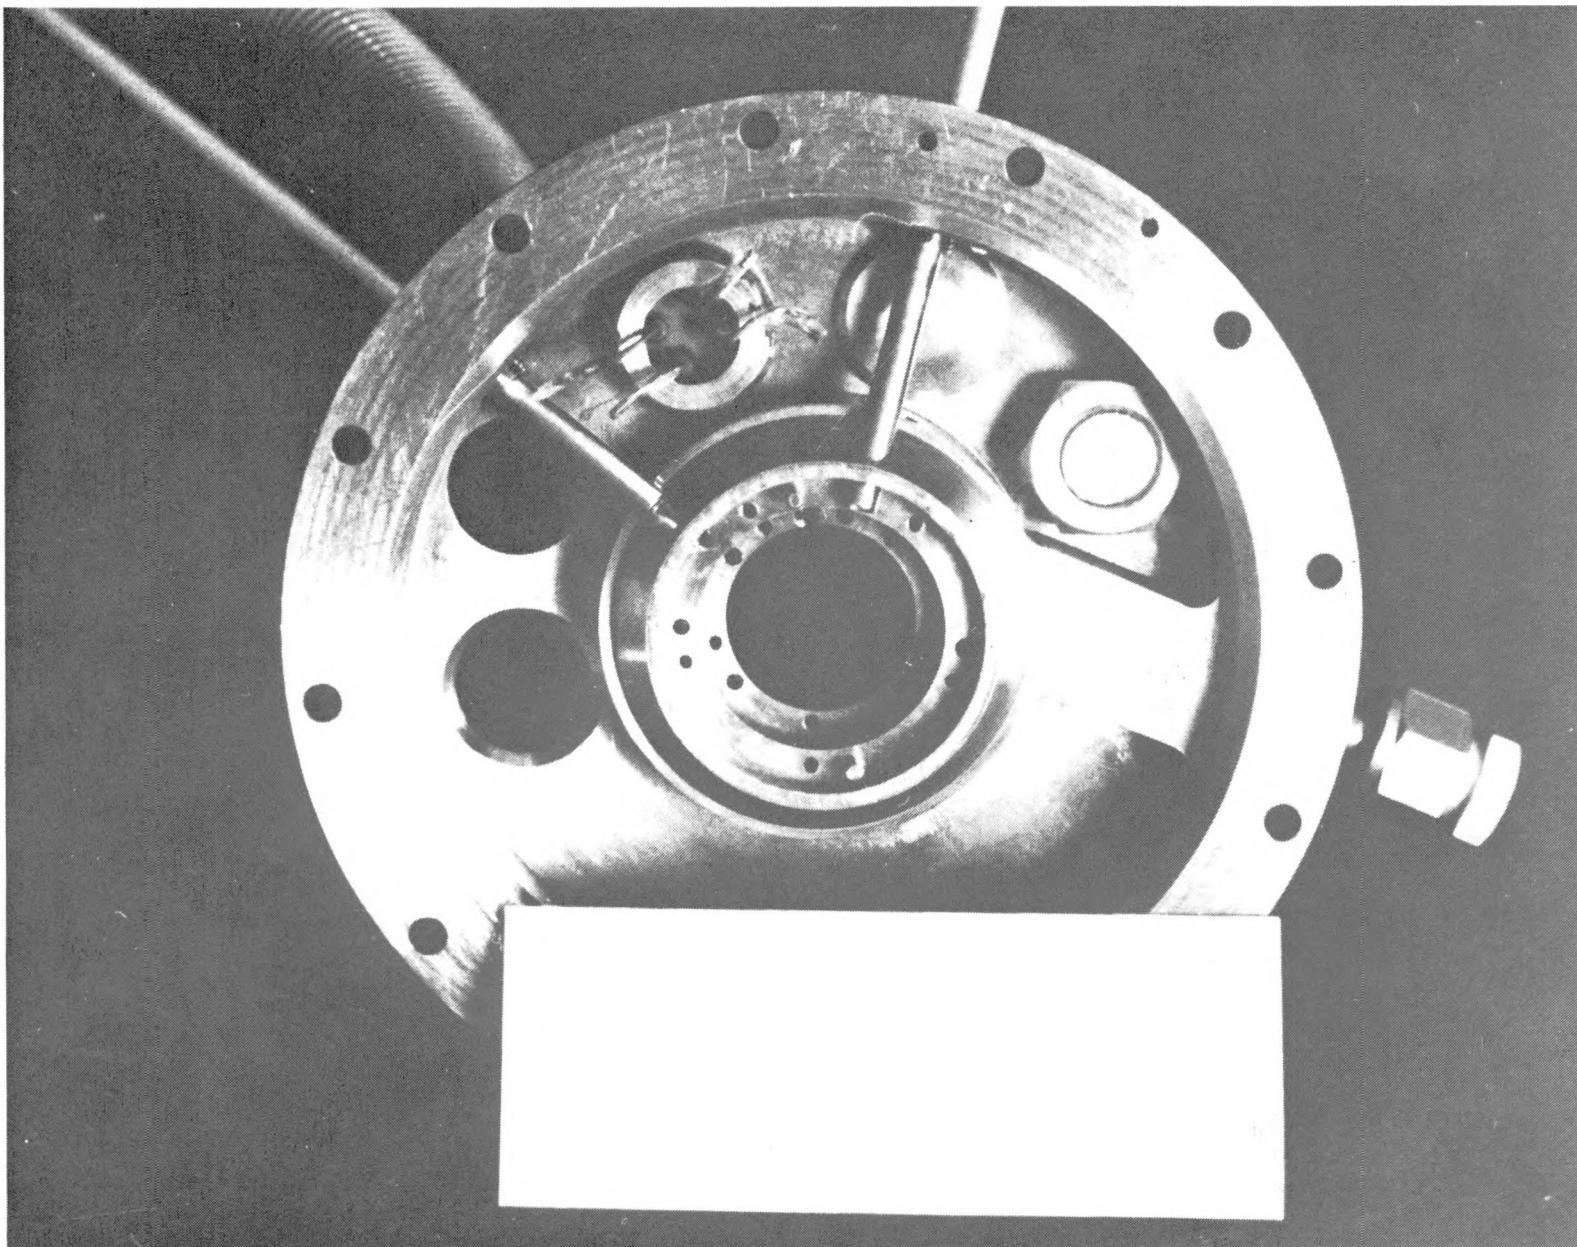
Figure 7-5. Method of External Lubrication for Stabilized Bearings

TAP builds 15 through 19 incorporated two squeeze-film-damped journal bearings with external lubrication (Figure 7-5) and two internally lubricated thrust bearings.

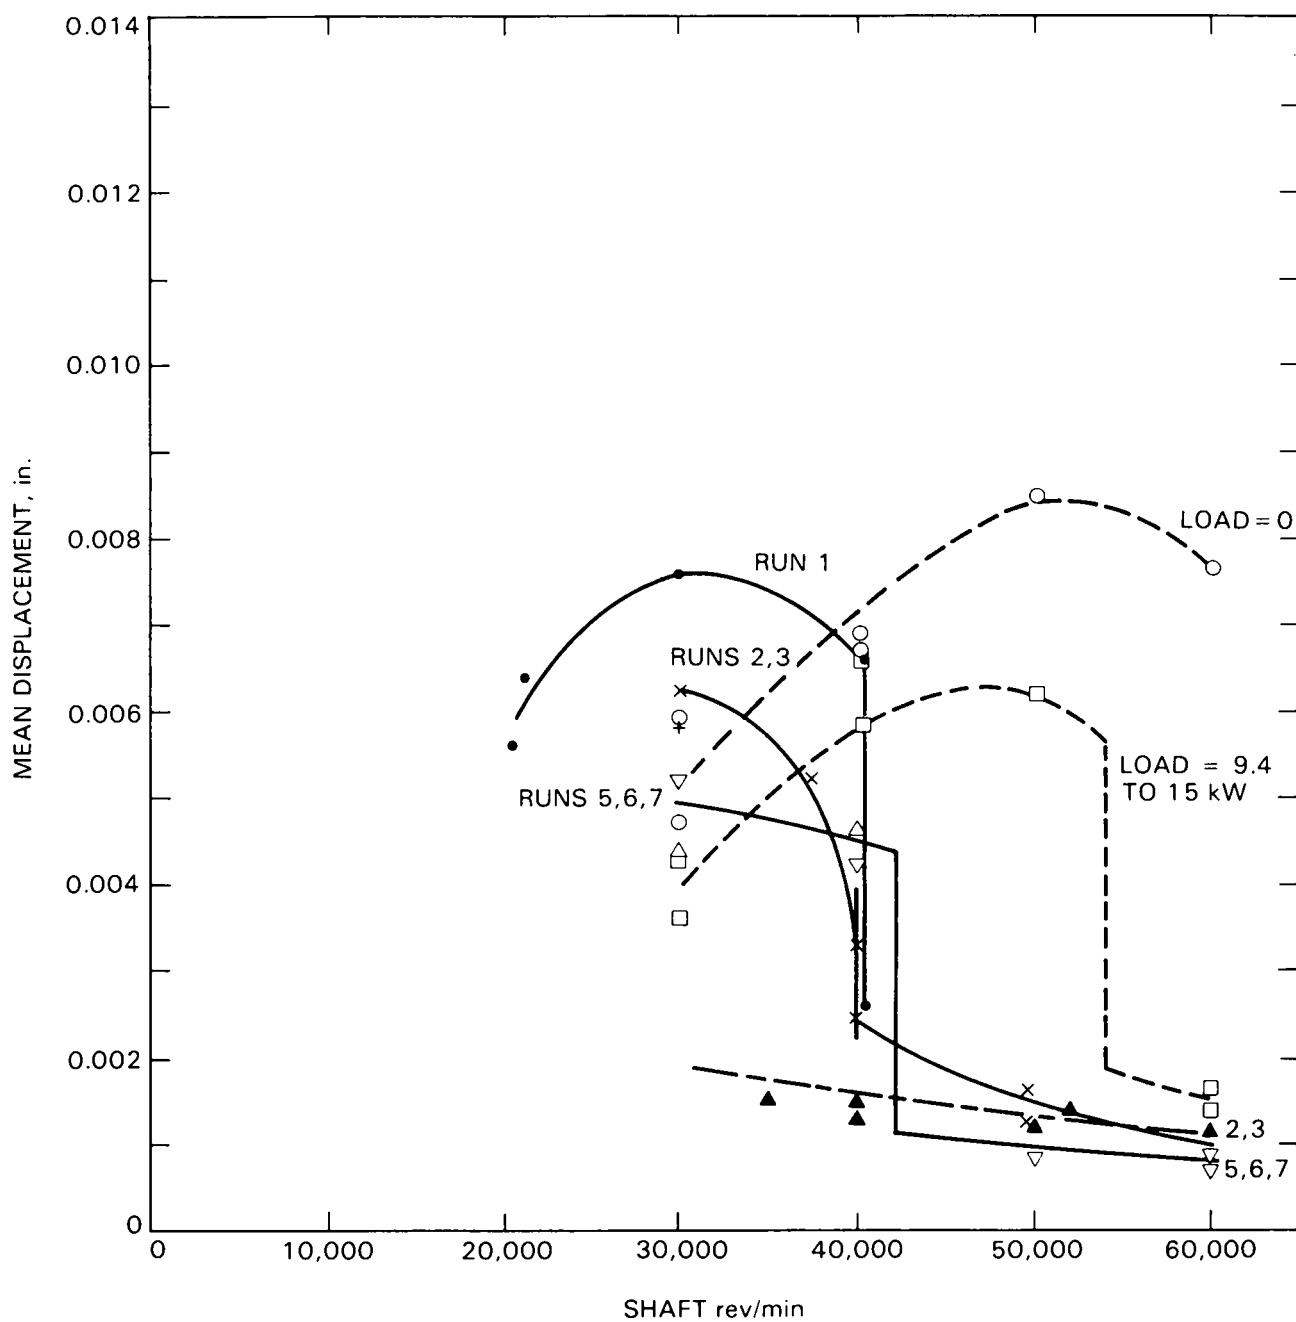
The damping coefficient of the journal bearings was adjusted by changing the fluid leakage resistance path out of the damper section. This was essentially a trial-and-error process to minimize the total shaft displacement, which was a strong function of shaft speed and loading. Radial displacements as high as 8 mils observed in build 15 were reduced to between 1 and 2 mils in build 19 (Figure 7-6). The subsynchronous instability was never eliminated; however, the frequency and amplitude were decreased by adjustments to the squeeze-film-damped journal bearings. The compliance in the damper made the total displacement of the shaft greater for the squeeze-film-damped journal bearing than for the tilting-pad bearing. This resulted in thrust bearing wear caused by excessive angular displacement of the shaft.

Figure 7-6. Total Shaft Displacement with the Squeeze-Film-Damped Journal Bearing

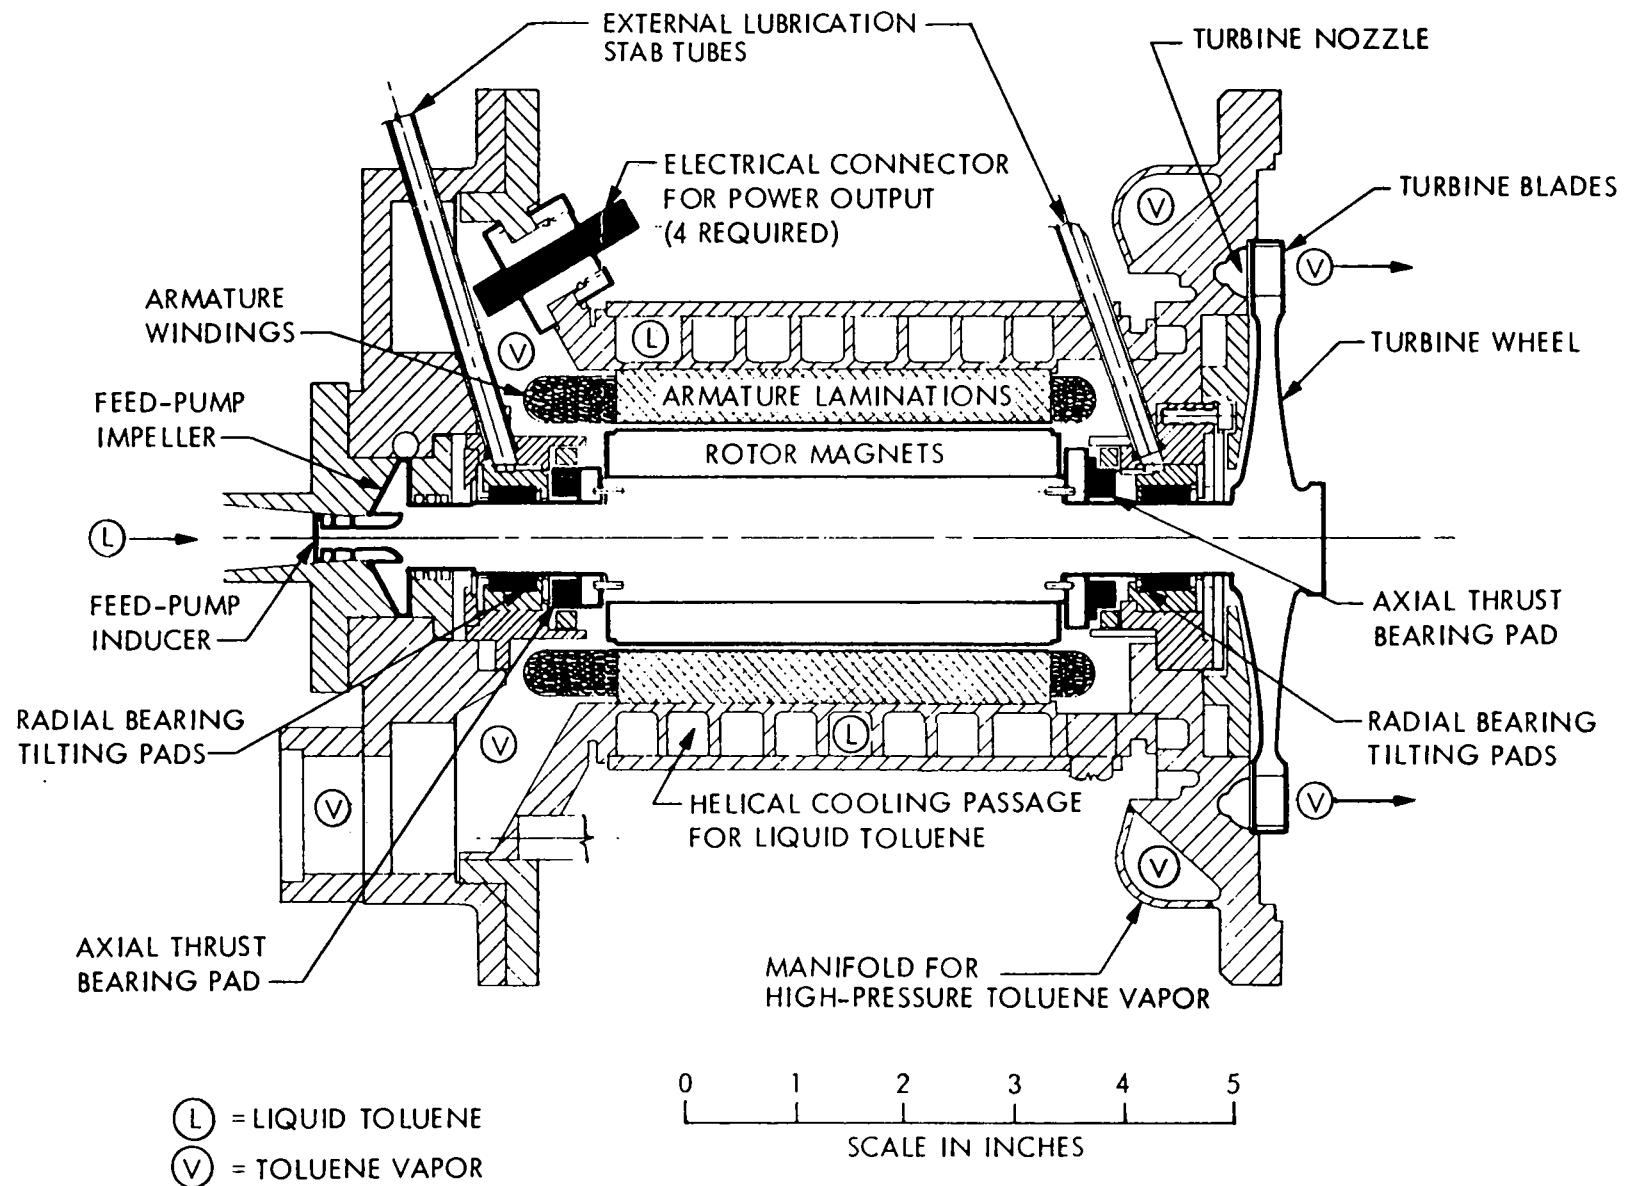
Figure 7-8. Externally Lubricated: Waukesha Five-Pad Tilting-Pad Journal Bearings and Fogg Flat Pad/Raleigh Step Thrust Bearings

Tap builds 20 to 23 were tested, using fully externally lubricated thrust and Waukesha-supplied, five-pad tilting-pad journal bearings (Figure 7-8). Figure 7-9 shows how holes were placed in the lubrication grooves in the pump and turbine end thrust bearings, thus allowing flow from the flooded journal bearing lubricant reservoir onto the thrust bearing surfaces. Figure 7-10 shows both sides of the Waukesha five-pad tilting-pad journal bearing housing with one bronze end seal removed for better viewing. The five radial tubes delivered lubricant near the leading edge of each pad and maintained a fully flooded bearing housing. The same five tubes also functioned as anti-rotation pins for each pad. The two smaller pins in the figure are end seal anti-rotation pins. Figure 7-11 shows a pad from a Waukesha-designed five-pad tilting-pad journal bearing before and after testing. Waukesha fabricated the original pads and B-N duplicated their manufacturing capabilities for subsequent pads.

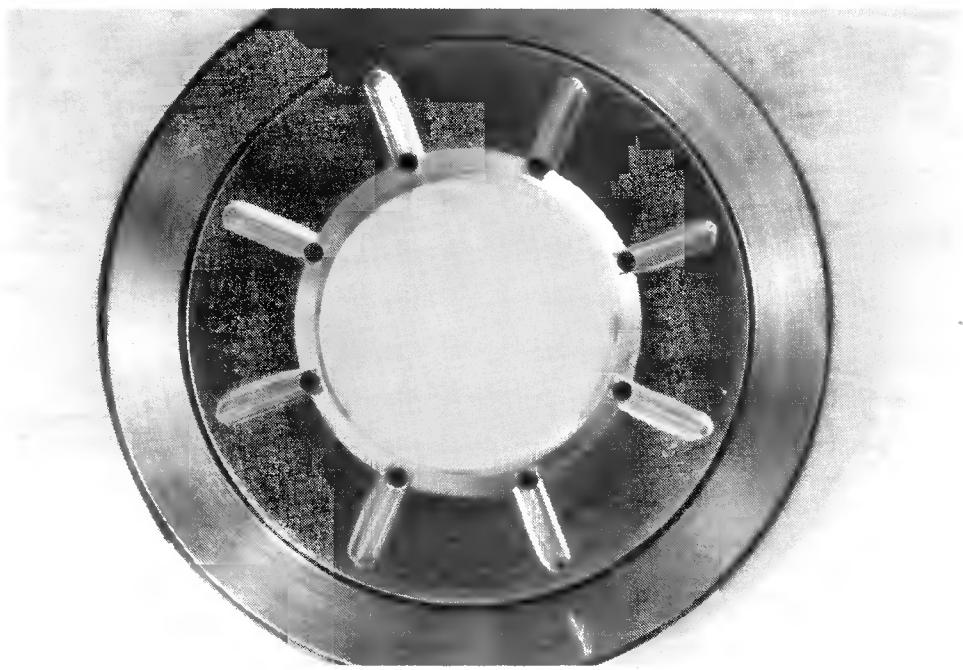
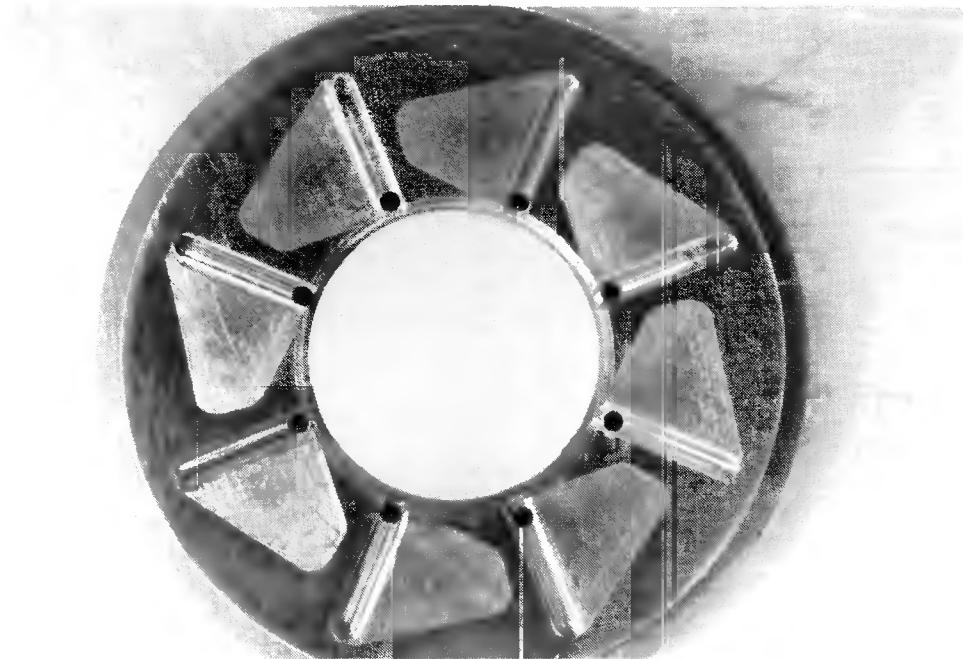
Figure 7-9. Externally Lubricated Thrust Bearings

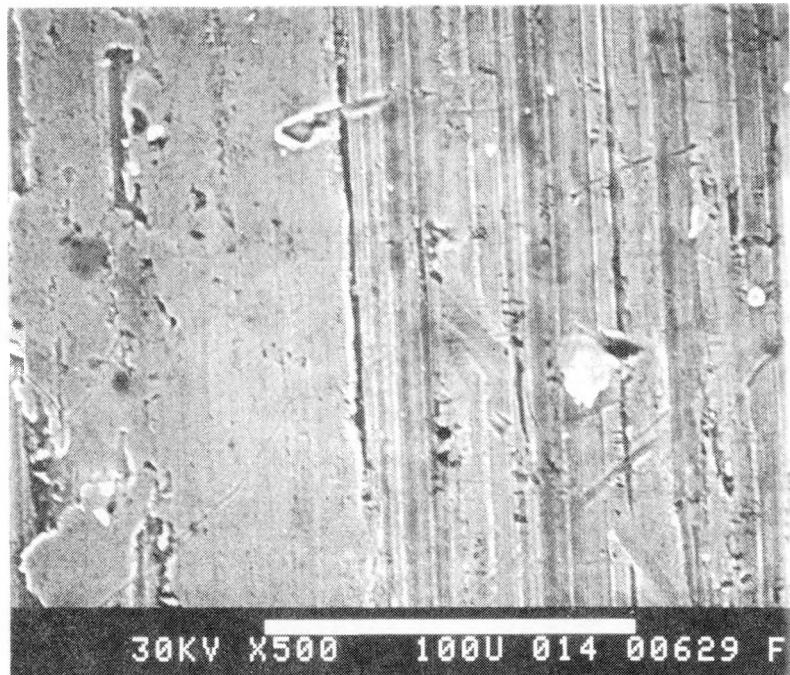
An extensive analysis of the build 21 damaged bearing surfaces was conducted by FACC using an electron beam microscope. The damaged surface on each pad had a frosted appearance, which was determined to be a number of separate but closely packed pits. Figures 7-12 and 7-13 show various magnifications of the pitted surfaces and compare them to unpitted zones. A chemical analysis inside the pits revealed high concentrations of zinc and chlorine, which were not present in the virgin babbitt or bearing material. This change is shown in Figure 7-14 where the virgin material analysis and an analysis inside a single pit are compared on one plot.

Figure 7-13. Leading Edge Surface of a Waukesha Pad without Electrical Discharge Pitting

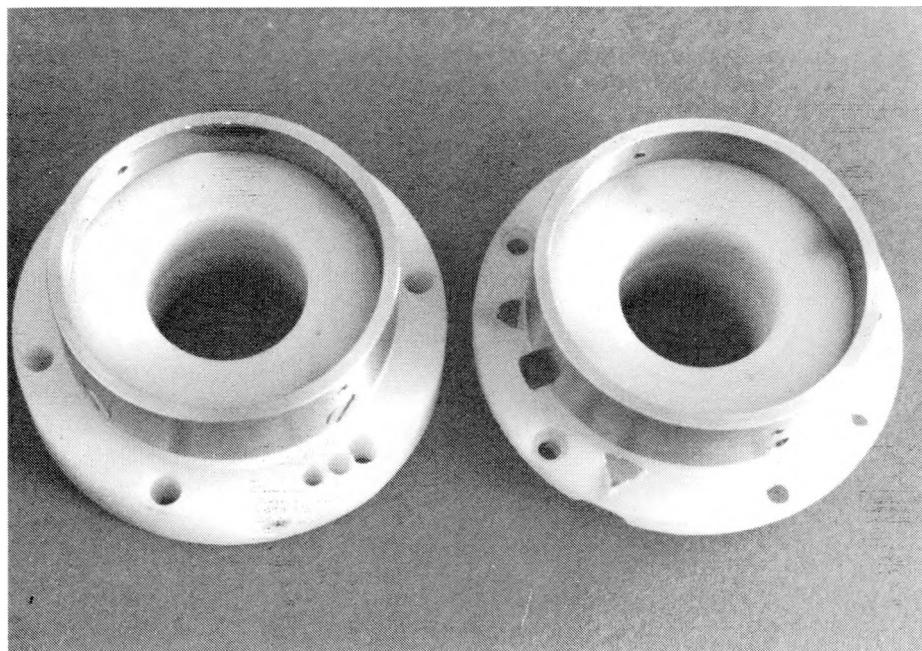
Figure 7-16. Electrically Insulated Bearing Carriers

The five-pad Waukesha tilting-pad bearings, using B-N-fabricated pads and mounted in an electrically insulated nylon bearing carrier (Figure 7-16), were used in TAP builds 30 to 35 with essentially no changes. Figure 7-17 shows the pump and turbine end thrust bearings mounted on the insulated bearing carriers and provides a good view of the grooves that disperse the lubricant over the bearing face and the holes supplying fluid from the flooded bearing reservoir to the grooves. A total of approximately 21 h of operation were accumulated on these builds with no bearing distress or electrical arcing. The success of these tests at various altitude angles from horizontal to vertical and various powers and speeds indicated that the bearings were ready for hot testing in the engine.

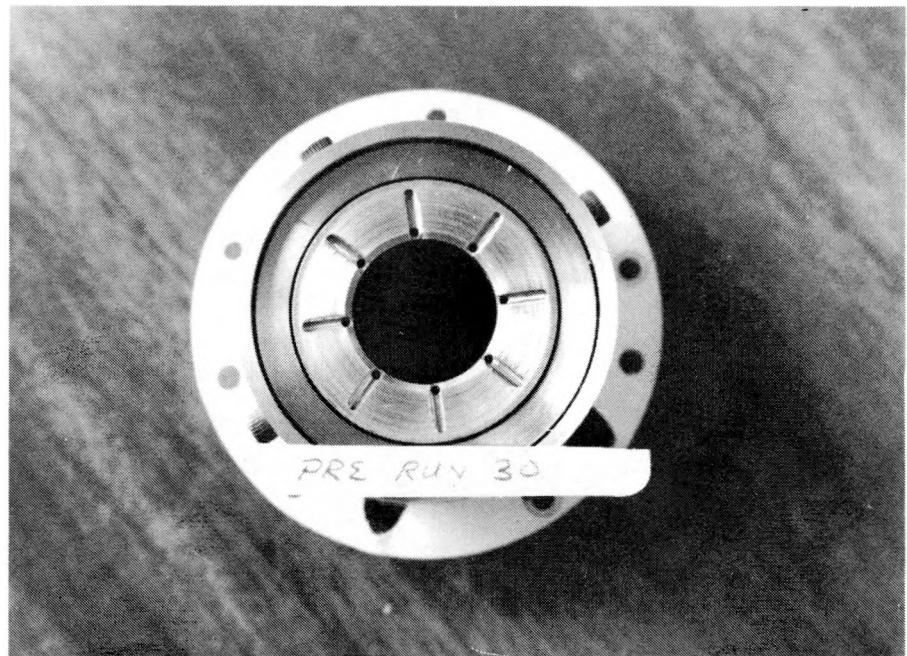
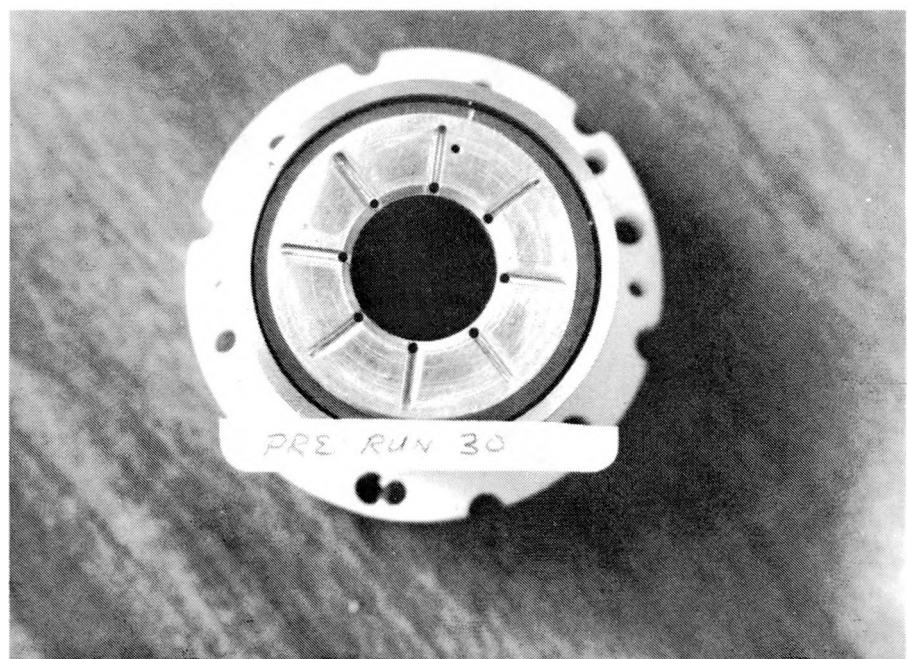
Figure 7-17. Electrically Insulated Bearing Carriers with (a) Pump End and (b) Turbine End Thrust Bearings Mounted

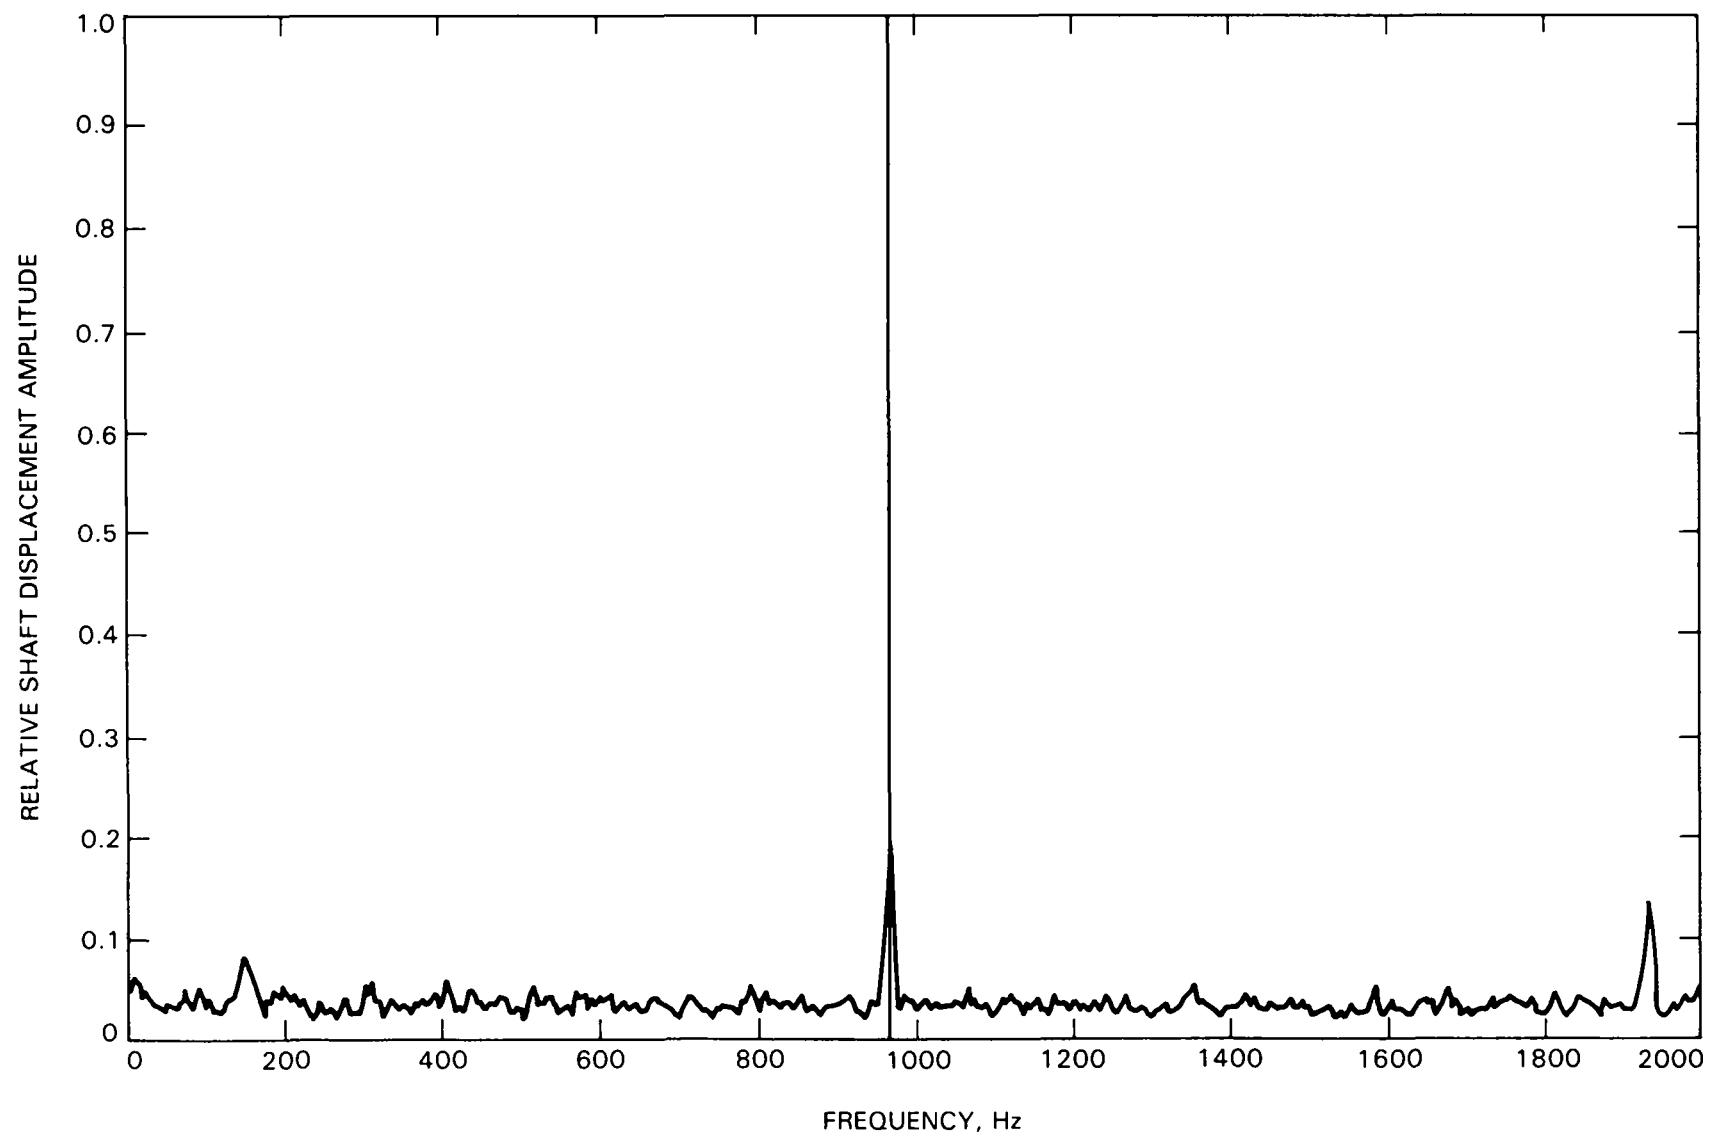
allowing the 100-h test results to be available for the November 1, 1983, DOE-scheduled ORC review. The only effect this had was that additional hours were run at 5 and 90 deg, and fewer hours were run at 45 deg. Figures 8-1 and 8-2 are shaft displacement amplitude versus frequency for TAP builds 38 and 39 (90- and 5-deg inclination) using comparable amplitude scales. Results of the test showed inclination angle does not seem to affect shaft dynamics and no bearing wear or component damage was observed.

Figure 8-1. Typical Shaft Displacement Spectrum of Waukesha Five-Pad Bearing at 90 deg on October 19, 1983 (Pump End "Y" Probe, TAP Build 38)

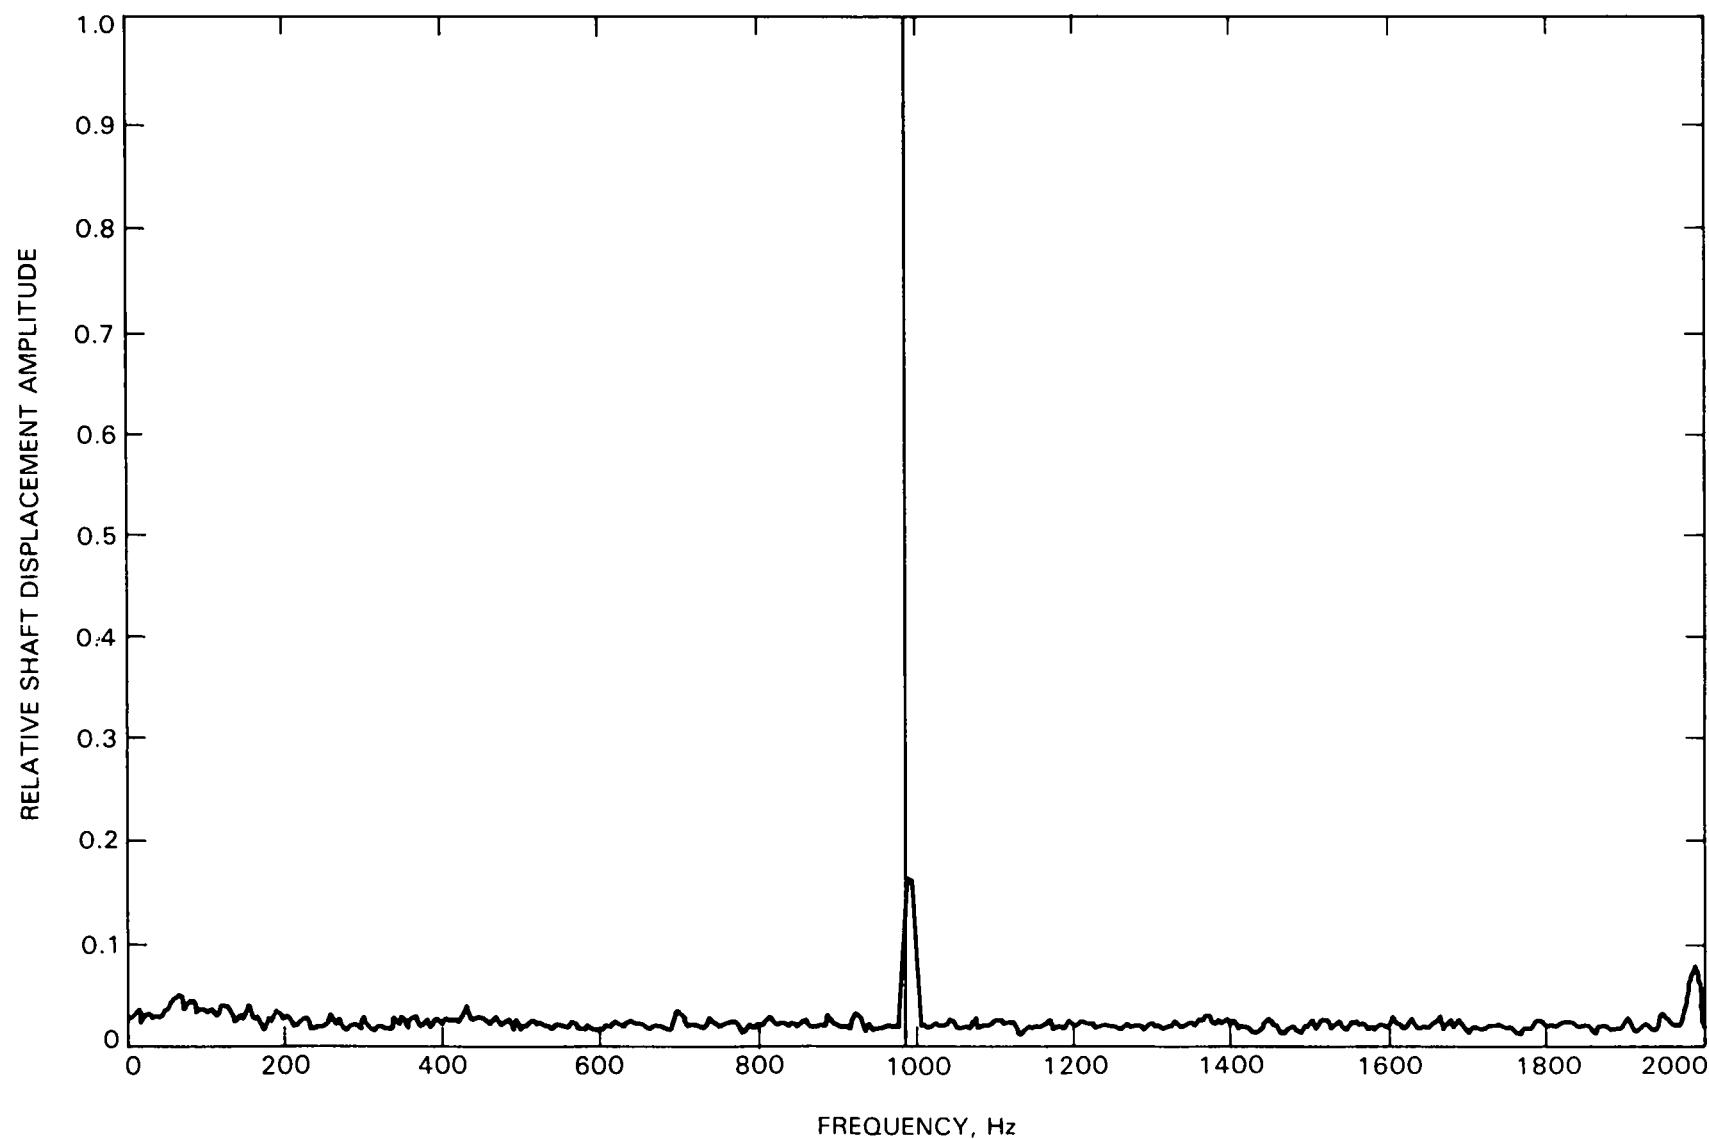
Figure 8-2. Typical Shaft Displacement Spectrum of Waukesha Five-Pad Bearing at 5 deg on October 29, 1983 (Pump End "X" Probe, TAP Build 39)
