DOE/NASA/20320-30  
NASA TM-81719

# Test Evaluation of a Laminated-Wood Wind-Turbine-Blade Concept

James R. Faddoul  
National Aeronautics and Space Administration  
Lewis Research Center

May 1981

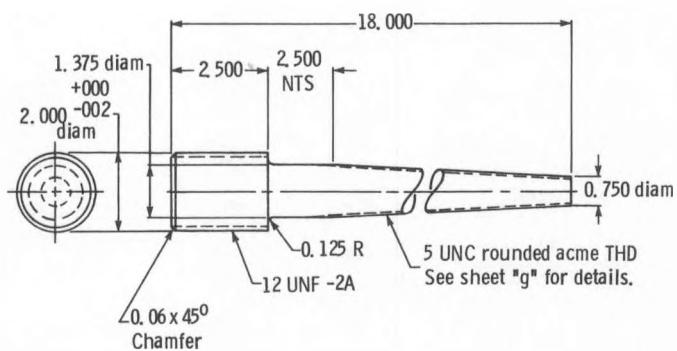
Figure 15. - Tapered stud configurations.

(a) 1 3/8" to 3/4" taper ratio.

1. Stud configuration (imbedded portion) should be tapered similar to that shown in Figure 15(a). Thread type and taper ratio appear to be rather insignificant to overall performance.
2. The hole in the wood should be step tapered.

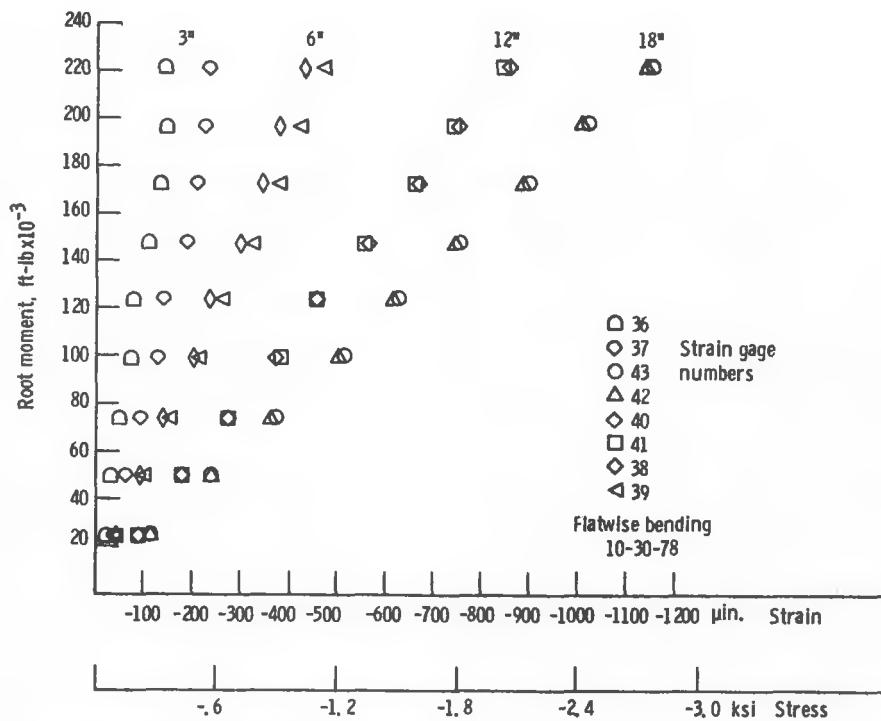
Figure 24. - Wood compressive stress over and between studs as measured during flatwise bending.

Response of all strain gauges was repeatable and linear with respect to applied load. EI curves and complete strain gauge locations are shown in Figures 22 and 23. The strain gauges placed over one stud and between two studs (see Fig. 23(c)) showed almost identical response to loading (see Fig. 24) indicating that the studs were transferring the bending load efficiently and without high peak stresses in the wood. The maximum stress recorded occurred during flatwise loading to 224,000 ft-lb and was less than 3400 psi (compression). When the applied moment is ratioed to the 116,000 ft-lb cut-out wind condition moment ( $10^7$  cycles) the stress drops to 1760 psi which is well below the 2200 psi infinite life design allowable stress. Once again, when a high level, limited cycle, load condition is considered an infinite life case, a significant, 25%, positive margin of safety is shown. Figures 25 and 26 show some of the measured maximum strain data for flatwise bending and comparisons with predicted data. As can be seen, the predicted data is conservative (greater than or equal to the measured data). The occasional large discrepancies between measured and predicted values for certain gauges are attributed to the fact that the predicted values were based on the assumption that the trailing edge panels were slotted and contributed little to the load carrying capability. In the actual case, the panels were not slotted and therefore shifted the chordwise neutral axis and the load sharing within the structure. Table 3 presents the predicted versus the measured values for selected strain gauges in the three loading cases.

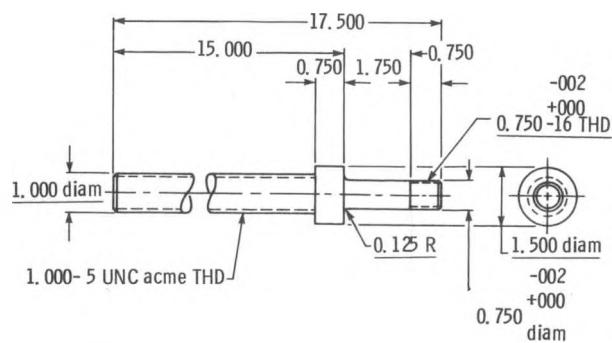
Figure 31. - Drawing of replacement stud in 20' wood blade test section.

Rather than abandon the test, the specimen was sent back to the contractor, Gougeon Bros., Inc., for replacement of the studs. This became an ordeal as it was quickly learned that removal was not easy. A number of staples had been used in the construction of this blade section (a practice which is no longer used) and the staples made the use of a deep hole saw difficult. An attempt was then made to simply unscrew the studs from the epoxy. This resulted in breaking the stud. The unscrewing technique was then tried in combination with application of a high amperage current to heat the stud and soften the epoxy. This was equally unsuccessful. Finally, the hole saw technique was made to work by "brute force" with the result that a rather large and uneven hole was left in the blade as each stud was removed. These holes were subsequently smoothed and tapered by a large boring cutter and were then filled by matching tapered wood plugs made from laminated fir. When all studs had been removed and the holes filled, the root of the test section was redrilled and fitted with 24 new studs having a slightly modified configuration (Fig. 31) featuring a 3/4 in. diameter threaded shank rather than the

previously used 5/8 in. diameter. This modification was based on the decision that mating with a hub spindle on the wind turbine would require a very stiff flange which could quite easily accomodate a 3/4 in. stud. Consequently, prior to sending the test section back to Ft. Eustis, a 10 in. long spool piece was machined (Fig. 32).

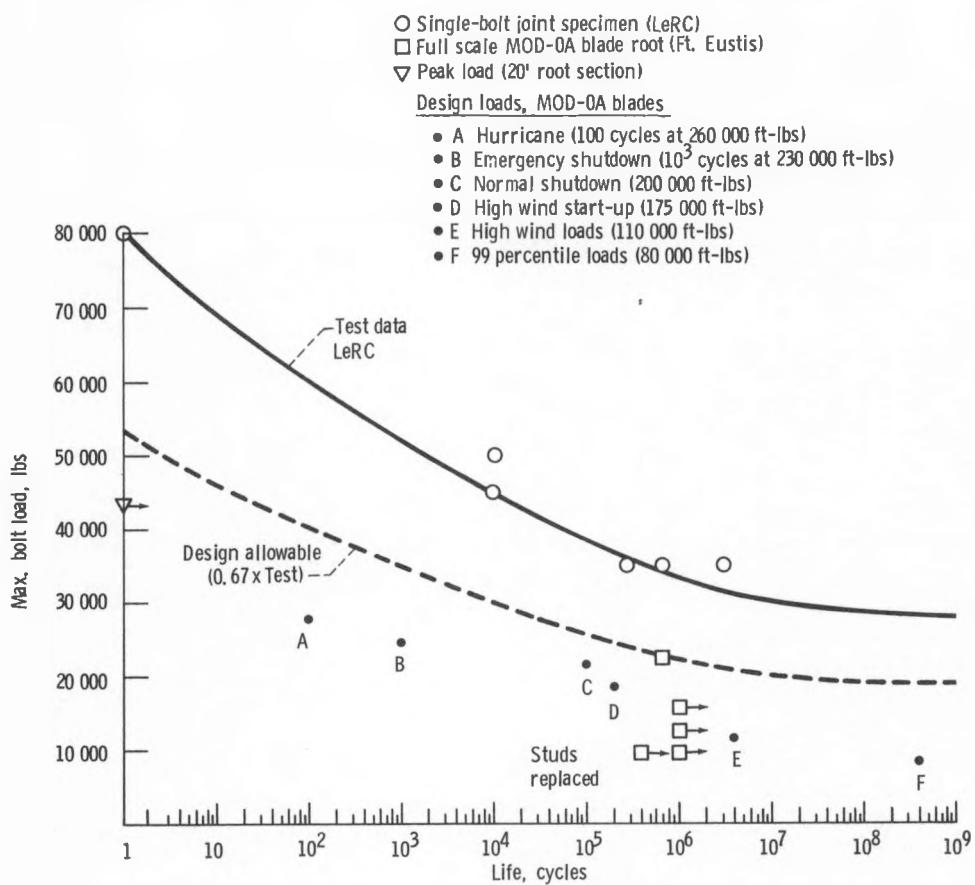
Figure 33 is a summary of the test conditions at Ft. Eustis as compared to both the blade operating requirements and the individual stud test data. It should be noted that Figure 33 has converted the actual test moments to a maximum bolt load based on the number of studs and the bolt circle diameter. To convert back to moment, multiply the bolt load by 9 (approximate) to obtain the moment in ft-lb. The most significant point to be extracted from Figure 33 is, however, that while the actual testing of the blade section was far in excess of the MOD-OA design points there was no failure of the wind or bend joints. In addition, 670,000 cycles were required to fail studs even though there was a severe stress concentration built into the stud and  $3 \times 10^6$  cycles at lower loads had been previously applied.

Figure 33. - Fatigue data for bolt-to-wood tension joints fabricated by Gougeon Bros., Inc.

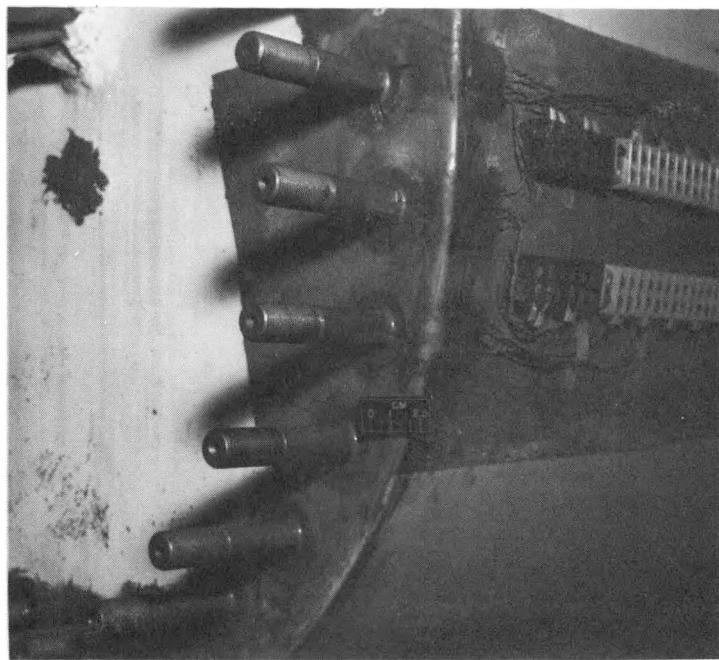
4.3.1. Stud Pretorque Tests. - For this test, three adjacent studs were each instrumented with four strain gauges. The gauges were applied by grinding flats on the unthreaded portion of the 3/4 in. stud. Orientation of the gauges and the studs was as shown in Figure 34. Very fine lead wires (36 gauge) were used and grooves were ground in the face of the stud shoulder to preclude crushing of the wire when the spool was put on and the nuts were torqued. The spool piece was then slipped into position and all the studs but the three having strain gauges (and those broken) were torqued to 150 ft-lb. The blade was then mounted on the test stand as a cantilever beam and the strain gauges on the instrumented studs were zeroed.

Figure 34. - Studs with flats for strain gages (lead wires and strain gages removed).

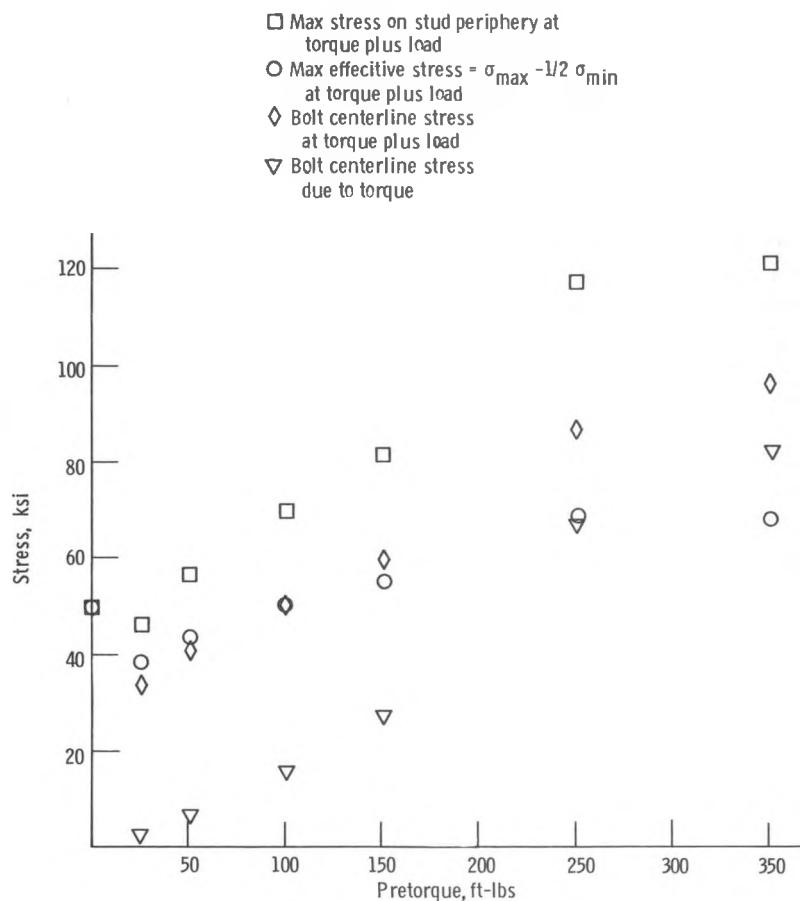
Nuts were then placed on each of the three instrumented studs and pretorque was applied. Then, a bending moment was imposed on the blade in discreet steps and the change in stud strain for each step (including the pretorque step) was measured. The strain data from the four gauges on each stud was then used to determine the center-line stress and a maximum perifial stress for each load level and each stud. Plots of the most highly stressed stud are shown in Figure 35. As can be seen, pretorque of the stud-through-flange configuration of the wood blade does not eliminate the cyclic stresses in the shank of the bolt. This finding is in contrast to the typical flange-to-flange joint where the bolts can be pretorqued to produce a stress that will hold the flange faces together under the highest load to be expected. Normally in a bolted joint with sufficient pretorque in the bolts, subsequent changes in stress in the bolt are very small or non-existent as long as the load does not exceed that for which the pretorque was established. For 3/4 in. bolts, the pretorque can be as high as 400 ft-lb. However, for the stud-to-flange connection of the wood wind turbine blade, pretorque above 250 ft-lb would probably tend to decrease cyclic capability. Additional test data will be developed and reported at a later date. However, it appears that there is a rather broad range of torque values (50 - 200 ft-lb) that will produce satisfactory fatigue results. And, even at 350 ft-lb, the value selected for the fatigue testing at Ft. Eustis, a properly designed stud provides a positive margin of safety on fatigue.

Figure 35. - Effect of pretorque on bolt stresses. (Max loaded tensile stud.)

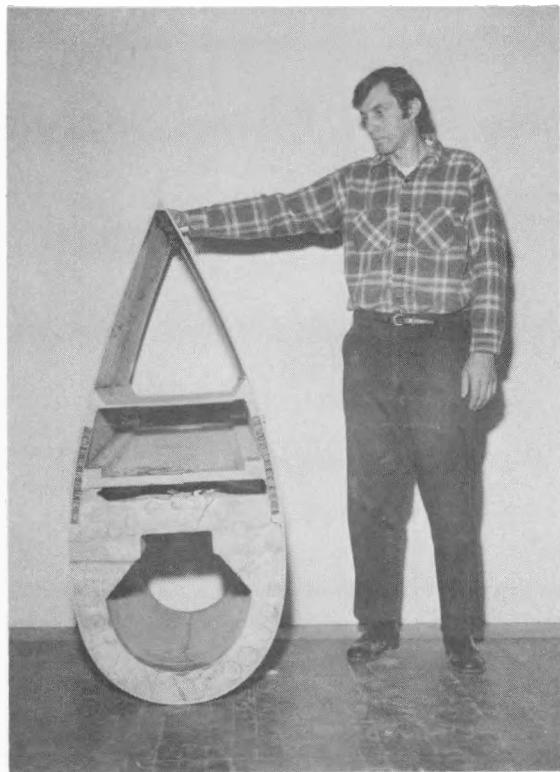
Figure 40. - Inboard section cut from 20 foot wood blade test specimen.

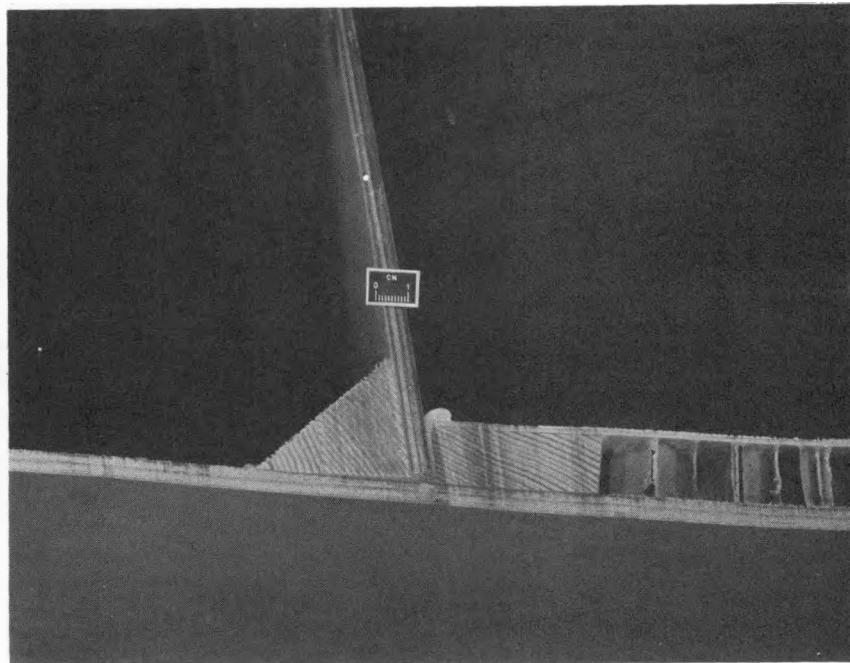
Figure 42. - Shear web and Vertical reinforced afterbody panel in outboard portion of 20 foot test section.
