PAPER FOR PRESENTATION AT THE
1978 WINTER MEETING OF THE
AMERICAN NUCLEAR SOCIETY

BEHAVIOR OF FOUR PWR RODS
SUBJECTED TO A SIMULATED LOSS-OF-COOLANT
ACCIDENT IN THE POWER BURST FACILITY

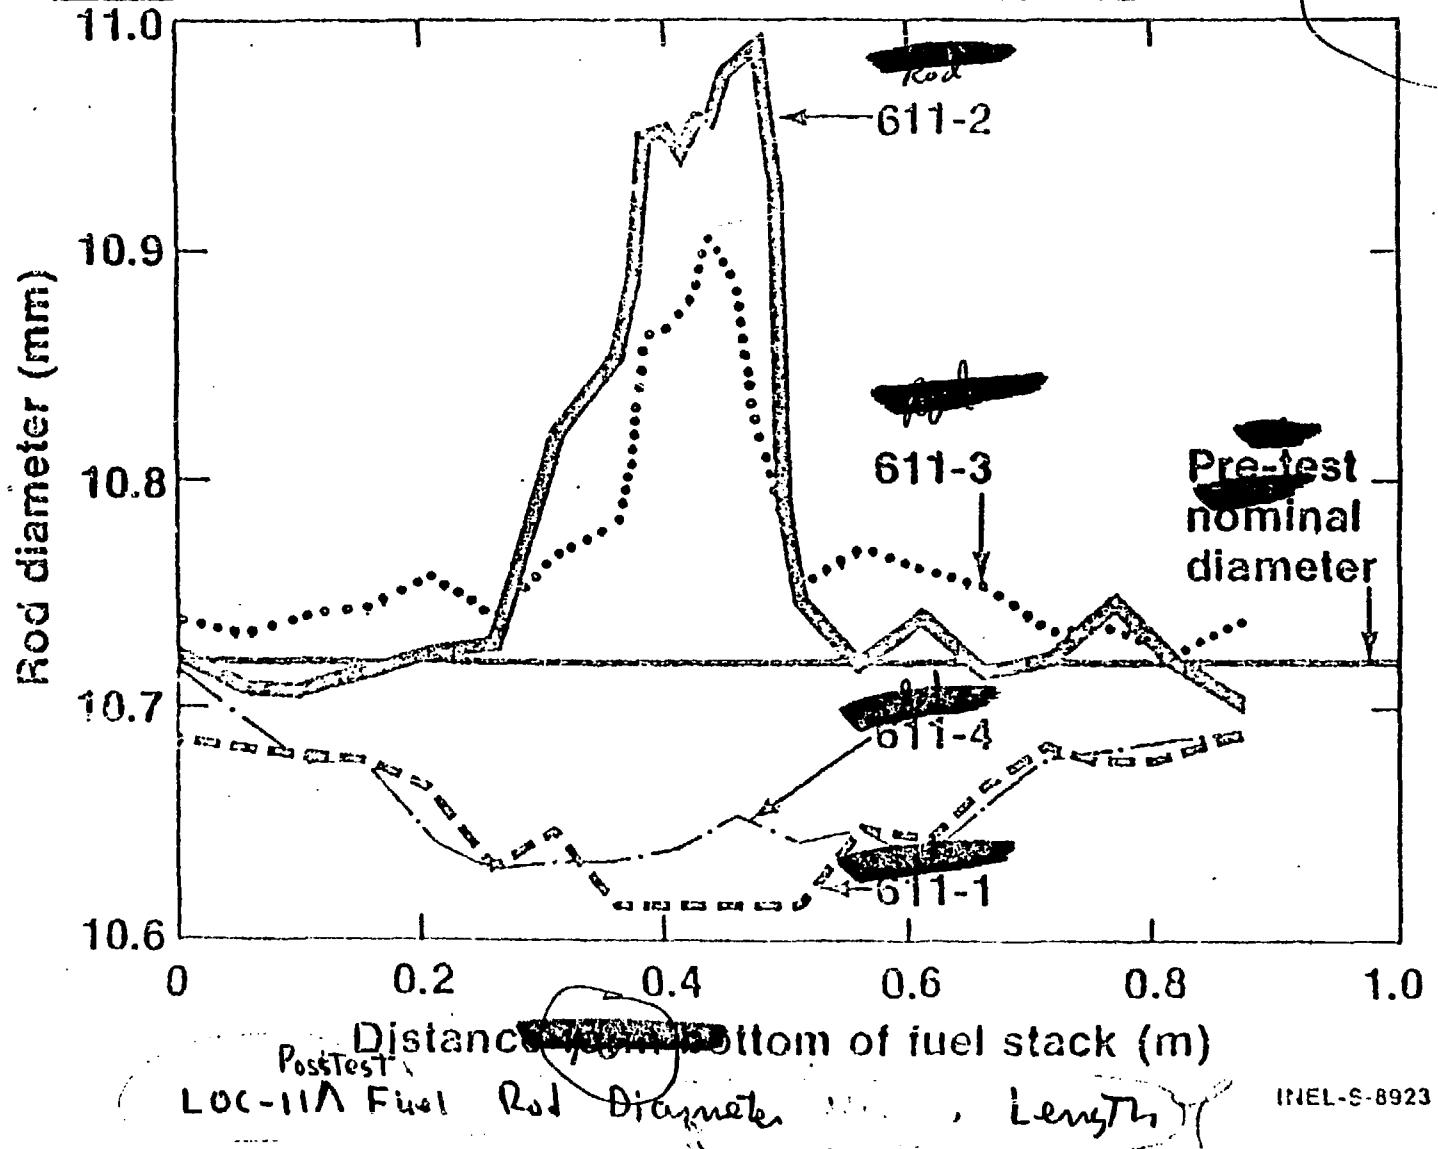
Cladding deformation occurred on all four rods during the transient. No bowing was observed after the test. However, the diameter changes illustrated in Figure 1 occurred. The atmospheric pressure rods showed a diameter reduction of 0.1 mm, and the pressurized rods a diameter increase of 0.2 to 0.3 mm.

LOC-11 Fuel Rod Diameter Versus Length
