FEMP-2562
PAPER

VITRIFICATION DEVELOPMENT AND EXPERIENCES AT FERNALD, OHIO

For presentation at the
Institute of Nuclear Materials Management
39th Annual Meeting
Naples, Florida, July 26-30, 1998

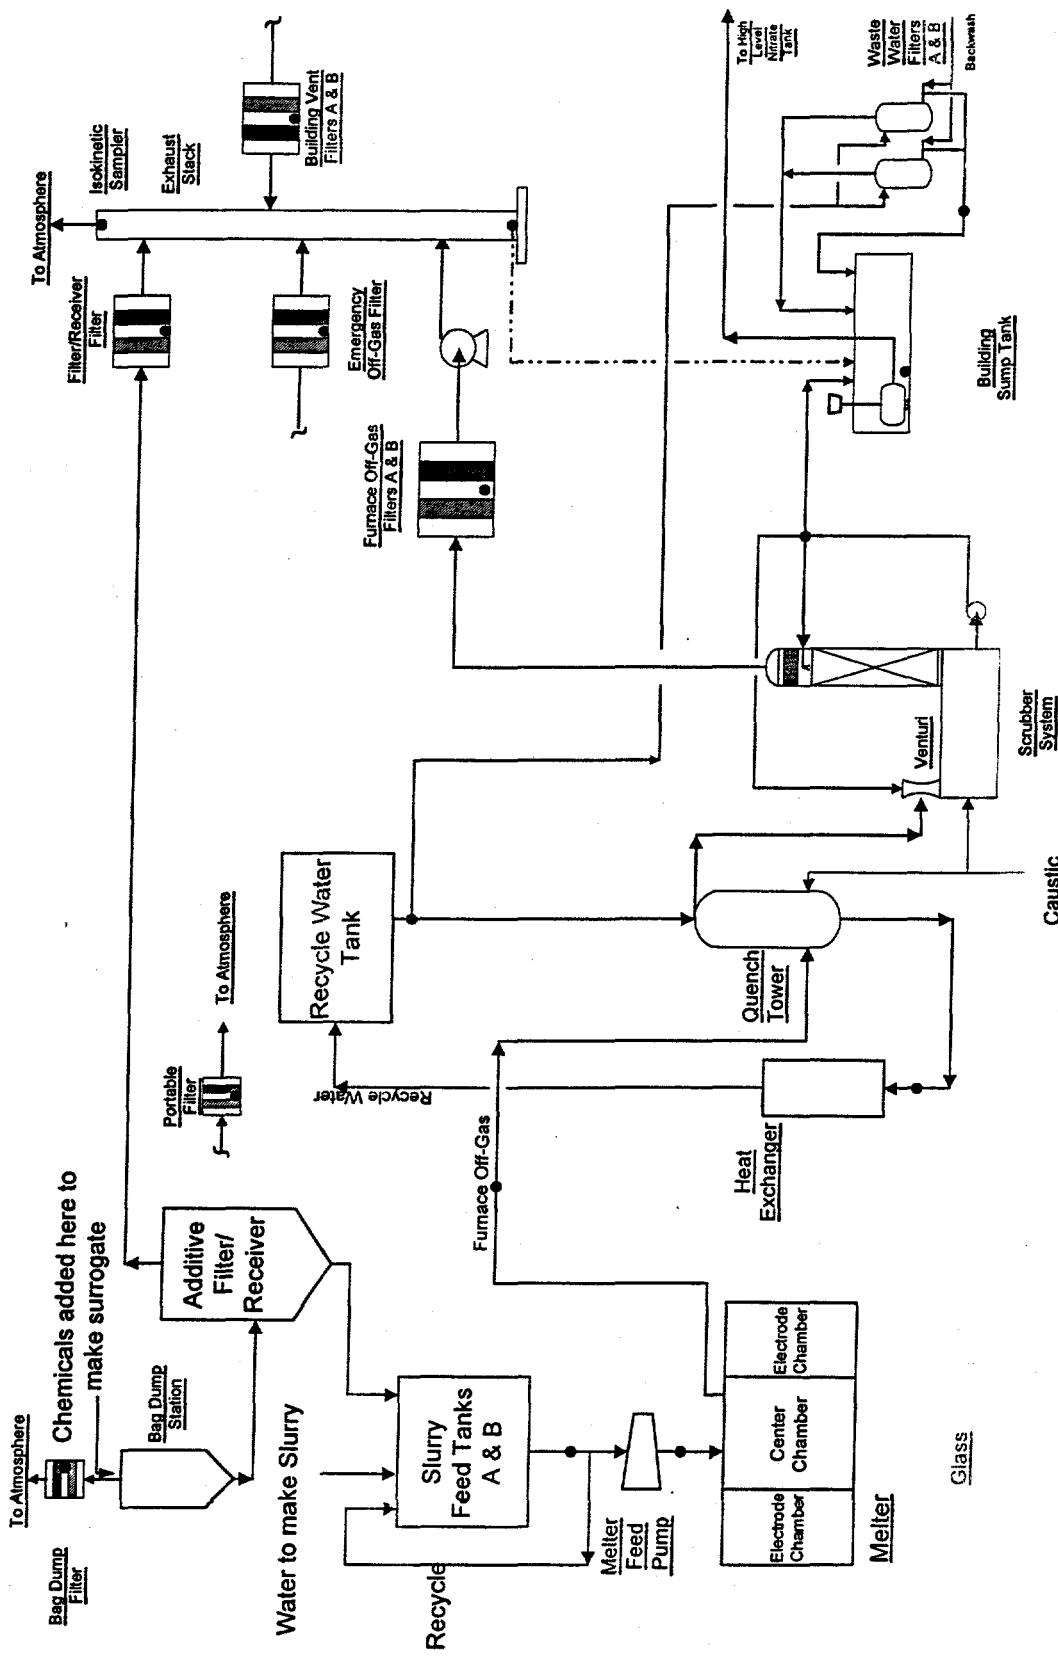
Schematic Process Flow Diagram of the Pilot Plant

During startup of the pilot plant, significant difficulties were found with the systems. Consequently, the system was down frequently until corrections or modifications were made. The resulting uptime (the percentage of time that materials were being fed to the melter during a 24-hour period) experienced during Campaign 1 was 19%. Campaign 2 was 27% and Campaign 4 increased to 42%. Uptime estimates for the pilot plant were originally high but later estimated to be 20 to 30% when considering difficulties discovered during System Operability Testing and other facility operating efficiencies. Some delay time due to changes in testing direction and laboratory analyses also contributed to the low uptime. As reported in the VITPP Phase I Treatability Study Reports⁷, the primary causes for the low uptime of the pilot plant were due to inadequacies in the slurry feed, the off-gas systems, and the melter discharge chamber.

The off-gas system presented problems as well. The excess water vapor from the melter put an extra burden on the off-gas system and at times overwhelmed the system. To prevent unnecessary activation of the emergency off-gas system, waste slurry feed rates were kept low. Originally the pilot plant off-gas system design included a chiller to remove most of the moisture. However, the chiller was removed from the design (because of cost) and the off-gas system had to rely on a desiccant tower containing moisture-absorbing materials (desiccants) to remove the water. The desiccant tower experienced difficulties because there was too much water vapor to handle - the desiccant would gel/compact together and water would channel through the bed. Replacing the desiccant bed was time consuming and resulted in reduced plant uptime. In addition, carryover of particulates from the melter off-gas plenums partially plugged the system, reducing the off-gas flow. This condition required reducing the slurry feed to the melter. Frequent cleaning of the off-gas components further reduced the plant uptime.
