Experimental Flight Test Vibration Measurements and Nondestructive Inspection on a USCG HC-130H Aircraft

David G. Moore and Craig R. Jones
FAA Airworthiness Assurance NDI Validation Center (AANC)
Sandia National Laboratories, Albuquerque, NM 87185-0615

LCDR Joseph E. Mihelic and ADC James D. Barnes
U.S. Coast Guard (USCG) Aircraft Repair and Supply Center (ARSC)
Elizabeth City, NC 27909-5001

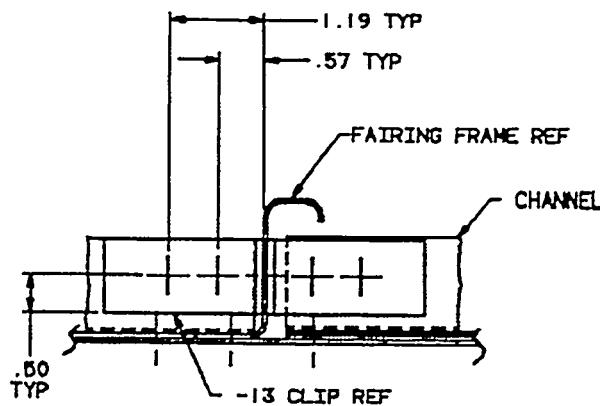
Figure 3: Sectional view of the wheel well Fairing. Button head fasteners are Not shown.

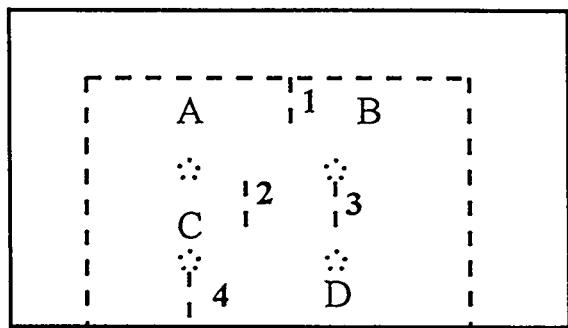
Figure 5: Reference standard used for calibration.
 Top plate 6.35 x 11.4 x 0.178 cm.
 Bottom plate 5.72 x 8.89 x 0.203 cm.
 EDM notches width 0.152 mm,
 Length 12.7 mm.

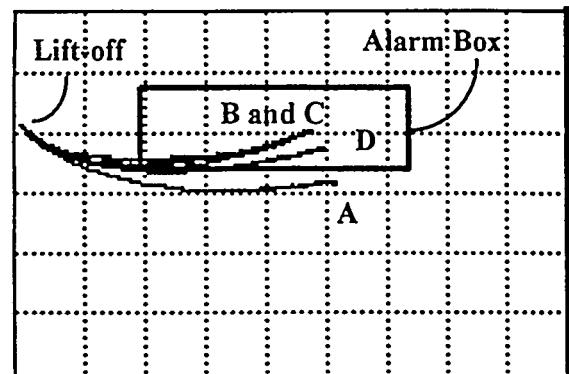
Figure 6: Signals produced on the reference Standard at all four positions.
 Displayed is the response from a Clear fastener and EDM notches 1.78 mm below the surface.
