SANDIA REPORT

SAND97-8012 • UC-706
Unlimited Release
Printed April 1998

Quality Improvement Program for the B83 Bomb Hand Truck

M. B. Loll, S. A. Buck

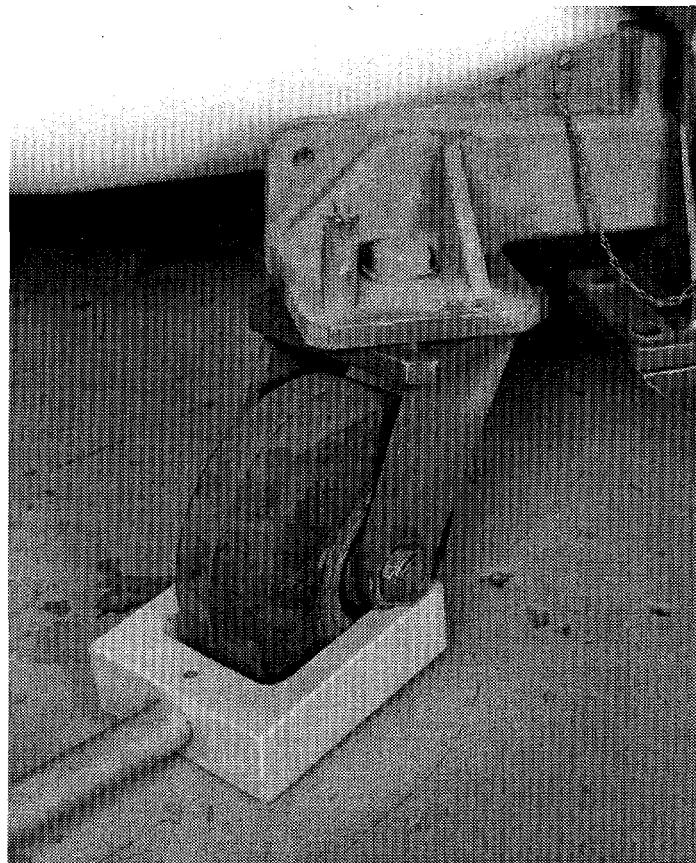
Figure 11. H1640 Castering tool engaging wheel hub on flat-sided caster assembly.

The H1640 castering tool (Figure 28) was designed to rotate the caster assembly on the B83 bomb hand truck replacing the H631 and H1216 tools, which could damage the housings on the barrel casters. The new tool engages the wheel across the hub (Figure 11) rather than on the caster frame. The forks on the H631 and H1216 were designed to engage the flat-sided caster yoke (frame) and results in gouges on the curved frame for the barrel casters

A new castering tool, the H1640, replaced the H631 and H1216 for the B83. The new tool will not gouge the frame (yoke) on the barrel casters.

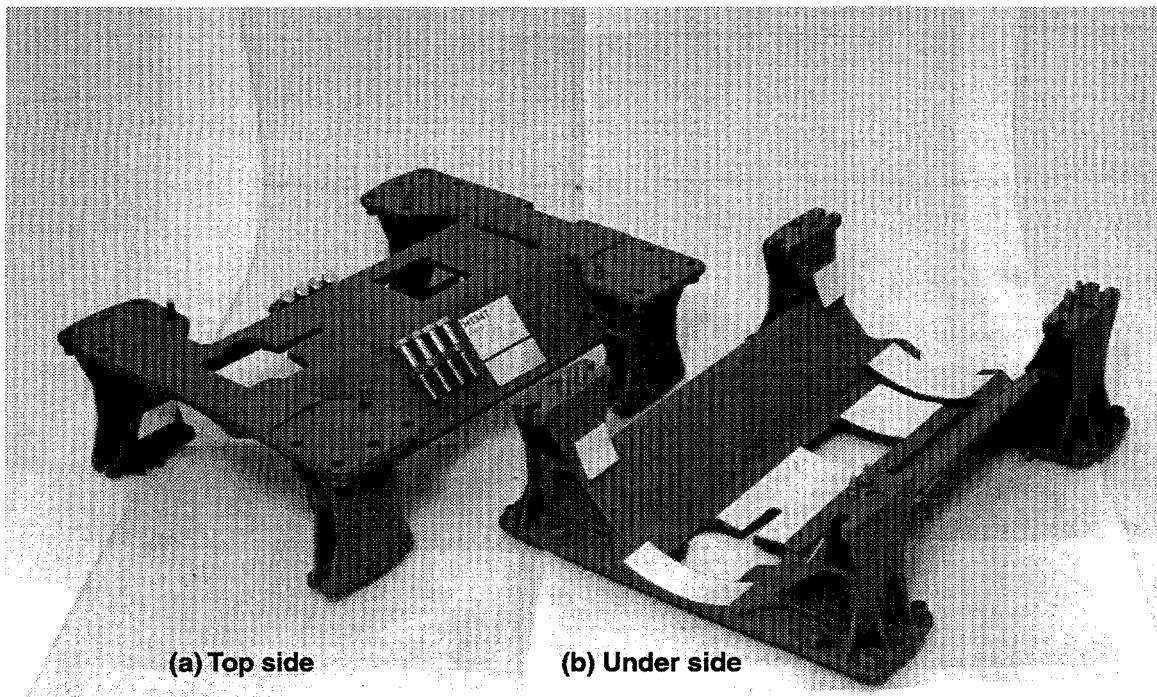
Figure 18. H1347-associated stacking fixture, P/N 450232-00.

The most critical function of the stacking fixture is restraining the movement of the B83 in the 10-g, 5-g, 2-g accident scenario for the SST. The primary interface between the stacking fixture and the B83 are the bomb lugs. When the B83 is loaded nose forward in the direction of travel, both lugs are forced directly into the strongest area of the stacking fixture casting. Unfortunately, when the weapon is loaded tail forward in the direction of travel, only one lug will make contact with the stacking fixture (see Figure 1). The single point of contact is not with the strong arched casting but with a 3/4-inch plate, (450234-00) weakened by a slot for clearance for the H1004 bomb hoisting adapter. Testing showed the stacking fixture does not meet the 10-g requirement for tail-forward loading in the direction of travel.

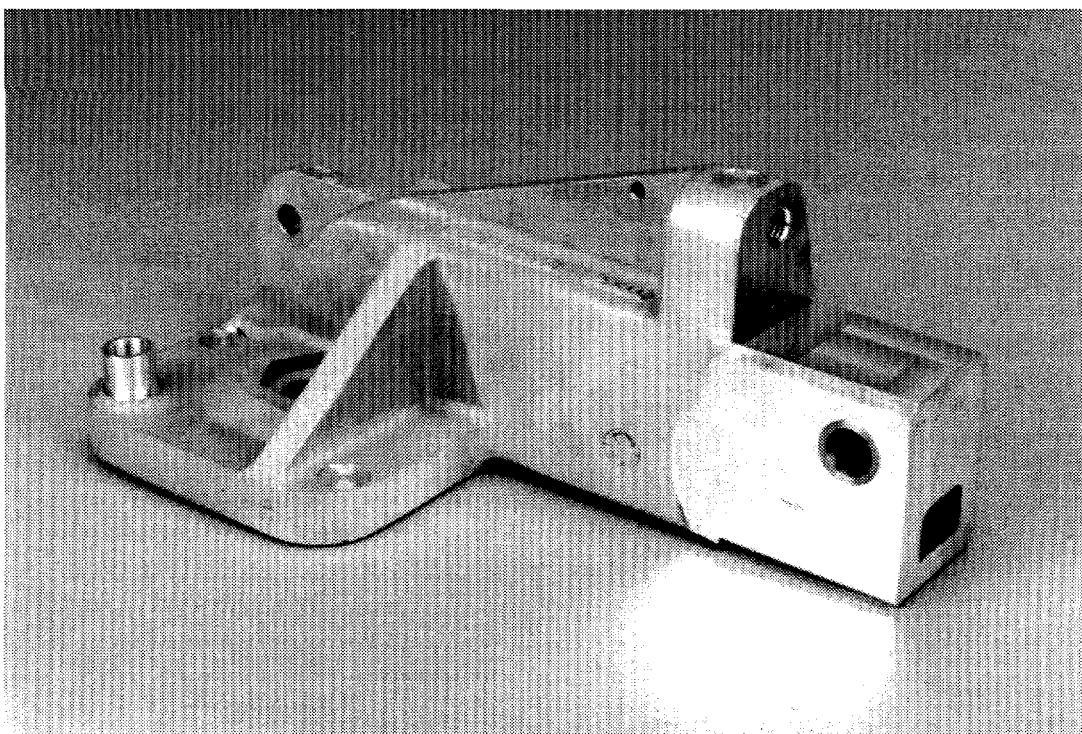
Option 4 is being pursued. A caster redesign program has been completed resulting in a stronger mounting bracket (Figures 21 and 22). Geometry changes to add more material in critical areas, reducing the interference fit between the steel sleeve and bracket, use of a higher strength casting material (A357-T6 aluminum), and improved casting processes resulted in prototype caster mounting brackets that have been tested to above 8 g (46,000 pounds) without failure. These tests were accomplished during March 1997 and reported in SAND97-8263, Appendix A (Ref. 9).

- a) Adding more material to the end of the mounting bracket.
- b) Increasing the width of the mounting bracket and tightening the tolerances reducing clearance to the cavity on the cradle assembly. This reduces twisting of the mounting bracket within the cavity under heavy loads.
- c) Filling in the space between the two walls of the bracket in the region of the steel sleeve. A supporting web was also added inside the bracket (Figure 22).

Figure 21. Prototype of a stronger caster mounting bracket (A357-T6).

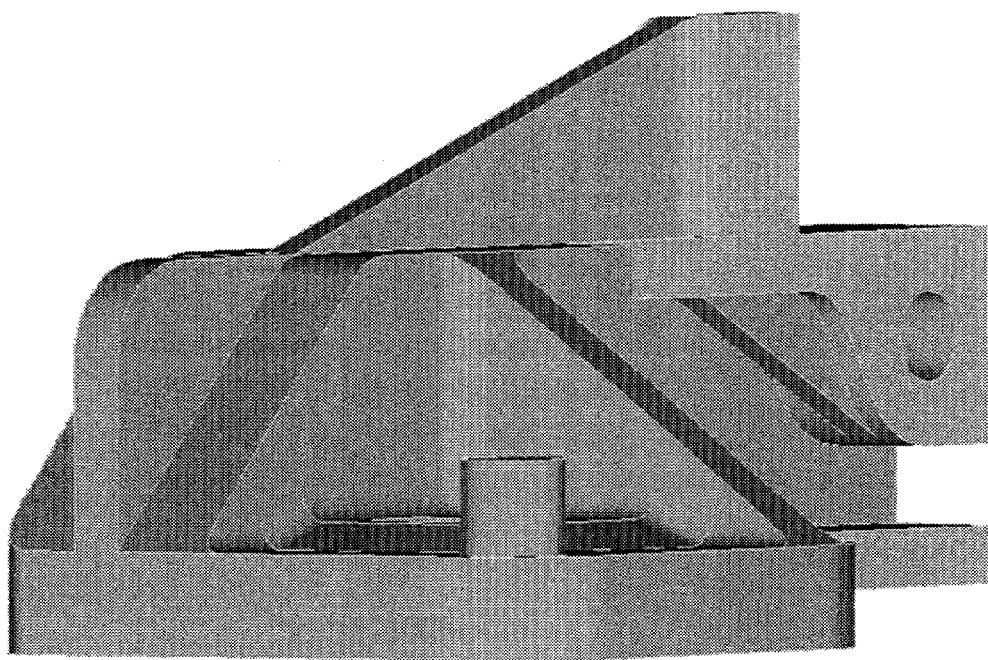
Figure 22. Cutaway of prototype caster mounting bracket.

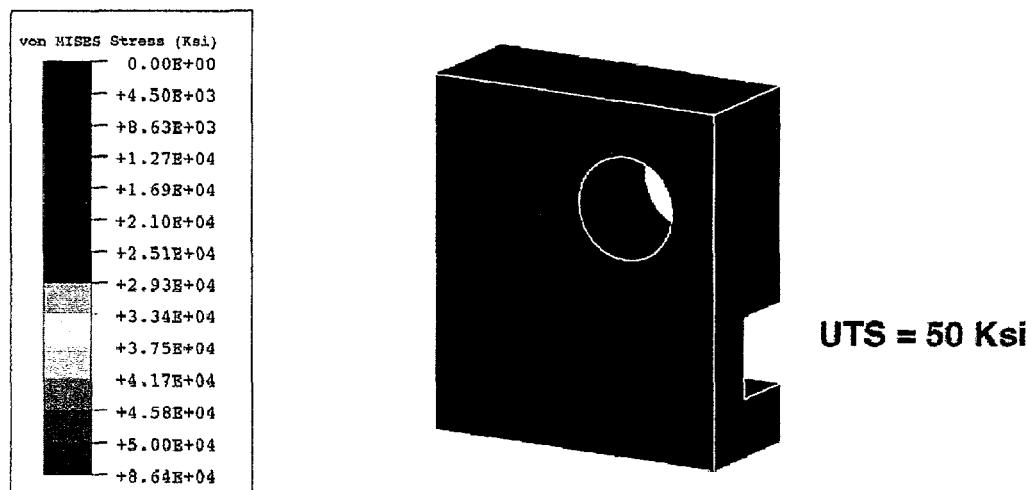
A comparison of the stresses has been made for the current mounting bracket with A356-T6 properties (Figure 24) and the stronger design using A357-T6 (Figure 25) at a 5-g vertical load. (See Table 7 for the material properties.) The former shows a large area exceeds the 38,000-psi ultimate strength of the A356-T6 material. The stronger design with an ultimate strength of 50,000 psi shows a stress level of approximately 20,000 psi, a design margin of 2.5 at the 5-g level. We estimate the design margin at approximately 1.8 at the 7-g requirement.

Figure 25. Stress distribution in stronger mounting bracket (A357-T6, aluminum).

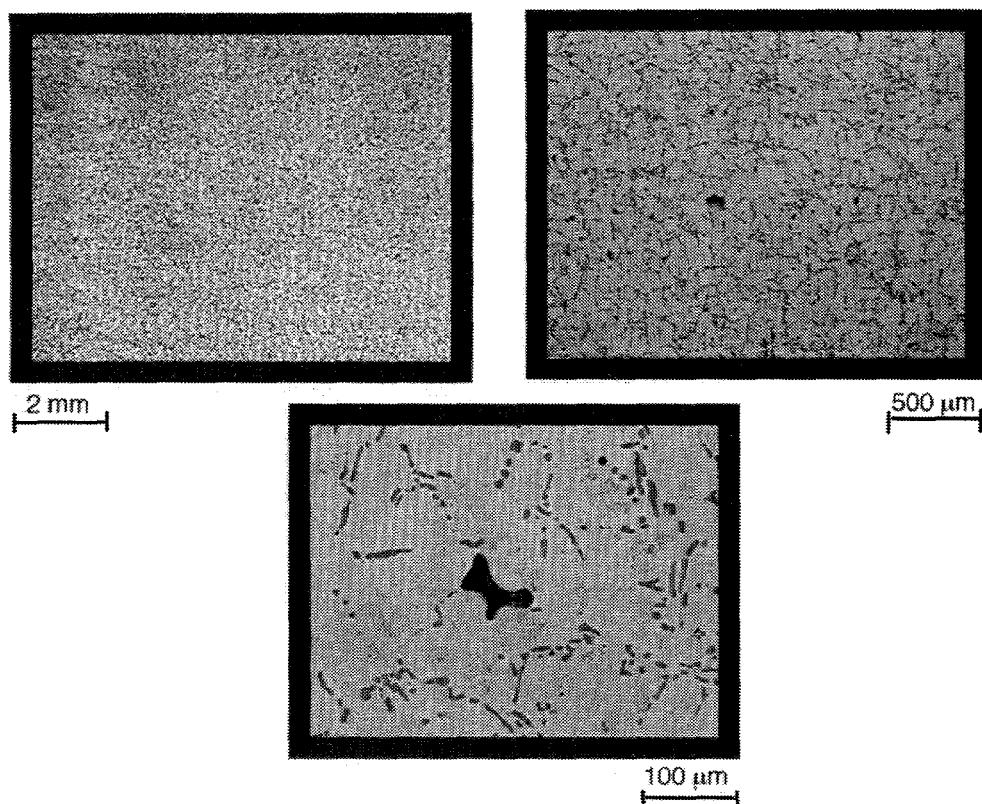
The improved casting process greatly reduced the void content of the prototype A357-T6 castings over those made with the A356-T6 castings produced in the 1960s timeframe. Metallographic samples using image analysis techniques were made on the A356-T6 and A357-T6 brackets (Ref. 11) with the results shown in Figures 26 and 27 respectively. The A356-T6 castings show an average void content of 1-1.5 % with some areas as high as 3%. Void sizes for the A356 casting averaged 0.5 mm but some were as large as 1.0 mm. The A357-T6 castings had negligible void content. The reduction in void content resulted in 6-9% elongation test results for the A357-T6 compared to the 3% obtained for the A356-T6 (see Table 7).

Figure 27. Voids in A357-T6 aluminum casting.
