Determination and Microscopic Study of Incipient Defects in Irradiated Power Reactor Fuel Rods

EPRI NP-812
Project 829
Final Report
July 1978

V. Pasupathi and J. S. Perrin
BATTELLE'S COLUMBUS LABORATORIES

This final report presents the results of nondestructive and destructive examinations carried out on the Point Beach-1 (PWR) and Dresden-3 (BWR) candidate fuel rods selected for the study of pellet-clad interaction (PCI) induced incipient defects. In addition, the report includes results of examination of sections from Oskarshamn-1 (BWR) fuel rods.

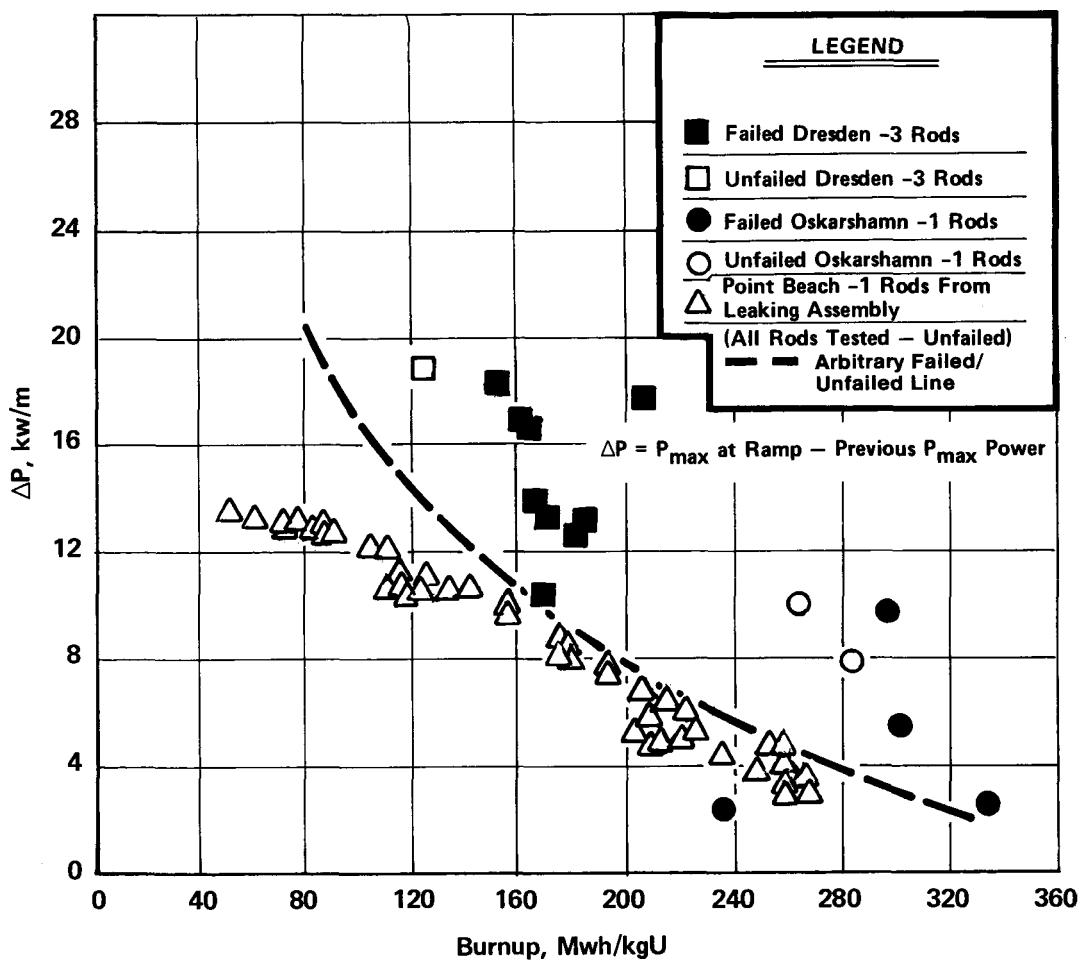
Figure 2.2-1 shows the relationship between the power change (ΔP) and burnup for the rod axial location which experienced the power ramp. Here ΔP is defined as the difference between the maximum power during the ramp and the previous maximum power for that location. Figure 2.2-2 shows a similar plot of local rod peak power (P_{max}) during ramp versus local burnup. In both figures failed and unfailed rods are indicated to show the frequency of fuel rod failures for the given power history condition.

Examination of Figures 2.2-1 and 2.2-2 show a clear separation of data between the low and the high failure frequency conditions.

Figure 2.2-1. Relationship Between Power Change ΔP and Burnup for Failure-No Failure Condition

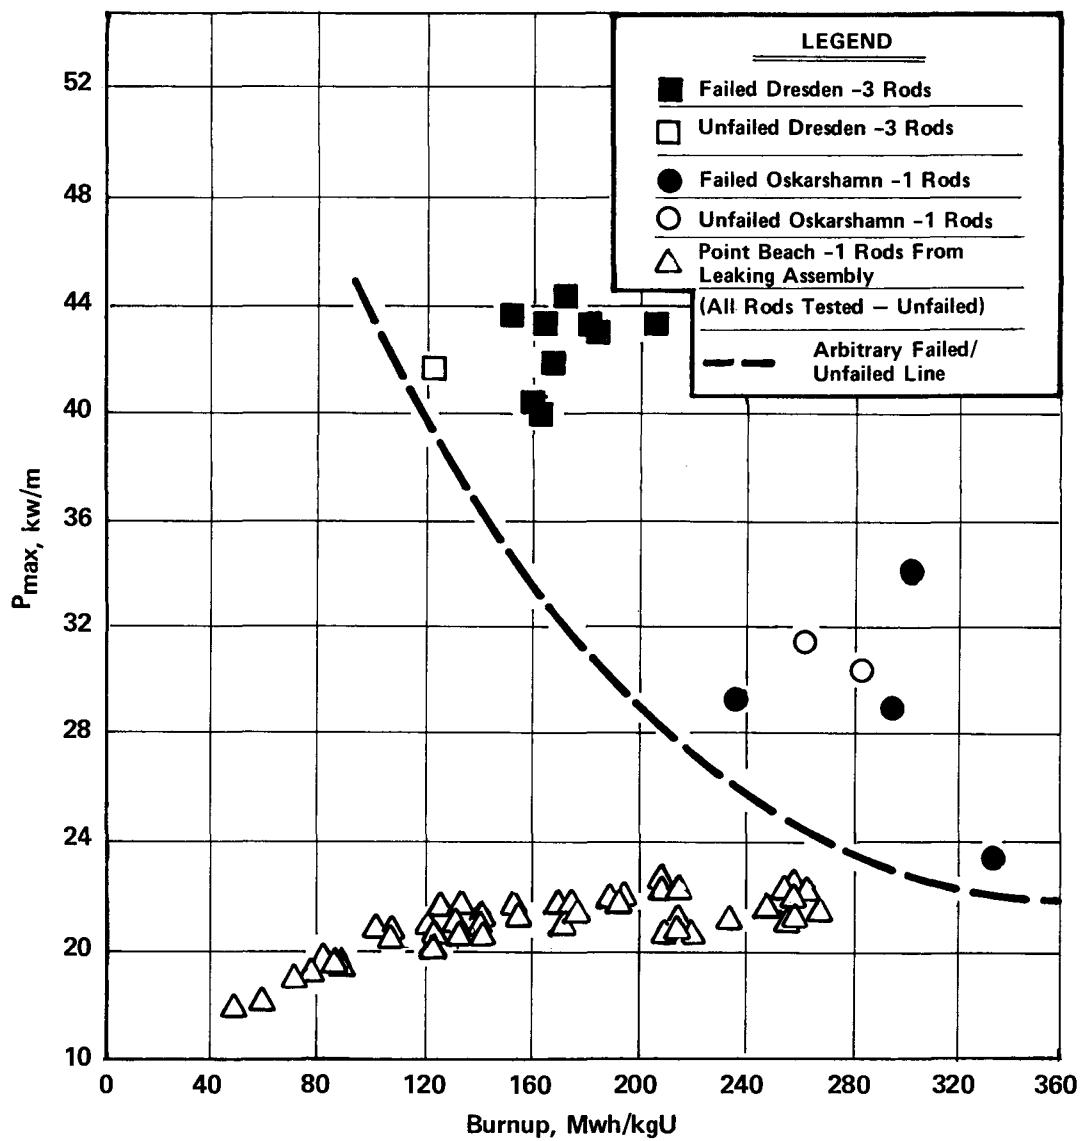
Figure 2.2-2. Relationship Between Peak Power (P_{max}) and Burnup
For Failure-No Failure Condition

It is to be noted that the Dresden-3 and Oskarshamn-1 rods selected for the program were expected to contain cladding defects. In this sense the data from these rods are biased towards high failure frequency. Thus, any quantitative correlation derived can be misleading. However, qualitative trends can be identified as shown by the dashed lines in Figures 2.2-1 and 2.2-2 representing fail-no fail conditions.

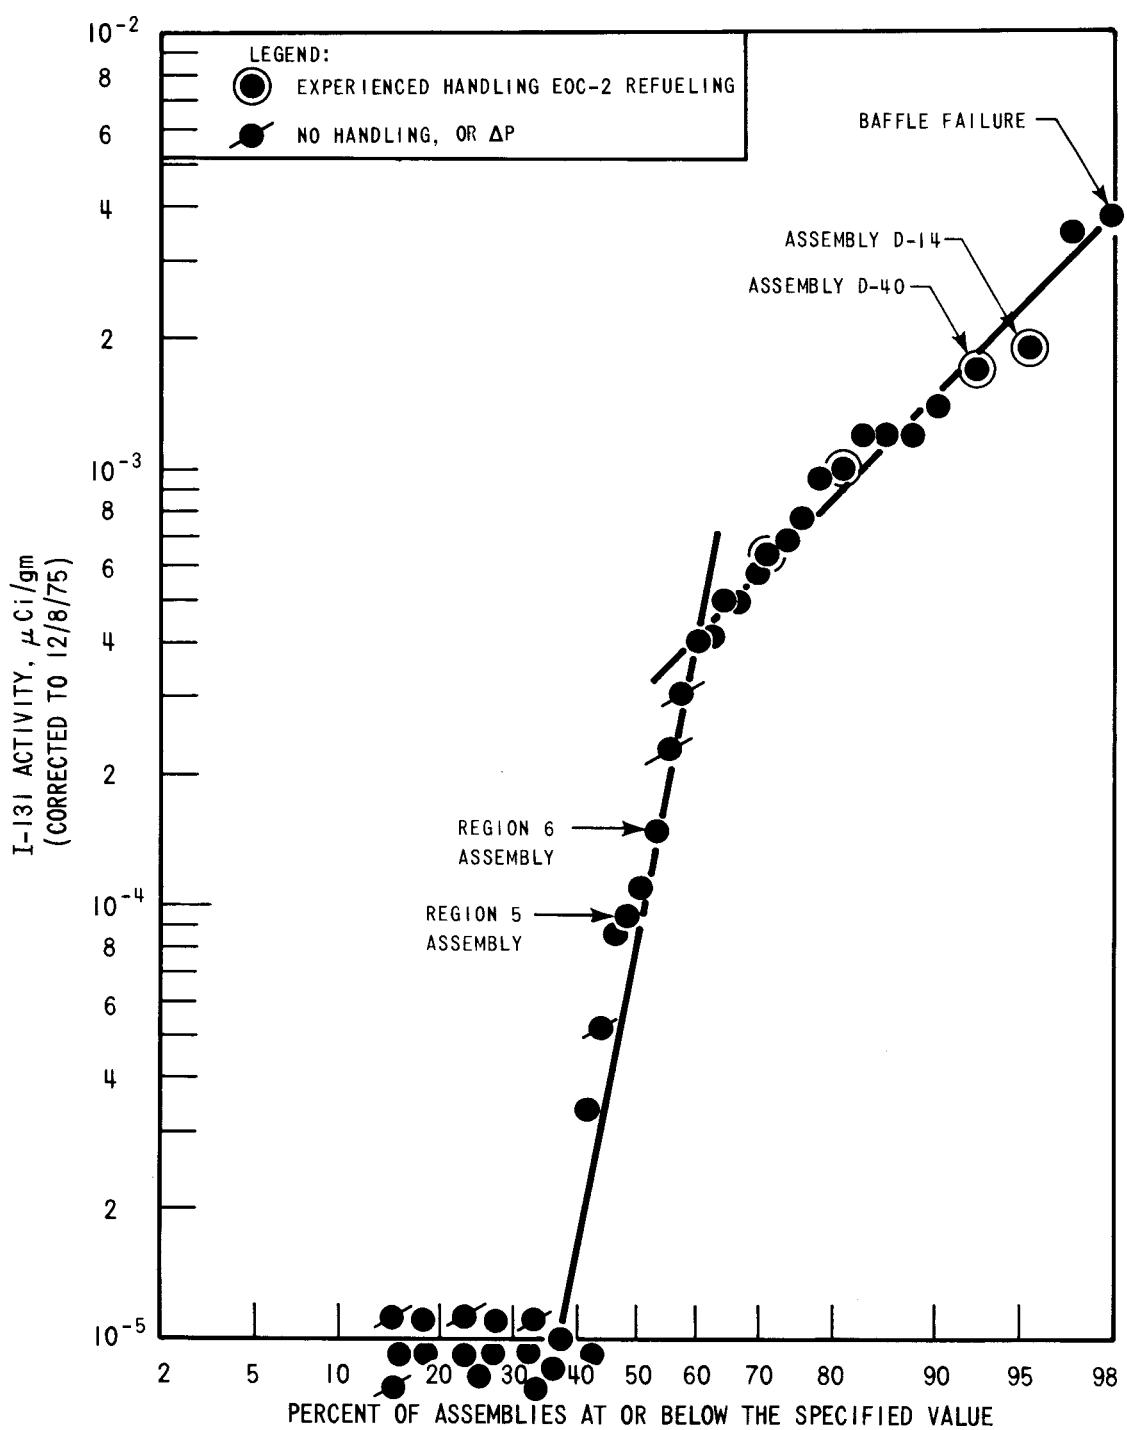
The fuel assembly leak test can generally identify the leaking assemblies. However, the leak-test results cannot be interpreted in terms of the number of perforated fuel rods in a leaking assembly.

Figure 3.1-6. Point Beach Unit 1 End of Cycle 3 Leak Test Results

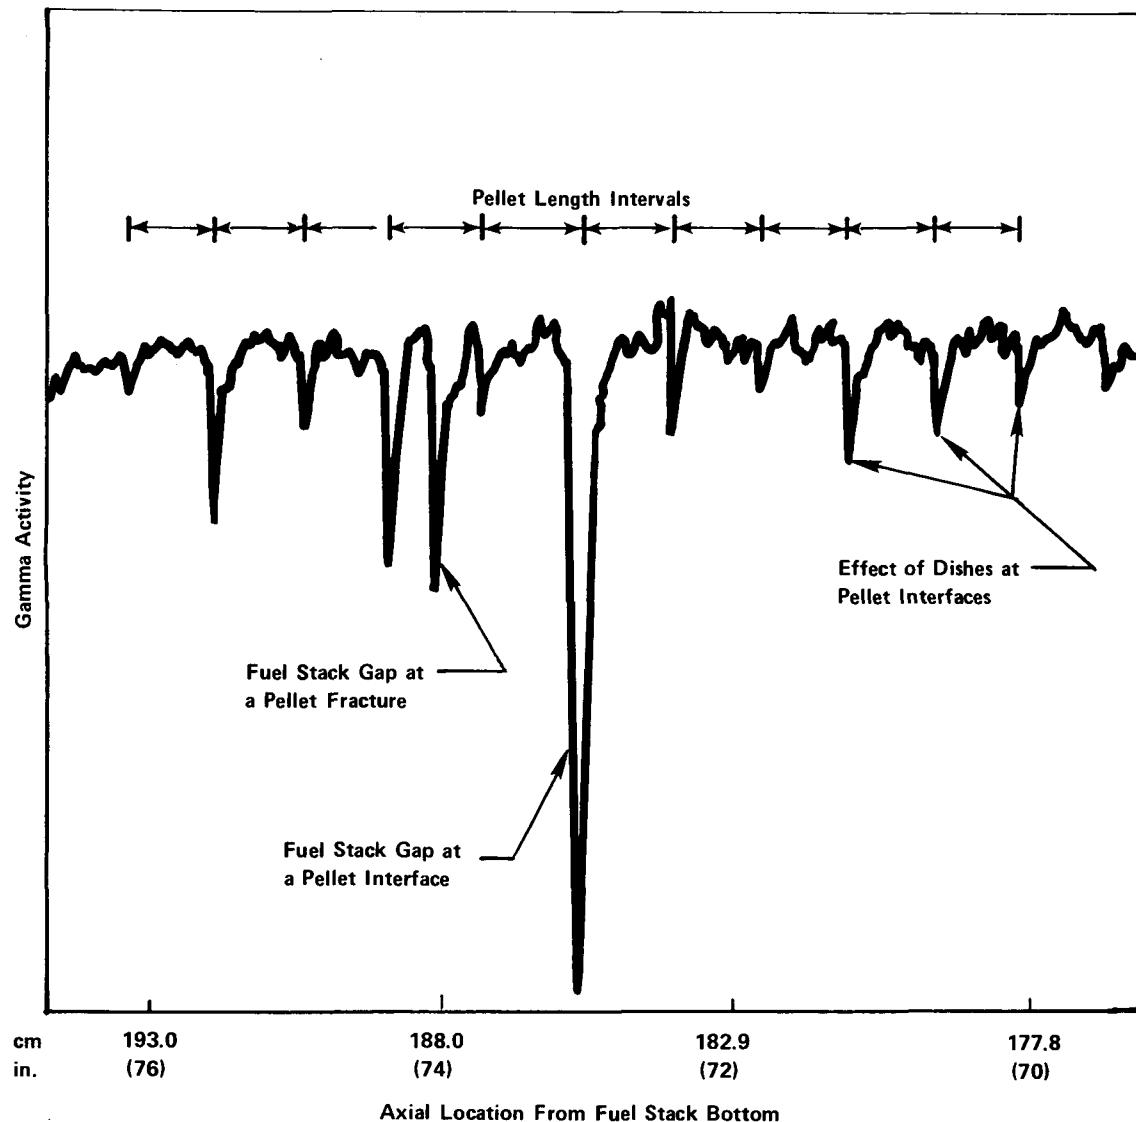
All the fuel rods studied tended to show small gaps in the fuel stacks, predominantly at pellet interfaces. The widths of gaps were calculated assuming that the area of the gamma activity depression at the gap is proportional to the volume of missing fuel. This technique has been previously used by W and qualified by using a standard prepared from irradiated fuel pellets and containing known gaps. The maximum width of a single gap observed in the 10 rods was 0.62 cm (0.244 inch) and the maximum cumulative length of all the gaps in any one rod was 1.52 cm (0.599 inch). Table 3.1-4 summarizes the gap data for the removable rod 045 and the standard rod A-1 both of which were destructively examined in the program (Section 3.1.5.4). Full details for all 10 rods have been previously published (4).

Figure 3.1-9. Appearance of Gamma Activity Profile from Gross Gamma Scan on Point Beach Rod I-13, Assembly D-14, Showing Fuel Stack Gaps and a Fractured Pellet

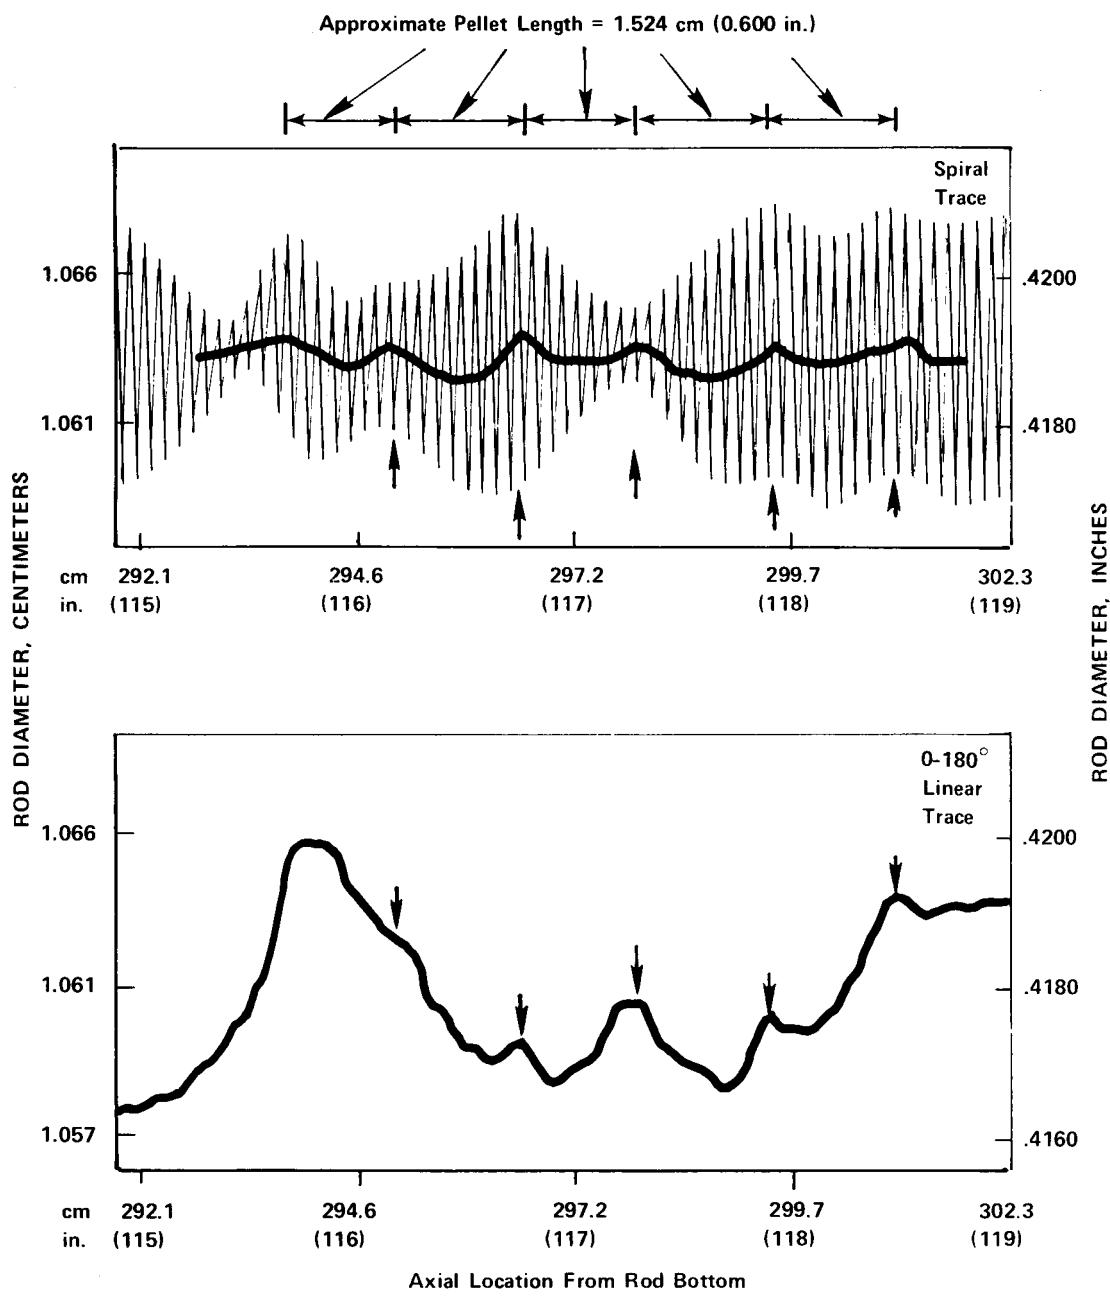
Ridging. All fuel rods profiled showed some evidence of clad ridging at fuel pellet interfaces. The ridge heights and locations appeared to vary significantly. The maximum diametral ridge height was estimated to be 0.014 mm (0.6 mil). Evaluation of ridge data from sister rod 037 (1) indicates that in general the ridge height increased only a little (i.e., 0-0.007 mm) during the second cycle of operation (reactor Cycle 3). Figure 3.1-13 shows examples of clad ridging observed in the spiral and linear diameter traces on rod 045. It is to be noted that in general the location of the ridges from both types of profilometry measurement coincide reasonably well. The ridges occur at pellet length intervals. The spiral profilometry data in Figure 3.1-13 also clearly illustrates the ovality of rod 045; it is of interest to note that the ridges are clearly discernable (though small) even where the cladding is oval. In several instances, evidence of local diameter increases, possibly due to wedged or cocked pellets, was observed. An example is illustrated in Figure 3.1-14. Further details of the profilometry data may be obtained from Reference 4.

Figure 3.1-13. Examples of Clad Ridging Observed in the Spiral and Linear Diameter Profile Traces from Rod 045

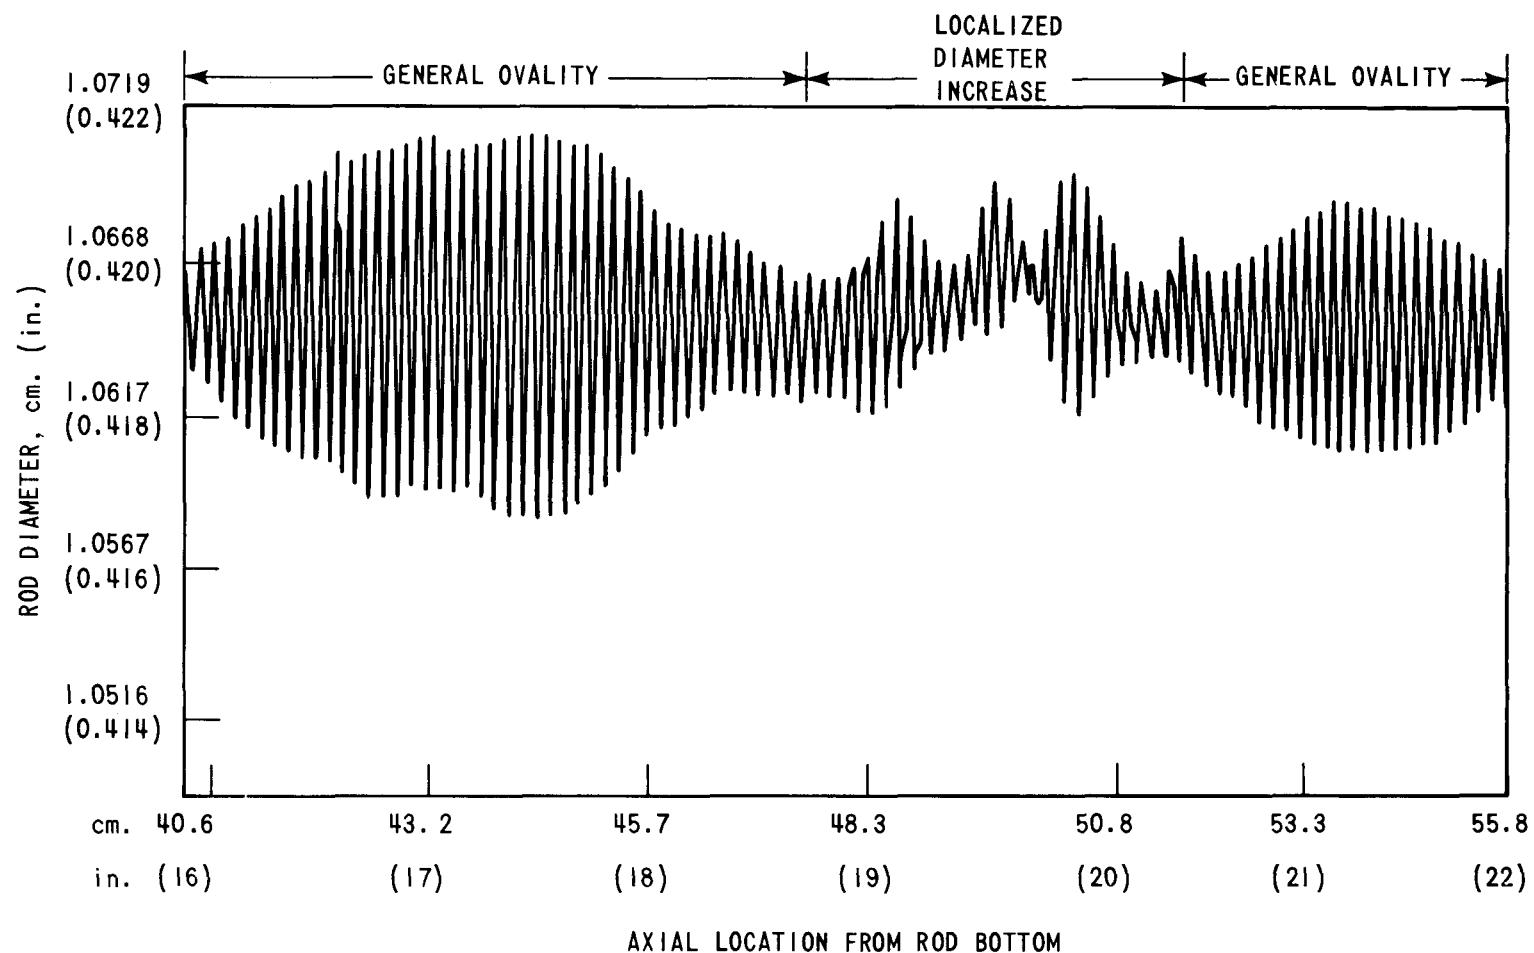
Figure 3.1-14. Spiral Diameter Trace Depicting an Area of Localized Diameter Increase Within a Generally Oval Region. Point Beach-1 Rod K-6

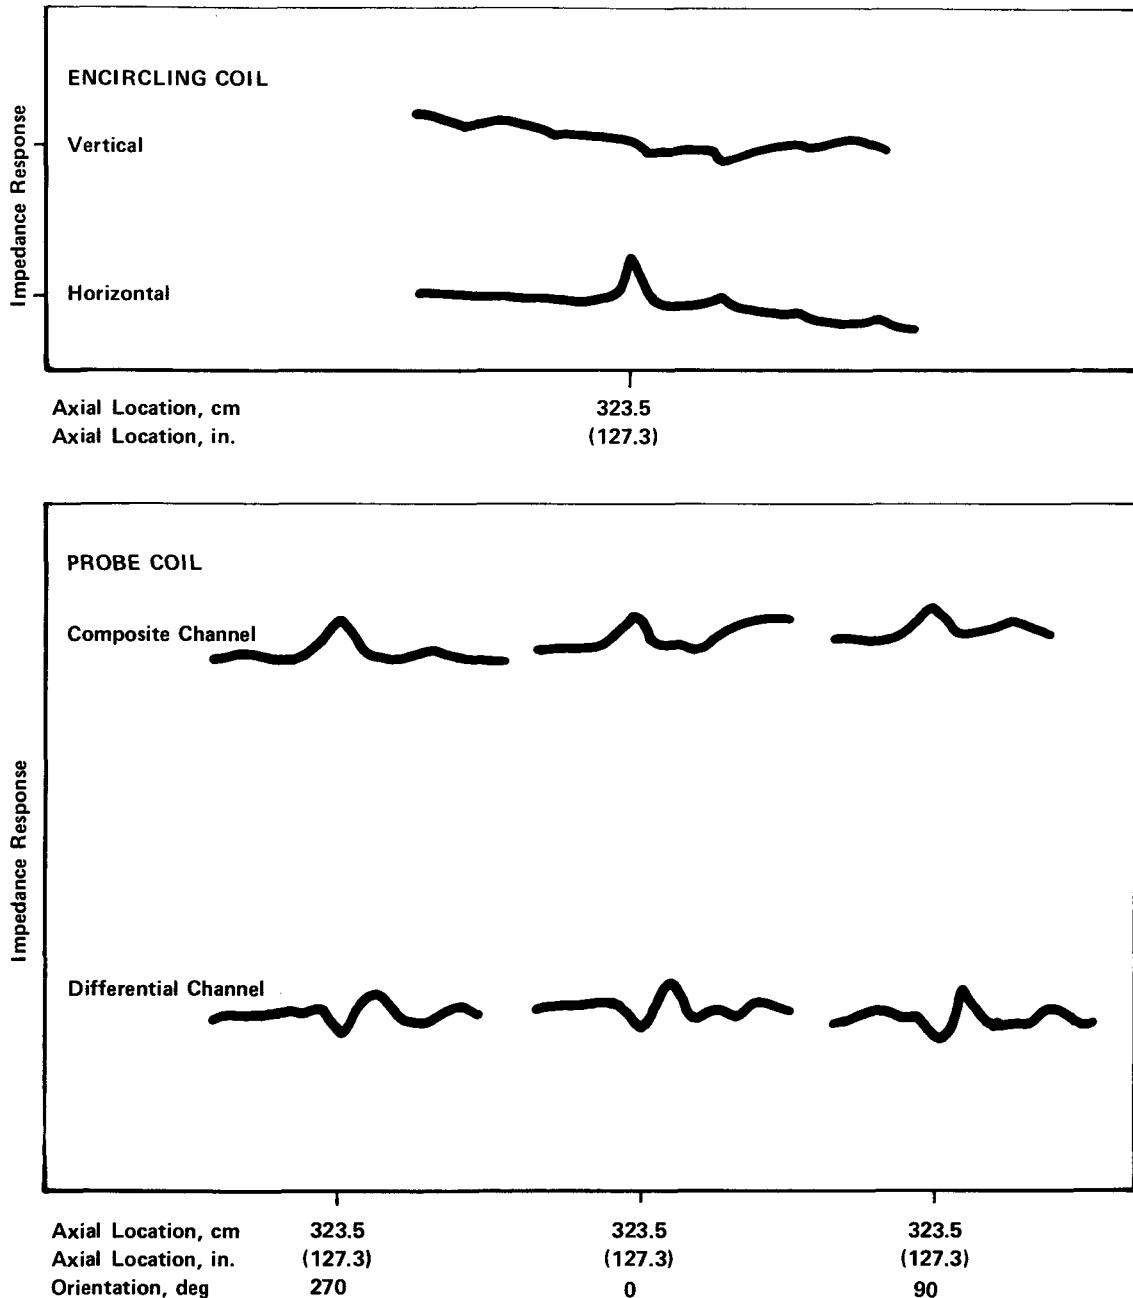
Figure 3.1-15. Encircling Coil and Probe Eddy Current Responses for Point Beach-1 Rod 045 at 323.5 cm (127.8 in.) from the Bottom of the Rod

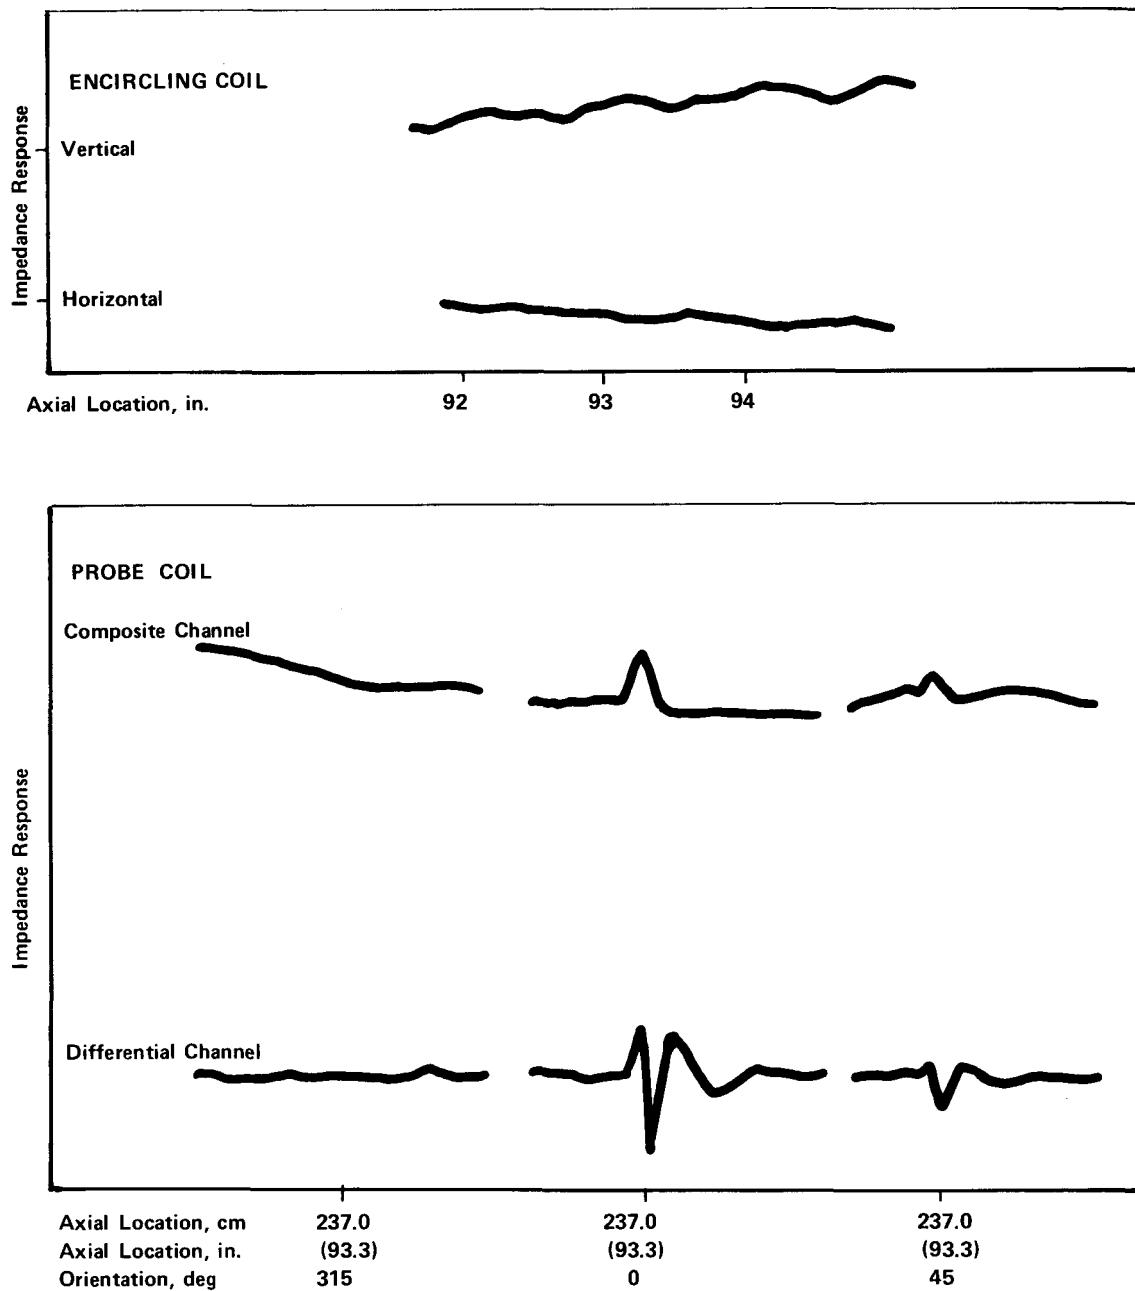
Figure 3.1-16. Encircling Coil and Probe Eddy Current Responses for Point Beach-1 Rod A-1 at ~ 237 cm (93.3 in.) from Rod Bottom

Axial location 236.0 cm (92.9 inches): Probe eddy current indication only (no coil EC signal) which coincided with peak power location (64

percent of fuel column height; see Section 3.1.3.2 (See Figure 3.1-16). Probe indication unique to one azimuthal orientation.

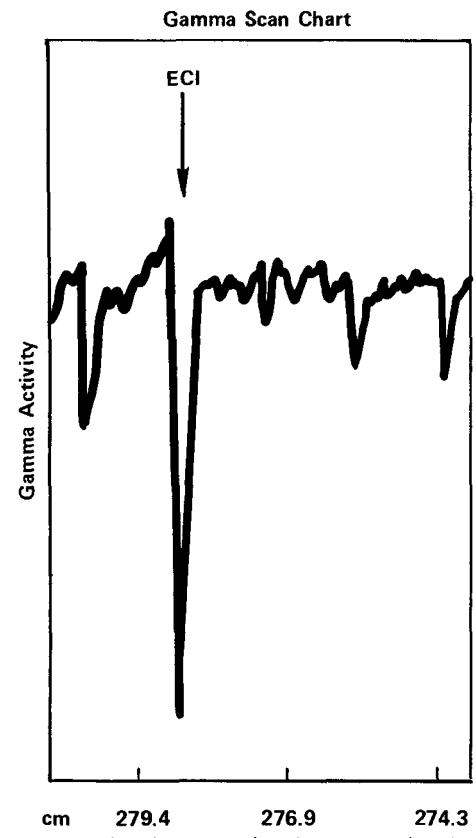
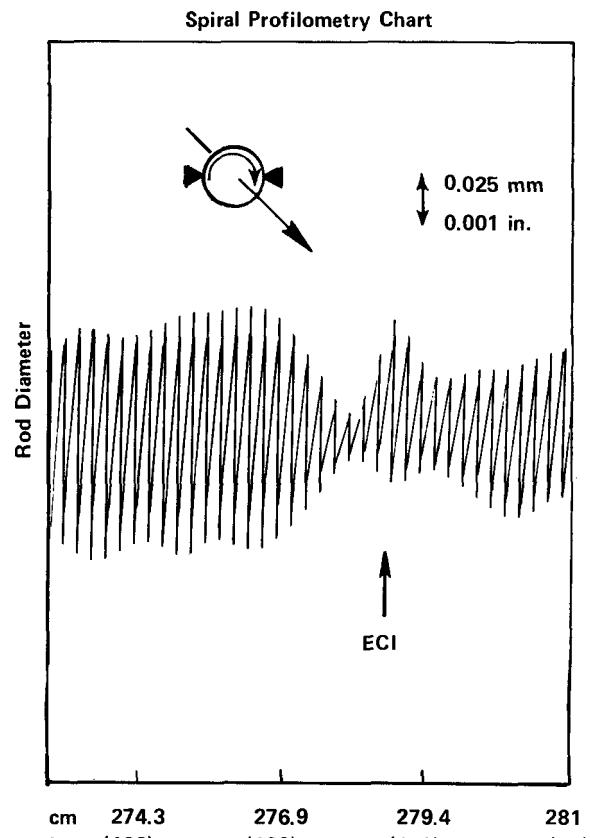
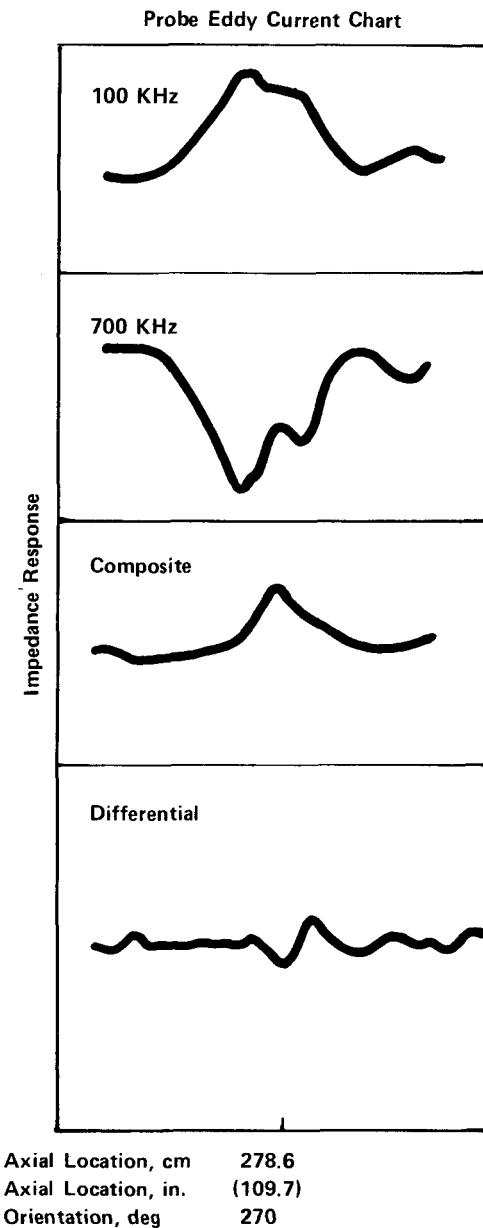
In comparing both types of eddy current signals with profilometry and gamma scan data, it is apparent that local clad bulges, believed to be due to pellet wedging and associated hang up of the fuel column (resulting in small axial gaps), also result in signals symptomatic of potential defects. An example is illustrated for rod 045 in Figure 3.1-17. This section of the fuel rod was also subsequently examined metallographically.

Figure 3.1-17. Probe Coil Eddy Current Indication Observed at the Location of Fuel Stack Gap and Rod Diameter Increase in Point Beach-1 Rod 045

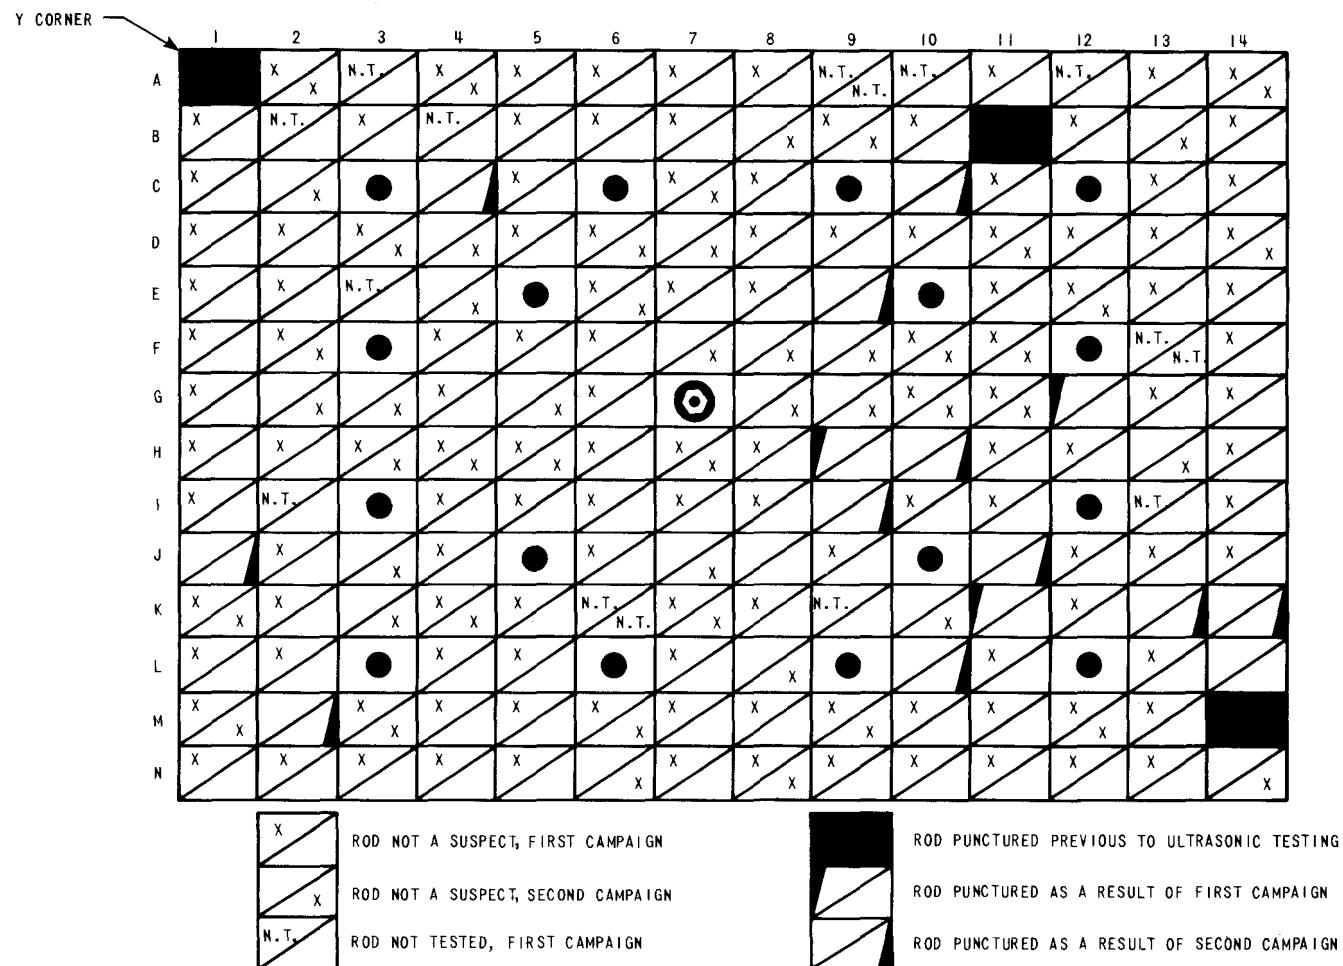
A summary of the ultrasonic test results for fuel Assembly D-14 is provided in Figure 3.1-25. In addition to indicating the ultrasonic test results, the figure illustrates the location of rods punctured prior to the ultrasonic testing and the location of rods selected for puncturing as a result of the two ultrasonic campaigns.

Figure 3.1-25 Ultrasonic Test Results on Point Beach Assembly D-14

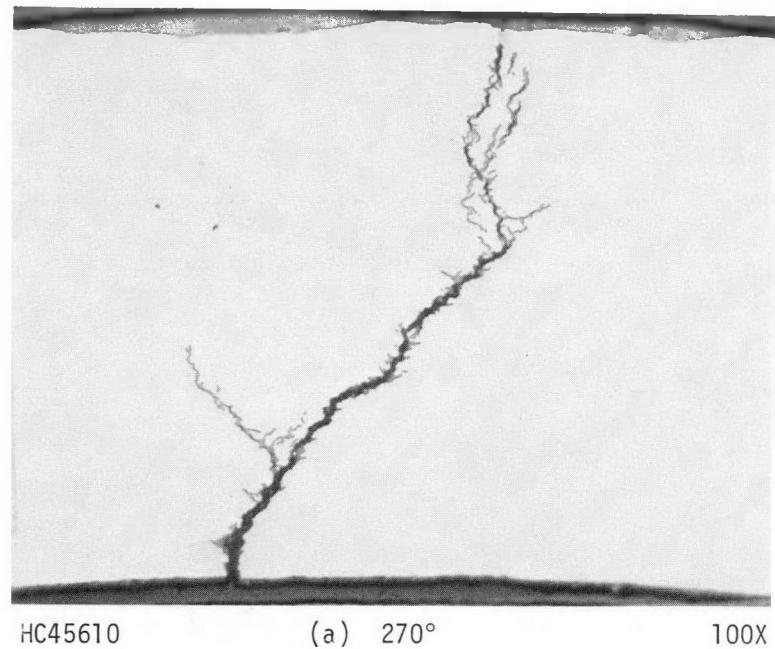
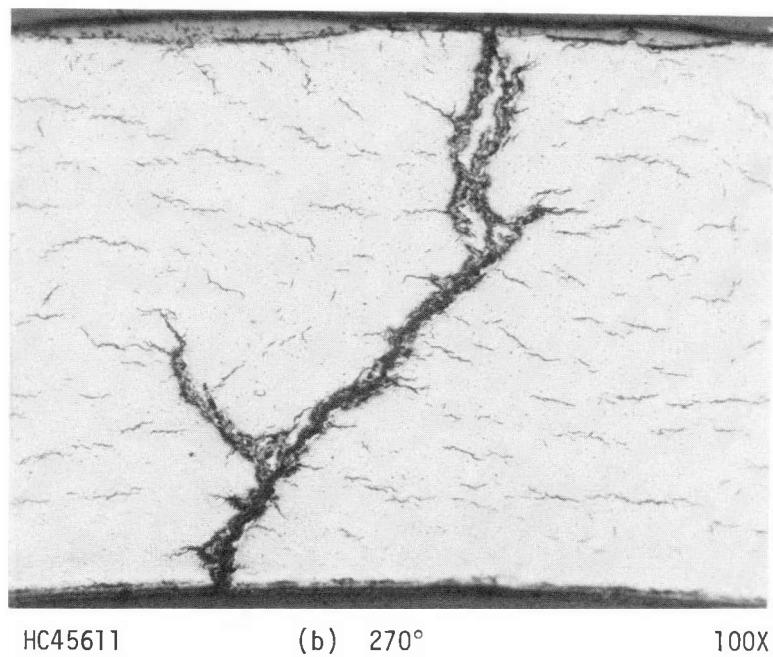
with some hydriding and a cluster of cracks in the hydrided region. Figure 3.2-2 shows the appearance of the through-wall crack at the location of the strong eddy current indications.

- The absence of any significant diameter change at this location suggests that the crack was caused by a PCI-induced stress corrosion cracking mechanism.
- The presence of corrosion products in the crack and an absence of high concentration of hydride suggests the crack to be a primary defect and not related to secondary hydriding observed in failed fuel rods.
- The presence of corrosion products in the crack suggests the rod to have sealed itself and explains the ability of the rod to sustain a vacuum and overpressure during fission gas collection and void volume measurements. This also explains why the poolside ultrasonic inspection system showed these rods to be unfailed. This system requires liquid phase water in the failed rods for an unambiguous detection of failed fuel rods.

On the basis of the examinations carried out on the sample, the axial length of the crack is estimated to be 13 mm (~ 0.5 inch).

Figure 3.2-2 Appearance of the Through-Wall Crack in the Specimen from Rod KB-5249 Near the Center of the Eddy Current Signal at 35.7 cm (14 in.) from Rod Bottom

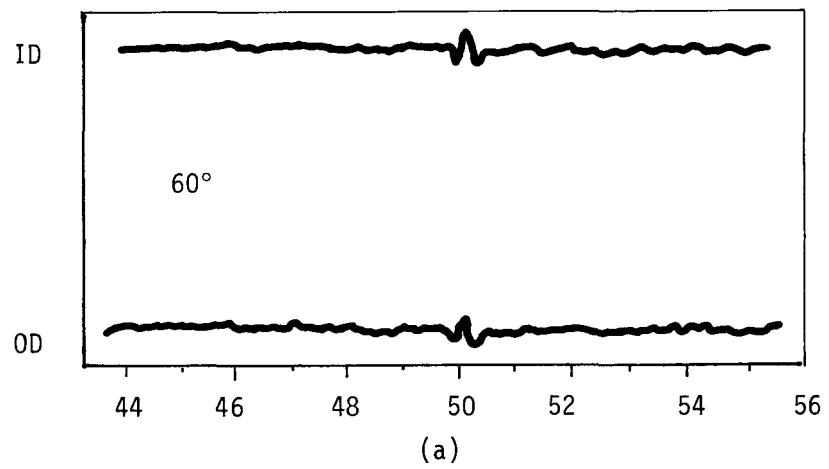
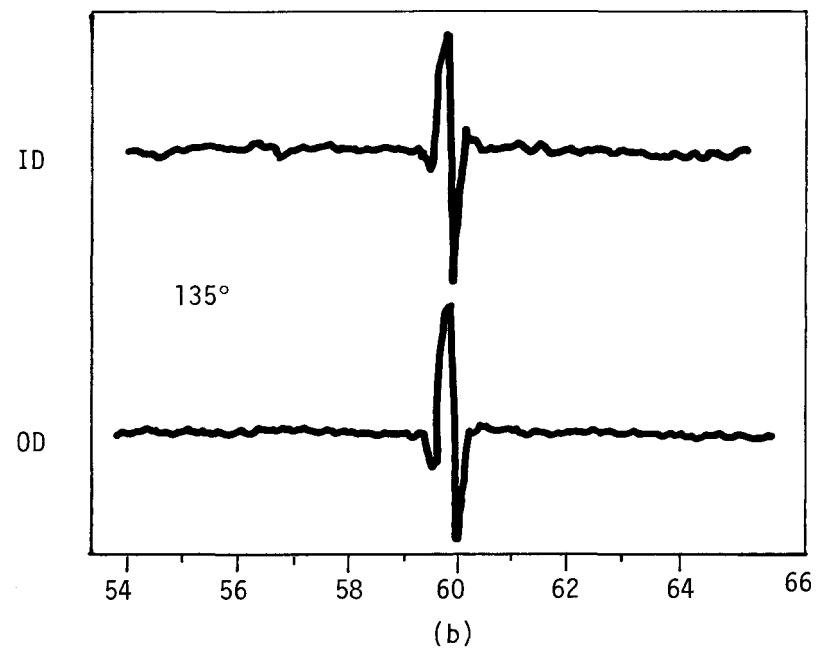
Figure 3.2-7. Comparison of (a) Weak and (b) Strong Eddy Current Indications--ANL

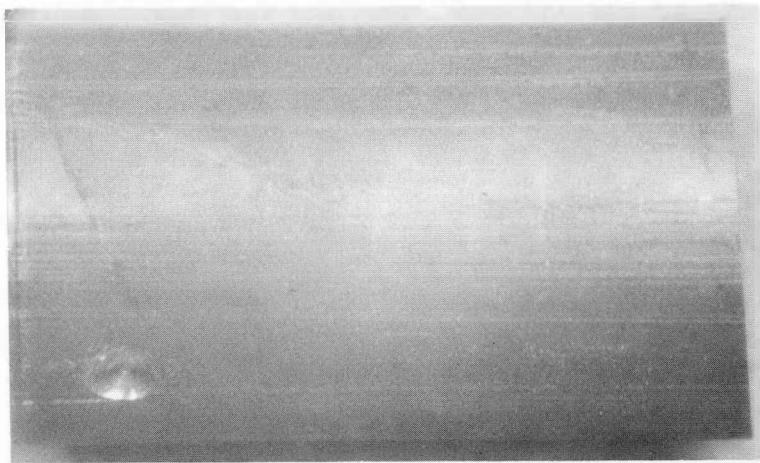
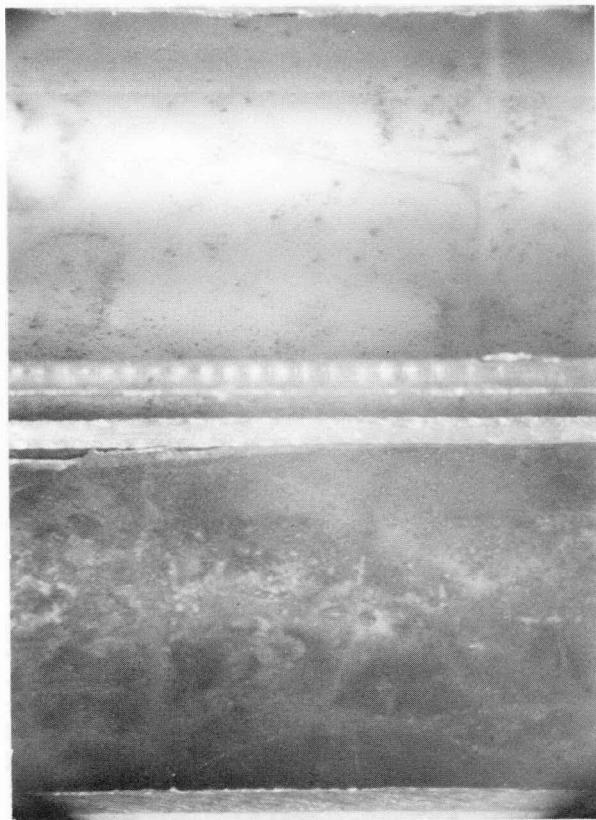
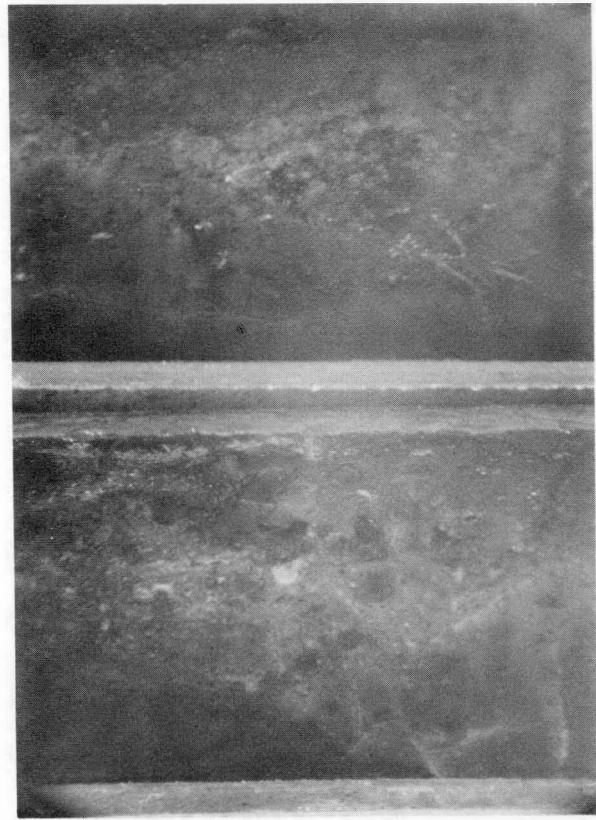
The outside cladding surfaces of the ring sections, Nos. 3, 5, and 7, looked quite clean and had numerous straight axial scratches or grooves (Figure 3.2-8a) which apparently were shallow. They might have been produced during withdrawal of the fuel rods. The outside surface of the slit section, No.15, had only a few shallow grooves. The outside surfaces of the ring sections, Nos. 16 and 19 were black and had no visible grooves. The inside of the slit cladding section, No. 4, is shown in Figure 3.3-8b. Part of the surface is shiny with some markings indicating the location of a fuel pellet-to-pellet interface and of fuel cracks. The other half of the surface is dark, consisting of a rather thick layer (probably an oxide) which possibly constitutes the fuel-cladding interaction layer, and which is partially spalled (see arrow). To this layer numerous fuel particles are bonded. The location of fuel cracks and pellet-pellet interfaces are visible. The inner surfaces of the slit sections, No. 6 (Figure 3.2-8c) and No. 15, are

Figure 3.2-8 Macrophotographs of Cladding Sections From Rod KD-0451 ~ 3.5X

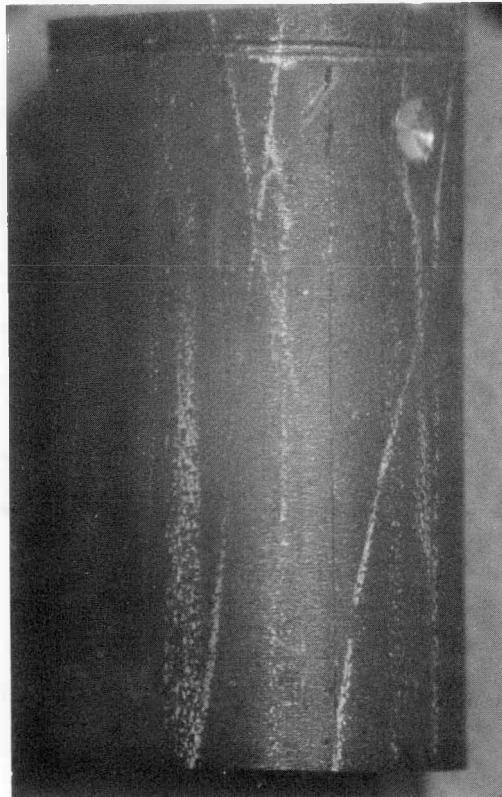
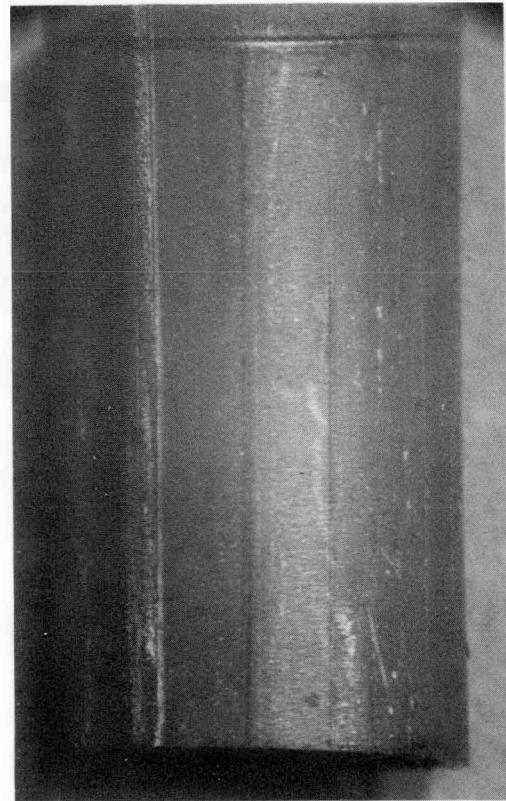
Figure 3.2-9 Macrophotographs Of Outside Surface of Cladding Section 19
From Rod KE-2225 ~ 3.5X

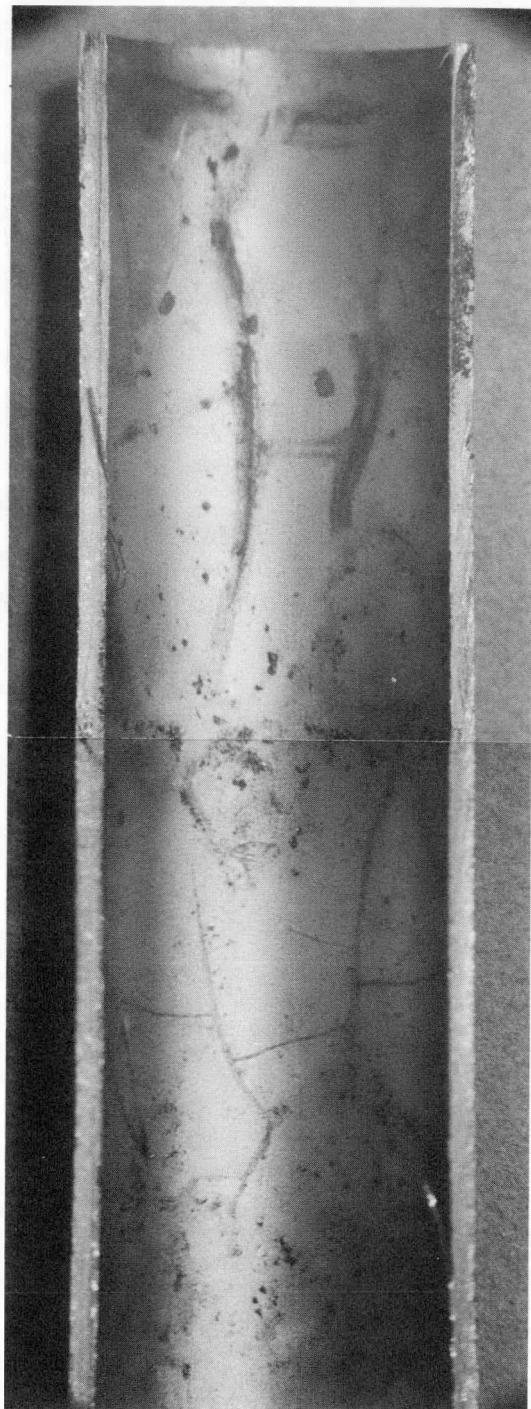
Figure 3.2-10 Macrophotographs Of One-Half Of Inside Surface Of Cladding Section 3 From Rod KE-2225 ~ 3.5X

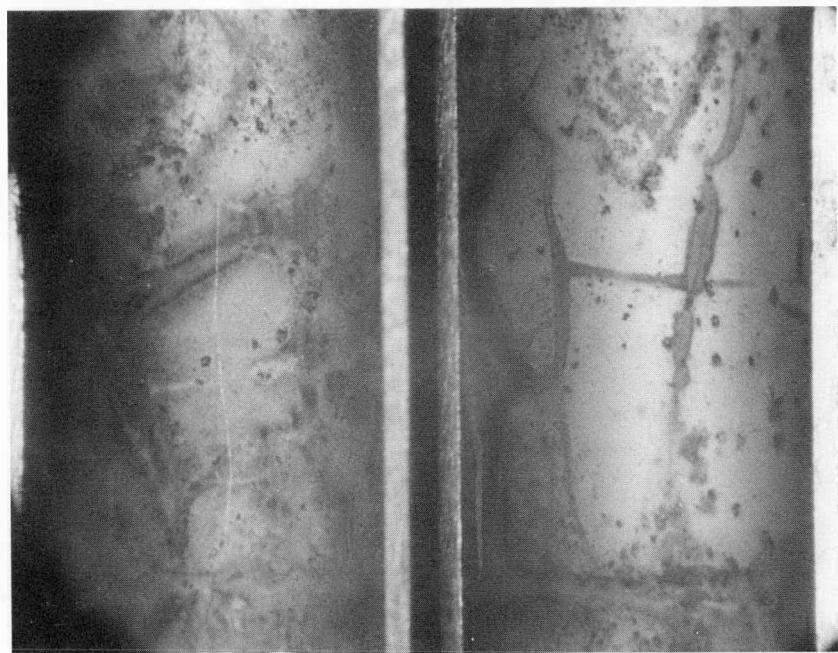
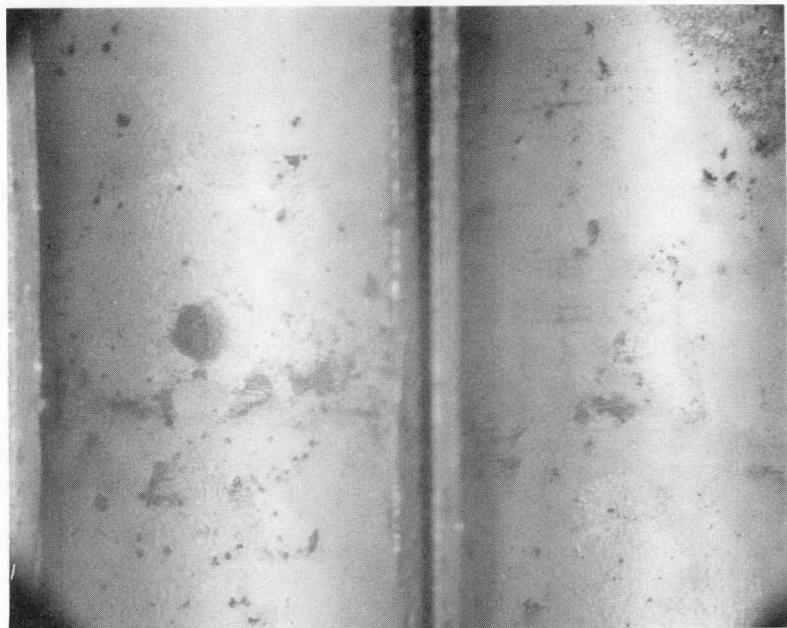
Figure 3.2-11. Macrophotographs of Inside Surface of Cladding Sections from Rod KE-2225 ~ 3.5X

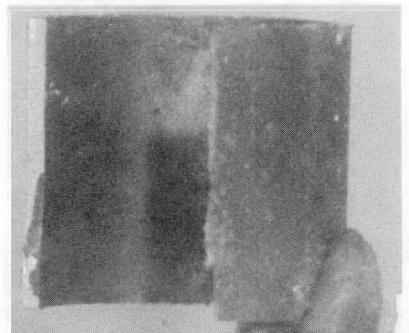
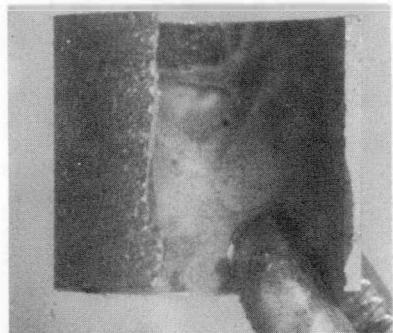
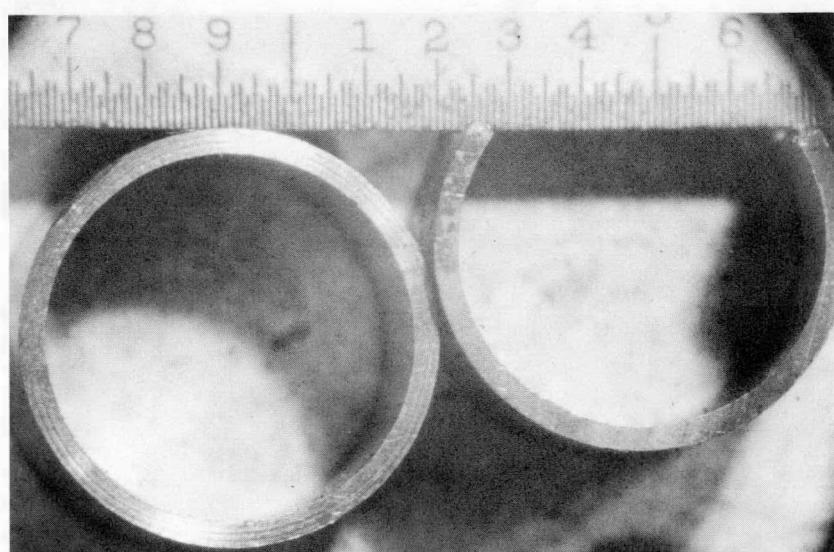
For testing the irradiated cladding, a ring 1.3 cm (1/2 inch) long was cut from rod KE-2225, at the location of the suspected incipient defect, i.e., 36.8 to 38.1 cm (14.5 to 15 inches) from the bottom of the fuel rod. The ring was placed over the mandrel with the 0-degree position of the rod over the mandrel split. (The major eddy current defect indication was located at 0 degree.) The mandrel with the sample was immersed in liquid nitrogen for approximately 5 minutes. Then the mandrel was expanded until the ring split. The ring, after the experiment, is shown in Figure 3.2-13. A piece of the ring was missing* and two incipient

a. CRACK A AT 0° AZIMUTH $\sim 3X$

b. CRACK B AT 105° AZIMUTH $\sim 3X$

Figure 3.2-13 Section 5, 14.5 to 15 Inches from Bottom of Rod KE-2225, after Expanding Mandrel Test
