Determination and Microscopic Study of Incipient Defects in Irradiated Power Reactor Fuel Rods

EPRI NP-812
Project 829
Final Report
July 1978

V. Pasupathi and J. S. Perrin
BATTELLE'S COLUMBUS LABORATORIES

This final report presents the results of nondestructive and destructive examinations carried out on the Point Beach-1 (PWR) and Dresden-3 (BWR) candidate fuel rods selected for the study of pellet-clad interaction (PCI) induced incipient defects. In addition, the report includes results of examination of sections from Oskarshamn-1 (BWR) fuel rods.

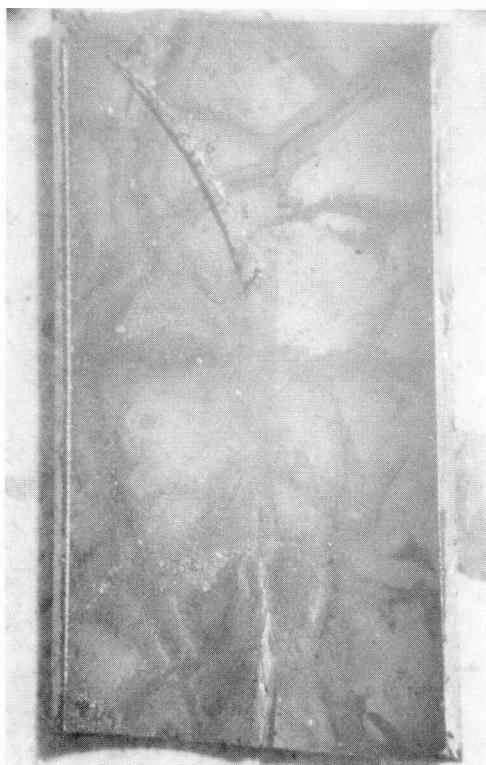
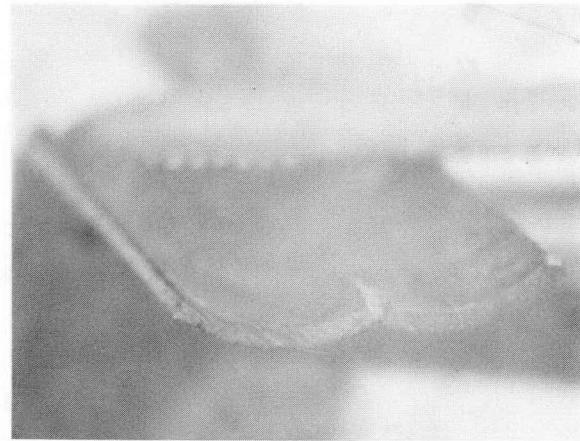
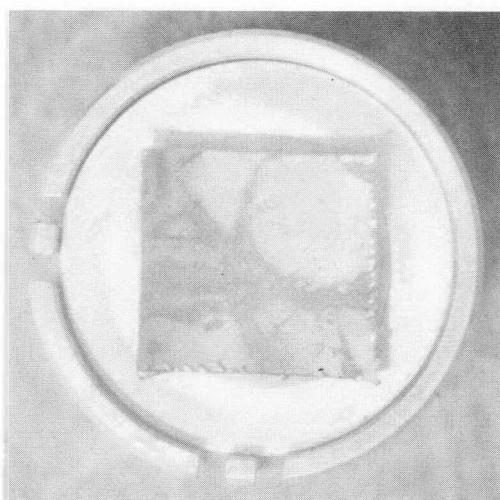
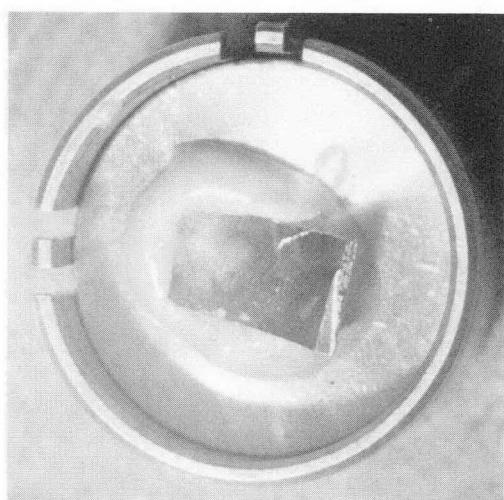
During flattening, the cladding cracked along this cut (Figure 3.2-15c). Two SEM samples were cut from the section, one of them containing the crack, as seen in Figures 3.2-15d and e.

c. LOWER HALF OF SECTION WITH CRACK CAUSED BY CUT

Figure 3.2-15 Section 5, 11-1/2 To 12-1/2 Inches From Bottom Of Rod
KE-2225, Flattened ~ 3.5X

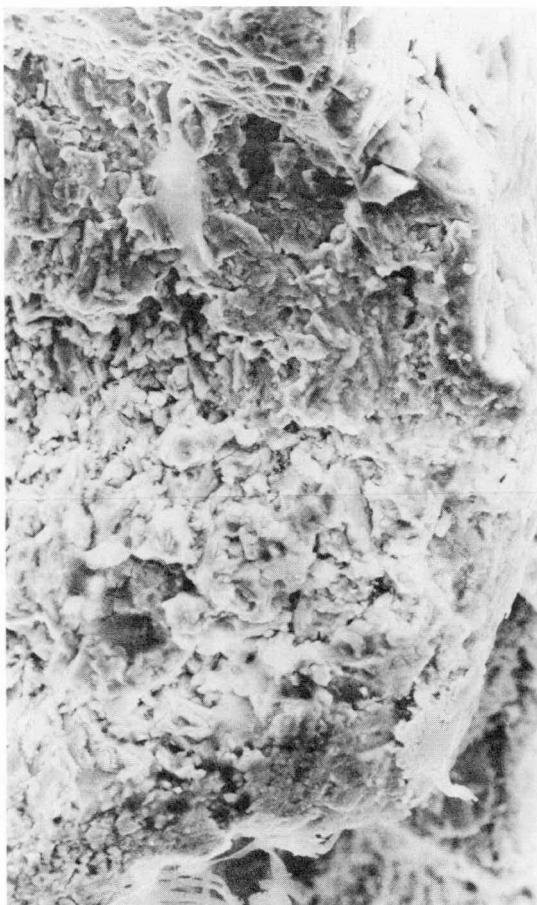
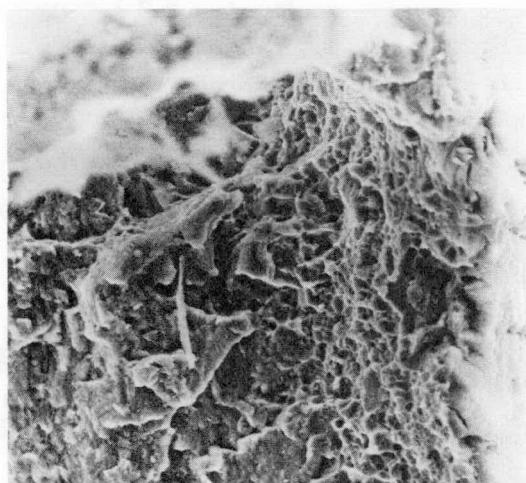
a. UPPER CRACK BRANCH, STRESS CORROSION FRACTURE

b. LOWER CRACK BRANCH WITH DUCTILE FRACTURE LIP

Figure 3.2-19. Rod KE-2225, Crack A; Lower Part of Figure 3.2-18
800X

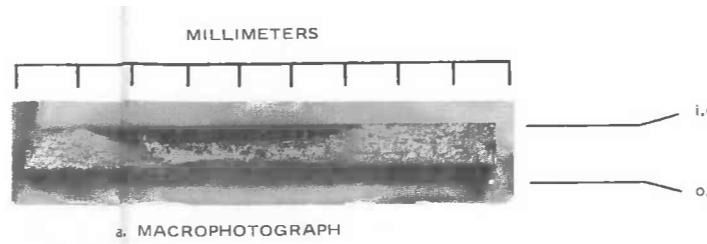
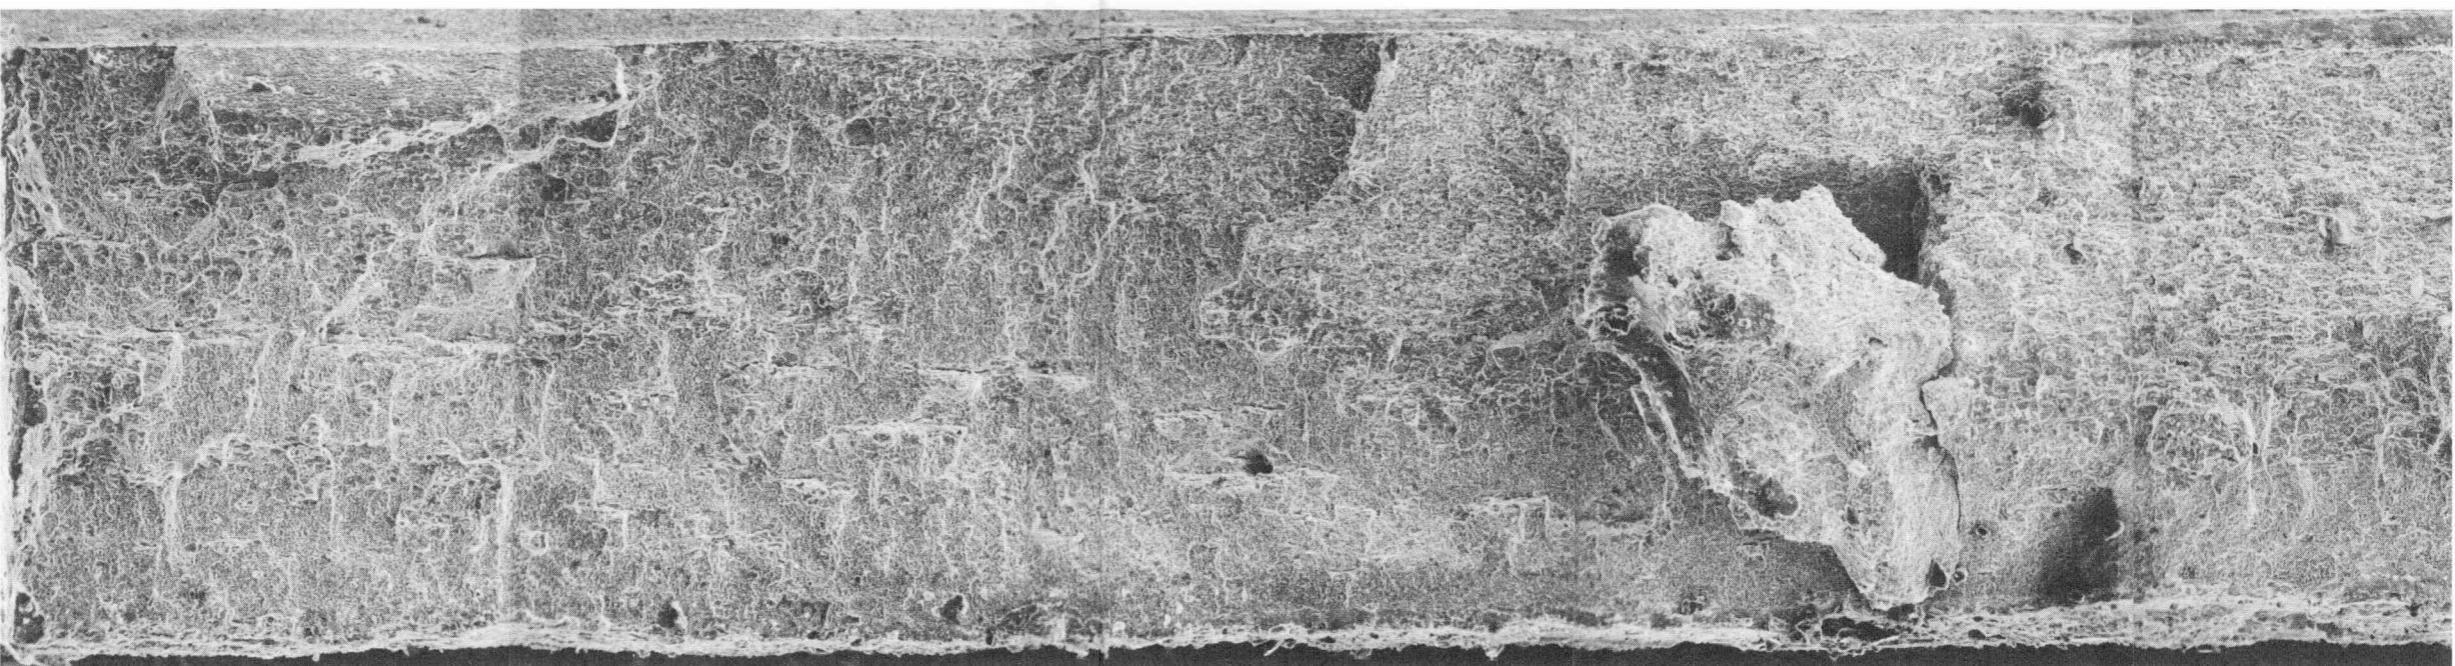
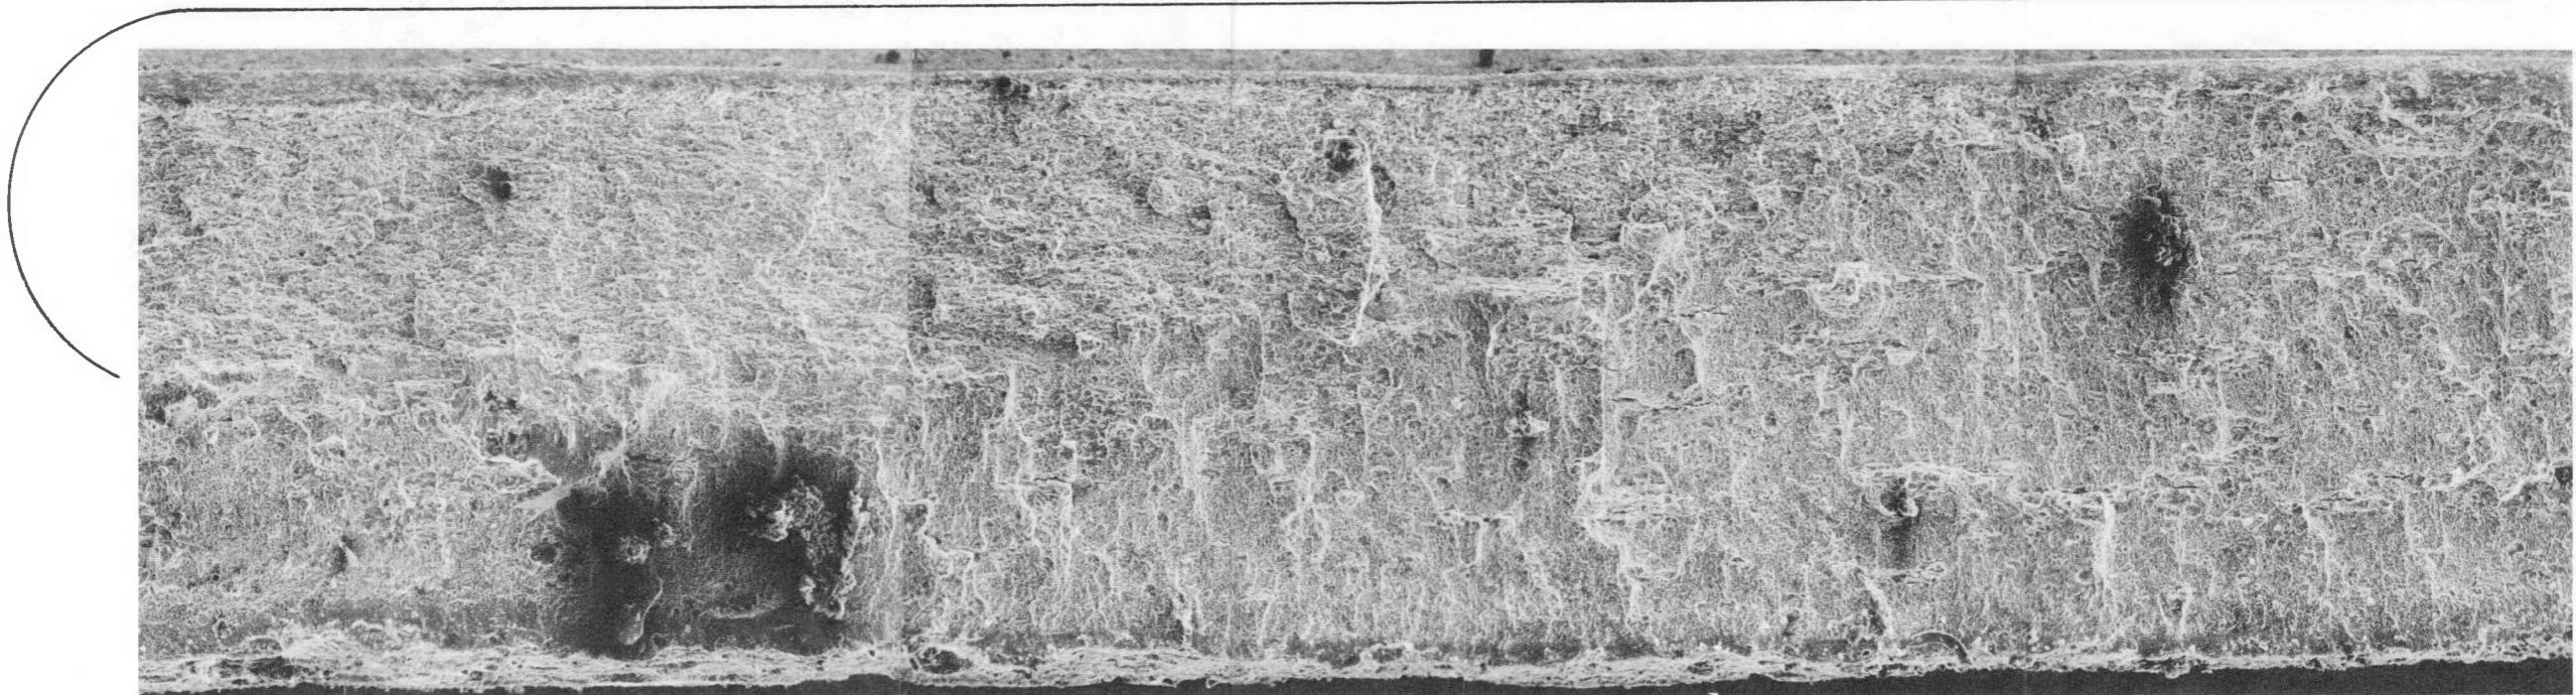
Figure 3.2-24. Rod KE-2225, Whole Fracture Surface of Crack B

Figure 3.2-23 gives an overview of all SEM micrographs of fracture B. This crack (Figure 3.2-24) at the cladding inner surface is ~ 5.0 mm long, i.e., nearly as long as crack A; however, it penetrates only about half the wall thickness. It has two branches near one end (the loose chunk is bordered by the two branches). Higher magnifications of the fracture surface (Figures 3.2-25 to 30) show the different fractographic features in more detail. Near the inner cladding surface, i.e., at the crack origin, the crack surface is oxidized (Figure 3.2-26) but not enough to obscure the cleavage and fluting features characteristic of stress corrosion cracking (16). Figure 3.2-30 shows an area less oxidized near the crack tip, where cleavage and fluting can be recognized (Figure 3.2-30c). The crack tip (Figures 3.2-25 and 3.2-27) is recognizable by the first appearance of ductile dimples. The fresh fracture (i.e., the fracture produced by the expanding mandrel) again is characterized by islands of quasi-cleavage (Figures 3.2-27 to 30) possibly associated with hydrides. Also in the fresh fracture, cracks are observed lying in a circumferential plane (Figures 3.2-27, 30, and 31; also see Figure 3.2-33). Such cracks may also be associated with hydrides. More definitive evidence of the presence of hydrides will be presented later in this Section.

b. COMPOSITE SEM MICROGRAPHS 100X

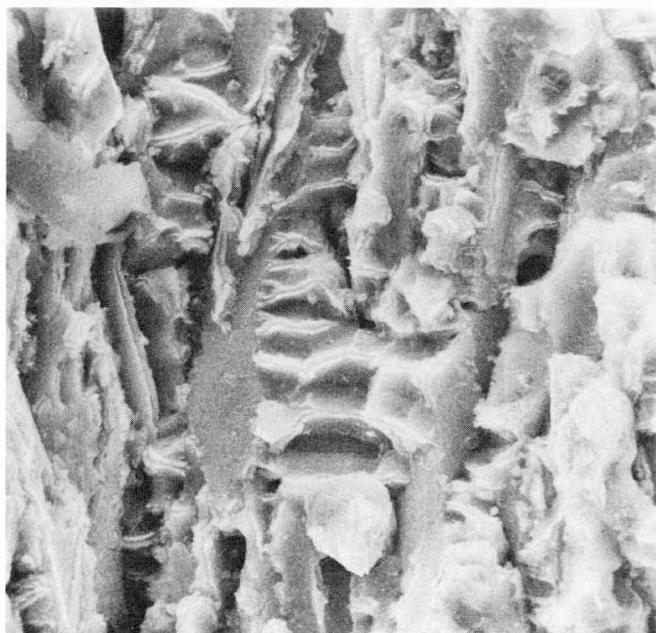
Figure 3.2-26. Rod KE-2225, Crack B; Part of Figure 3.2-21
Near Inside Cladding Surface, Stress
Corrosion Fracture

b. PART OF (a), CLEAVAGE AND FLUTING FEATURES 3000X

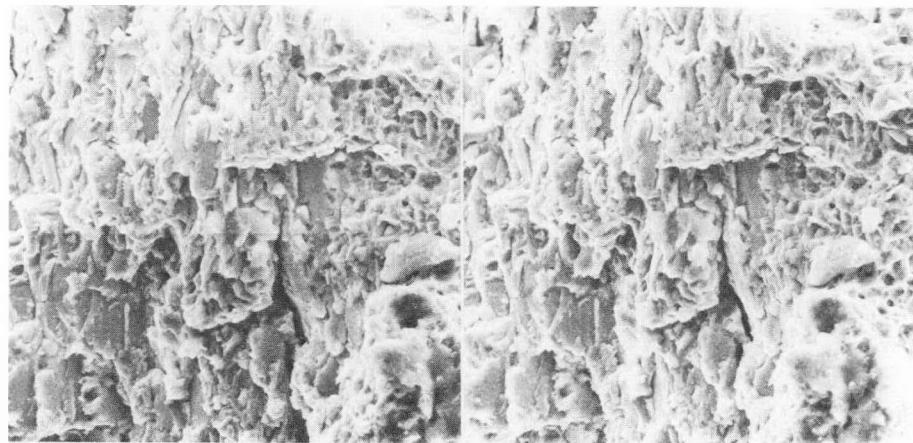
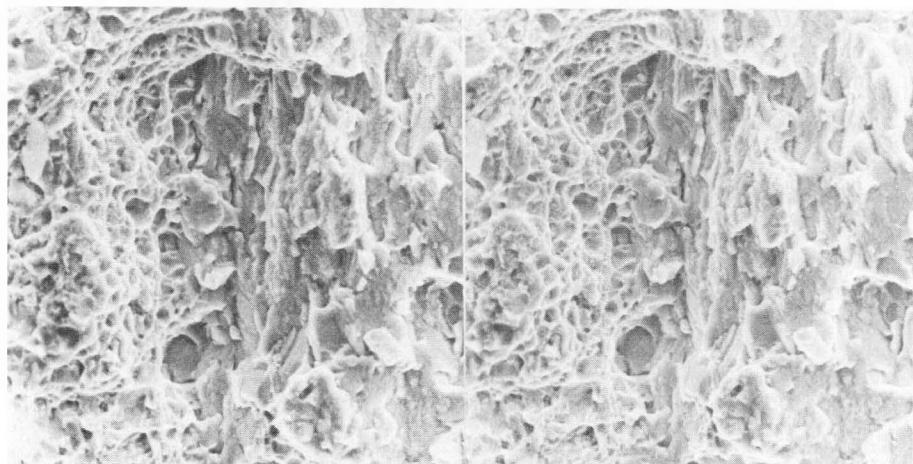
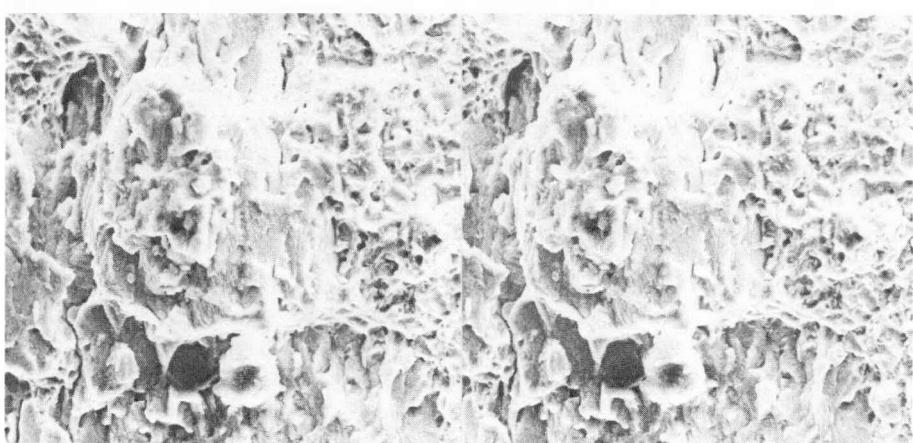
Figure 3.2-28. Rod KE-2225, Crack B; Part of Figure 3.2-27 at Crack Tip (Stereo Pairs)

a. STRESS CORROSION CRACK TIP — TRANSITION TO DUCTILE DIMPLES

b. QUASI-CLEAVAGE AND DIMPLES

c. QUASI-CLEAVAGE AND DIMPLES

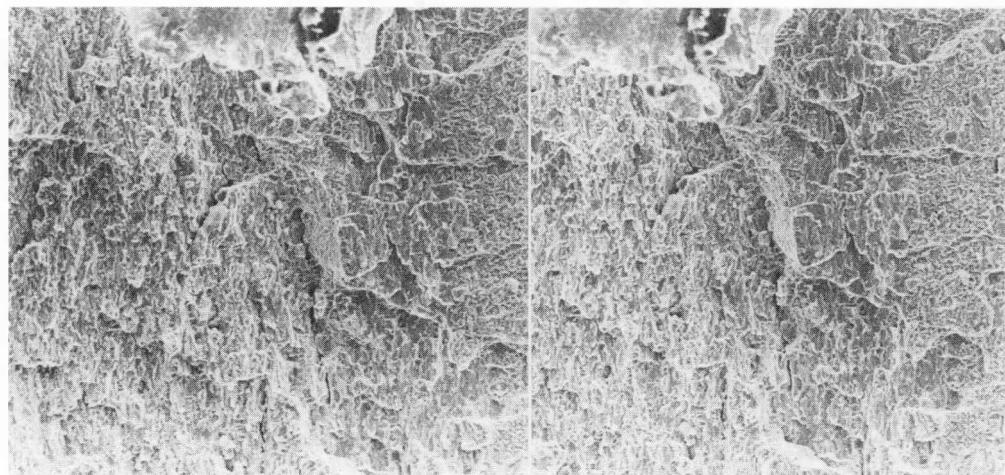
Figure 3.2-30. Rod KE-2225, Crack B; Area Near Crack Tip
(See Figure 3.2-23 for Location)

a. STEREO PAIR 200X

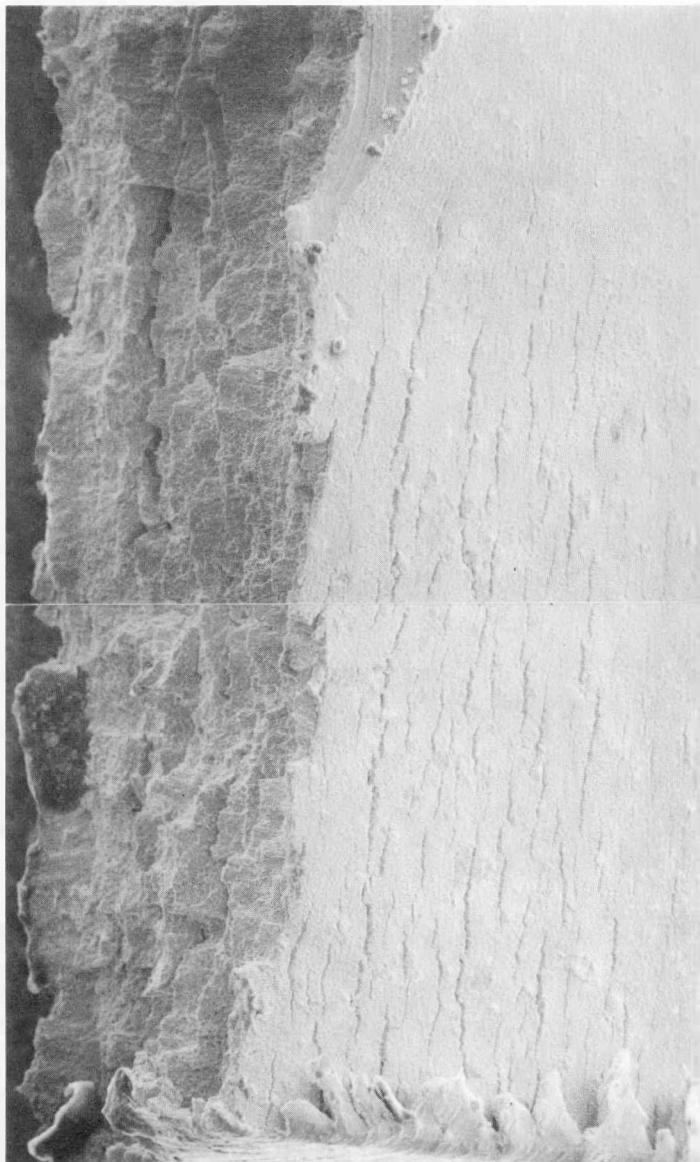
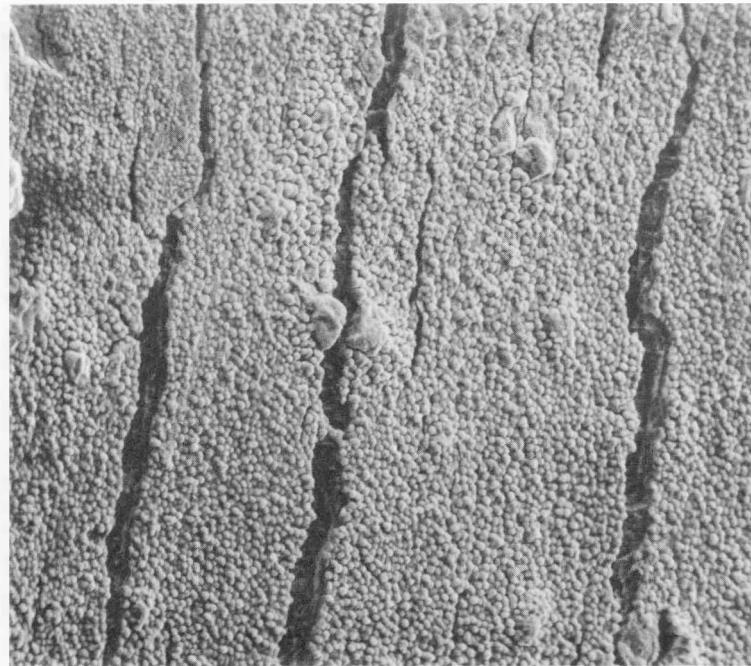
Figure 3.2-32. Rod KE-2225, Section 5C, Flattened

is shown in Figures 3.2-32a and 33. The fracture mode is completely ductile signifying that no incipient crack was present at this location. The flattening has caused numerous longitudinal cracks (Figure 3.2-32), but these cracks apparently penetrate only the UO_2 - ZrO_2 interaction layer and possibly the ZrO_2 .

a. CRACK SURFACE AND INSIDE CLADDING SURFACE 100X

b. INSIDE CLADDING SURFACE WITH BEADED INTERACTION LAYER 500X

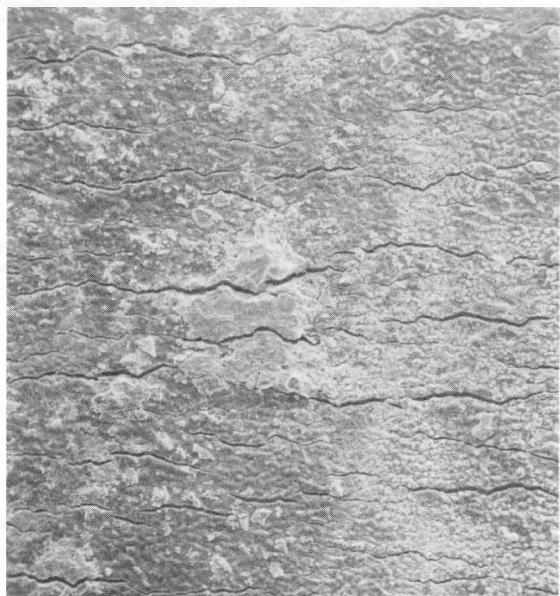
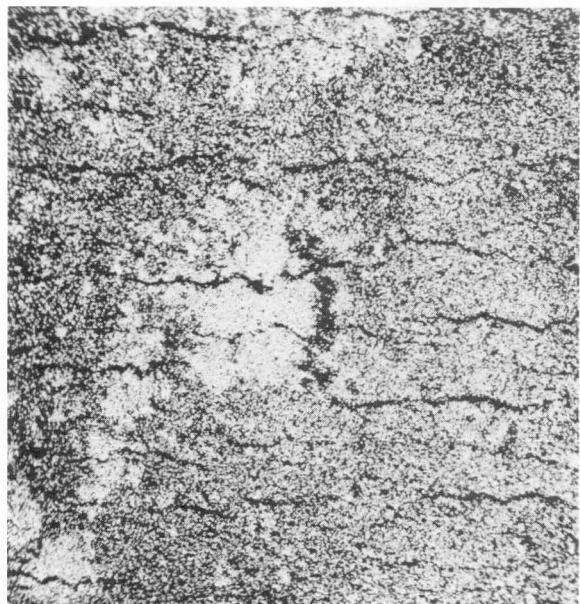
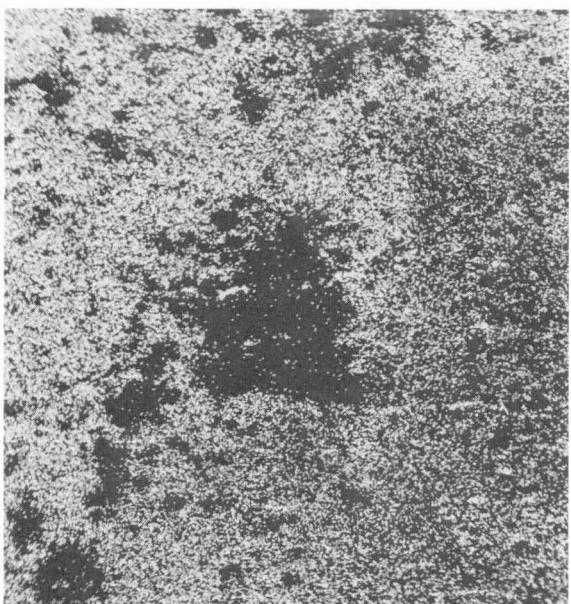
Figure 3.2-35. Rod KE-2225, Section 5D, Flattened; Area Near Center
of Figure 3.2-34 200X

The uncracked section (5D) has similar surface cracks (Figures 3.2-34, 35a, and 36a). UO_2 pieces are bonded to the surface and an interaction layer of varying morphology has formed. This layer has a beaded surface (Figure 3.2-37, also Figure 3.2-32b) with the bead size possibly dependent on the local temperature and/or on the proximity of the UO_2 pellet surface. The bead size changes at the location of a pellet-pellet interface (Figure 3.2-37). The beads, or small nodules, contain uranium (Figures 3.2-38 and 39). Cracking of the interaction layer has occurred only during flattening of the cladding. This can be seen in Figure 3.2-40 taken near the incipient Crack A exposed by the expanding mandrel test (but not flattened). Here the layer has occasional holes but no cracks. Its surface is relatively smooth giving the impression that beads might have coalesced. The layer contains both uranium and zirconium as seen in the X-ray maps, Figures 3.2-35 and 36. Since fission products are also expected in the interaction layer, X-rays of cesium and tellurium were made to pinpoint the location of these elements (Figures 3.2-38 and 39). Cesium is mainly associated with UO_2 particles. The tellurium signal is barely above background; no particular spatial tellurium concentrations was found.

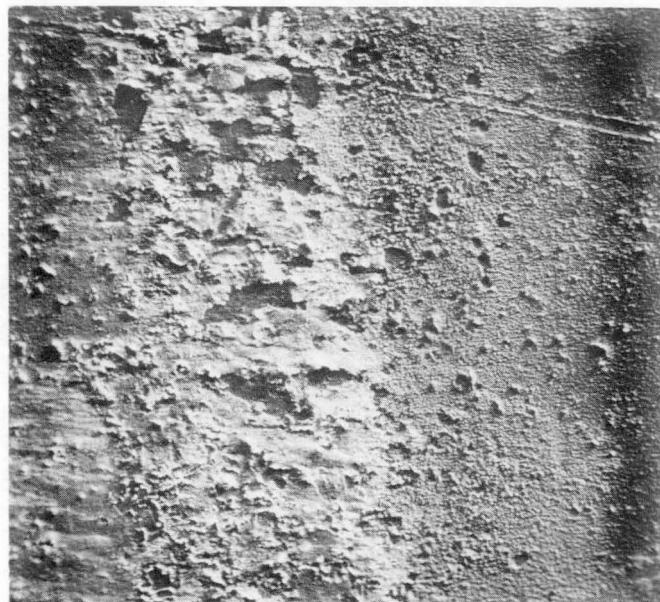
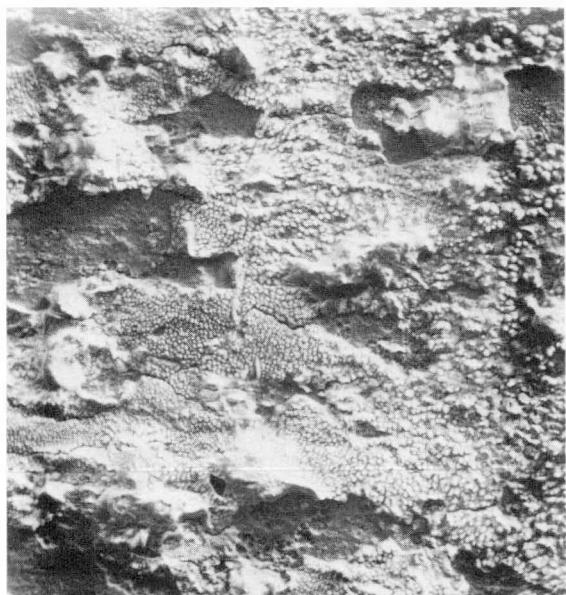
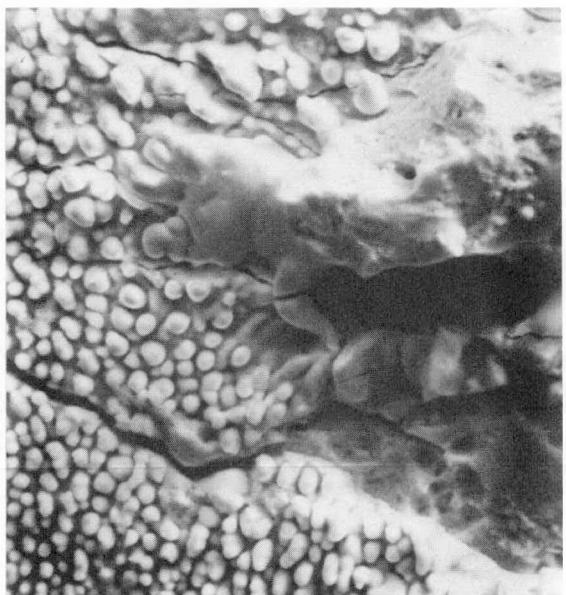
Figure 3.2-37. Rod KE-2225, Section 5D, Flattened; Area Including Location of Fuel Pellet-To-Pellet Interface

↑
PELLET INTERFACE

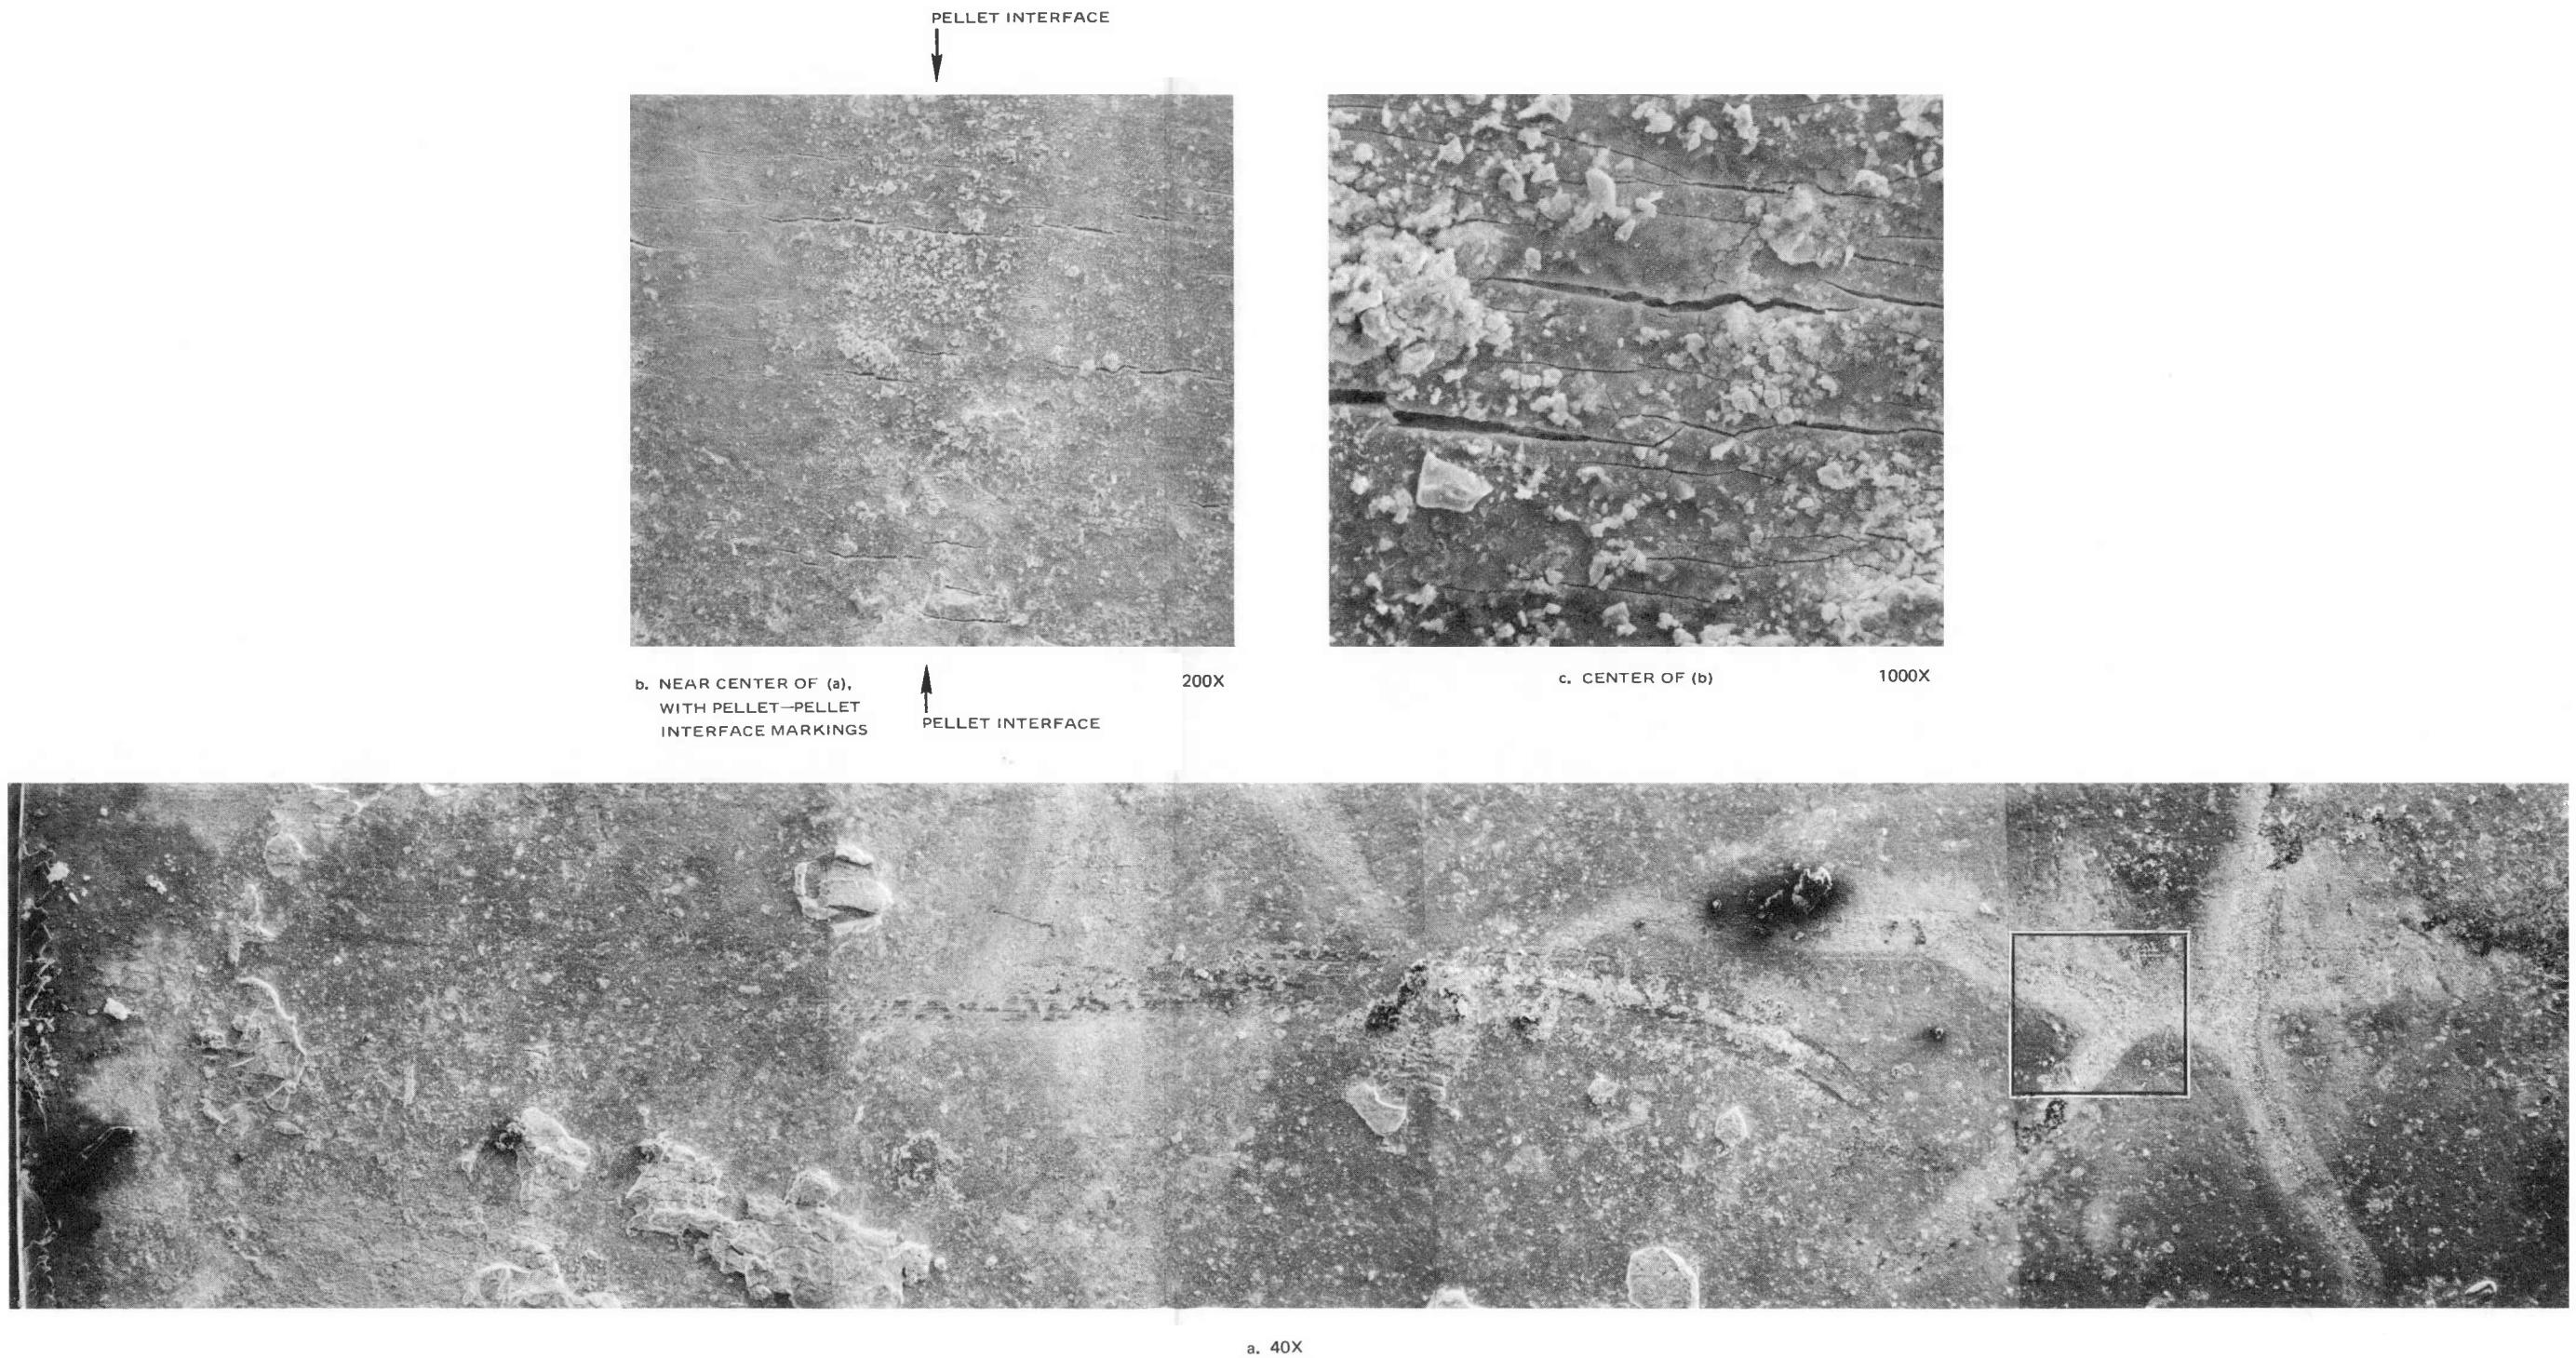
Figure 3.2-41. Rod KD-0451, Section 5A, Flattened

The inside surface of this unfailed rod (Figures 3.2-41 to 48) also contains longitudinal surface cracks involving only the interaction layer and the ZrO_2 as was the case in rod KE-2225. However, the interaction layer looks different from that in the failed rod.

In Section 5 (Figures 3.2-41 to 43a) the surface is not beaded. In certain regions, apparently related to fuel cracks and interfaces, the layer has holes and discontinuities (Figures 3.2-42 and 43b, and c). X-ray maps show that numerous small UO_2 particles (Figures 40c and 42a) are bonded to the cladding surface. Considerable amounts of Te and smaller amounts of Cs are associated with UO_2 particles (Figure 3.2-44c and d).

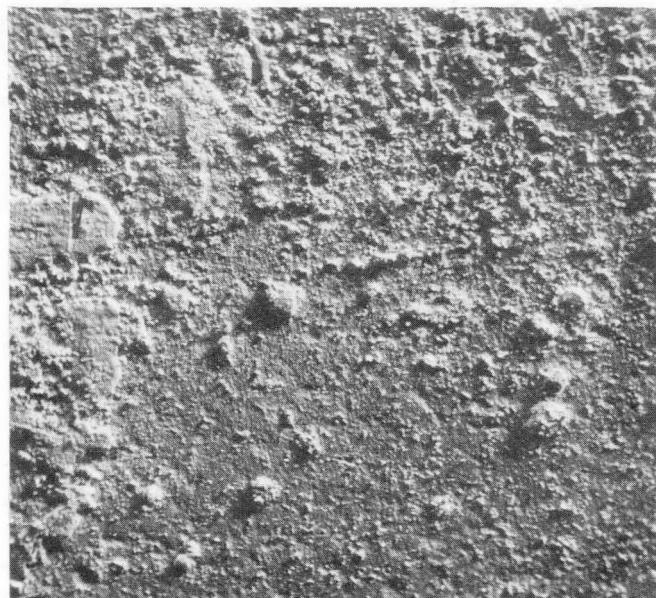
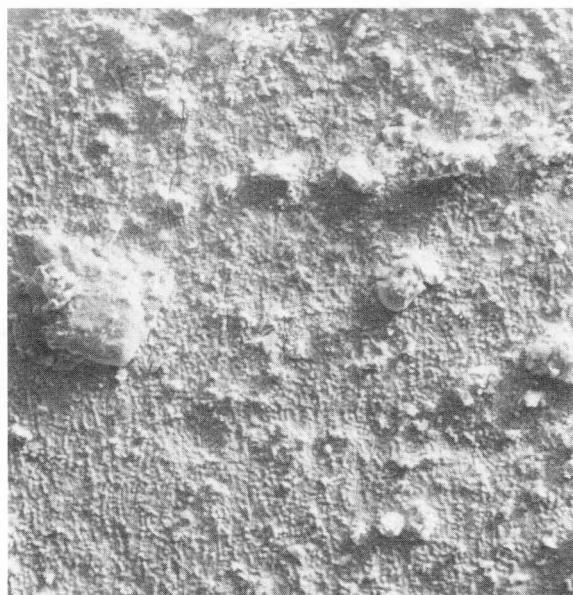
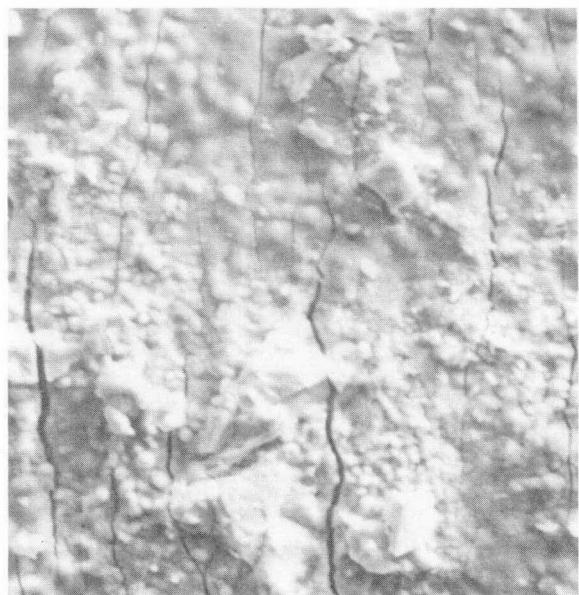
Figure 3.2-47. Rod KD-0451, Section 15, Flattened

In Section 15 at the high burnup end of the rod (but no power transient) the features on the cladding inner surface are much smaller (Figure 3.2-47) than in the other sections. Many UO_2 particles of various sizes are bonded to the cladding. The interaction layer is bumpy and undulating but apparently of rather uniform composition (within the spatial resolution of the X-ray mapping technique--Figure 3.2-48). Small amounts of Cs are associated with UO_2 and the amount of Te is hardly above background.

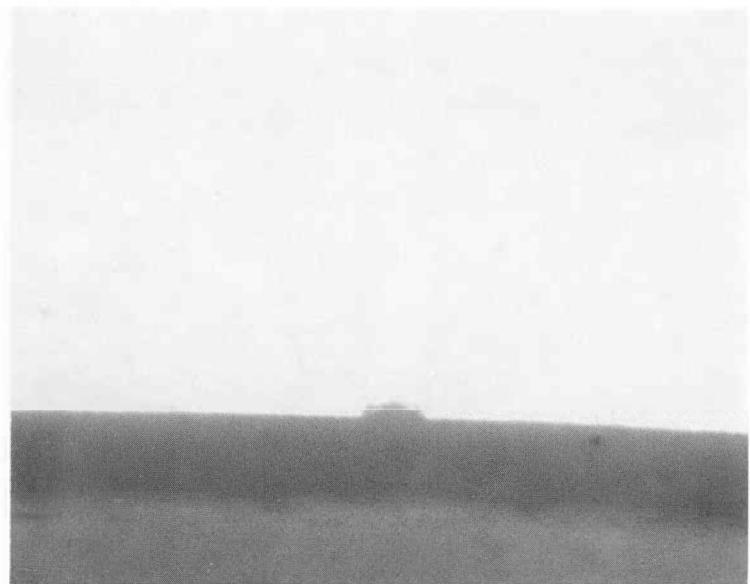
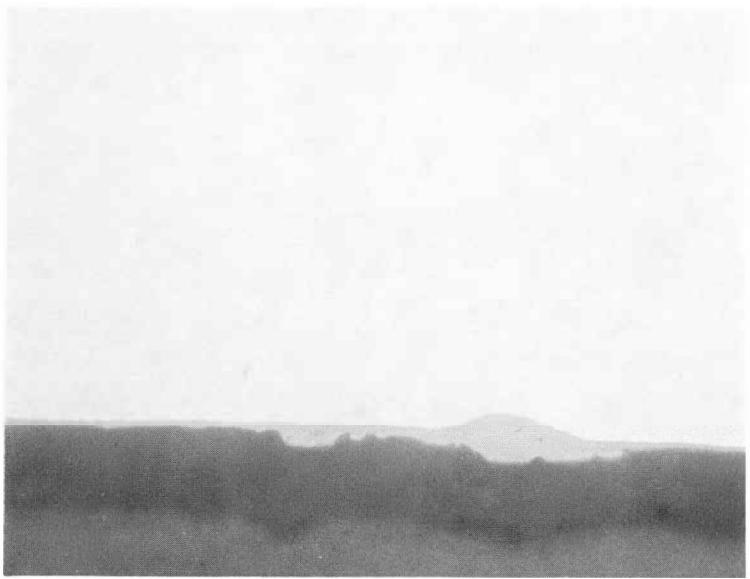
Figure 3.2-49. Rod KE-2225, Section 5, Metallographic Cross Section
11.5 to 12.5 Inches from Bottom of Rod, Unetched 500X

The sample cut next to the flattened piece [29.2 to 31.8 cm (11-1/2 to 12-1/2 inches) from the bottom of the rod] shows a few small fuel particles bonded to the cladding (Figure 3.2-49b). An occasional pit (Figure 3.2-49a) appears to be insignificant; it has not served for crack initiation. The ring cut next to the incipient cracks [36.3 to 36.8 cm (14.3 to 14.5 inches) from the bottom] does not contain any cracks. It shows the same features as the other sample, e.g., occasional fuel particles bonded to the cladding (Figure 3.2-50a). The hydride distribution is uniform and the amount of hydrides appears small (Figure 3.2-50b). In the sample cut through fracture A the amount of hydrides is slightly larger (Figure 3.2-51) and apparently their orientation has been modified by the stress pattern at the tip of the incipient crack. The hydrides are oriented predominantly circumferentially out to the crack tip; beyond that, near the outside surface of the cladding, the orientation is predominately radial (Figures 3.2-52). These results tend to confirm the interpretation given the flaky or quasi-cleavage fractographic features (see above Section a). The longitudinal section [29.2 to 31.8 cm (11-1/2 to 12-1/2 inches) from the bottom] has long hydride stringers (Figure 3.2-53). From Figures 3.2-50 to 53 it is concluded that the hydrides form long ribbons or bands in axial direction with a length many times their width.

a. SMALL PIT ON INSIDE CLADDING SURFACE

b. FUEL BONDED TO CLADDING IN PIT

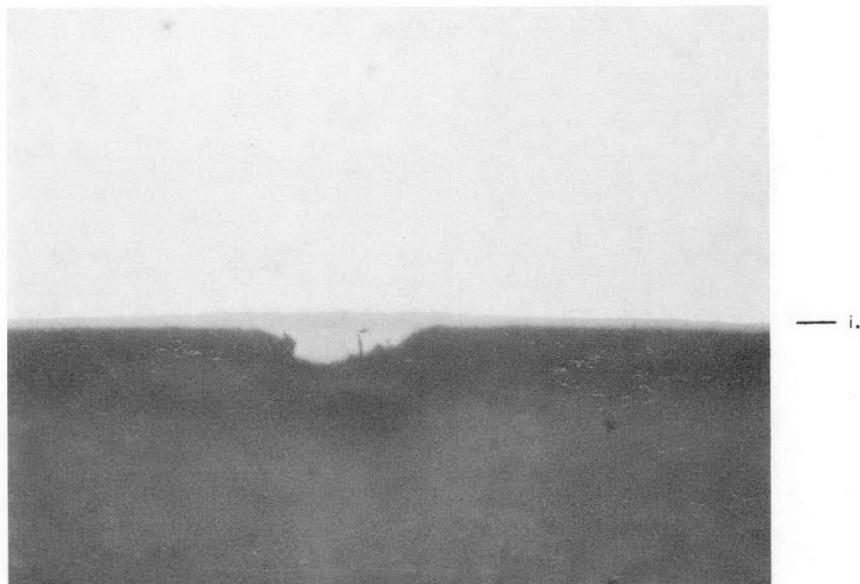
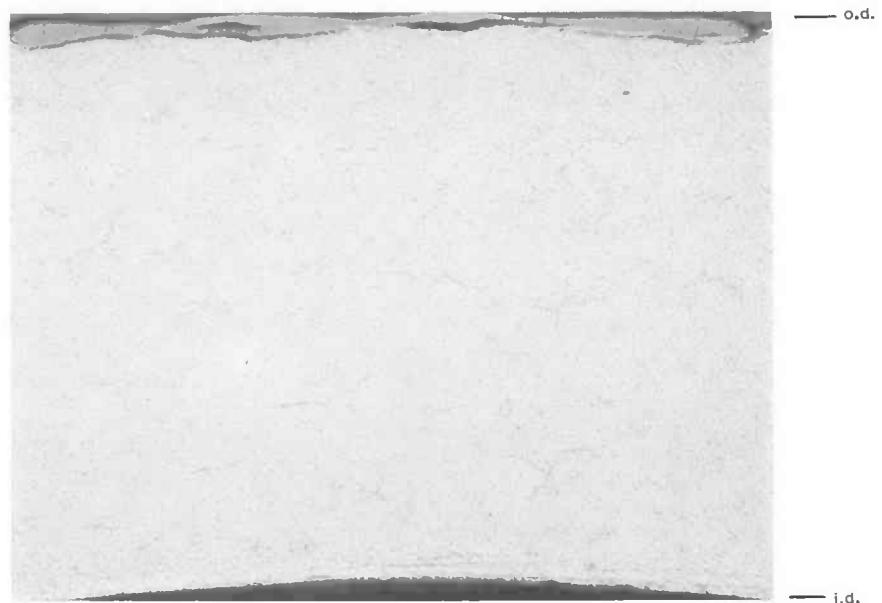
Figure 3.2-50. Rod KE-2225, Section 5, Metallographic Cross Section
14.3 to 14.5 Inch from Bottom of Rod

a. UNETCHED, FUEL BONDED TO CLAD, 500X

b. ETCHED, SMALL AMOUNT OF HYDRIDES, 100X

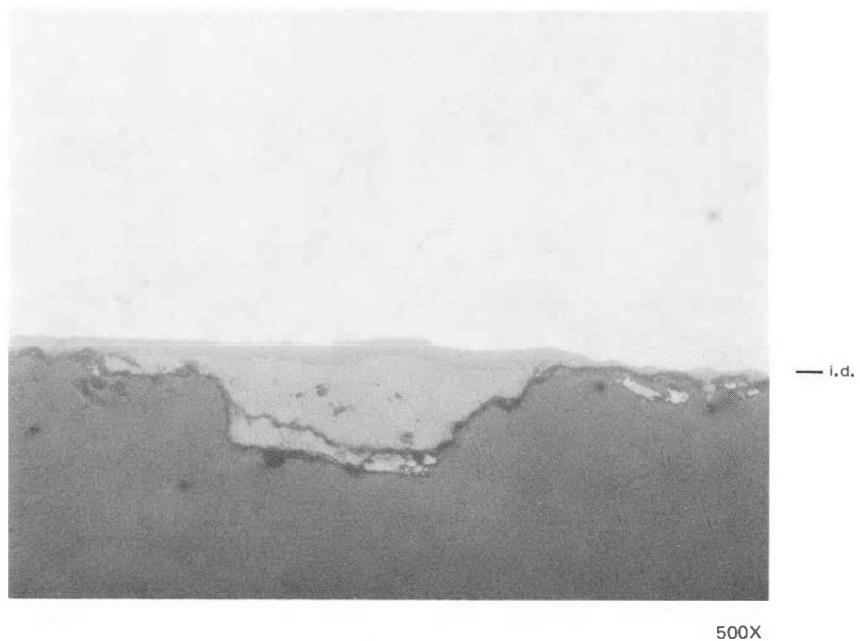
In the section at the 25.4 to 27.9 cm (10 to 11 inches) axial location no defects were found. Occasionally, fuel particles are bonded to the cladding (Figure 3.2-54). The section 297.2 to 299.7 cm (117 to 118 inches) from the bottom has a few oxide-filled pits on the cladding outer surface (Figure 53a). On the cladding inner surface shallow pits (Figure 3.2-55a and bonded fuel (Figure 3.2-55c) are seen. The bonding layer between ZrO_2 and UO_2 in Figure 3.2-55c contains round features corresponding in size to the beaded surfaces seen in SEM micrographs of the cladding inner surface (e.g., Figure 3.2-32b). In one place a shallow spalling crack parallel to the surface was observed (Figure 3.2-55d). However, this crack did not propagate into the cladding.

Figure 3.2-54. Rod KD-0451, Section 5, Metallographic Cross Section
10 to 11 Inches from Bottom of Rod, Unetched; Fuel
Bonded to Cladding with Smooth Interaction Layer

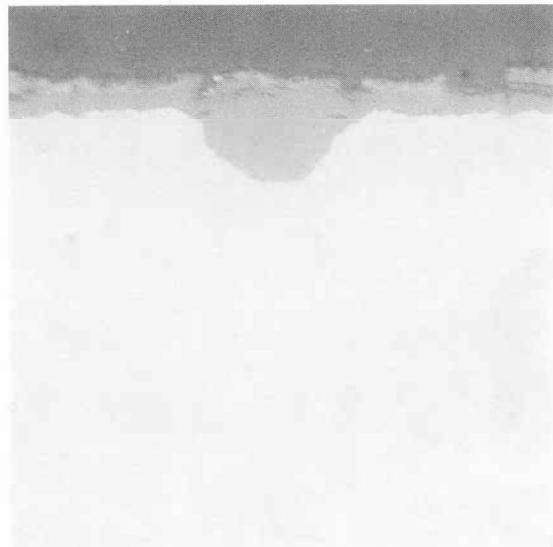
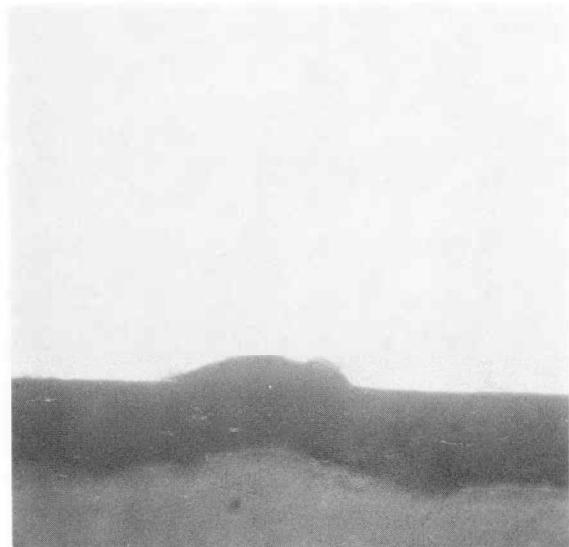
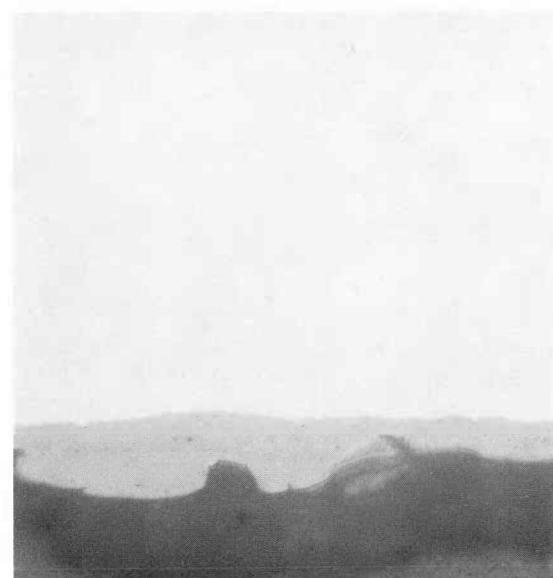
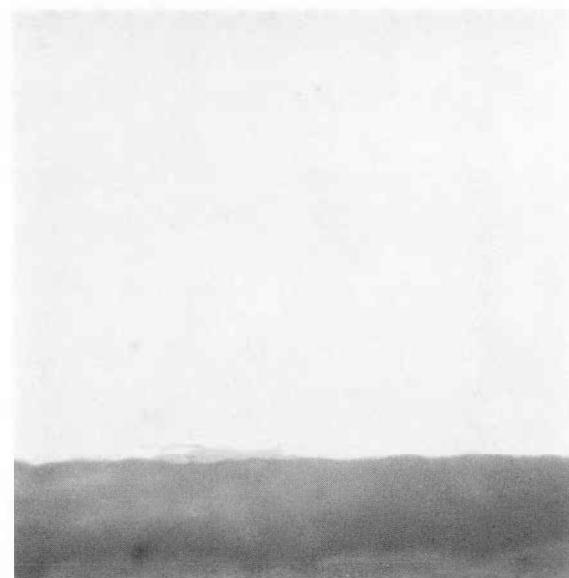
Figure 3.2-55. Rod KD-0451 Section 16, Metallographic Cross Section 117 to 118 Inches from Bottom of Rod, Unetched 500X

a. OXIDE-FILLED PIT ON OUTSIDE OF CLADDING

b. SHALLOW PIT ON INSIDE OF CLADDING

c. FUEL BONDED TO CLADDING WITH
BEADED INTERACTION LAYER

d. SHALLOW SPALLING CRACK ON INSIDE OF CLADDING
