Determination and Microscopic Study of Incipient Defects in Irradiated Power Reactor Fuel Rods

EPRI NP-812
Project 829
Final Report
July 1978

V. Pasupathi and J. S. Perrin
BATTELLE'S COLUMBUS LABORATORIES

This final report presents the results of nondestructive and destructive examinations carried out on the Point Beach-1 (PWR) and Dresden-3 (BWR) candidate fuel rods selected for the study of pellet-clad interaction (PCI) induced incipient defects. In addition, the report includes results of examination of sections from Oskarshamn-1 (BWR) fuel rods.

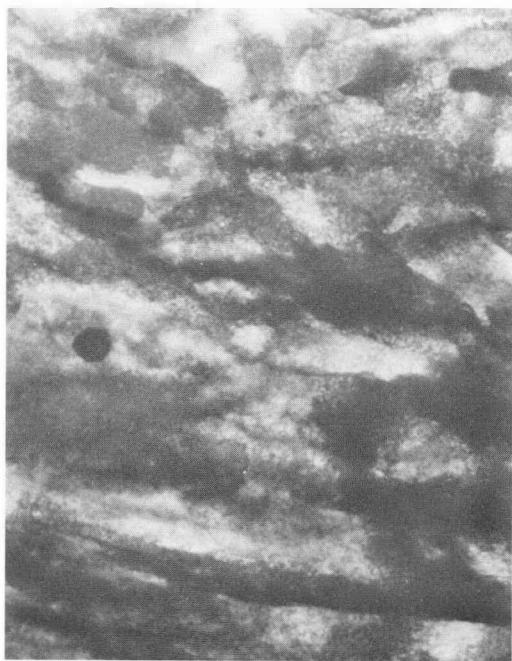
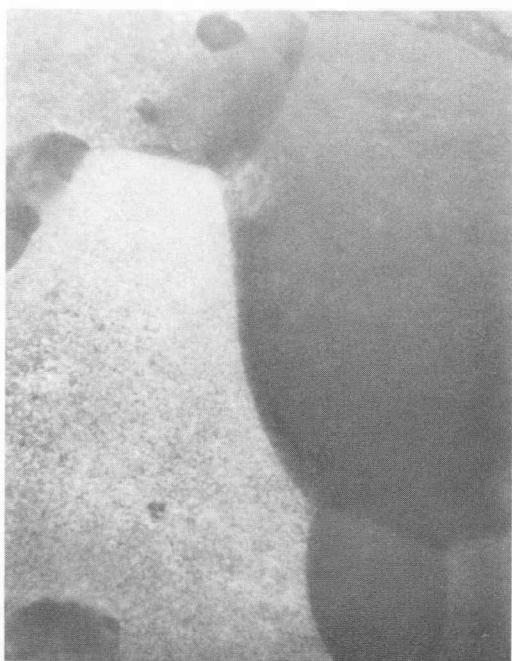
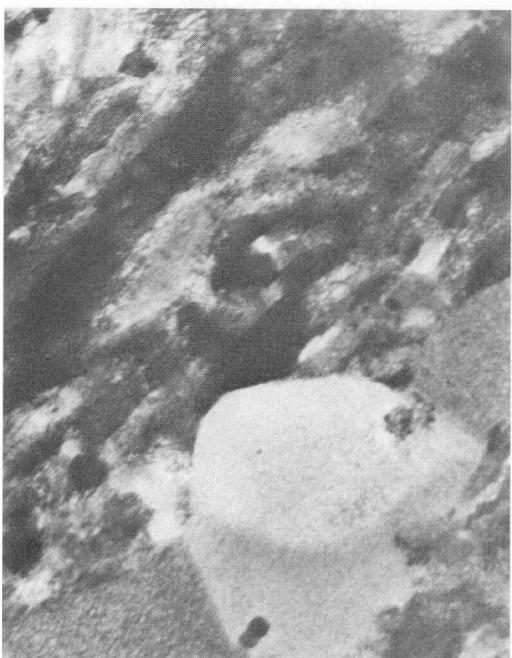
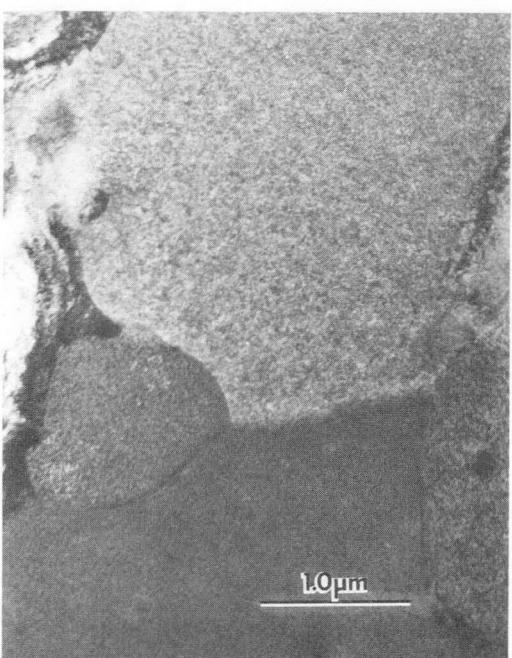
Figure 3.2-56. Microstructures of Fuel Rod KD-0451 Showing Mixed Unrecrystallized and Recrystallized Portions

The microstructures of all ring sections of this rod consist of partially recrystallized material characteristic of the post-forming stress relief anneal and examples are shown in Figure 3.2-56. In the recrystallized grains, corduroyed images, Figure 3.2-57, were often observed and were consistent with such features generally observed in irradiated Zircaloy (17). In the unrecrystallized regions $\vec{c} + \vec{a}$ dislocations introduced during the forming process could be observed when the basal planes were diffracting as shown in Figure 3.2-58. The Burgers vectors of these dislocations have a \vec{c} -axis component; purely \vec{a} -type dislocations are out of contrast here. The inference that they are $\vec{c} + \vec{a}$ is based on the crystallographic constraints (18) and on experience (19). The radiation damage observable in recrystallized material consists of small black dots, illustrated in Figure 3.2-59 which are characteristic of unresolvable dislocation loops.

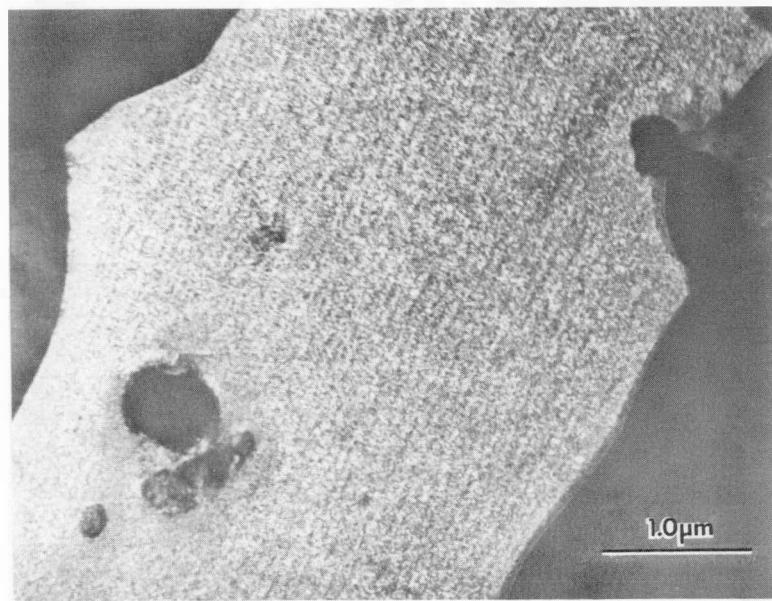
b. SECTION 7

Figure 3.2-57. Corduroy Image Effects in Fuel Rod KD-0451

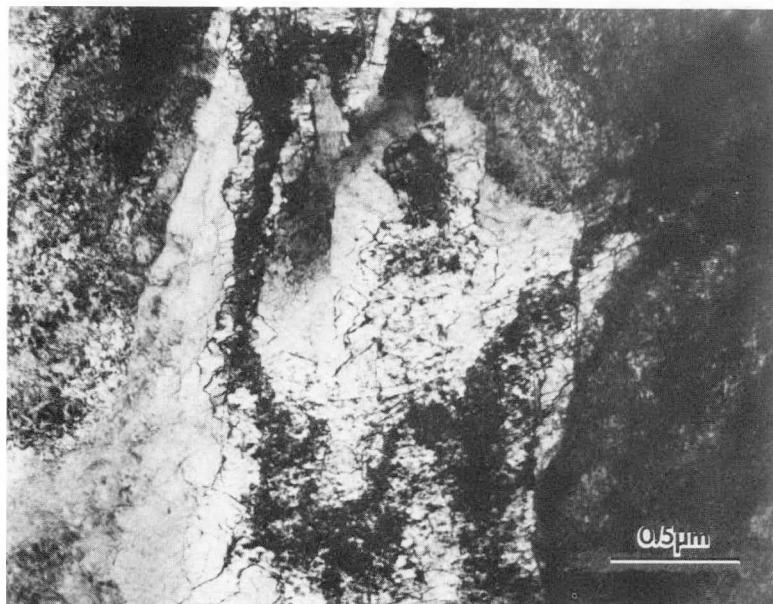
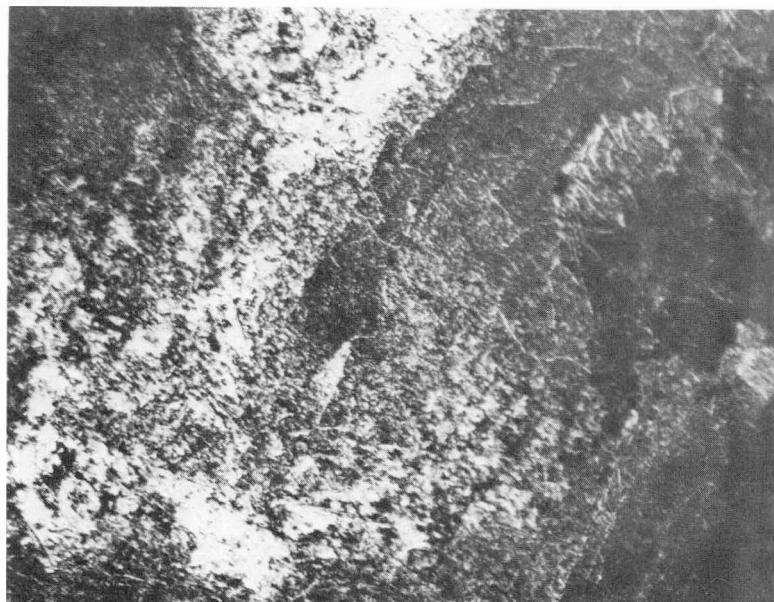
Figure 3.2-58. $\bar{c} + \bar{a}$ Dislocations in Unrecrystallized Areas of Fuel Rod KD-0451 Observed with Basal Planes Diffracting

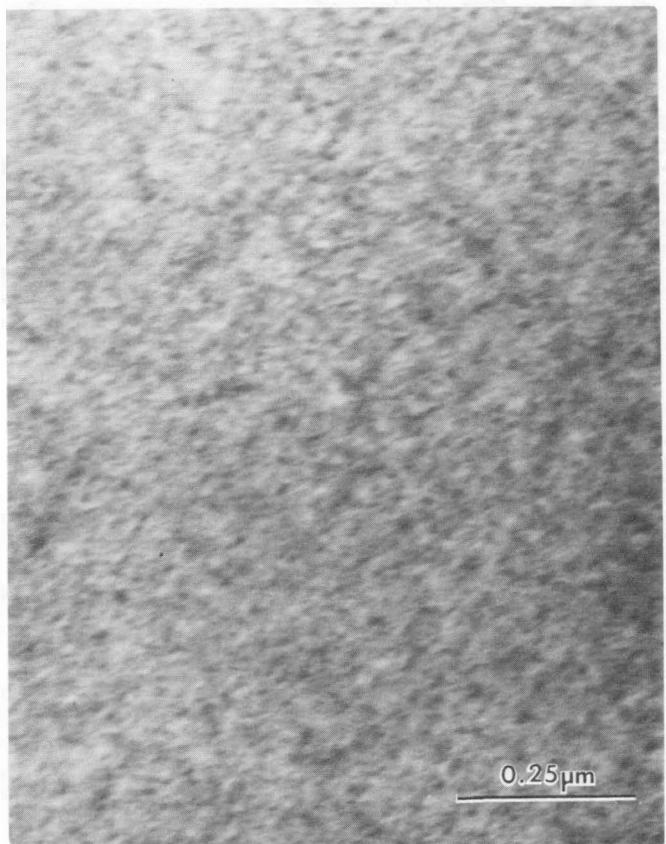
Figure 3.2-59. "Black Spot" Radiation Damage in Recrystallized Portion of Fuel Rod KD-0451, Section 7

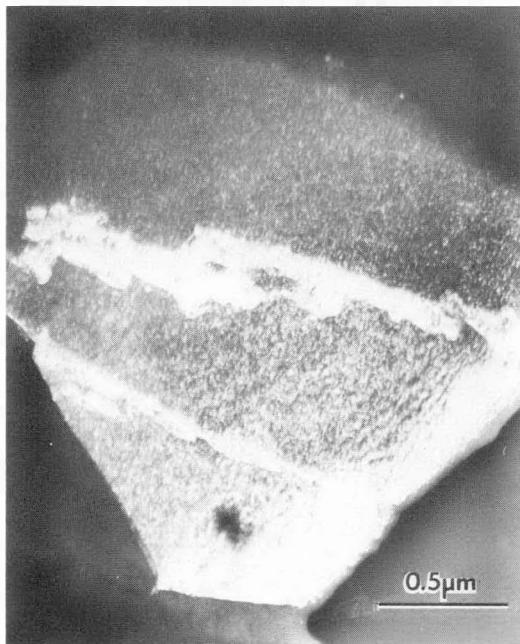
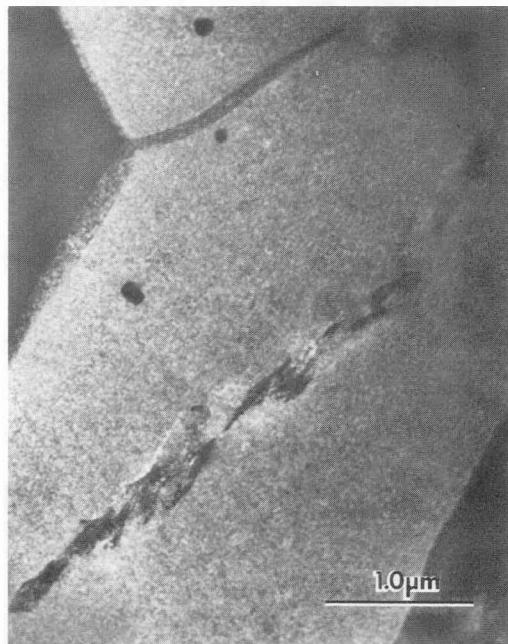
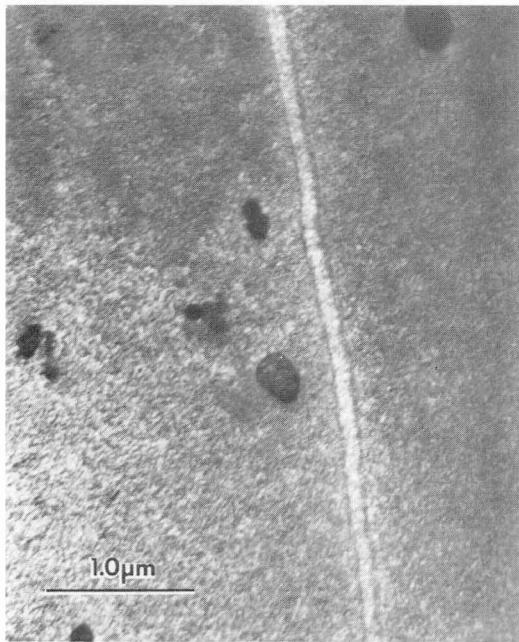
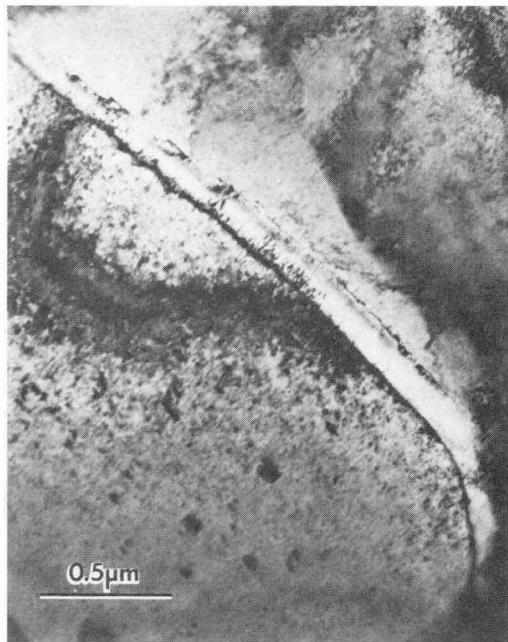
In the two outermost sections of this rod, the low power bottom section (No. 3) and also the plenum section (No. 19), no unusual features were observed which could be related to in-service deformation. However, in the intermediate cladding sections, various features were observed that may be related to such deformation. The most common observations consist of defected recrystallized grains with features shown in Figure 3.2-60. From the diffracted spots generated by these features, they could be analyzed as hydrides although it was difficult to distinguish them from twins in some cases.

Figure 3.2-60. Hydrides in High Power and High Burnup Regions of Fuel Rod KD-0451

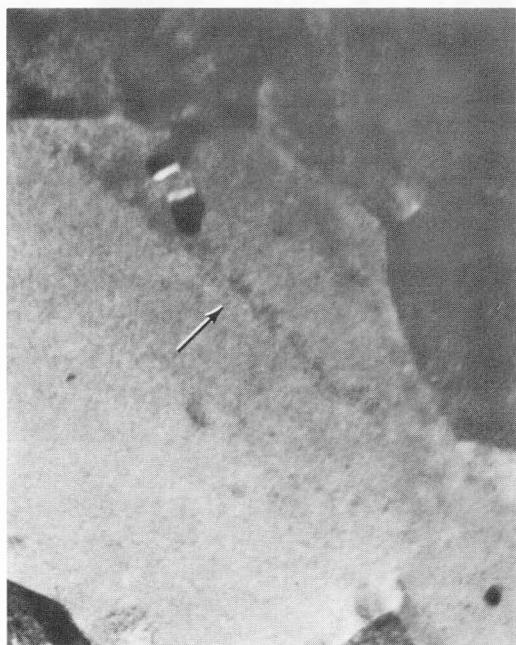
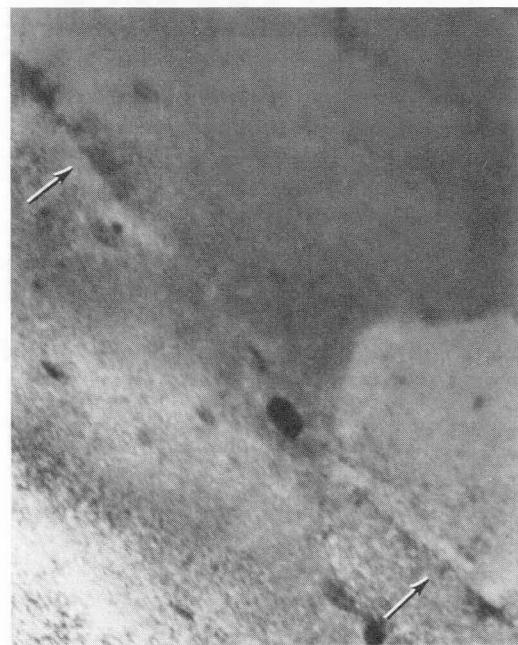
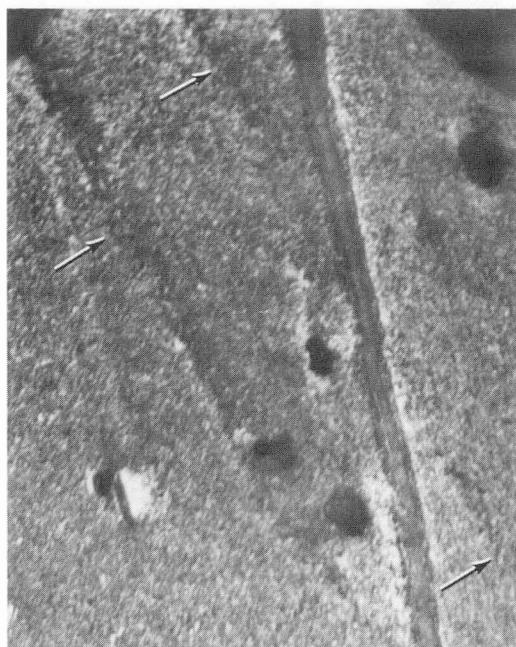
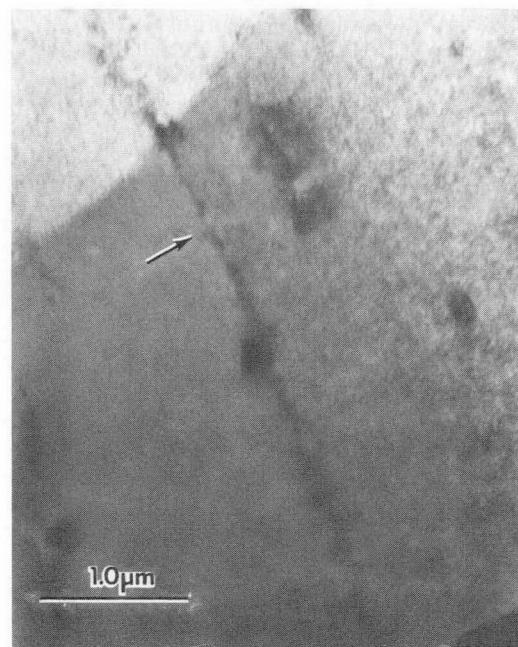
In the power transient region, a number of very weak features could be found which were in appearance like dislocation channels, although much healed by further irradiation. These features are illustrated in Figure 3.2-61. The contrast from these channels was such that they were entirely unnoticeable unless diffracting conditions were carefully adjusted (compare Figure 3.2-60c and Figure 3.2-61c obtained from the same grain). They did, however, extend from grain to grain and were parallel with traces of $\{10\bar{1}1\}$, $\{10\bar{1}2\}$, and $\{10\bar{1}3\}$ planes.

Figure 3.2-61. Faint Dislocation Channels in Fuel Rod KD-0451, Section 7

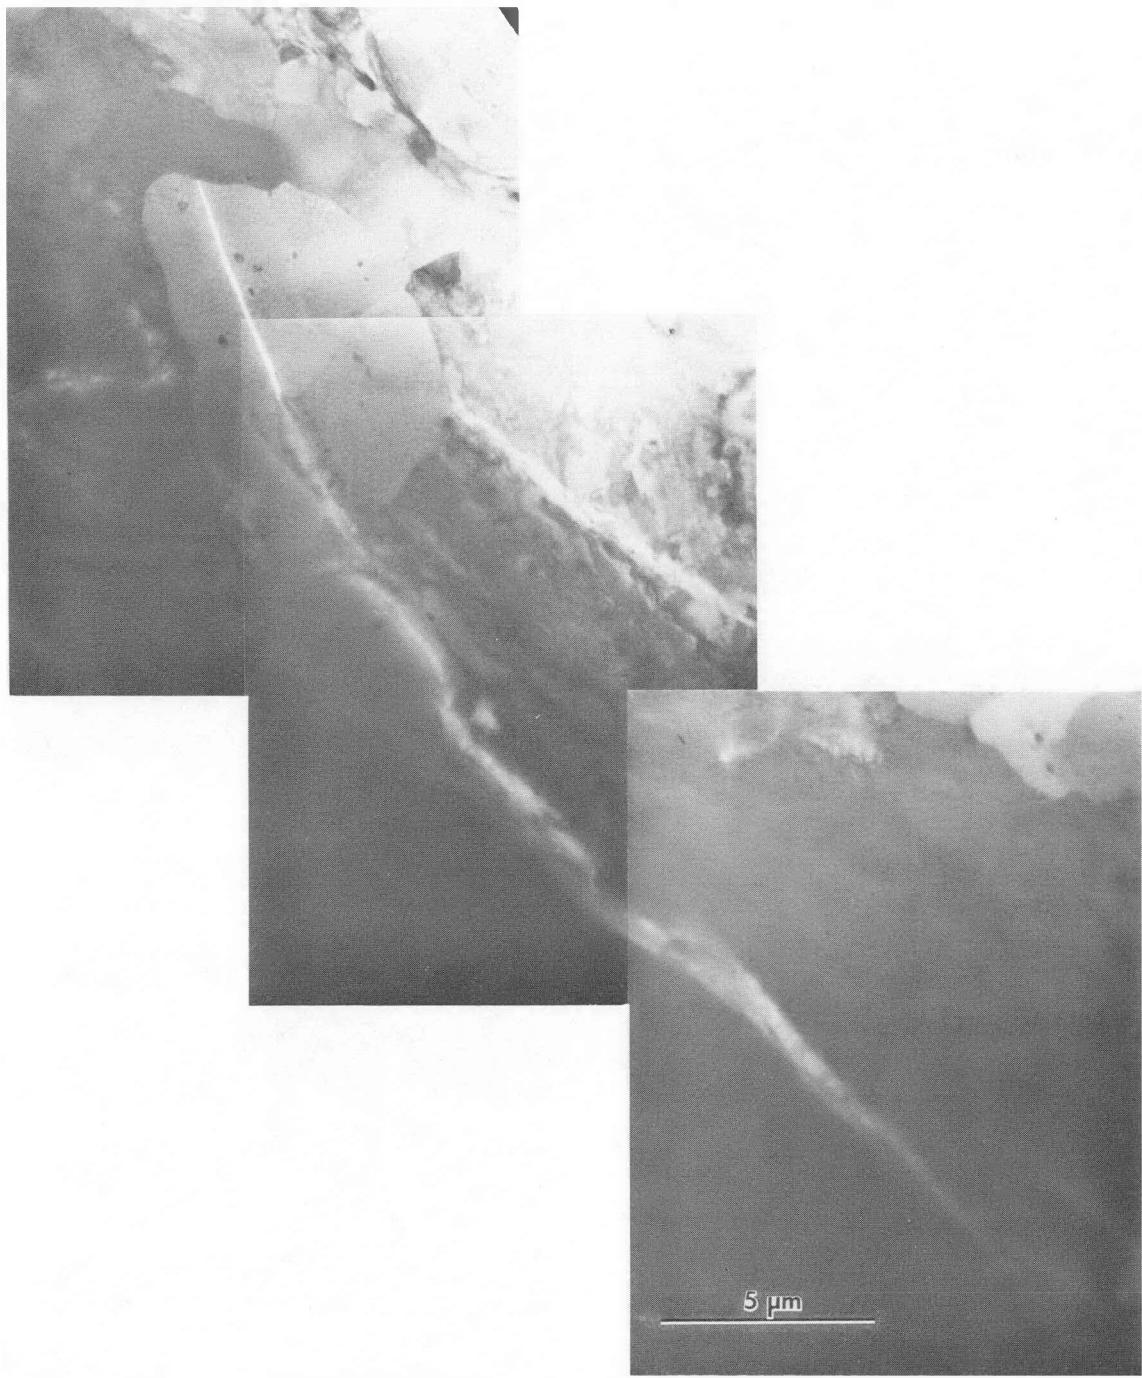
Figure 3.2-62a. Continuous Grain-to-Grain Features Exhibiting Anomalous Electron Transparency in Thick Foil Regions of Fuel Rod KD-0451, Section 7

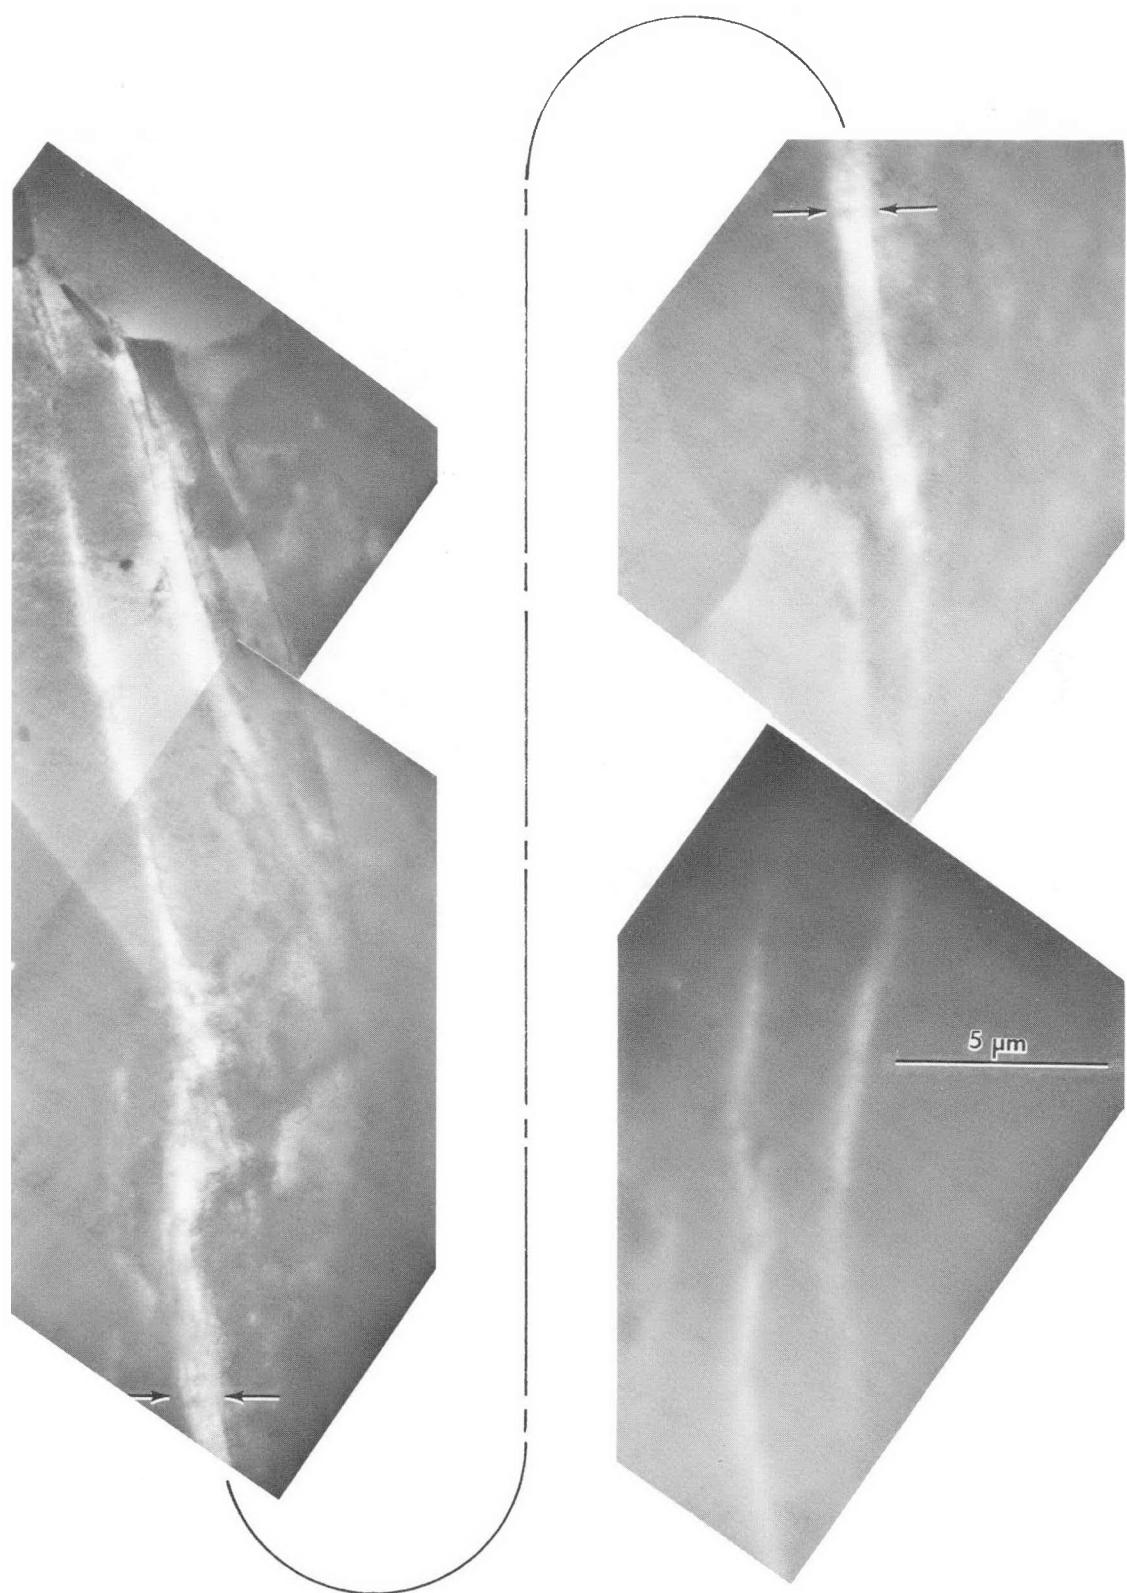
Figure 3.2-62b. Similar to Figure 3.2-62a, Arrows Indicate Continuation

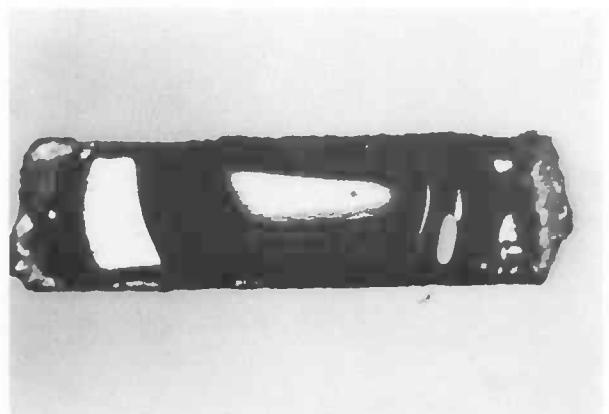
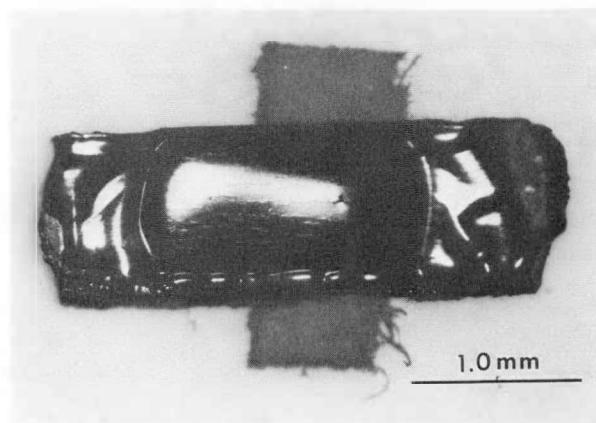
When the polished areas of the electron microscopy specimens were viewed optically, they appeared to be smooth and shiny, but striations could be observed when reflecting conditions were adjusted. It is important to note that these striations were observed on almost all the specimens, even that obtained from the plenum region as shown in Figure 3.2-63 and are generally along the axial direction of the cladding. The electropolished dish of a TEM specimen is approximately 0.13 mm (0.005 inch) deep, and the striations appear to be relatively straight on the steeply inclined edges of the dish indicating that the normal to the planar defect involved is in the radial direction of the tubing. It will be shown shortly that these features are hydride stringers.

Figure 3.2-63. Optical Images of Transmission Electron Microscopy Specimens from Fuel Rod KD-0451 Showing Stringerlike Features in the Axial Direction of the Cladding

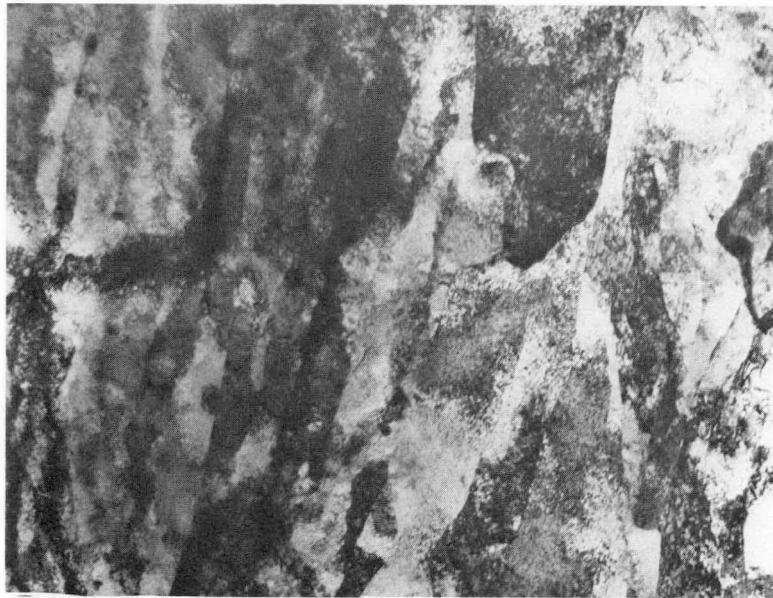
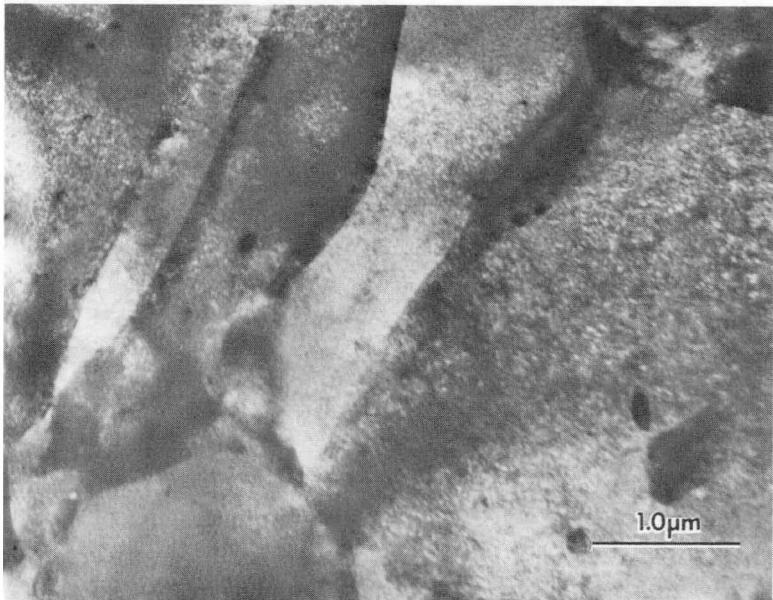
The one ring specimen for this rod was located approximately in the high transient power region and microstructural features were essentially the same as was observed in rod KD-0451. Figure 3.2-64 shows that a mixture of unrecrystallized and recrystallized material is present. Figure 3.2-65 illustrates some of the defected recrystallized grains including hydride plates and twinned material (Figure 3.2-65a) of sufficient volume to give an unmistakable α -zirconium diffraction pattern.

Figure 3.2-64. a. Unrecrystallized, b. Recrystallized Regions of Fuel Rod KE-2225

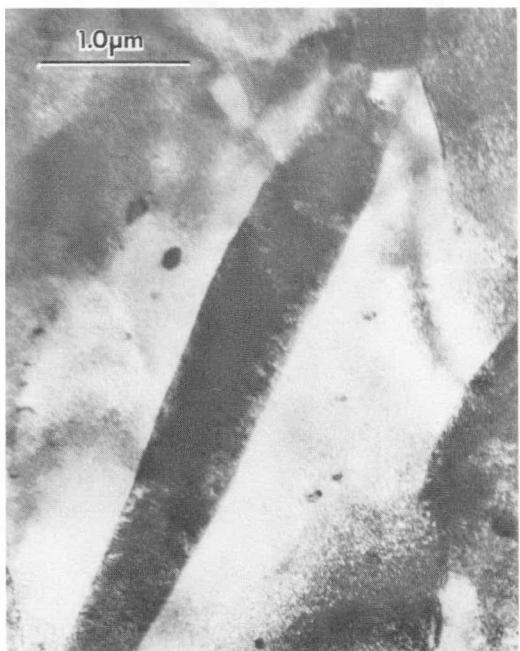
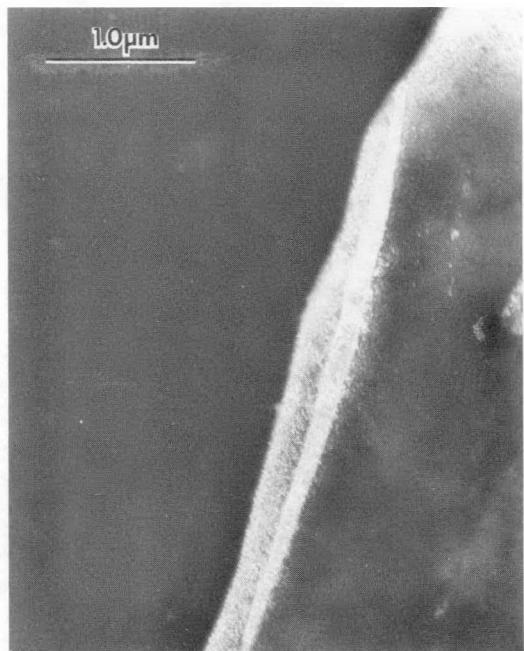
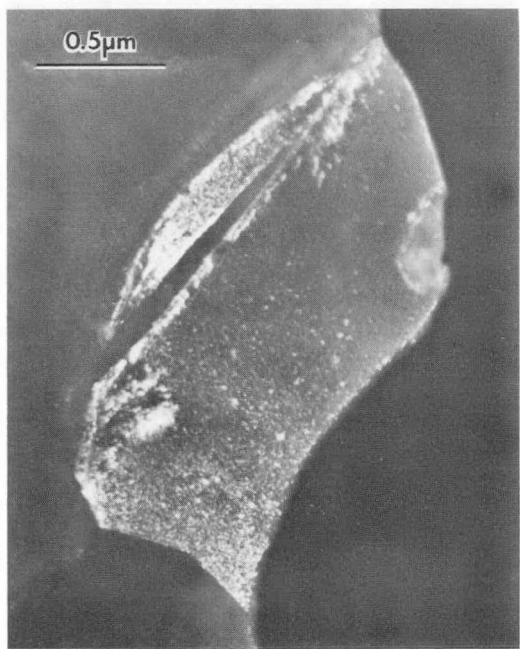
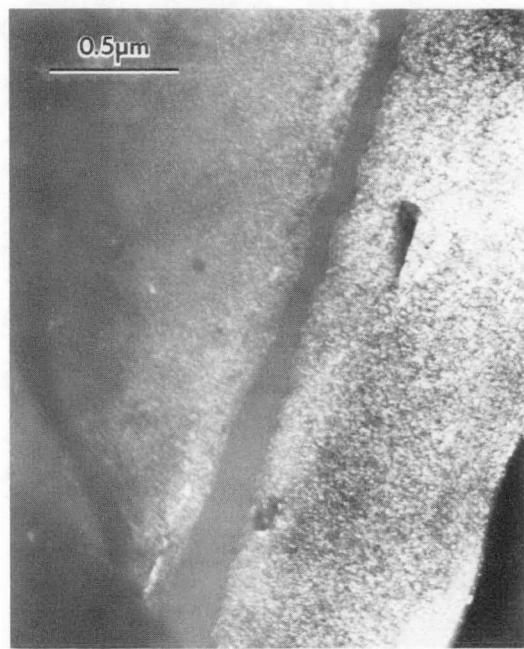
Figure 3.2-65. Twins and Hydrides in Ramp Region of Fuel Rod KE-2225

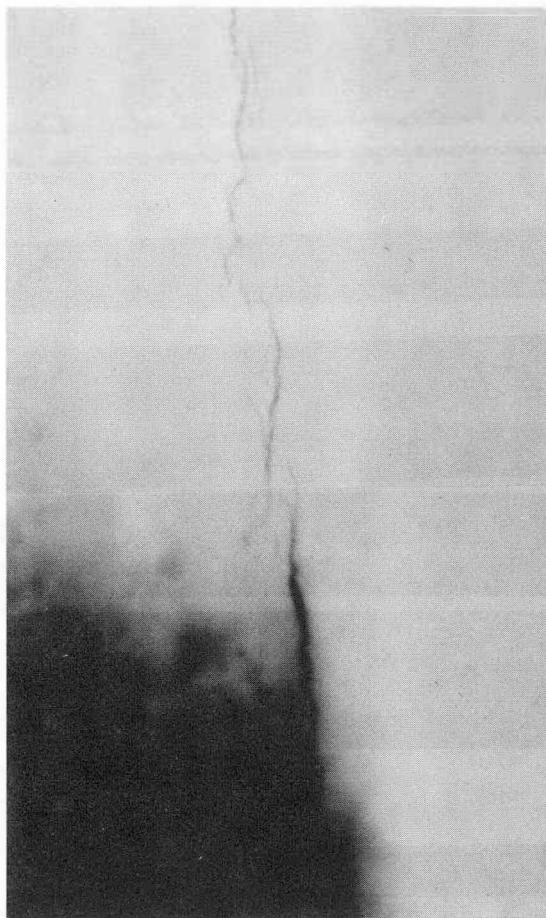
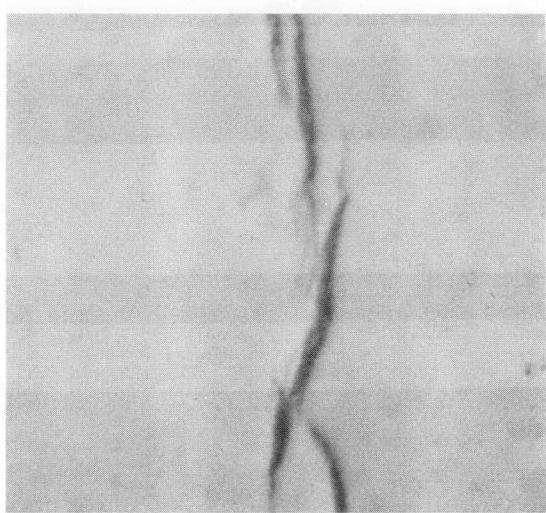
specimen. This same area is shown as it appears optically in Figure 3.2-67 and shows that the electron transparent features are of the same nature as the stringerlike features observed in both rods. Backscattered electron images obtained in the scanning electron microscope with a solid state detector pair are shown in Figure 3.2-68 where it can be seen that the features differ from the surrounding material in composition and are not topographical features, that is, the surfaces of the electropolished foils are smooth and image contrast is obtained from compositional changes. A discussion of this technique for use of back-scattered electron images in a SEM to detect hydrides in Zircaloy has been written by Wolff, and that discussion appears in Appendix E. The image contrast in Figure 3.2-68 shows that the string-like features are hydrides. The anomalous transmission of electrons in the TEM images of these defects is consistent with the decreased density, on the order of 13 percent, associated with zirconium hydride (20). The presence of such long and numerous hydrides was also seen in the longitudinal metallography sample (Figure 3.2-53).

Figure 3.2-68. SEM Backscattered Electron Images of Stringerlike Features of Fuel Rod KE-2225

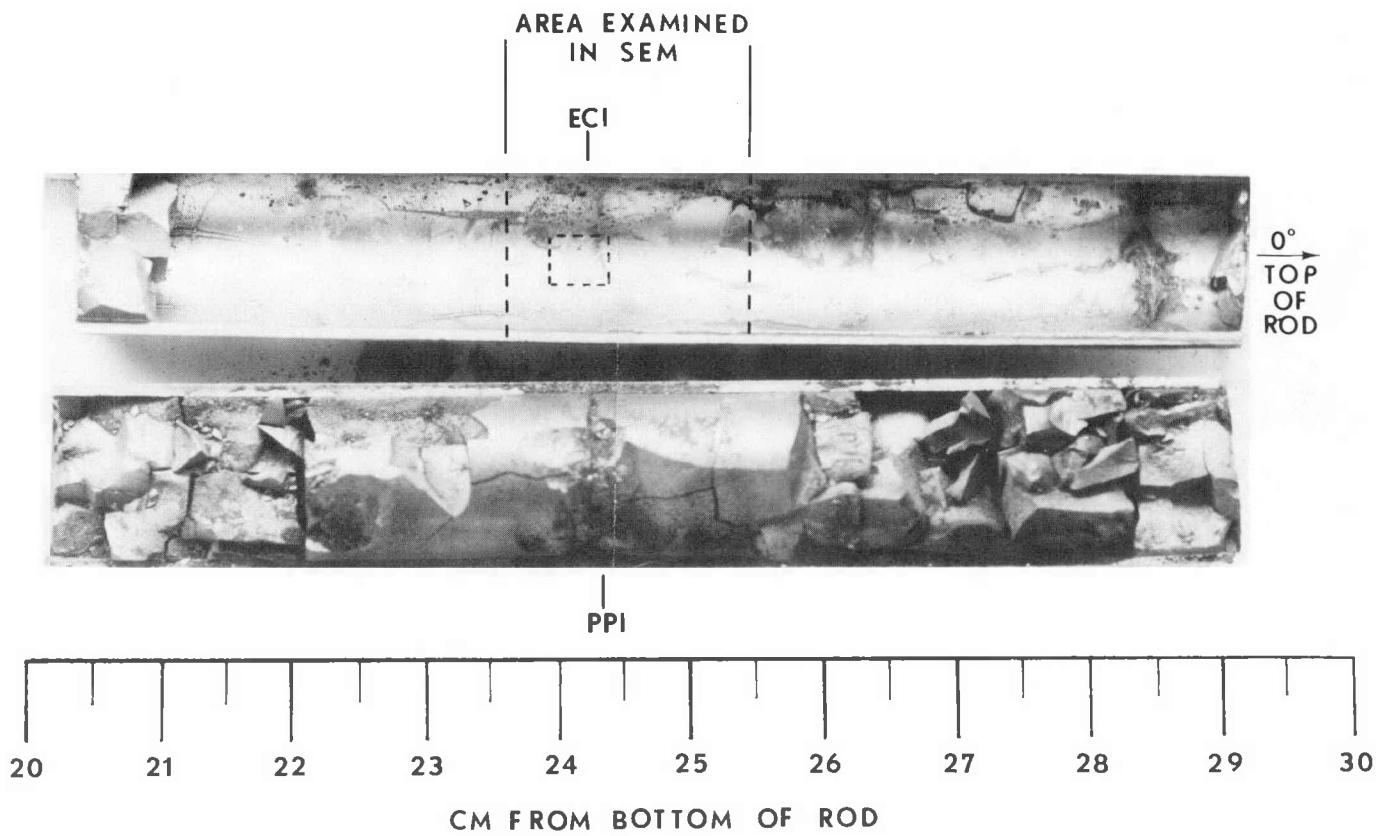
The two halves of specimen ANL#4 are shown in Figure 3.2-70. The burr mark, which identifies the end of the specimen towards the top of the rod as well as the 0-degree orientation, is located at the right end of the photograph at 90 degrees to the clamshell cut of the cladding without fuel. The location of the eddy current signal is at the 24.3 cm level and at the 15 degree orientation. The inner surface was a light brown metallic color and was relatively free of heavy deposits. The dark lines that meander over the inner surface correspond to cracks in the fuel pellets. In several areas, large fuel particles (~ 1 mm in diameter), including one at the location of the eddy current indication (ECI) can be seen adhering to the inner surface. The inner surfaces of all three pieces of cladding are compared in Figure 3.2-71. Specimens ANL#4 and ANL#6 had very similar appearances. Specimen ANL#2, from the bottom of the rod, had a slightly darker inner surface, and the lines corresponding to fuel cracks and pellet-pellet interfaces were lighter than those seen on the other two samples.

Figure 3.2-70. Clam Shell Sections of Specimen ANL #4 Showing Location of ECI

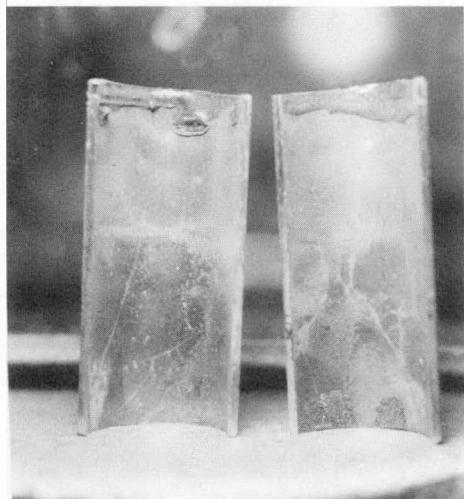
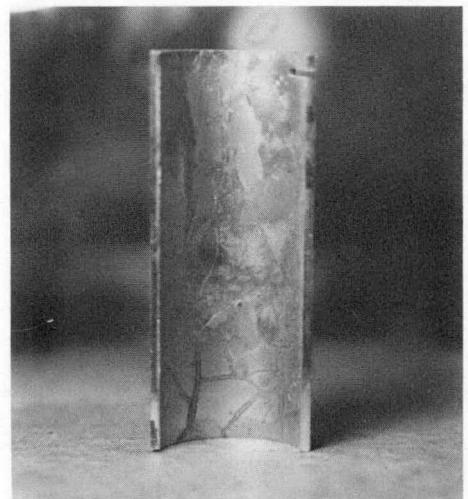
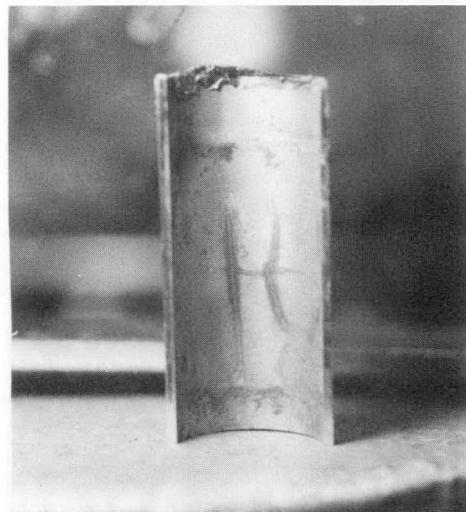
Figure 3.2-71. Inner Surface of Specimens (a) ANL #2, (b) ANL #4, and (c) ANL #6 2X

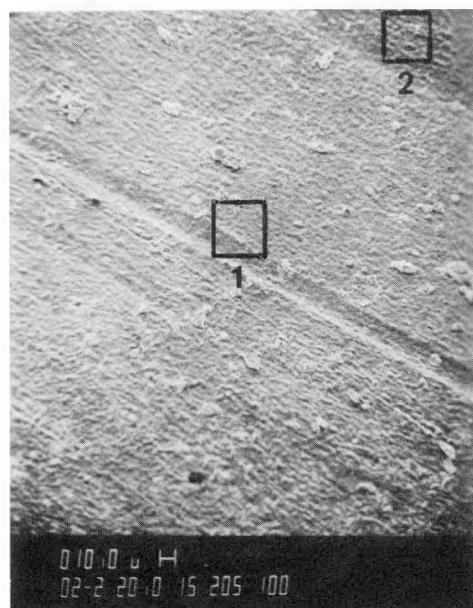
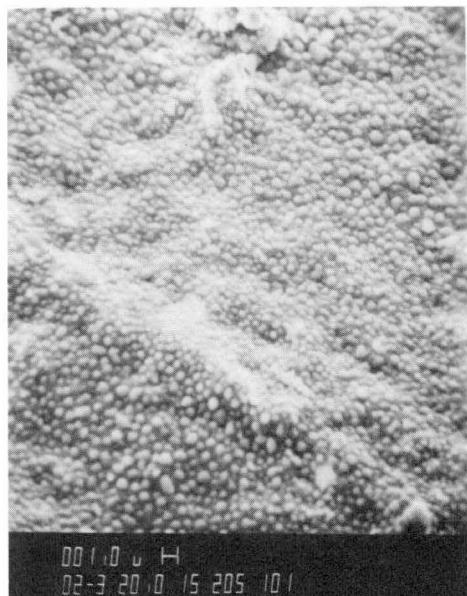
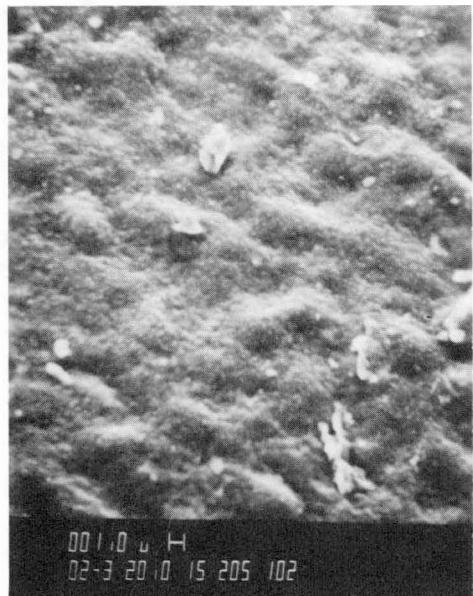
The structure associated with the lines which were opposite fuel cracks is shown in Figure 3.2-73 (Area A, Figure 3.2-72). There are no heavy deposits in the area, but a higher magnification micrograph, Figure 3.2-73b, reveals that the surface is covered with light hemispherical nodules or beads. The diameters of the nodules range from 0.5 to 1.0 μm . In this particular case, shown in Figure 3.2-73, a preexisting scratch has also been covered with the nodules. The inner surface adjacent to the line shows a complete absence of nodules (Figure 3.2-73c). The surface, which is composed of hills and valleys approximately 5 μm across, is typical of the clean surface areas observed on these specimens. X-ray analysis of the area covered with nodules indicates a high concentration of uranium in addition to zirconium. No fission products were detected with the SEM X-ray system (a collimated energy dispersive X-ray spectrometer). However, electron microprobe measurements of a similar area from this piece of cladding revealed the presence of trace amounts of cesium. [Other work at ANL has shown similar nodules to contain uranium, cesium and tellurium (6).] In the area without nodular growths, the X-ray measurements showed a high zirconium concentration with a low concentration of uranium. Again, no fission products were detected on the SEM X-ray system.

Figure 3.2-73. Dark Line Corresponding to Fuel Cracks
(a) Close-up of Area A, Figure 3.2-72
(b) Nodules from Area 1
(c) Smooth Surface from Area 2

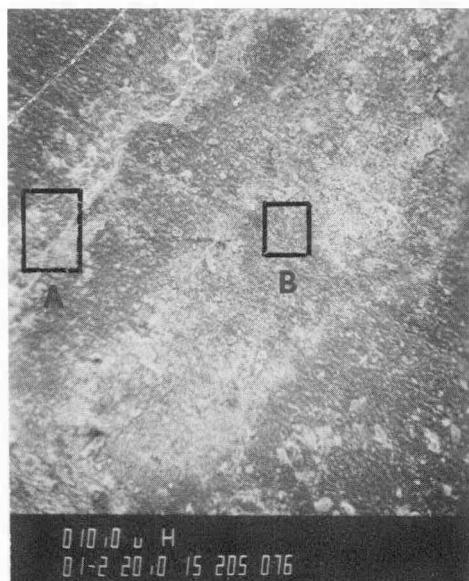
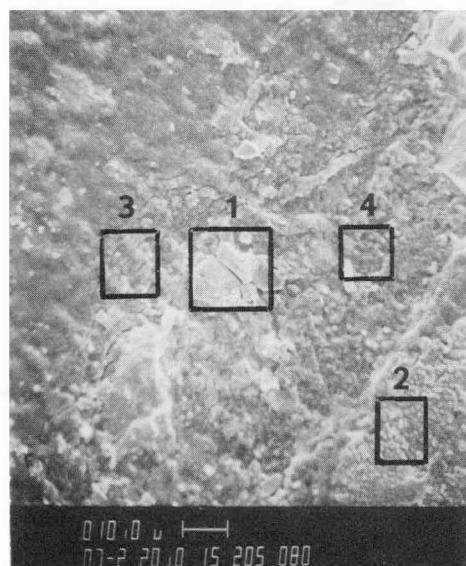
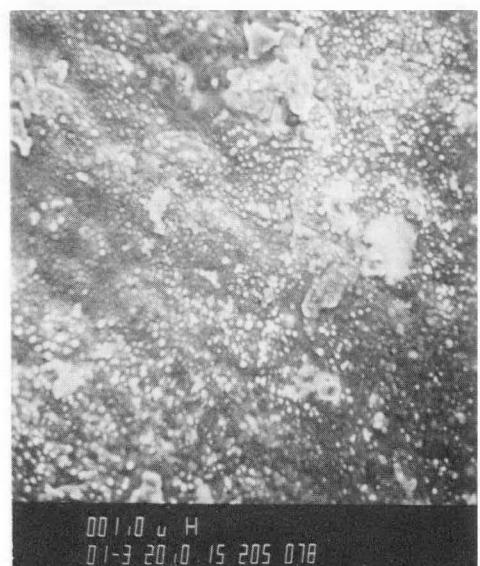
A portion of a PPI (Area B, Figure 3.2-72) is shown in Figure 3.2-74. There are several areas where heavy deposits were observed, as is illustrated in Figure 3.2-74c. The deposits appear to be either adhering pieces of fuel (Area 1) or nodular growths (Area 2) similar to those previously discussed. The zirconium oxide layer adjacent to some of the deposits shows cracking (Area 3), and the original oxide layer in some areas is absent (Area 4). Figure 3.2-74c shows the formation of submicron size nodular growths in the PPI region (Area B, Figure 3.2-74a). The fuel deposits and nodular growths show a high concentration of uranium, but fission products were not detected.

Figure 3.2-74. Pellet-Pellet Interface

(b) Area A--Areas 1 to 4 are Detailed in Text

(c) Area B

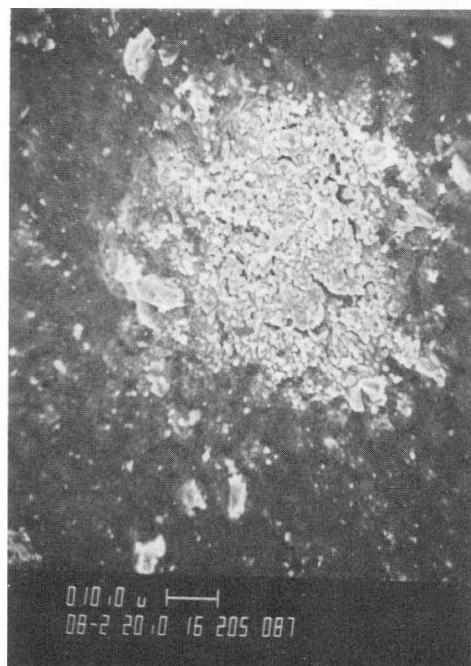
Figure 3.2-75. Fuel Particle Adhering to Inner Surface. Area C, Fig. 3.2-72

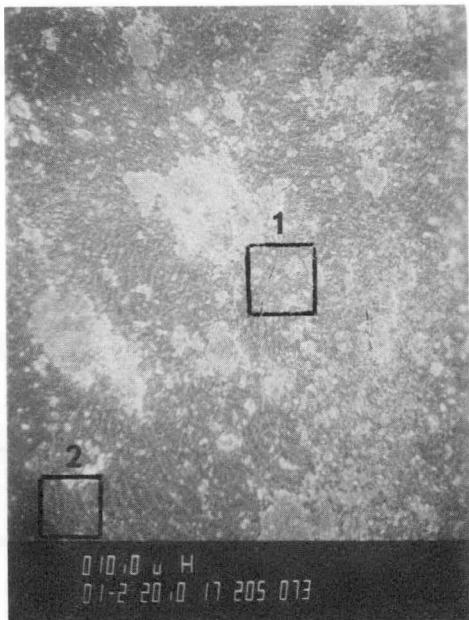
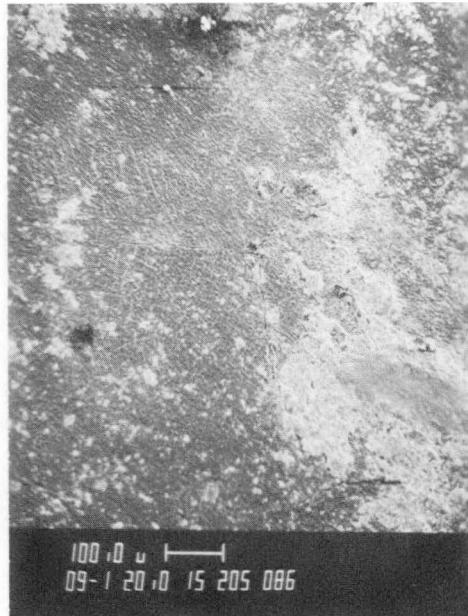
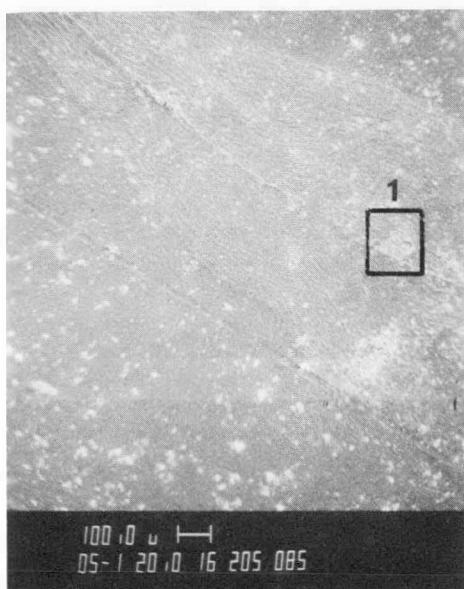
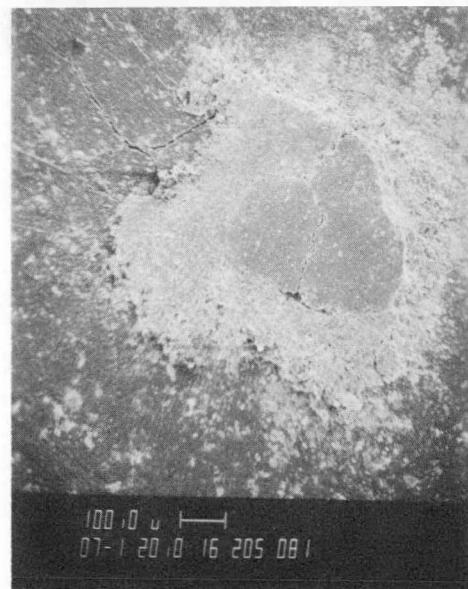
A significant feature on the inner surface shown in Area D of Figure 3.2-72, is the extensive surface mounding. Closer examination of this area indicated the presence of cladding defects shown in Figure 3.2-76 which generally had no particular orientation. Stereomicrographs of the defects showed that they were present only in the mounded areas. Cladding defects were also observed in several other areas. These defects were usually in the vicinity of both large adherent fuel particles and extensive cracking of the surface oxide. Examples of such defects from areas E, F, G, and H, of Figure 3.2-72 are illustrated in Figure 3.2-77. The oxide cracking often forms a circular pattern on the inner surface with the cladding defects located near the center of the pattern with no particular orientation. Figure 3.2-78 shows closeups of the main defect and the edge of the area of surface cracking from Areas 1 and 2 of Figure 3.2-77a.

Areas G and H of Figure 3.2-72 (Figures 3.2-77c and d) combine to form the largest defect area in the vicinity of the ECI with a total length of oxide cracking plus fuel particle of ~ 2.5 mm. This area was examined in detail, ultrasonically cleaned in ethanol, and reexamined. The surface of the extensive area of oxide cracking is shown in Figure 3.2-79a (Area A, Figure 3.2-77c). In addition to the oxide cracks, there is an area approximately 50 μm in diameter where the oxide is absent. The surface of the underlying Zircaloy is shown in Figure 3.2-79b. In order to examine the substrate, the oxide was removed by ultrasonic cleaning. The mounted piece of cladding was cleaned by placing it in a beaker filled with ethanol into which the tip of the ultrasonic unit was lowered to a point just

Figure 3.2-77. Defect Structures Observed in Area of ECI (a) Area E, Figure 3.2-72, (b) Area F, Figure 3.2-72, (c) Area G, Figure 3.2-72, (d) Area H, Figure 3.2-72

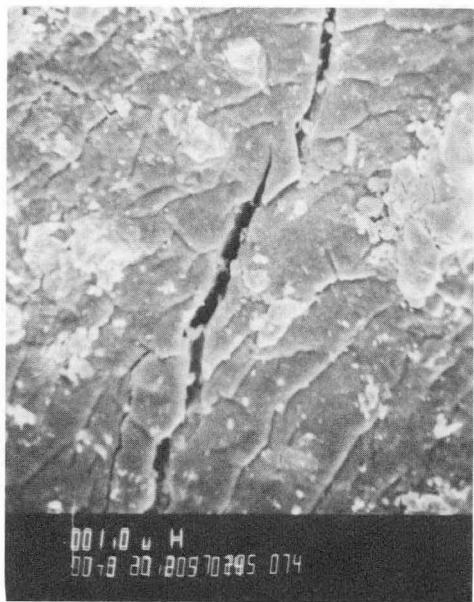
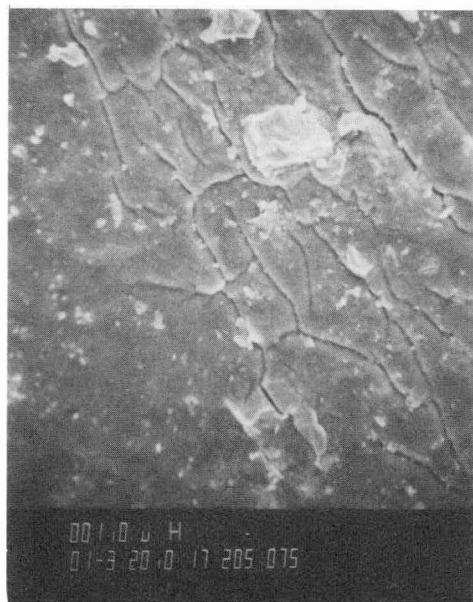
Figure 3.2-78. Close-Ups of (a) Area 1, Figure 3.2-77a and (b) Area 2, Figure 3.2-77a

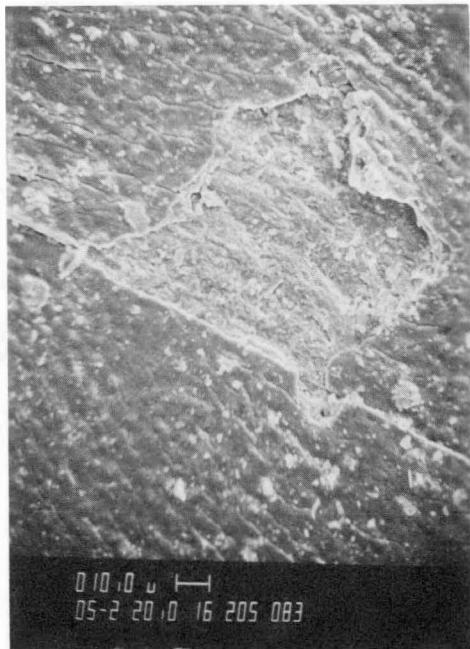
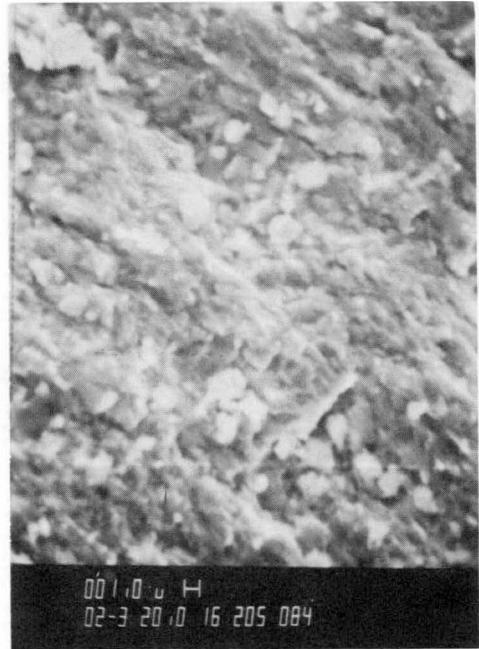
Figure 3.2-79. Close-Ups of Area of Oxide Surface Cracking (a) Area 1, Figure 3.2-77c, (b) Middle of (a)

above the cladding inner surface. A 1 to 3 minute cleaning was usually sufficient to remove deposits and portions of the zirconium oxide. The ultrasonic cleaning removed the fuel particle and a significant amount of oxide from the cracked area as shown in Figure 3.2-80. The pit which remained at the site of the fuel particle is estimated to penetrate $\sim 50 \mu\text{m}$ into the cladding. The base of the pit is shown in Figure 3.2-80d. The particles in the pit are composed primarily of uranium, but zirconium is also present. The Zircaloy surface where the oxide layer was removed from the area of surface cracking is shown in Figure 3.2-80c. The surface resembles that shown in Figure 3.2-79a without the debris particles.
