Determination and Microscopic Study of Incipient Defects in Irradiated Power Reactor Fuel Rods

EPRI NP-812
Project 829
Final Report
July 1978

V. Pasupathi and J. S. Perrin
BATTELLE'S COLUMBUS LABORATORIES

This final report presents the results of nondestructive and destructive examinations carried out on the Point Beach-1 (PWR) and Dresden-3 (BWR) candidate fuel rods selected for the study of pellet-clad interaction (PCI) induced incipient defects. In addition, the report includes results of examination of sections from Oskarshamn-1 (BWR) fuel rods.

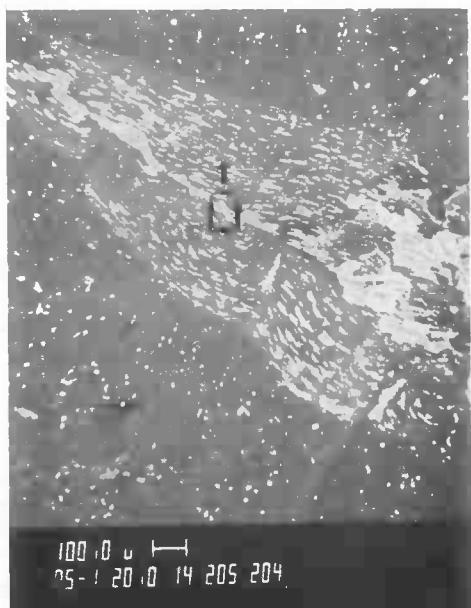
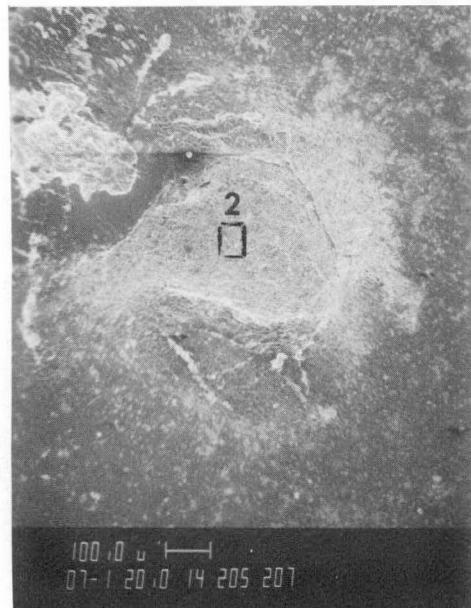
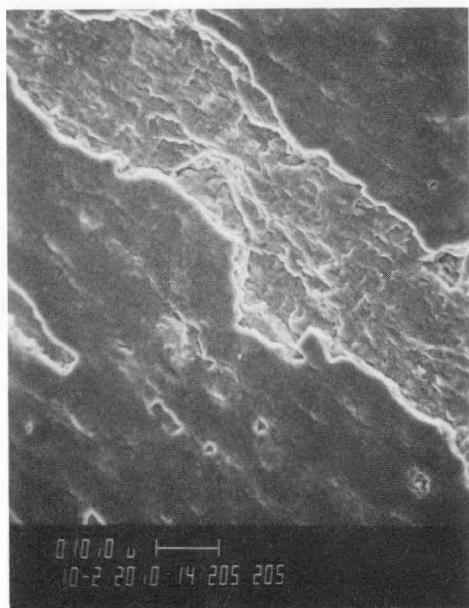
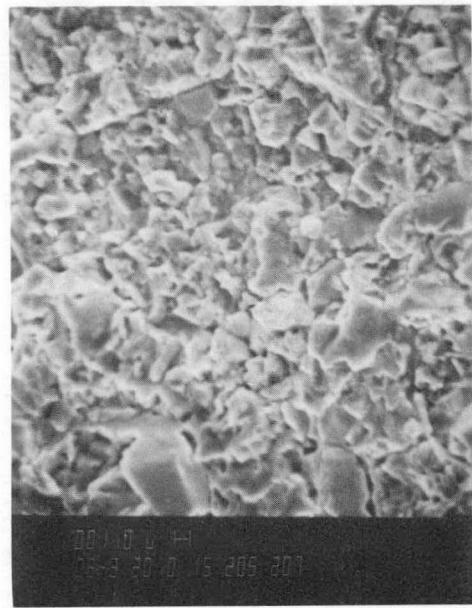
above the cladding inner surface. A 1 to 3 minute cleaning was usually sufficient to remove deposits and portions of the zirconium oxide. The ultrasonic cleaning removed the fuel particle and a significant amount of oxide from the cracked area as shown in Figure 3.2-80. The pit which remained at the site of the fuel particle is estimated to penetrate $\sim 50 \mu\text{m}$ into the cladding. The base of the pit is shown in Figure 3.2-80d. The particles in the pit are composed primarily of uranium, but zirconium is also present. The Zircaloy surface where the oxide layer was removed from the area of surface cracking is shown in Figure 3.2-80c. The surface resembles that shown in Figure 3.2-79a without the debris particles.

Figure 3.2-80 (a) Area G, Figure 3.2-72 after Ultrasonic Cleaning
(b) Area H, Figure 3.2-72 after Ultrasonic Cleaning
(c) Area 1 in (a), (d) Area 2 in (b)

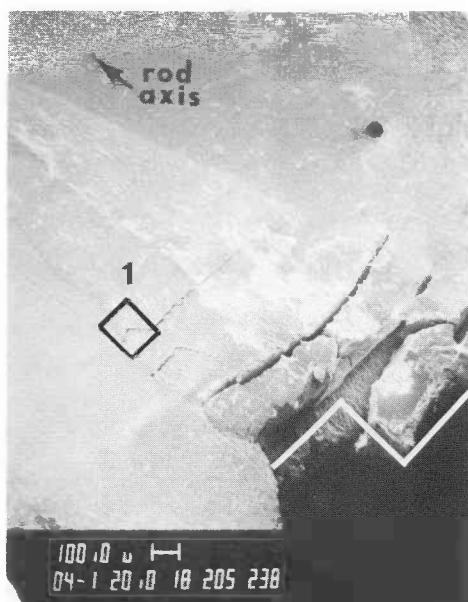
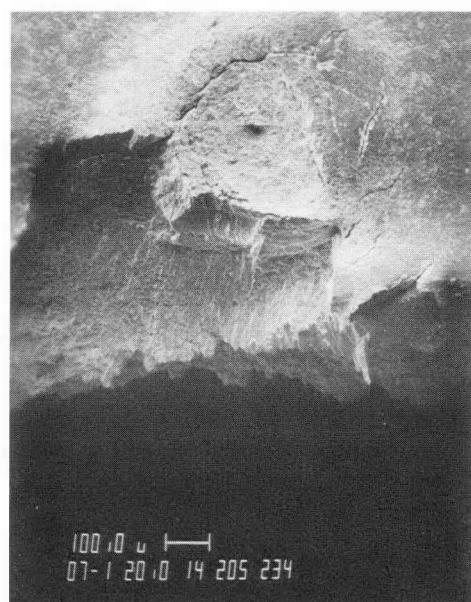
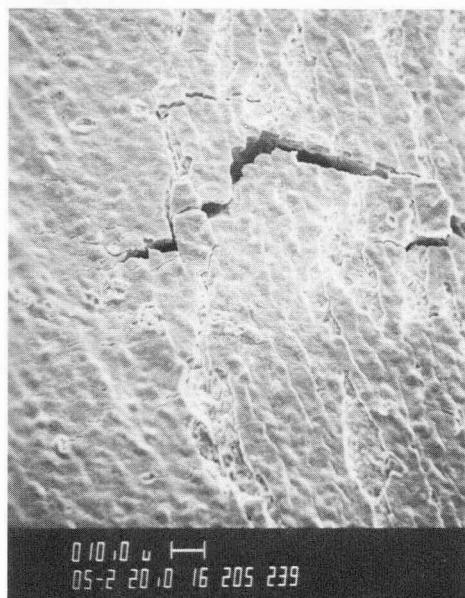
A fracture surface emanating from a preexisting defect is mapped in Figure 3.2-82. This defect was in the region of oxide cracking shown in Figure 3.2-81. Three modes of fracture are apparent at higher magnification: an undistinguished area within $50 \mu\text{m}$ of the inner surface, a brittle fracture which penetrates $\sim 150 \mu\text{m}$, and a ductile fracture elsewhere. The line between the brittle and ductile fracture roughly follows a circular arc. The arc crosses the inner surface at the boundaries of the inner surface cracking. The microstructure of the fracture surface from the inner surface towards the outer surface is shown in Figure 3.2-83 where the three fracture modes can be seen clearly. Area A, adjacent to the inner surface has a more rounded appearance than the brittle fracture below it

Figure 3.2-81 (a) Area G, Figure 3.2-72 after 3-Point Bending,
(b) Area H, Figure 3.2-72 after 3-Point Bending,
(c) Area 1 in (a)

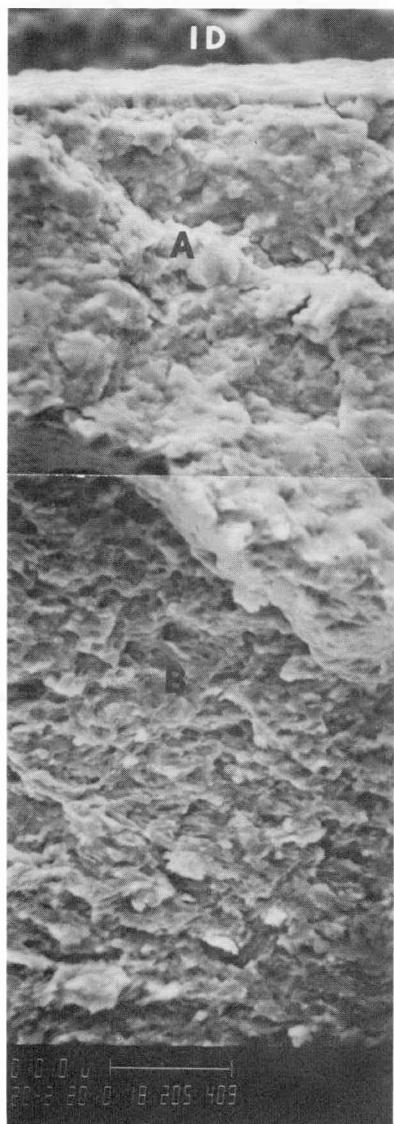
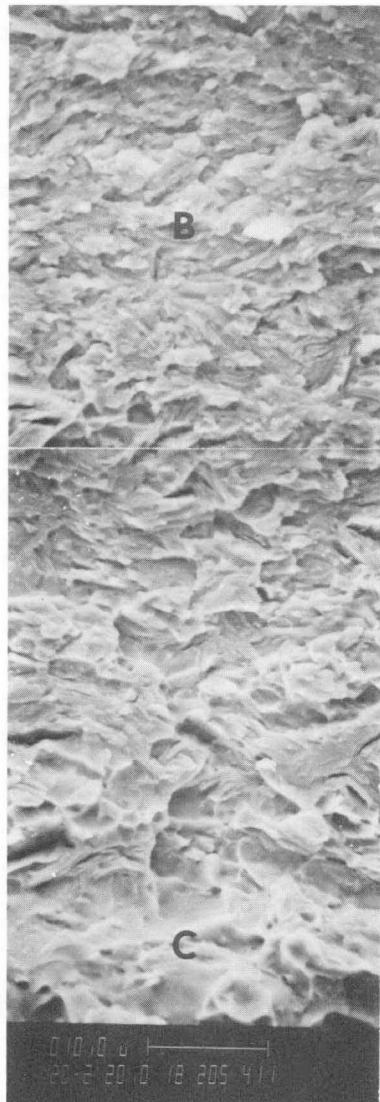
Figure 3.2-83 Map of Area 1 of Fracture Map of Figure 3.2-82
Undistinguished Area (A), Brittle Area (B), and
Ductile Area (C)

(Area B). Neither fracture surface showed any evidence of cleavage and fluting which is typical of SCC fractures in Zircaloy. The remaining fracture surface is composed of the dimpled features typical of ductile fracture. The brittle fracture surface of Area B and the ductile fracture surface of Area C were observed on other surfaces produced by three-point bending in areas where oxide cracking existed on the inner surface, but the fracture surface of Area A was observed only on surfaces that were produced from pre-existing defects.

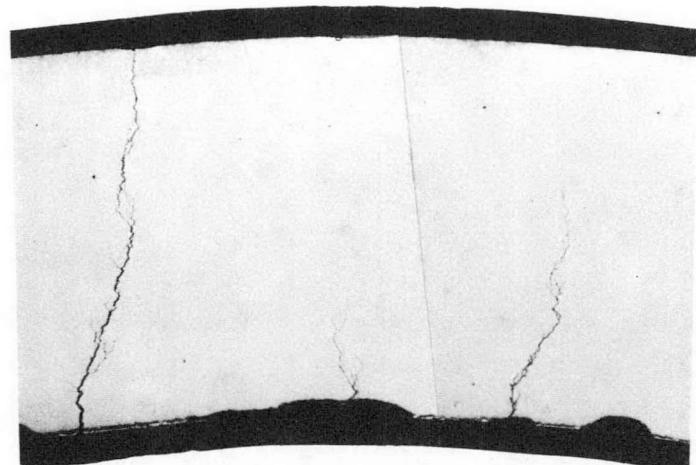
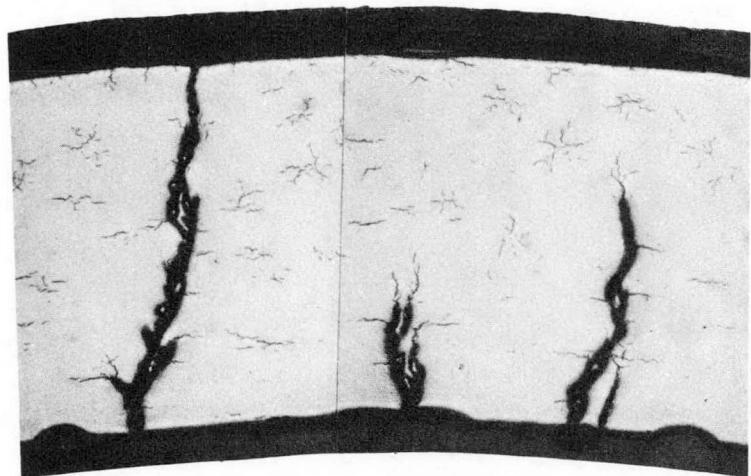
It was considered that 10 of the rods might have failed due to the ramp experiment and that the cracks located by cesium extrusion were primary PCI cracks. In four cases metallographic evidence of SCC was found. The cracks exhibited the narrow, branched morphology, oriented at 90 degrees to the inside surface (Figure 3.3-5) and there was more than one crack in each sample. In the vicinity of the likely SCC cracks, there were pits on the inner surface, some were empty, while others were filled with debris. The cracks originated both between and in the pits.

Figure 3.3-5 Primary PCI Cracks Observed in Oskarshamn-1 Fuel Rods
(a) As-polished (b) Etched

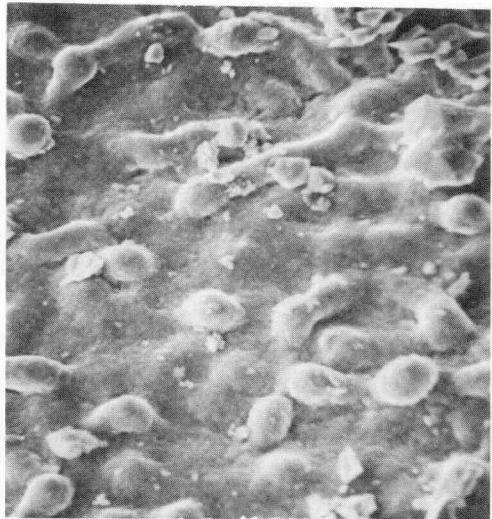
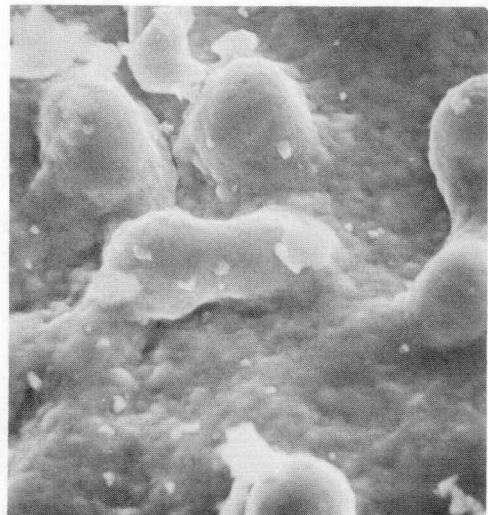
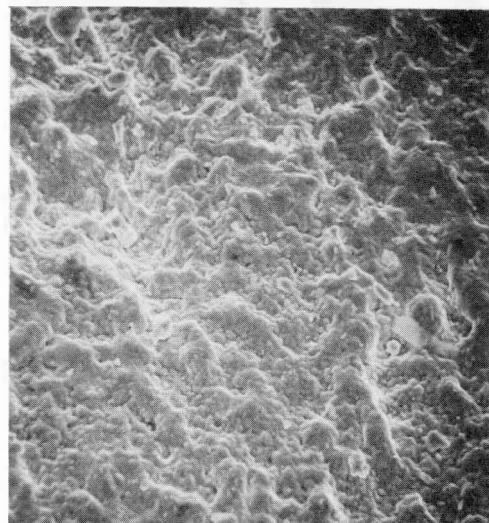
Figure 3.3-9 (a) Wormlike Growths on Specimen 10K (1000X)
(b) Close-Up of Wormlike Growths (4000X)
(c) Nodular Surface on Specimen 10K (1000X)

appearance was observed (Figure 3.3-9c). The small nodules were roughly hemispherical in shape and were less than a micron in diameter. Longer nodules were also observed in the area, and their size was approximately the same as the wormlike growths. Only uranium and zirconium were detected in the wormlike and nodular growths.

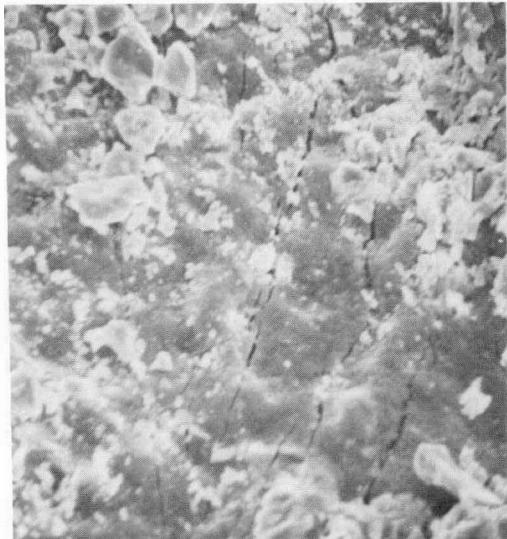
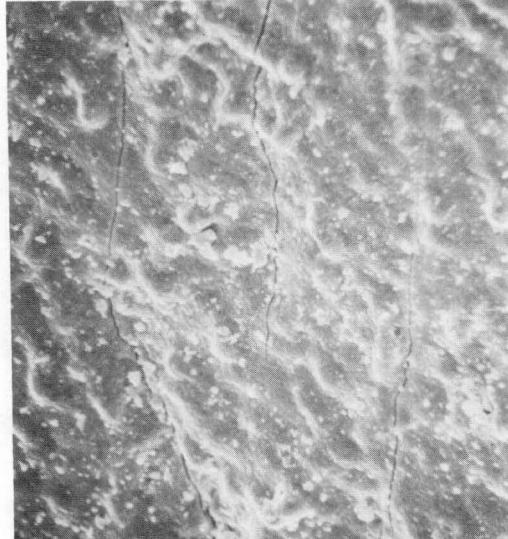
Longitudinal surface cracks were observed on the inner surfaces of Specimens 11K and 14K (see Figures 3.3-10a and b). They occurred in isolated areas and were quite narrow, ~ 0.25 μm wide, and sharp in appearance. The crack paths usually did not follow any surface features. It is believed that these cracks could have been produced during specimen preparation. To test this hypothesis, Specimen 14K was flattened to produce additional cracking. The cracks produced were uniformly distributed over the inner surface and were similar in appearance to the cracks previously observed (see Figure 3.3-10c). The fractures produced were ductile in character and it is assumed that the surface cracks initially observed, if they penetrated the substrate, would not have shown SCC characteristics.

Figure 3.3-10 (a) Cracks on Inner Surface of Specimen 11K (2000X)
(b) Cracks on Inner Surface of Specimen 14K (1000X)
(c) Cracks Produced by Flattening Specimen 14K (700X)

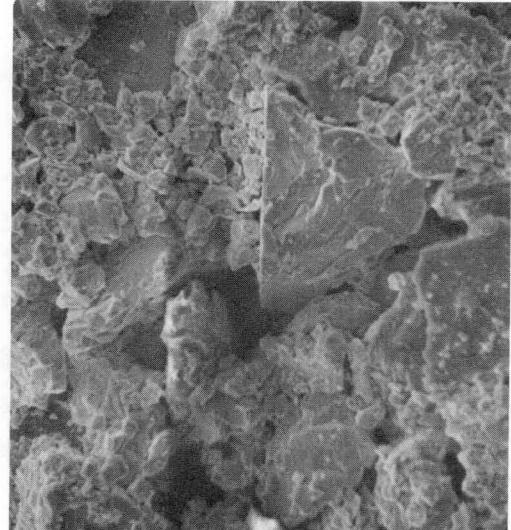
Although the optical appearance of these specimens was different from the specimens from unfailed rods, the surface features observed in the SEM were very similar. The wormlike and nodular Zircaloy structures were again present over a large portion of the inner surfaces and the fuel particles were of a similar nature. The size and surface distribution of the particles appeared to vary from specimen to specimen. Specimen 15K exhibited numerous line deposits of U_2 (Figure 3.3-12a) while Specimen 19K was relatively clean with only small UO_2 particles scattered on the surface. Large (20-30 μm) U_2 particles were observed on the inner surface of Specimen 16K (Figure 3.3-12b). No surface cracks were observed on any of the specimens.

Figure 3.3-12 (a) UO_2 Line Deposits on Specimen 15K (60X)
(b) UO_2 Particles on Specimen 16K (700X)

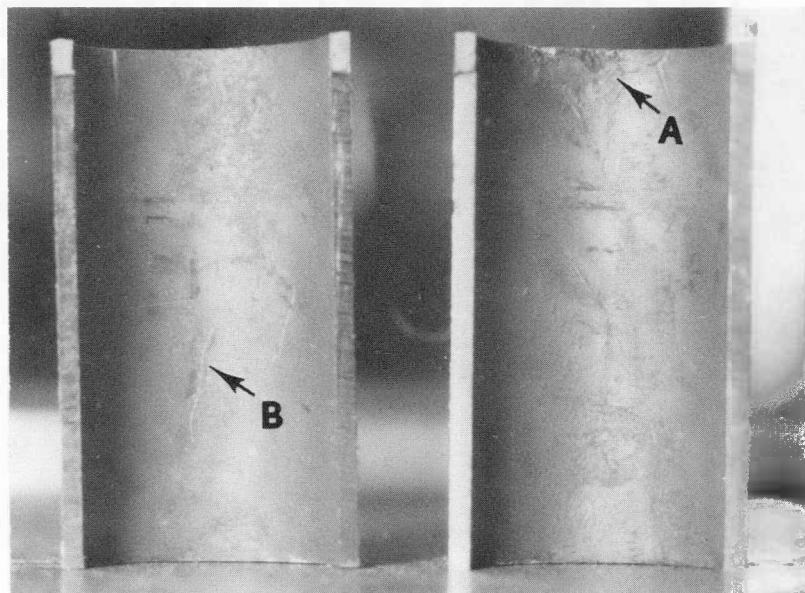
The initial sectioning of Specimen 4K consisted of cutting a 3 mm thick ring from one end to shorten the piece so that it would fit in the longitudinal sectioning fixture, and then making the longitudinal clamshell cut. As shown in Figure 3.3-13, most of the inner surface was black with deposits of fuel and was similar in appearance to Specimens 15K, 16K, 19K, and 20K. A few thin (< 0.5 mm) white lines were observed in the longitudinal direction. The most important feature on the inner surface was a 4 μm diameter circular pit found visually near the end of the specimen through which the initial ring cut had passed. The pit, shown in Figure 3.3-13, was a metallic purple color and had penetrated the cladding to a substantial degree.

Figure 3.3-13. Inner Surface of Specimen 4K
Defect is Located at Area A (2.5X)

Close examination of the surface pit shown in Figure 3.3-13 indicated there was a through-wall crack associated with it as shown in Figure 3.3-15. It is not known if the crack was present before sectioning or if the crack was created during sectioning. The pit surface indicates a nonductile fracture (Figure 3.3-16), but the cleavage and fluting which are typical of SCC failures are not present. Only zirconium was detected on this surface. Another circular defect, which was very similar in appearance to this one, was located on the 3 mm thick ring, is shown in Figure 3.3-17. Figure 3.3-17 also shows a longitudinal crack associated with the defect. Closer examination of the crack near the defect showed that a surface layer had been removed from the vicinity of the crack (Figure 3.3-18a). This surface layer proved to be rich in uranium (Figure 3.3-18b).

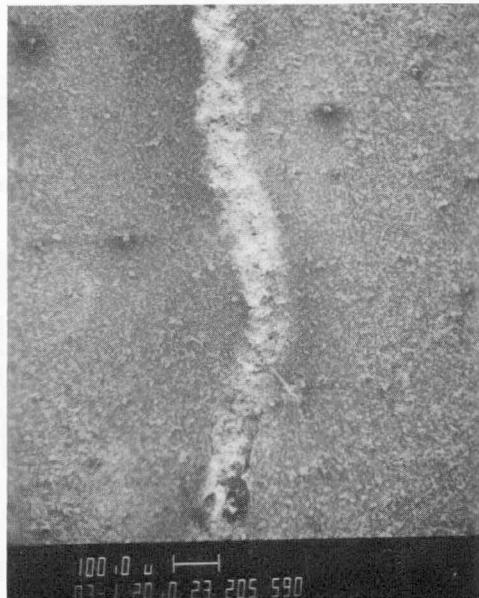
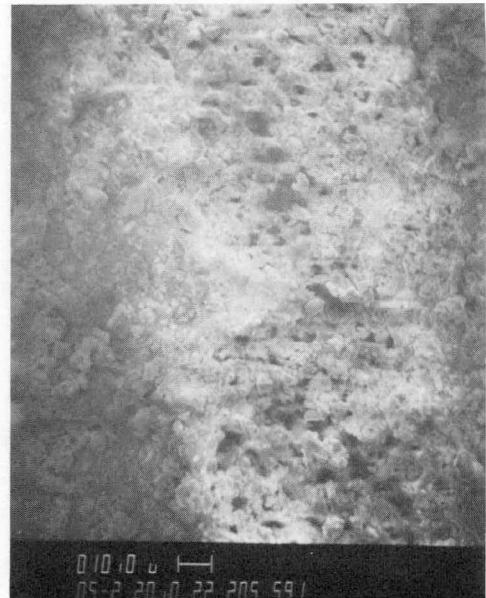
Figure 3.3-14. (a) White Line Deposit from Specimen 4K (Area B, Figure 3.3-13;
(b) Close-Up of (a)

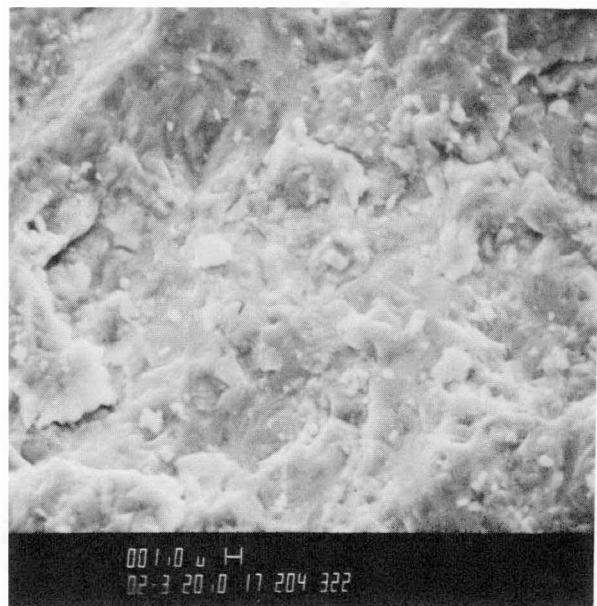
Figure 3.3-16. Fracture Surface of Defect on Inner Surface of Specimen 4K (Area A, Fig. 3.3-13)

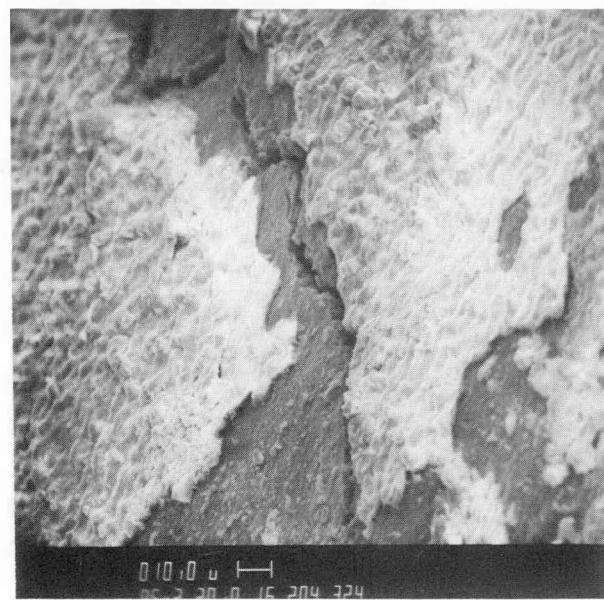
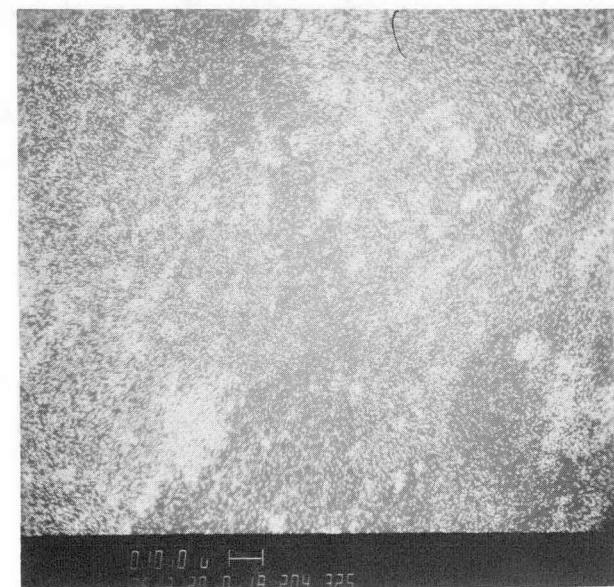
Figure 3.3-18 (a) Crack Associated With Defect Shown in Area A, Figure 3.3-17, and (b) Uranium Map of (a)

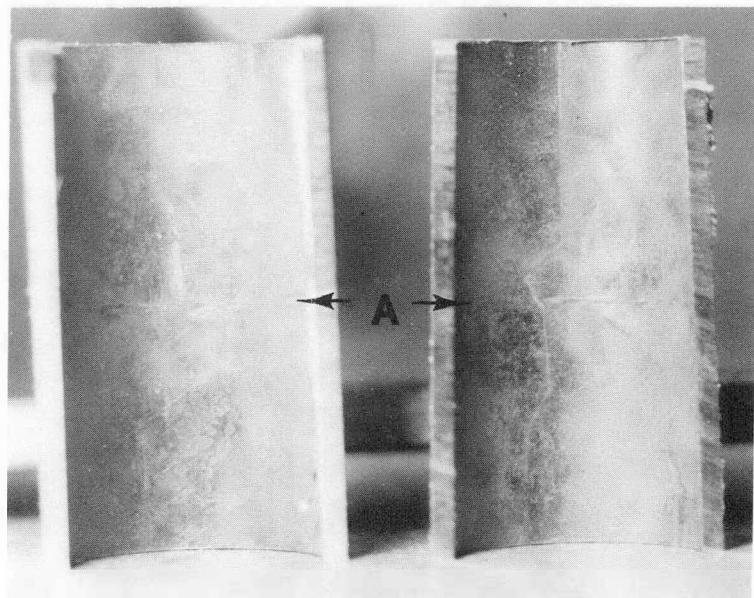
The inner surface of Specimen 8K, shown in Figure 3.3-19, was optically similar in appearance to specimens which did not exhibit eddy current indications from failed rods. A circumferential line, possibly the location of a pellet-pellet interface, was observed in the middle of the specimen (Area A, Figure 3.3-19). No defects or cracks were found during visual examination.

Figure 3.3-19. Inner Surface of Specimen 8K (~ 2.5X)
Neg. No. MSD-192105

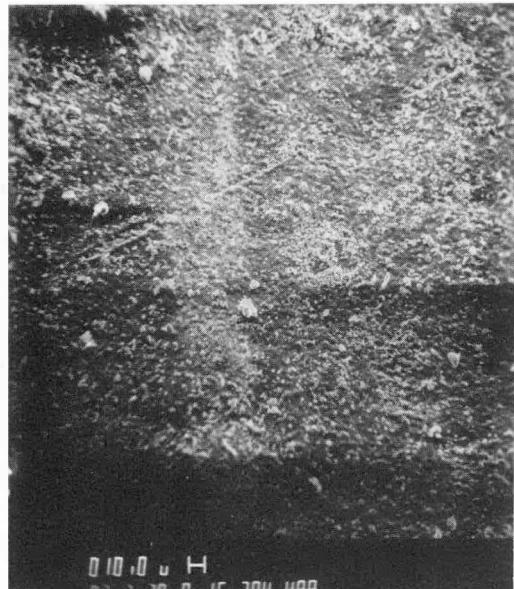
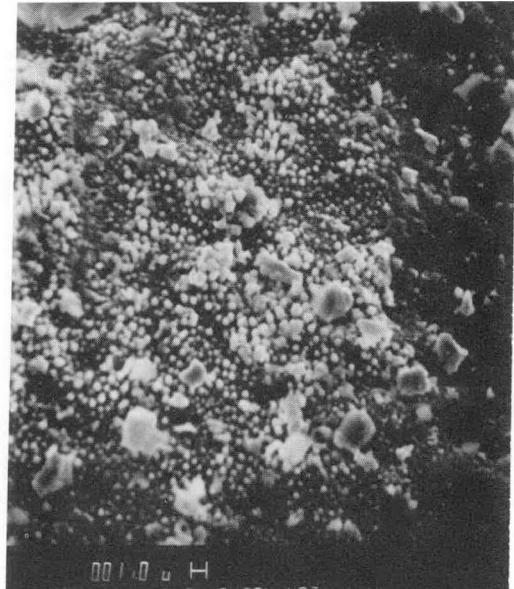
Figure 3.3-20 (a) Light Strip on Inner Surface of Specimen 8K (200X), and (b) Close-Up of (a) (2000X)

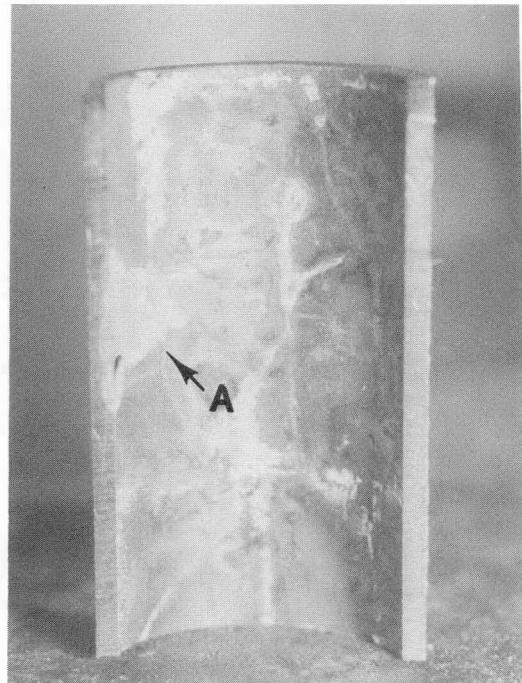
The inner surface of Specimen 2K, shown in Figure 3.3-22, was partially covered by heavy white deposits. The initial longitudinal cut passed through a major defect (Point A), which resulted in the removal of the white deposit in that area. The size of the exposed area was approximately 6.5 x 6.5 mm. Other white deposits on the surface were linear or circular. The linear deposits on the surface were linear or circular. The linear deposits varied in width from 0.5 to 2 mm, while two large circular deposits were approximately 5 mm in diameter. Darker deposits were also observed on the surface. Although they did not appear visually to be fuel deposits, X-ray analysis indicated they were high in uranium content with a small quantity of cesium. The SEM examination indicated that the presence of these large deposits over most of the surface resulted in a charge buildup of the specimen from the electron beam. The charge buildup, which indicates the nonconducting nature of the deposits, was not observed in any of the other specimens. Such a charge buildup from deposits containing uranium could be due to a higher oxide of uranium than UO_2 . A higher oxide would result from water ingress to the rod and subsequent fuel oxidation. A low magnification SEM map of the 2K surface indicating significant features is shown in Figure 3.3-23.

Figure 3.3-22 Inner Surface of Specimen 2K (~ 2.5X)
Defect is Located at Area A. Negative
Number MSD-191632

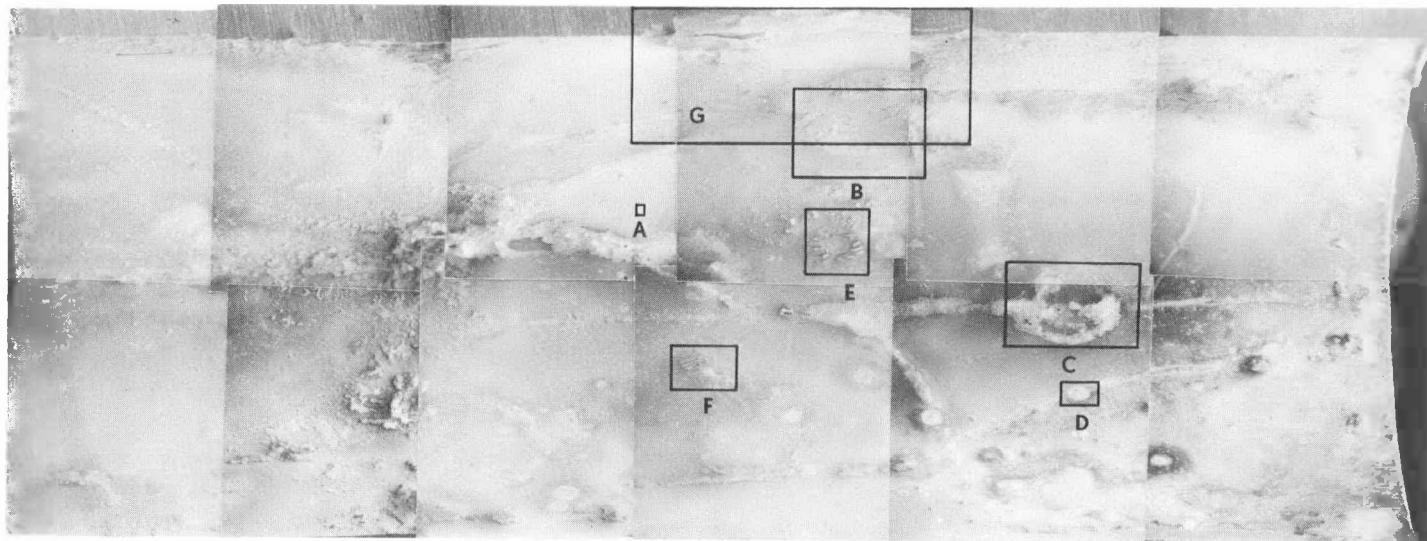
Figure 3.3-23 SEM Composite of Specimen 2K

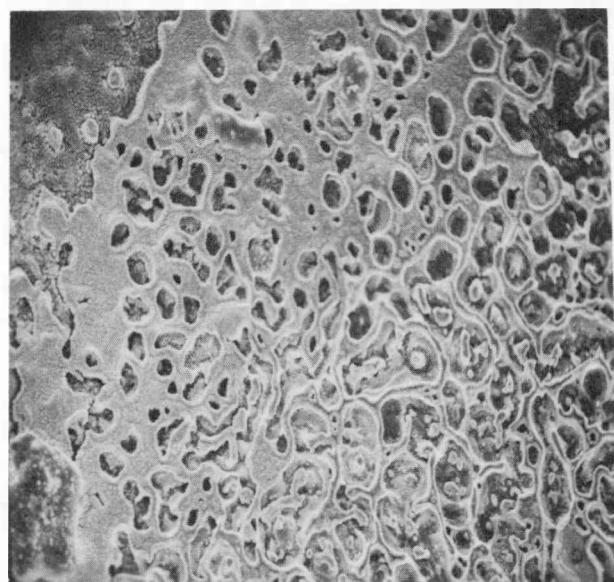
In several areas on 2K, the uranium-containing deposits appeared to be the result of liquid flow in channels between the fuel and cladding, as shown in Figure 3.3-24 (Area A, Figure 3.3-23). Surface cracking of the heaviest uranium containing deposits was observed, while in areas where the deposits were absent, the wormlike growths seen in previous samples were observed. Two areas showed circular cracking of the Zircaloy over a width of 2-3 mm in the vicinity of heavy uranium-containing deposits (Areas B and C, Figure 3.3-23). A close-up of Area B, Figure 3.3-23 is shown in Figure 3.3-25. This area is raised on the periphery, depressed around the center, and again raised in the center. A typical example of a fuel deposit is shown in Figure 3.3-26a (Area D, Figure 3.3-23). The fuel had a rounded appearance, rather than the blocky appearance seen in previous samples, and the deposit was surrounded

Figure 3.3-24 Uranium Containing Deposit on Inner Surface of
Specimen 2K (Area A, Fig. 3.3-23) 400X
Neg. No. MSD-204133

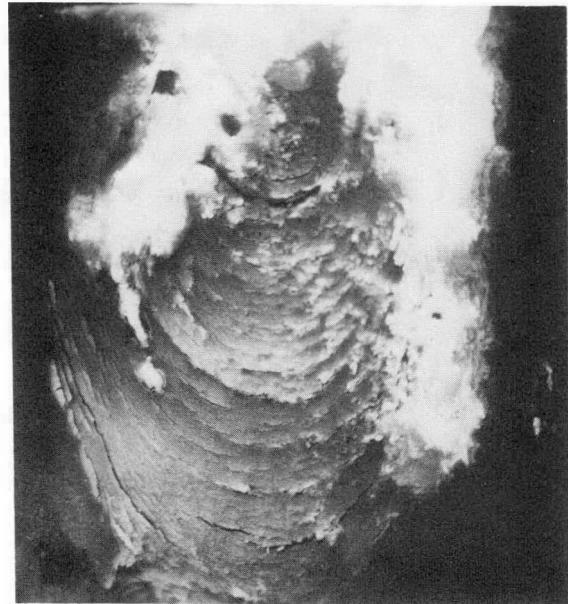
Figure 3.3-25 Circular Cracks Near Large Uranium Containing Deposit on Inner Surface of Specimen 2K (Area B, Fig. 3.3-23) 30X
Neg. No. MSD-204129

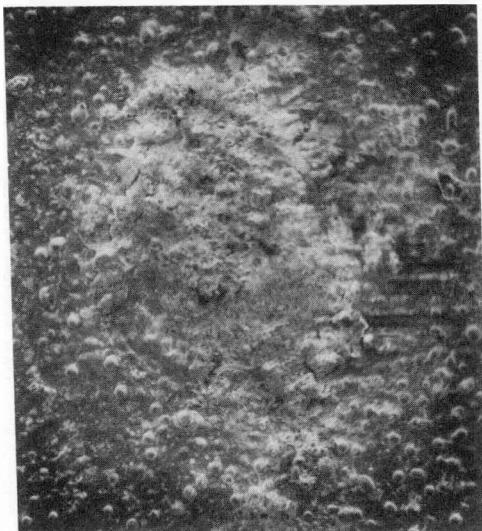
Figure 3.3-26 (a) Circular Deposit Containing a High Uranium Concentration (Area D, Figure 20), 200X, Negative Number MSD-204285. (b) Uranium Map of (a) Negative Number MSD-204286

by a halo that had a high uranium concentration (Figure 3.3-26b). Surface oxide flaking was observed in two areas (Areas E and F, Figure 3.3-23). Figure 3.3-27 (Area E, Figure 3.3-23) shows a uranium-containing particle, possibly a deformed piece of fuel, surrounded by surface flaking. The light areas of the flakes are the result of electron charge buildup.

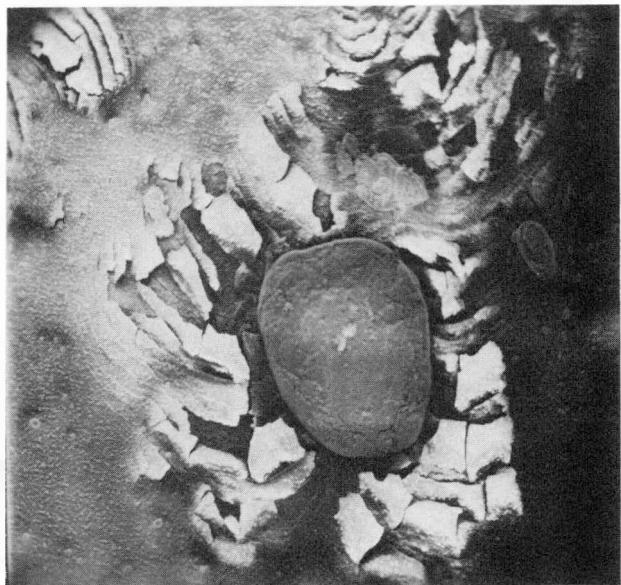
Figure 3.3-27 Surface Oxide Flaking Near Uranium-Rich Deposit
(Area E, Figure 3.3-23), 60X, Negative Number
MSD-204121

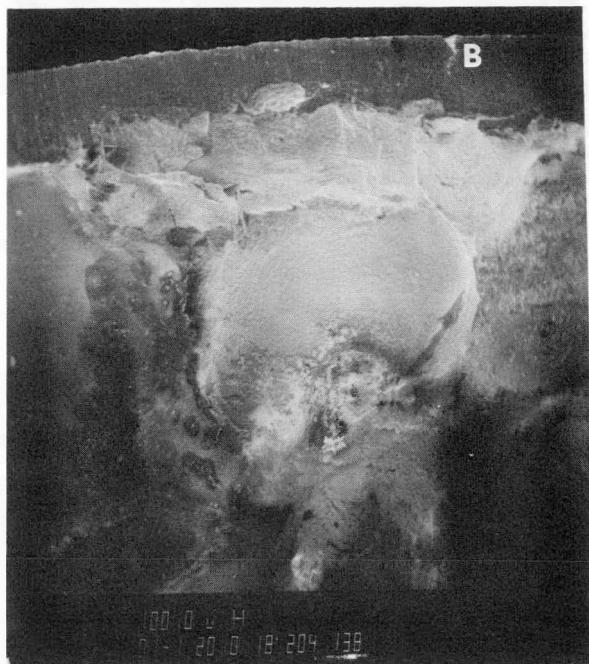
The defect which was exposed by the sectioning of 2K is shown in Figure 3.3-28 (Area G, Figure 3.3-23). A portion of the Ziracloy substrate was removed along with the white deposit. In some areas the depression is ~ 50 percent of the cladding thickness. The surface of the exposed Zircaloy at the defect site shown in Figure 3.3-29 indicates a brittle fracture, but it does not have the cleavage and fluting features of an SCC failure. A through-wall crack was also present at this site (Area B, Figure 3.3-28). However, it is not known if this crack was present prior to sectioning or whether it was created by the sectioning process. The surface of the crack near the outer surface contains a large amount of debris as shown in Figure 3.3-30. Several elements including calcium, zinc, cesium, uranium, and iron were found at isolated points on this surface. Only zirconium was detected on the exposed Zircaloy substrate on the inner surface.

Figure 3.3-28 Defect Site of Specimen 2K (Area A, Figure 3.3-22
and Area 6, Figure 3.3-23). Area B Indicates a
Through-wall Crack

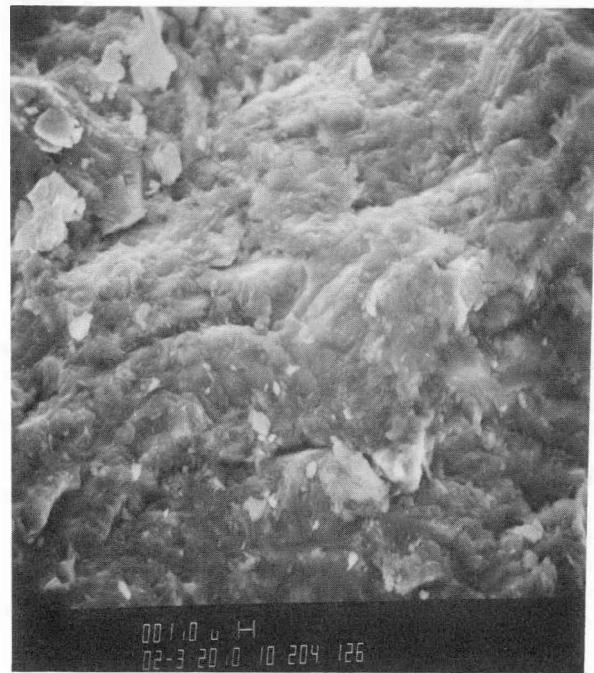
Figure 3.3-29 Fracture Surface of Defect from Specimen 2K

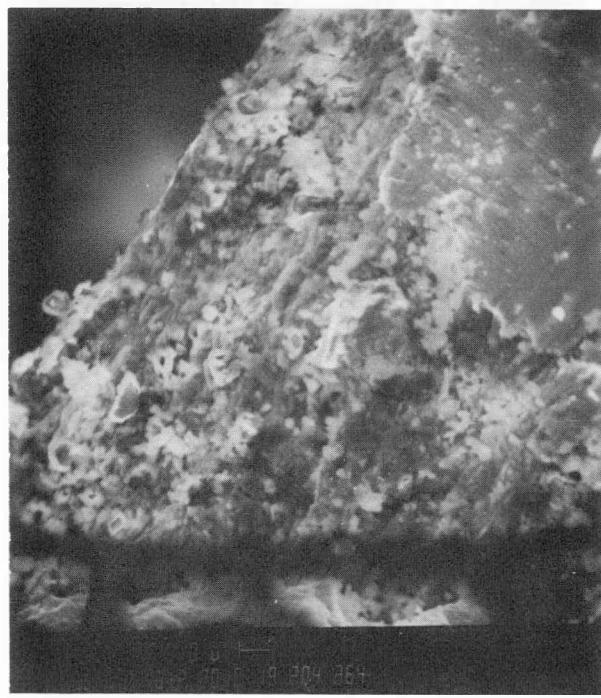
Figure 3.3-30. Through-Wall Crack Surface Near Outside of Specimen 2K

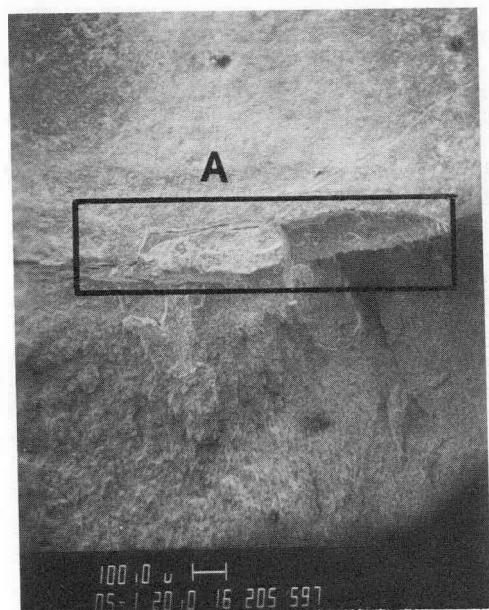
The fracture surface corresponding to the circumferential cracks in Specimen 8K is shown in Figure 3.3-31. Two distinct fracture types can be delineated: a dark smooth surface which travels ~ 150 μm into the cladding, and a more irregular surface over the rest of the fracture. The fracture types can be seen more clearly in a higher magnification map of the area shown in Figure 3.3-32. The area of smooth fracture follows a circular arc and has a width of approximately 1.5 mm.

Figure 3.3-31 Fracture Along Circumferential
Cracks in Specimen 8K
(Fig. 3.3-21)

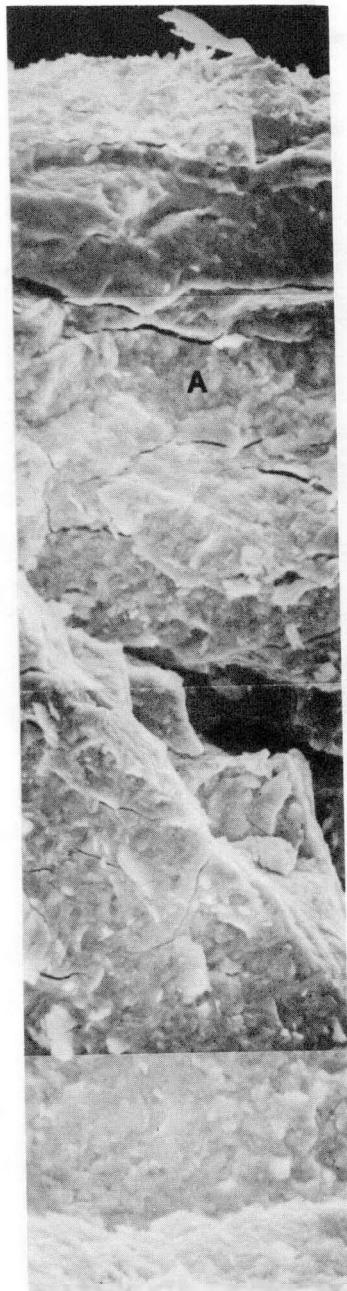
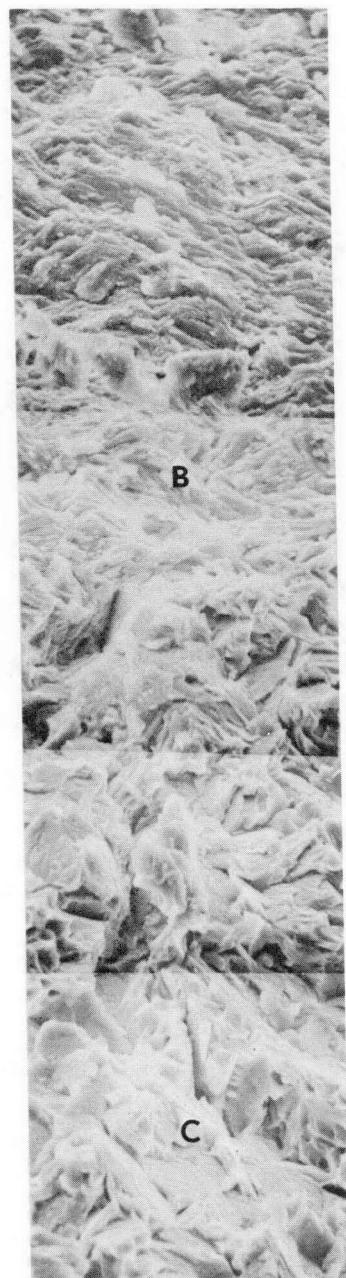
Figure 3.3-33 Fracture Map from Specimen 8K of Area A, Figure 3.3-32

The microstructure of the fracture surface from the inner surface towards the outer surface is shown in Figure 3.3-33 where several modes of fracture can be seen. Area A, adjacent to the inner surface, has a rounded appearance with some secondary cracking. Area B, $\sim 100 \mu\text{m}$ from the inner surface has a more brittle character than Area A. Neither fracture surface showed any evidence of cleavage and fluting which is typical of SCC fractures in Zircaloy. Area C, below $150 \mu\text{m}$ from the inner surface, shows a mixed ductile-brittle fracture mode. Area C is representative of most of the fracture surface away from the inner surface and was undoubtedly created during the bending process.

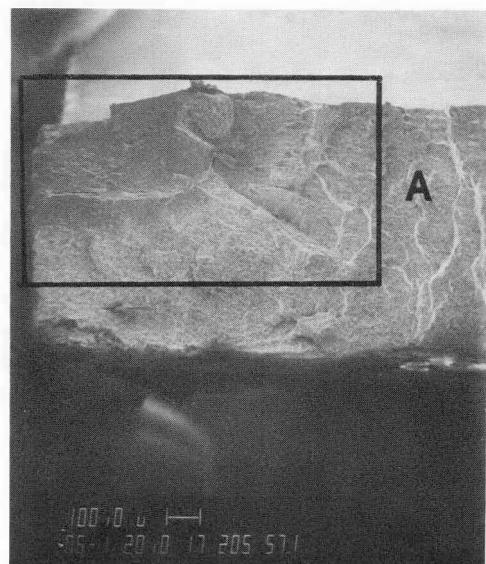
The fracture surface exposed by three point bending of the pit and longitudinal crack of Specimen 4K is shown in Figure 3.3-34. Three fracture modes can be seen in a high magnification map of the area (Figure 3.3-35). These fracture modes correspond to those observed in Specimen 8K. Area A represents the area of undistinguished or rounded fracture, Area B represents the area of brittle fracture, and Area C represents the area of mixed ductile-brittle fracture. The microstructures of the fracture surface are shown in Figure 3.3-36. The undistinguished fracture penetrates $\sim 250 \mu\text{m}$ from the inner surface. Below this point and continuing to the outer surface is the brittle fracture surface. Neither fracture showed evidence of cleavage and fluting. The remaining surface away from the pit was composed of the mixed-mode fracture.

Figure 3.3-34 Fracture Through Pit and Longitudinal Crack of Specimen 4K, Figure 3.3-17

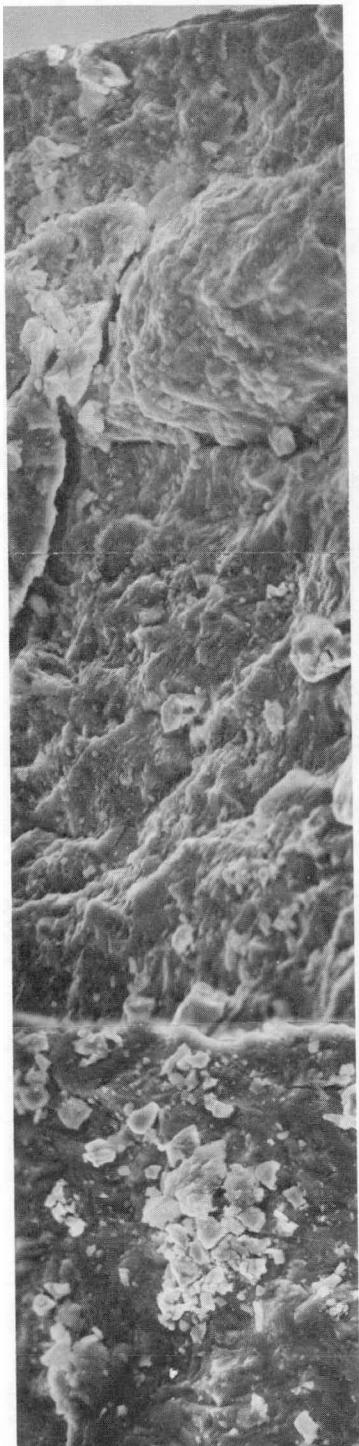
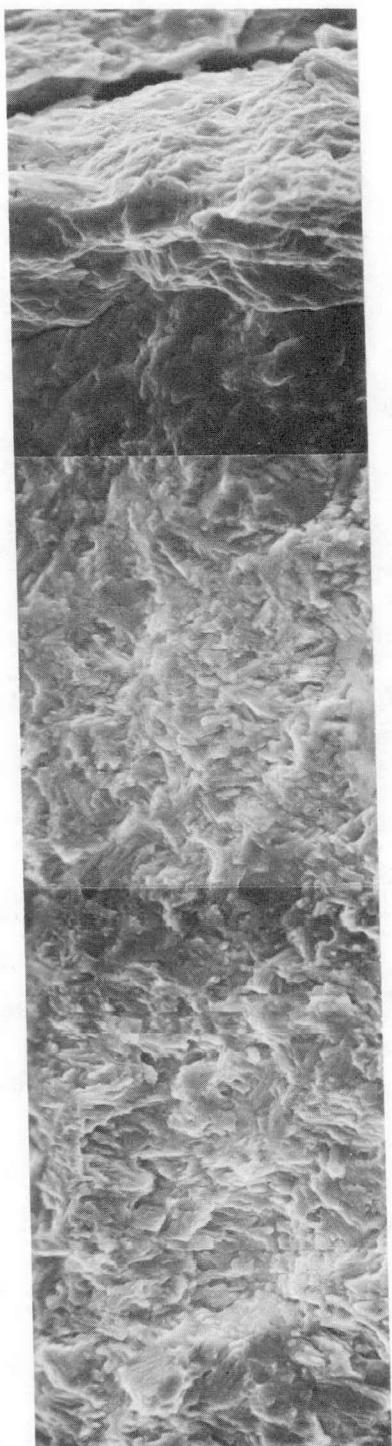
Figure 3.3-36 Fracture Maps from Specimen 4K of (a) Area A, Figure 3.3-35, and (b) Area B, Figure 3.3-35

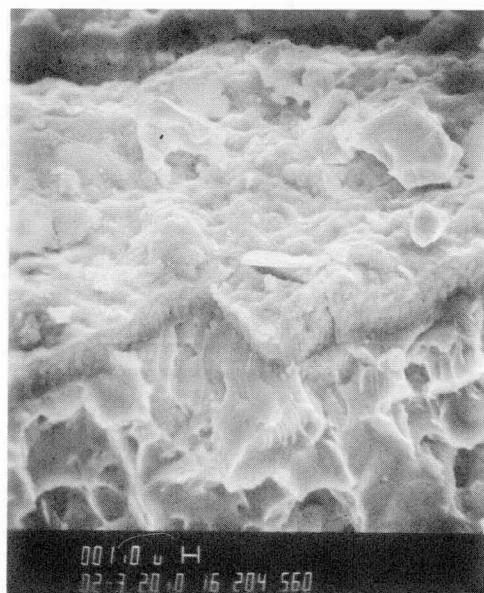
Figure 3.3-37 Surface Oxide of Specimen 14K

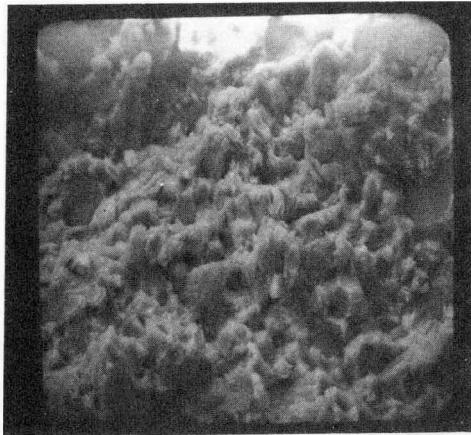
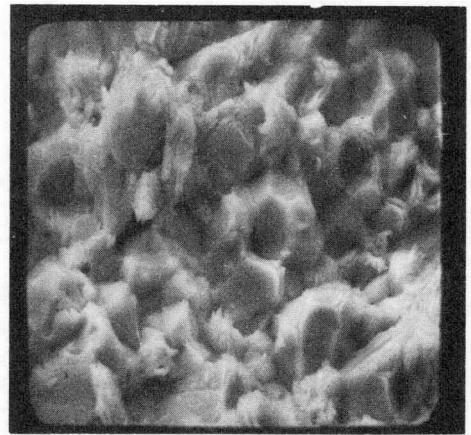
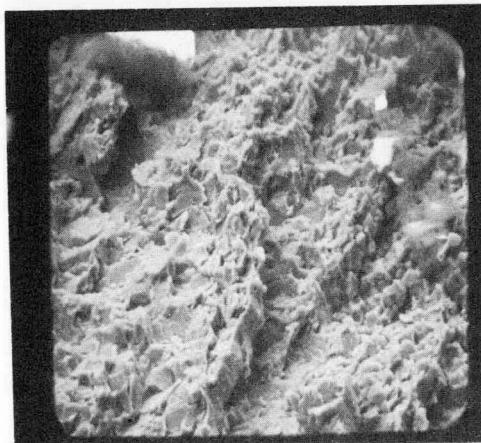
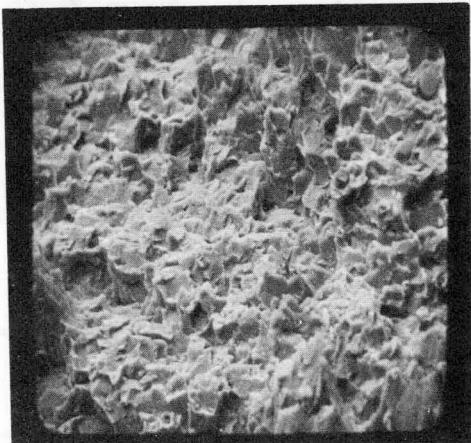
In contrast to the results from ANL, fracture surfaces examined by ASEA-Atom at Studsvik did exhibit features typical of SCC similar to the Dresden-3 samples. Figure 3.3-38 shows some examples of the fracture surfaces observed at Studsvik. Comparison of the Studsvik results (Figure 3.3-38) with those from Dresden-3 (Figure 3.2-26 and 3.2-30) show a greater proportion of intergranular fracture in the Oskarshamn samples. This is probably due to differences in heat treatment of the two claddings (fully recrystallized Oskarshamn cladding versus stress relieved Dresden-3 cladding).

Figure 3.3-38 Appearance of Fracture Surface Near Clad
Inner Surface of Oskarshamn-1 Fuel Rods

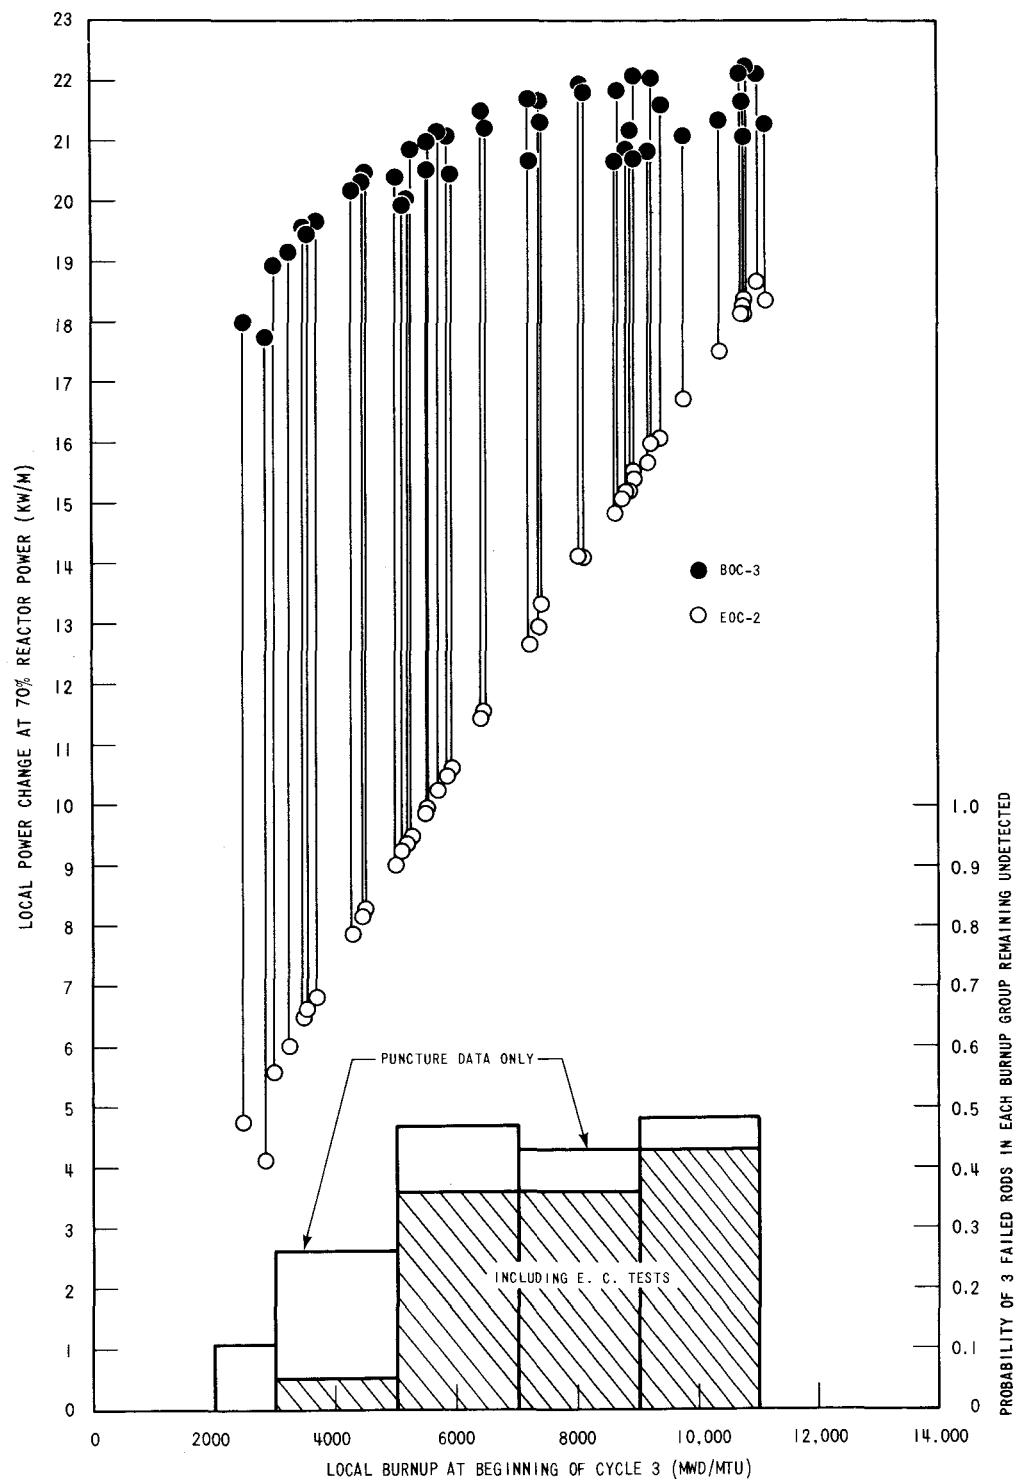
Figure 4.1-1 Power Increase During Cycle 3 Startup of Punctured Fuel Rods. Point Beach-1, Fuel Assembly D-14

as previously stated, the coolant activity first became significant during reactor power escalation from 50 percent to 70 percent of full power. The figure illustrates that at the time significant coolant activity was evident during the startup, the lowest burnup rods (local burnup of 2500 MWD/MTU) had experienced local power increases of approximately 18 kw/m (5.48 kw/ft); in contrast, the highest burnup rods (local burnups of 11,000 MWD/MTU) had experienced much lower local power increases of approximately 4/kw/m (1.2 kw/ft).

Included in Figure 4.1-1 for convenience is plotted (from Table 4.1-1) the probability of 3 perforated rods remaining undetected in a given burnup subgroup. Despite the wide range of power change duty demonstrated, the probability of 3 perforated rods remaining undetected in any burnup subgroup is small. If more than 3 failed rods are assumed to exist in the assembly, the probability that all rods are confined to a single burnup subgroup becomes even smaller. In view of the threefold difference in power increase between the rods irradiated to 5,000 MWD/MTU and 11,000 MWD/MTU burnup, respectively, at the time of the reactor postrefueling startup, the apparent independence of failure probability with burnup, and power swing, is striking. The combined data of Table 4.1-1 and Figure 4.1-1 tend to suggest that the failure probability in fuel Assembly D-14 is dependent only on absolute power level obtained during the startup (for the rapid rate of power change), since at any given reactor power, the absolute power level achieved is relatively insensitive to rod burnup.
