SAND88-2902 • UC-70

Analysis of the Accidental Explosion at Pepcon, Henderson, Nevada, May 4, 1988

Jack W. Reed

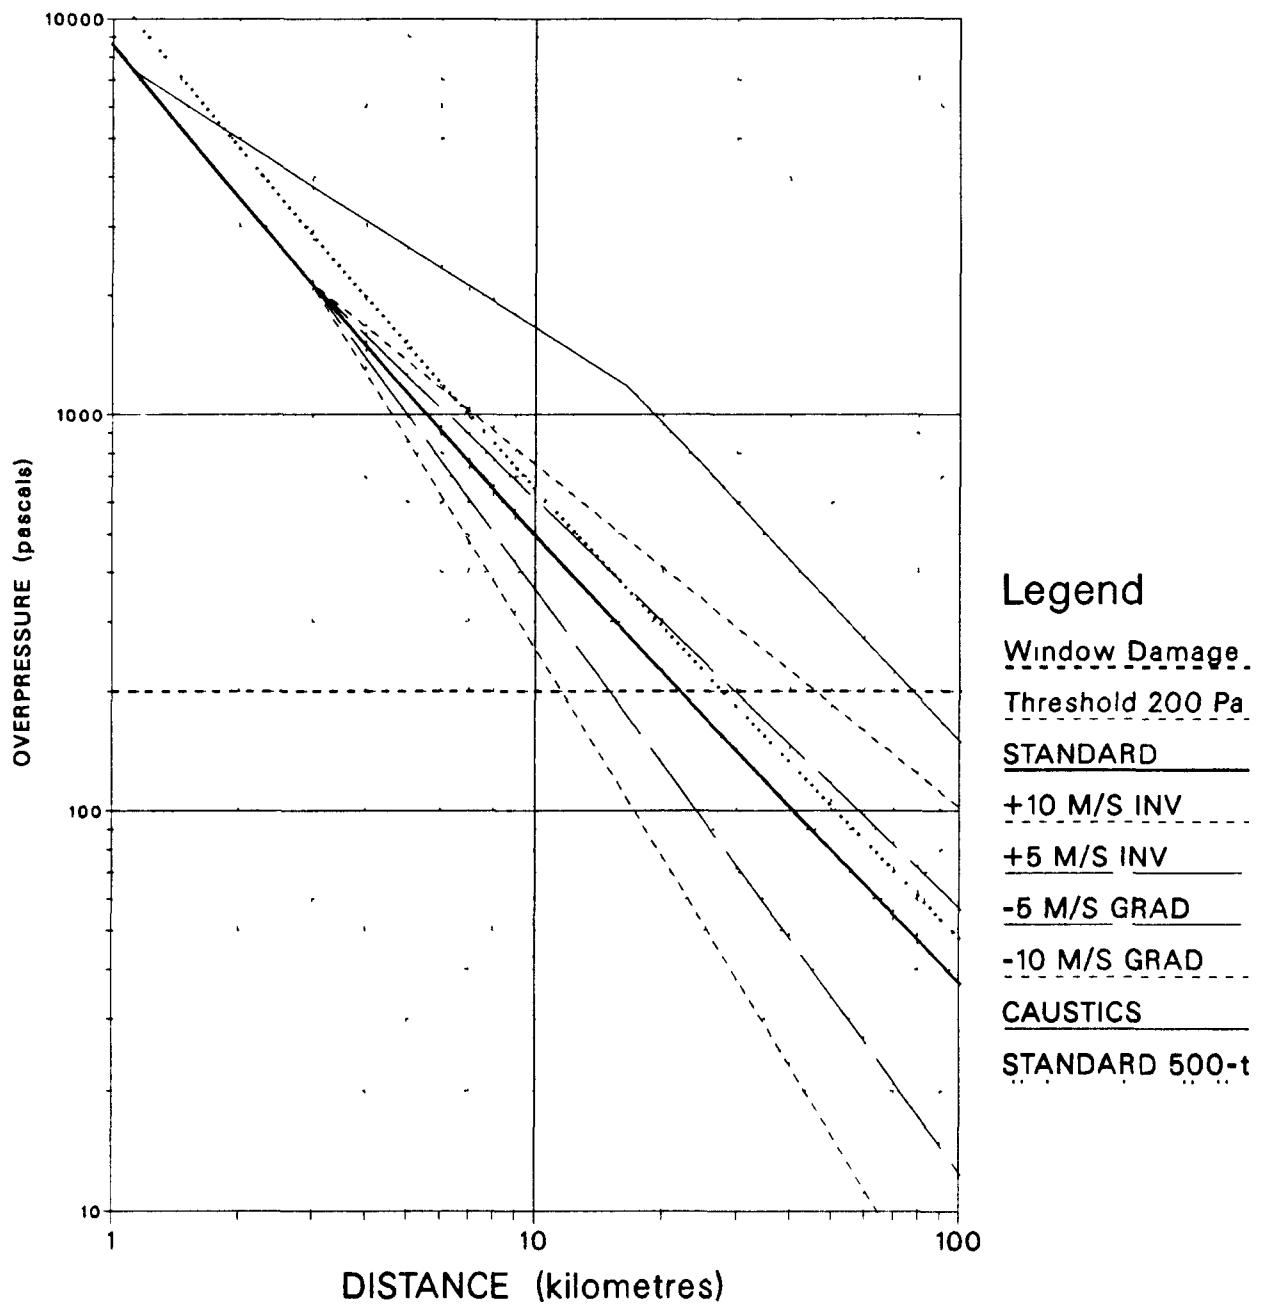
Figure 4. Airblast overpressure versus distance curves for 1-kt NE free-air burst (or 250-ton TNT surface burst), at 579 m MSL altitude, 94.1 kPa ambient pressure.

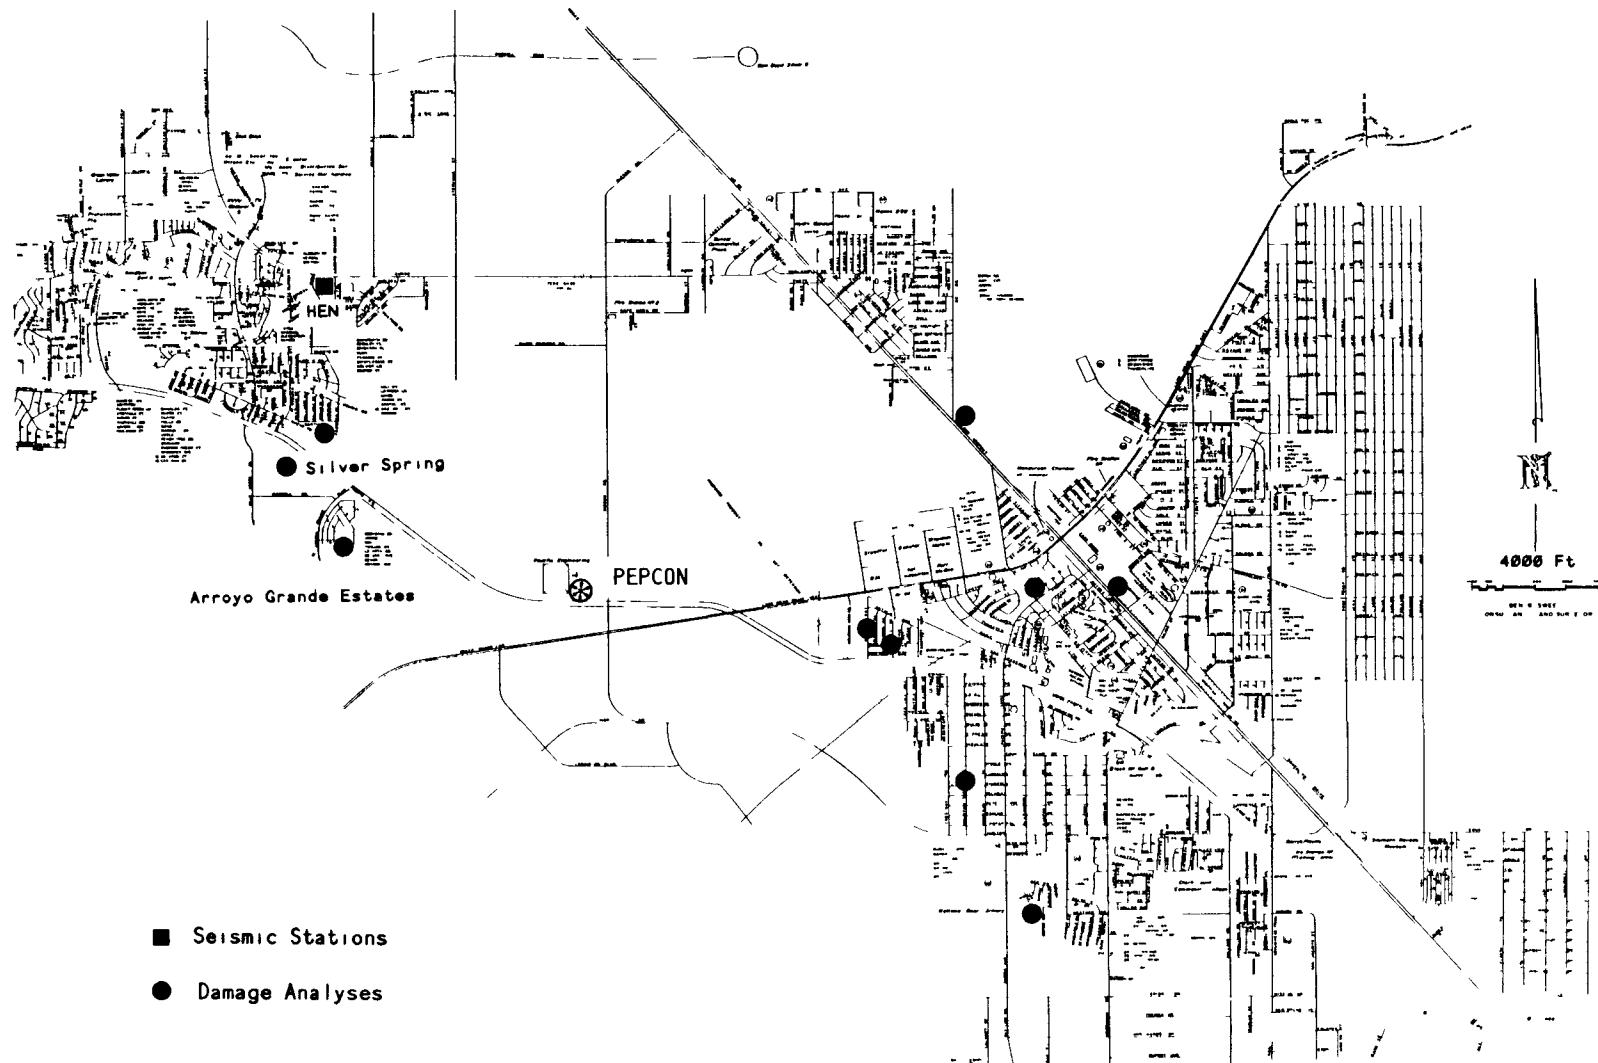
Figure 9 Street map of Henderson, Nevada, (from Henderson Chamber of Commerce), with explosion site and locations for damage analyses

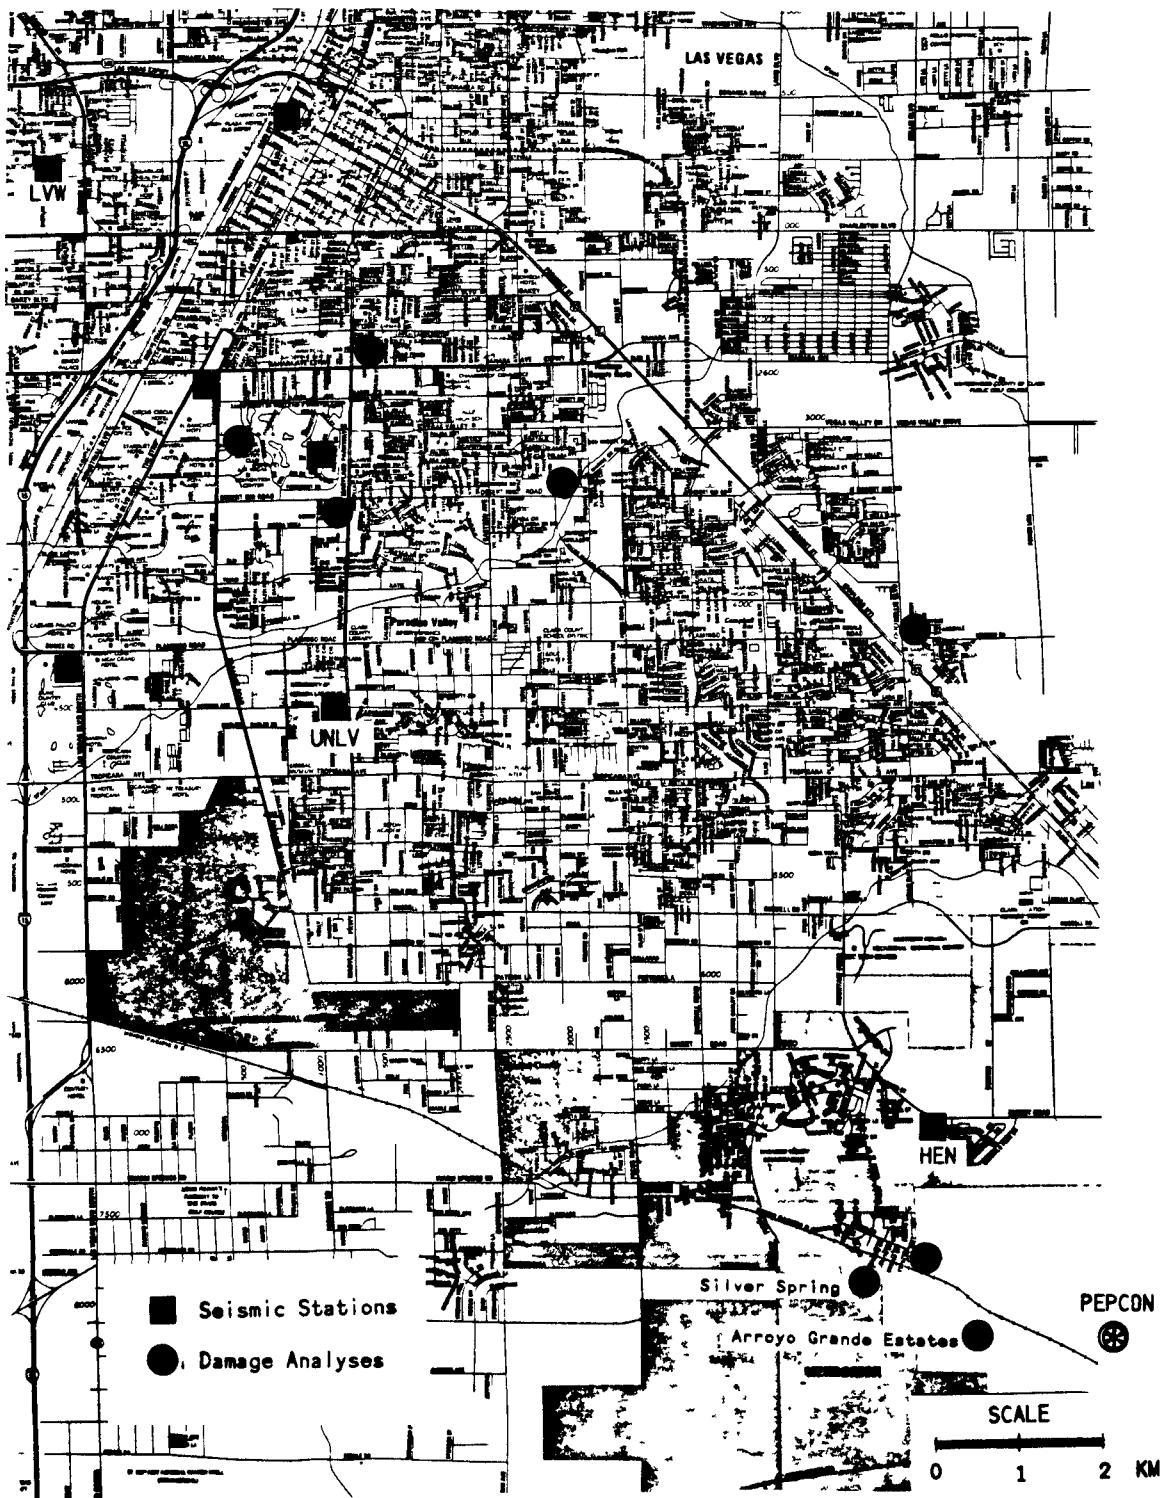
J. L. Woodruff, of URS/John A. Blume & Associates, seismic consultants to DOE-NVO, lives near Boulder Highway and Flamingo Road, Las Vegas, about 9 km from the blast according to the Las Vegas map in Figure 11. He reported that about one-third of his neighbors had window damage. This was interpreted as 330-Pa overpressure, near the -10 m/s gradient curve and clearly lacking any strong enhancement in spite of their generally downwind direction. They were probably in the "silent zone" between focused caustic arcs.

Continuous recordings are made at Station S-2, at the University of Nevada Las Vegas (UNLV) Chemistry Building, off Maryland Parkway and south of Flamingo Road, and at the Las Vegas water pumping plant, S-8, north of Charleston Avenue in northwest Las Vegas, as shown in Figure 11. It had been hoped that these recordings could be used to determine times for the various reported explosions, but it appears that only the first and third explosion were strong enough to cause a readable oscillation. Some recorders were not even triggered to operate by ground motion arriving from the first explosion wave, and only recorded the airblast wave. Clear audibility of only two blasts was also reported (R. C. Bass, SNLA-7111, pers. comm., 1988) from a point on Sahara Boulevard, between Paradise Road and Maryland Parkway. On the other hand, as previously cited, a video-camera recording gave both video and audio indications of a moderately large explosion about one second before the final, large blast.

Figure 11. Street map of Las Vegas, Nevada (from Rand McNally), with explosion site and locations for damage analyses.
