DOE/ET/20279-114

MATERIALS, PROCESSES AND TESTING LABORATORY
TECHNICAL PROGRESS REPORT:
MARCH, APRIL, MAY, JUNE 1980

30 October 1980

Massachusetts Institute of Technology
Lincoln Laboratory
Lexington, Massachusetts 02173

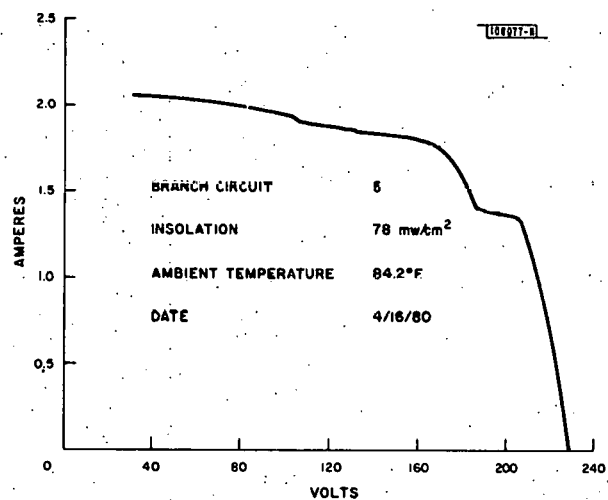
Fig. 21. UTA branch circuit 5.

An I-V curve was made during the morning for each branch circuit, each of which consists of 40 modules—four in parallel by 10 in series. There were four branch circuits that had obvious failures—strings 5, 9, 11, and 16 (Figs. 21-24). After replacing the failures, the branch-circuit I-V curves no longer showed a step near the peak power point. However, steps were evident at voltages away from the peak power point for several branch circuits (Fig. 25) after the failure replacement in the curve for string 16. The array field was washed withalconox and hot water to determine whether cleaning the array would smooth out the I-V curves.

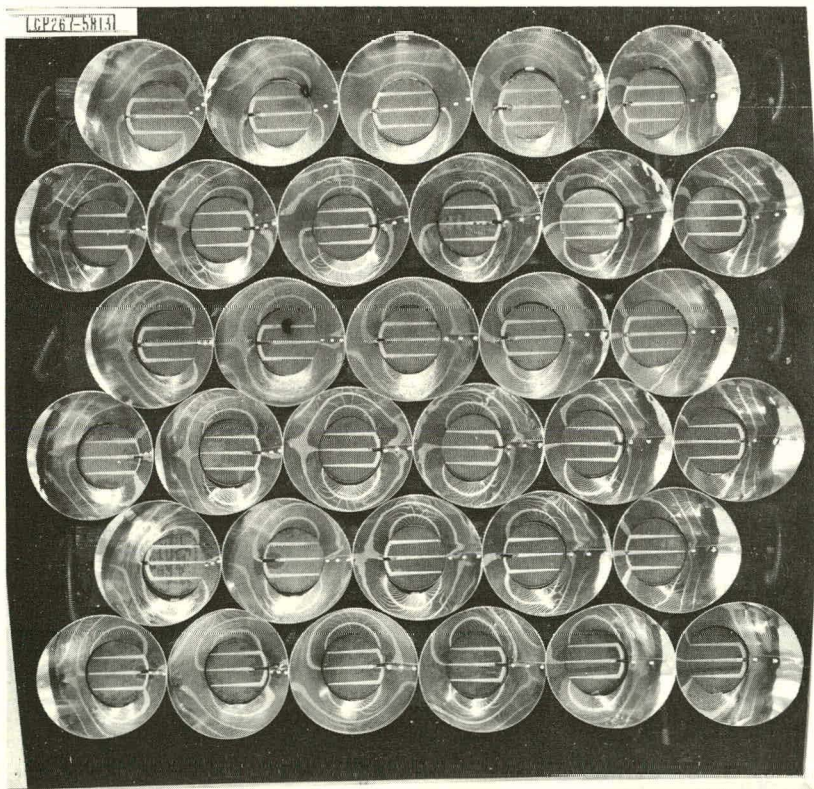
Fig. 46. Model G PV/T module.

On April 28, 1980 a newly received Model G photovoltaic/thermal (PV/T) air module (Fig. 46) was examined visually. The front plexiglass protective dome was not disturbed for this receiving examination so that the weather seal would remain intact for forthcoming testing and evaluation.

a. Taped/Spliced Wires

The wires, connecting each row of cells to the adjoining row of cells, were twisted together, soldered, and then the spliced area was wrapped with black electrical tape for insulation. The weather resistance of this type of splice is notoriously poor and these connections may prove to be a potential problem area.
