**U.S. DEPARTMENT OF ENERGY
FEDERAL ENERGY REGULATORY COMMISSION**

**THE CON EDISON POWER FAILURE
OF JULY 13 AND 14, 1977**

**FINAL STAFF REPORT
JUNE 1978**

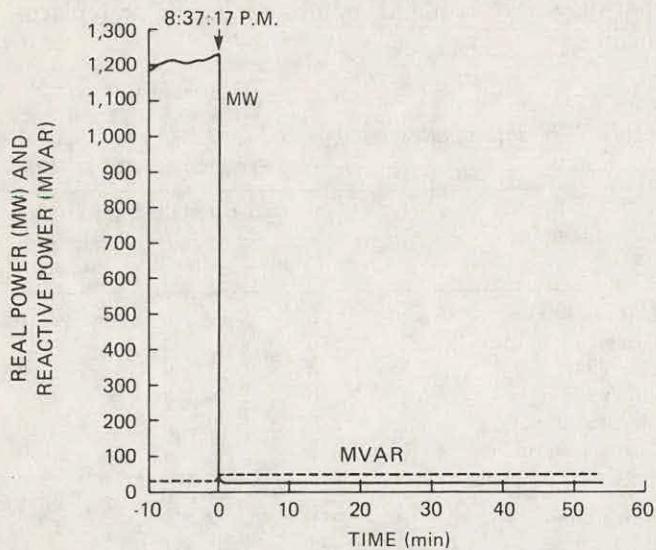
Figure V-9.—Total 345-kV line flows, Buchanan South to Millwood West (W97 and W98), July 13, 1977.

(1) At 8:37:17 p.m. (hours:minutes:seconds), a lightning stroke caused a fault on both circuits (W97, W98) of a double-circuit 345-kV transmission line between the Buchanan South and Millwood West Substations. Circuit breakers at Buchanan South opened, but because of a design error in the protective system, a transfer trip signal (to Ladentown) was initiated that opened the 345-kV line from Buchanan South to Ladentown (Y88). Indian Point No. 3, without a transmission path for its output, tripped off the line and shut down. Relaying operation prevented (by protective system design) the normal reclosure of the Buchanan South breakers, leaving W97 and W98 open. Because the Ladentown tie had been carrying 427 MW and Indian Point No. 3 had been generating 883 MW, the result was the total loss of the 1,310 MW of power imported through this connection. Power flow into Con Edison's system from other interconnections immediately increased by 1,265 MW; the remaining deficiency of 45 MW was made up by a slight increase in output of various generators and by a slight drop in load related to a very small drop in system frequency. System

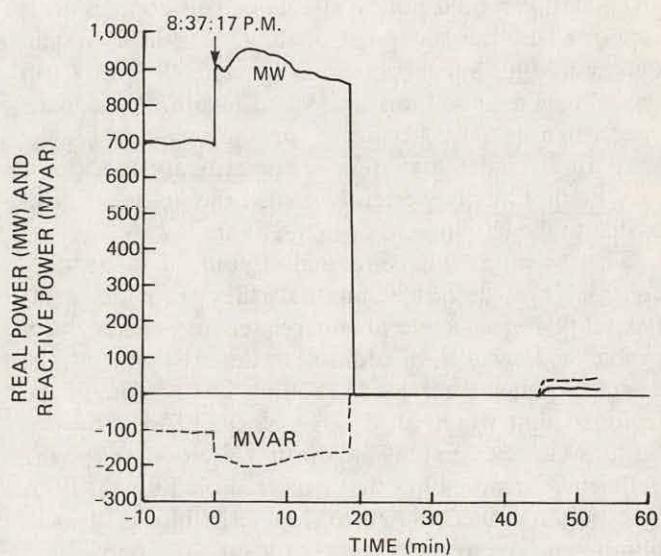
Figure V-11.—345-kV line flows, Pleasant Valley North to Millwood West (W81), July 13, 1977.

conditions were stable following the first incident. One transmission line, a feeder from Pleasant Valley to Millwood West (W81), was carrying power over its normal rating but within its long-term emergency limit.

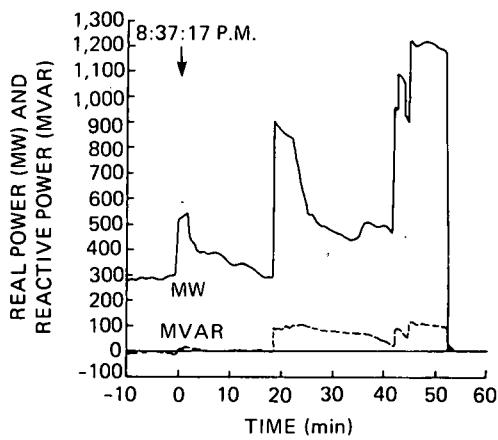
Figure V-18.—230-kV line flows, Linden to Goethals (A2253), July 13, 1977.

(7) About 7 minutes later, at 9:29:41 p.m., the 230-kV interconnection from Goethals to Linden opened as a result of a failure in the heavily overloaded phase-angle-regulating transformer that was an integral part of this connection. The resulting loss of power to Con Edison was about 1,150 MW. The last remaining tie from Con Edison to external sources, two 138-kV feeders from Pleasant Valley to Millwood East (W11/9825 and W16/9826), tripped immediately from the accompanying power swing.

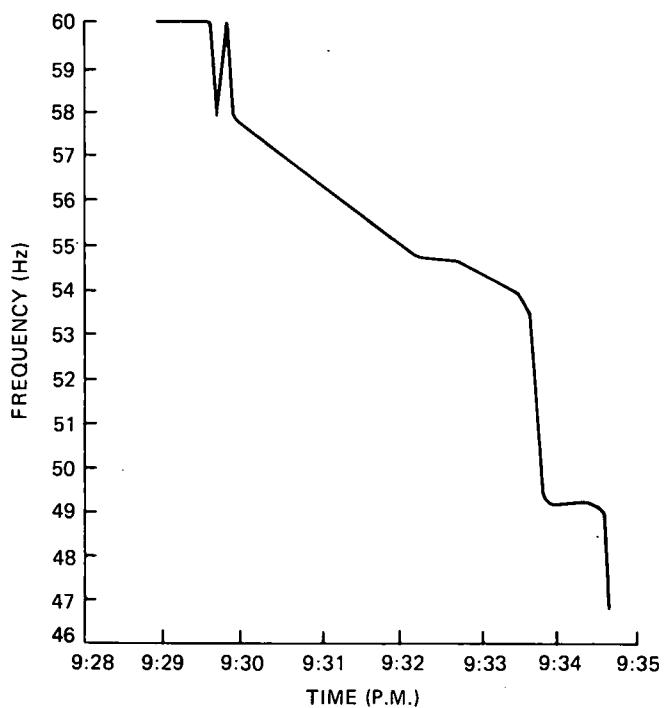
Figure V-23.—System frequency vs. time, determined from energy control center audio tape recorder.

After the fault in the Con Edison's Goethals to Linden (Public Service Electric & Gas Co.) 230-kV phase-angle-regulating transformer and subsequent separation of the Con Edison system from the eastern United States interconnected power system, frequency dropped rapidly in the island area because of a large imbalance between island generation and load. Con Edison's island load was 5,981 MW (net) and island generation was 4,282 MW (net), a generation deficiency of 1,699 MW, or 28.4 percent. A graph of system frequency, obtained by Con Edison from spectral analysis of the energy control center tape record, is shown in figure V-23.

The exact frequency response during the first 10 seconds of isolation is not known because of the absence of data from high-speed instrumentation, but results from the two computer simulations and audio tape analysis correlate reasonably well. The simulations

showed that the frequency declined over the first 2 seconds at a rate between 1.0 and 1.3 Hz/second with an abrupt change at 2 seconds as a result of load

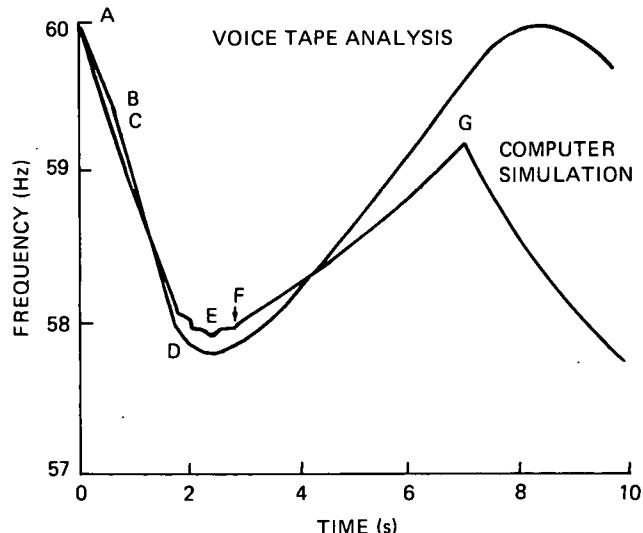
Figure V-24.—System simulation of July 13, 1977, disturbance: 345-kV bus frequency vs. time.

- A: LINDEN TO GOETHALS 230-kV LINE TRIPPED AT TIME T = 0+ s
- B: PLEASANT VALLEY TO MOHANSIC 138-kV LINE TRIPPED AT T = 0.57 s
- C: PLEASANT VALLEY TO CARMEL 138-kV LINE TRIPPED AT T = 0.75 s
- D: 4-kV LOAD SHED AT 59.3 Hz
- E: 4-kV AND LOW-VOLTAGE NETWORK LOAD SHED AT 58.8 Hz
- F: NETWORK LOAD SHED AT 58.3 Hz
- G: RAVENSWOOD NO. 3 TRIPPED

shedding. The absolute frequency at this point ranged between 57.4 and 57.9 Hz. At least three levels of underfrequency relays operated to shed load. These were set to operate at 59.3, 58.8, and 58.3 Hz. An additional, fourth and final block of load shedding, set to operate at 57.8 Hz, was assumed to operate at the 2-second point in the FERC staff simulation. This block was shed at a later time in the Con Edison computer simulation. An audit of underfrequency relay targets indicated that a total load of 2,230.6 MW, or 37.3 percent, was shed automatically by underfrequency relays. The total amount covered by the first three underfrequency settings was about 1,435 MW, or 24.0 percent. After the initial drop, the frequency recovered at a rate of between 0.25 and 0.80 Hz/second for 4 to 6 seconds. At a point in this period, the Ravenswood No. 3 generating unit carrying 844 MW of load tripped off by loss of field relay. Loss of this unit left the island area with a net generation deficiency between 8.3 and 21.6 percent, depending upon whether the fourth block of load shedding was activated before or after tripping of Ravenswood No. 3. The frequency declined again at a rate of between 0.4 and 0.5 Hz/second. The results of the Con Edison analysis and the FERC staff simulation with regard to frequency after islanding are shown in figures V-24 and V-25, respectively. Table V-8 gives the
