HALF-BEAD WELD REPAIRS FOR
IN-SERVICE APPLICATIONS*

P. P. Holz, Sr. Development Engineer

Oak Ridge National Laboratory
Oak Ridge, Tennessee 37830

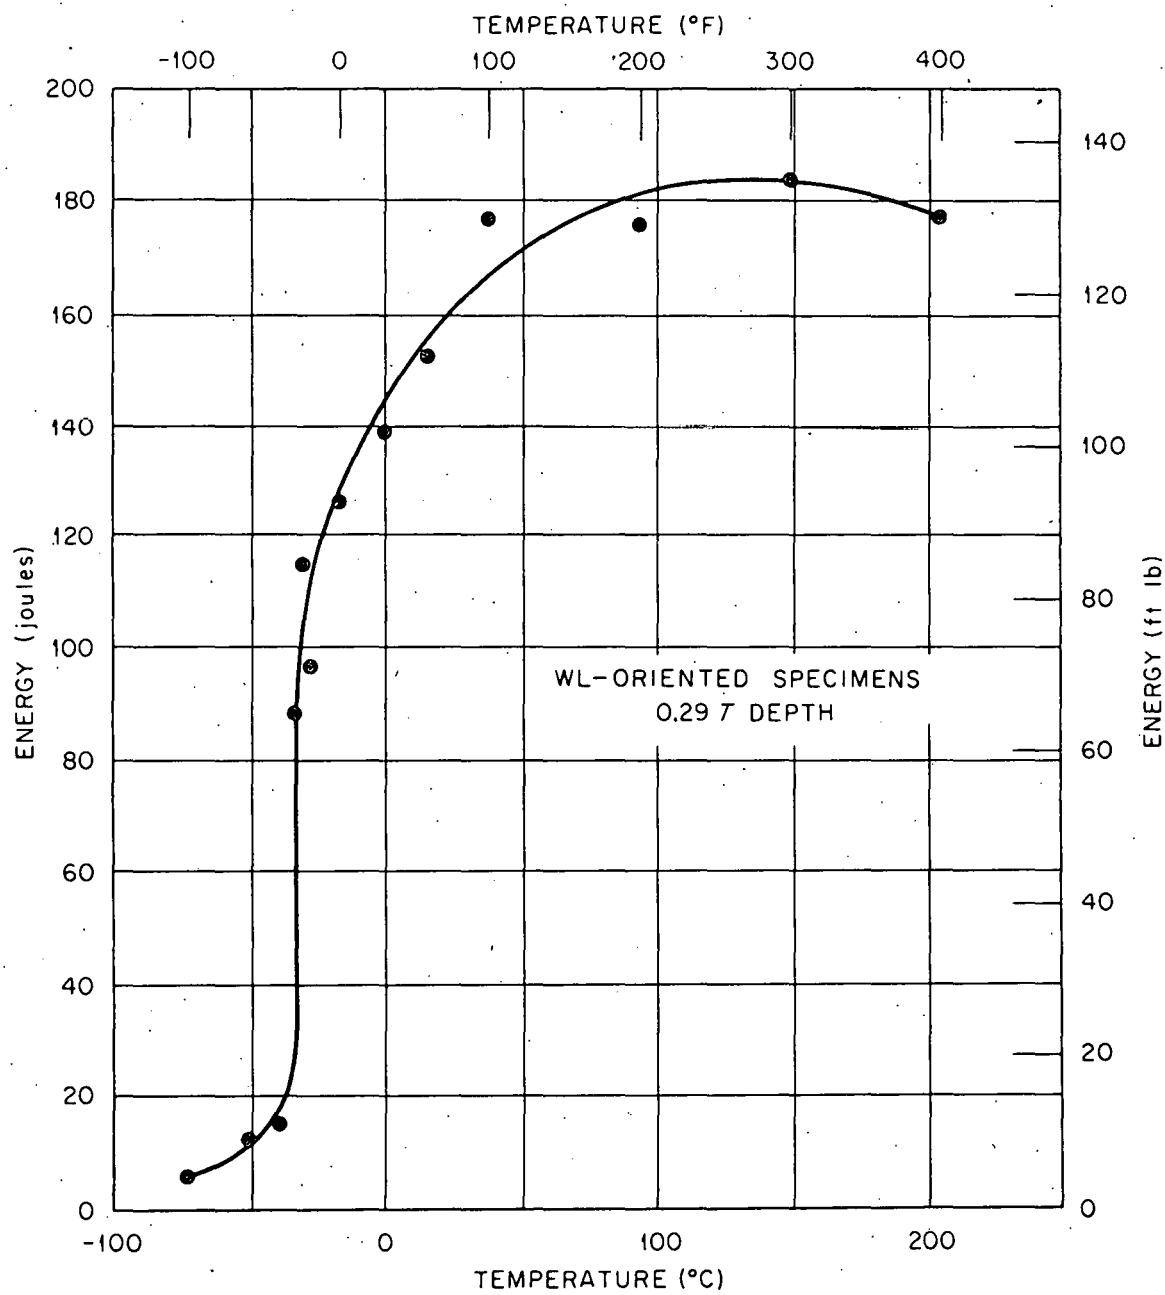
Fig. 3. Variation of Charpy V impact energy with temperature for half-bead test weldment W-1 in weld metal.

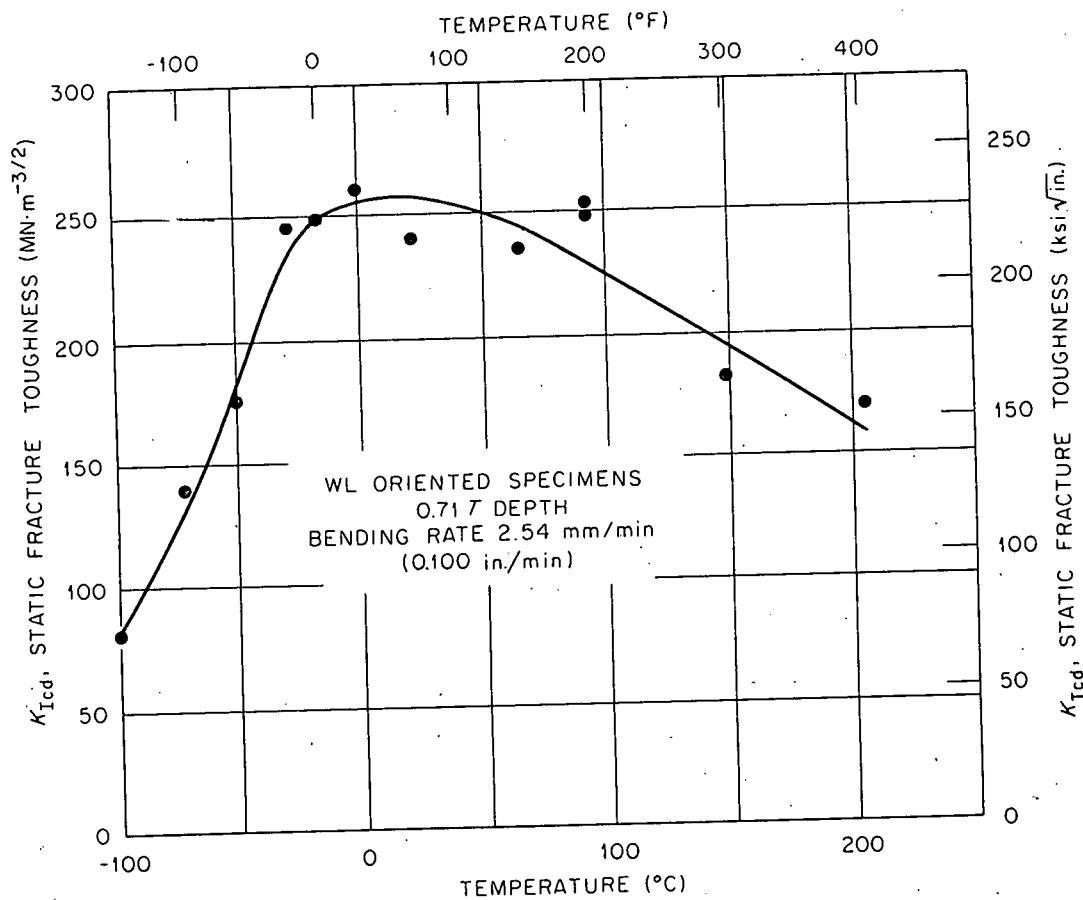
Fig. 4. Variation of fracture toughness with temperature as determined from slow bend tests of precracked Charpy specimens from half-bead test weldment W-1 in weld metal.
