FATIGUE CRACKING OF COEXTRUDED 304L/CS TUBES

R. W. Swindeman, J. R. Keiser, and P. J. Maziasz

Oak Ridge National Laboratory, Oak Ridge TN 37831-6155

ABSTRACT

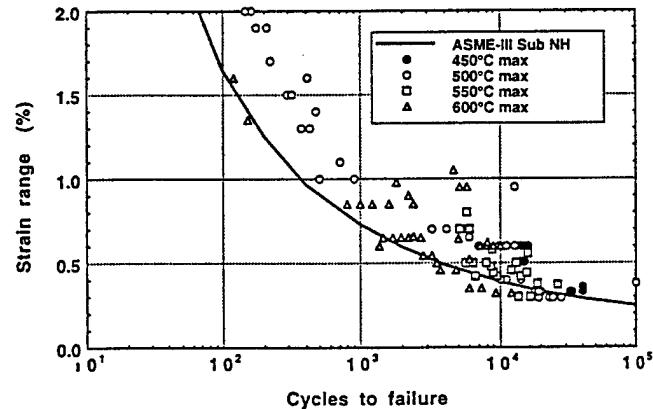
Fig. 1. Comparison of thermal fatigue data to the ASME design curve for 427°C.

The fatigue data for stainless steels provided in Fig. 1 may be used as a reference for assessing the likelihood that the cracking of composite tubes is due to thermal fatigue. If the thermal fatigue results from an upward temperature transient that heats the cladding to 540°C and the cooler base metal and surrounding tubes fully restrain the cladding, then the maximum strain that the cladding could experience is in the vicinity of 0.5%. The stress range corresponding to this strain range exceeds 500 MPa. For fatigue to occur, the same local

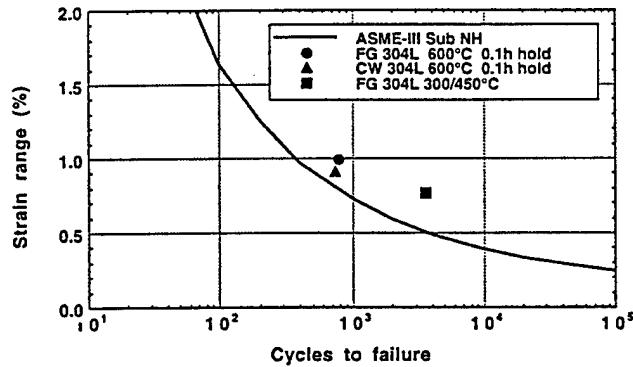
in the coextruded tubes. The room temperature tensile yield was found to be near 300 MPa. Fatigue specimens were machined from the plate and tested under isothermal and thermal fatigue conditions using techniques conforming to ASTM E 606. Isothermal fatigue tests were performed at 300 and 600°C, with and without tensile hold time at the peak temperature, and strain range values below 1%. The material exhibited fatigue behavior typical of the data base on which the ASME code curves were developed. An additional fatigue test at 600°C with a 0.1 hour hold time was performed on a specimen from the cold rolled plate. Although much stronger, the fatigue life of the cold worked material (CW 304L) was the same as the annealed specimen (FG 304L), as shown in Fig. 2. Two thermal mechanical fatigue tests were performed. In one case, the specimen was fully restrained during the cycle from 300 to 600°C. The specimen was cycled until the stress range was stabilized (200 cycles), then the test was stopped and the specimen examined metallurgically. In the other case, a mechanical strain was imposed as the specimen cycled between 300 and 450°C. The test at 0.6% mechanical strain range was discontinued at 3600 cycles, which was near the expected life.

Fig. 2. Comparison of fatigue data for 304LSS simulated cladding with the ASME design curve for 427°C.
