61  
OVERVIEW OF THE DOE STUDIES OF RECOVERY BOILER FLOOR TUBE CRACKING

**ABSTRACT**

## CHARACTERIZATION OF CRACKING IN RECOVERY BOILER FLOOR TUBES

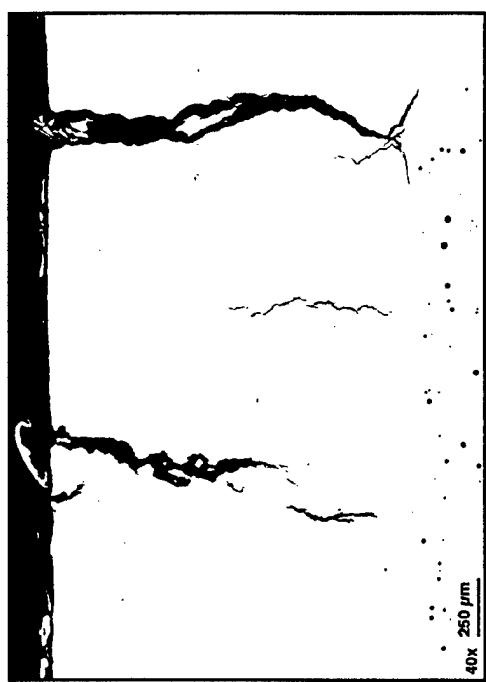
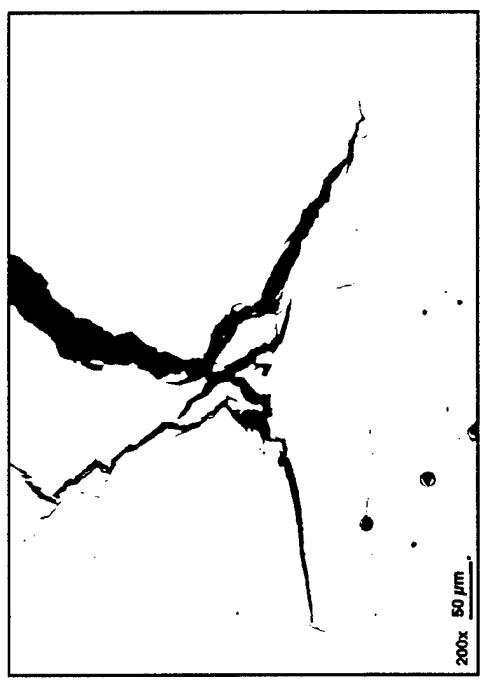
fig. 3

Micrographs of cracks in the areas of the tube where there seems to be no preferred cracking orientation show wider cracks that contain a lot of corrosion product (see Fig. 3). These cracks also tend to turn and run along the interface rather than proceeding through it.

Figure 3. Cross section of composite tube showing craze cracks.

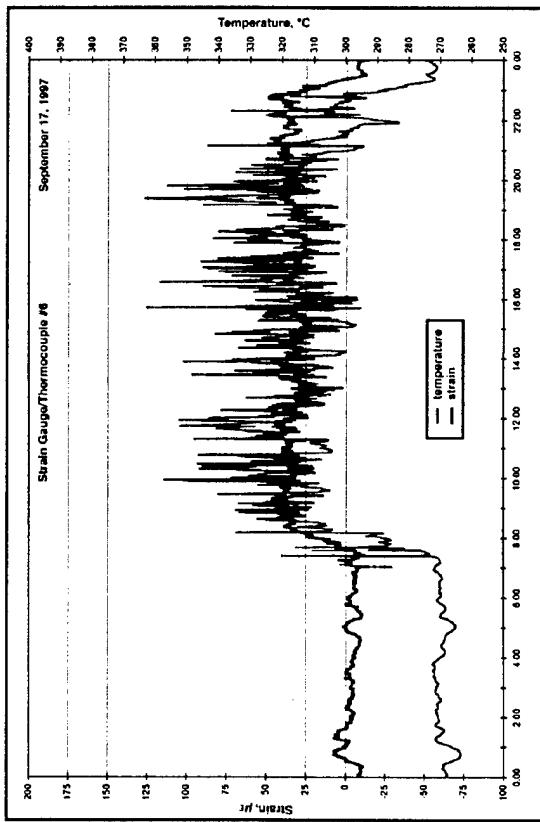
fig.8

Figure 8. Example of a series of low amplitude fluctuations in strain and temperature detected on a recovery boiler floor.

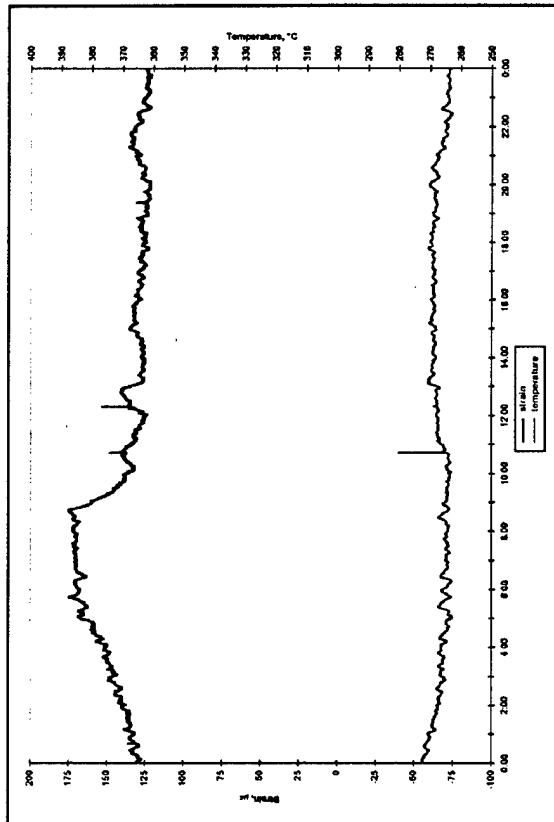
fig.9

Figure 9. Example of strain change without a temperature change seen with strain gauge and thermocouple on a recovery boiler floor tube.

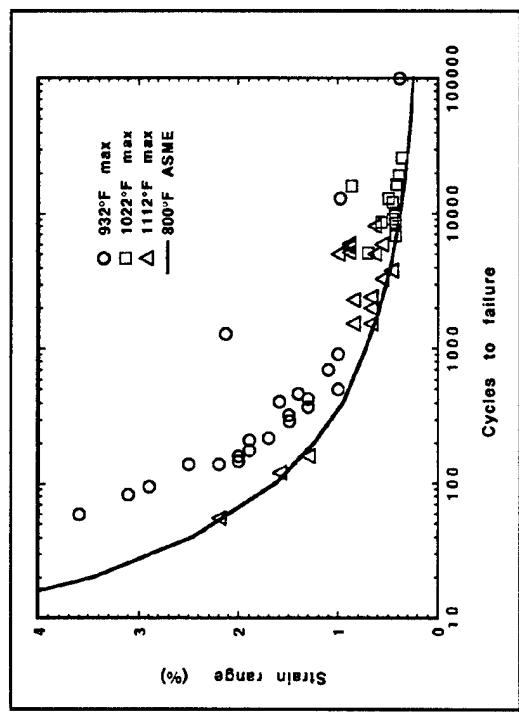
fig. 10

Data on thermal fatigue of 304 stainless steel, shown in Fig. 10, was collected and used to assess the likelihood that temperature fluctuations in recovery boiler tubes could cause sufficient damage to result in cracking. These results indicate that the strain resulting from a temperature variation from 300 to 450  $^{\circ}\text{C}$  would require in excess of 100,000 cycles to reach the design curve for that alloy. For a temperature variation of 300 to 540  $^{\circ}\text{C}$ , a region of a tube would have to experience this transient 10,000 or more times for fatigue to occur. Based on temperature measurements reported in this paper and by others [10-12], there is no indication that any section of floor tubing accumulates this number of cycles.

Figure 10. Thermal fatigue data for 304 stainless steel showing the ASME design curve along with results for cycles to higher temperatures.
