NUREG/CR-5220
Creare TM-1189
Vol. 2
R4

Diagnosis of Condensation-Induced Waterhammer

Case Studies

Prepared by
M.G. Izenson, P.H. Rothe, G.B. Wallis

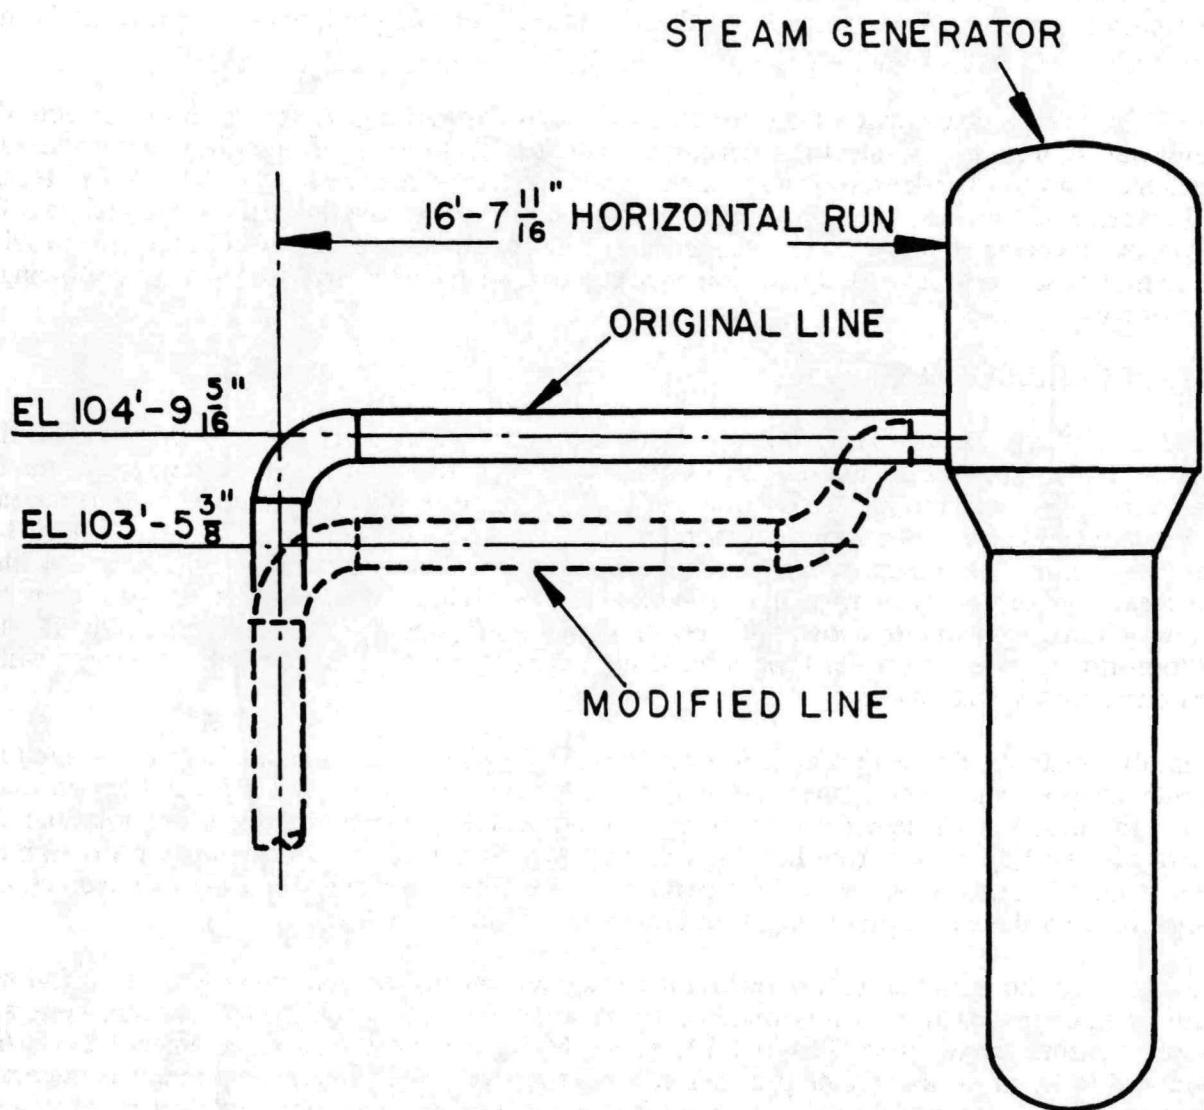
Figure 1.3 FEEDWATER PIPING TO STEAM GENERATOR #2

The layout of feedwater pipe #2 is shown in isometric projection in Figure 1.2. After the containment penetration there is a long horizontal run at el. 58'-9", followed by gradual rise up to el. 96'. About 17 feet from steam generator #2 there is a vertical rise to el. 104'-9", which is the level of the feedwater nozzle. Figure 1.3 illustrates the final horizontal pipe run to the steam generator (Figure 1.3 also shows how the feedline was modified following the waterhammer).

Prior to initiating the tests, the horizontal run of piping leading up to steam generator #2 was shortened from 17 feet to 4 feet by dropping a section of pipe by approximately one pipe diameter (see Figure 1.3). Feedpipes leading to the remaining steam generators were not altered. An extensive test program was carried out to verify the adequacy of the new piping geometry and operational procedures. The test program ultimately required four months to complete.

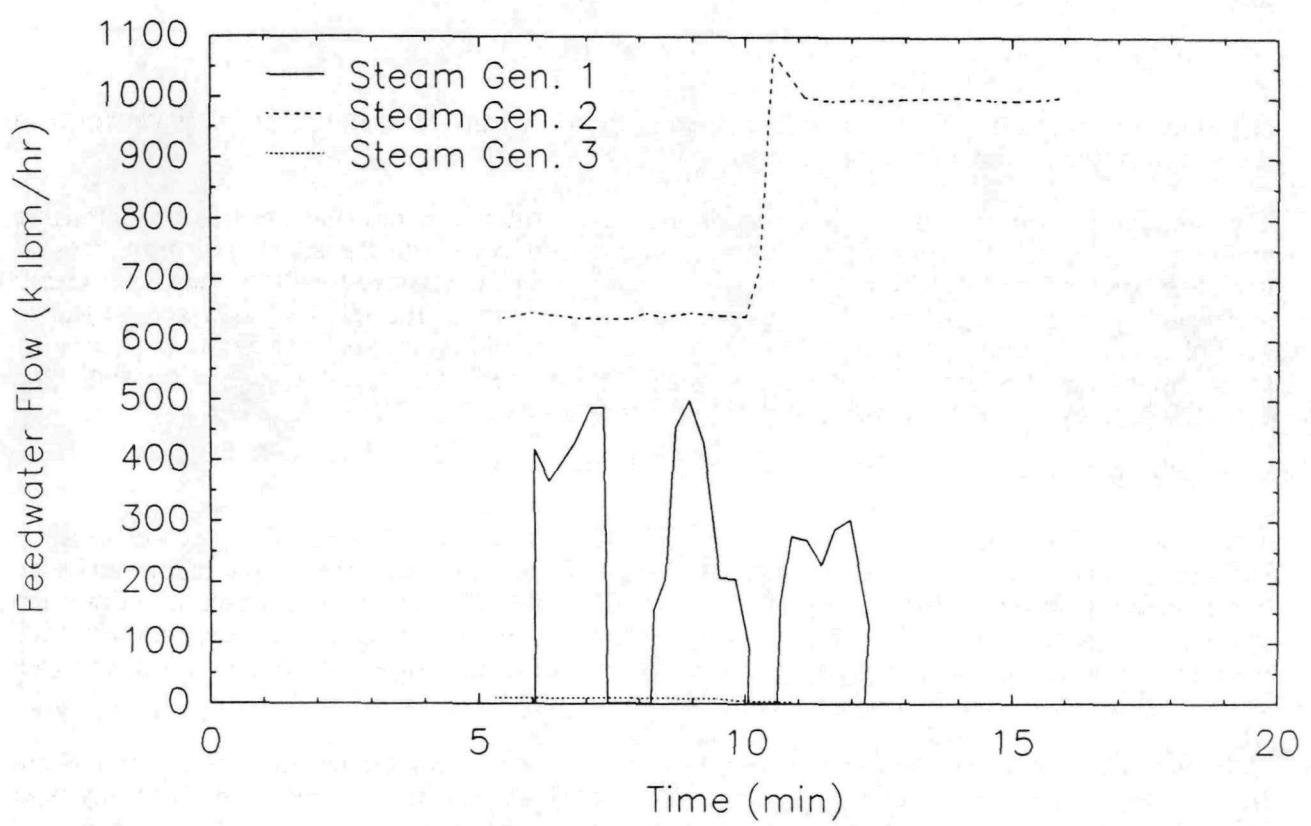
Figure 1.11 RECORD OF FEEDWATER FLOW

Data is available from the feedwater flow sensors and is presented in Figure 1.11. However, the flow sensors are intended to indicate normal feedwater flow and are grossly inaccurate at the small flowrates provided by the AFW system. However, auxiliary feedwater flow is controlled automatically following a feedwater trip. The three loops are thus automatically supplied with 420 gpm of auxiliary feedwater. If this flow splits uniformly, each steam generator received 140 gpm. This flow rate and its distribution are imprecise and can be altered by manual control. Unfortunately, there is no known record of operator actions in this instance.

The feedwater flow data, though inaccurate, does have one significant feature. The flow reading from the #2 feedpipe has a large fluctuation soon after the water level in steam generator #2 fell below the feedpipe. This spike may indicate the occurrence of the first subcooled water slug impact.

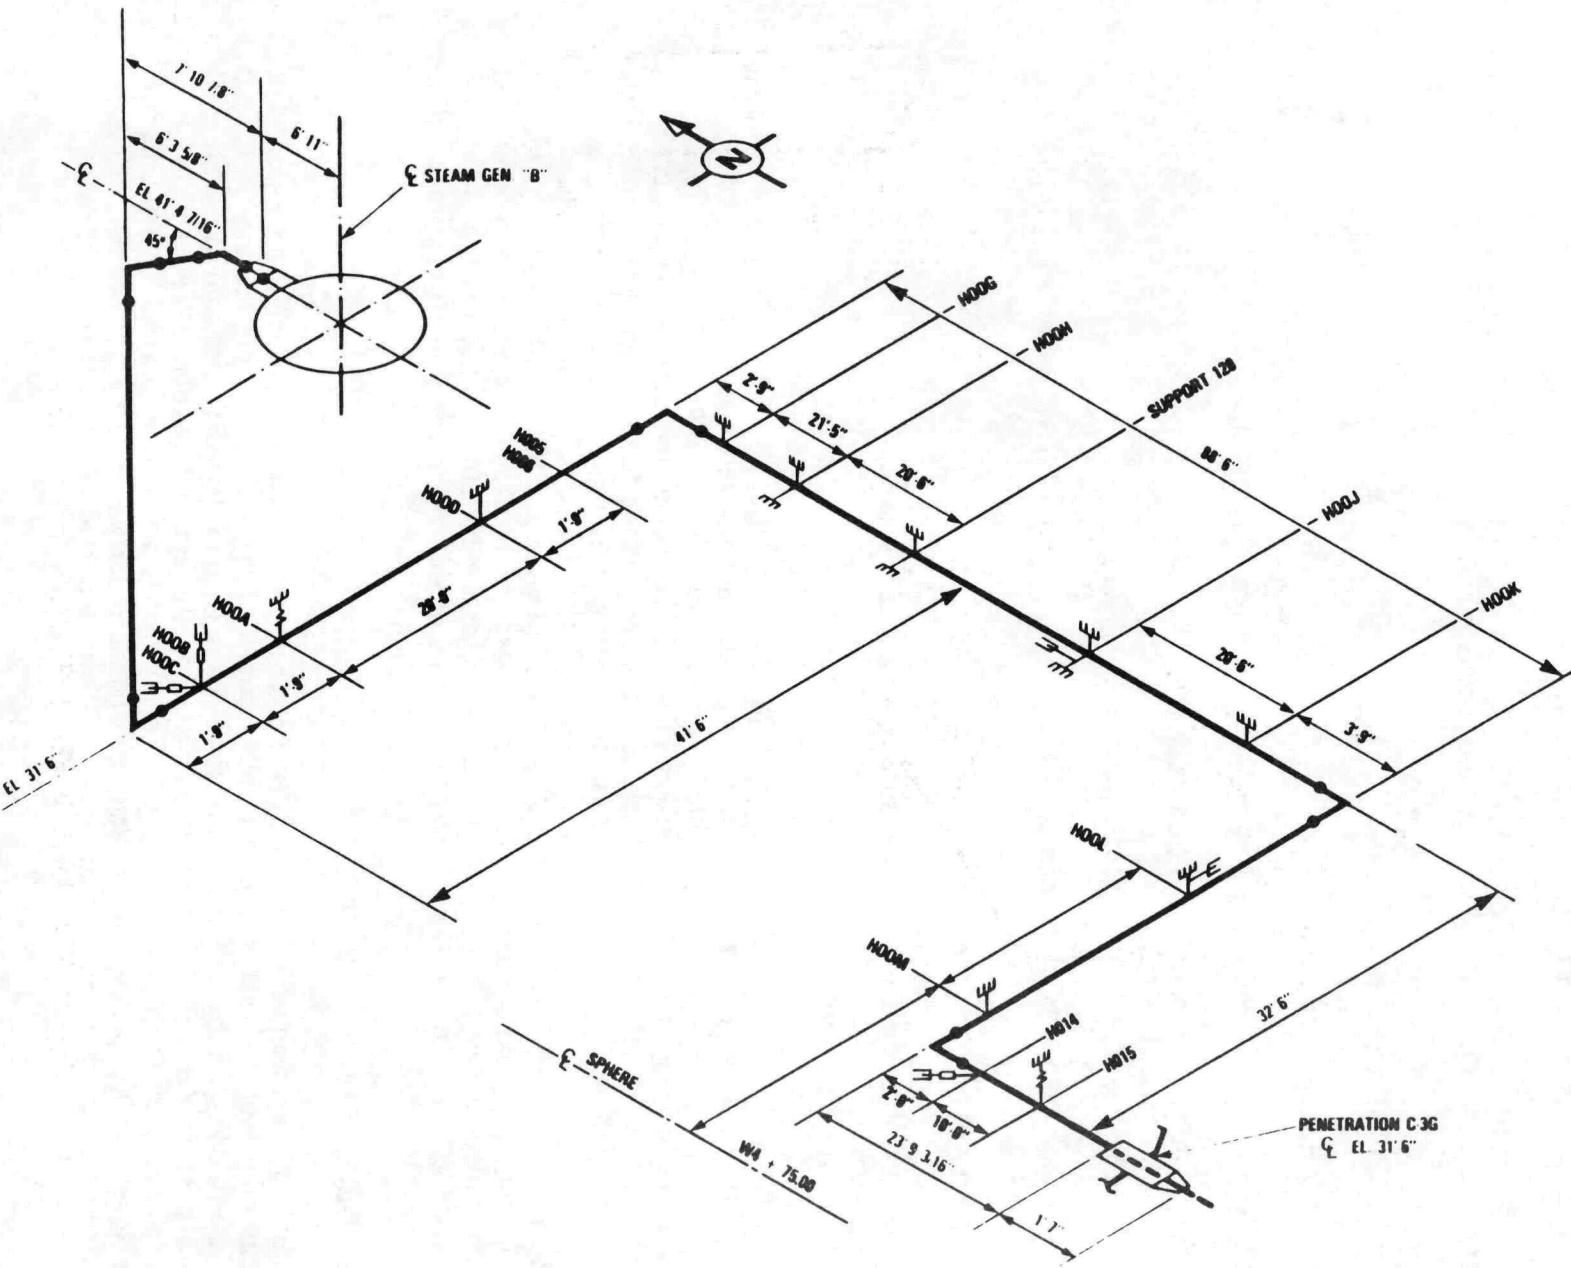
Figure 2.1 FEEDWATER LOOP B PIPING AND SUPPORT LAYOUT

The loop B feedwater pipe was severely damaged in two locations. The northeast elbow (see Figure 2.1) was dented on the inside and slightly bulged, indicating plastic yielding. An axial crack roughly 80 inches long was found near support H00K, as shown in Figure 2.3. The crack penetrates 25% of the pipe wall on average, extending to 30% at its deepest point. The entire 10-inch line was displaced up to several feet both vertically and horizontally, as shown in Figures 2.4 and 2.5. (These Figures are the results of detailed post-event surveys.)

Preliminary considerations regarding the event center are discussed referring again to Figure 2.1, which shows loop B inside containment and the locations of the most severe damage.

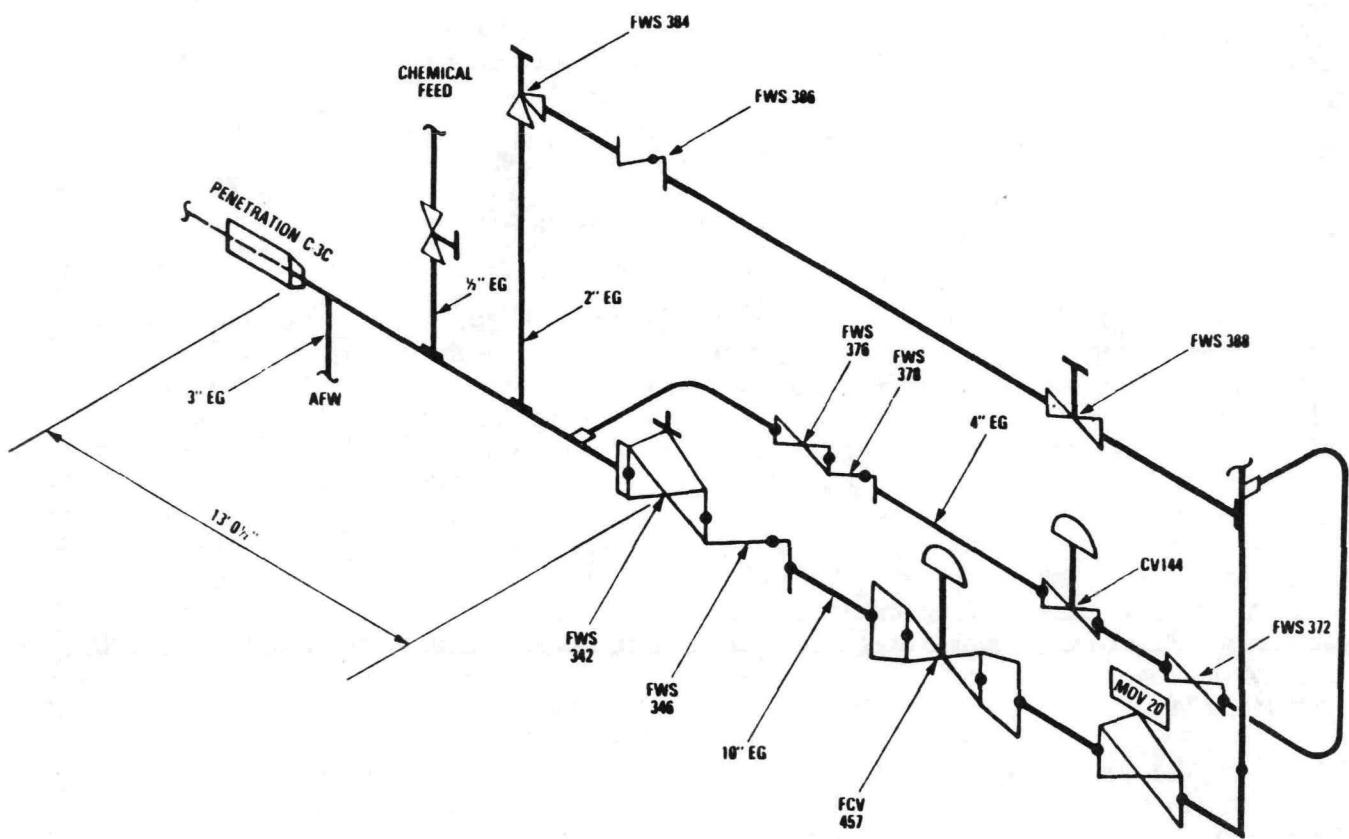
Figure 2.2 LOOP B FEEDWATER CONTROL STATION

The loop B flow control station is located outside the containment building. Several valves were damaged by the waterhammer, including check valve FWS-378 and flow control valve FCV-457 (see Figure 2.2).

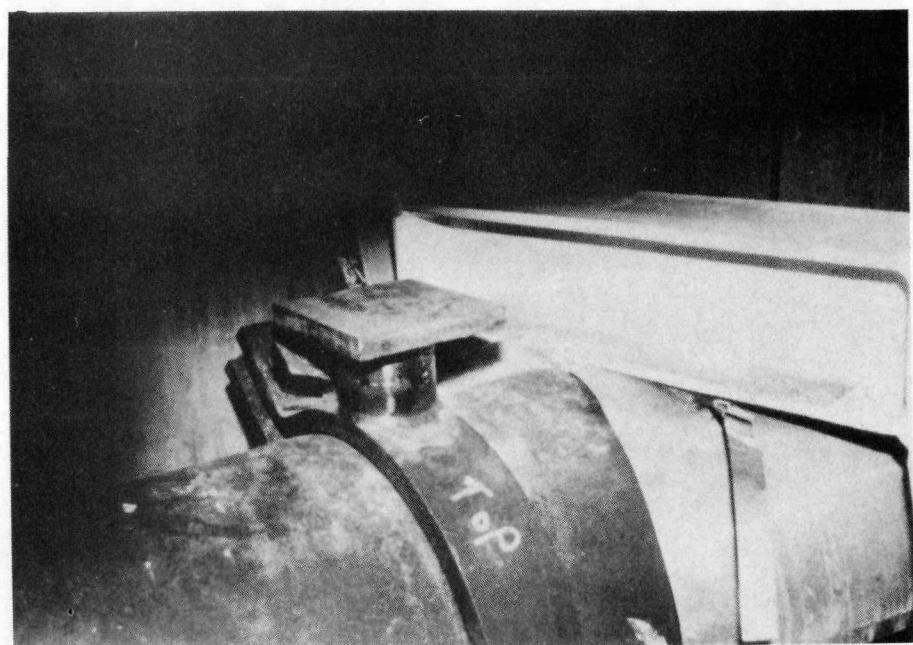
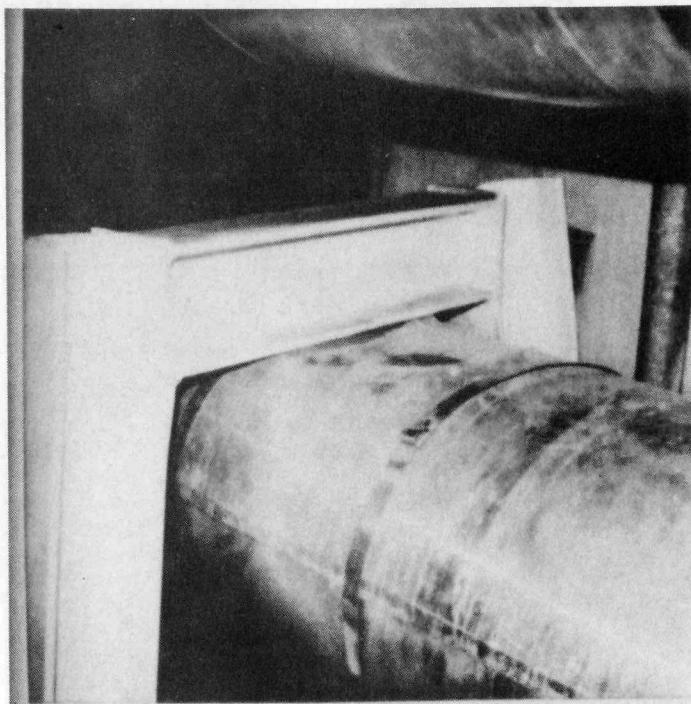
Figure 2.10 SUPPORT HOOK

Damage to piping supports along this line was also severe in some instances. The locations of loop B piping supports inside containment are illustrated in Figure 2.1. Table 2.2 describes some of the damage, and Figures 2.6 through 2.13 are photographs of the various support stations taken soon after the event. Figure 2.14 shows the loop B containment penetration viewed from outside containment. Note the concrete surrounding the penetration is cracked due to excessive force from the pipe.

SI-01-0392-H-00K
LOOKING SOUTH-WEST

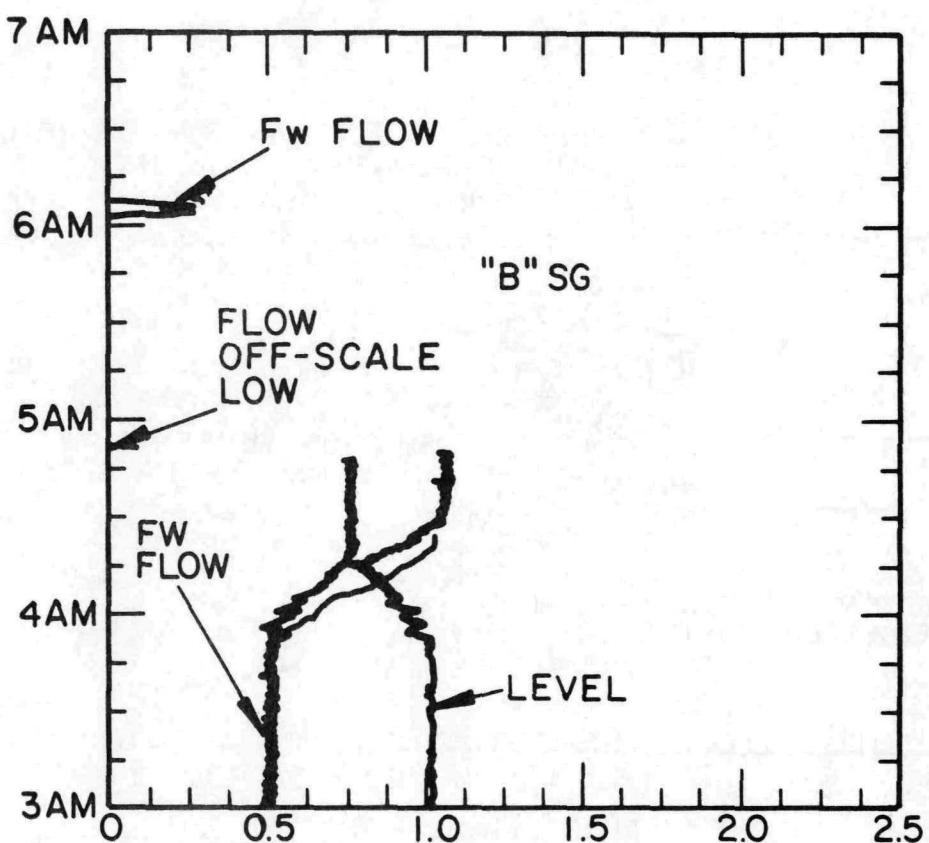
Figure 2.22 RECORDS OF FEEDWATER FLOW IN LOOP B

The record of the flow rate in feedwater loop B is presented in Figure 2.22. Flow is measured just upstream of the loop B flow control station. Prior to the event, the strip chart shows increasing flow from 4:00 up to the event in response to a planned rise in reactor power. The record drops to zero during the loss of power, but remains low and offscale even after ac power is restored. This is as expected, since at this point the feedline was isolated.

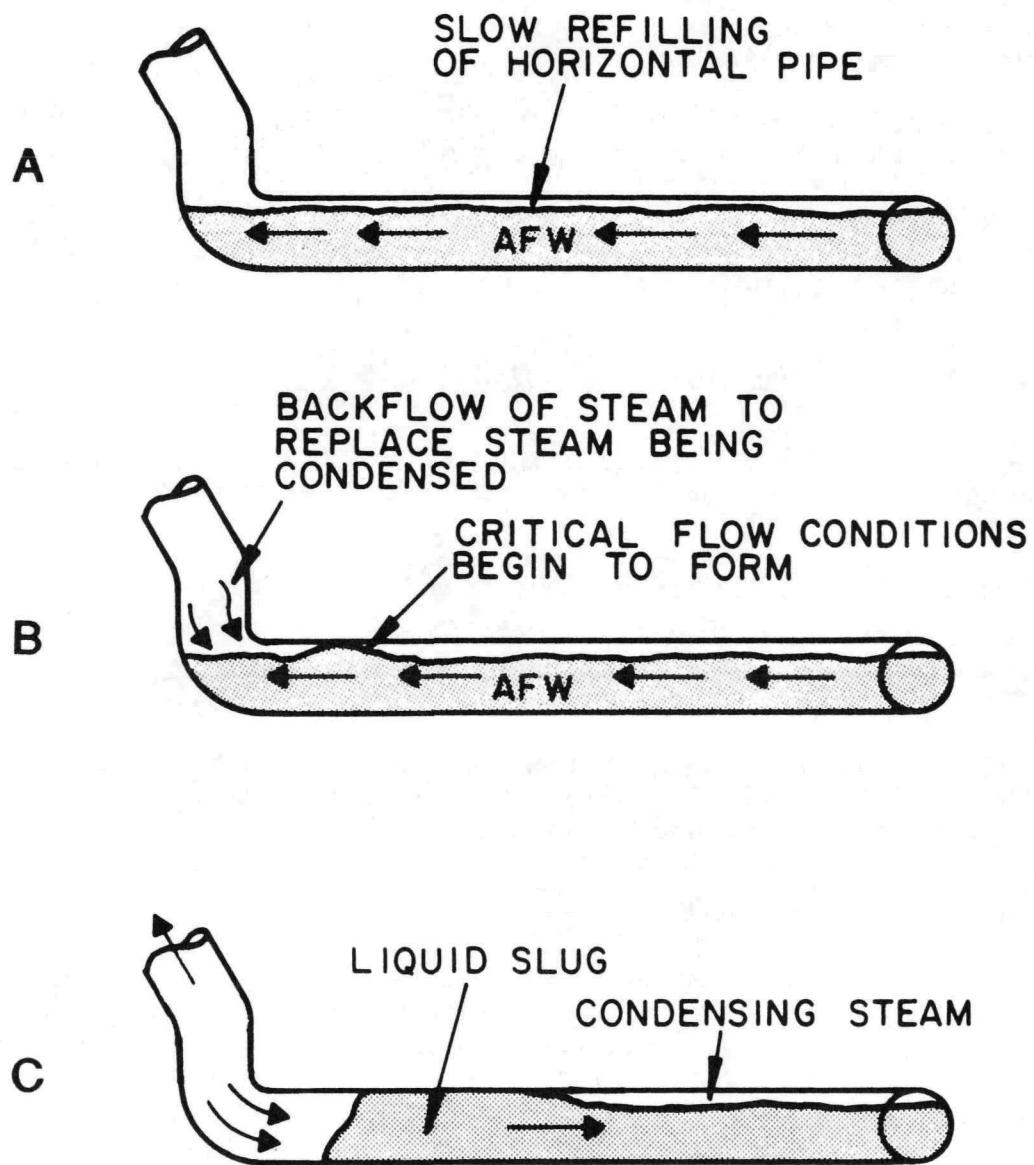
Figure 2.24 REFILLING OF LOOP B LEADING TO WATERHAMMER

This situation is illustrated schematically in Figure 2.24. Segment A shows a portion of the feedline isolated on the right and with a source of high pressure steam on the left. Cold AFW is injected at a low rate into the line near the isolated end, condensing steam and causing more steam to flow into the line. As more cool water enters the feedline, the rate of steam condensation increases because the surface area of cold water has increased. When the pipe is nearly full of water (segment B), rapidly condensing steam flows at a high rate over the free surface. Waves are generated which contact the upper surface of the pipe, isolate a pocket of steam, and are the nucleus of a liquid slug.

The event scenario now proceeds just as in the previous case study. A liquid slug has trapped a pocket of hot steam which rapidly condenses and reduces the pressure in the pocket. The slug is accelerated into the low pressure void by the 725 psig steam acting on its other face. This is illustrated in segment C of Figure 2.24.

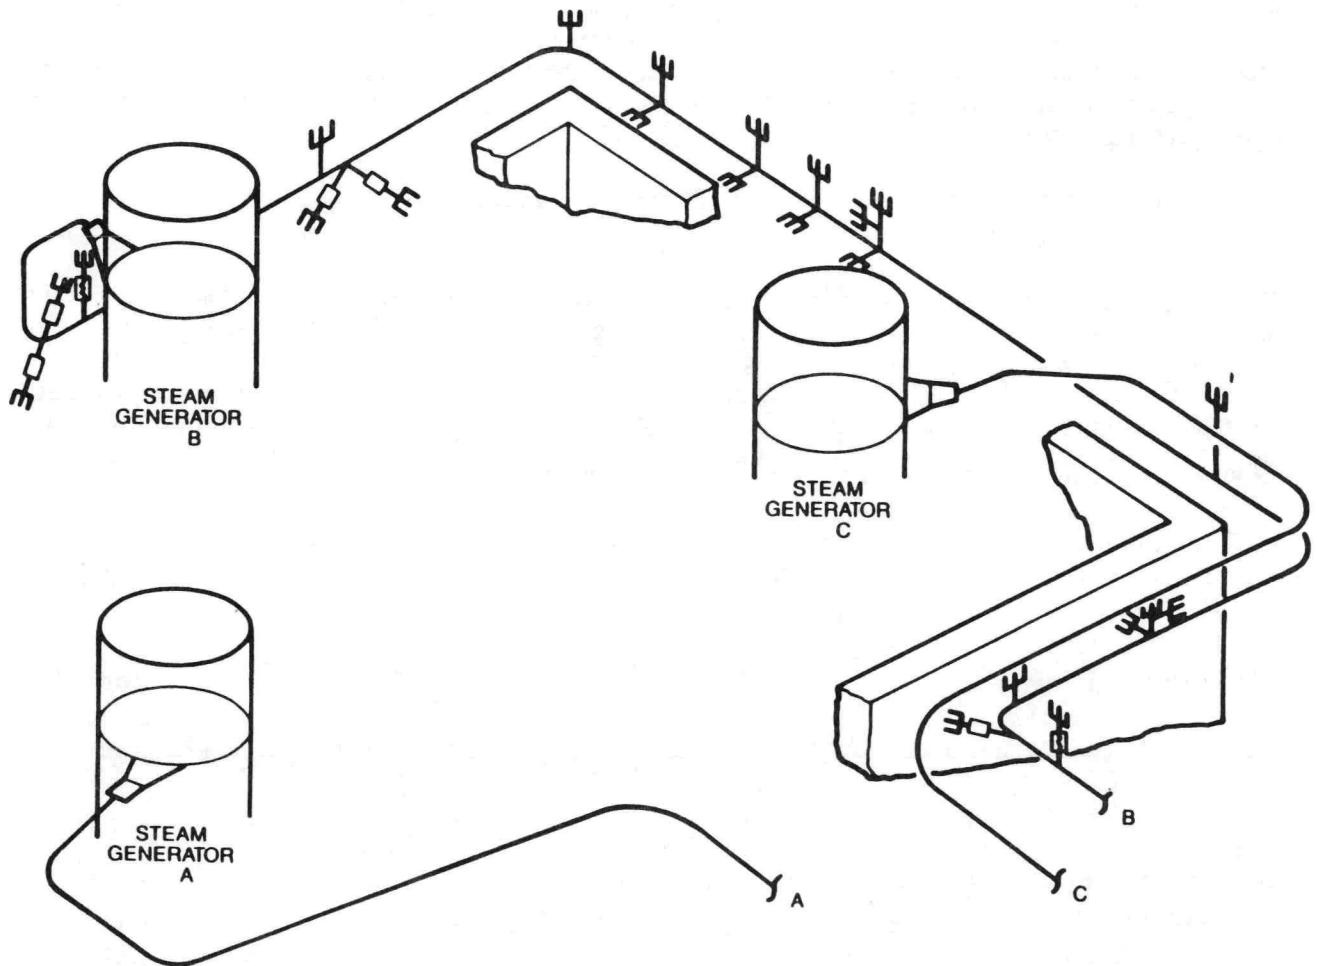
Figure 2.25 FEEDWATER LOOPS A, B AND C

A rough isometric showing all three feedwater lines is presented in Figure 2.25. Loops A and C are each about 125 feet long, which is significantly shorter than loop B. At the time of the waterhammer, they would already have been filled up to their respective steam generators.

This is a partial explanation why no waterhammer occurred in these two loops; it is still not clear why a waterhammer could not have occurred in these pipes before they were completely filled.

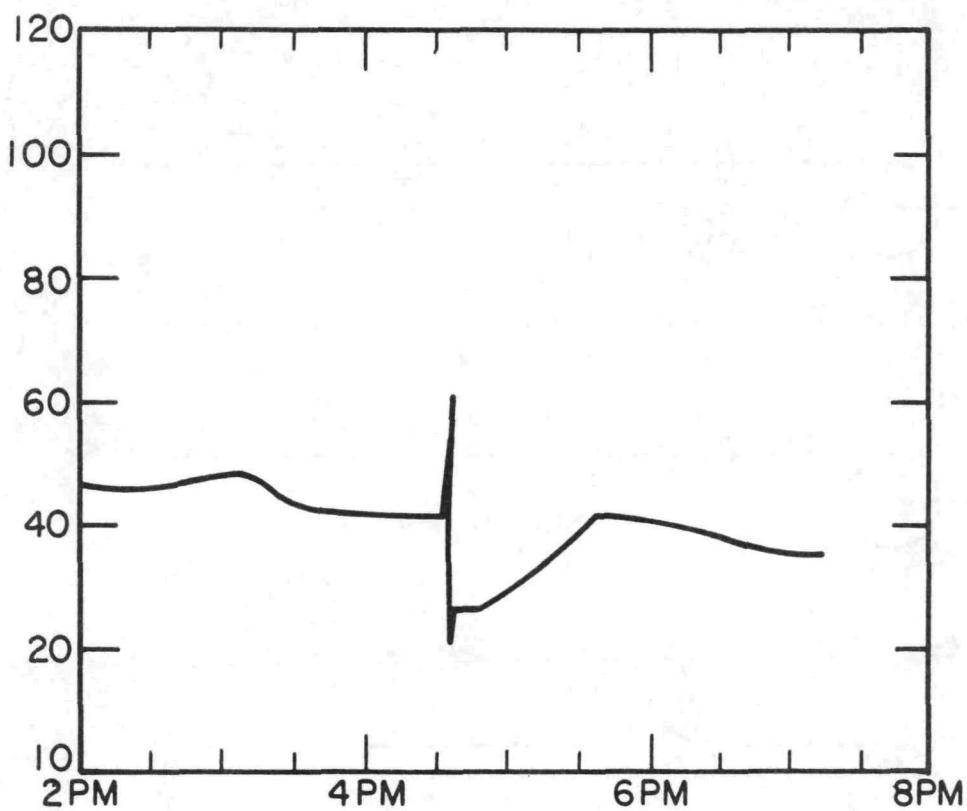
Figure 3.3 RECORD OF STEAM GENERATOR WATER LEVEL

The valve lineup during the event suggests that there was no net flow through the feedline. However, records of the steam generator water level indicate that this could not have been the case. A strip chart showing the steam generator water level from around the time of the event is shown in Figure 3.3. There are two notable features of the water level record. First, the level shows a very sharp spike immediately following the opening of the BF19 valve. Following the spike there is a more gradual (about 20 seconds long) decrease in water level.

The sharp rise in steam generator water level is due to level swell which occurs upon depressurization. The steam generator depressurized when the BF19 valve was opened, so there must have been a direct fluid path from BF19 to SG#3. This could only happen if the BF22 check valve failed (recall that the motor-operator was not used to actively shut the valve).

The gradual decrease in water level following the level swell indicates a flow of liquid from the steam generator into the feedpipe. This decrease in inventory is further evidence for check valve failure.

The flowrate in the feedline during the steam generator blowdown can be estimated from the decrease in steam generator water level. Discounting the initial level swell, the steam generator level indicated in Figure 3.3 dropped from 41% to 26% of the narrow (12 foot) level range during the event. This represents about 210 ft³ of water drained from the steam generator (this number is determined from a vendor-supplied curve showing steam generator volume vs. level). The flow period lasted from 20 to 30 seconds, implying a flowrate between 7 and 10.5 ft³/s (3,100 to 4,700 gpm).

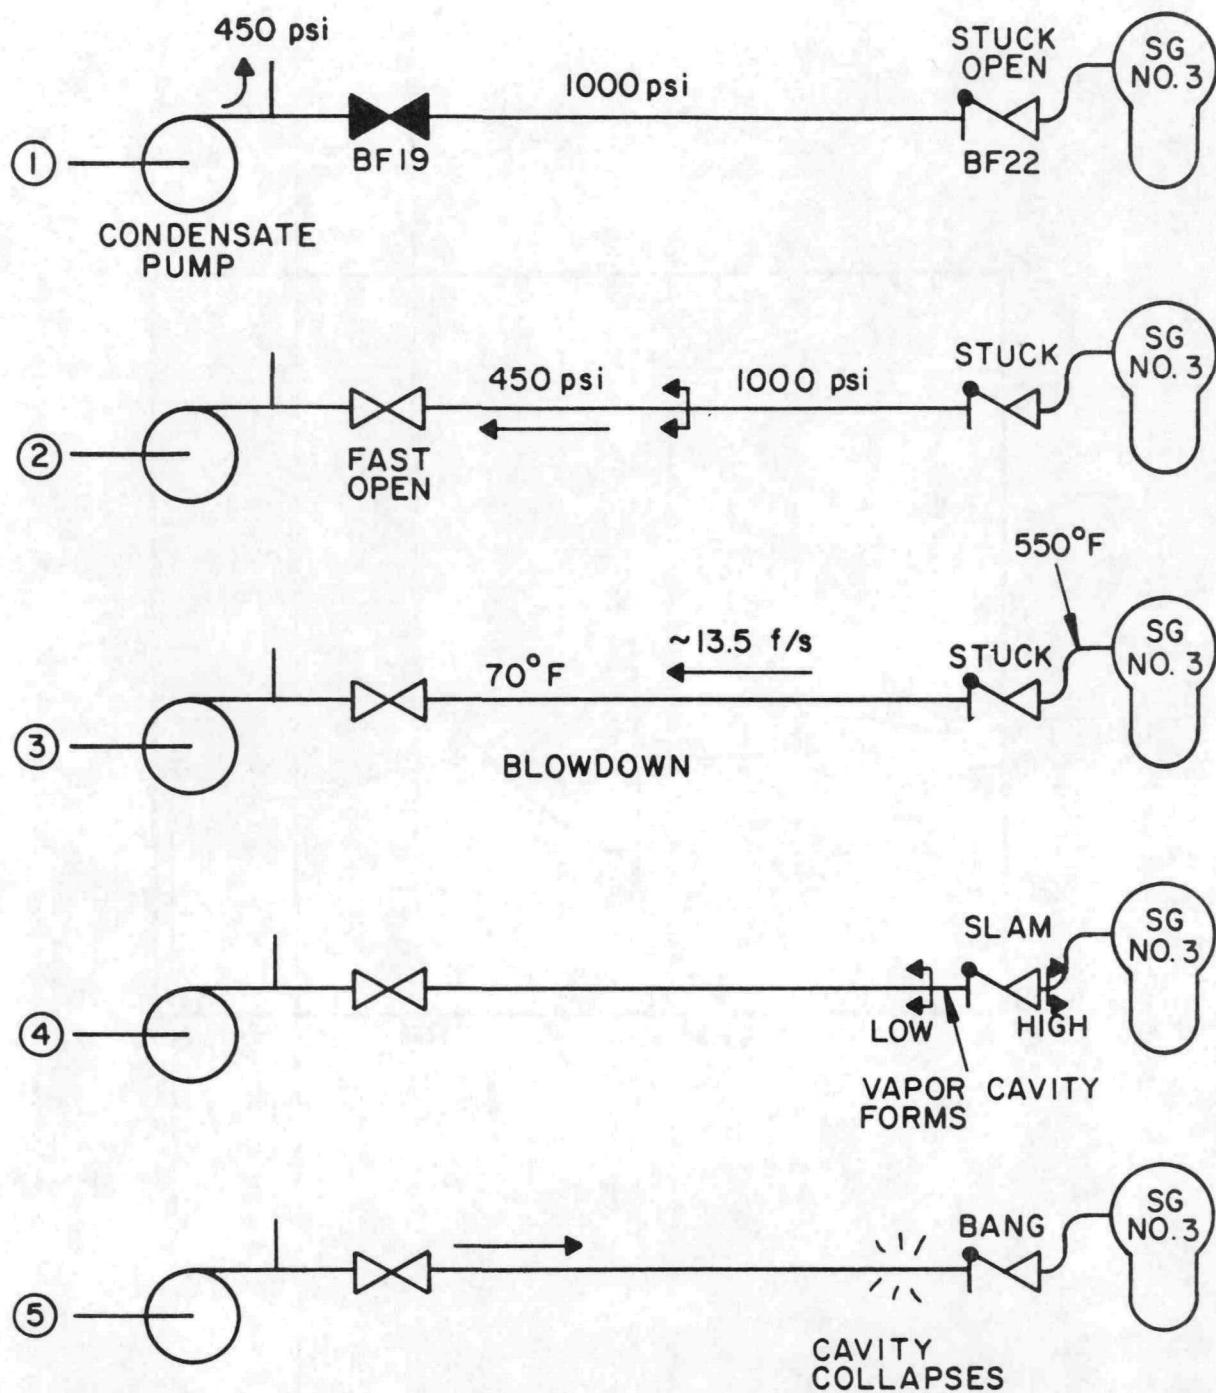
Figure 3.4 EVENT SCENARIO FOR VOID COLLAPSE IN THE FEEDWATER SYSTEM

The BF22 stop/check valve was stuck open due to loose debris in the valve seat, as illustrated in section 1 of Figure 3.4. As a result, the initial pressure in the #3 feedline from the BF19 feedwater control valve to the steam generator was roughly 1,000 psi. The BF19 valve was opened for testing under these unusual circumstances. Normally the pressure difference across the valve is small and acts in the direction of normal feedwater flow. In this case, however, a large differential pressure (probably over 500 psi) acted on the valve opposite to the normal flow direction. As a result, the valve actuator controls acted to very suddenly open the valve completely.

In response to the sudden valve opening, a depressurization wave was initiated in the feedline which travelled upstream to SG#3 (section 2, Figure 3.4). The depressurization wave eventually reached the steam generator and caused the level swell indicated in the strip chart. At this point water began to flow from the steam generator through the #3 feedline back to the condenser, illustrated in section 3 of Figure 3.4.

Flow from the steam generator stopped when the BF22 stop/check valve closed. It is speculated that a high flow rate of water back through the stuck valve eventually dislodged the debris which prevented it from closing (section 4, Figure 3.4). The check valve slammed shut and prevented further flow in the feedline.

The pumped water column eventually condenses the entire vapor cavity and strikes the condenser-side of the BF22 stop/check valve, as shown in Section 5 of Figure 3.4.

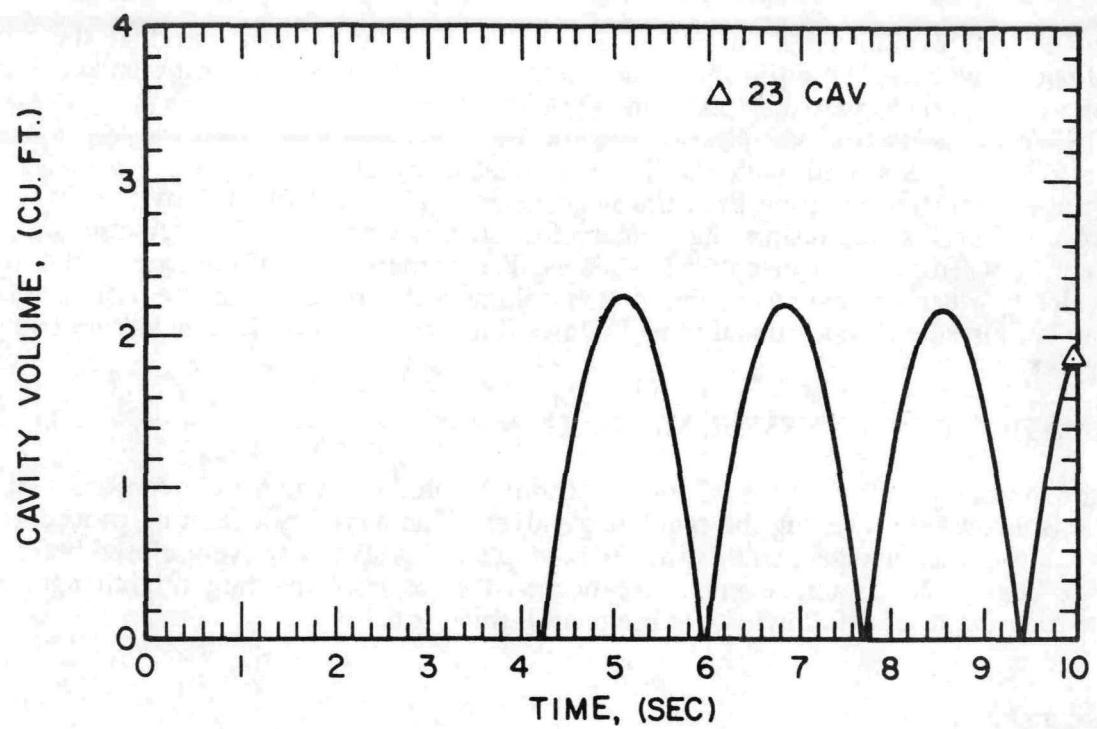
Figure 3.6 CALCULATED CAVITY VOLUME UPSTREAM OF THE BF22 STOP/CHECK VALVE

Some of the major results of the analysis are presented in Figures 3.6 and 3.7. The vapor cavity volume on the condenser side of the BF22 stop/check valve (node 23E) is shown in Figure 3.6 as a function of time. (In the simulation the steady blowdown from the steam generator was modeled for only a few seconds; the BF22 valve closes abruptly at $t = 4$ s in the Figure). The calculated cavity reached a maximum of about 2 ft³ approximately 1 second after the check valve slammed shut. The cavity then collapsed and generated a pressure spike

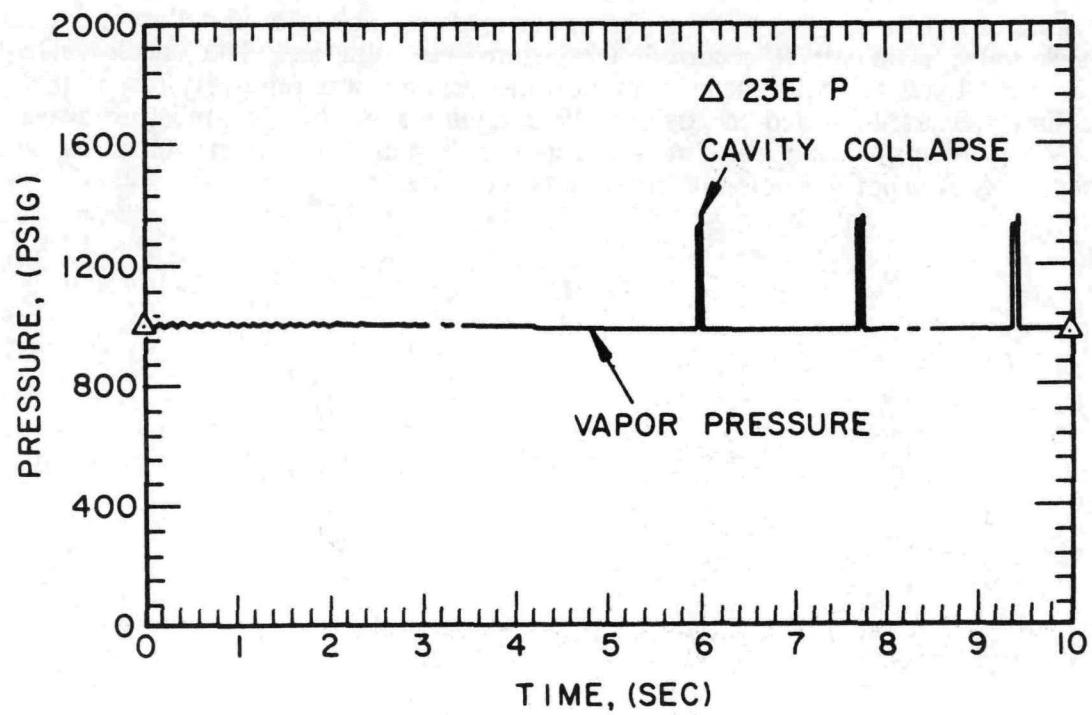
Figure 3.7 CALCULATED WATERHAMMER PRESSURE DUE TO CAVITY COLLAPSE

of about 400 psi, as illustrated in Figure 3.7. The calculation indicates that the cavity oscillated due to wave reflection in the feedline, generating a series of pressure spikes. Axial piping forces due to these pressure spikes are 62,000 lb_f.

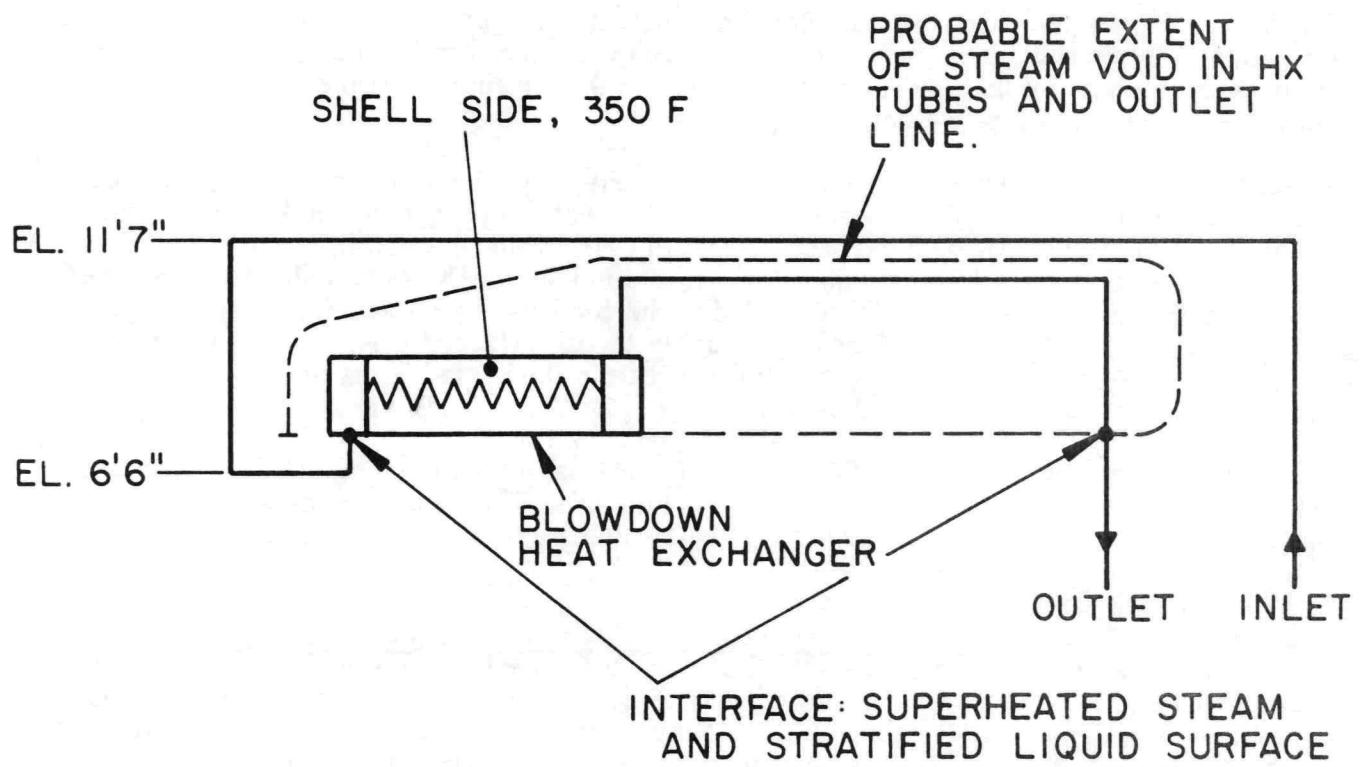
Figure 4.4 VOID FORMATION IN THE BLOWDOWN HEAT EXCHANGER

As the condensate from the inlet line is accelerated, the hot interface which bordered the steam void is disrupted. Rapid condensation occurs on the cool condensate from the inlet line. The steam provides little cushioning effect, and the slug acceleration and impact is governed primarily by the pump startup dynamics.

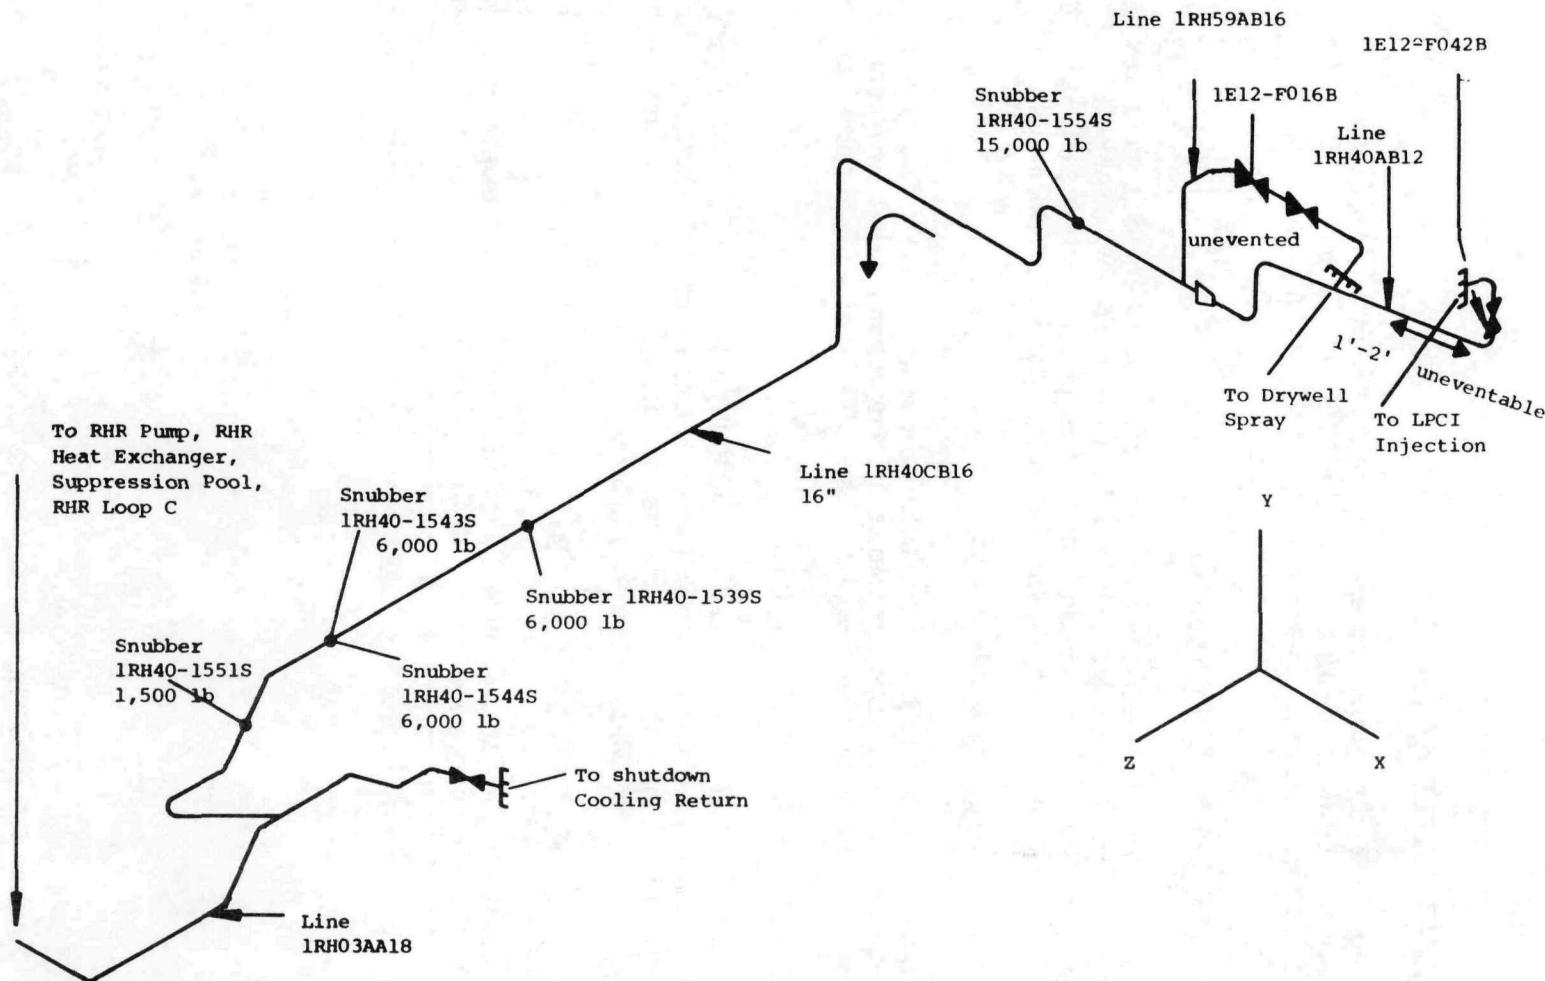
Figure 5.5 PARTIAL ISOMETRIC OF SUBSYSTEM 1RH-08

Some of the snubber damage reports which indicate severe internal damage are presented in Table 5.1. (The snubber components described in the damage reports are illustrated in Fig. 5.4.) The locations of the severely damaged snubbers are indicated on piping isometric diagrams in Figures 5.5 and 5.6. Following the snubber inspections, piping in the adjacent RHR subsystems was inspected but no further damage was found.

The RHR system has several stretches of horizontal pipe, some of which are shown in Figures 5.5 and 5.6. However, a subcooled water slug event in one of these pipes is unlikely for several reasons. First, such an event requires a steam reservoir which is unavailable in the RHR system. Second, subcooled water slug events are typically of very large magnitude. It is unlikely that such an event would not have been noticed at the time it occurred. Finally, the snubber damage is distributed over a large part of the RHR system. The maximum damage from a subcooled water slug event is typically greater than this and is found in fewer locations (for example, see Chapter 1).

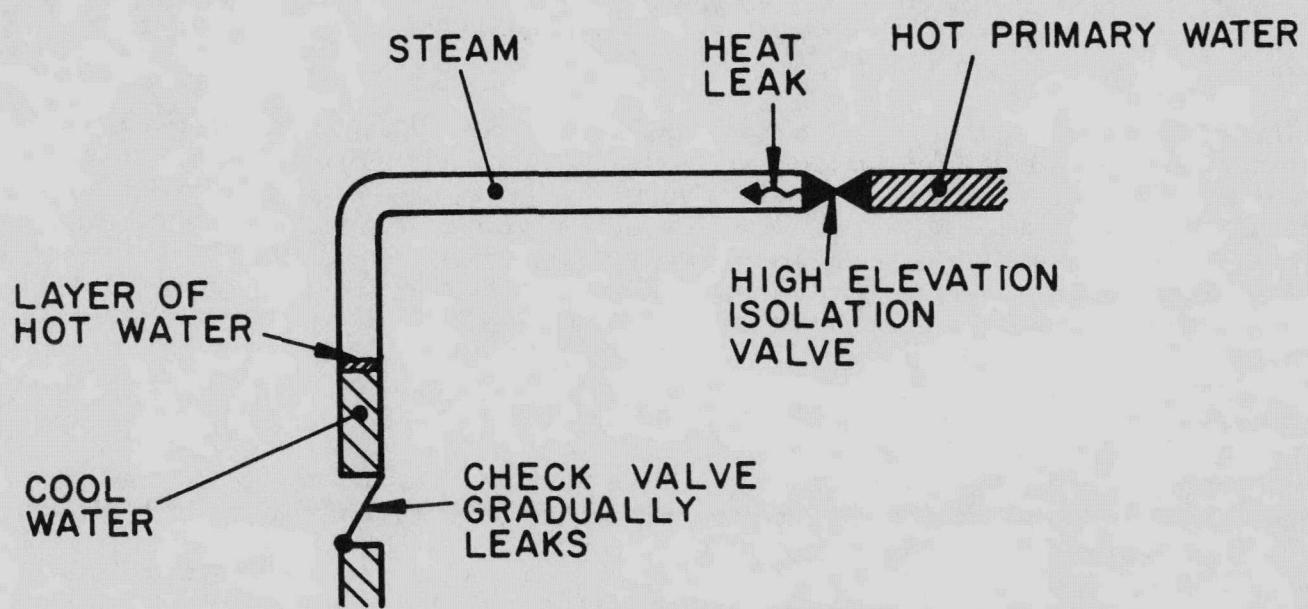
Figure 5.7 EVENT CENTER IN UPPER ELEVATIONS OF THE RHR SYSTEM

High points in the RHR system are a more likely event center. Possible mechanisms are illustrated in Figure 5.7. Drain down from high elevations is a common method of void formation. Under the proper conditions, heat leakage across the isolation valves from the primary system is another potential voiding mechanism. Furthermore, these mechanisms could form several voids in the various high elevation, isolated subsystems. This could explain the low intensity and distributed nature of the damage.

It has already been shown that a steam void could have formed in the upper elevations of the RHR system. Possible mechanisms are heat leakage across the isolation valves from the primary system, or depressurization and drain down due to failure of the keep full system. These mechanisms may have acted simultaneously.
