USGS - OFR - 97-129
DE-F602-93ER/436

Ground Fracturing at the Southern End of Summit Ridge Caused by October 17, 1989 Loma Prieta, California, Earthquake Sequence

(Maps of Summit Ridge Shear Zones, en echelon tension cracks, complex and compound fractures, and small faults that formed coactively with the earthquake sequence)

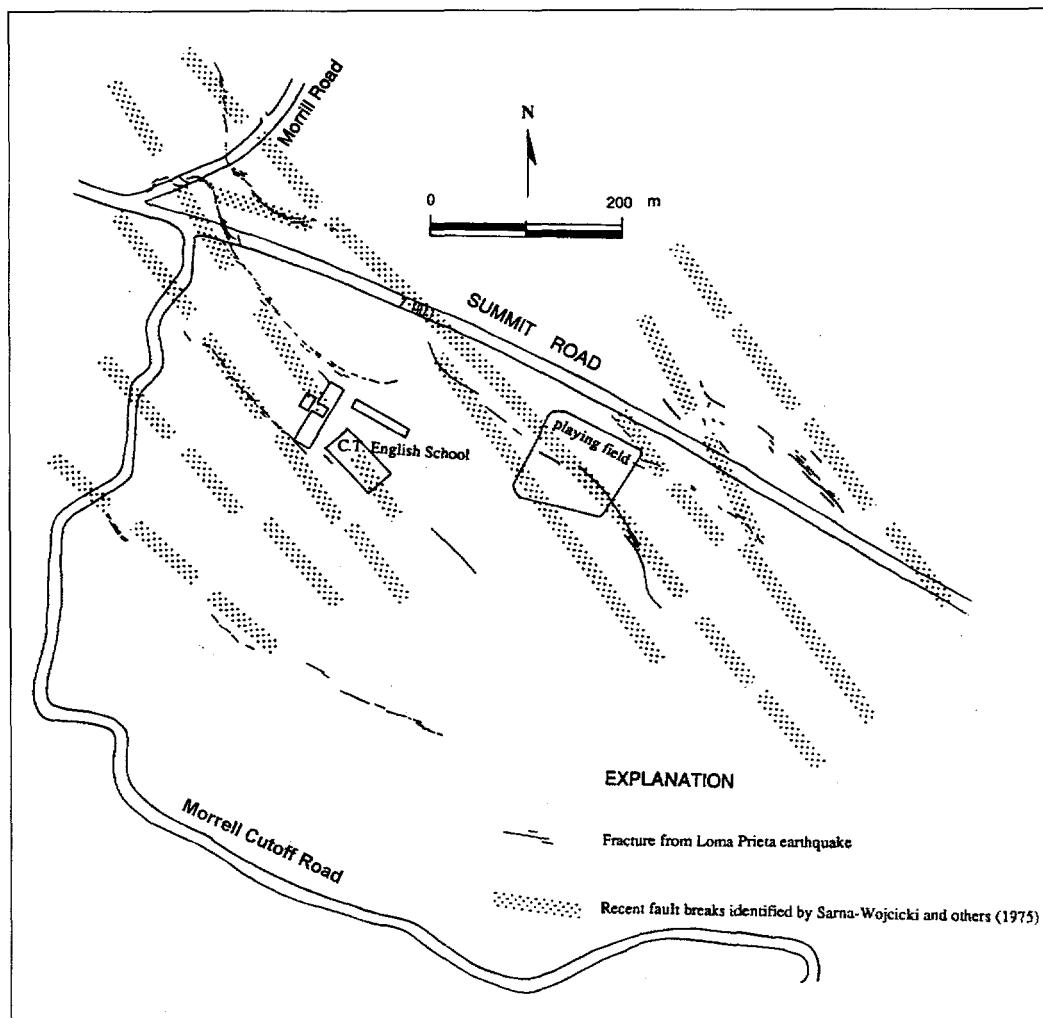
If we exclude from consideration the fracture zones in the Christmas tree farm area that are arcuate or in other ways appear to be associated with parts of old landslide masses, the remaining fractures shown are closely associated both in position and orientation with distinctive topographic forms. These forms include plunging troughs, or elongated depressions with axes that trend obliquely to the axis of Summit Ridge. Figure 12 shows that the orientations and positions of fracture zones in the southeast end of Summit Ridge are essentially coincident with the lineations mapped by Sarna-Wojcicki and others (1975). Except for one lineation on the hillside about 75 m southwest of the C.T. English School, all the troughs contain coseismic fractures.

The correlation between the elongated depressions or plunging troughs and the co-seismic fracture zones in the Christmas tree farm area (Plate 1) is so strong that, when we mapped the tree farm around the C.T. English School area, we anticipated finding each fracture zone. As we walked between the trees and spotted a plunging trough ahead, we would anticipate finding a fracture zone not in the axis of the trough, but on the southwest flank of the trough. The fracture zones typically were where we expected them to be. We found the two fracture zones bounding the C.T. English School buildings on the northeast and southwest sides, as well as the short fracture zone about 75 m southeast of the larger building of the C.T. English School, in this position relative to the troughs plunging. We found a fracture zone defined by only a few aligned cracks on the southwest flank of the trough

Figure 12.
Comparison of synoptic map of traces of fracture zones (narrow lines) apparently unrelated to differential movement of landslide masses in the Christmas tree farm area (mapped in 1990 after the Loma Prieta earthquake) and enlargement of map of lineaments (broad, dotted dashes) mapped by Sarna-Wojcicki and others (1975), based on a field and photogrammetric study of fault-related topographic features along the San Andreas fault zone.

immediately adjacent to Summit Road, about 60 m southwest of Loma Prieta School (Plate 1) only because we expected a fracture zone in that location and persisted in criss-crossing the grass- and tree-covered hillslope, looking for cracks in the grass. Thus we are impressed with the correlation between the positions and orientations of the fracture zones with plunging troughs.
