SAND98-1016
Unlimited Release
Printed August 1998

Damage Tolerance Assessment of Bonded Composite Doubler Repairs for Commercial Aircraft Applications

Dennis Roach

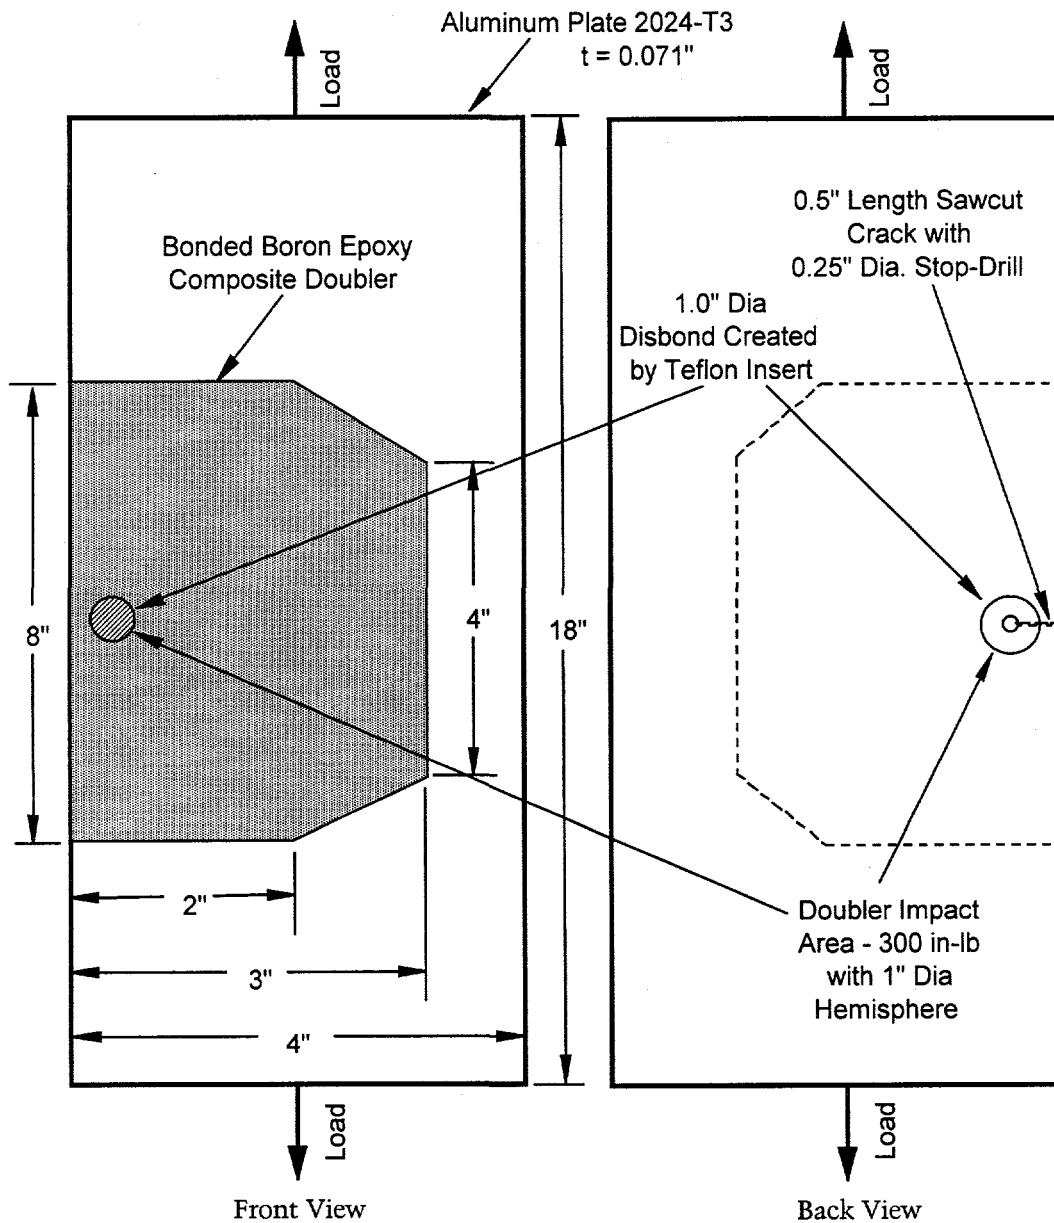
8. BE-8: Stop-drilled, 0.5" sawcut edge crack in the aluminum plate with collocated 300 in-lb impact damage from a 1" diameter hemispherical tip; collocated 1" diameter disbond; 160°F hot-wet conditioning (Figure 14).

Figure 14: Composite Tension Test Coupon - Configuration BE-8

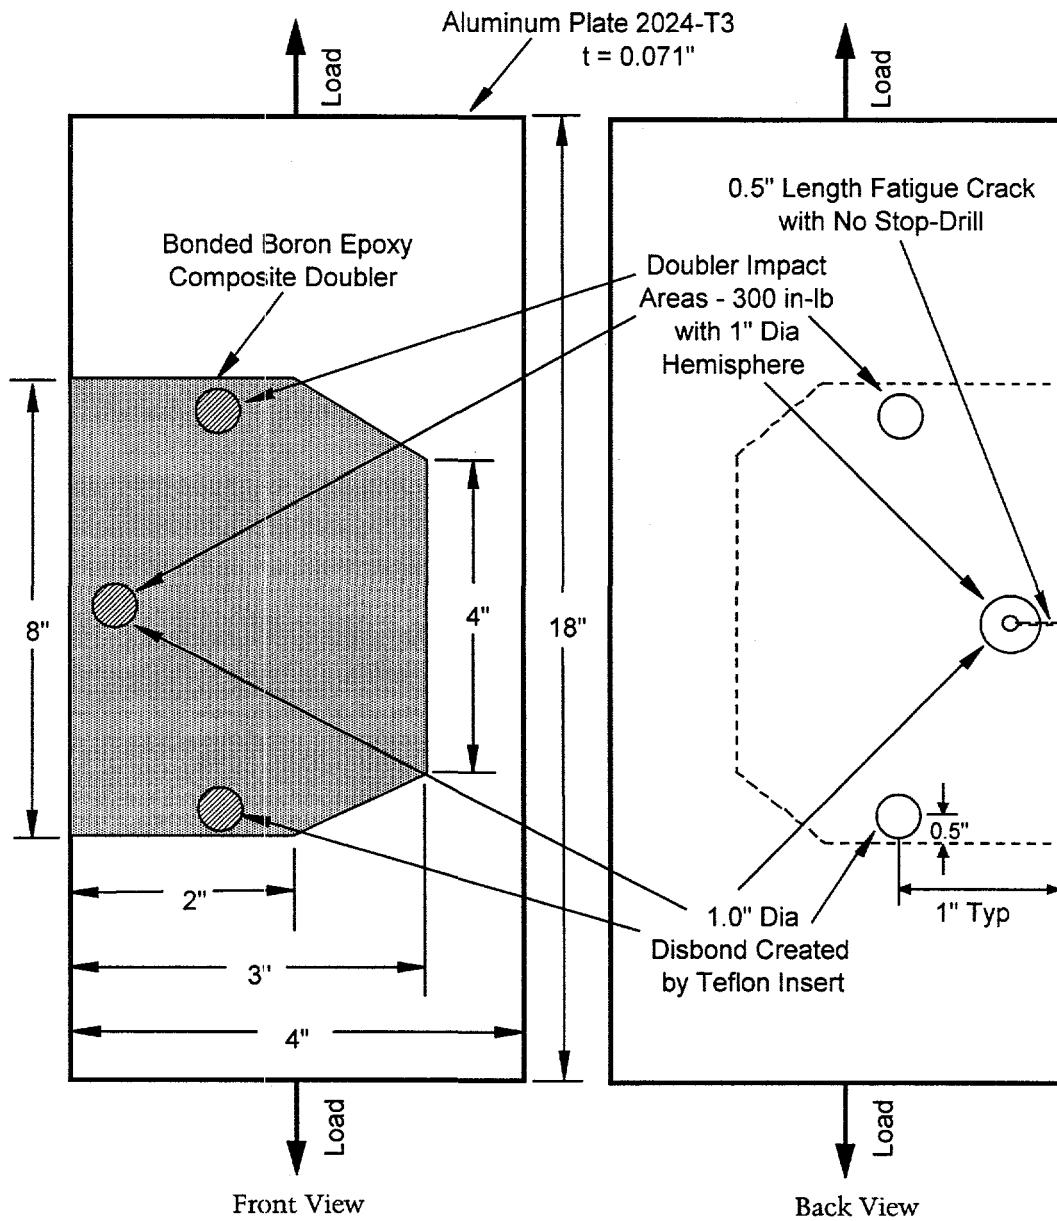
9. BE-9: Unabated 0.5" fatigue crack at the edge of the aluminum plate with collocated 300 in-lb impact damage from a 1" diameter hemispherical tip; similar impact damage along doubler edge; collocated 1" diameter disbonds at both impact locations; 160°F hot-wet conditioning (Figure 15).

Figure 15: Composite Tension Test Coupon - Configuration BE-9

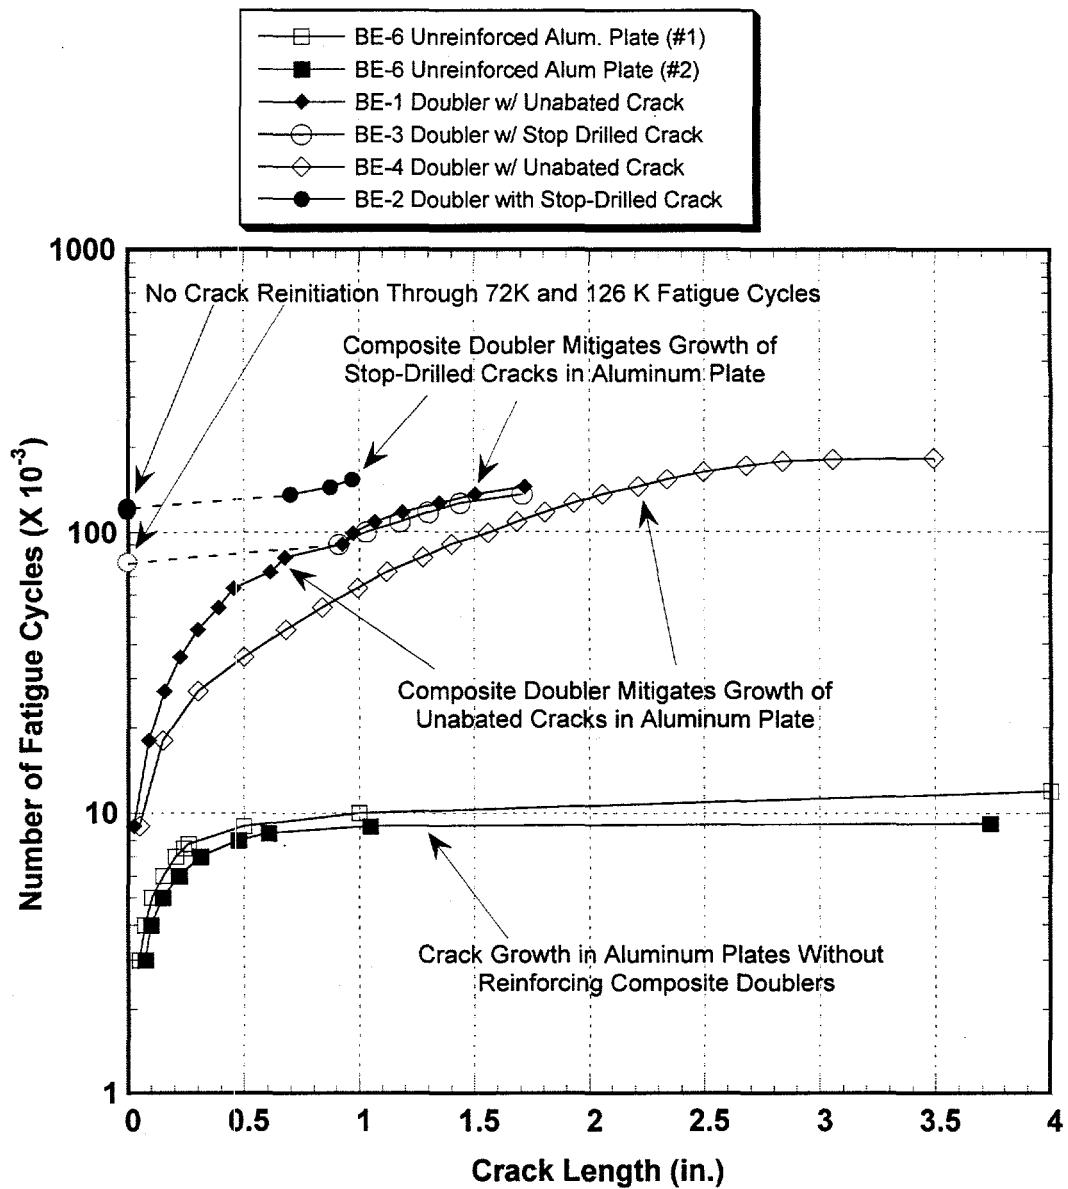
- a. Disbond and Crack Flaws - Note the delay in crack reinitiation until 72,000 and 126,000 cycles in the Figure 25 BE-2 and BE-3 curves. Because of this initial crack growth arrest, specimens Lock2 (BE-2) and Lock3 (BE-3) experienced total crack growths of less than 1.75" up through 144 K fatigue cycles (four design lifetimes of the L-1011 aircraft).

Figure 25: Fatigue Crack Growth in 2024-T3 Plates With and Without Reinforcing Composite Doublers (Configurations BE-1 through BE-6; Specimens Lock1 through Lock7)

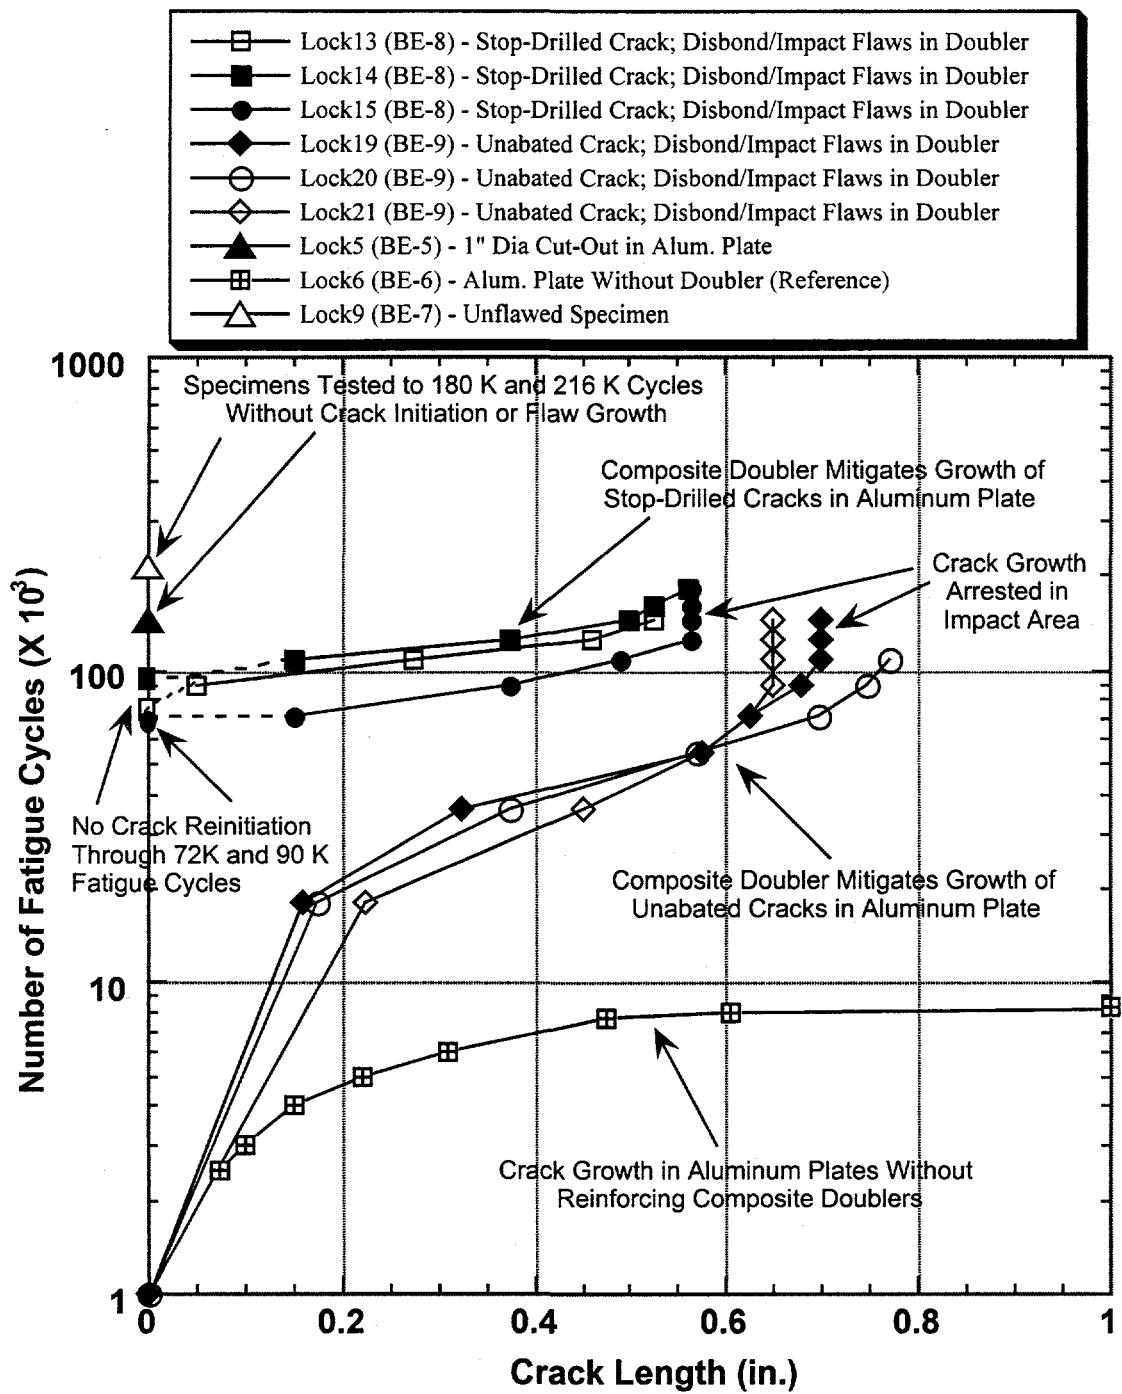
- b. Disbonds and Cracks with Impact Damage and Hot, Wet Conditioning - Figure 26 shows the fatigue crack growth for the unabated crack specimens in the BE-9

configuration. In this configuration, the disbonds noted above were accompanied by collocated impact damage directly over the crack and along the edge of the doubler (see Fig. 15). Prior to testing, the specimens were also subjected to hot, wet conditioning until a 10% (by weight) water absorption was achieved. The impact phenomenon discussed above was also present in configuration BE-9; crack growth was arrested in the impact area. Specimens Lock19 and Lock21 experienced total crack growths of 0.70" or less after 144,000 fatigue cycles. The plots of Lock19 and Lock21 in Fig. 26 show that all of the crack growth occurred during the first 90,000 fatigue cycles after which time the crack growth was halted in the impact area.

After three fatigue lifetimes, the Lock20 specimen experienced crack growth of less than 0.80". Thus, an allowable crack length of 1.0" would still not be present after 108,000, post-installation "flight" cycles. Unfortunately, it appears that this specimen had a small notch (manufacturing or handling defect) in the edge of the aluminum skin. The notch may have acted as an initiator for a crack which formed just outside the upper boundary of the composite doubler footprint. This crack, without the benefit of the doubler reinforcement, grew across the aluminum plate and caused a failure of the test specimen outside of the doubler. As a result, no doubler performance data could be obtained beyond 108,000 fatigue cycles.

Figure 26: Fatigue Crack Growth in 2024-T3 Plates With and Without Reinforcing Composite Doublers
(Configurations BE-6 through BE-9; Spec. Lock6, Lock9, Lock10-12, Lock 16-18)

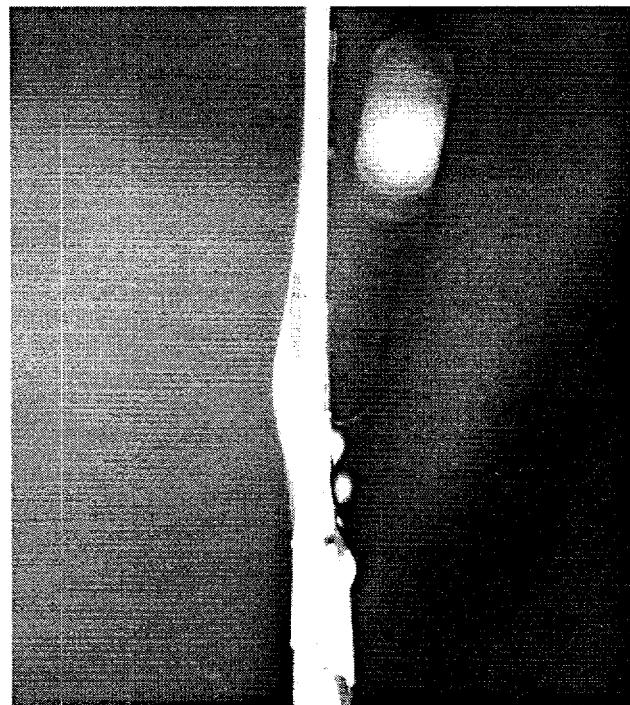
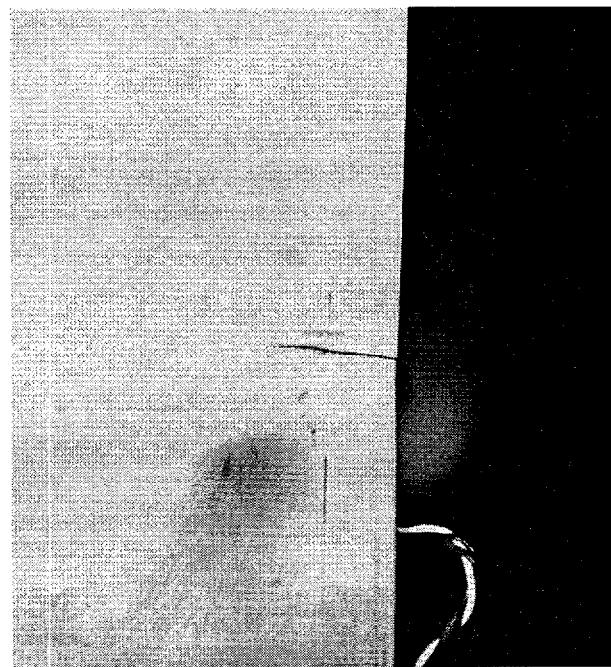
Following the composite doubler installation and prior to environmental conditioning (see section 2.3.4), impact damage was imparted to Specimen Configurations BE-8 and BE-9 (specimens Lock10-Lock21). The locations for impact damage were selected to induce the most adverse effect on crack growth mitigation and/or the ability of the doubler to transfer load. Figures 14 and 15 and drawing AANC-1 (see Appendix A) provide the design, fabrication and inspection details. The impact was performed with a 1 inch diameter steel hemisphere tip. A guide tube, lined with Teflon film or equivalent, was used to direct the path of the impact mass. The specimens were fully supported by plates on the front and back side. The plates had appropriate window cut-outs to apply the impact damage.

Figure 27: Impact Damage on Composite Coupons

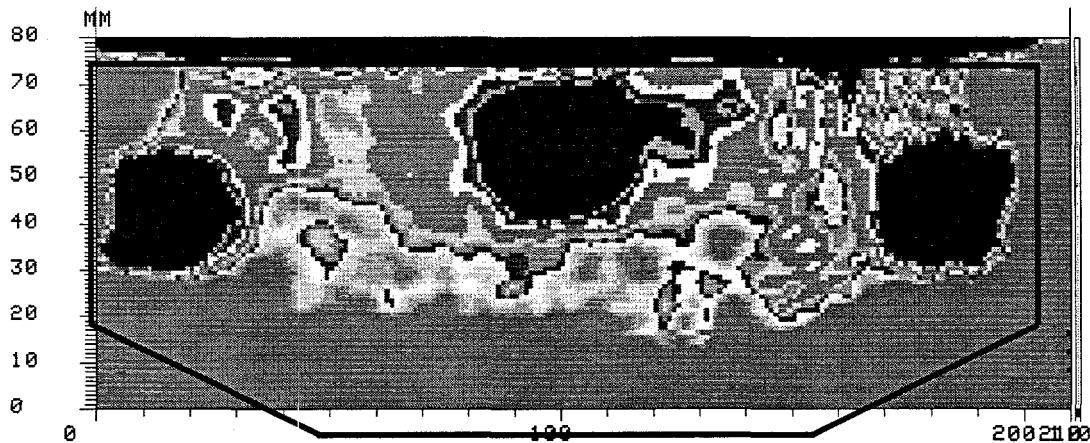
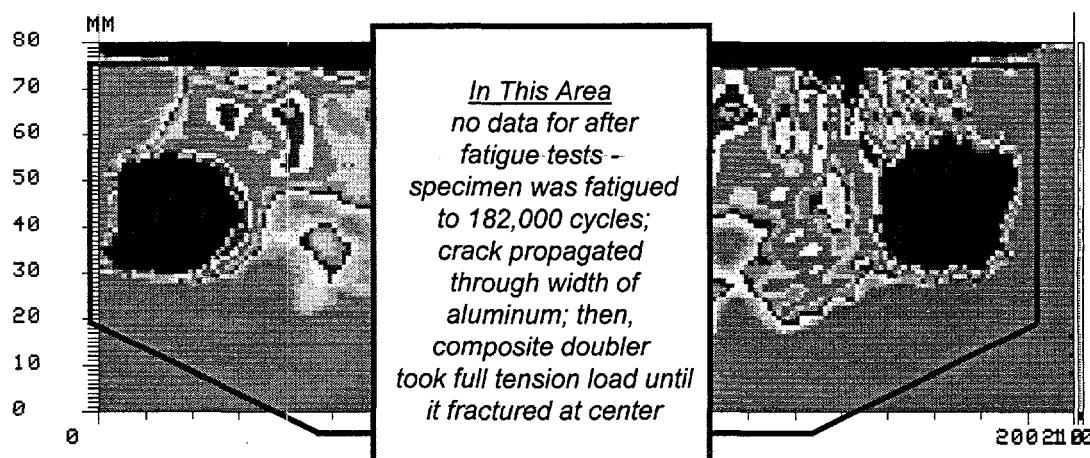
- 2) Specimen Lock4 (Config. BE-4; ref. flaw drawing Fig. 10) - Figure 31 shows that the disbond flaws - located in the critical load transfer region at the doubler's edge - did not grow or change shape during the fatigue tests. This specimen was fatigued beyond the limits of the test goals in order to determine a cycles-to-failure number for this configuration. The crack propagated through the specimen after 182,000 cycles (in excess of five lifetimes). Since the specimen was failed, it was not possible to obtain NDI data in the area of failure as shown in Fig. 31.

Figure 31: Fatigue Specimen Lock4 (Configuration BE-4) Flaw Profile
Before and After 182,000 Fatigue Cycles

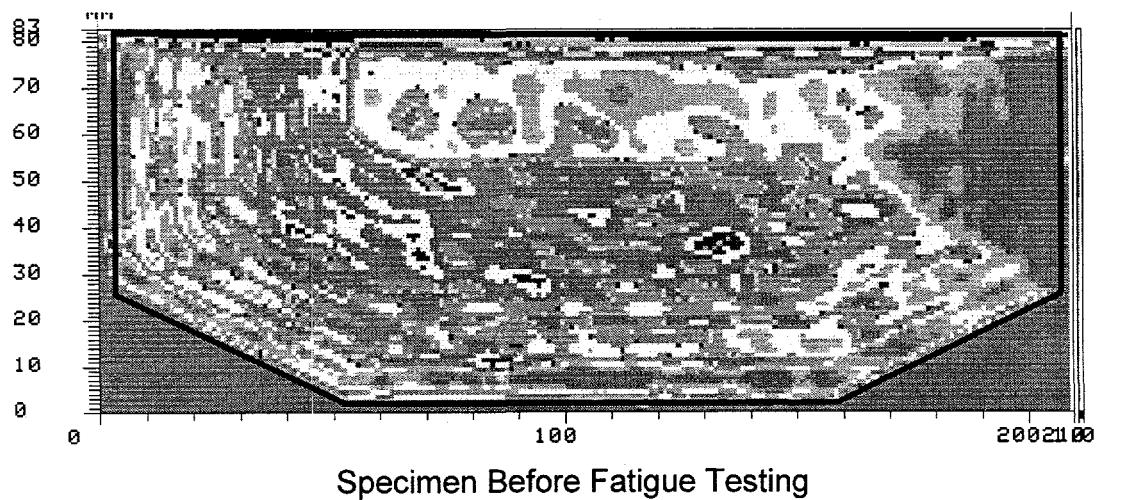
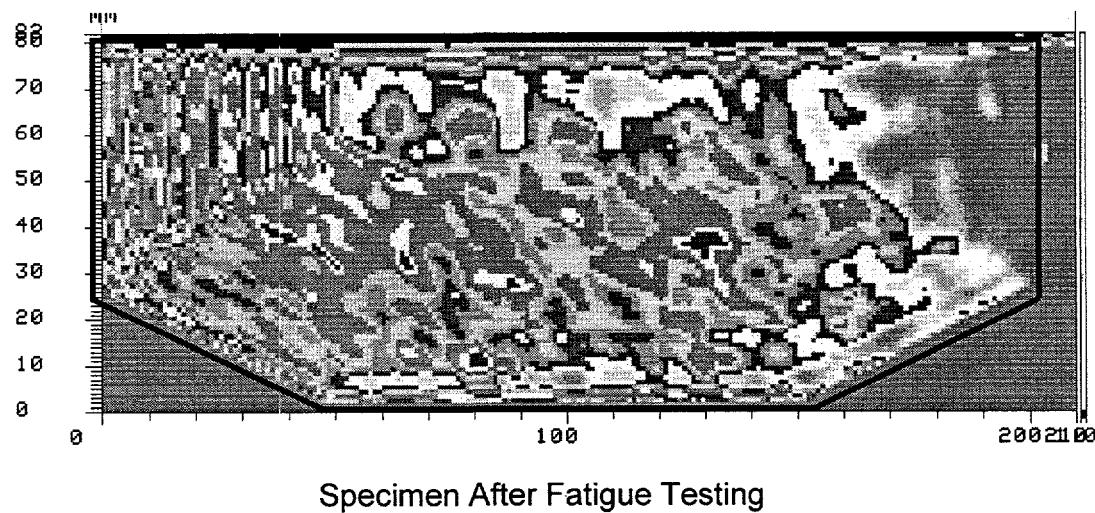
- 3) Specimen Lock 5 (Config. BE-5; ref. flaw drawing Fig. 11) - The 1" diameter cut-out in the aluminum plate is visible in Figure 32. There are no other flaws in the installation. No disbonds initiated during 180,000 fatigue cycles.

**Figure 32: Fatigue Specimen Lock5 (Configuration BE-5) Flaw Profile
Before and After 180,000 Fatigue Cycles;
No Flaw Growth After Five L-1011 Fatigue Lifetimes**

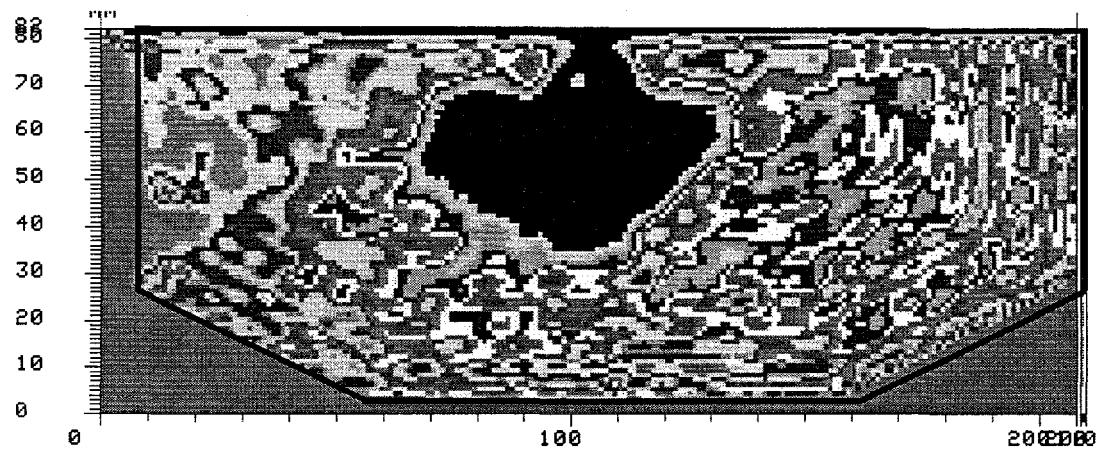
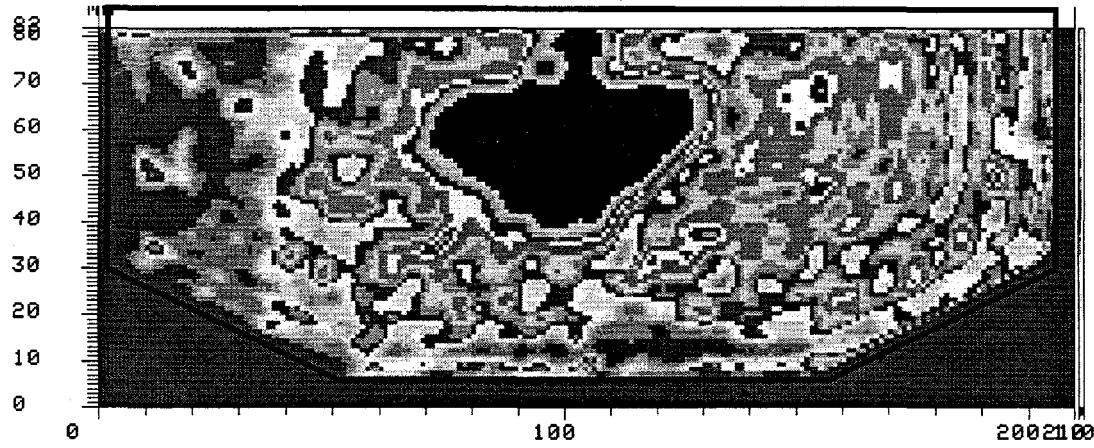
- 4) Specimen Lock9 (Config. BE-7; ref. flaw drawing Fig. 13) - This configuration represents the optimum installation and Figure 33 shows that the test specimens did not have any flaws. Further, post-test inspections revealed that no disbonds or delaminations developed during 216,000 fatigue cycles (six L-1011 lifetimes).

**Figure 33: Fatigue Specimen Lock9 (Configuration BE-7) Flaw Profile
Before and After 216,000 Fatigue Cycles;
No Flaw Growth After Six L-1011 Fatigue Lifetimes**

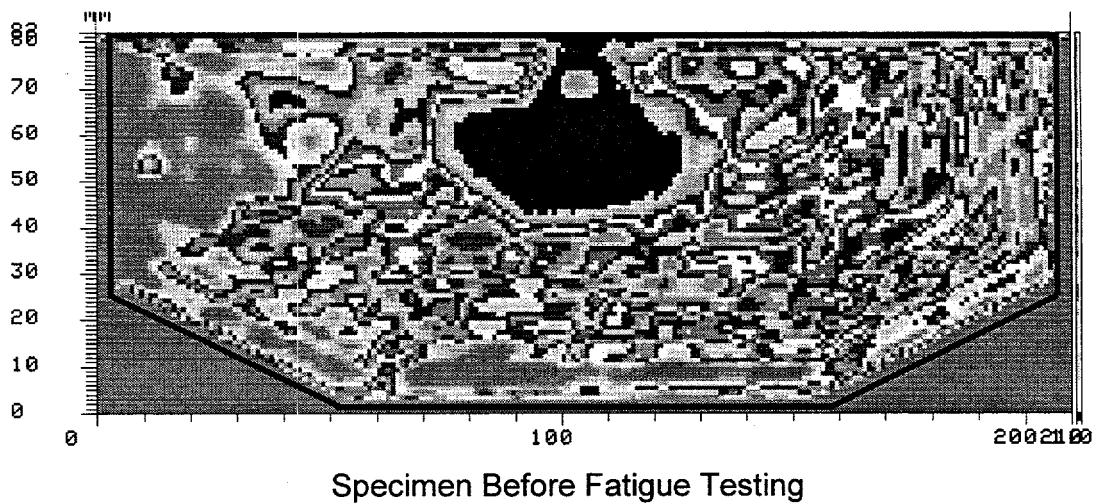
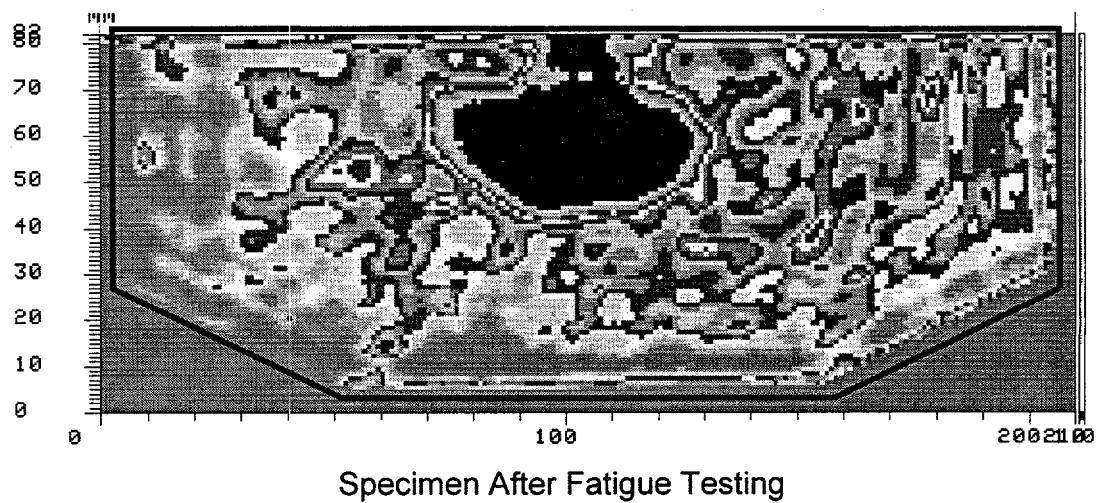
- 5) Specimens Lock13 and Lock14 (Config. BE-8; ref. flaw drawing Fig. 14) - Figures 34 and 35 contain the before-and-after fatigue test comparisons of NDI results. The ultrasonic scans show: 1) the engineered disbond and impact damage in the original test specimens and, 2) no change in the specimens' flaw profile after 144,000 and 180,000 fatigue cycles.

**Figure 34: Fatigue Specimen Lock13 (Configuration BE-8) Flaw Profile
Before and After 144,000 Fatigue Cycles;
No Change in Flaw Profile After Four L-1011 Fatigue Lifetimes**

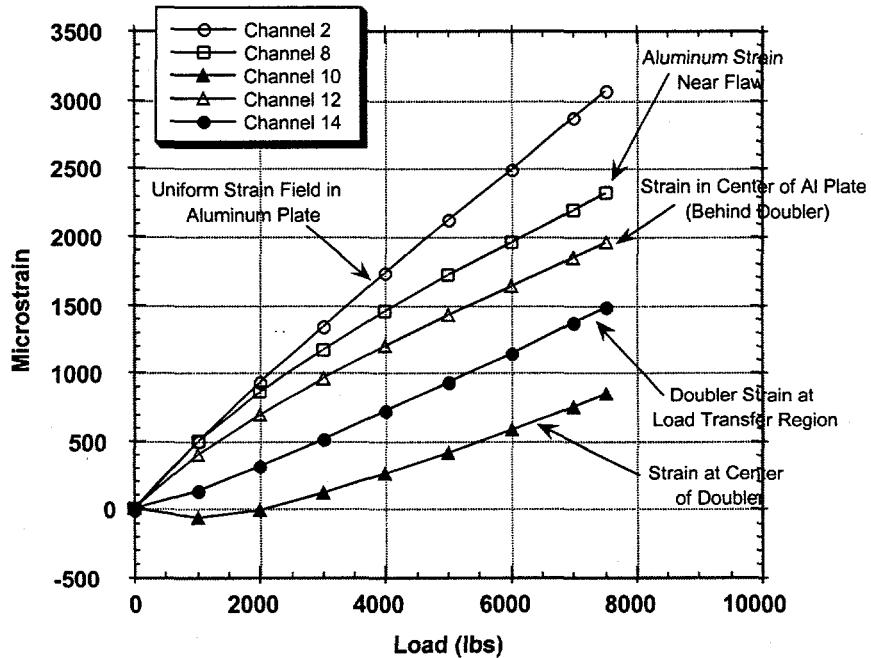
- Configuration BE-1 (Specimen Lock1; ref. Fig. 16 for gage locations) - axial strains are shown in Fig. 39; lateral strains are shown in Fig. 40. Strain reduction in aluminum plate (Channels 8 and 12) and the corresponding strain shedding into the doubler (Channels 10 and 14) is evident.

Figure 39: Axial Strain Field in Aluminum and Composite for Configuration BE-1 Specimens (ref. strain gage locations shown in Figure 16)

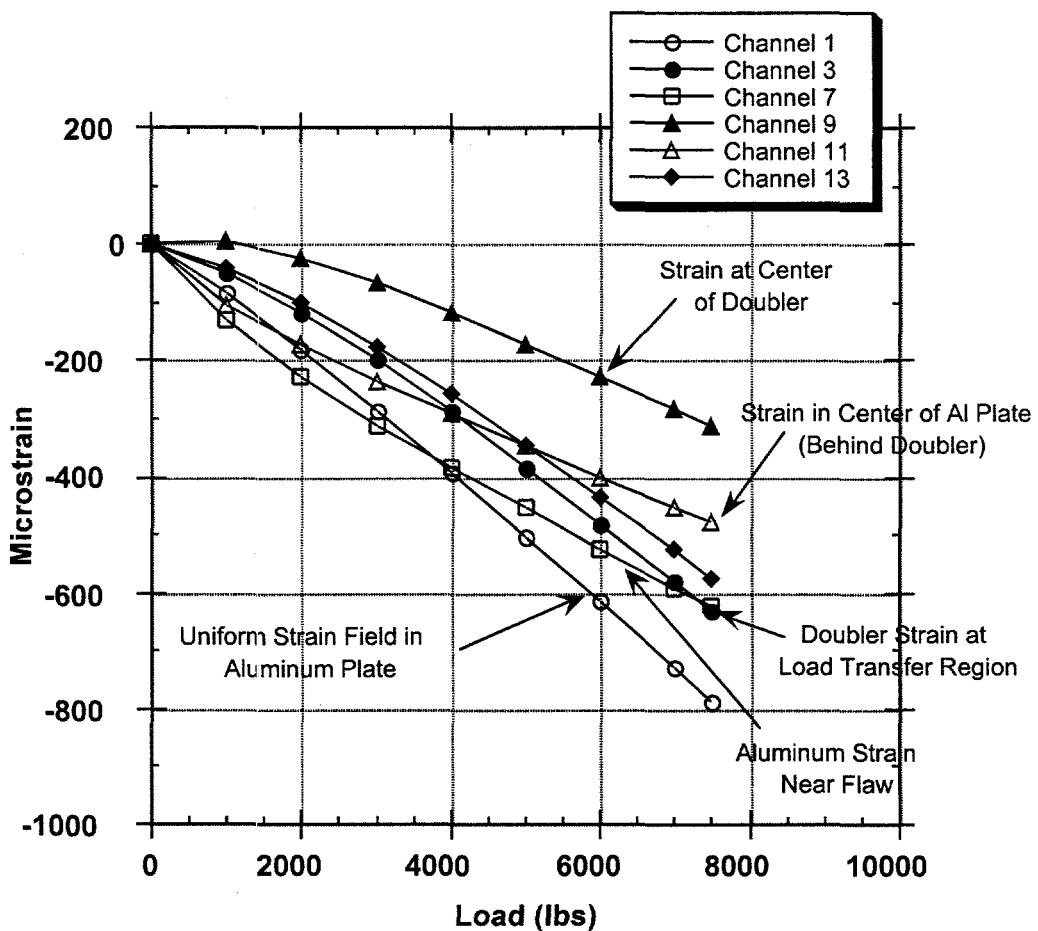
Figure 40: Lateral Strain Field in Aluminum and Composite for Configuration BE-1 Specimens (ref. strain gage locations shown in Figure 16)

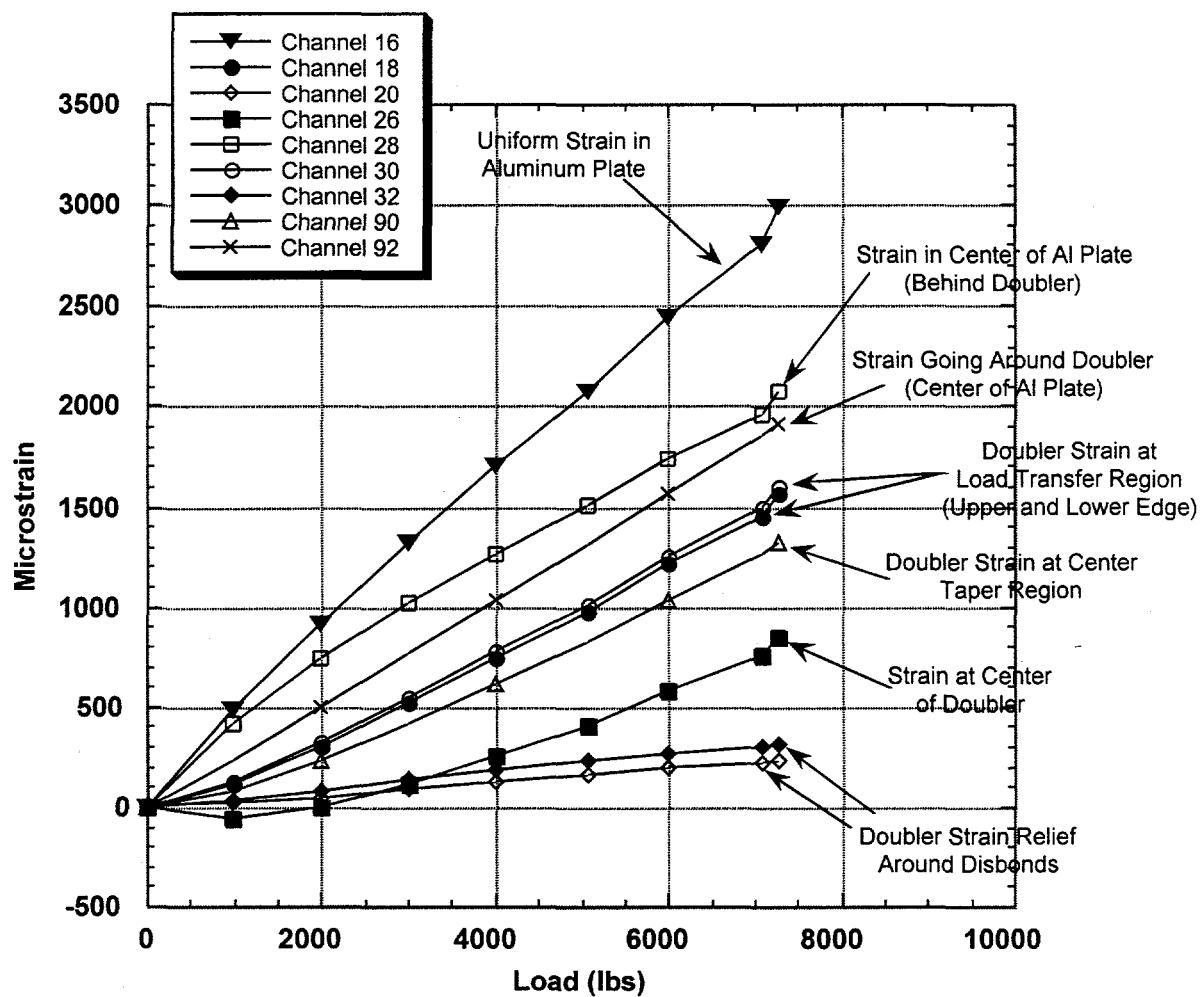
b. Configuration BE-2 (Specimen Lock 2; ref. Fig. 17 for gage locations) - axial strains are shown in Fig. 41; lateral strains are shown in Fig. 42. The load transfer is similar at the upper and lower taper regions (compare Ch. 18 and Ch. 30). The strain relief created by disbonds is evidenced by the low strains in Ch. 20 and 32. The large strains in gages immediately adjacent to the disbonds (Ch. 18 and Ch. 30) demonstrate that the disbonds effects are very localized. The doubler does not create excessive strain risers in the unreinforced aluminum immediately adjacent to the doubler (Ch. 92).

Figure 41: Axial Strain Field in Aluminum and Composite for Configuration BE-2 Specimens (ref. strain gage locations shown in Figure 17)

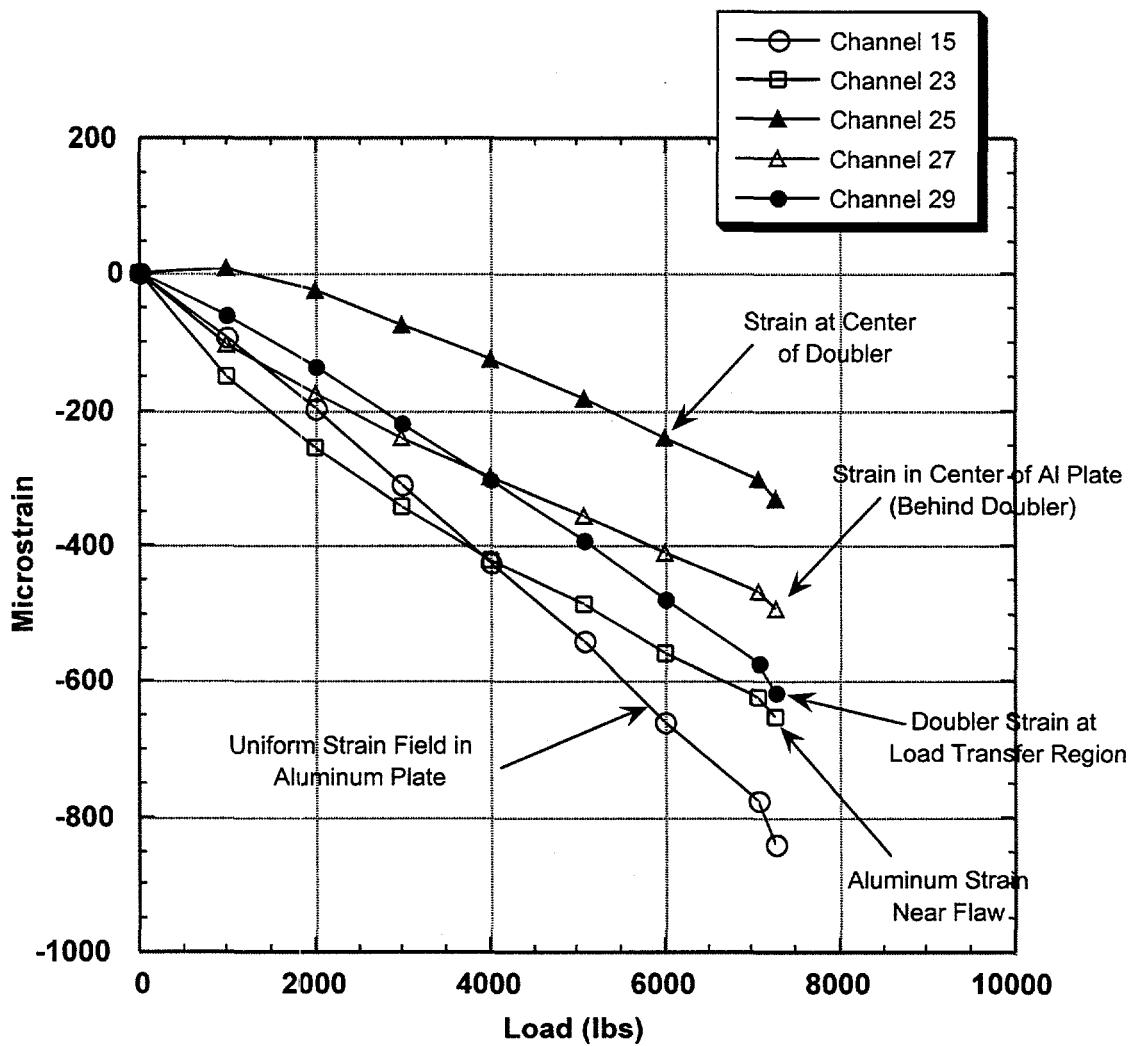
Figure 42: Lateral Strain Field in Aluminum and Composite for Configuration BE-2 Specimens (ref. strain gage locations shown in Figure 17)

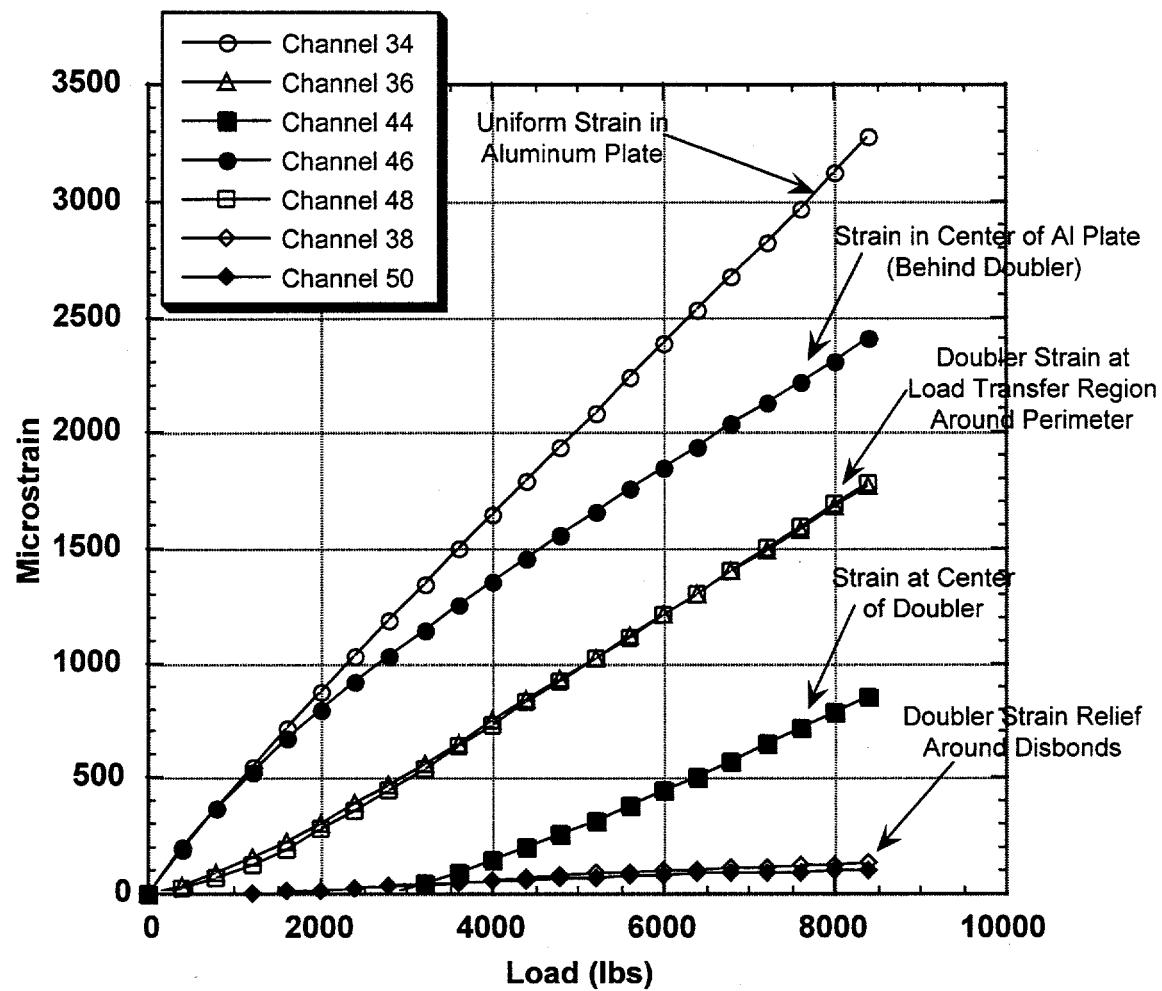
- c. Configuration BE-3 (Specimen Lock3; ref. Fig. 18 for gage locations) - axial strains are shown in Fig. 43; lateral strains are shown in Fig. 44. The strain fields and insights are similar to the BE-1 and BE-2 results.

Figure 43: Axial Strain Field in Aluminum and Composite for Configuration BE-3 Specimens (ref. strain gage locations shown in Figure 18)

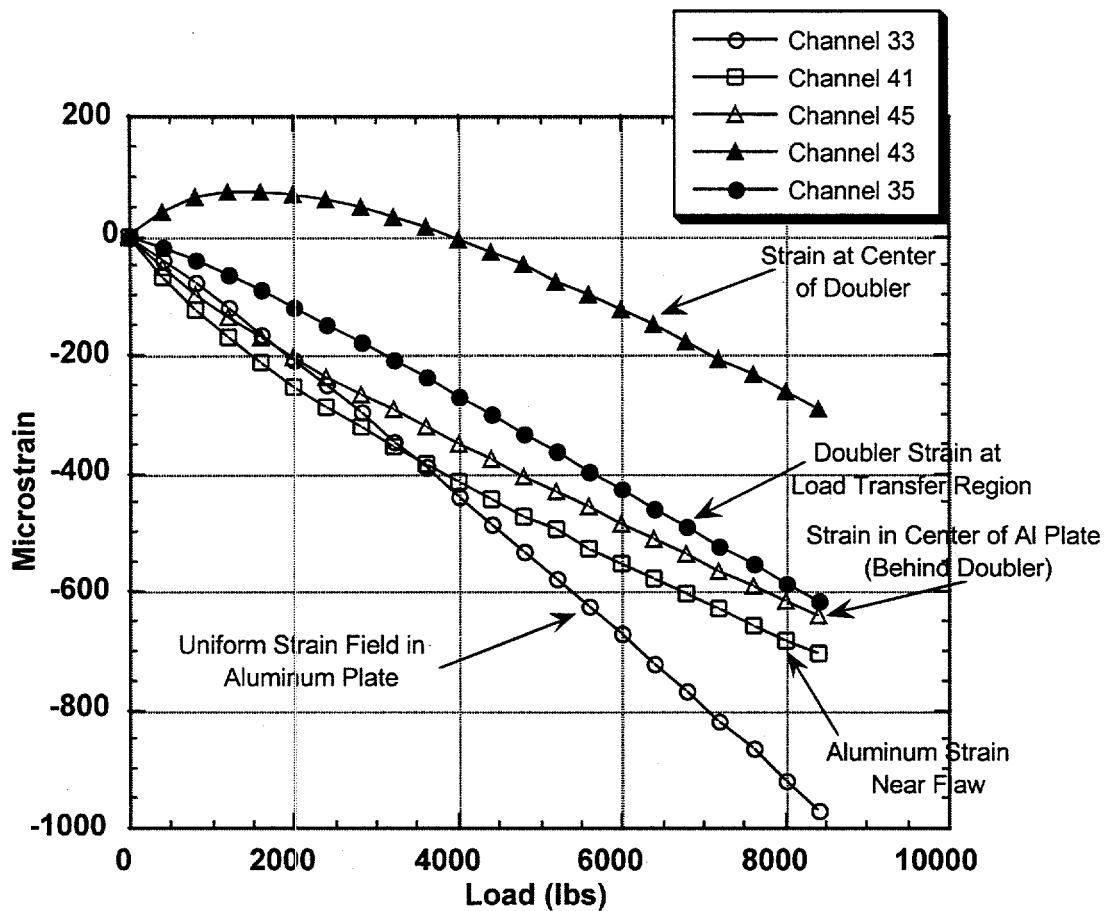
Figure 44: Lateral Strain Field in Aluminum and Composite for Configuration BE-3 Specimens (ref. strain gage locations shown in Figure 18)

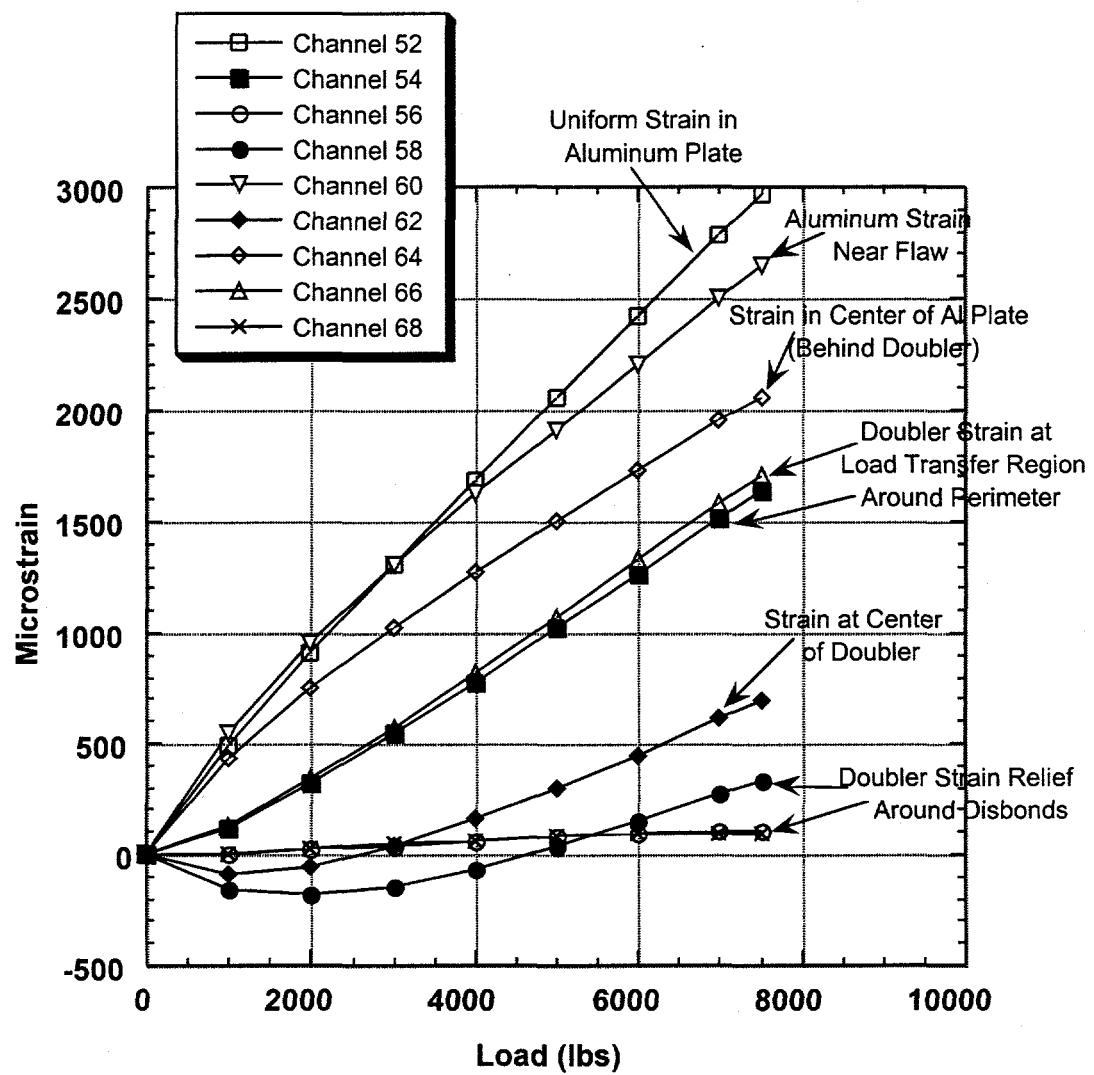
d. Configuration BE-4 (Specimen Lock4; ref. Fig. 19 for gage locations) - axial strains are shown in Fig. 45; lateral strains are shown in Fig. 46. The strain fields and insights are similar to the BE-1 and BE-2 results.

Figure 45: Axial Strain Field in Aluminum and Composite for Configuration BE-4 Specimens (ref. strain gage locations shown in Figure 19)

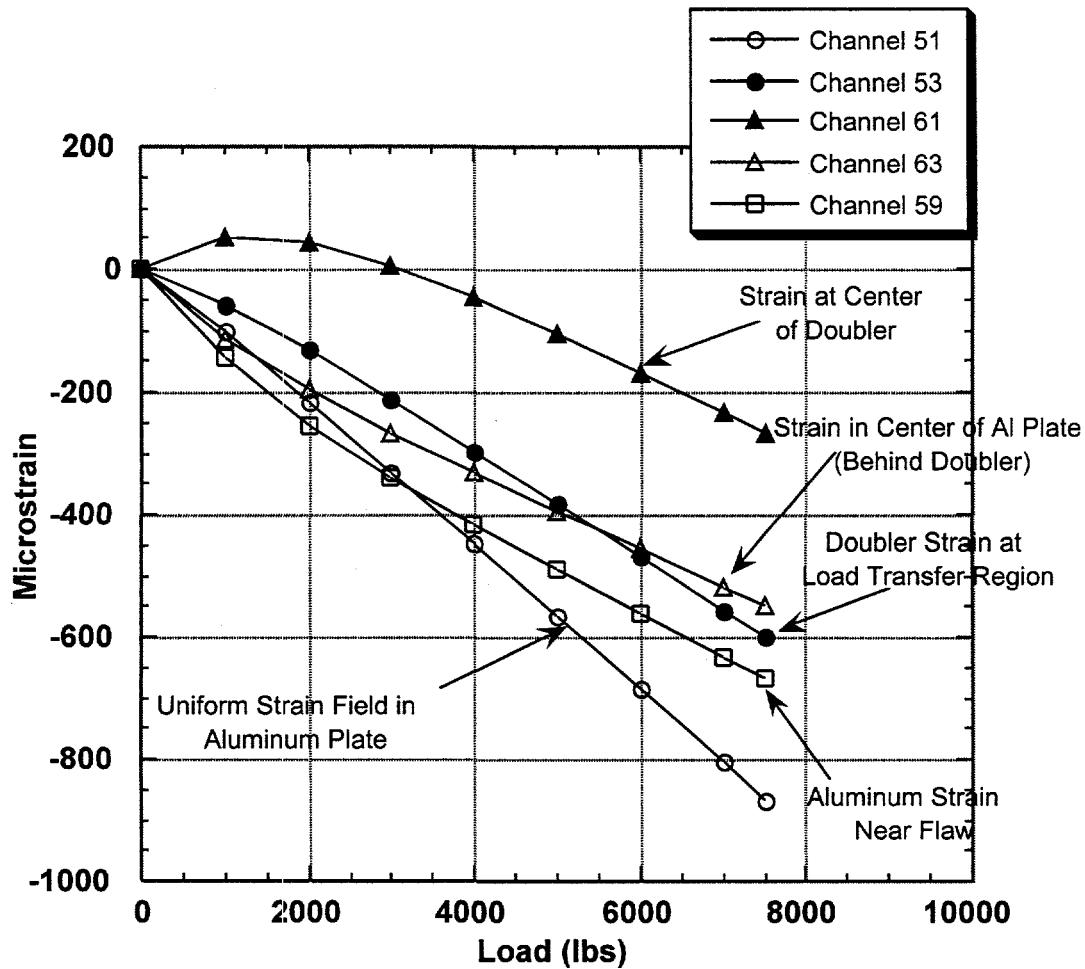
Figure 46: Lateral Strain Field in Aluminum and Composite for Configuration BE-4 Specimens (ref. strain gage locations shown in Figure 19)

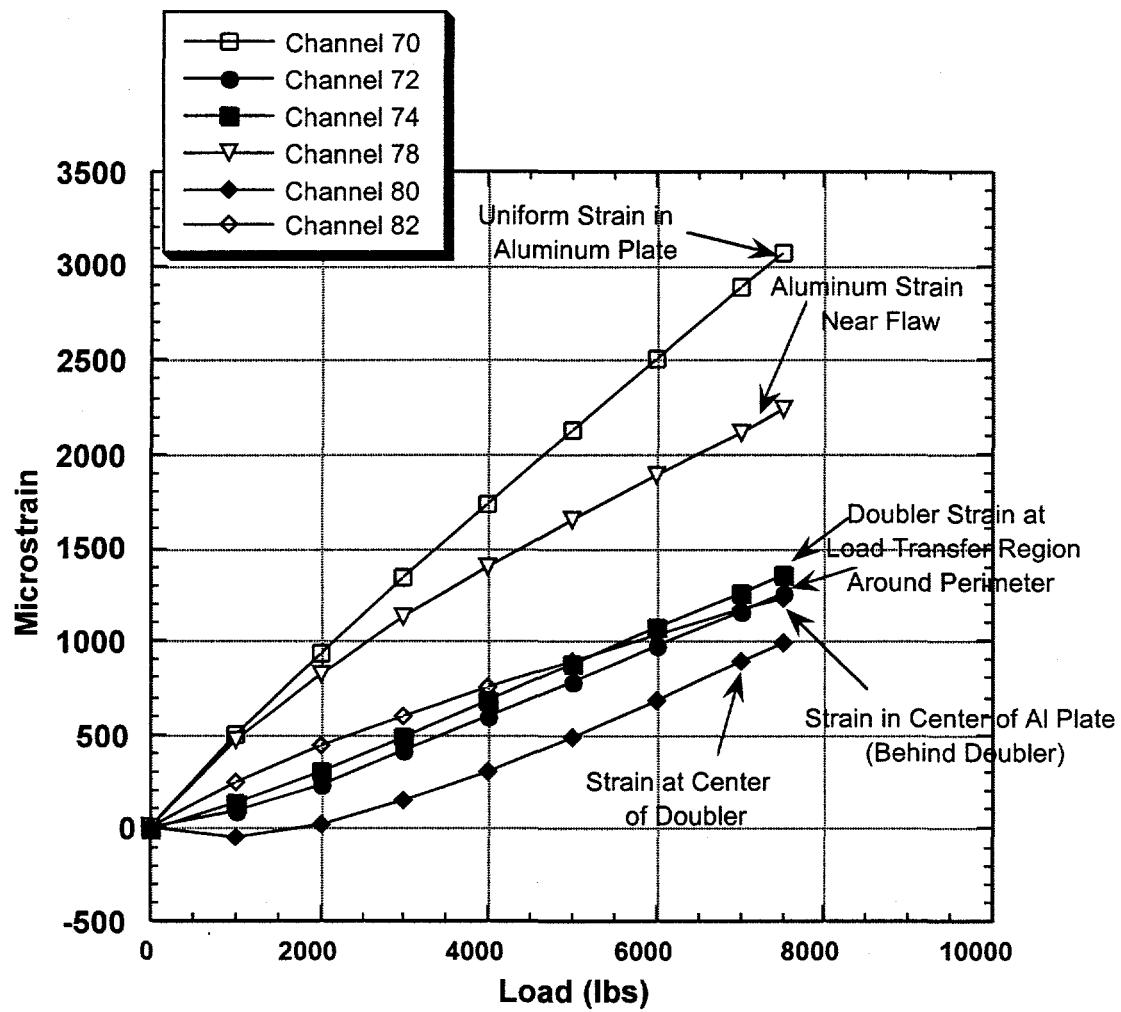
- e. Configuration BE-5 (Specimen Lock5; ref. Fig. 20 for gage locations) - axial strains are shown in Fig. 47; lateral strains are shown in Fig. 48. The strain fields and insights are similar to the BE-1 and BE-2 results. Note that strain risers around unreinforced holes are generally on the order of three times the uniform strain field away from the hole. Channel 78 shows that the strains at the aluminum cut-out are reduced substantially by the doubler. Rather than exhibiting the normal strain intensification (i.e. $6,000 \mu\epsilon = 2 \times 3,000 \mu\epsilon$ in uniform field), the strains are reduced below those of the gage outside the doubler area ($2,250 \mu\epsilon$).

Figure 47: Axial Strain Field in Aluminum and Composite for Configuration BE-5 Specimens (ref. strain gage locations shown in Figure 20)
