SAND98-1016
Unlimited Release
Printed August 1998

Damage Tolerance Assessment of Bonded Composite Doubler Repairs for Commercial Aircraft Applications

Dennis Roach

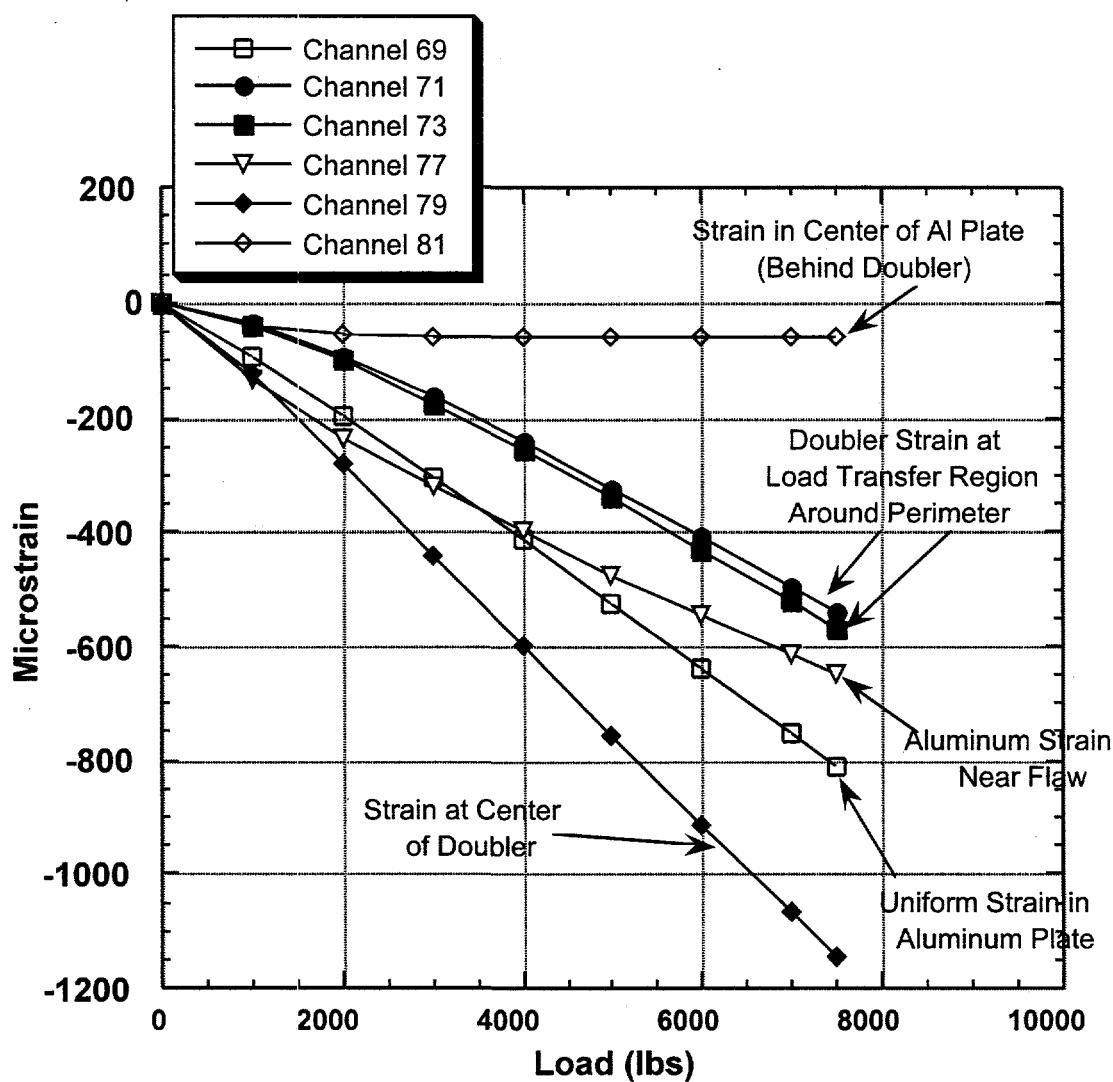
- e. Configuration BE-5 (Specimen Lock5; ref. Fig. 20 for gage locations) - axial strains are shown in Fig. 47; lateral strains are shown in Fig. 48. The strain fields and insights are similar to the BE-1 and BE-2 results. Note that strain risers around unreinforced holes are generally on the order of three times the uniform strain field away from the hole. Channel 78 shows that the strains at the aluminum cut-out are reduced substantially by the doubler. Rather than exhibiting the normal strain intensification (i.e. $6,000 \mu\epsilon = 2 \times 3,000 \mu\epsilon$ in uniform field), the strains are reduced below those of the gage outside the doubler area ($2,250 \mu\epsilon$).

Figure 48: Lateral Strain Field in Aluminum and Composite for Configuration BE-5 Specimens (ref. strain gage locations shown in Figure 20)

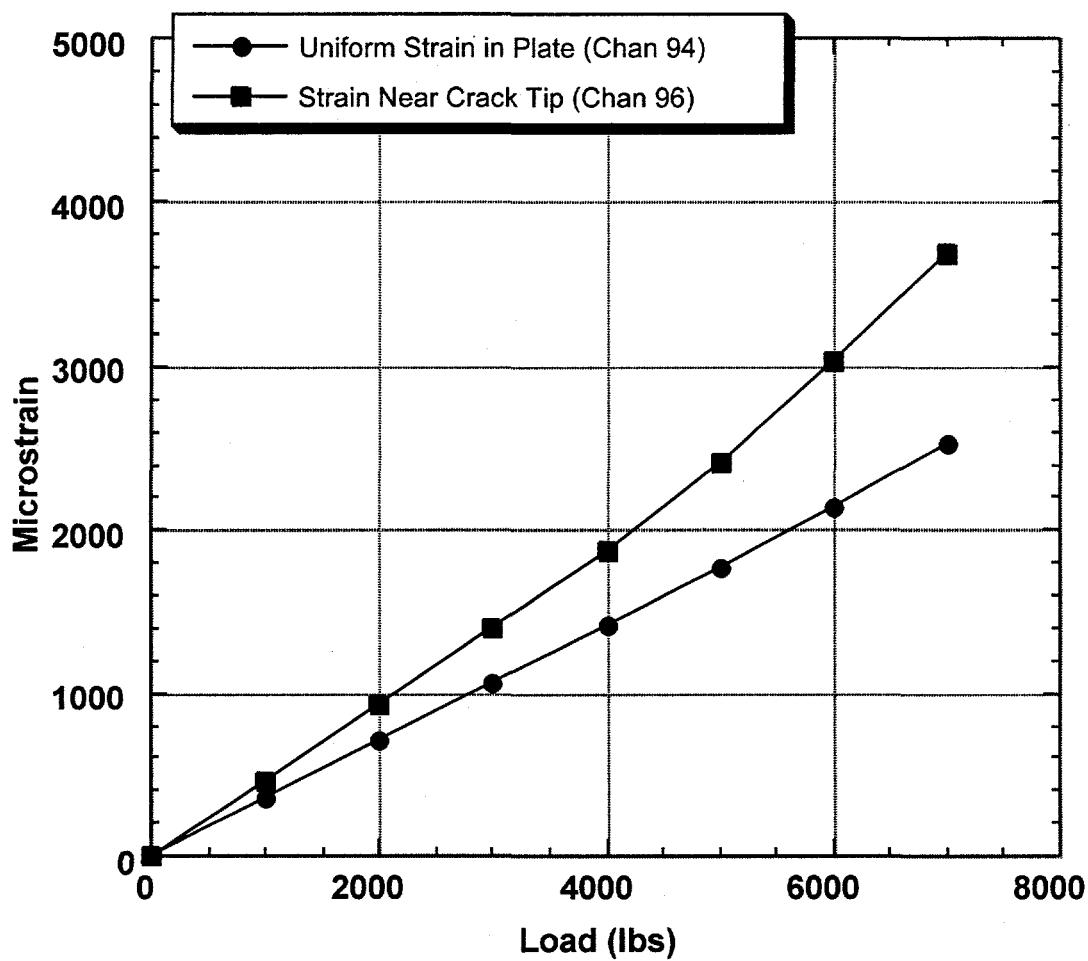
f. Configuration BE-6 (Specimen Lock6; ref. Fig. 21 for gage locations) - axial strains are shown in Fig. 49. Strain fields in an aluminum plate without a doubler are in the 2,500 $\mu\epsilon$ to 3,500 $\mu\epsilon$ range (Ch. 94 and Ch. 96).

Figure 49: Axial Strain Field in Aluminum and Composite for Configuration BE-6 Specimens (ref. strain gage locations shown in Figure 21)

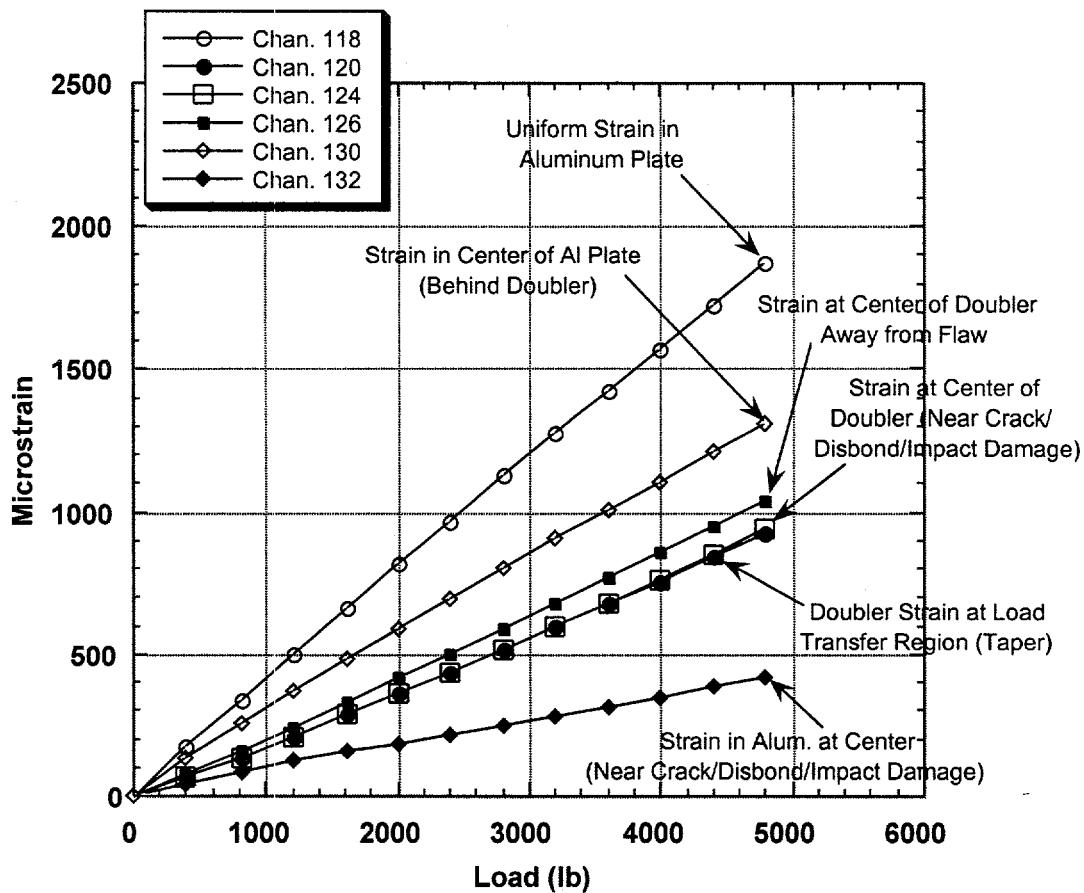
g. Configuration BE-8 (Specimen Lock14; ref. Fig. 23 for gage locations) - axial strains are shown in Fig. 50. The strain fields and insights are similar to the BE-1 through BE-5 results. The addition of impact damage to the center disbond did not degrade the doubler's ability to absorb a significant portion of the total strain in this region. Figures 29 and 30 show the typical flaw induced in configuration BE-8 specimens. However, channel 124 in Fig. 50 still indicates a 50% load transfer in the flaw area.

Figure 50: Axial Strain Field in Aluminum and Composite for Configuration BE-8 Specimens (ref. strain gage locations shown in Figure 23)

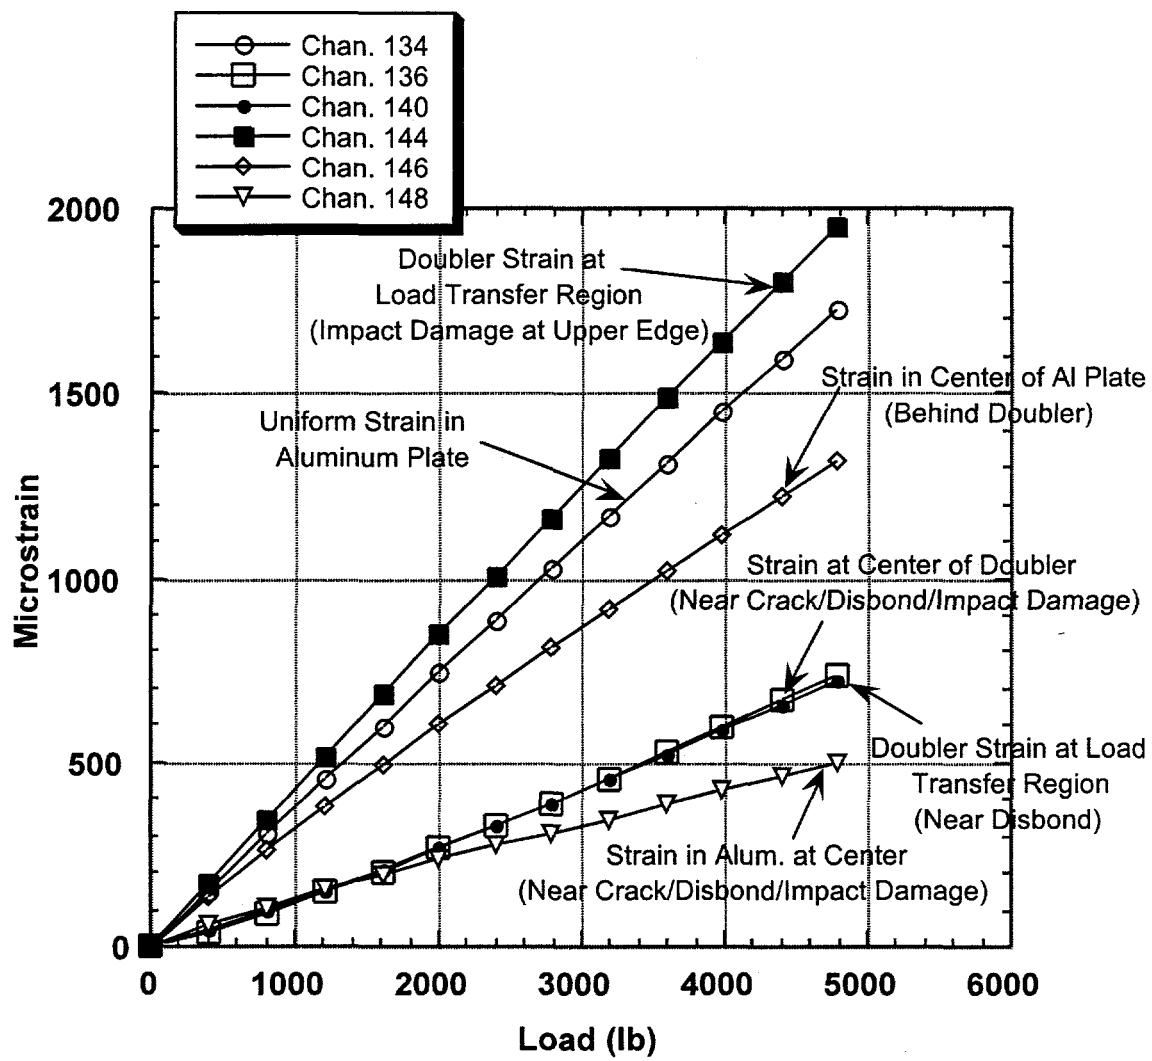
h. Configuration BE-9 (Specimen Lock20; ref. Fig. 24 for gage locations) - axial strains are shown in Fig. 51; lateral strains are shown in Fig. 52. The strain fields and insights are similar to the BE-1 through BE-5 results. Configuration BE-9 contains three separate disbond and/or impact areas as shown in Figures 36-38. The central impact/disbond area, as in configuration BE-8, achieved a load transfer of almost 50%. The impact damage at the tapered load transfer area (ref. Fig. 27) produced a local strain riser shown by channel 144. Thus, in spite of large plastic deformations in the parent skin and associated disbands, the doubler is still able to carry significant strains. Large strains immediately adjacent to the lower disbond (Ch. 136) reiterate the fact that relatively large disbond or delamination flaws (up to 1" diameter) in the composite doubler have only localized effects on strain. Overall, the three disbands in configuration BE-9 appear to have minimal effect on the doubler's ability to transfer load and relieve the parent aluminum plate.

Figure 51: Axial Strain Field in Aluminum and Composite for Configuration BE-9 Specimens (ref. strain gage locations shown in Figure 24)

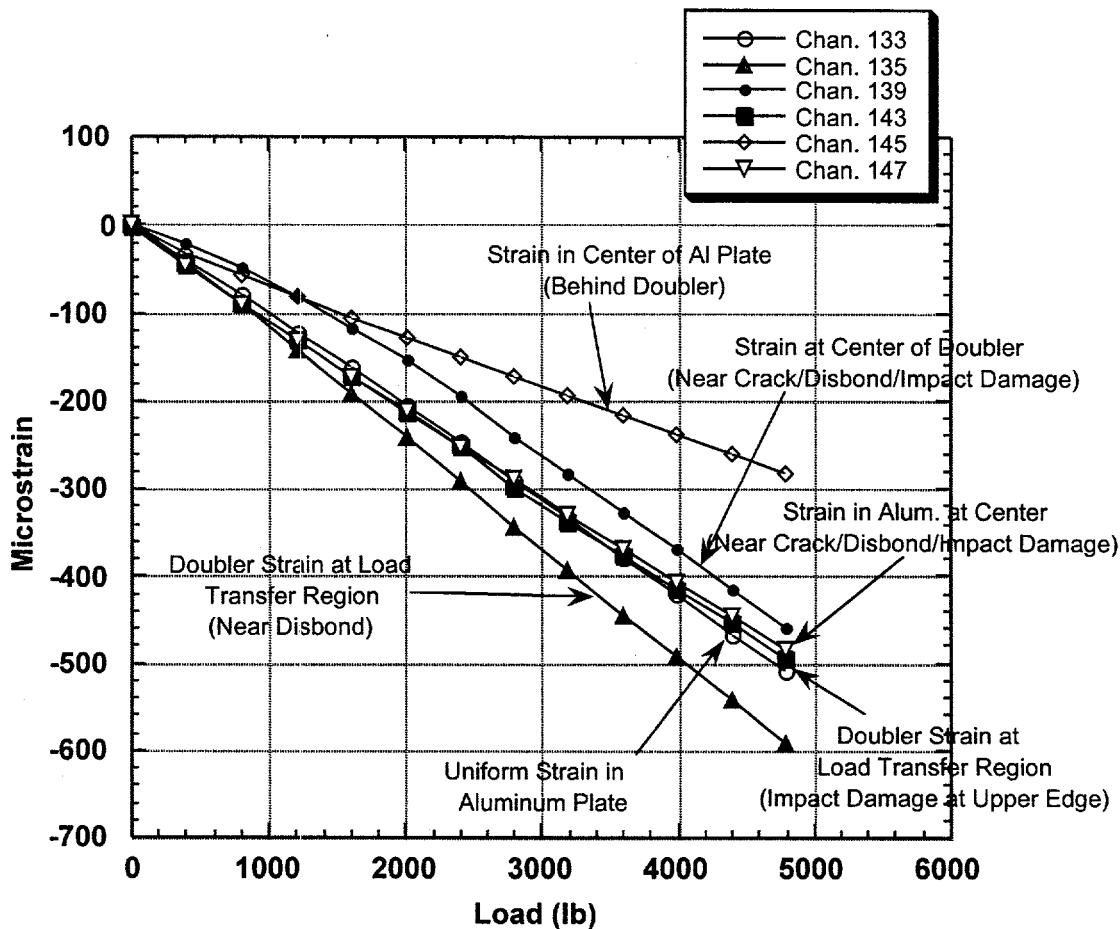
Figure 52: Lateral Strain Field in Aluminum and Composite for Configuration BE-9 Specimens (ref. strain gage locations shown in Figure 24)

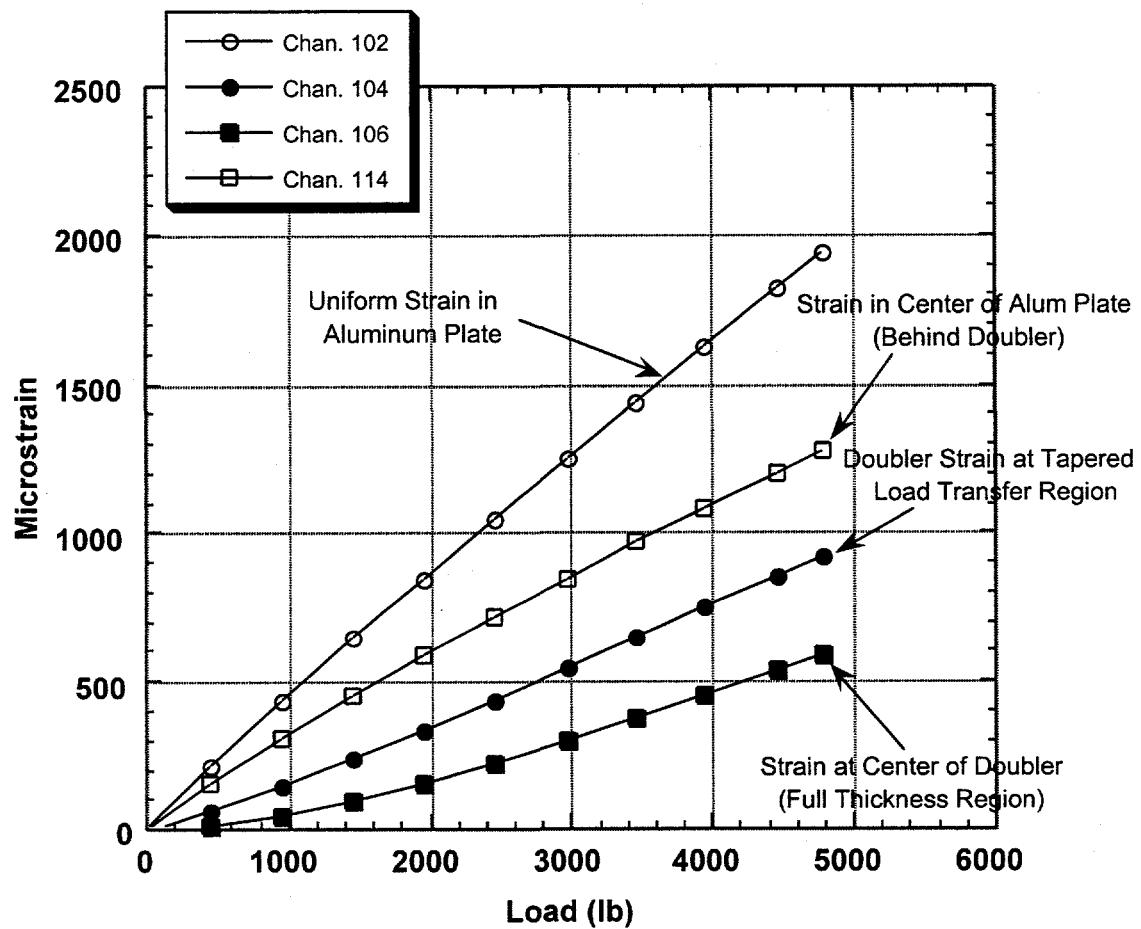
- i. Configuration BE-7 (Specimen Lock9; ref. Fig. 22 for gage locations) - axial strains are shown in Fig. 53; lateral strains are shown in Fig. 54. The strain fields and insights are similar to the BE-1 through BE-9 results.

Figure 53: Axial Strain Field in Aluminum and Composite for Configuration BE-7 Specimens (ref. strain gage locations shown in Figure 22)

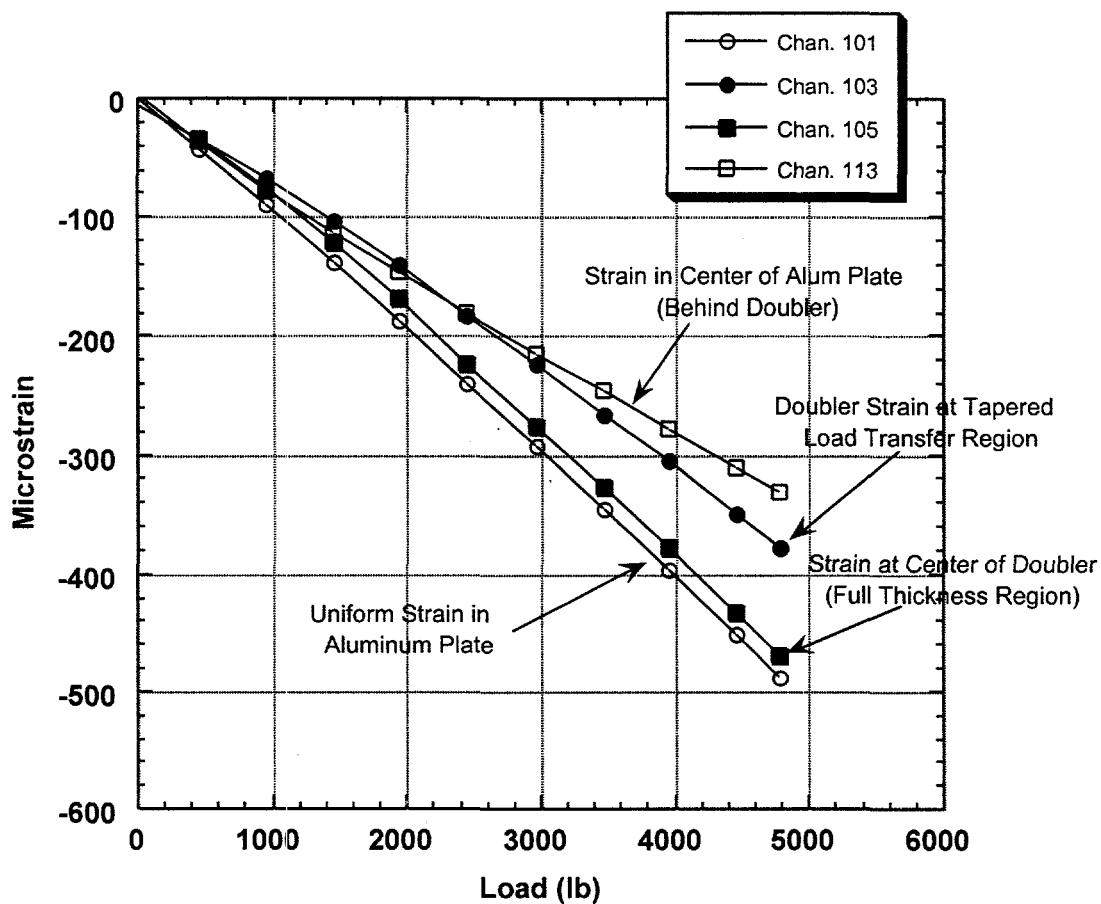
Figure 54: Lateral Strain Field in Aluminum and Composite for Configuration BE-7 Specimens (ref. strain gage locations shown in Figure 22)

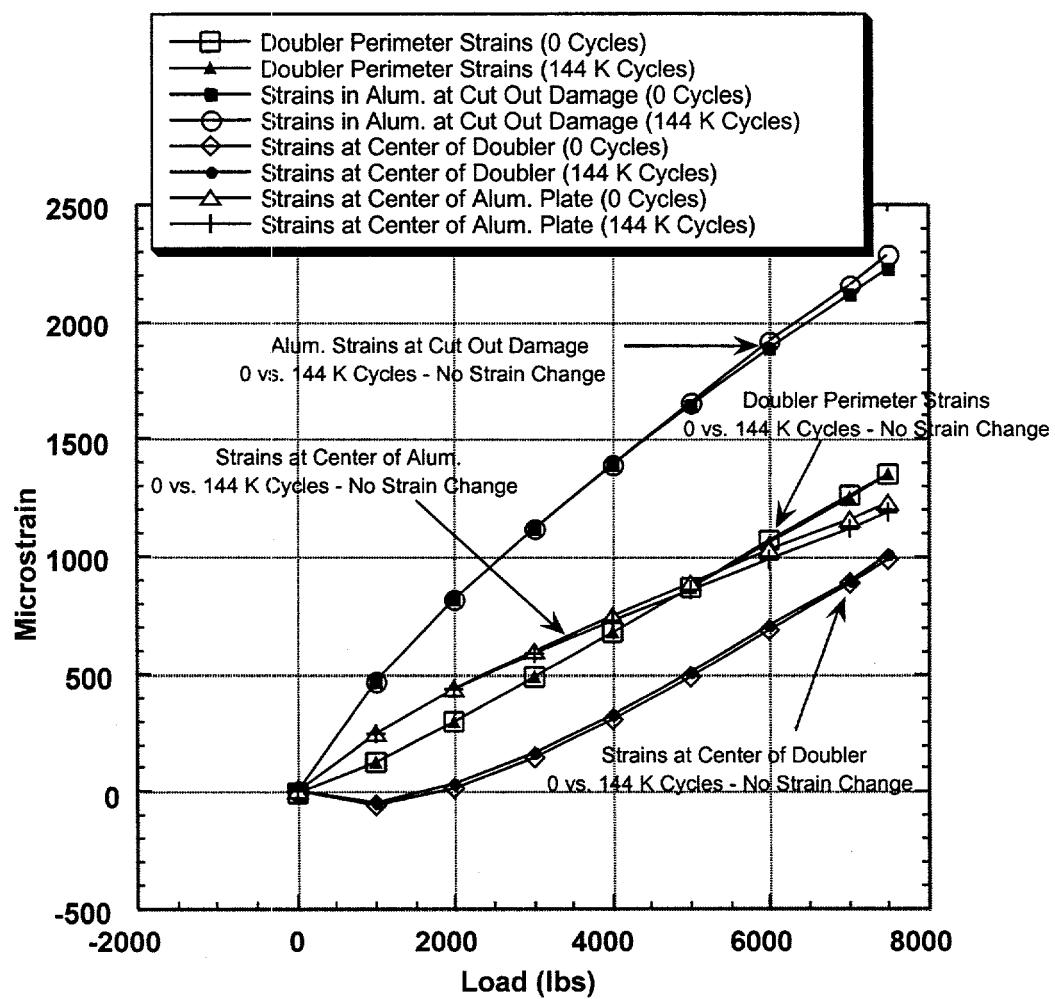
- No Change in Strain Field - Configurations BE-5 (aluminum cut-out damage), BE-7 (unflawed specimen), BE-8 (impact and disbond over fatigue crack), and BE-9 (multiple impacts and disbond over fatigue crack) exhibited little or no change in strain field during the course of their fatigue tests. The NDI before-and-after results in Figures 32-38 show that the initial "programmed" flaws did not change shape nor did any new flaws develop as a result of the fatigue loads. Quantitatively, the strain gage values acquired before and after fatigue testing substantiate the NDI results. Figure 63 plots the strain field for configuration BE-5 (specimen Lock5) before and

after 144,000 fatigue cycles. The before-and-after plots lie on top of each other demonstrating an unchanged strain field. Similarly, Figure 64 shows that the strains in the BE-7 configuration (specimen Lock9) were undisturbed by 144,000 fatigue cycles. Figures 65 and 66 show that, for the most part, configurations BE-8 (Lock14) and BE-9 (Lock20) were unaffected by the fatigue cycles. However, both configurations showed slight changes around the center crack growth area. In configuration BE-8, the strains increased in doubler channel 124 and aluminum channel 132 (ref. Fig. 65). Both of these channels are adjacent to the implanted fatigue crack which grew 0.56" in 180,000 cycles. Configuration BE-9 displayed the same phenomena where doubler channel 144 and aluminum channel 148 increased slightly as the fatigue crack grew 0.77" in 99,000 cycles (ref. Fig. 66).

Figure 63: Strain Field in Configuration BE-5 (Lock5) Remains Unchanged Over 144,000 Fatigue Cycles - No Flaw Growth in Doubler Installation

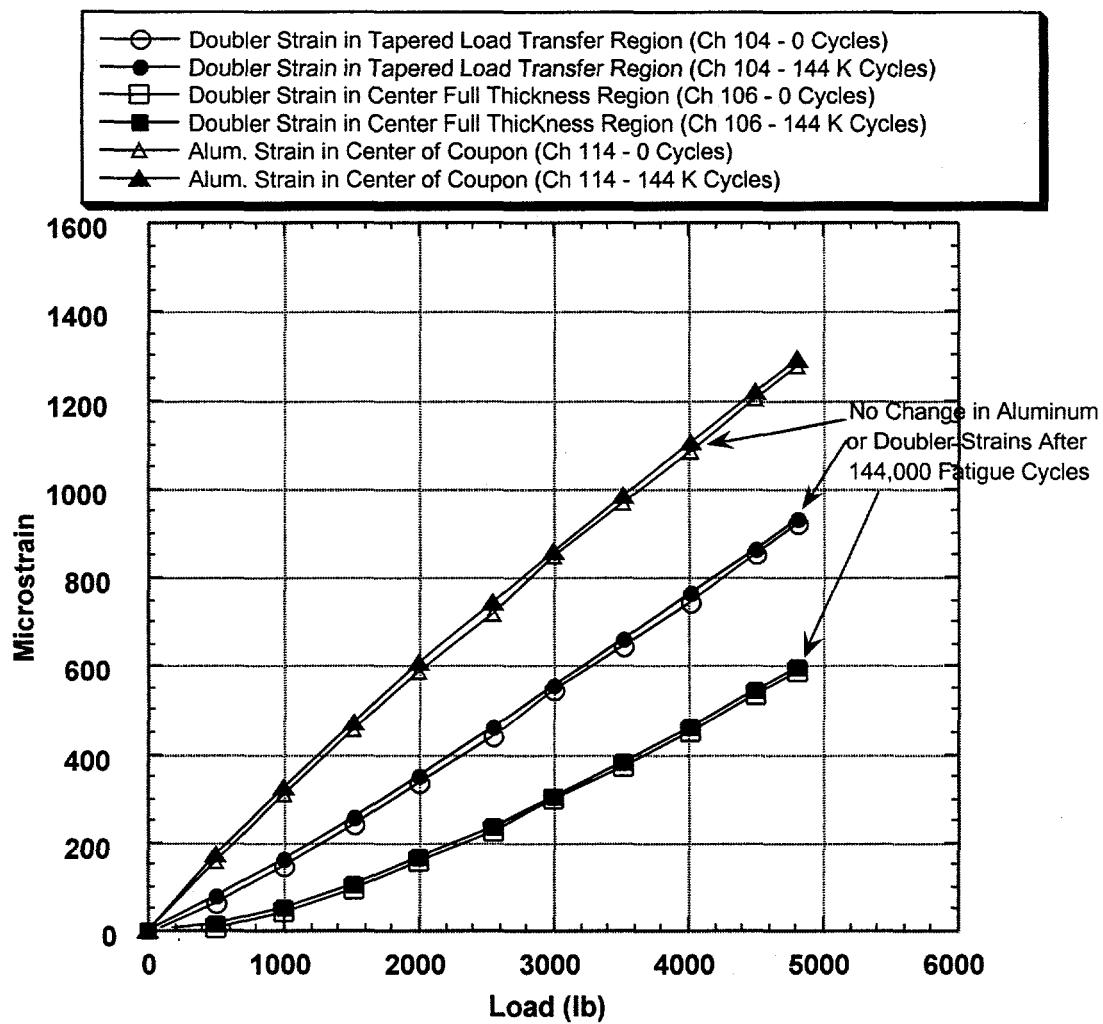
Figure 64: Strain Field in Configuration BE-7 (Lock9) Remains Unchanged Over 144,000 Fatigue Cycles - No Flaw Growth in Doubler Installation

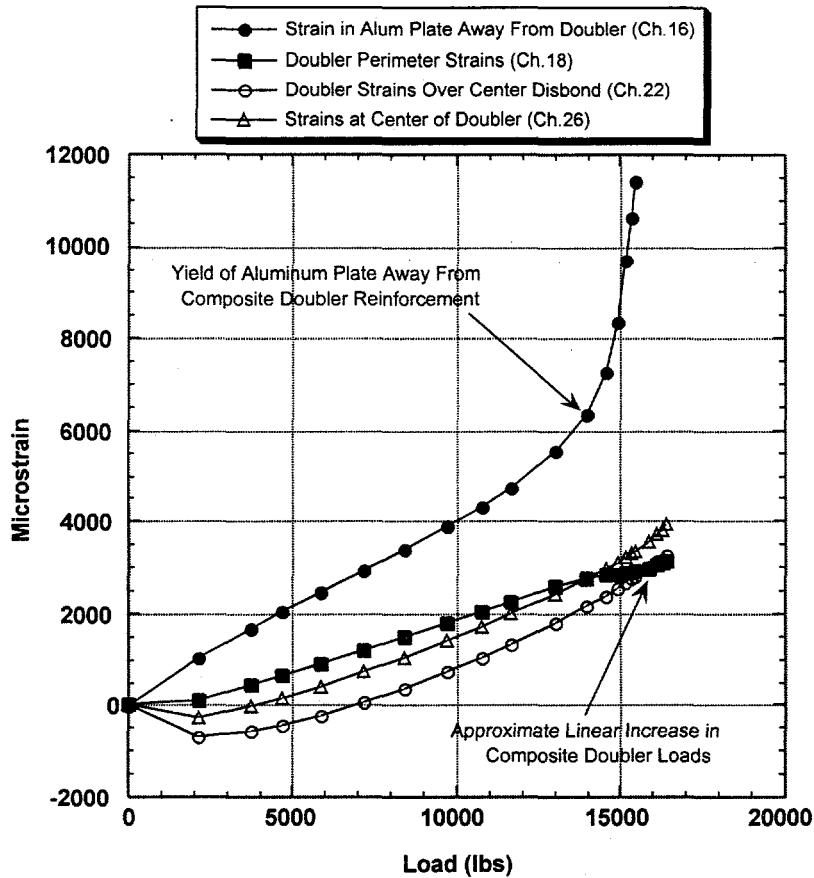
Figure 69 shows the strain field in specimen BE-2 up through failure. The aluminum plate away from the doubler (channel 16) began to yield at approximately 12,000 lbs. while the doubler continued to increase its load in a linear fashion. This load/response process continued until failure occurred at 103 ksi and the specimen could no longer sustain an increasing load. *Figure 69 illustrates that the composite doubler was able to transmit stresses in the plastic regime and that extensive yielding/loading beyond the initial yield level was required to fail the installation.*

Figure 69: Strain Fields in Composite Doubler and Aluminum Plate During Ultimate Failure Test (Configuration BE-2)
